# **MONTLAKE ELEMENTARY SCHOOL**

Certificate of Approval

Exterior Historic Stair Replacement and Revised Flag Pole Location

Revisions to the approved C of A scope for in-kind replacement of original entry stairs and modification of the proposed flagpole location.

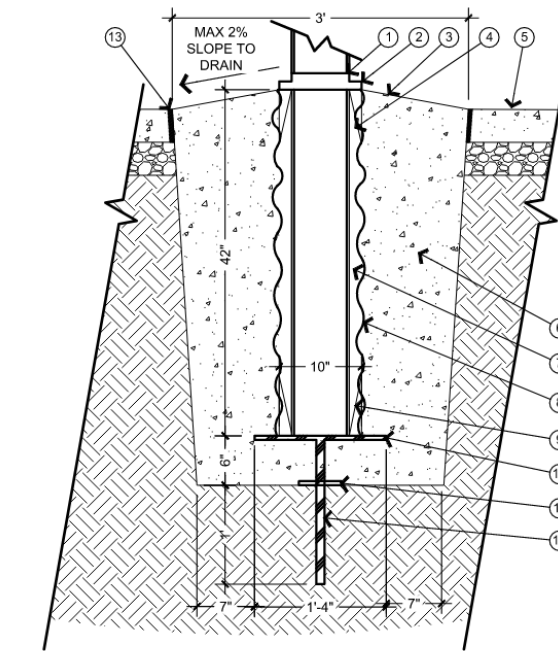
**9 FLAGPOLE FOOTING**  
SCALE: 1" = 1'-0"

1. SPUN ALUMINUM FLASH COLLAR
2. SEALANT
3. TOP OF CONCRETE TO SLOPE AWAY FROM PIPE
4. FOUR (4) HARDWOOD SPIKES
5. FINISH SURFACE
6. CONCRETE FOOTING, PER MANUFACTURER'S RECOMMENDATION
7. DRY SAND TAMPED IN PLACE AFTER PLUMBING
8. GALV. FOUNDATION SLEEVE
9. FOUR (4) STEEL WEDGES WELDED TO SLEEVE @ 90° INTERVALS
10. STEEL BASE PLATE
11. STEEL SUPPORT PLATE-WELDED TO SPIKE
12. STEEL GROUND SPIKE
13. ISOLATION JOINT @ ADJACENT CONCRETE PAVING

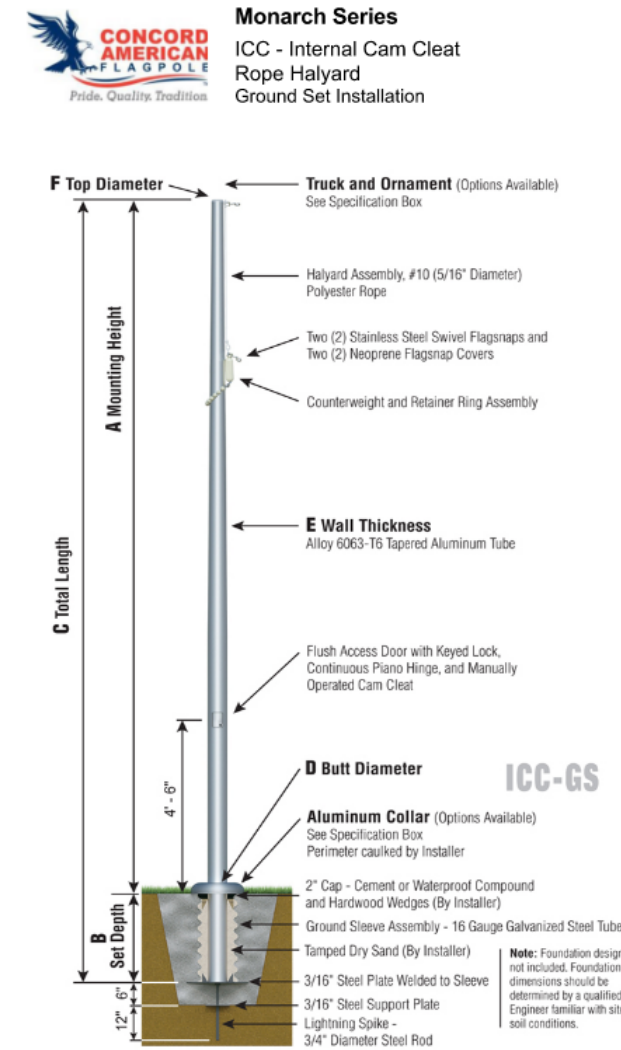
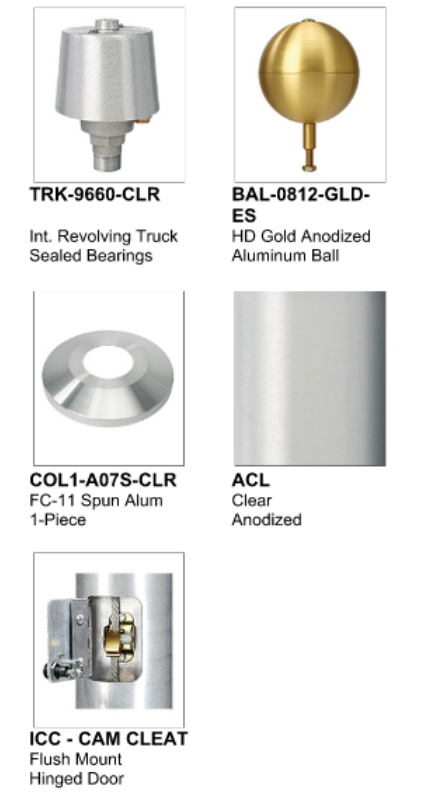
## ICC35D71 - ACL

Flag pole product specification

Specifications	
A. Mounting Height:	35'
B. Set Depth:	3'-6"
C. Total Length:	38'-6"
D. Butt Diameter:	7"
E. Wall Thickness:	.188"
F. Top Diameter:	3.5"
Flagpole Sections:	1
Shaft Weight:	212 lbs.
Hardware Weight:	18 lbs.
Ground Sleeve Weight:	39 lbs.
* Max Flag Size:	6' x 10'
* Max Wind Speed w/Nylon Flag:	107 mph
* Max Wind Speed No Flag:	167 mph
* Wind Speed Specifications from ANSI/NAAMM FP 1001-07
