1.1.5 Installation of new trees replacing previously removed diseased Birch trees

ECKSTEIN MIDDLE SCHOOL WINDOW REPLACEMENT LANDSCAPING IMPACTS & PROPOSED REPLACEMENT - REV 2

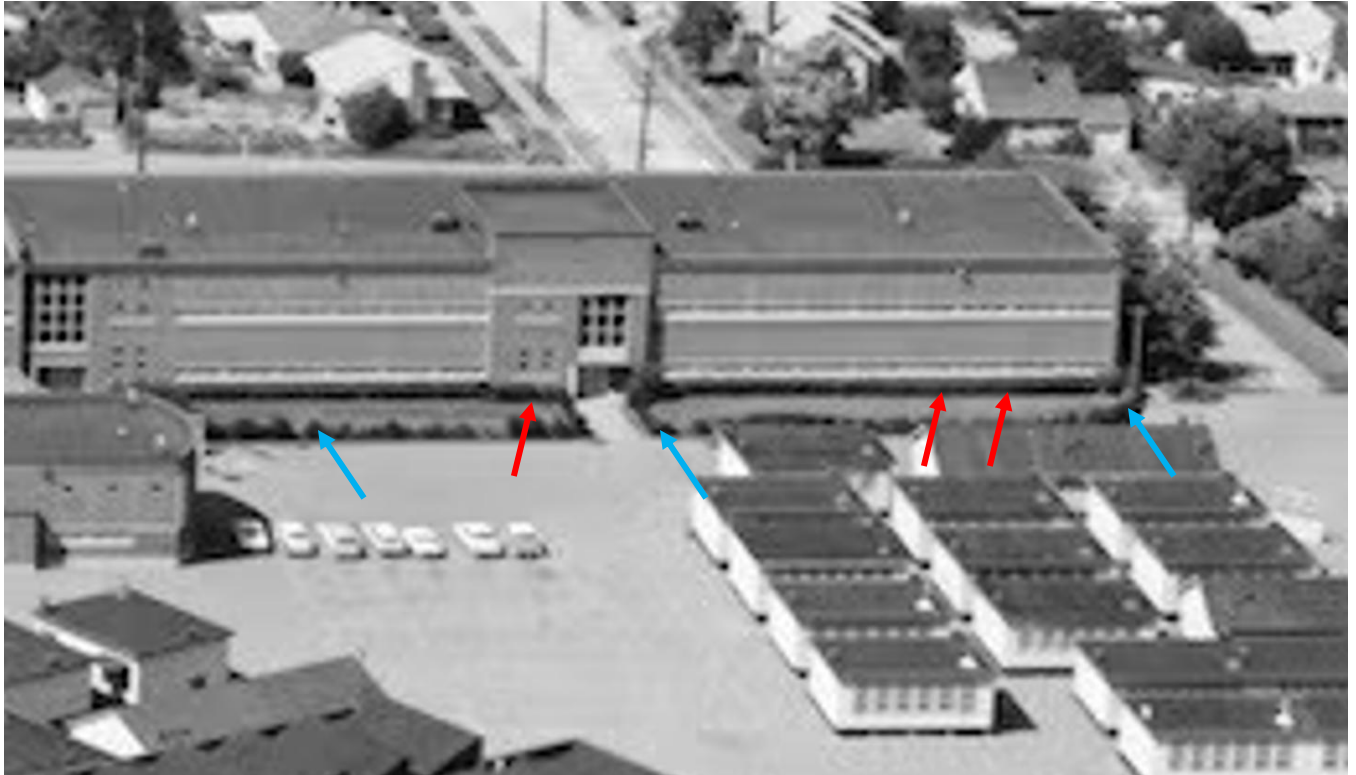
Image-7 above is an enlarged view of Image-6 (circa 1965). Note: Blue arrow points to shrubs that were planted along the edge of the parking area. There is no information or date for when these shrubs were previously removed and no replacement of these shrubs is included in this proposal. Note: The location of the previously removed diseased trees (which are not shown in this photo) is indicated by the red arrows above

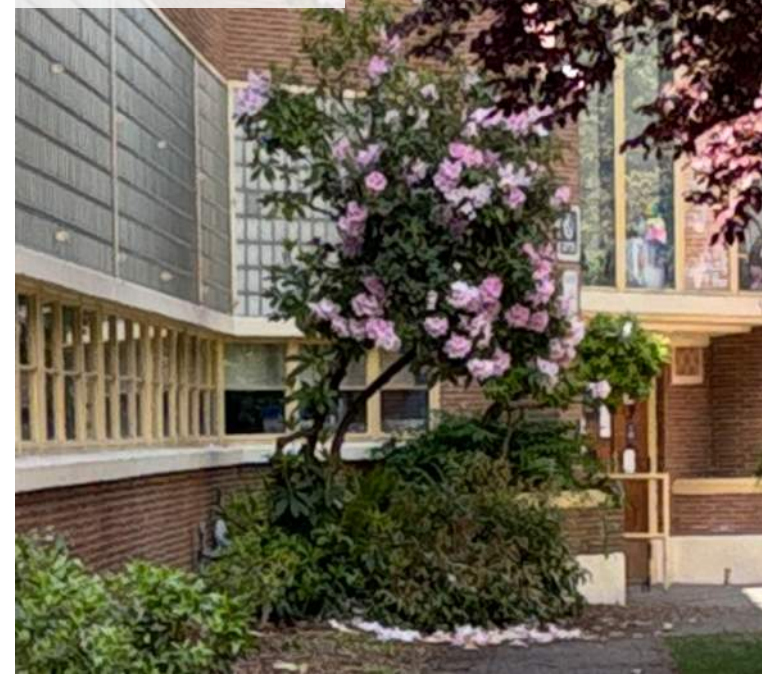
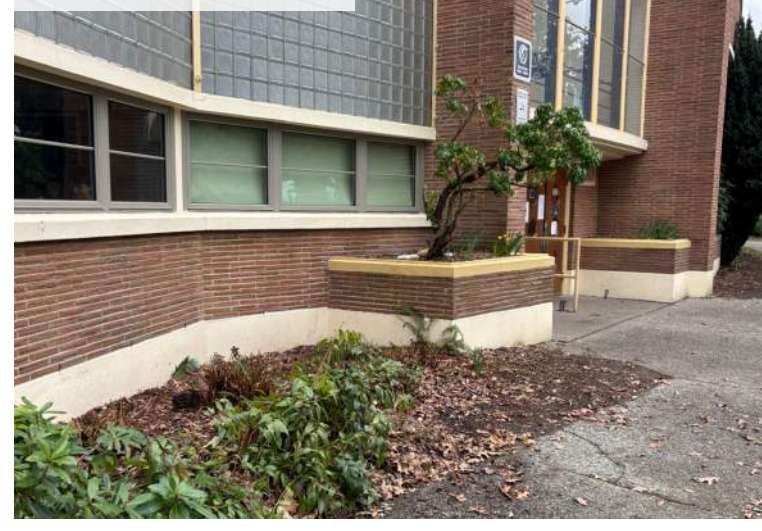
BEFORE PHASE 1

K LEUCOTHOE AND POLYSTICHUM SHRUBS PRUNED BACK DURING PHASE 1 ARE BEGINNING TO GROW BACK. NO REPLACEMENT ACTION PROPOSED. TREE FORM RHODODENDRON AND PIERIS WERE HEAVILY PRUNED DURING PHASE 1, MONITOR THROUGH THE GROWING SEASON FOR RECOVERY, REPLACING IN-KIND IN THE SAME LOCATION IN THE FALL IF PLANTS DO NOT SHOW SIGNS OF RECOVERY.

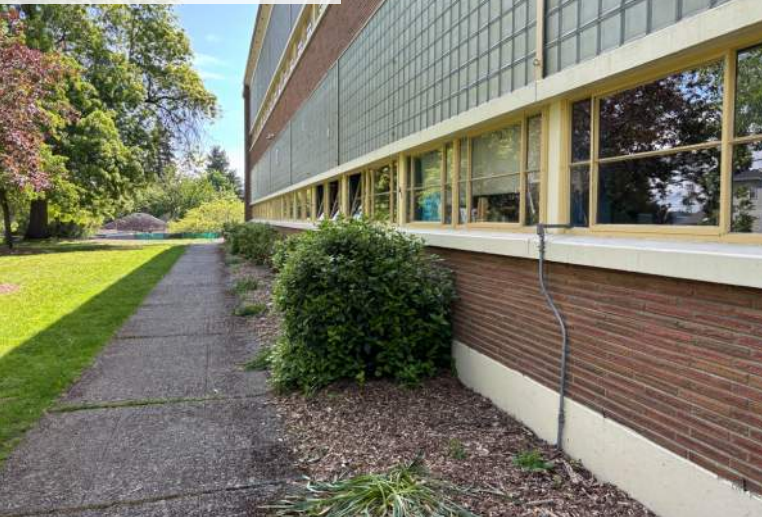
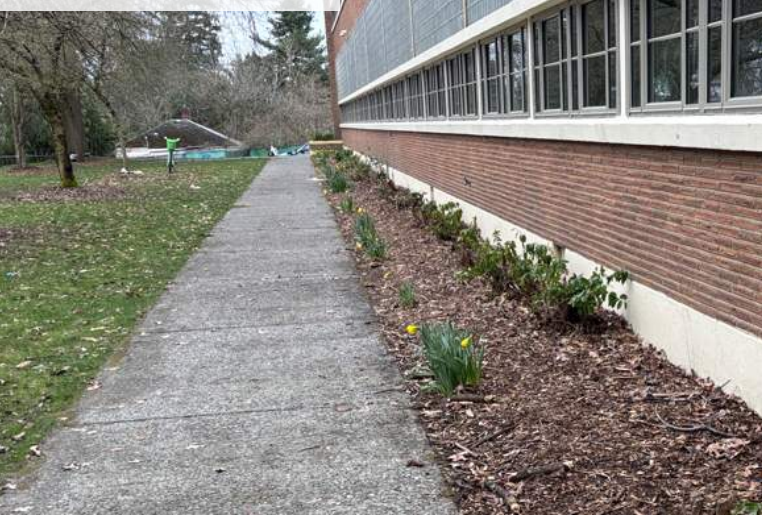
BEFORE PHASE 1

L PIERIS SHRUBS PRUNED TO 6" HEIGHT DURING PHASE 1 PER ARBORIST RECOMMENDATIONS ARE ALREADY BEGINNING TO GROW BACK - NO REPLACEMENT ACTION PROPOSED.

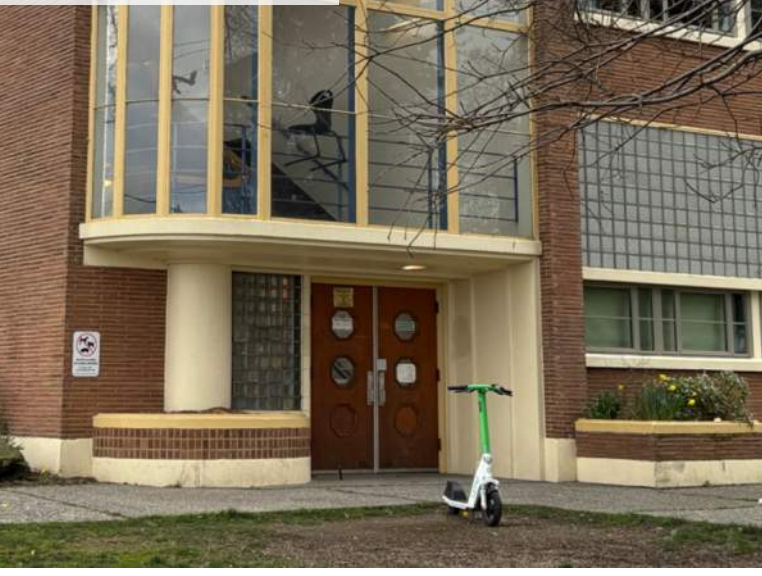
BEFORE PHASE 2

M NO IMPACT TO GROUNDCOVER AND DAPHNE SHRUB IN RAISED PLANTERS ADJACENT TO THE DOORS ANTICIPATED.

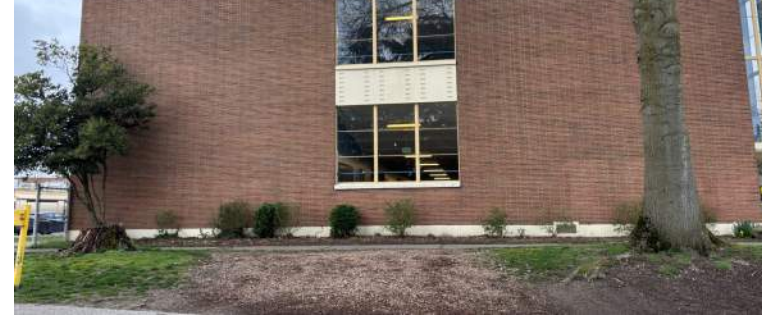
AFTER PHASE 1

N IMPACTS LIMITED TO TREE PRUNING COMPLETED DURING PHASE 1 TO ACCOMMODATE ROOF REPAIR WORK. NO IMPACT TO LIGUSTRUM SHRUBS ALONG BUILDING FACE ANTICIPATED DURING PHASE 2, LIFT ACCESS WIL BE USED TO COMPLETE WINDOW REPLACEMENT WORK IN THIS AREA.

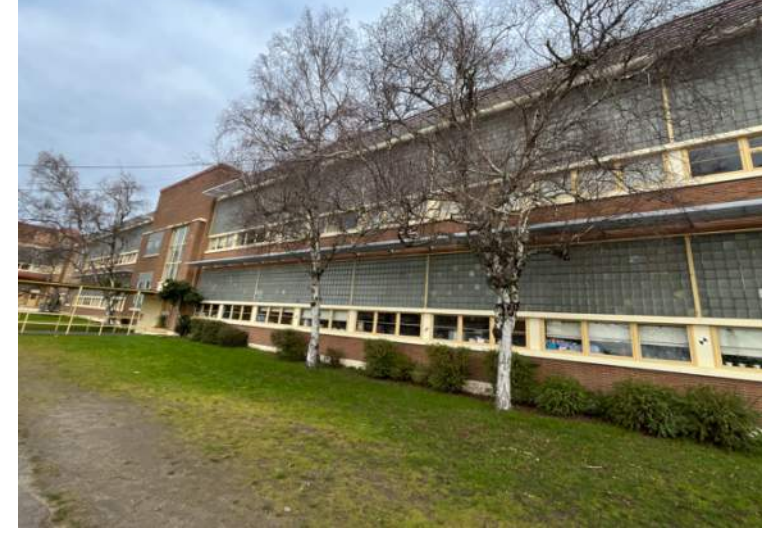
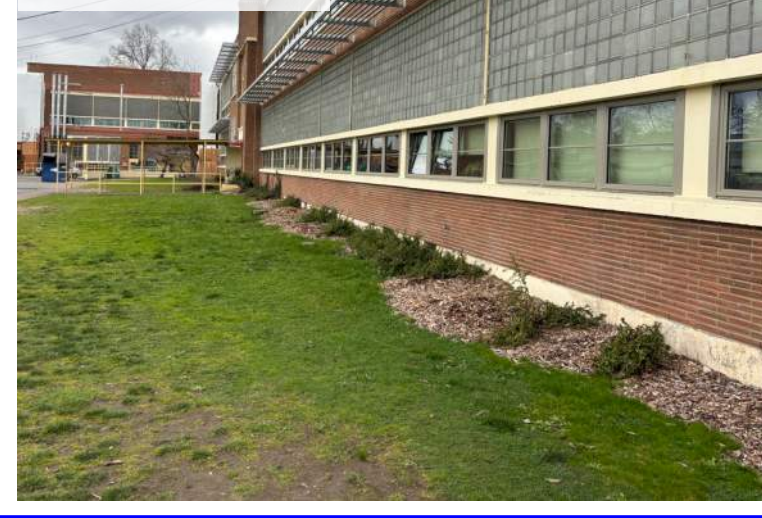
BEFORE PHASE 1

O ESCALLONIA SHRUBS PRUNED TO 6" HEIGHT DURING PHASE 1 PER ARBORIST RECOMMENDATIONS ARE BEGINNING TO GROW BACK - NO REPLACEMENT ACTION PROPOSED.

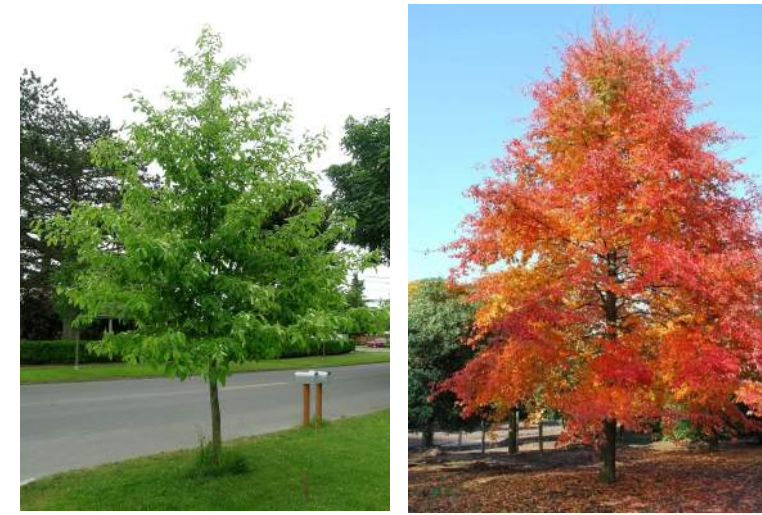
X EXISTING BIRCH TREES REMOVED BY SEATTLE PUBLIC SCHOOLS GROUNDS' TEAM PRIOR TO PH 1 WORK. PER SPS GROUNDS, ALL THREE TREES WERE DEAD/DYING DUE TO IMPACTS FROM THE BRONZE BIRCH BORER.

REPLACE REMOVED BIRCH TREES WITH THREE NEW NYSSA SYLVATICA IN THE LOCATIONS SHOWN. NEW TREES TO BE PLANTED MIN 15' FROM THE EXISTING BUILDING.

PROPOSED REPLACEMENT SPECIES:
NYSSA SYLVATICA
MEDIUM SIZE DECIDUOUS TREE
MATURE SIZE: 30-50' TALL, 20-30' SPREAD

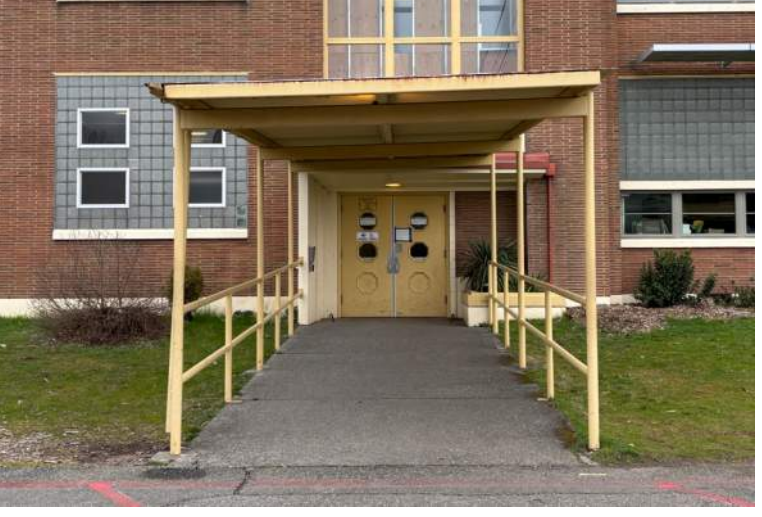
BEFORE PHASE 2

P NO IMPACT TO YUCCA SHRUBS IN RAISED PLANTER ANTICIPATED. SHRUBS WEST OF THE DOORS TO BE PRUNED BACK TO 4' HEIGHT TO ALLOW LIFT ACCESS FOR WINDOW AND GLASS BLOCK REPLACEMENT. NO REPLACEMENT ACTION PROPOSED.

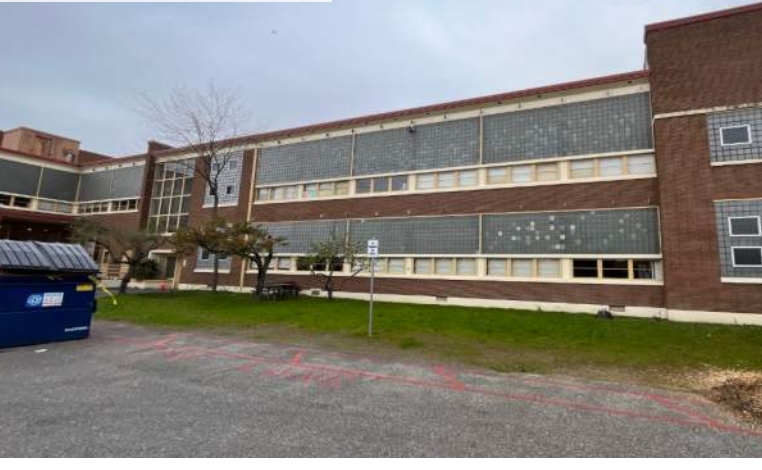
AFTER PHASE 1

Q IMPACTS LIMITED TO TREE PRUNING COMPLETED DURING PHASE 1 TO ACCOMMODATE LIFT ACCESS AND/OR SCAFFOLDING.

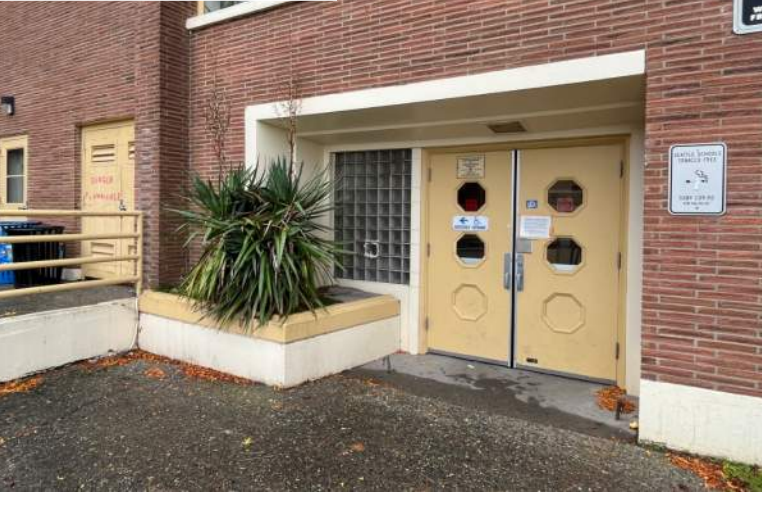
BEFORE PHASE 2

R NO IMPACT TO YUCCA SHRUBS IN RAISED PLANTER ADJACENT TO THE DOORS ANTICIPATED. LIFT ACCESS WILL BE USED TO COMPLETE WINDOW REPLACEMENT WORK IN THIS AREA.

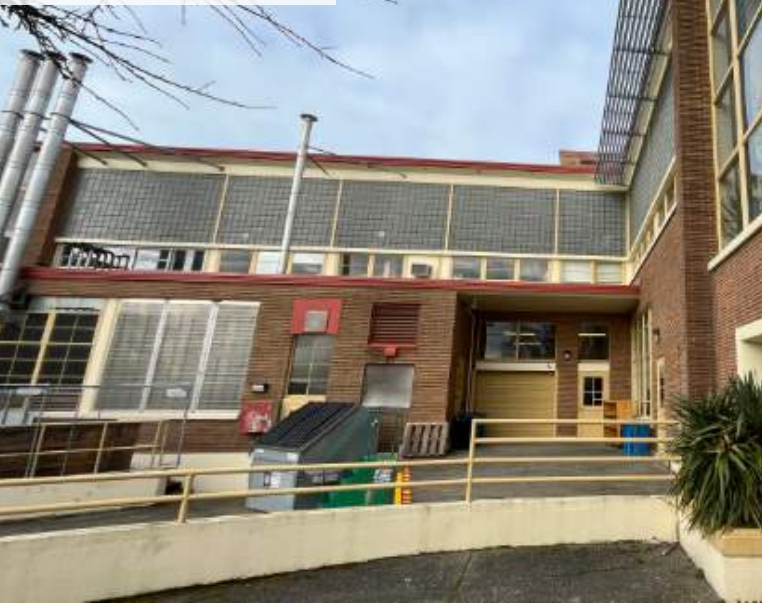
BEFORE PHASE 2

J NO EXISTING LANDSCAPING AT BUILDING FACE IN THIS AREA. IMPACTS WILL BE LIMITED TO MINOR TREE PRUNING WHERE NECESSARY TO ACCOMMODATE LIFT ACCESS AND/OR SCAFFOLDING.
