**RE: Special Valuation Application**

Enclosed is the Application and Certification of Special Valuation on Improvements to Historic Property for our Rainier Edmunds Bldg.

Here is a short summary of the completed rehabilitation work.

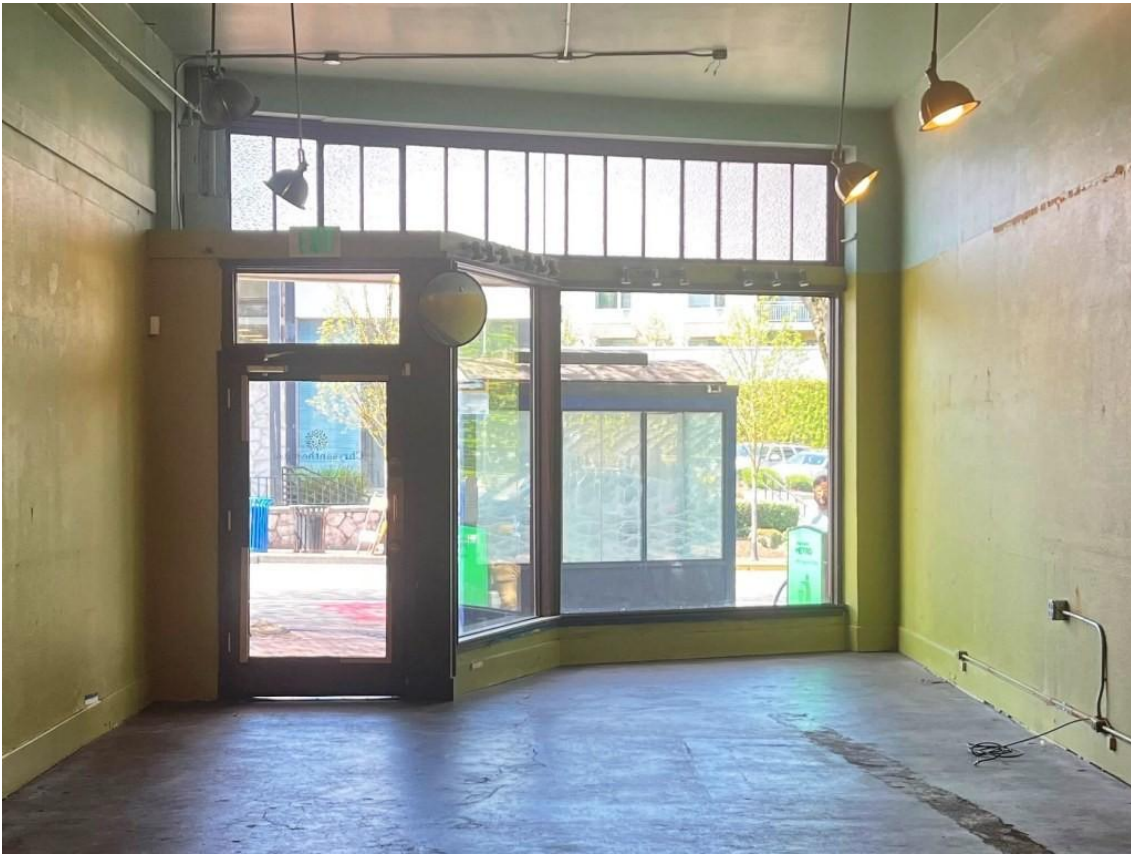
Storefront at 4820 Rainier Ave. S. prior to seismic brace frame installation.

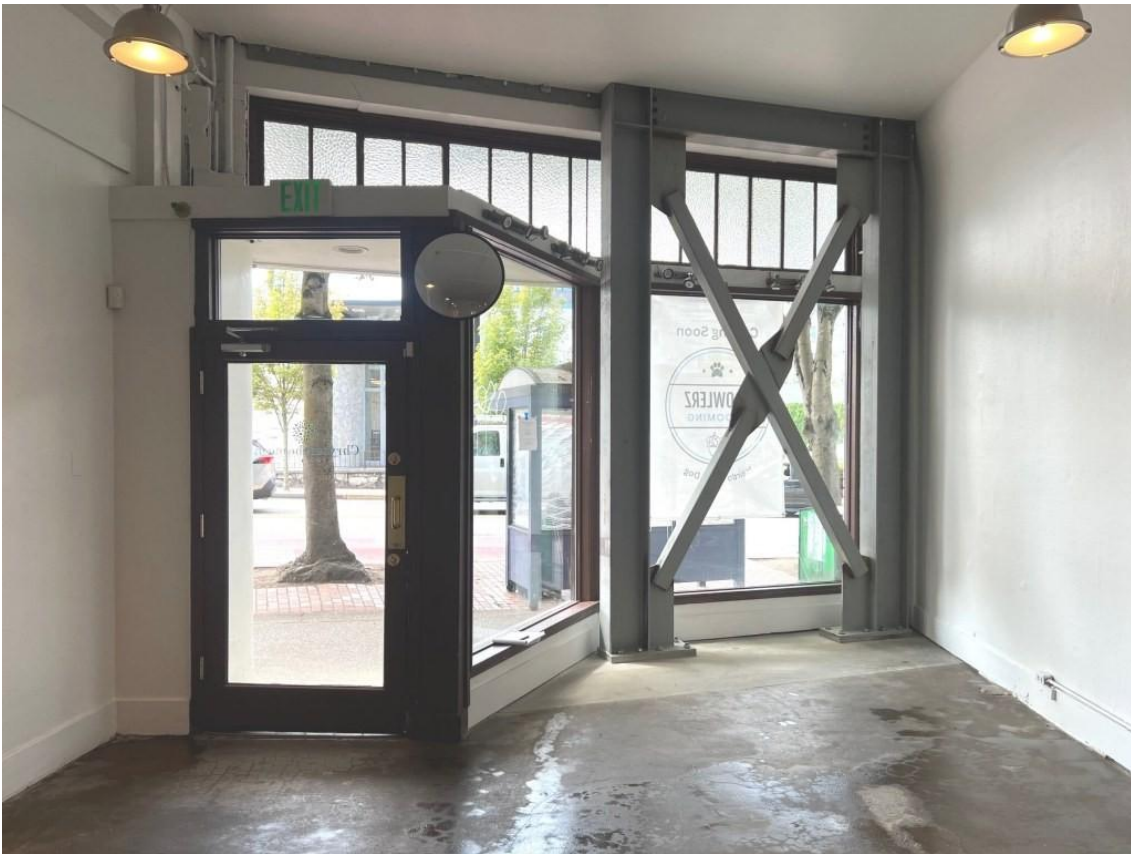
Storefront post seismic brace frame installation.

- Installation of a new steel brace-frame for seismic stability, and a floor grade beam to support it.
- Interior seismic ceiling to wall ties on the west, north and east walls of the retail bay at 4820 Rainier Ave. S., including new wood blocking and metal clips.

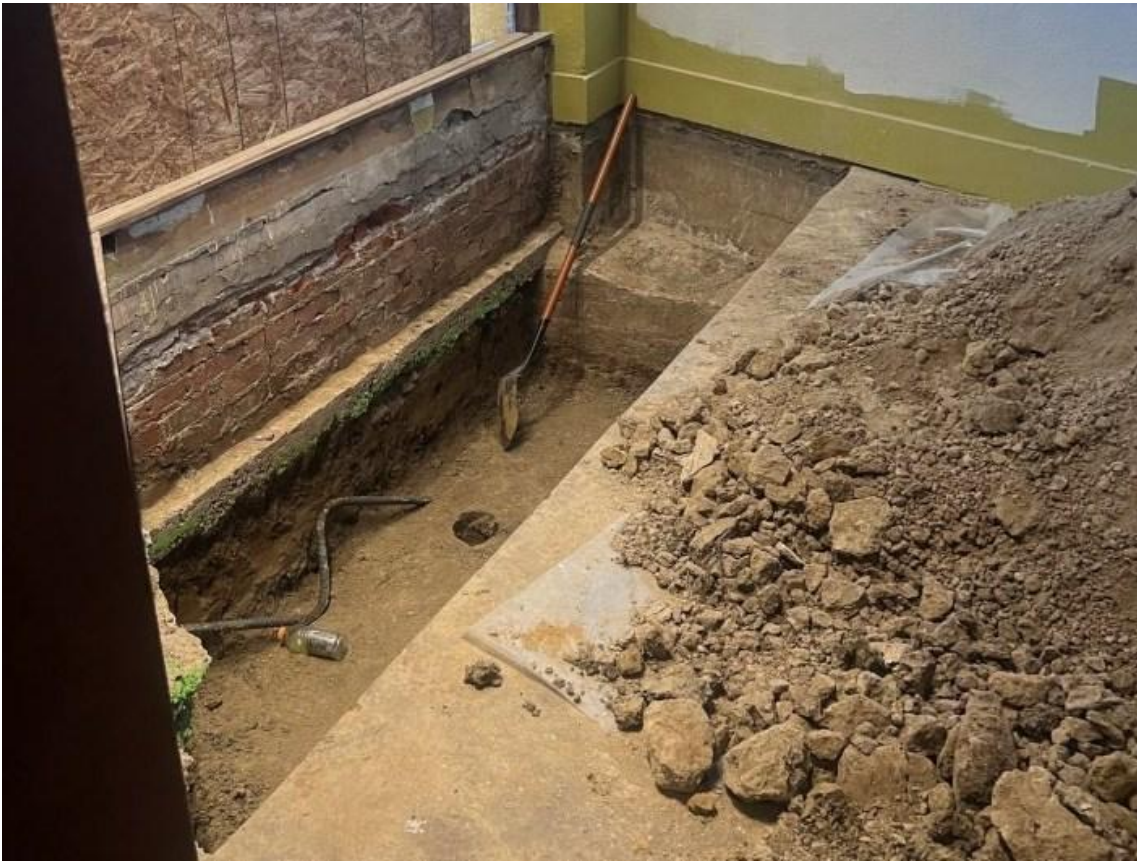
Excavation for new grade beam to support new brace frame.

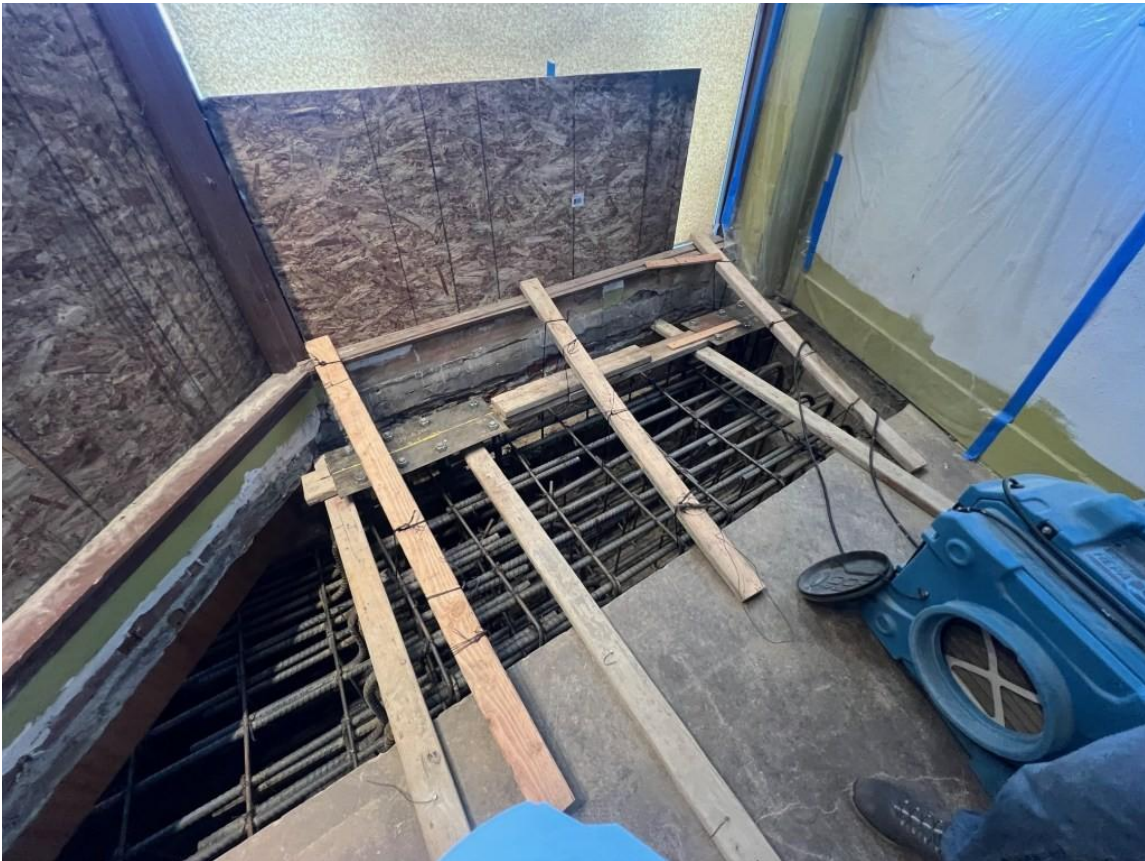
New rebar for grade beam support.

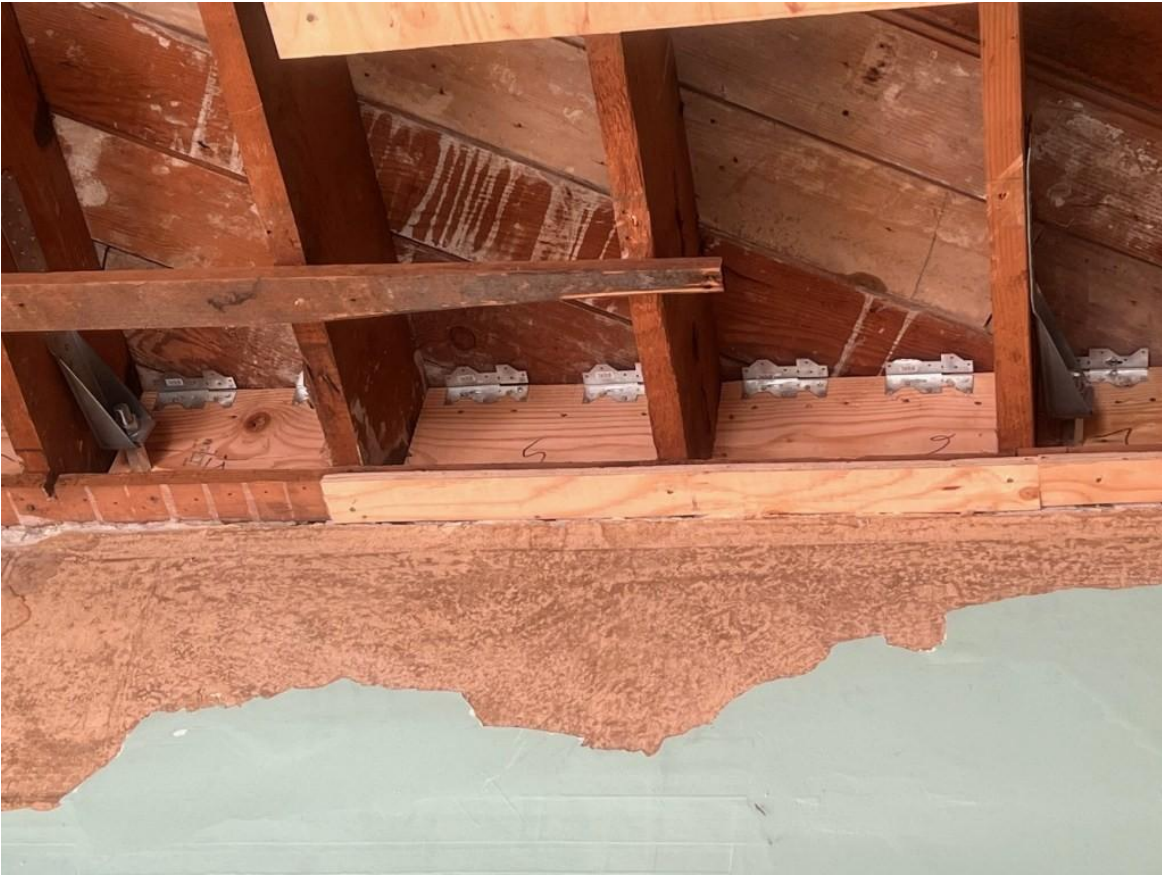
Installation of wood blocking and clips in joist pockets.

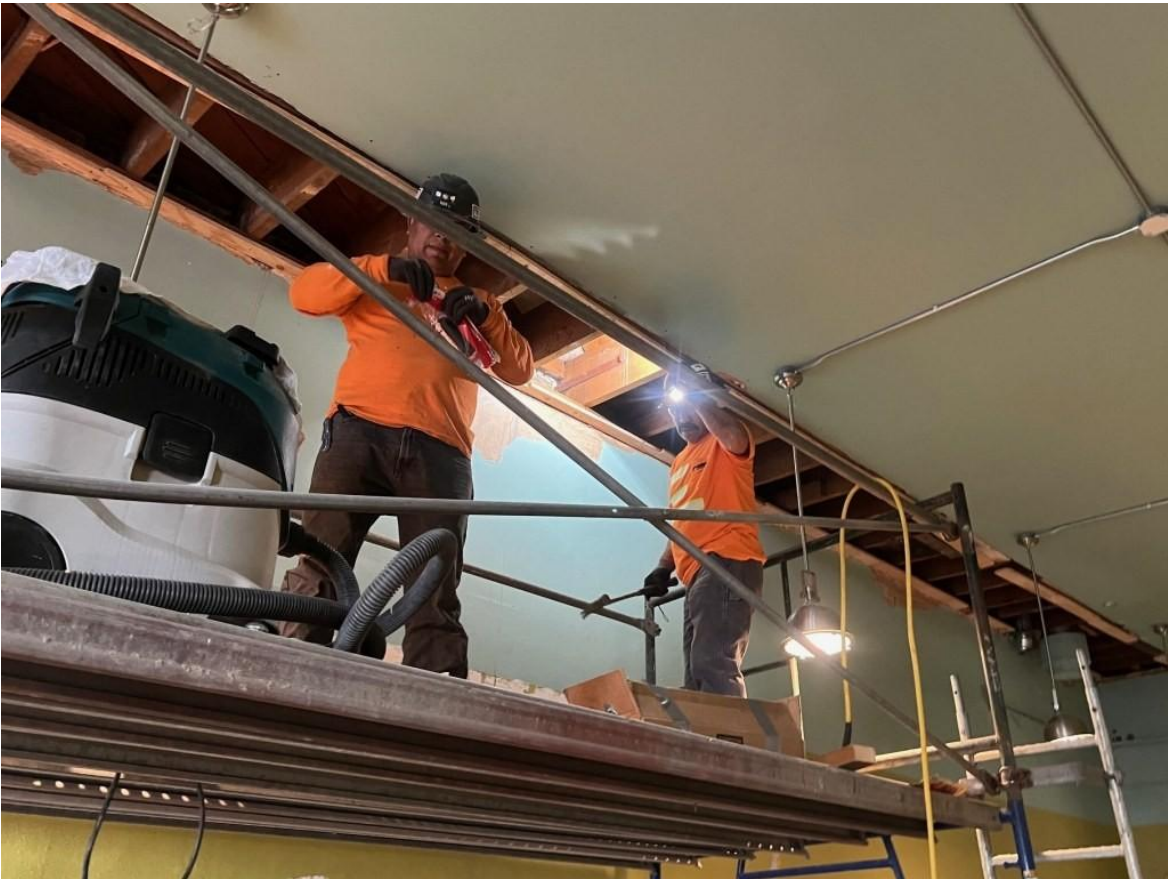
Installation of threaded rods & wall ties on West, North and East ceilings in 4820 Rainier Ave. S.

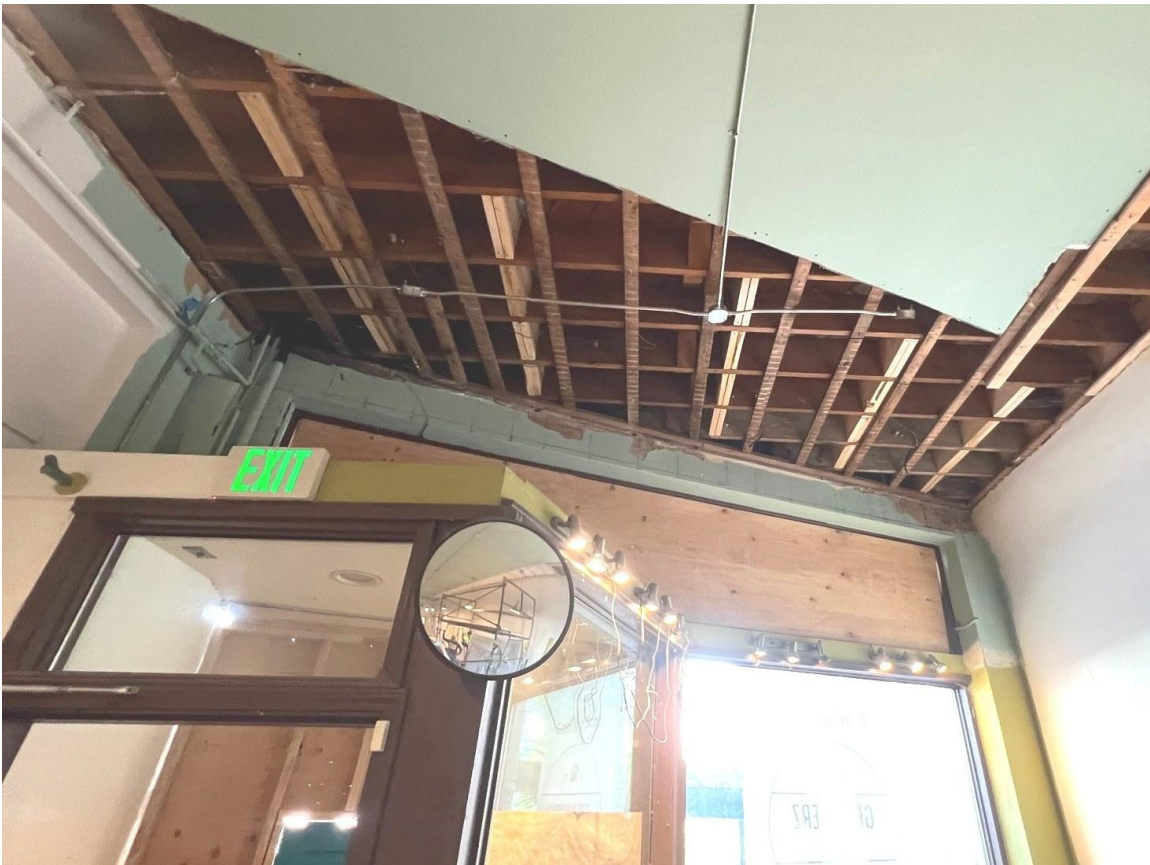
Wall ties and new blocking on West ceilings in 4820 Rainier Ave. S.

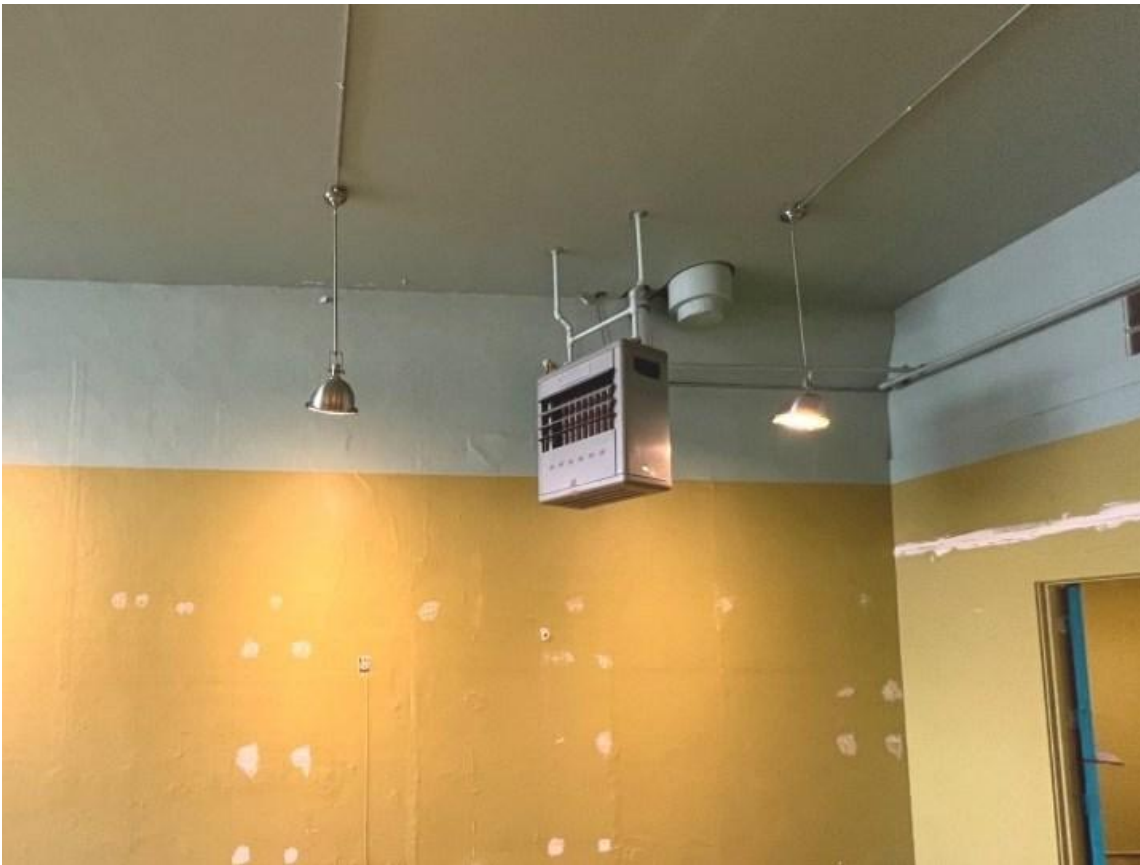
Old ceiling hung Gas Heater.

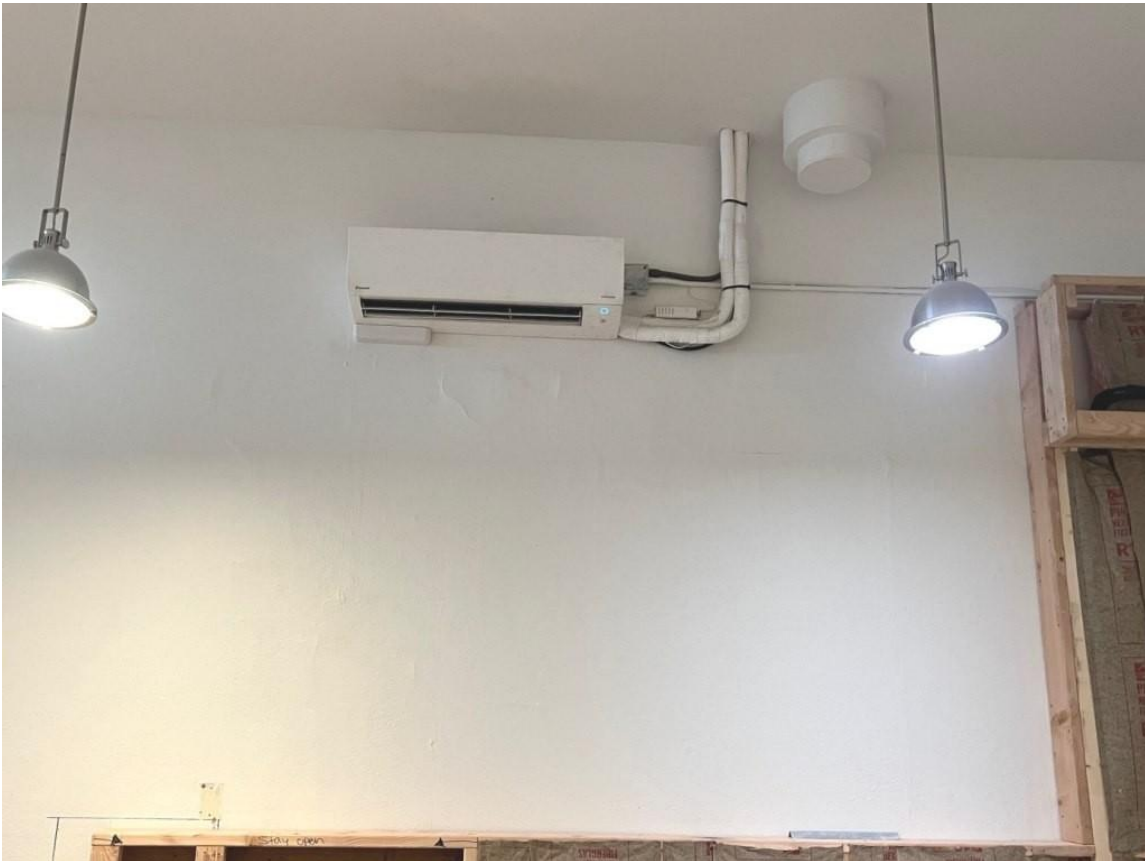
New Electric Heat Pump, providing both cooling and heating.

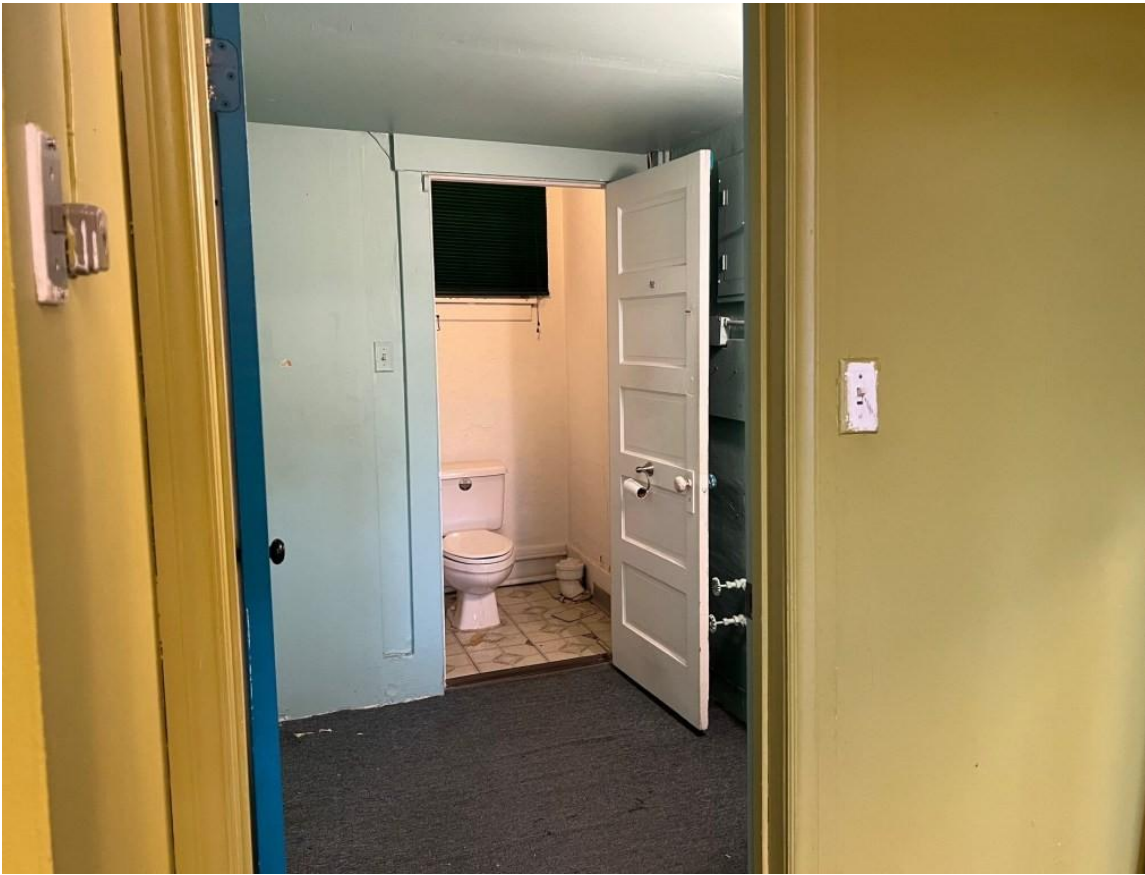
Old non-ADA compliant bathroom.

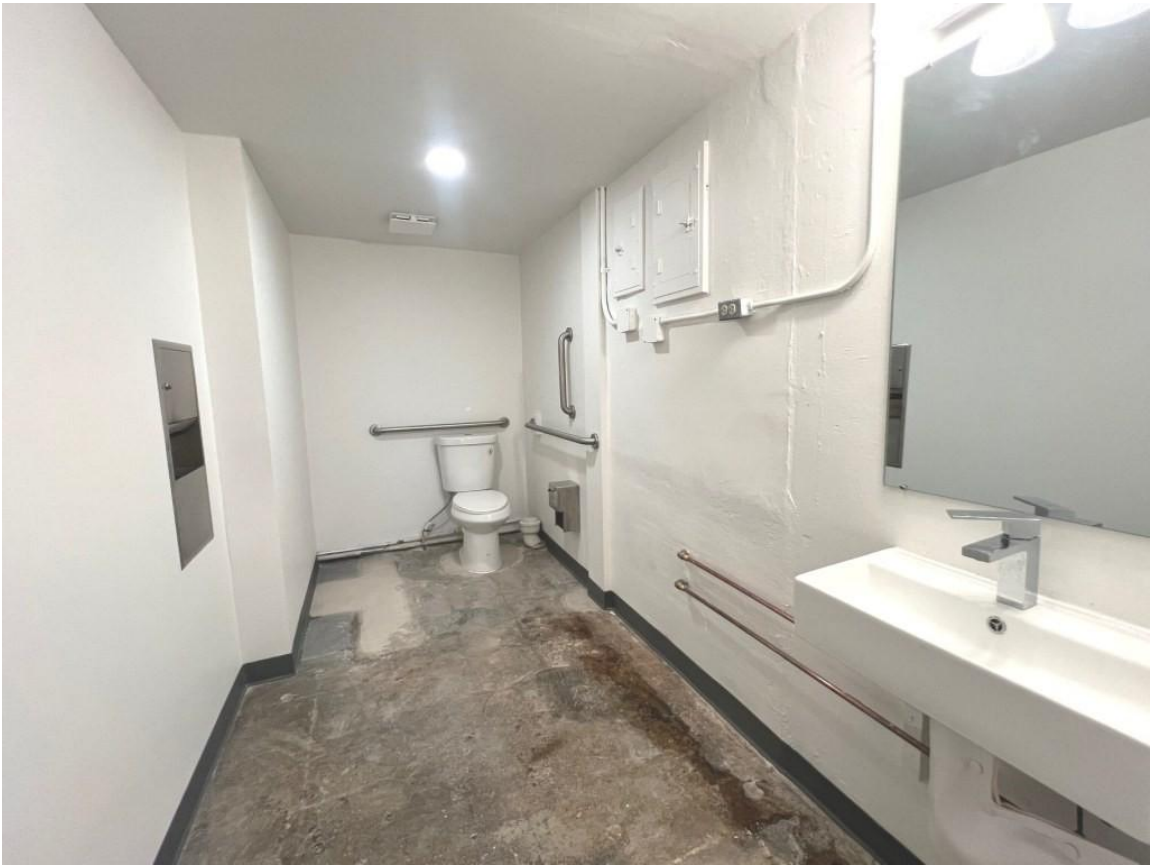
New ADA compliant bathroom.

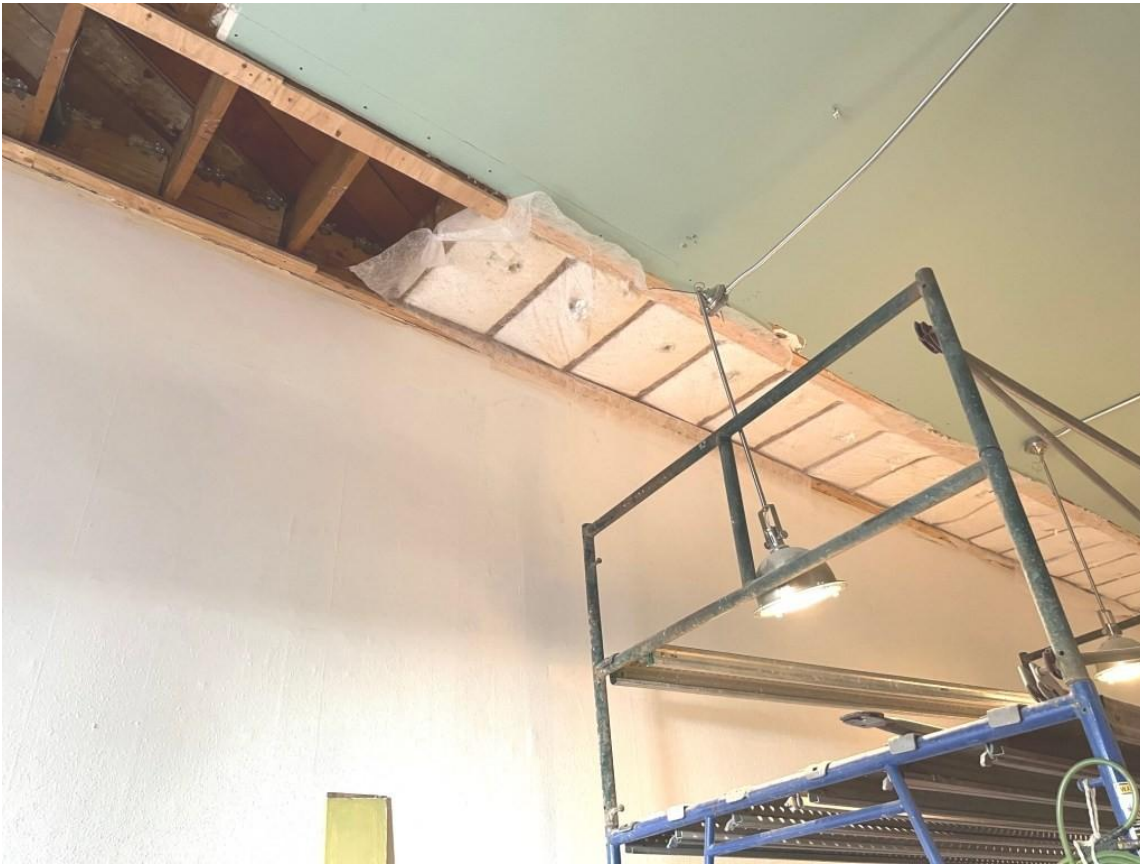
New blown-in ceiling insulation.

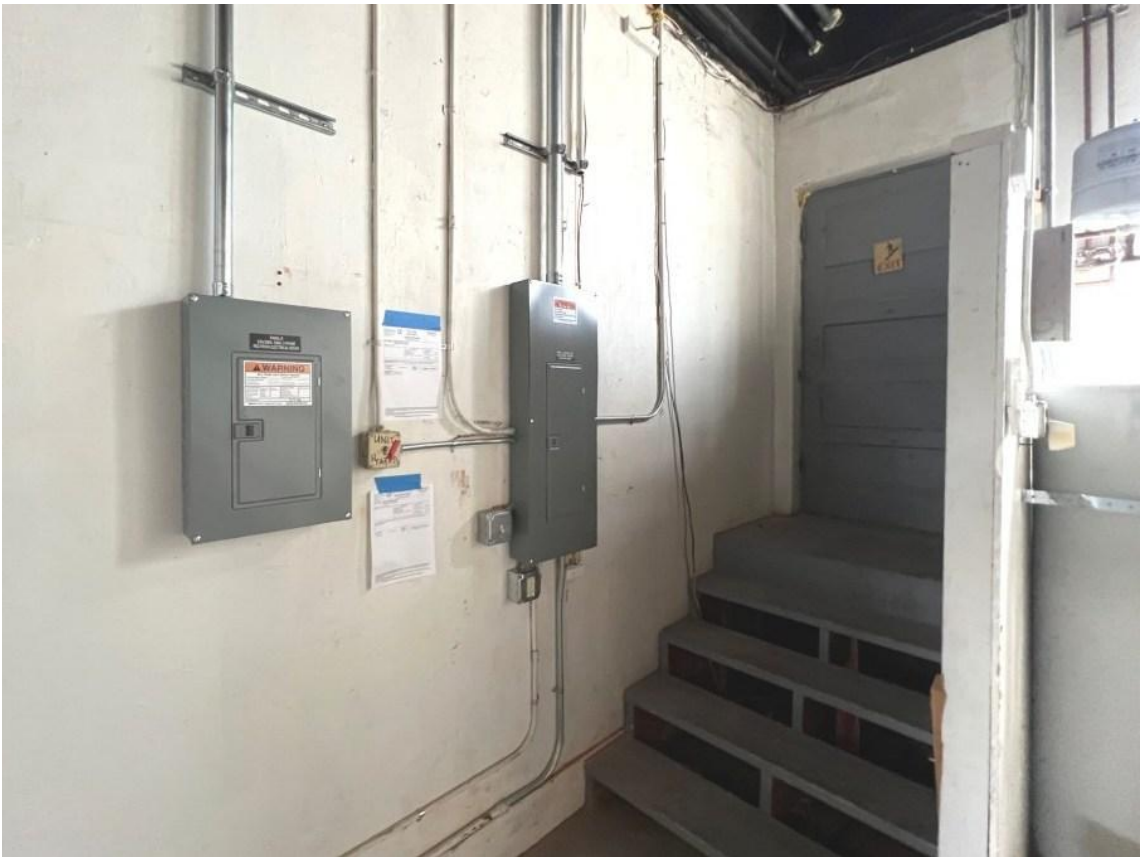
New 200-amp single phase panel and new 100 amp 3-phase panel.

- Installation of additional electrical power into the retail bay at 4820 Rainier Ave. S., including 200 amps of single-phase power, and 100 amps of 3-phase power.

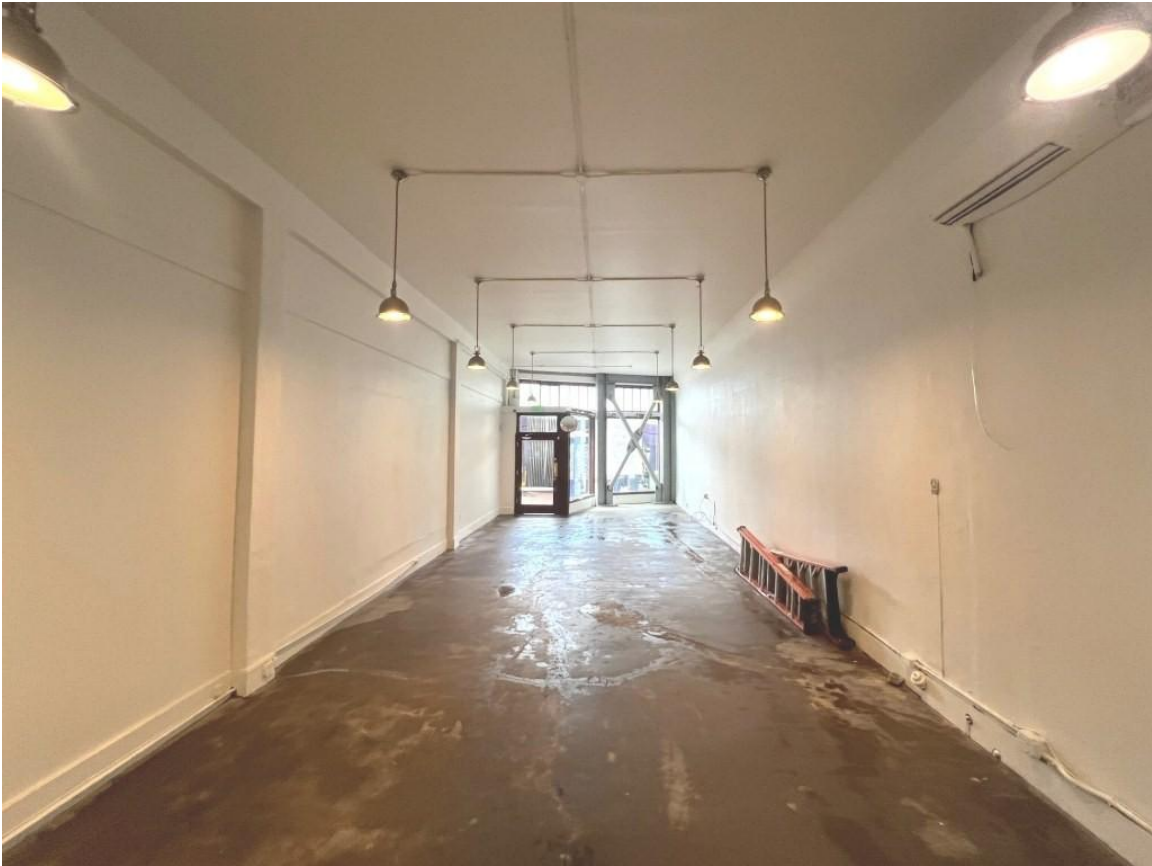
Post construction of 4820 Rainier Ave. S. retail bay.

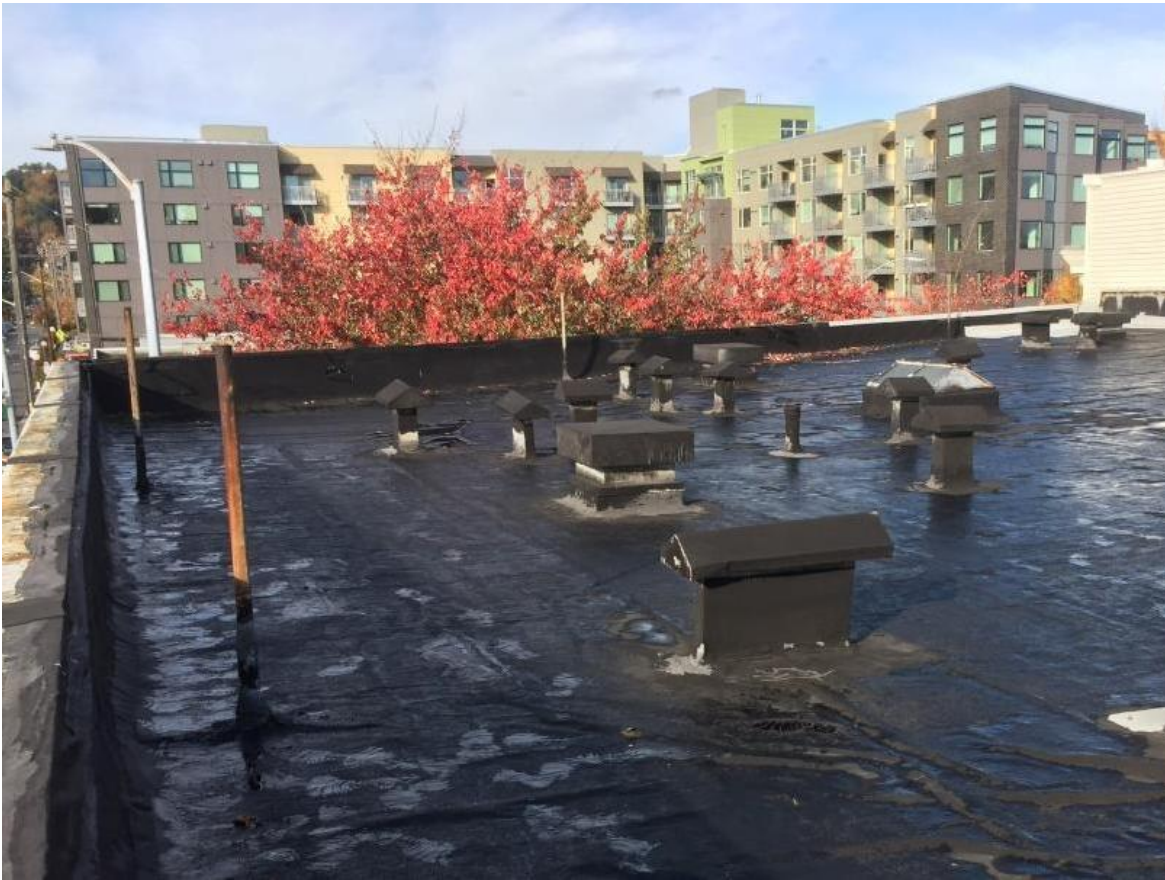
Old Roof prior to seismic upgrades and new roofing.

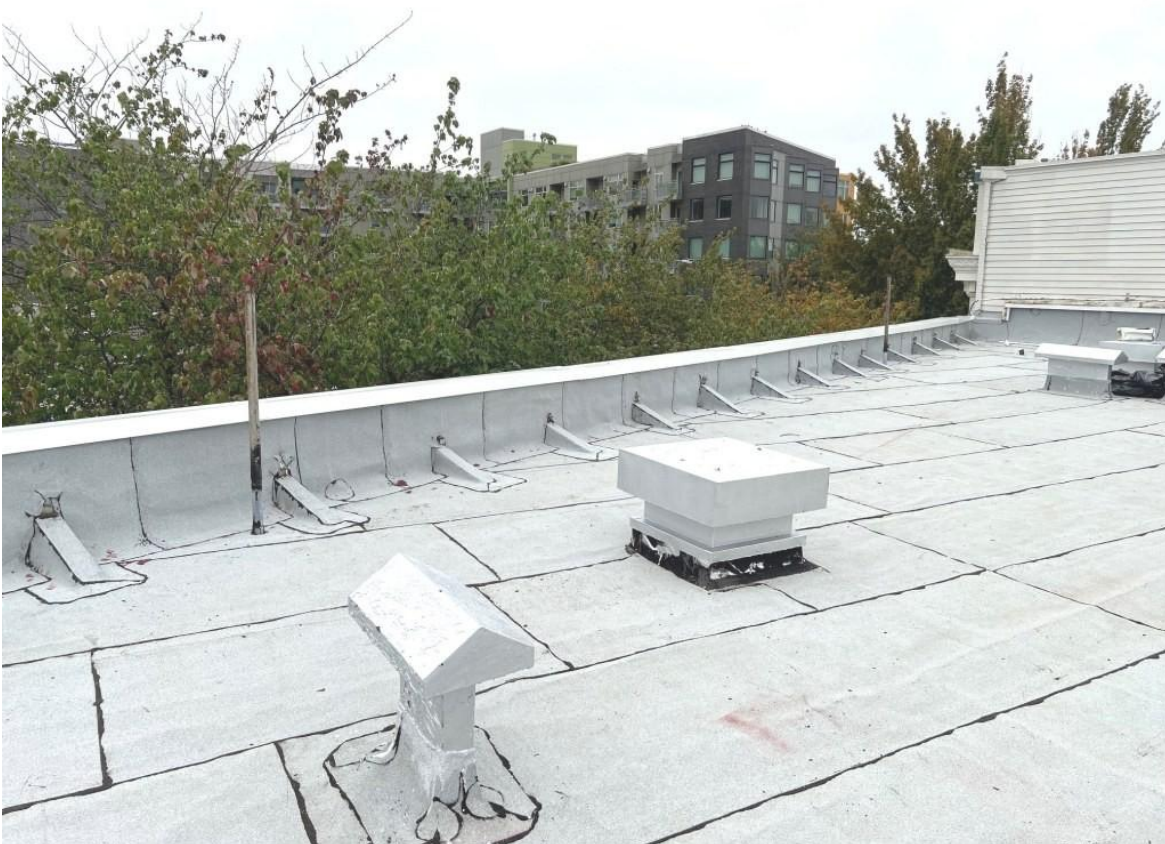
New Roof, new flashing and new cap metal, along with new seismic parapet bracing.

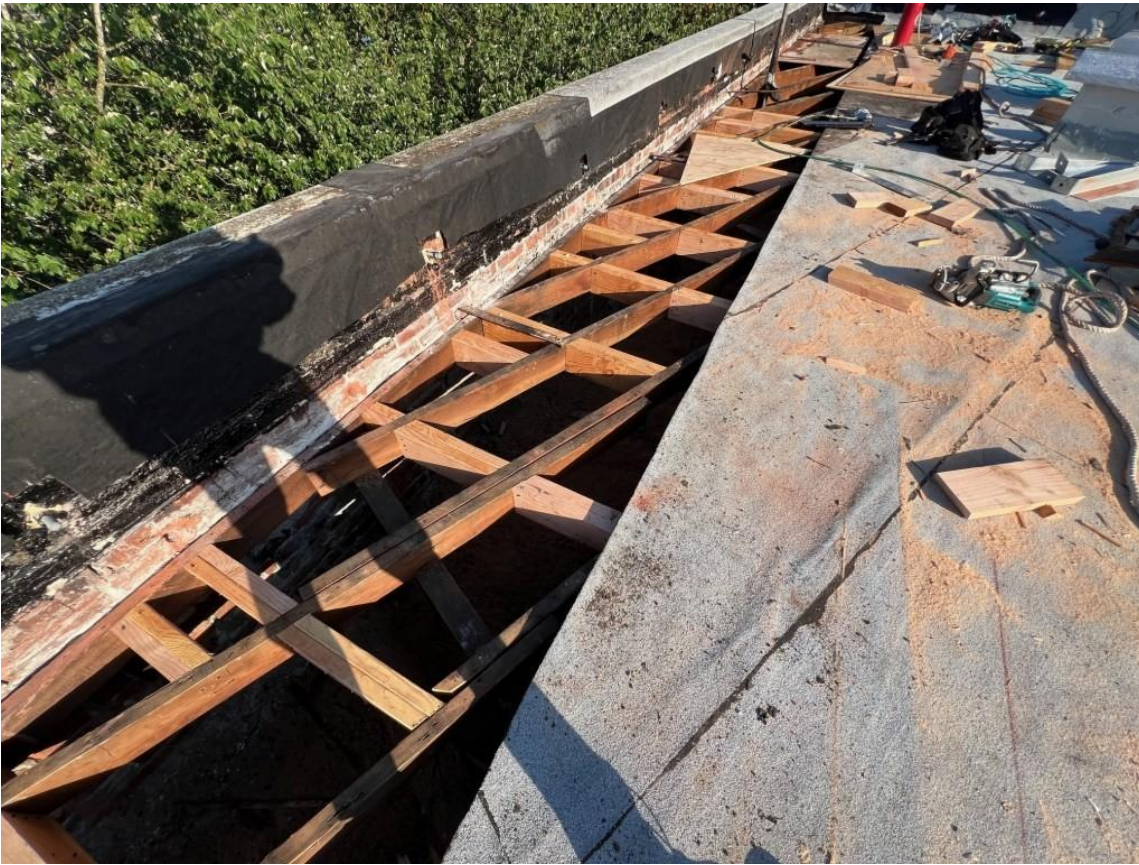
New bracing and blocking for parapet bracing on the west wall.

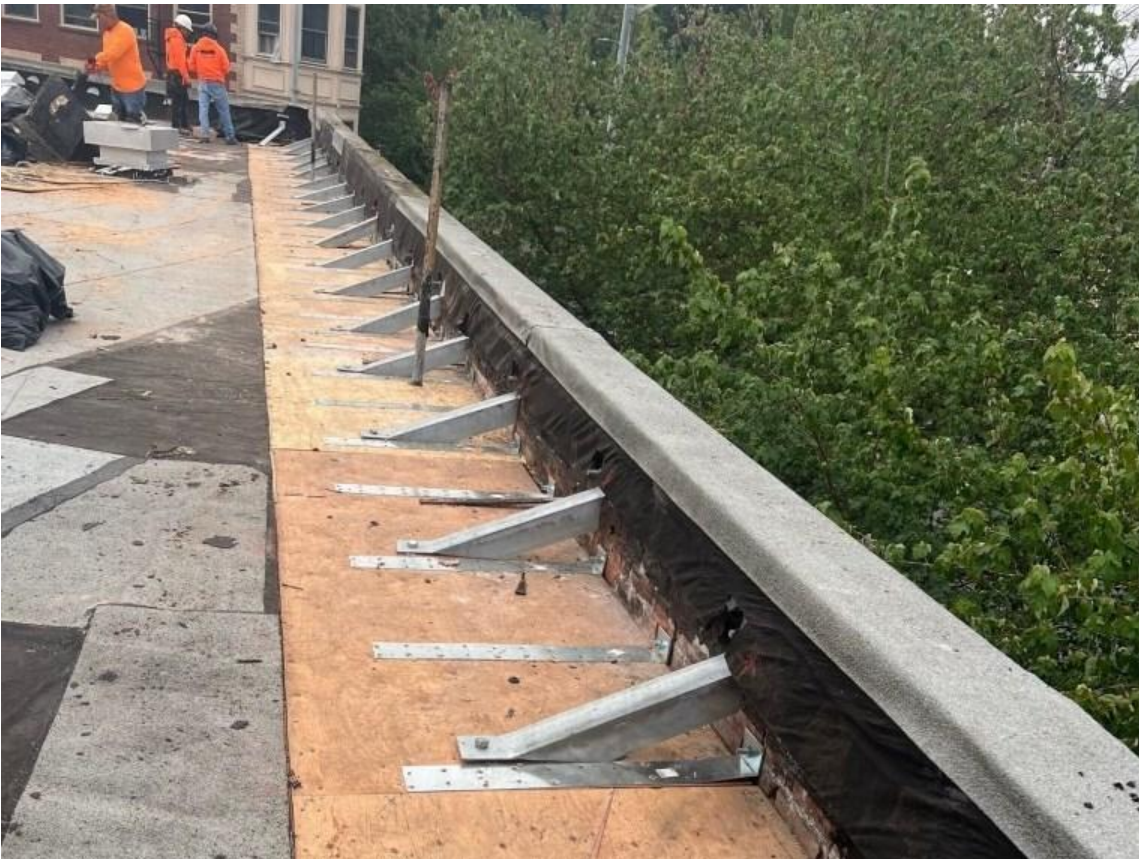
New parapet bracing west wall.

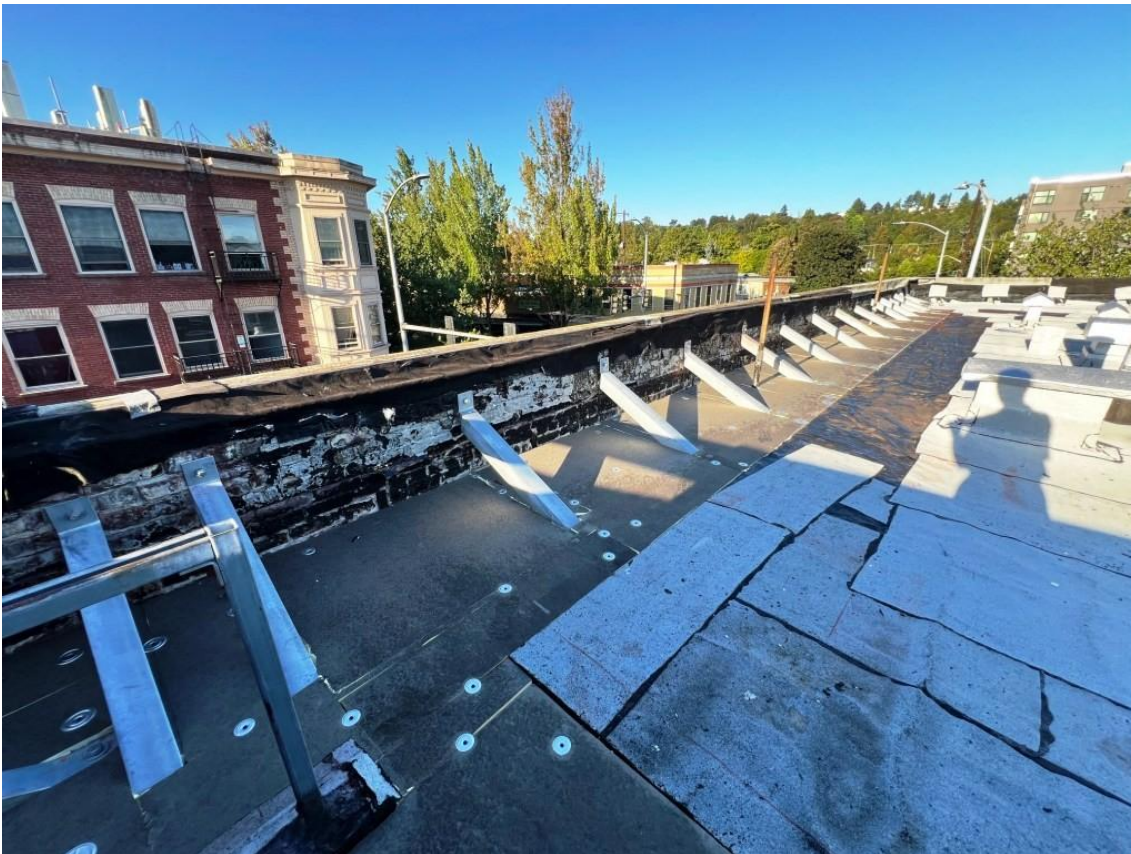
New parapet roof bracing on the south wall.

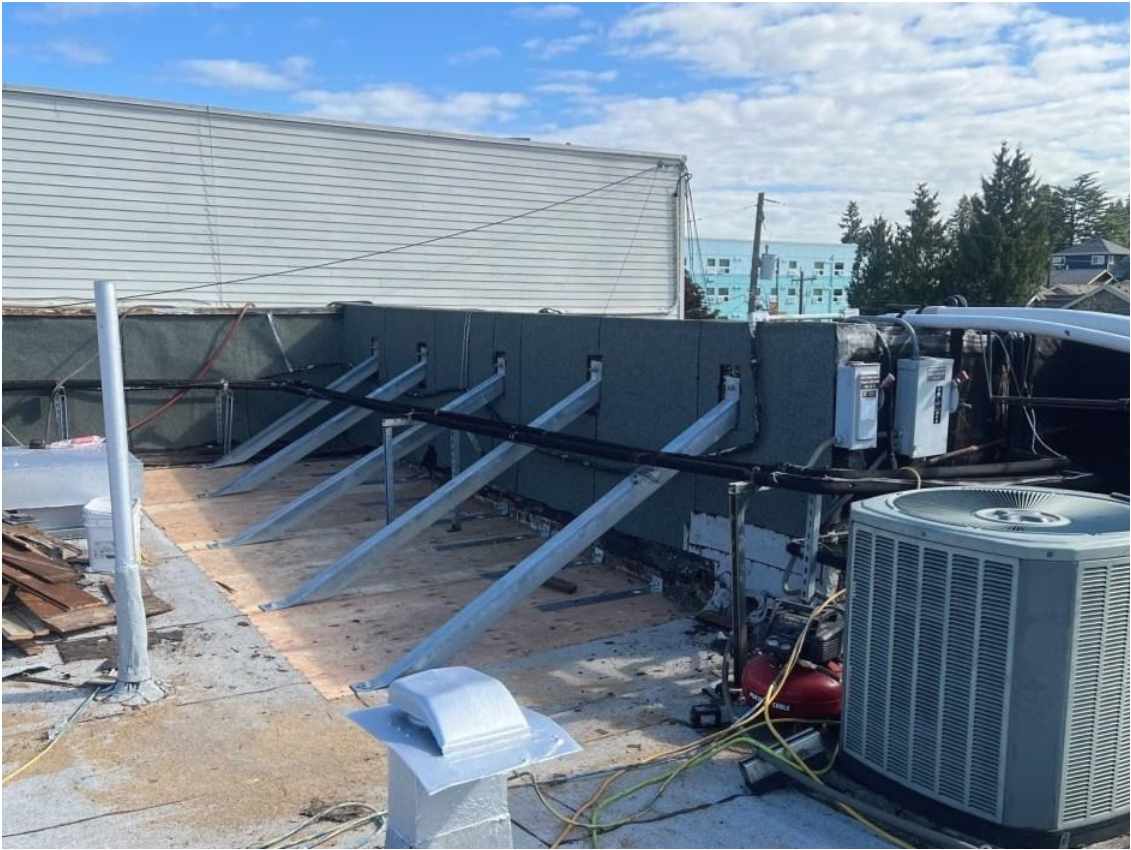
New Parapet bracing in NE corner of roof.

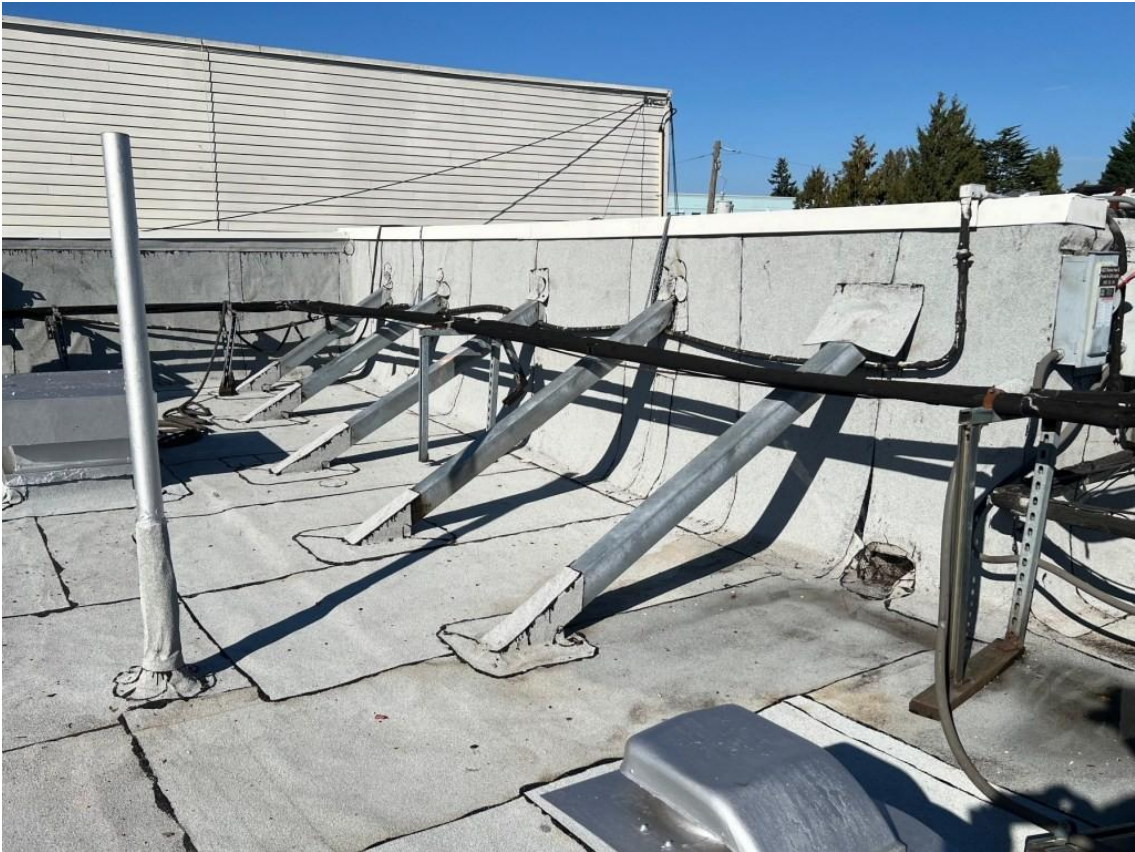
New Bracing and new roof.

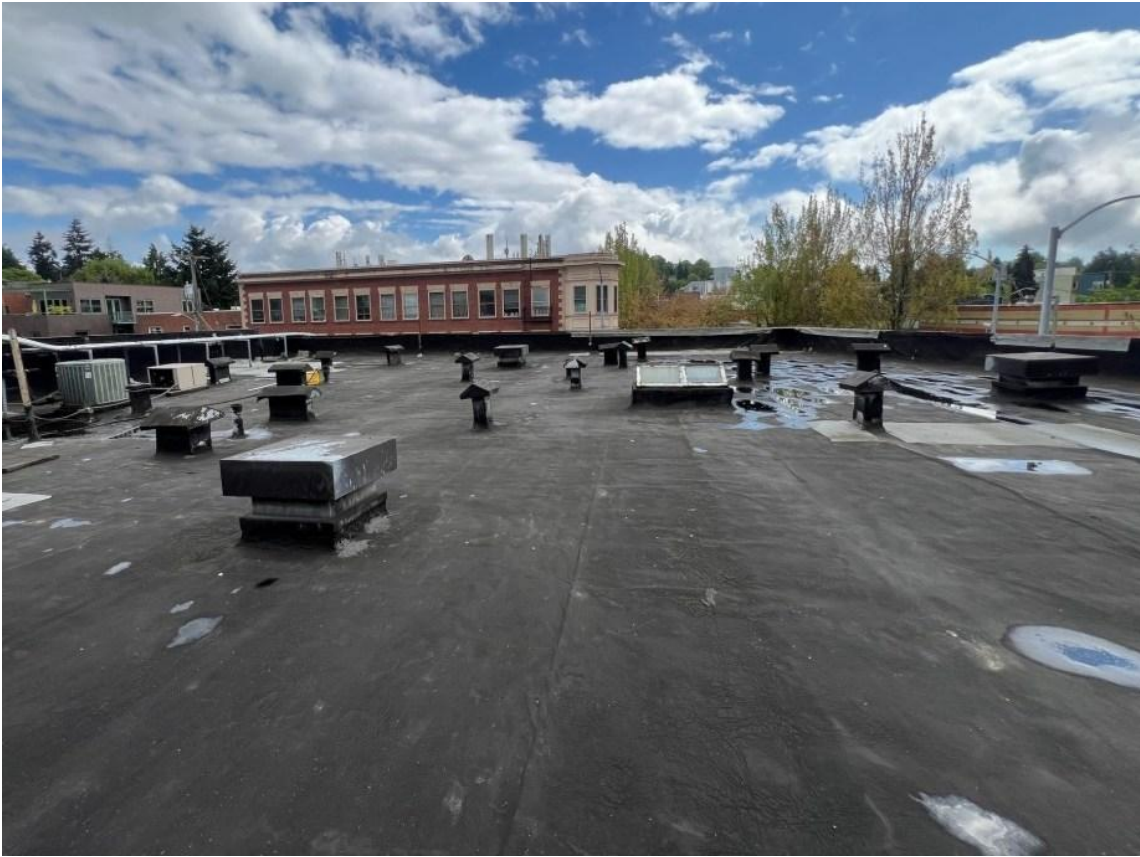
Old roof.

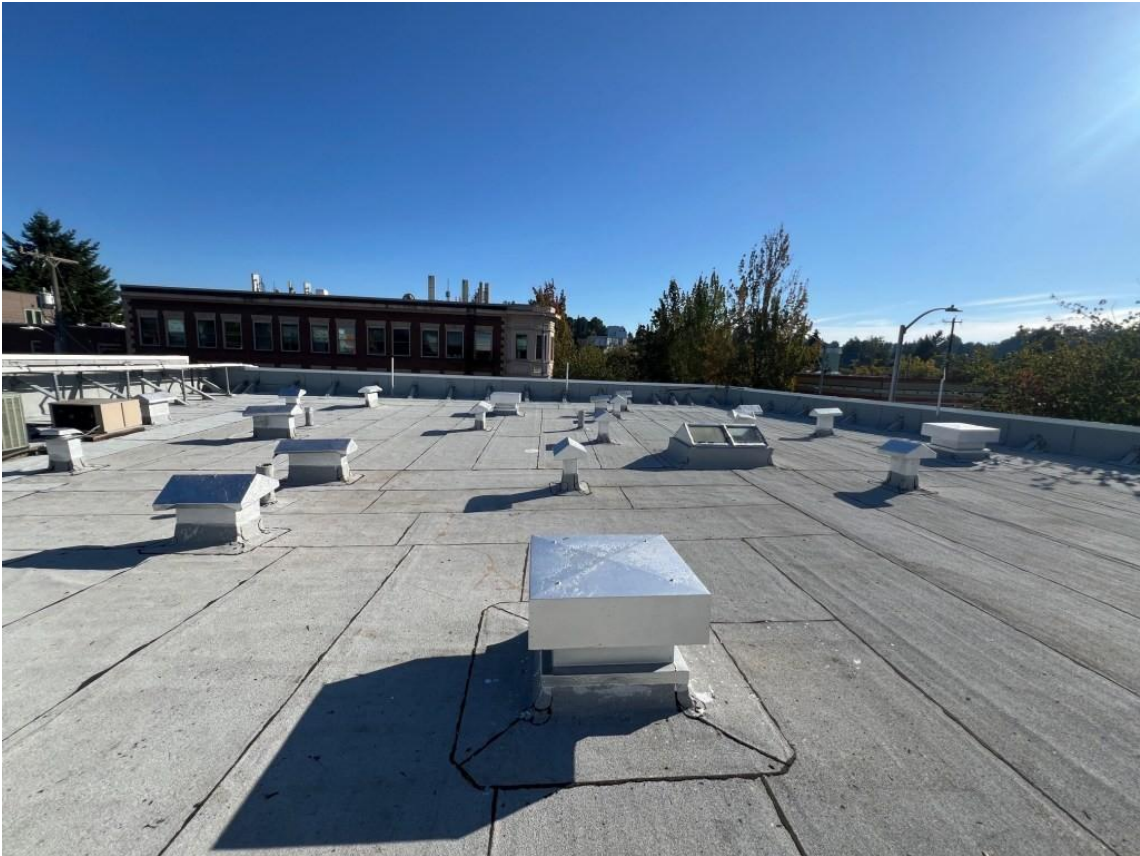
New Roof
