**RE: Special Valuation Application**

Enclosed is the Application and Certification of Special Valuation on Improvements to Historic Property for our Rainier Edmunds Bldg.

Here is a short summary of the completed rehabilitation work.

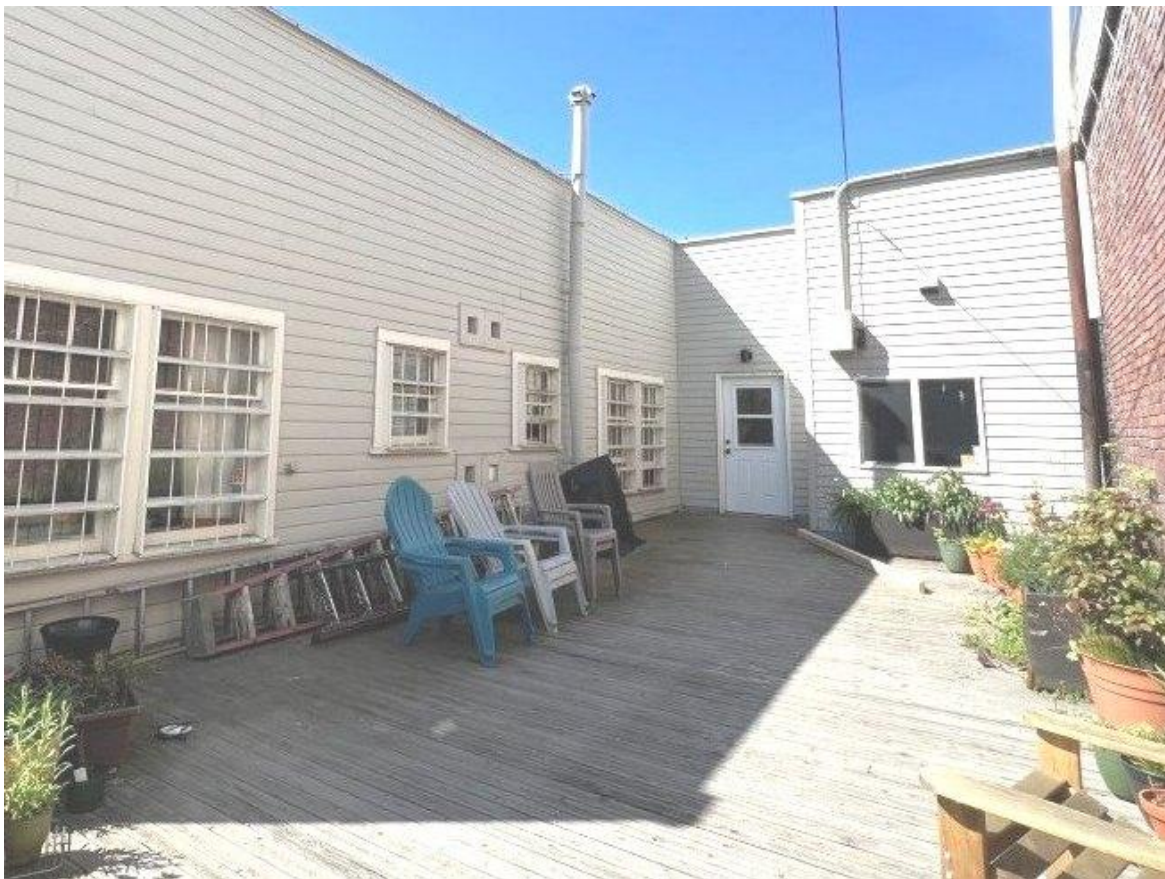
Back Deck with chairs covering broken deck rails.

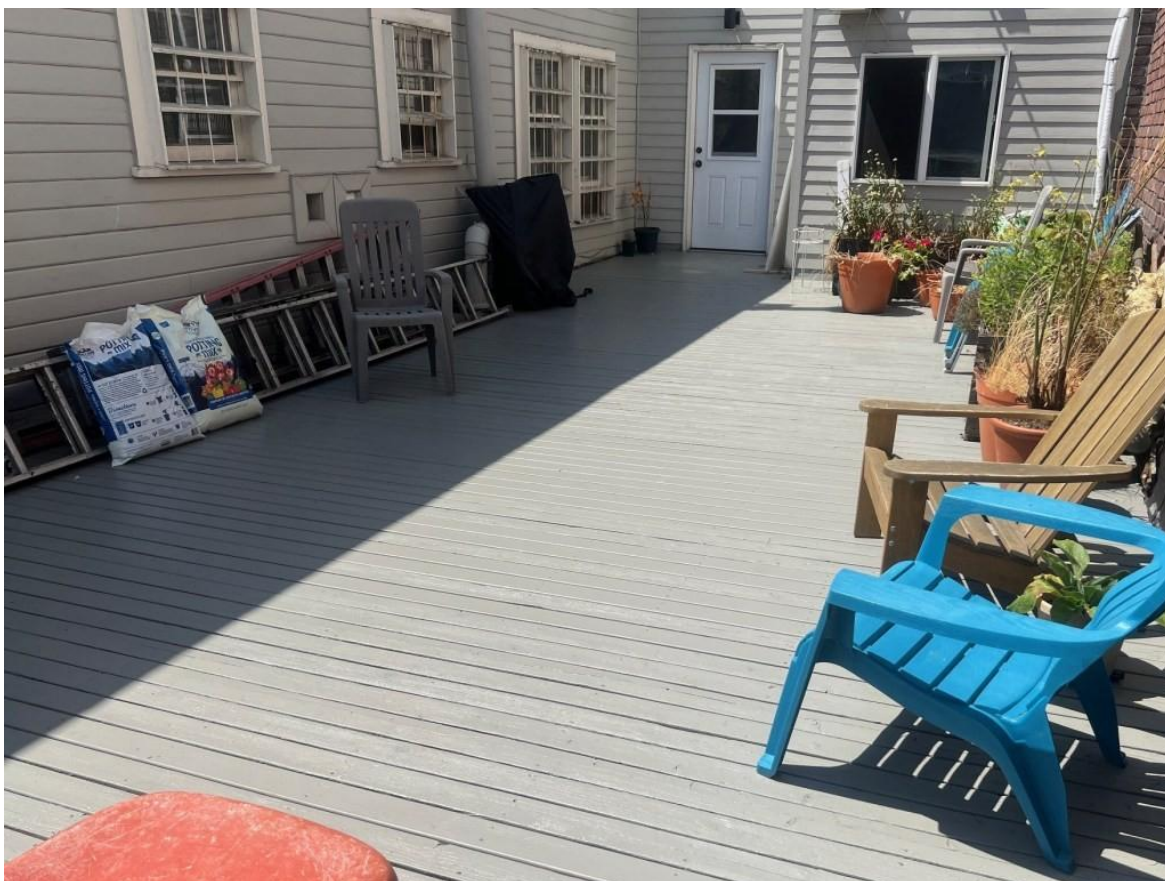
New deck rails as needed and new stain installed.

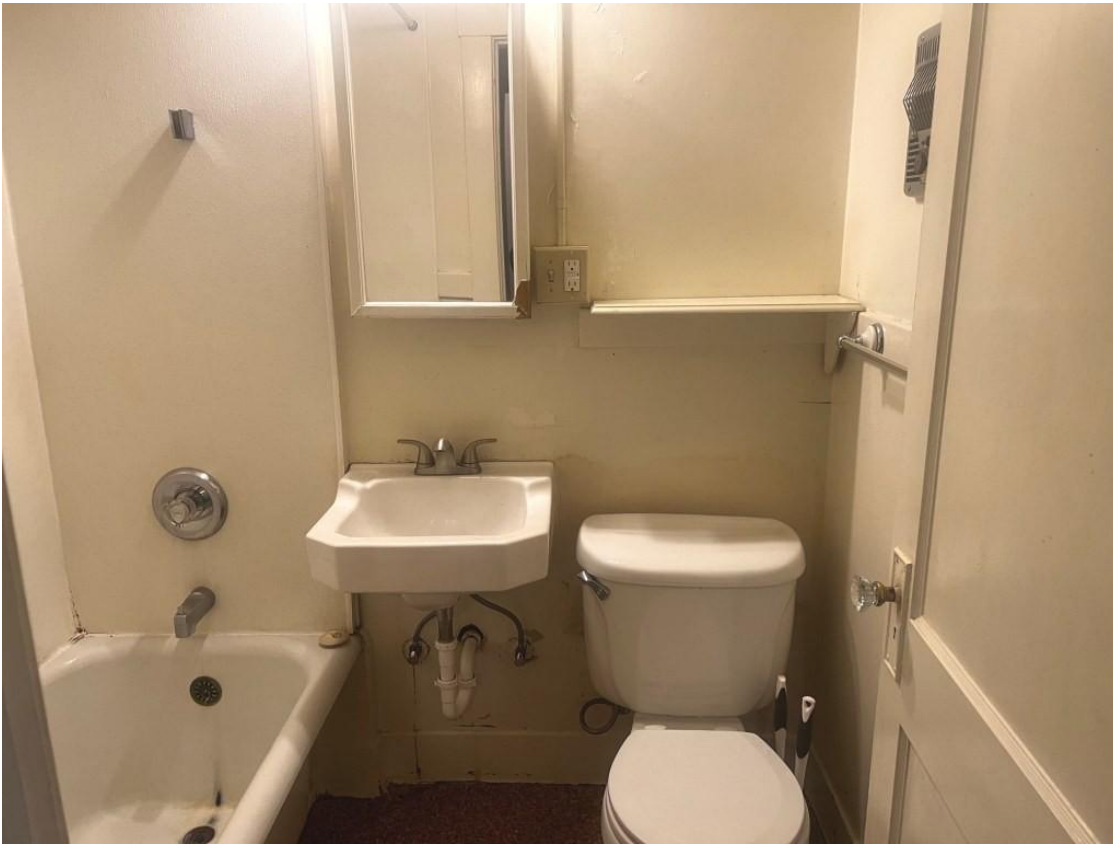
Old Bathroom with non-historic sink and cabinet

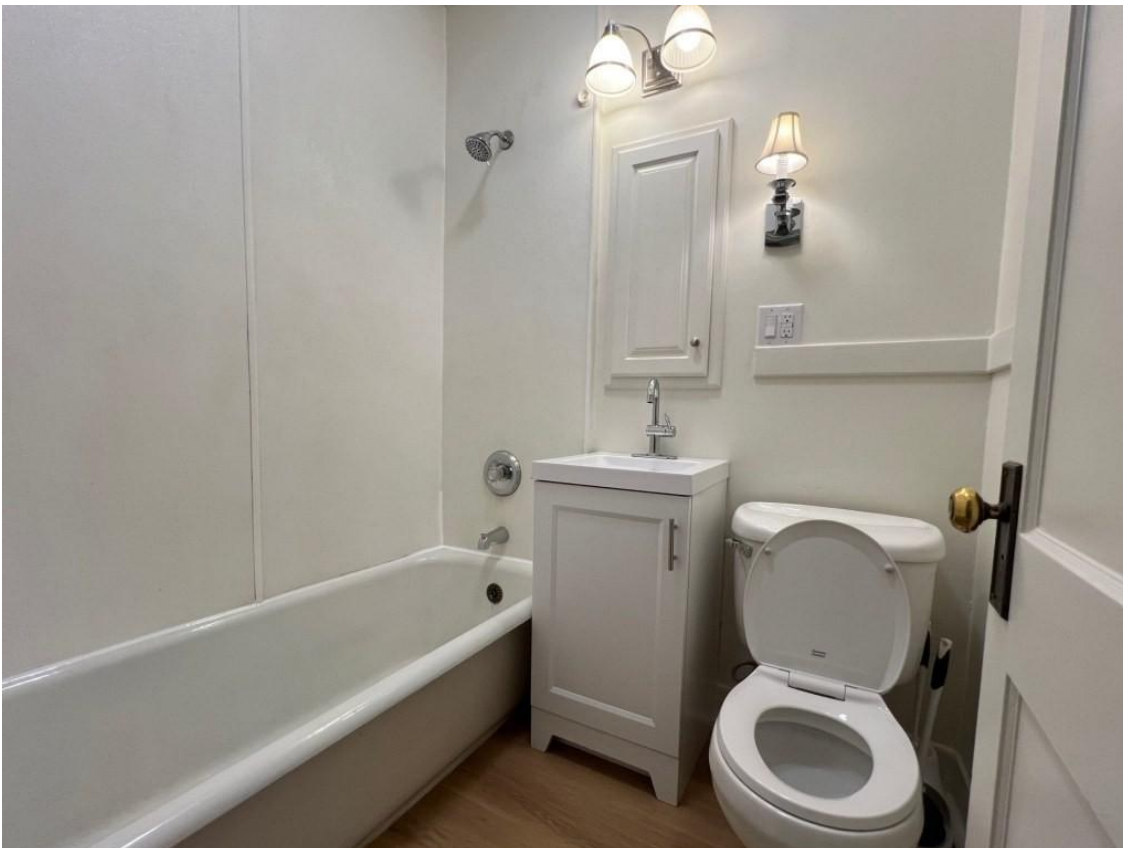
Renovated bathroom keeping historic cast iron tub with new fixtures.

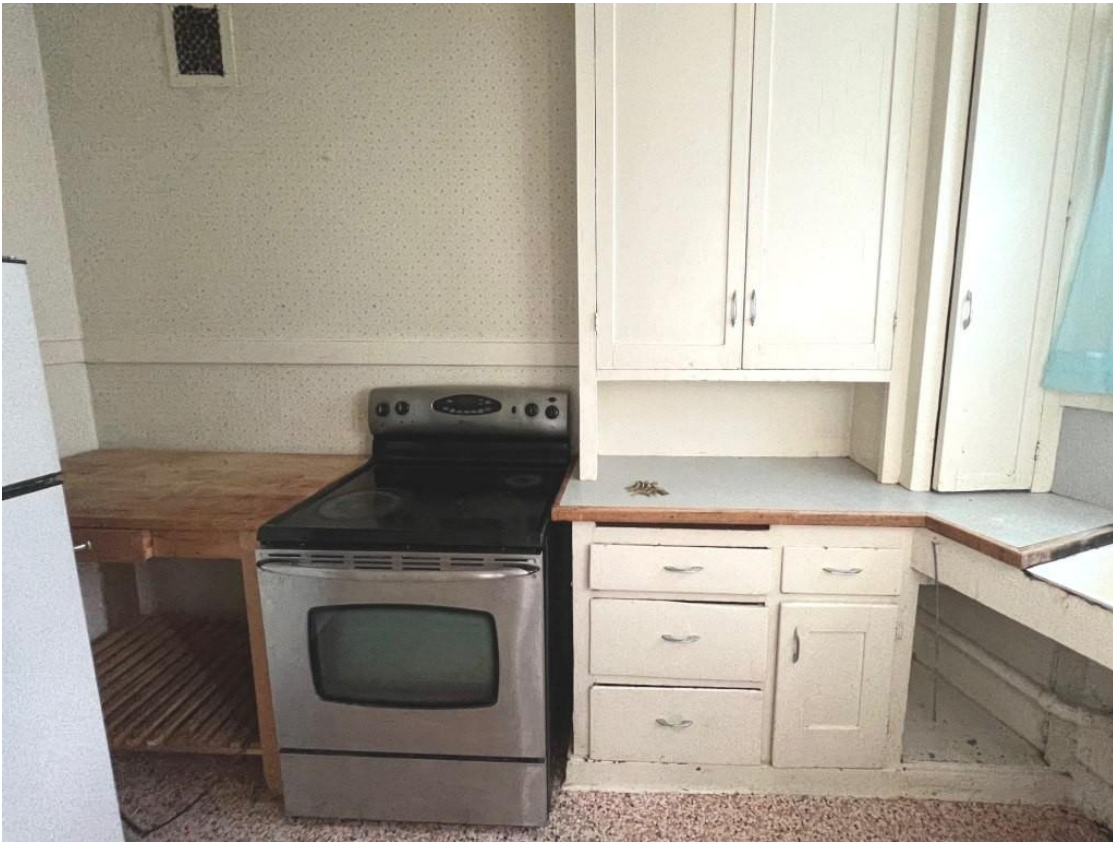
Old kitchen with mixed-match of finishes.

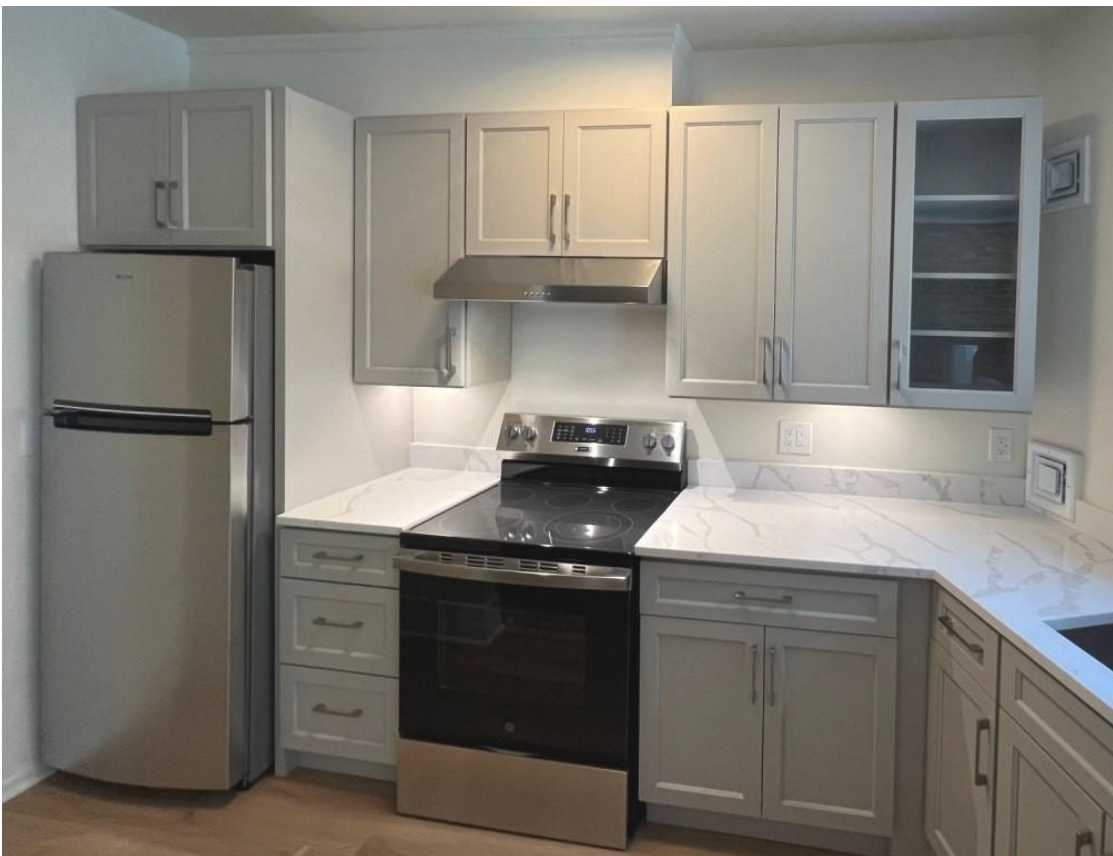
New kitchen with new exhaust hood, appliances, cabinets and counters.

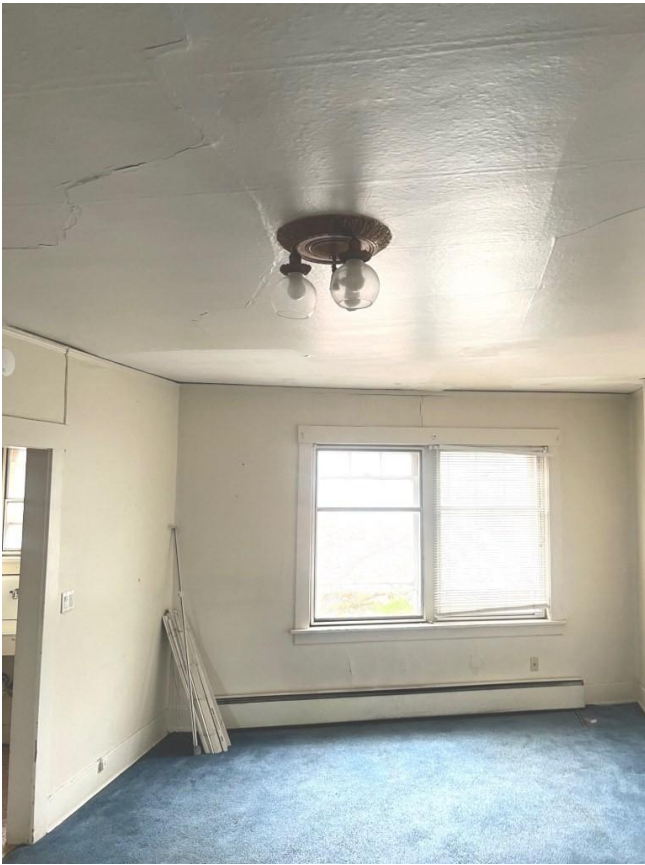
Old living room with old heater.

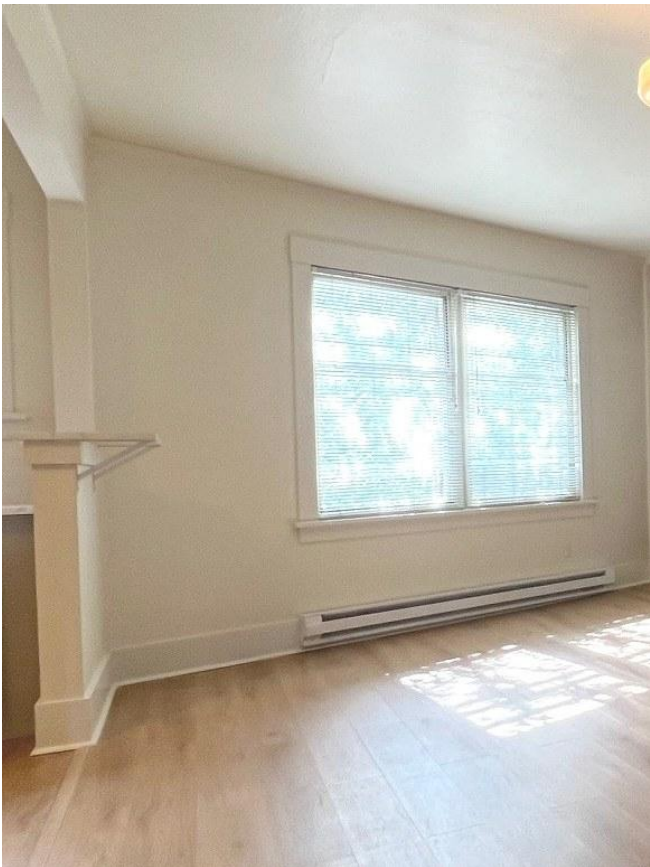
Renovated living room with new heater.

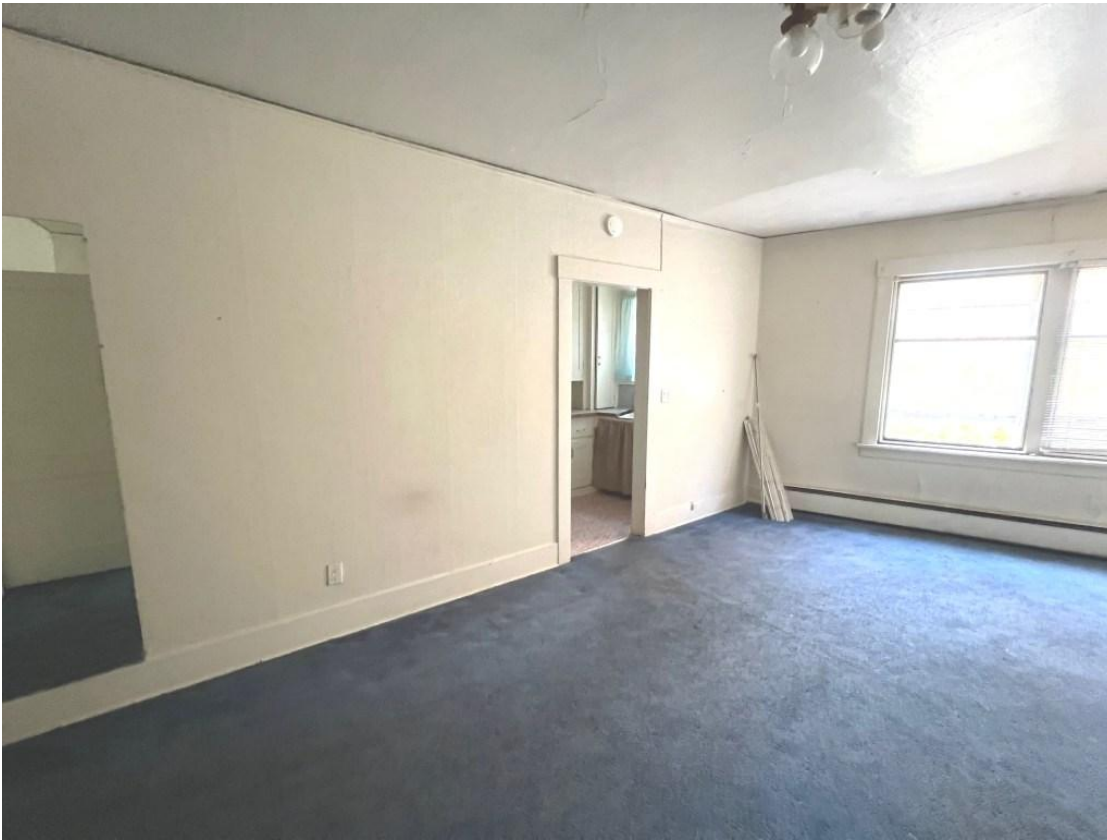
Old living room with old carpet and non-historic lighting.

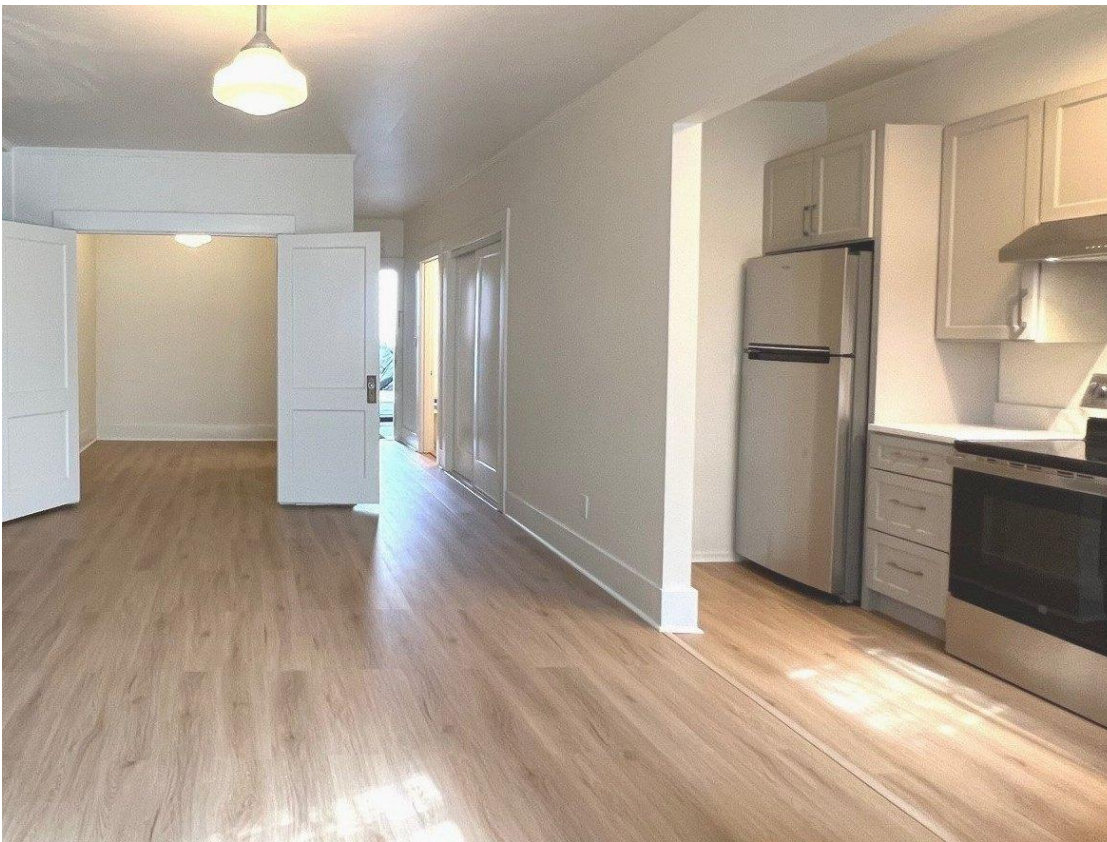
New Living room with new flooring and new lighting.
