Name: Dr. Scott and Imogene Woodin House
(Common, present or historic)

Street Address: 5801 Corson Avenue South, Seattle

Landmark Nomination Report

Dr. Scott and Imogene Woodin House 5801 Corson Avenue South Seattle, King County, Washington

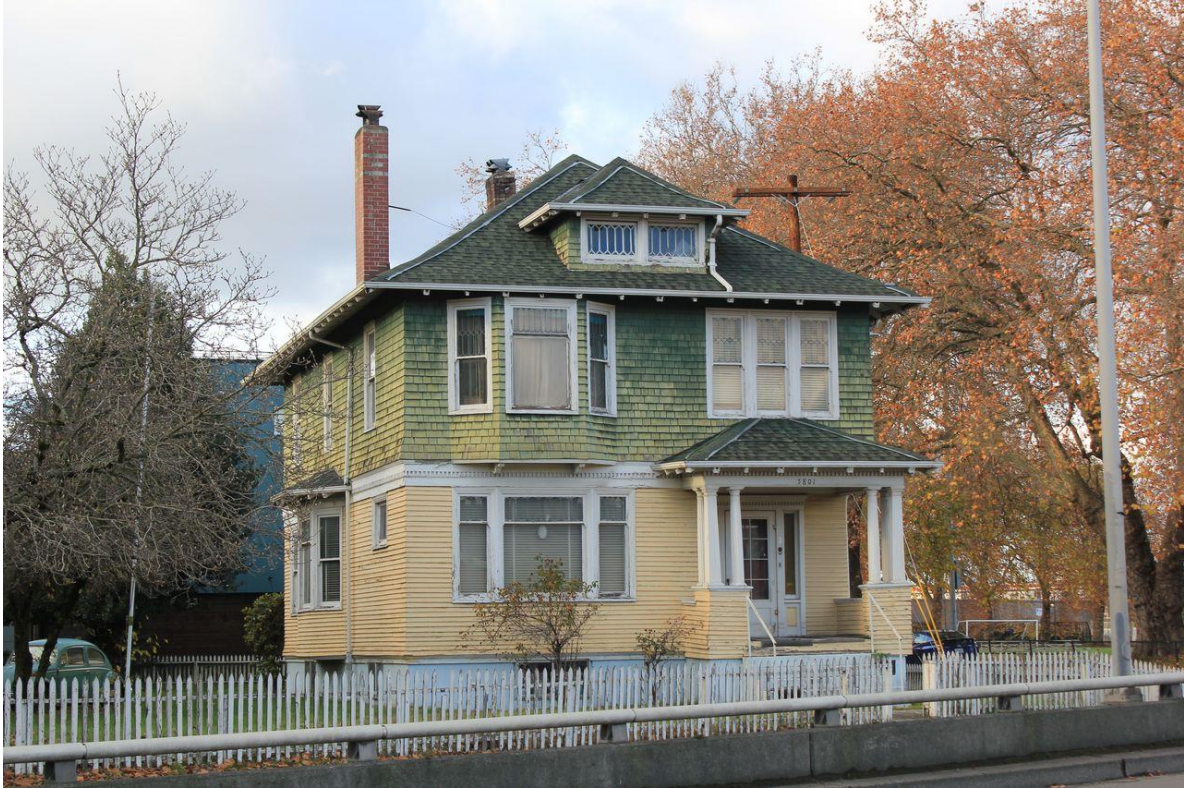
B1. Woodin House, view NW from Corson Ave S exit ramp

The **front (east) façade** contains an offset one-story hipped-roof porch entry with a large tripartite window with an upper leaded-glass sash positioned to one side (figures B1 and B4). The classically detailed porch has grouped, square, and circular fluted columns, raised on wooden plinth blocks, supporting a wood entablature and bracketed hipped roof (figures B12–B13). The porch is slightly inset and includes a classically-inspired single-door entry with sidelights topped by a dentilled crown. A projecting bay window (south) and grouped double-hung wood sash (north) occupy the second-floor level (figures B4–B5). The bay window contains three double-hung wood-sash windows with upper leaded-glass sashes and two decorative wood brackets at its underside. The central hipped-roof dormer contains paired, wood-mullioned sash windows.

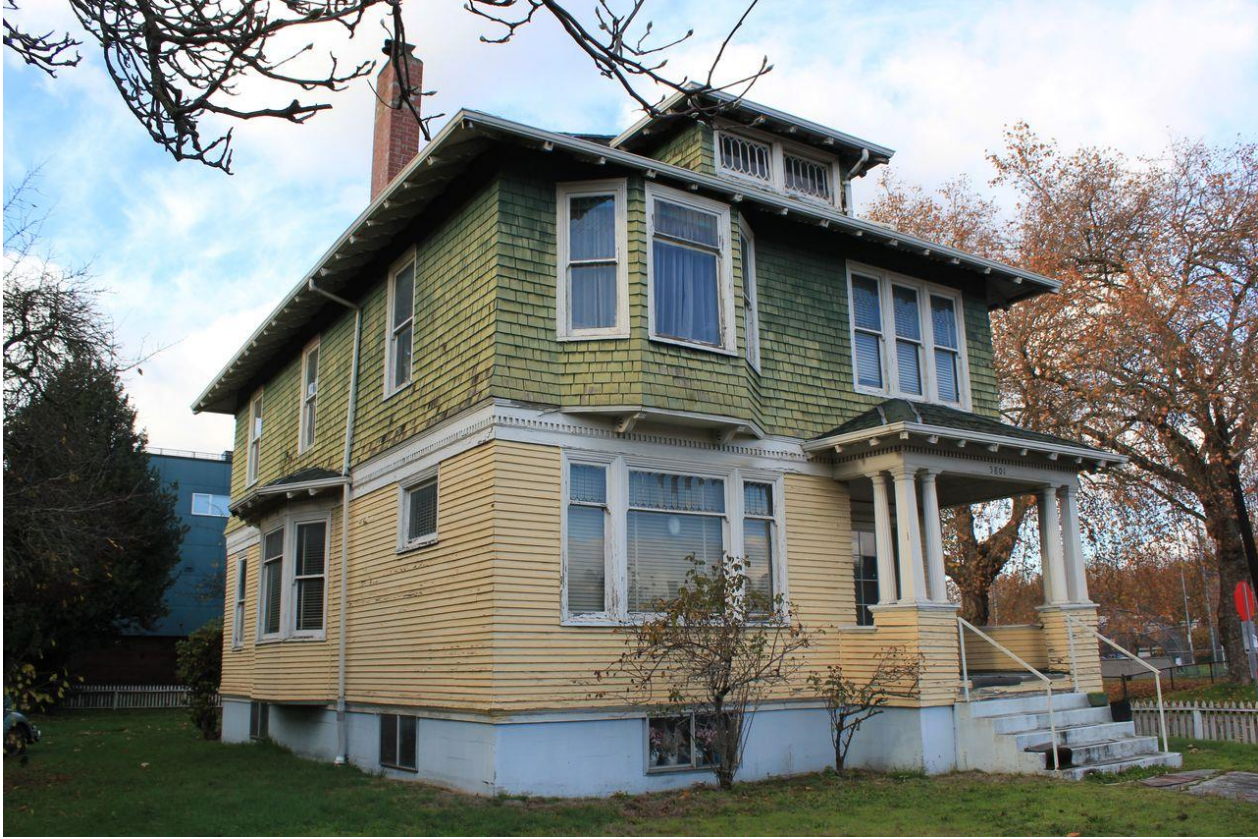
B4. Woodin House, view NNE from the side yard

The **south façade**, which overlooks the sprawling side yard with fruit trees, contains a first-story bay window centered on the elevation (figures B4, B6–B8). The center window of the bay has a leaded-glass sash. A small, rectangular window positioned to the east side of the bay contains the original leaded-glass sash. To the west of the bay is a double-hung, wood sash window. There are three double-hung, wood-sash windows on the second story. An interior brick chimney is located on this side of the house.

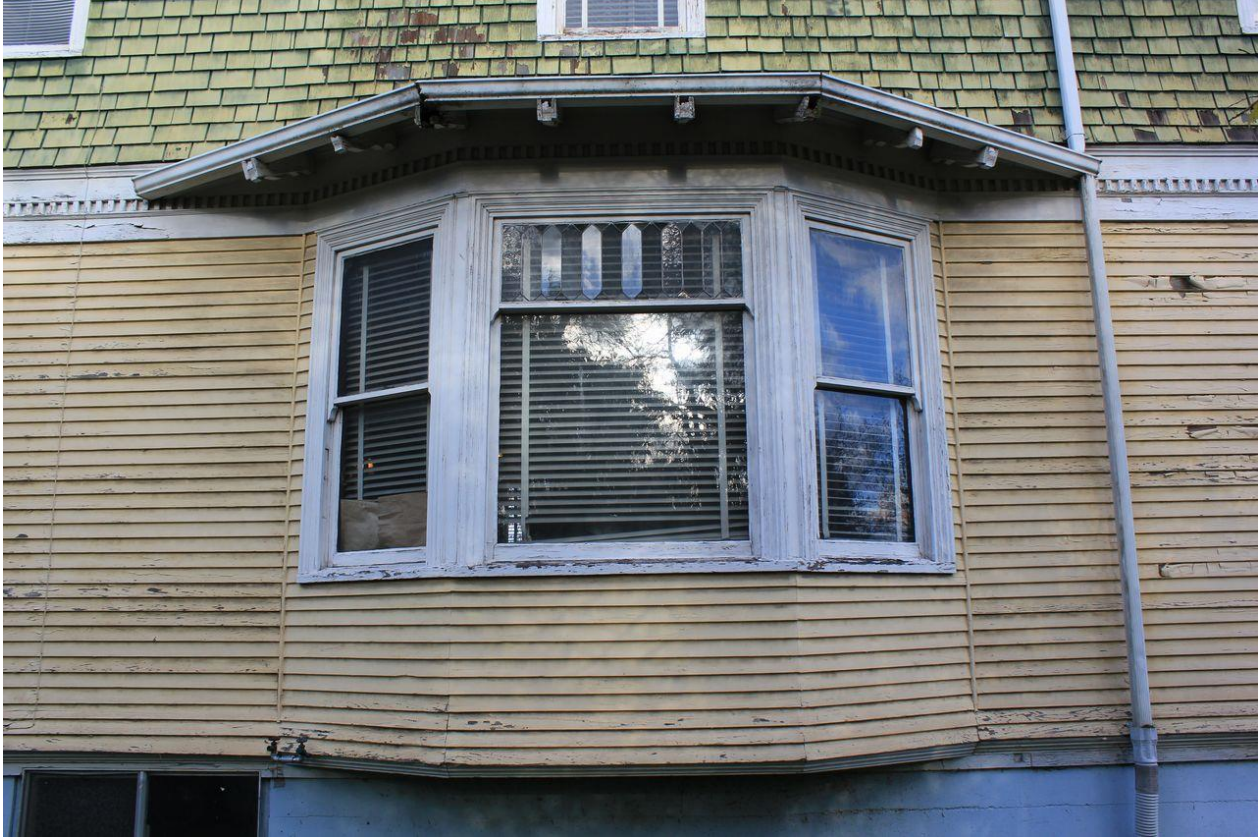
B8. Woodin House, 1st story bay window on SW side elevation

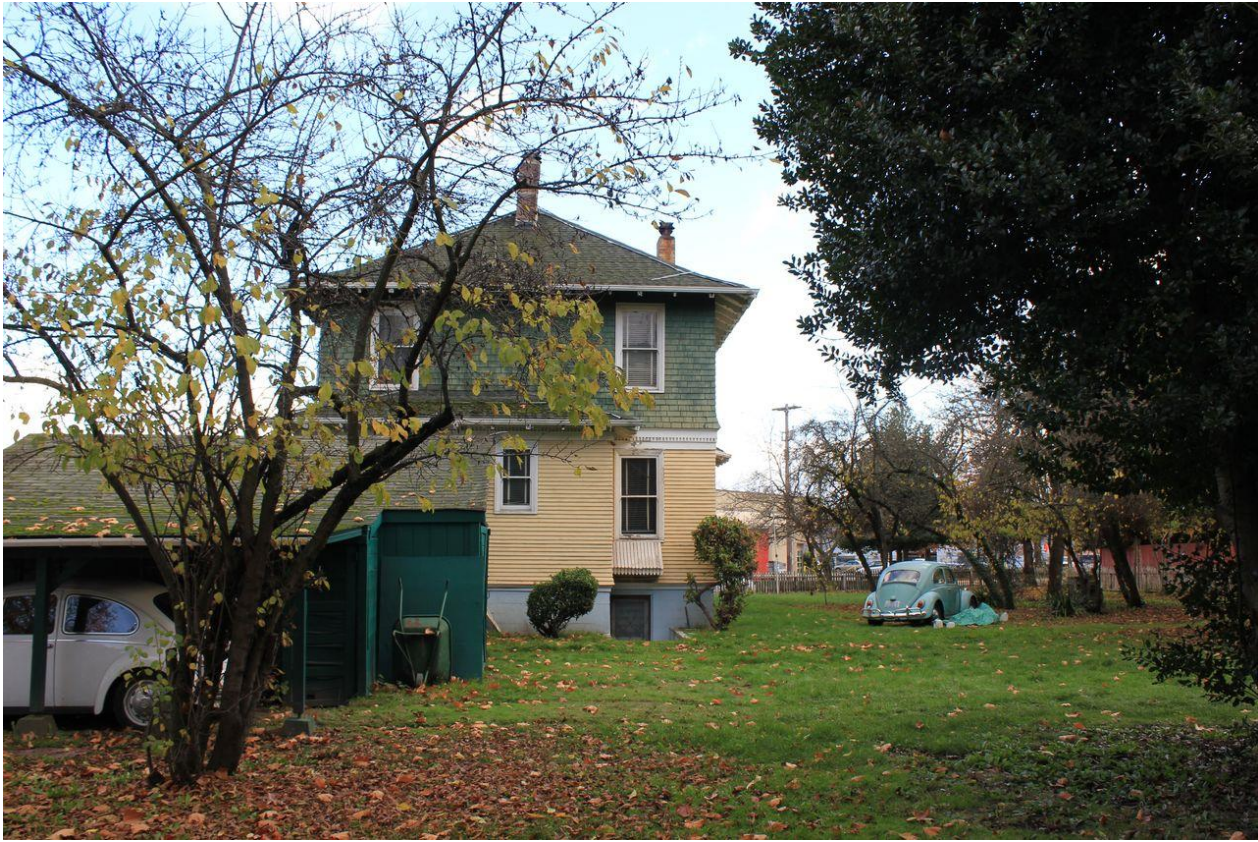
B9. Woodin House, view SE of rear elevation and garage

A one-story hipped roof bay, measuring 5 by 20 feet, is appended to the **rear (west) façade** (figures B7 and B9). The rear entry is centered on this bay, with concrete risers accessing the

The one-car, wood-frame garage has a shed roof with a later lean-to addition attached to the west side (figures B9-B10; C9). It is situated on a low concrete pier foundation. The exterior is a mix of wood claddings, including horizontal boards, drop siding, plywood panels, and vertical pressboard. The north façade that overlooks South Homer Street features just one opening—a single window opening with a missing sash. A hinged, double-door opening is on the south-facing side and is accessed from the rear yard.

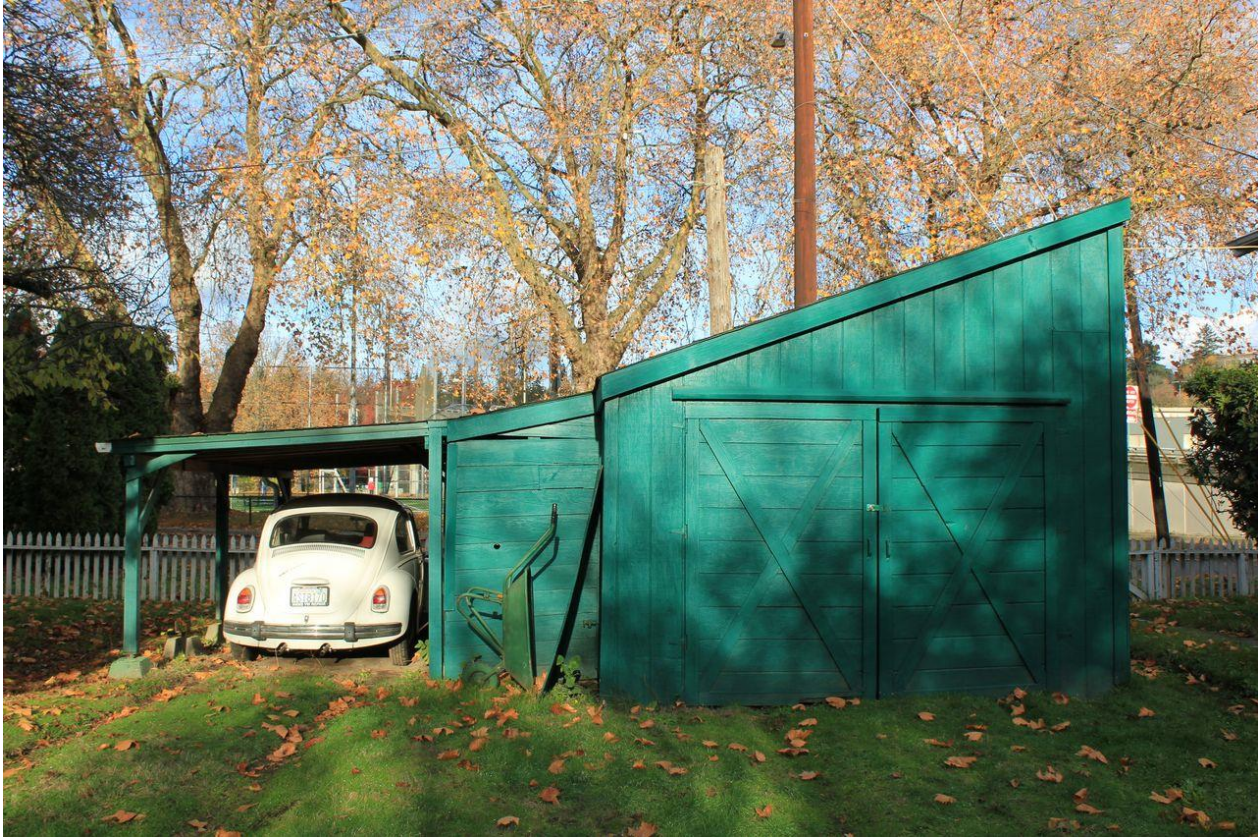
B10 Garage, view NE toward S Homer St

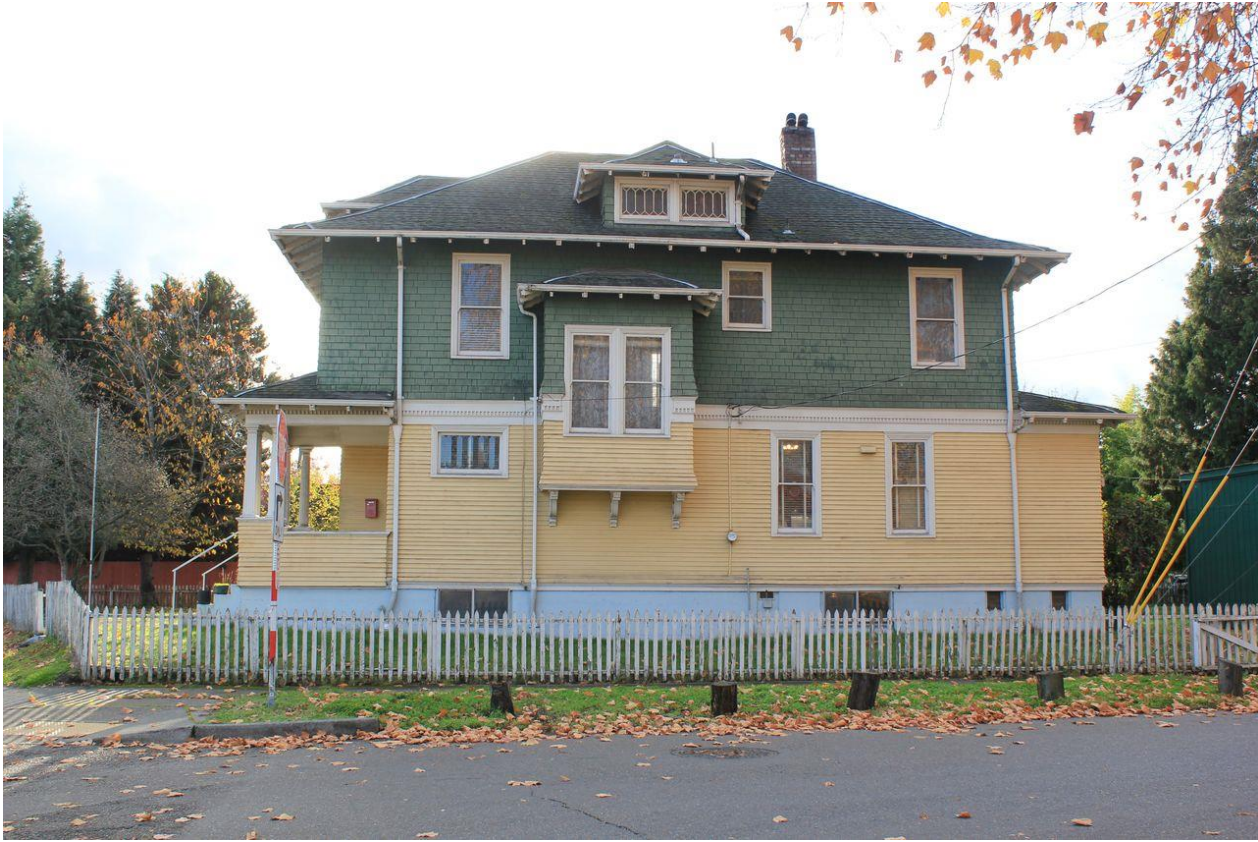
B11. Woodin House, view SW from S Homer St of side elevation

The **north façade**, which faces South Homer Street, features a cantilevered staircase bay supported by three scrolled wood brackets (figures B11–B12). The bay contains paired, double-hung wood sashes and incorporates the dentilled belt course that stretches across the main façade's midsection. A small, rectangular window positioned to the east side of the bay contains the original leaded-glass sash. Two double-hung, wood-sash windows occupy the west end of the first story. The upper story contains three double-hung, wood sash windows and a hipped roof dormer is centered on the roof slope above. The central hipped-roof dormer contains paired, wood-mullioned sash windows.

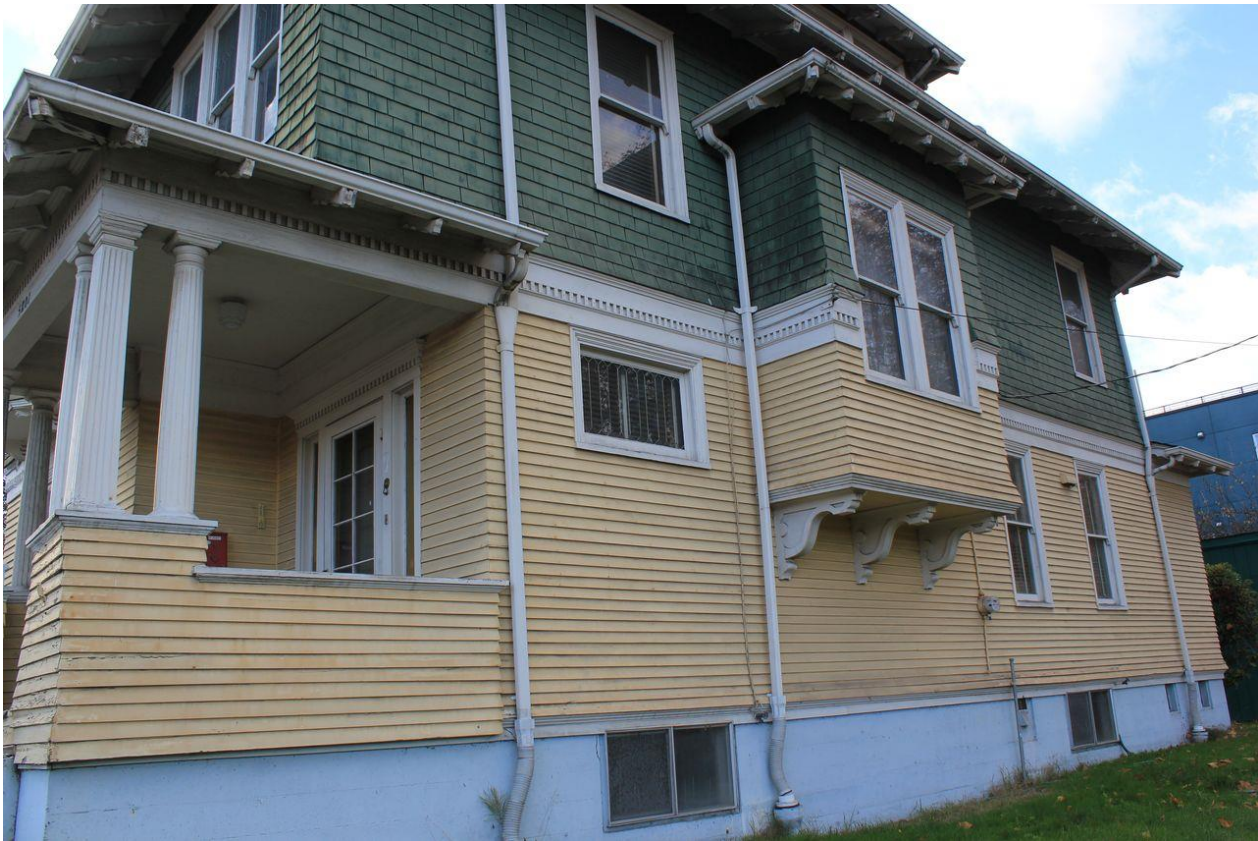
B12. Woodin House, view W showing the side of the porch and the square bay window on side NE side elevation

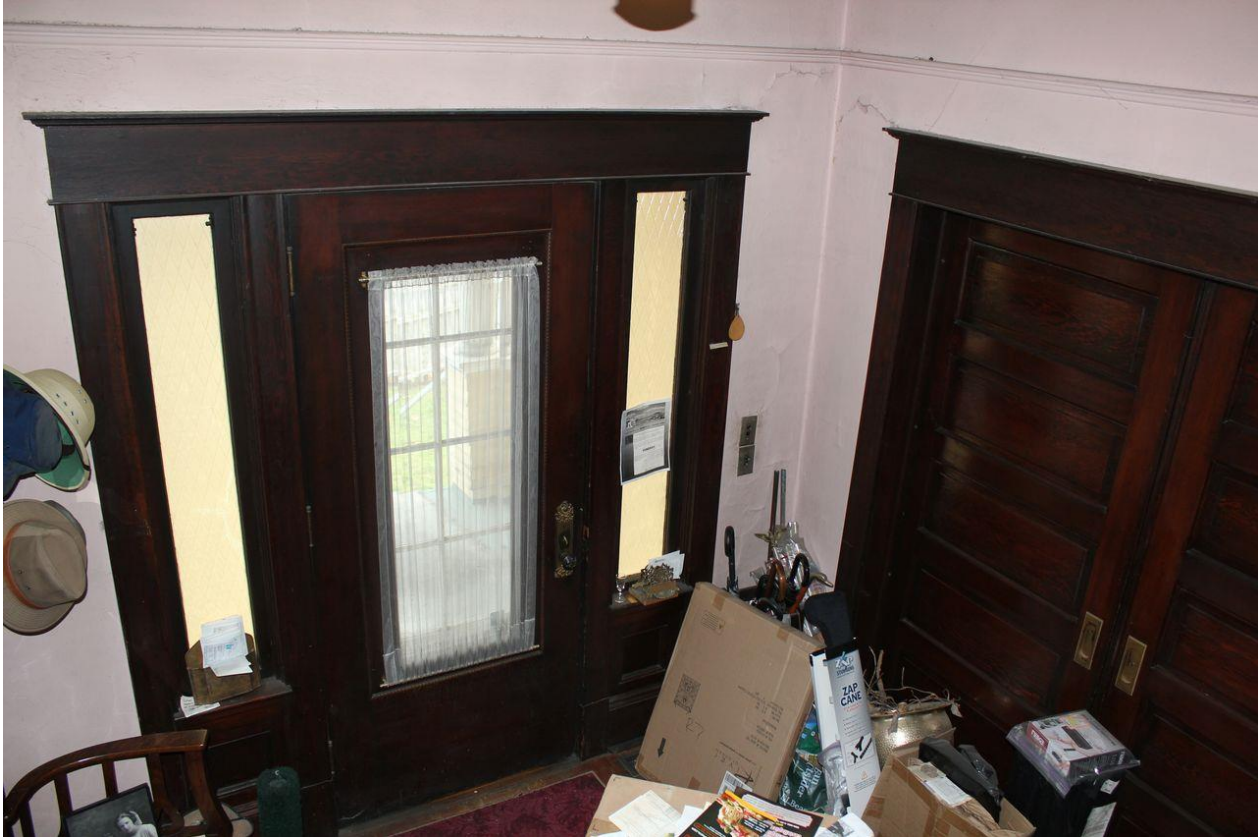
B14. Interior, view of primary entry taken from the main staircase to the 2nd floor

The u-shaped staircase to the second floor dominates the **entry hall**, with its paneled dark wood treatment and wainscoting (figures B14-B17). The balustrade features turned balusters capped by a smooth well-worn handrail. There are three newel posts, at the base, landing, and top of the staircase, each with a square base, a paneled shaft embellished with an egg-and-dart motif, and a square cap with fretwork. A single light fixture hangs in the entryway, and natural light illuminates the space from the front door, a small, leaded-glass window on the north wall, and tall paired windows at the staircase landing. Opposite the front door, beyond the base of the stairs, is a five-panel door that leads to the kitchen. The entry hall's south wall features five-panel pocket doors through which is the living room.

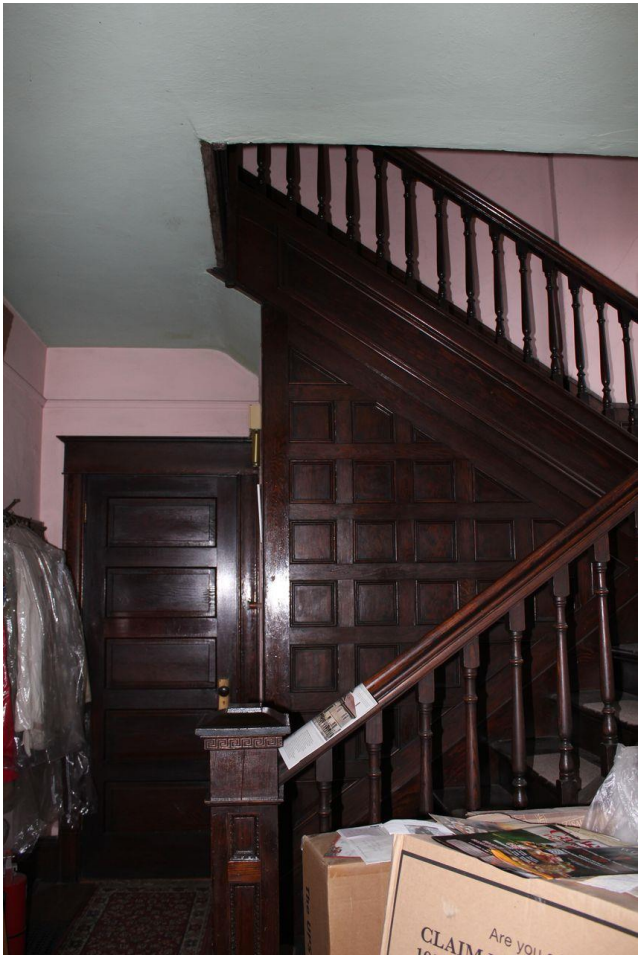
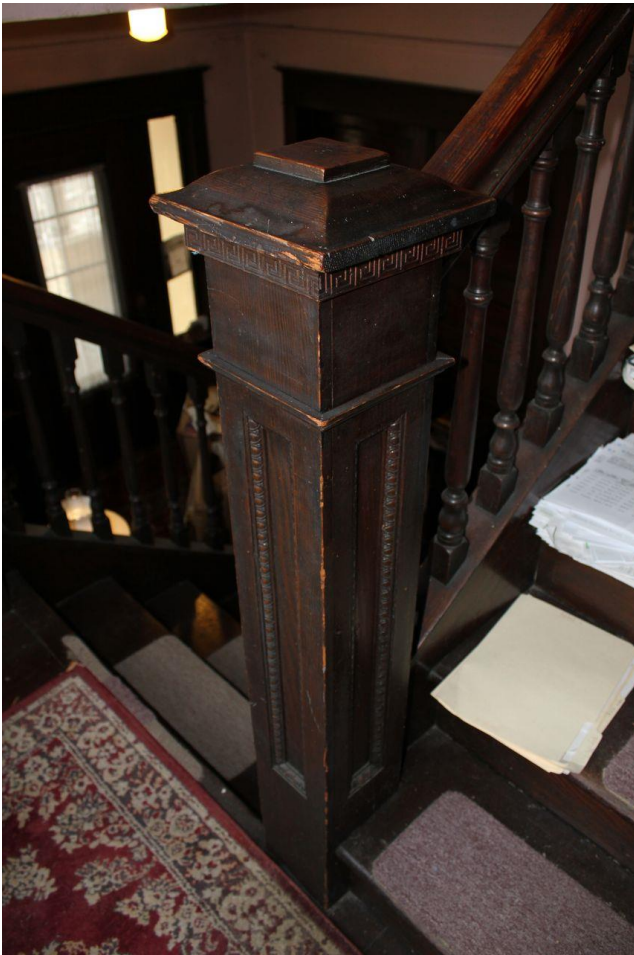
- B15. (Left photo) Interior, view of the kitchen door (left) and main staircase to the 2nd floor
- B16. (Right photo) Interior, view of newel post on main staircase between 1st and 2nd floors

The u-shaped staircase in the entry hall provides the only access to the **second floor** (figures B15-B17). The staircase terminates in a square center hall, which accesses all of the second-floor rooms (figures B18-B19). In all, there are eight five-panel doors in the hall. **Bedrooms** with built-in closets are situated in the four corners of the house. (The east corner bedroom, above the front porch, was Dr. Woodin's private practice examination room. No photos or accounts of the exam room's appearance survive and today the space appears very much like the other bedrooms.) A small **nursery** with a closet is centered on the south wall opposite the staircase. A **bathroom** with a wall-mounted porcelain sink, toilet, clawfoot tub, and built-in medicine cabinet is located next to the staircase. A door centered on the west wall accesses a **hall closet**. A door centered on the east wall of the hall leads to an **enclosed attic staircase**. The attic space is unfinished.

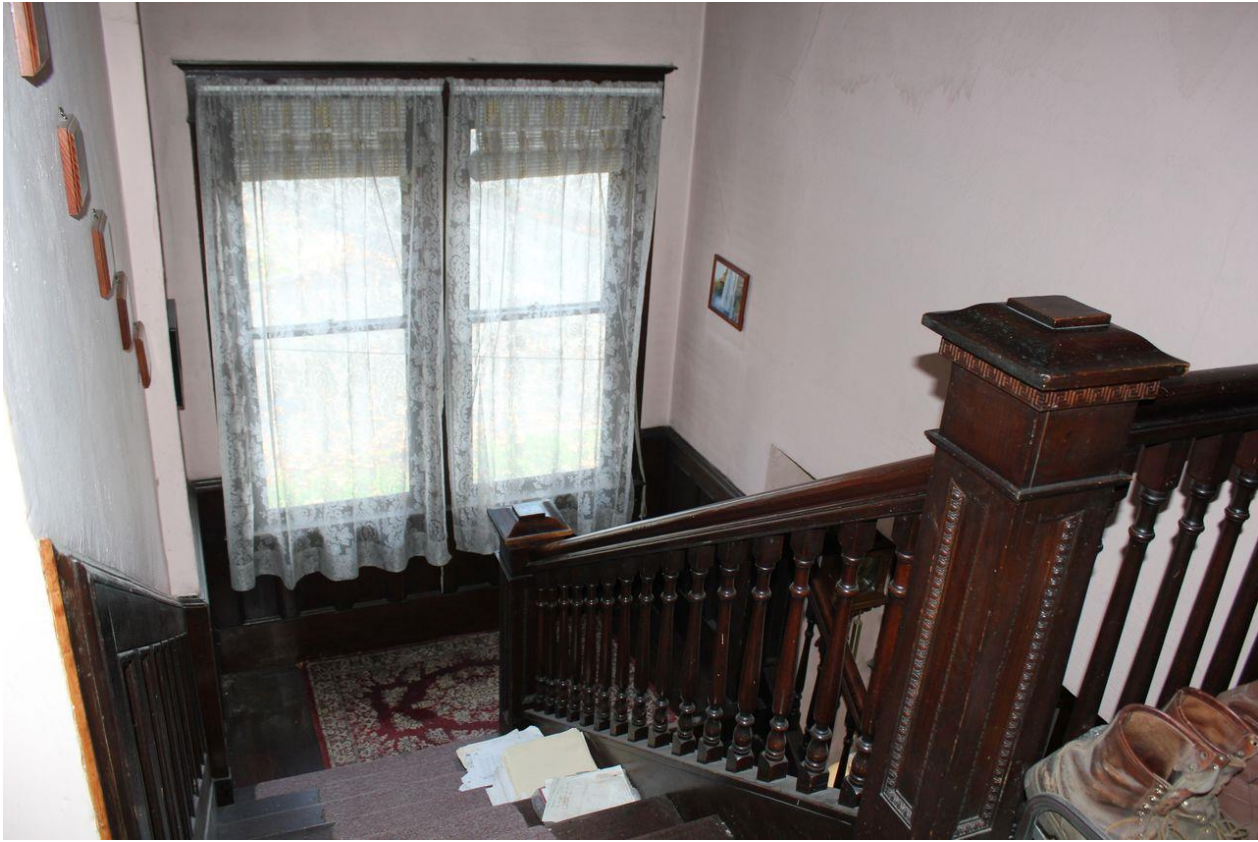
B17. Interior, view from the top of the staircase at the 2nd floor

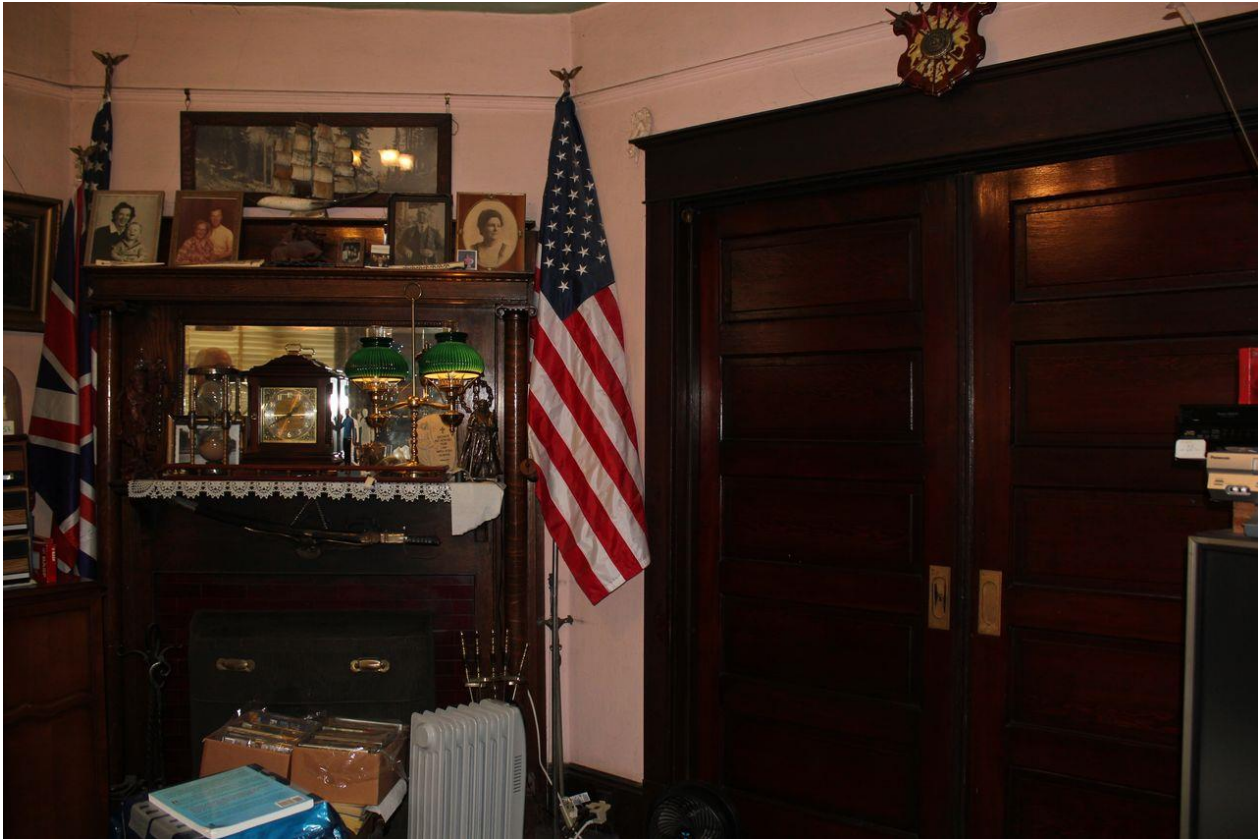
B26. Interior, 1st floor, view of fireplace and pocket doors

The **living room** occupies the southeast corner of the first floor (figures B25-B26). In the southwest corner of the living room is an impressive classically inspired fireplace and mantel. A small cast-iron coal burner and a red tile surround comprise the fireplace. The mantel includes a wood overmantel with a shelf and mirror supported by two narrow circular columns with delicate Ionic capitals. An original light fixture hangs from the ceiling at the center of the room. There is another five-panel pocket door on the west wall through which is the dining room.

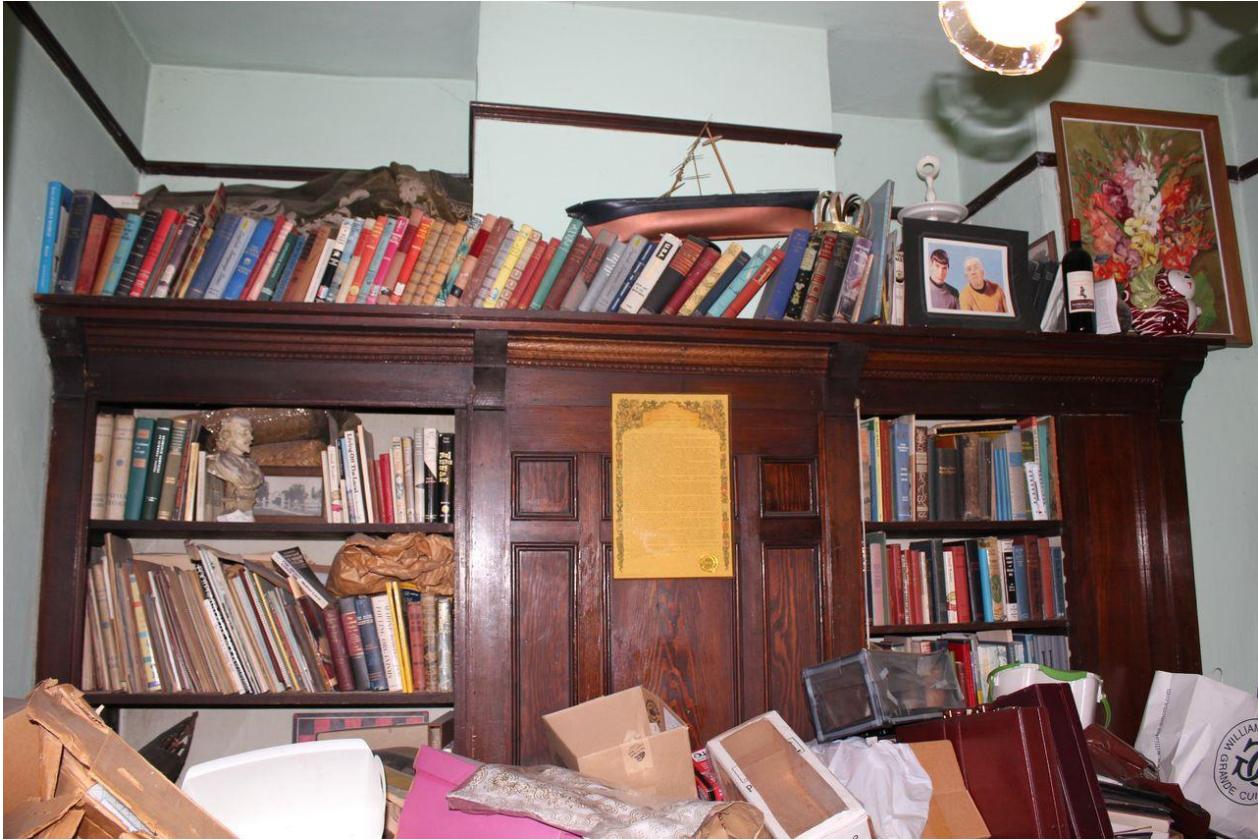
B27. Interior, 1st floor, library bookcases

The **library's** north wall features an enclosed chimney flue that services the kitchen on the other side of the wall (figure B27). The flue is faced with wood paneling and is flanked by built-in bookcases with crown molding, egg-and-dart trim, and scrolled brackets. An original light fixture hangs from the ceiling at the center of the room. A picture rail encircles the room. A five-panel door on the west wall opens to a closet.

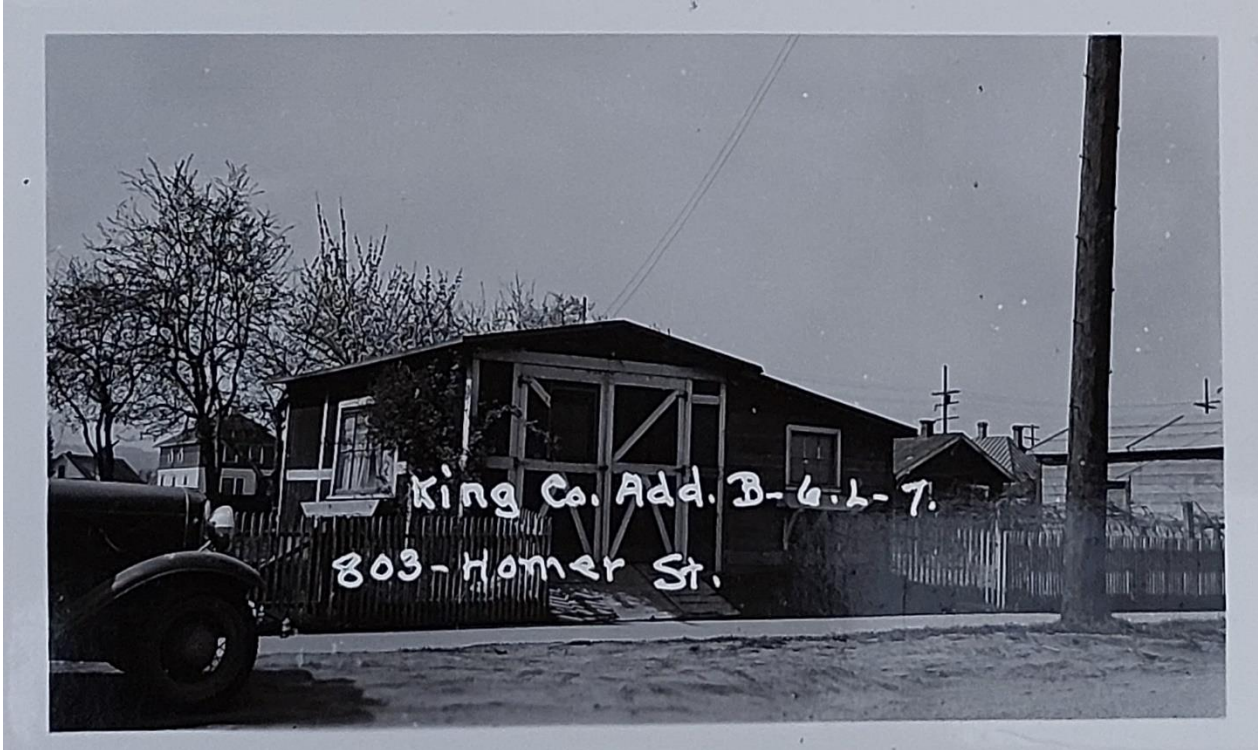
C9. Outbuilding behind Woodin House, 1937. Source: King County Assessor (Puget Sound Regional Archive, Bellevue, WA). Note the still-extant residence at 823 S. Orcas Street in the background.

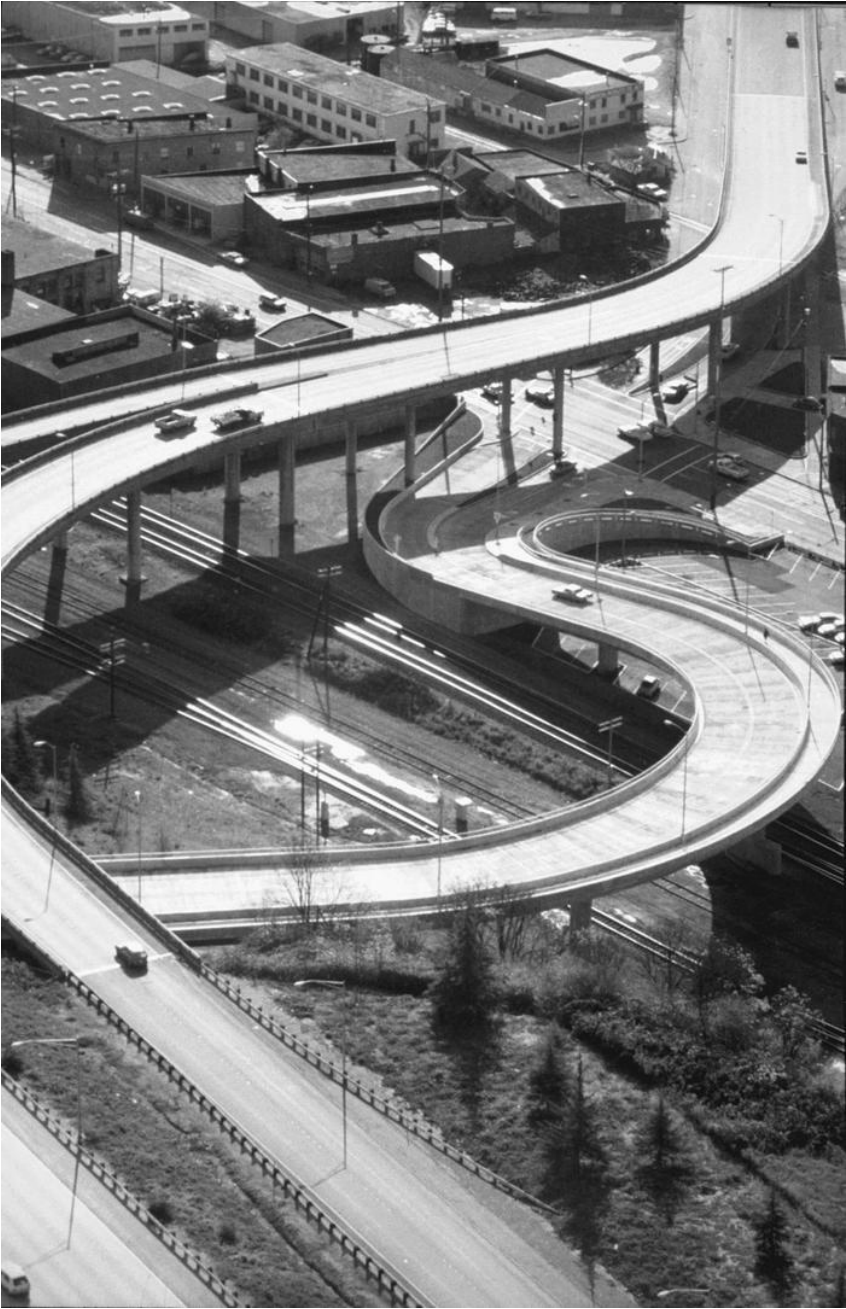
C10. Interstate 5 Exit at Corson Avenue South, ca. 1967. The Woodin House is not shown but is just out of sight at the top right. Source: Seattle Municipal Archives

Georgetown emerged from the war as a rapidly changing community overtaken by industrial development, and “as early as 1923, the entire area of Georgetown was identified as an industrial zone although area residents managed to force rezoning of the residential areas by 1942.”¹³ Following WWII, most wartime workers and their families moved on, and the Duwamish Bend housing project had closed by 1954. Once-thriving businesses shuttered, the movie theater and library closed, and the King County Hospital building was closed and torn down in 1956, the same year Seattle’s Comprehensive Plan called for “phasing out” the remaining residential areas in Georgetown.¹⁴ The completion of Interstate 5 through the area in 1962 significantly altered the landscape and local transportation network, creating physical barriers and cutting off the old community with that of south Beacon Hill. The Corson Avenue South exit off Interstate 5 brought traffic from the elevated highway into Georgetown toward East Marginal Way S and Highway 99 (figure C10).

Woodin residence in the 1960s when the development of Interstate 5 forced the relocation of the house to make way for the Corson Avenue South exit ramp (figure C10). The ramp was built on top of the old four-lane Corson Avenue South, taking approximately 28 feet along the east part of the property. The house was moved west approximately 25 feet onto a new concrete foundation in 1965-67.³⁹
