# 2ND AND VIRGINIA

# PROJECT OVERVIEW

The Terminal Sales Annex building is located in Seattle's Belltown neighborhood (1931 2nd Avenue) as a designated Seattle Landmark. The building was designed in the distinctive Collegiate Gothic Revival style by architect's Bebb & Gould. Charles Bebb was a leading innovator in the use of architectural terracotta in the Seattle area.

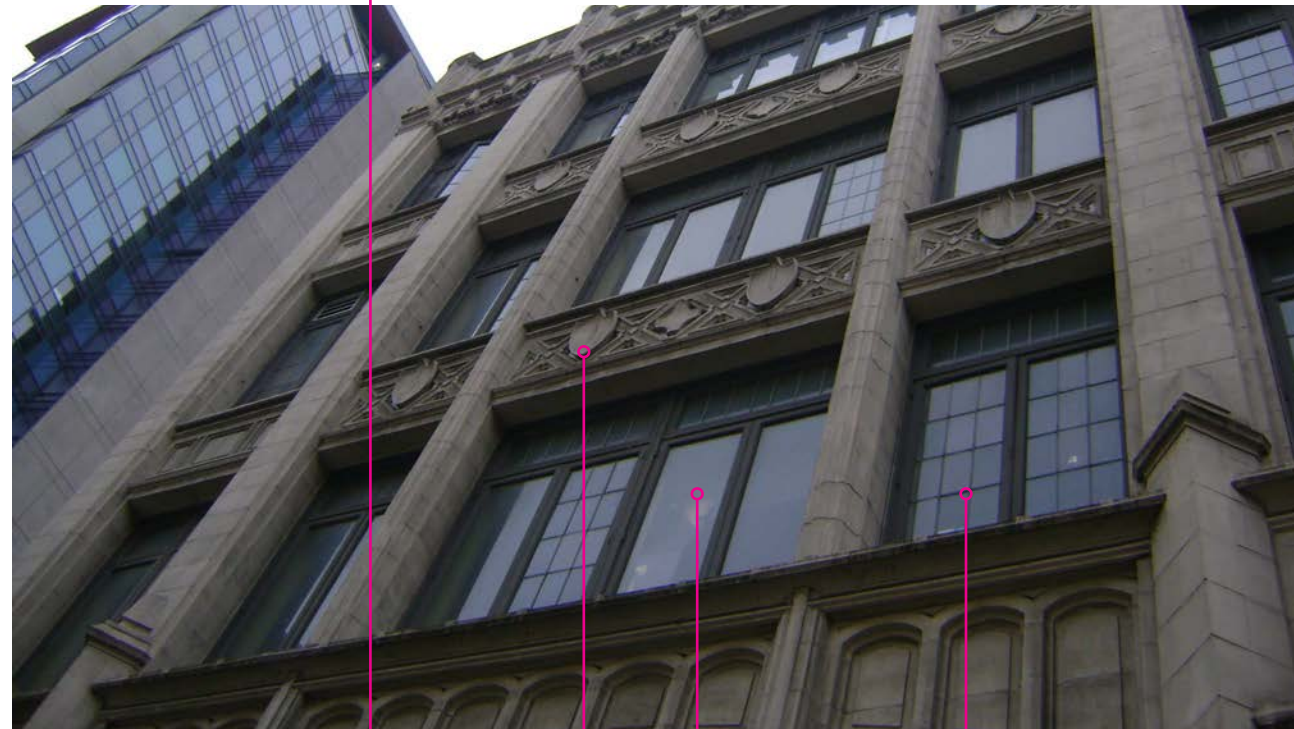
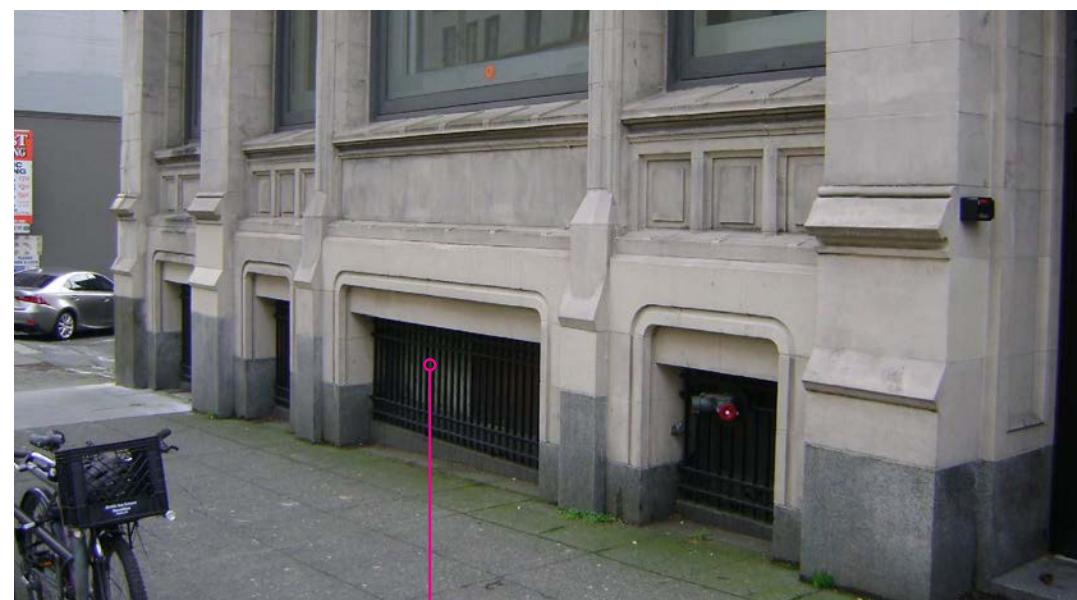
# Landmark Existing Conditions

- LEGEND**
1. Terra cotta over concrete column
  2. Terra cotta over steel column
  3. Colored "diaper" background
  4. Ornamental parapet, stylistically stepped like window lintels during that era
  5. Trefoil motifs at parapet
  6. Floor-to-ceiling Tudor-style wood windows
  7. Flat arch motifs on 1st floor frieze
  8. Painted metal sash @ arched windows
  9. Niche (1 of 2)
  10. Flush spandrel panels with Heraldry ornamentation
  11. Non-original single pane plate glass
  12. Original multi-paned leaded glass
  13. Grilles over basement windows

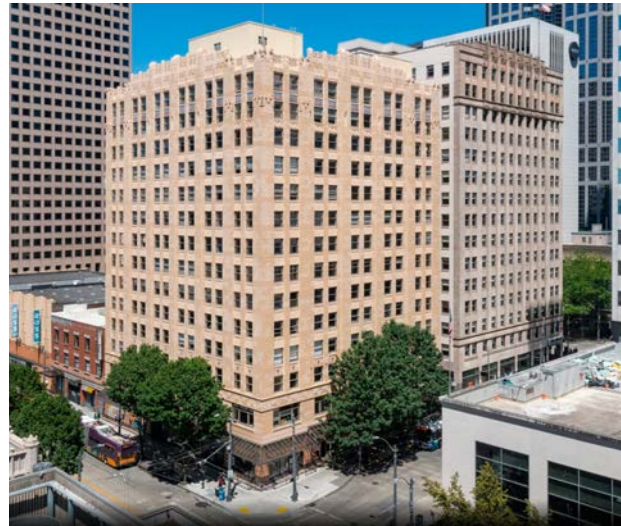
## Joseph Vance Building

- Selective Paint Removal at Entire Facade
- Stone Removal
- Stone Repair
- Stone Replacement
- Steel Repair or Replacement at Repair Areas
- Facade Cleaning
- Tuck Pointing
- Sealant Replacement

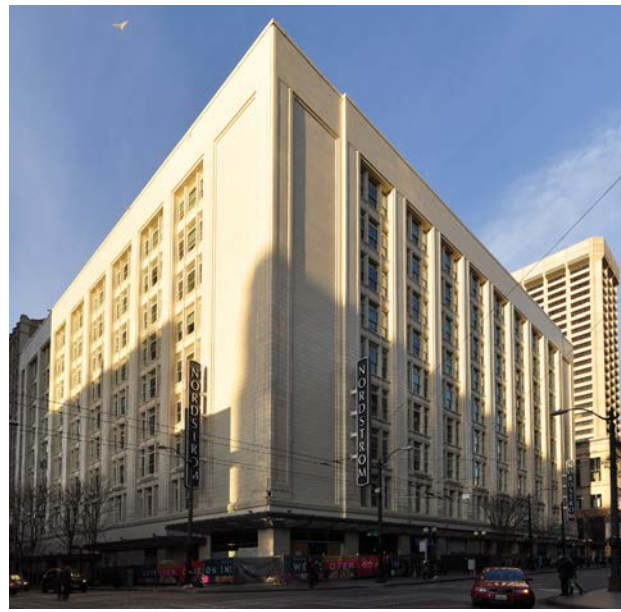
## Nordstrom Store 1

- Terra Cotta Patching
- 100% Tuck Pointing
- Terra Cotta Replacement with GFRC, Floors 2-5 at E, S and W Elevations Between Columns
- Facade Cleaning
- Sealant Replacement
- Window Restoration and Anchoring

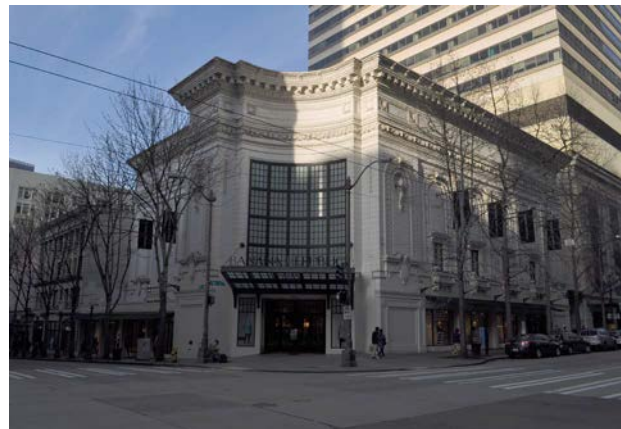
## Coliseum Theater

- Selective Paint Removal
- Stone Removal
- Stone Patching
- Stone Replacement
- Steel Repairs
- Facade Cleaning
- Tuck Pointing
- GFRC Panels at Storefront

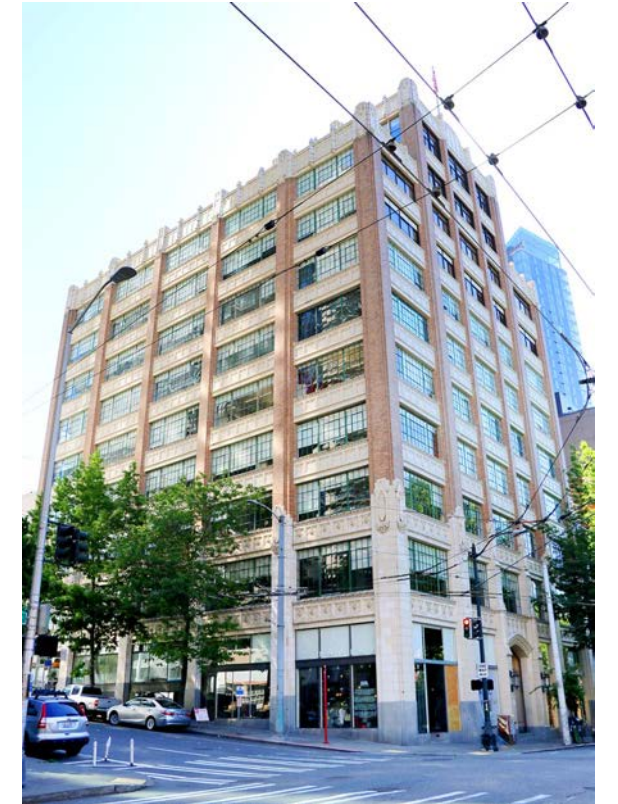
## Terminal Sales Building

- Terra Cotta Patching
- Terra Cotta Repair
- Tuck Pointing
- New Lintels Above Windows at West Elevation
- Facade Cleaning
- Sealant Replacement
