William Grose Center Landmarks Preservation

Revised 18 June 2024

Fire Station 6: Existing Conditions, Proposals, and Request for Guidance

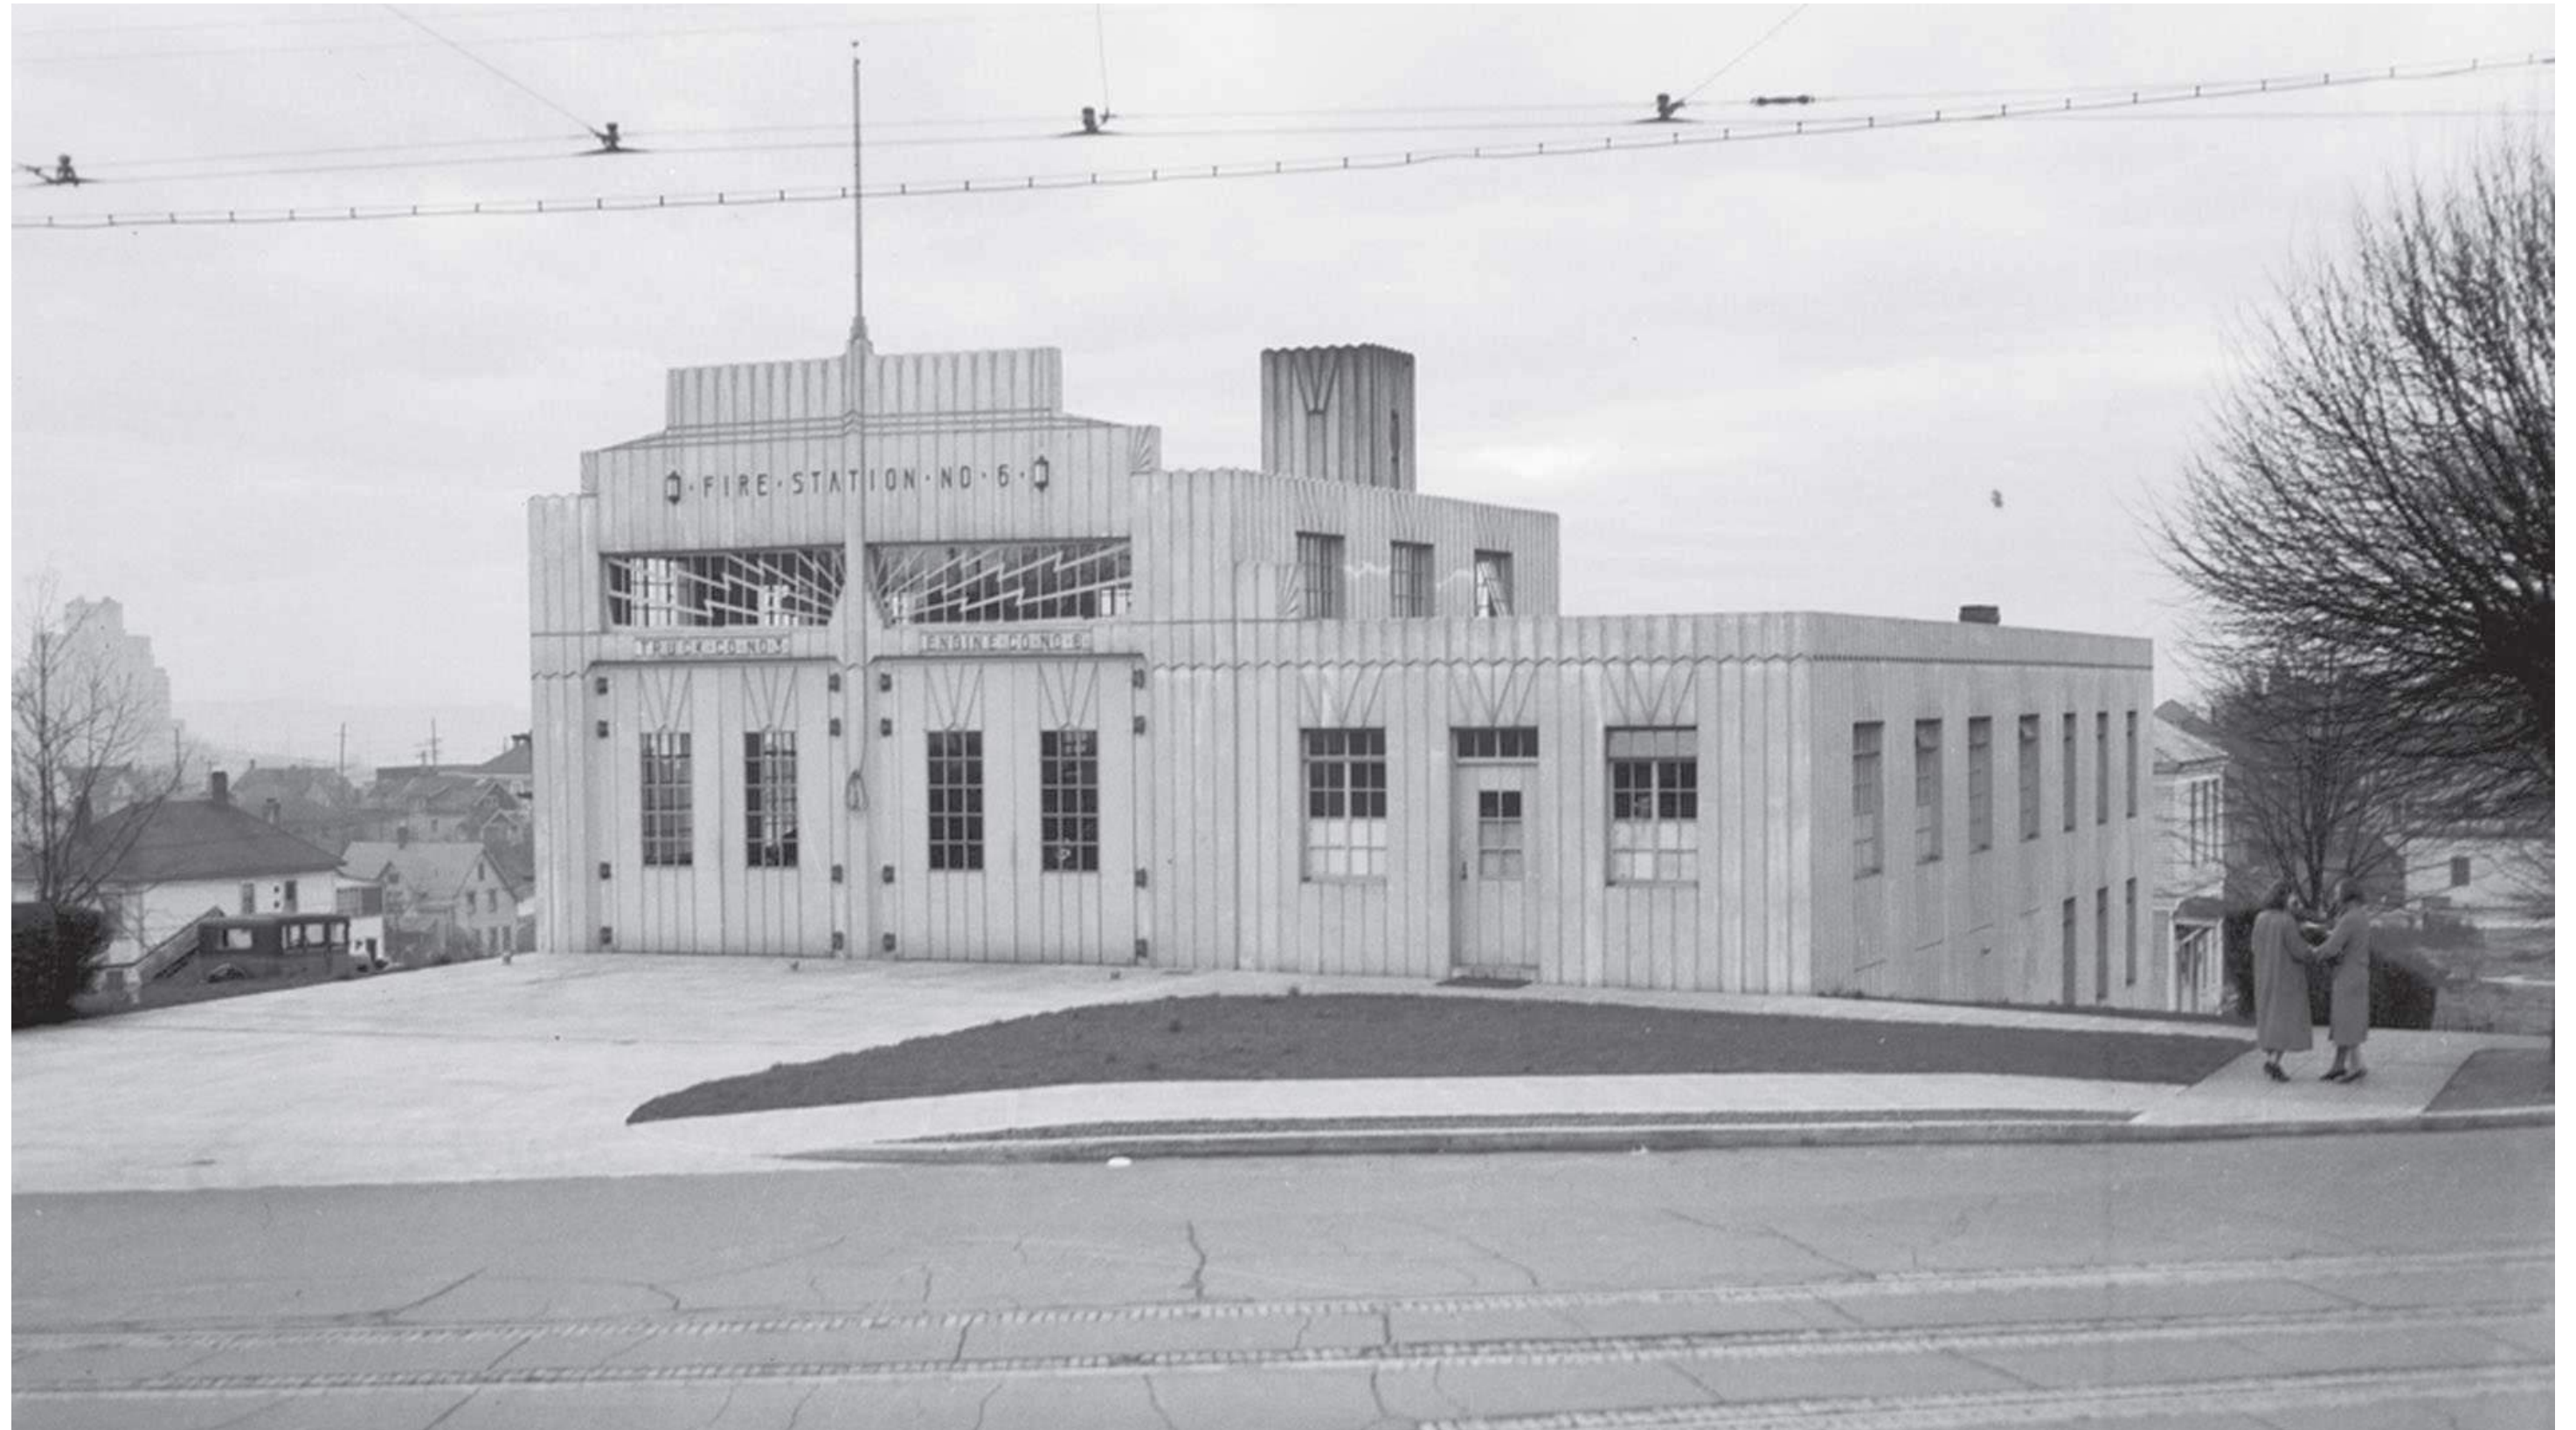
figure 1: Historic photo showing apparatus bay doors, lightning bolt window, and typical windows.

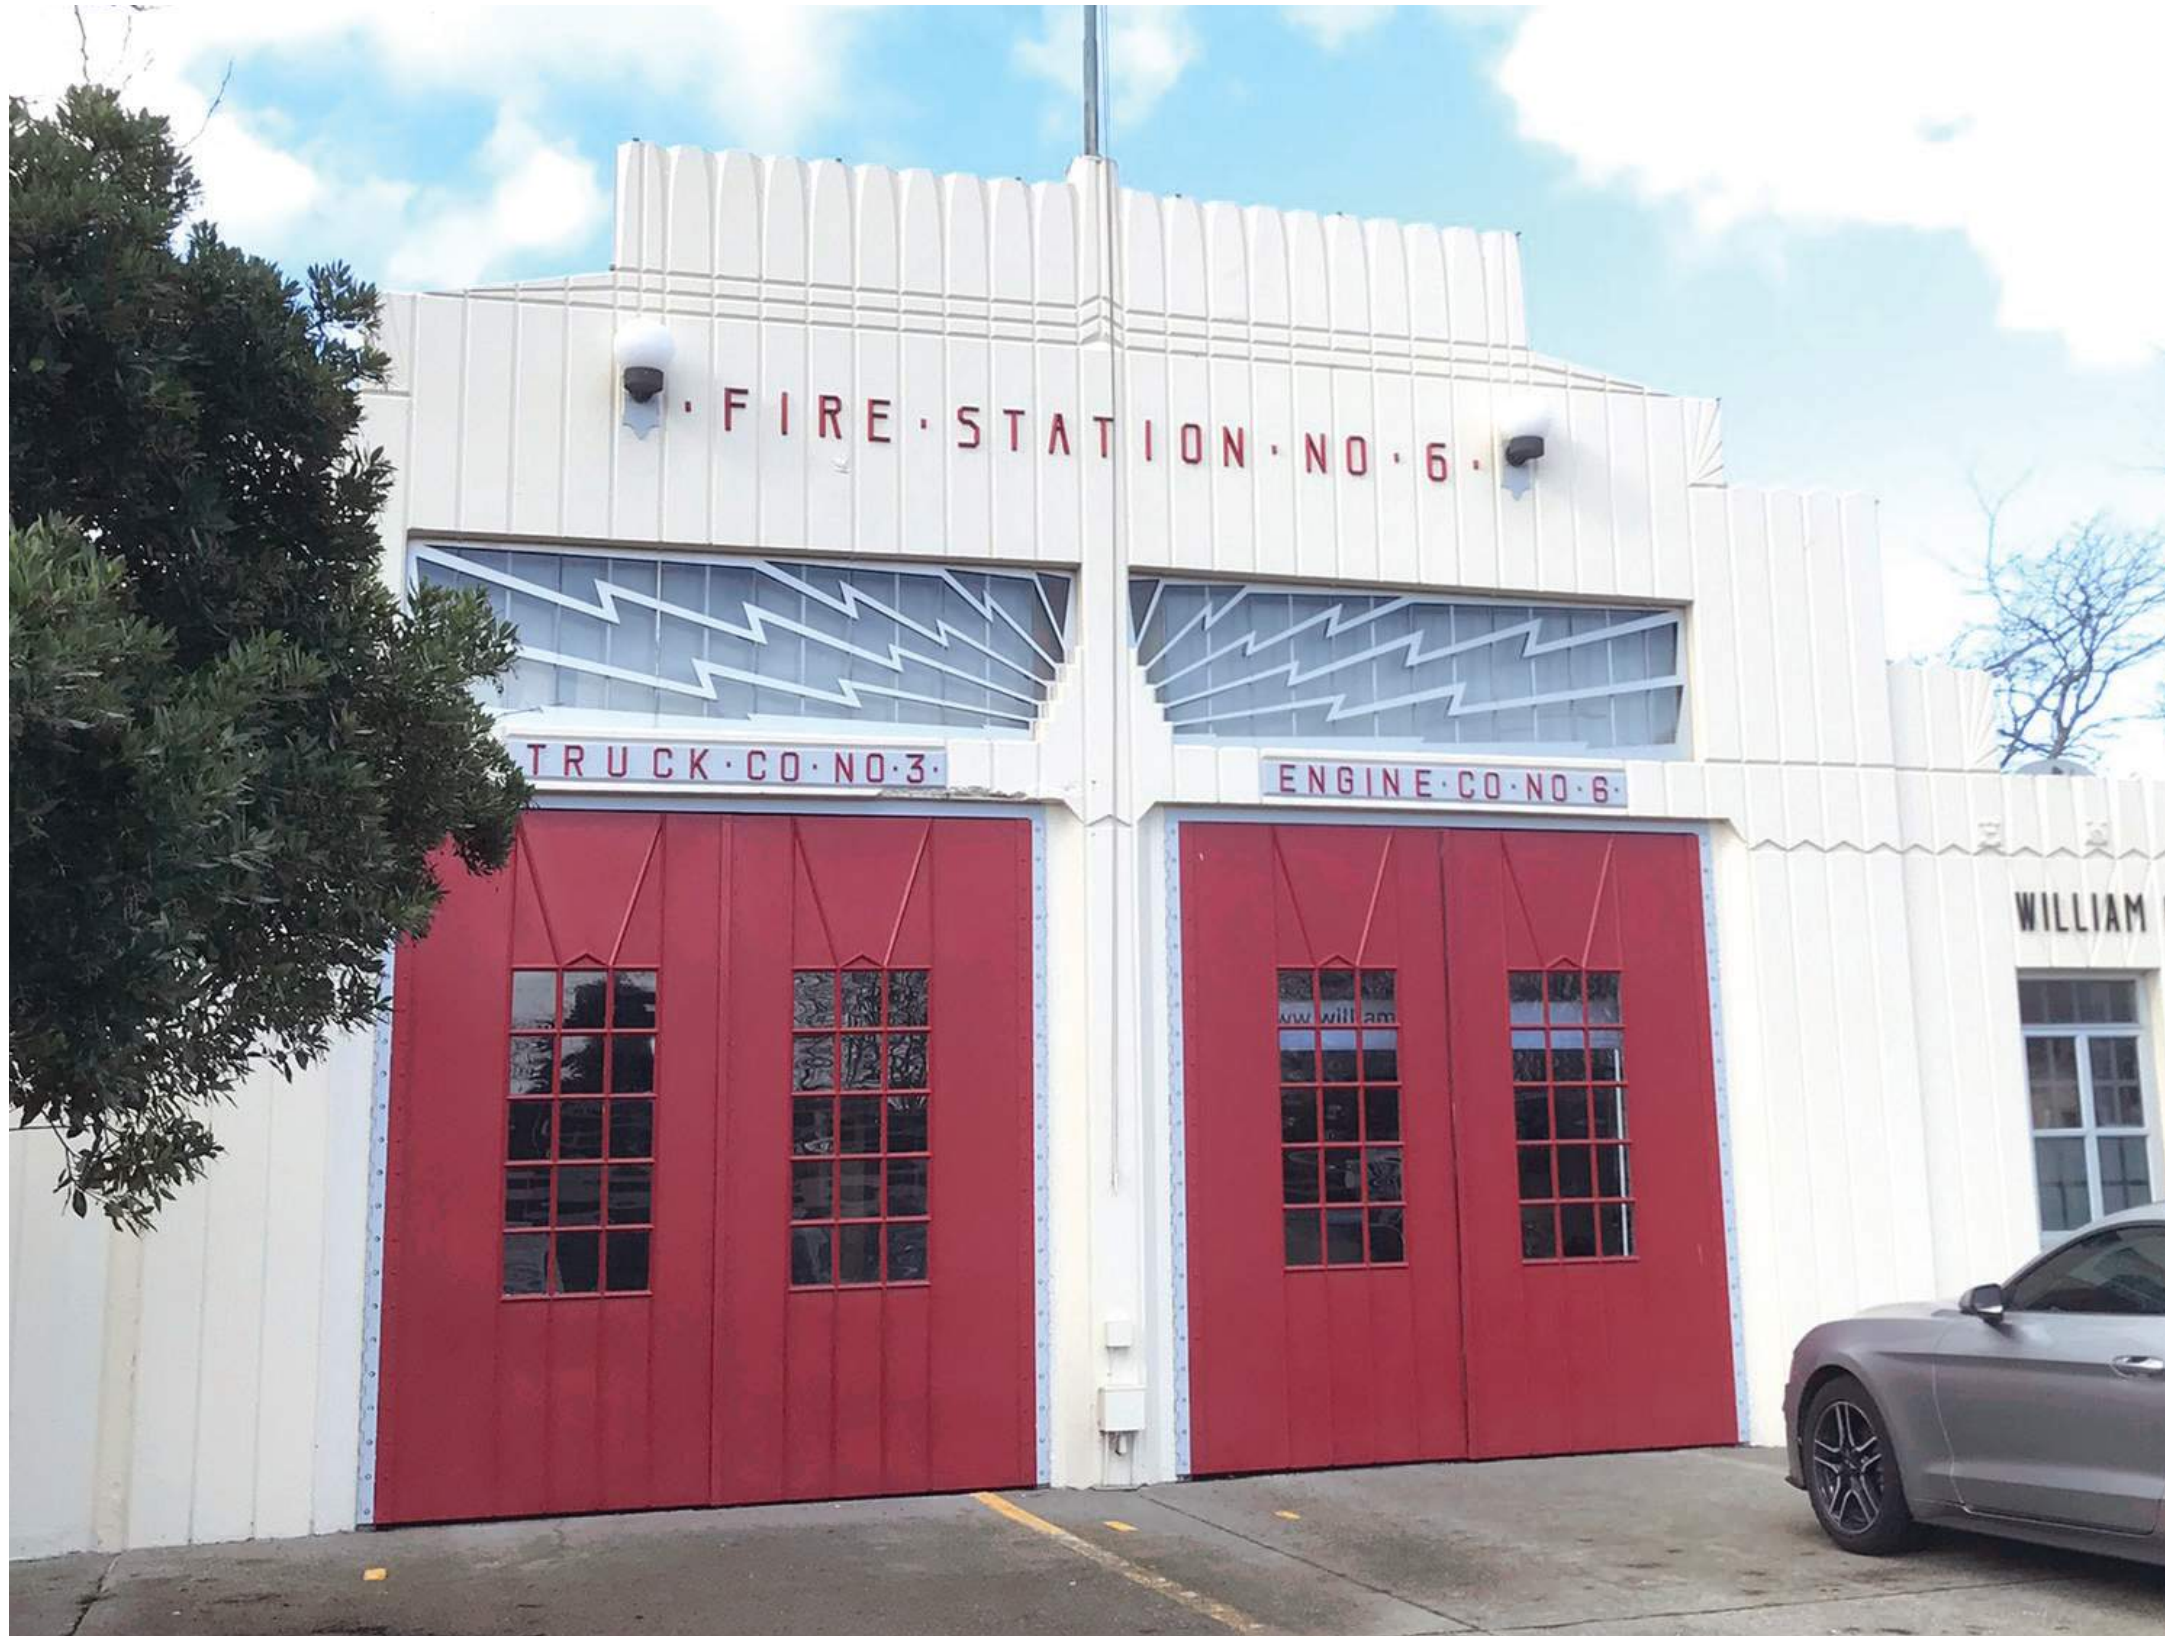
figure 52:
Current condition of apparatus bay doors, 1986 replica of original

Apparatus Bay Doors: Prior to 1986 the original wooden apparatus bay doors had been replaced with sectional overhead garage doors. The 1986 architect chose to reproduce the original doors with steel facsimiles including multi-pane glazing. The original steel strap hinges were replaced with continuous piano hinges, but otherwise the new doors are a convincing copy of the 1931 originals. (See photo page 18.)

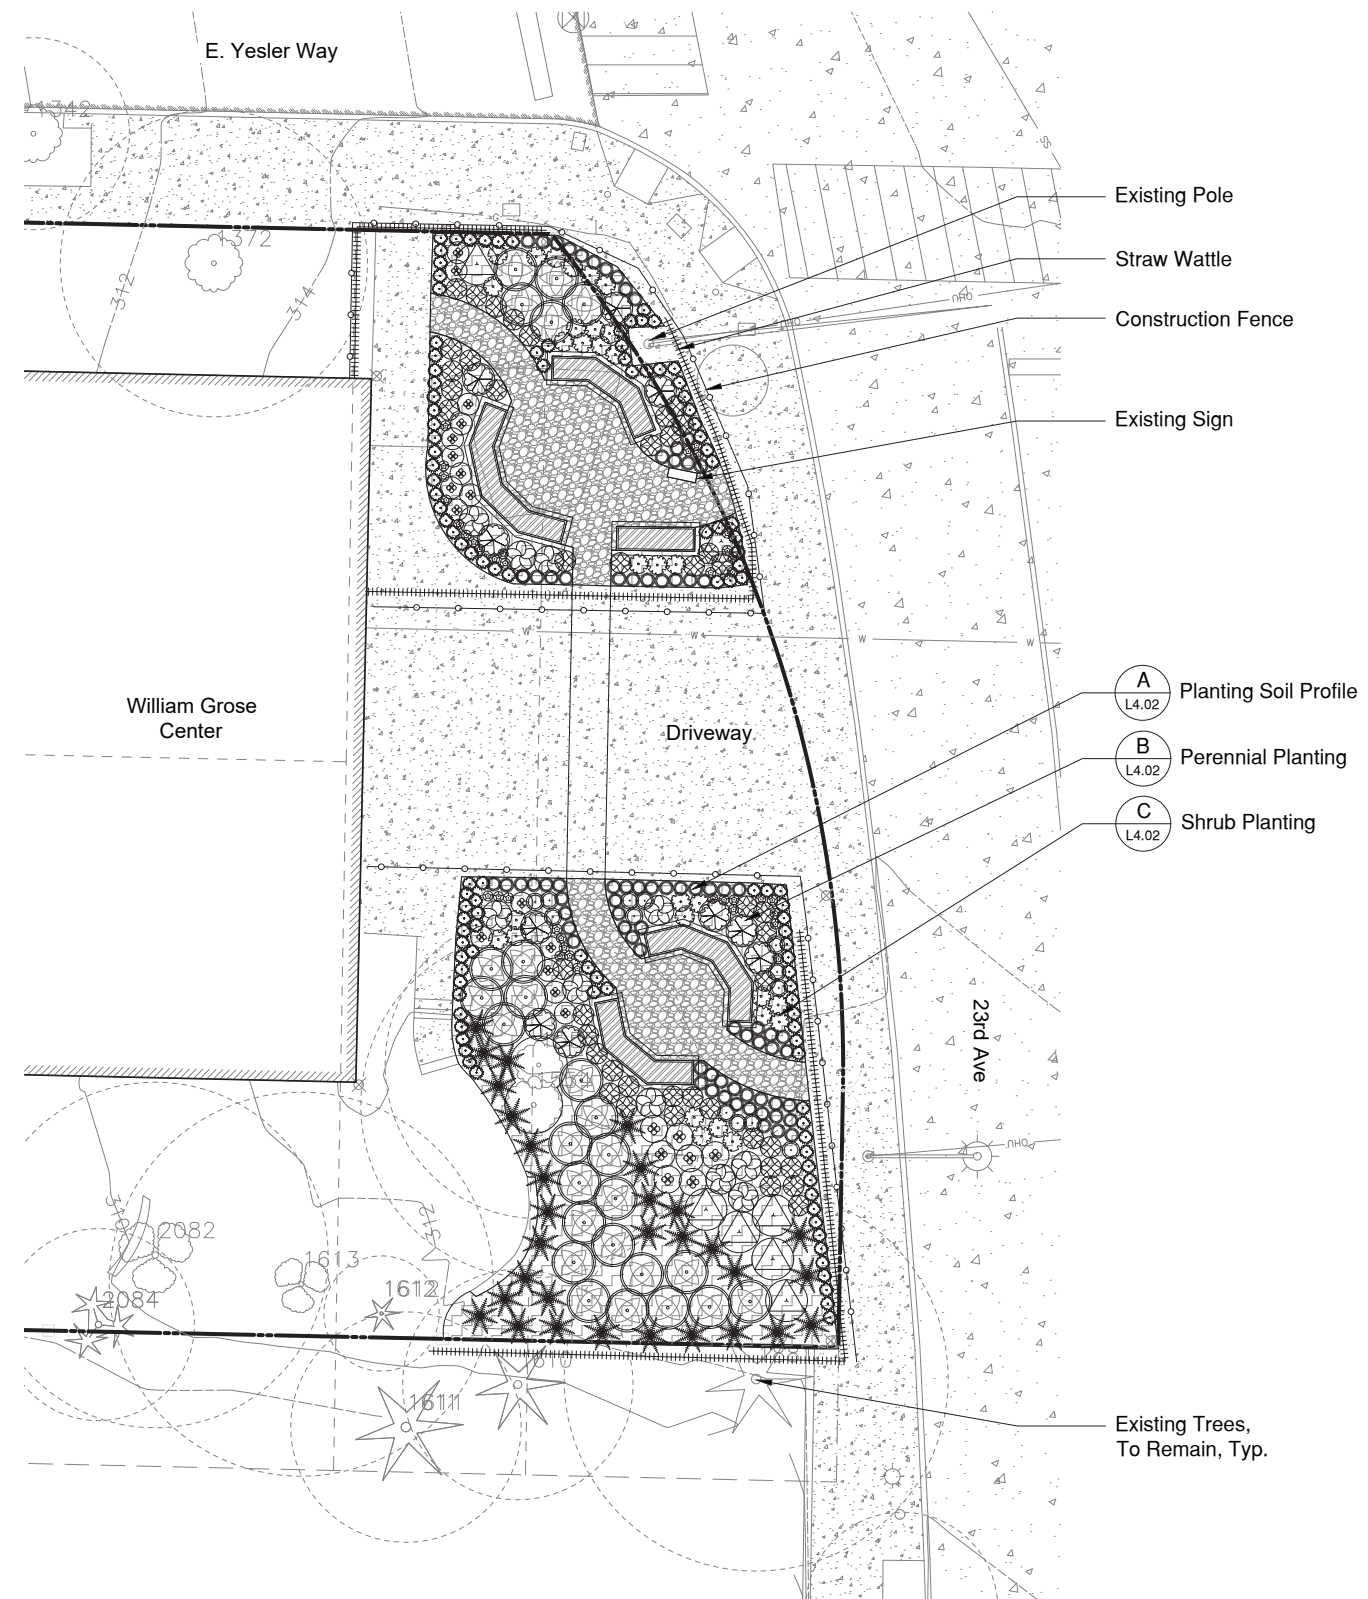
landscape plan

Planting Plan

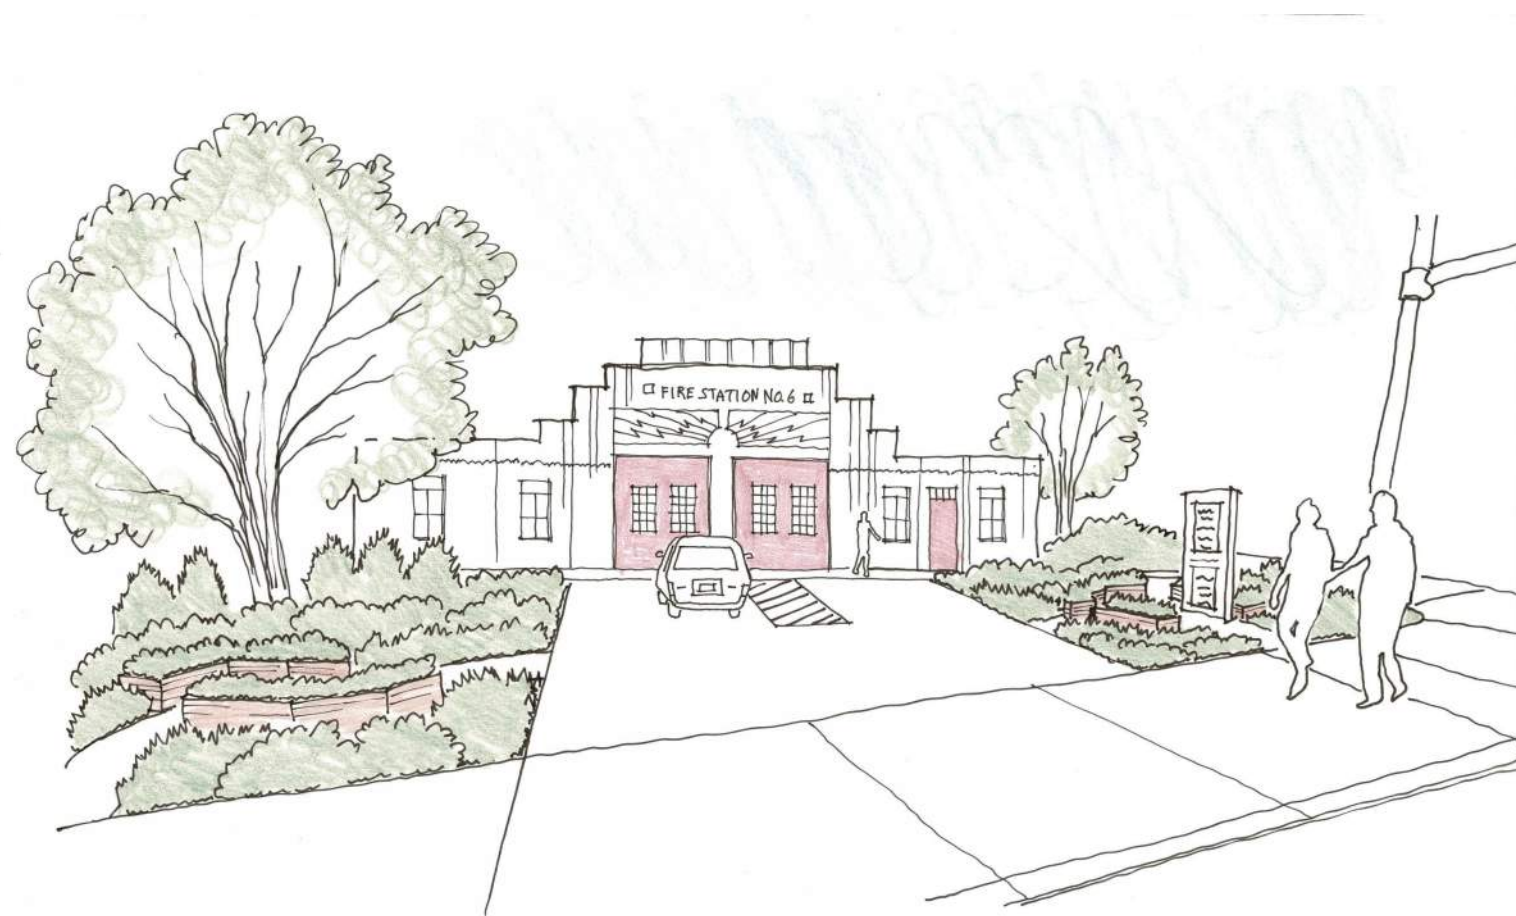
figure 59:
View from 23rd Ave. without proposed screening

Seattle Zoning Code Section SMC 23.45.536.D.1 requires that parking shall be screened from direct street view. We request Landmarks Board support to leave the existing concrete apron unchanged to preserve the relationship of the building to its site.

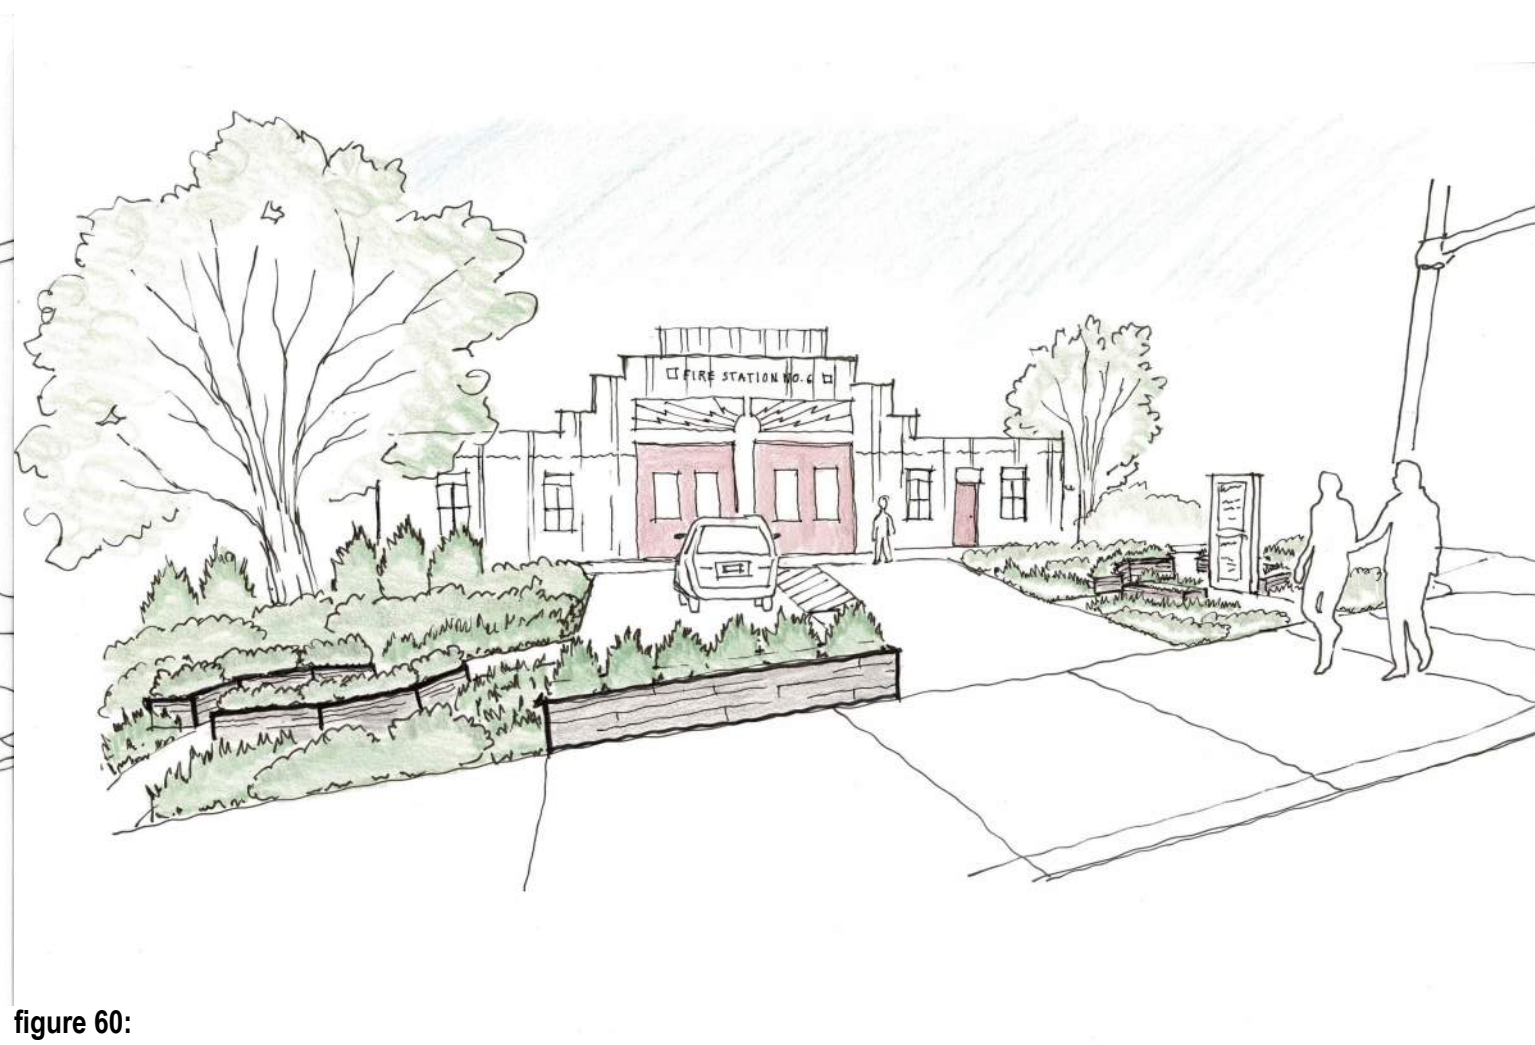
figure 60:
View from 23rd Ave. with proposed screening

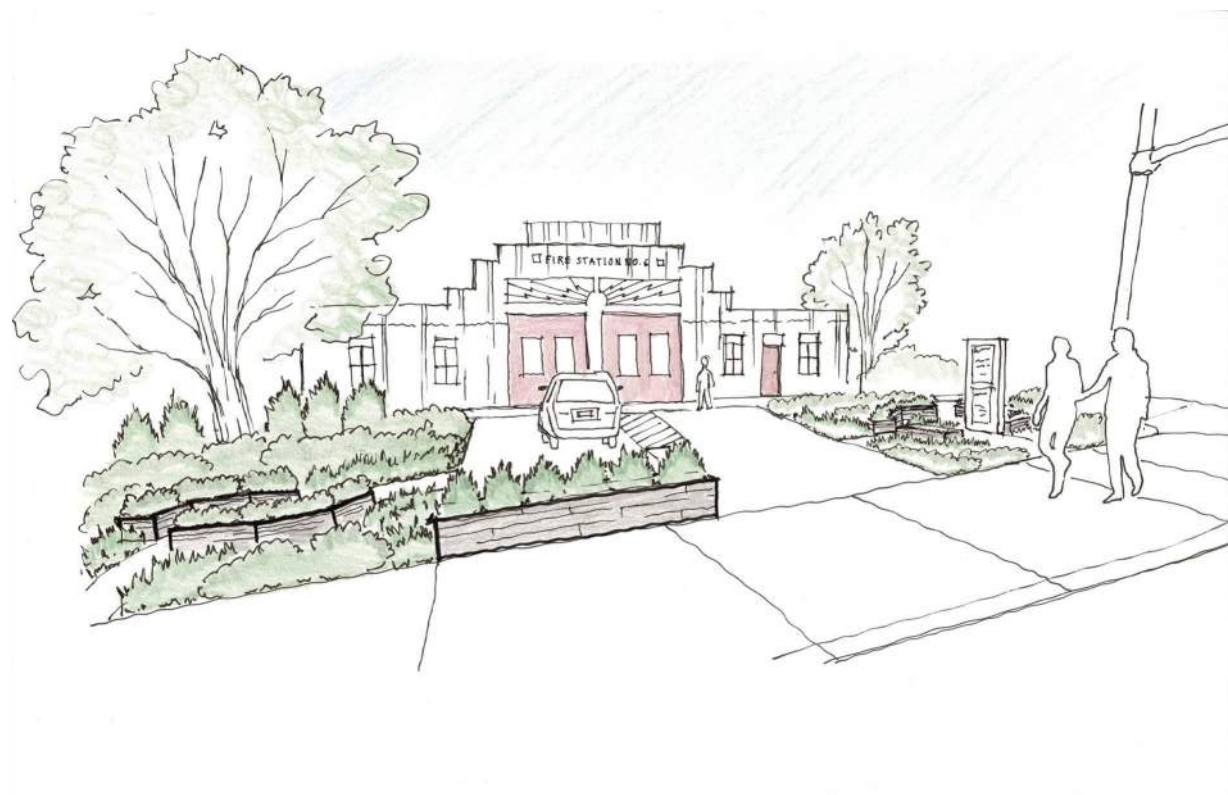
figure 61:
View from 23rd Ave. with proposed screening
