232 1st Avenue North

ARC BRIEFING 03.31.2023 Prepared by Generator Studio

EXISTING TRUSS CONDITION

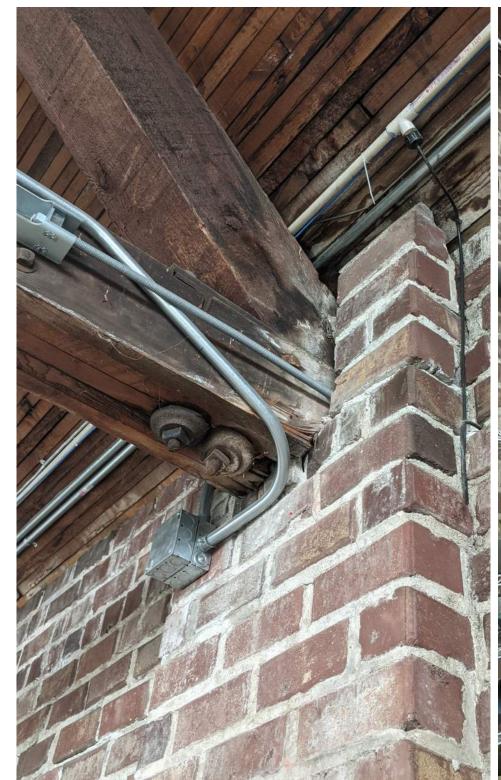
EXISTING TRUSS AT PILASTER

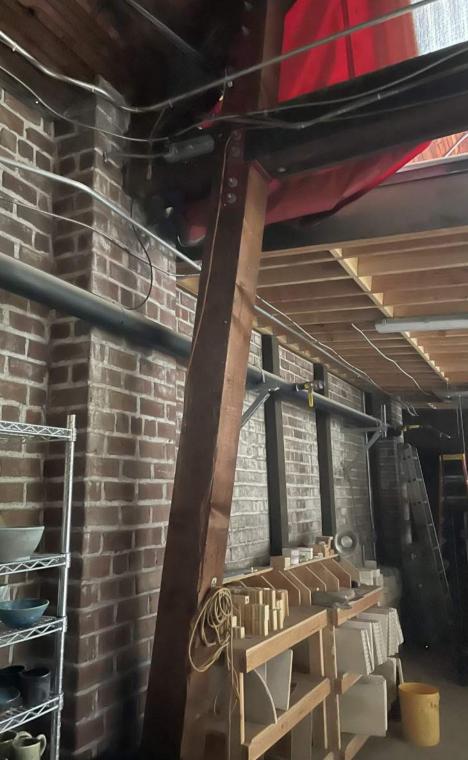
EXISTING TRUSS TIMBER SUPPORT

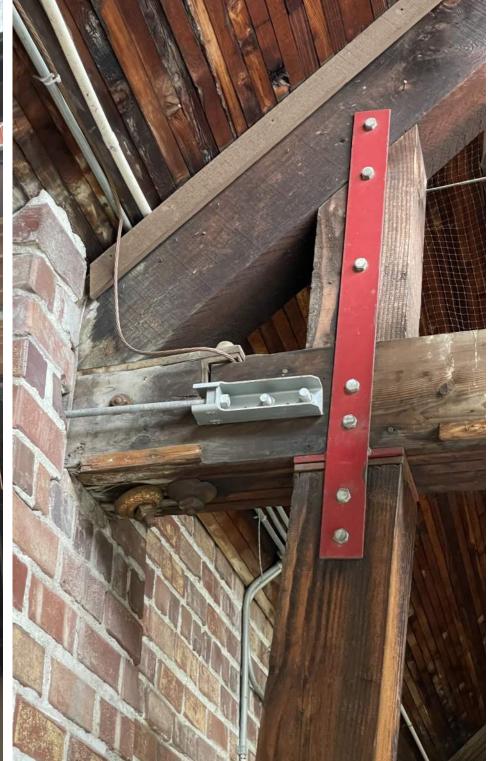
EXISTING TRUSS TIMBER SUPPORT AT PILASTER

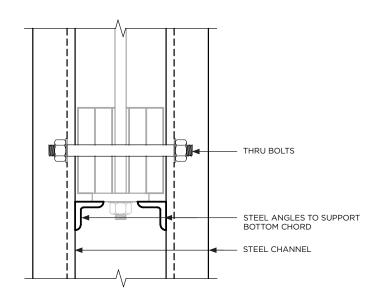
B SECTION LACED COL TO BOT CHORD

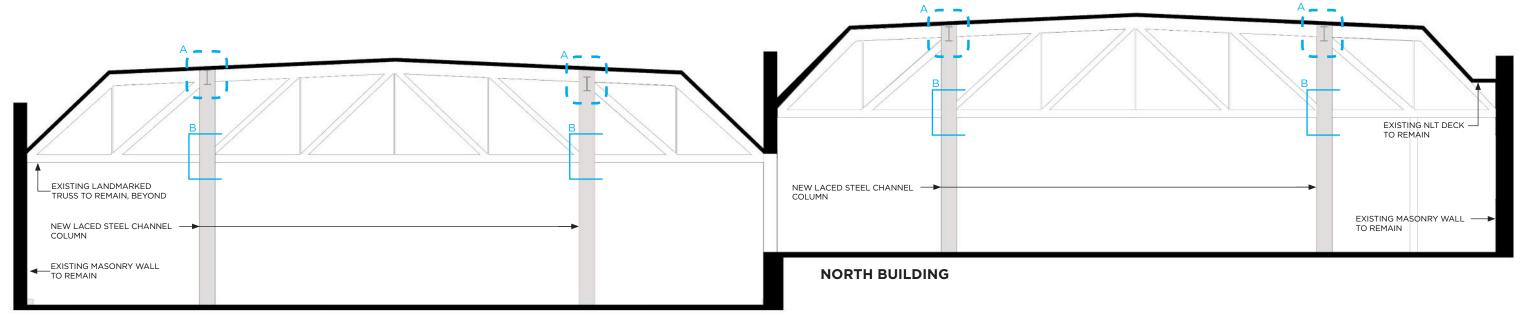
SOUTH BUILDING

NOTE: DIAGRAMS SHOW APPROXIMATE MAXIMUM GUSSET PLATE SIZES. FINAL GUSSET PLATES AND BRB CONNECTIONS ARE DELEGATED DESIGN TO THE BRACE MANUFACTURER. WHILE EVERY EFFORT HAS BEEN MADE TO REPRESENT THESE AS ACCURATELY AS POSSIBLE, PLEASE UNDERSTAND THE FINAL DESIGN WILL NOT BE COMPLETE UNTIL A MANUFACTURER IS ON BOARDED AND SHOP DRAWINGS ARE RECOVERED

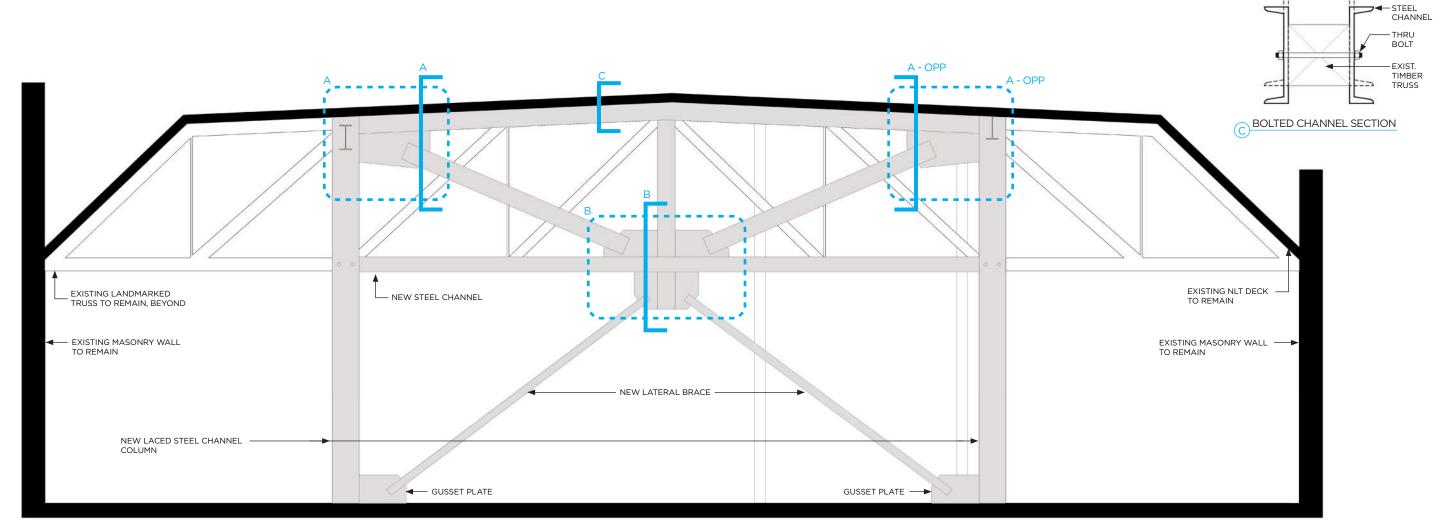
SOUTH BUILDING

NOTE: DIAGRAMS SHOW APPROXIMATE MAXIMUM GUSSET PLATE SIZES. FINAL GUSSET PLATES AND BRB CONNECTIONS ARE DELEGATED DESIGN TO THE BRACE MANUFACTURER. WHILE EVERY EFFORT HAS BEEN MADE TO REPRESENT THESE AS ACCURATELY AS POSSIBLE, PLEASE UNDERSTAND THE FINAL DESIGN WILL NOT BE COMPLETE UNTIL A MANUFACTURER IS ON BOARDED AND SHOP DRAWINGS ARE RECOVERED

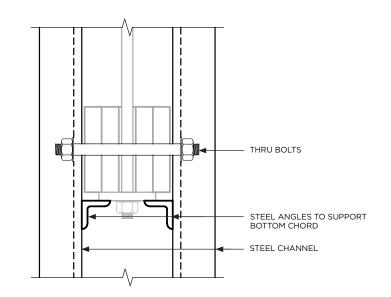
B SECTION LACED COL TO BOT CHORD

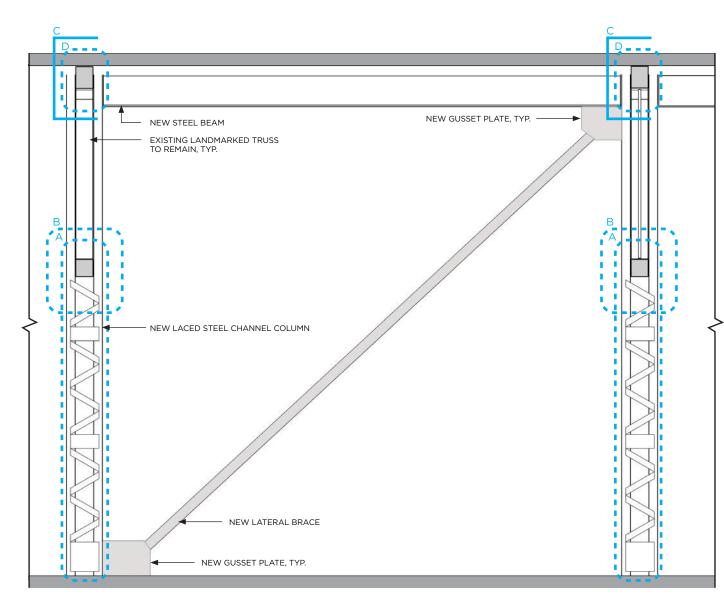
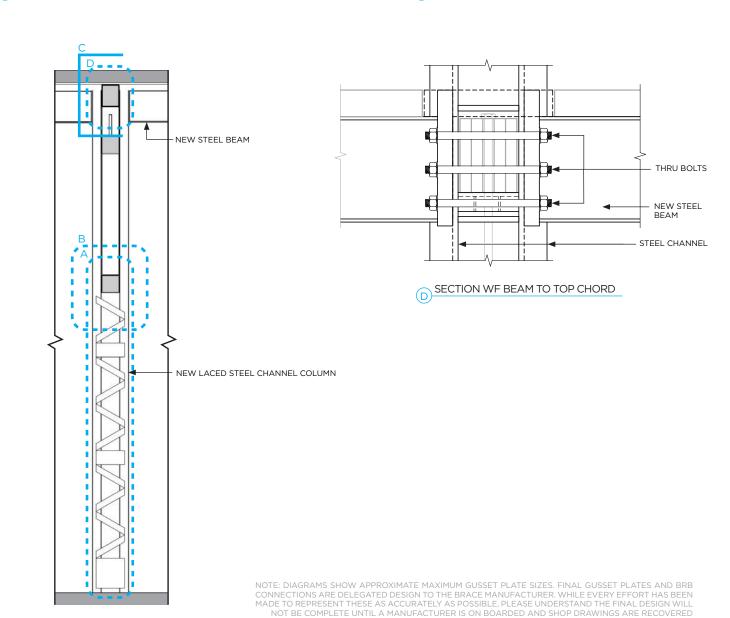
NORTH BUILDING LACED COLUMNS + BRACED FRAME

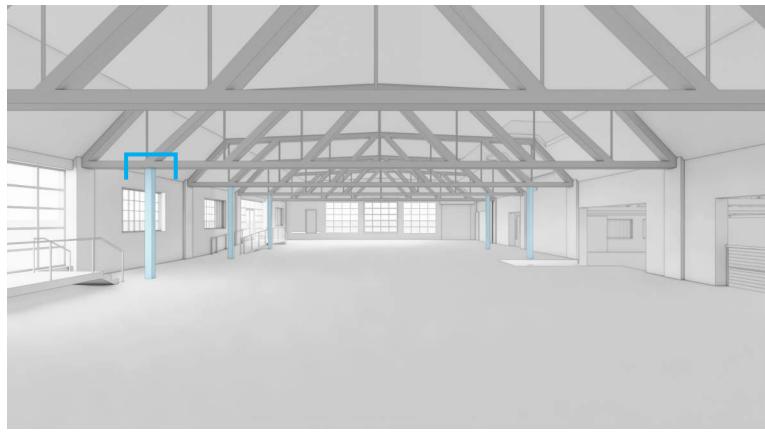
EXISTING NORTH BUILDING

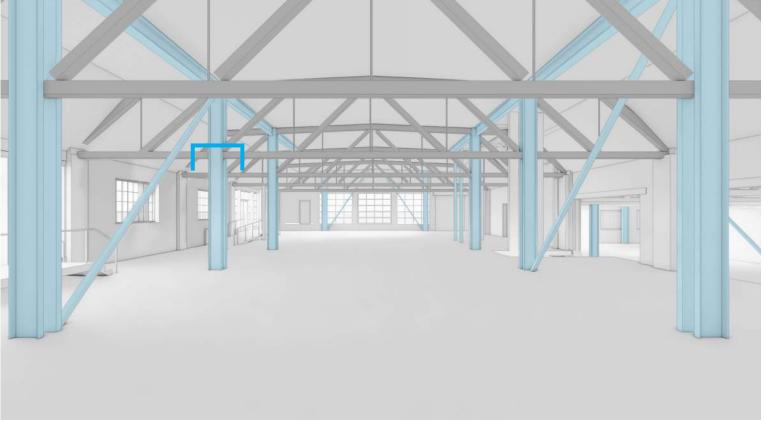
PREFERRED NORTH BUILDING

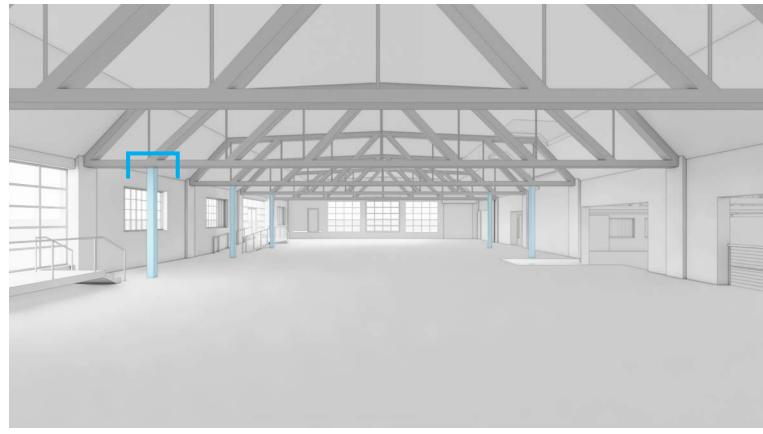
EXISTING NORTH BUILDING

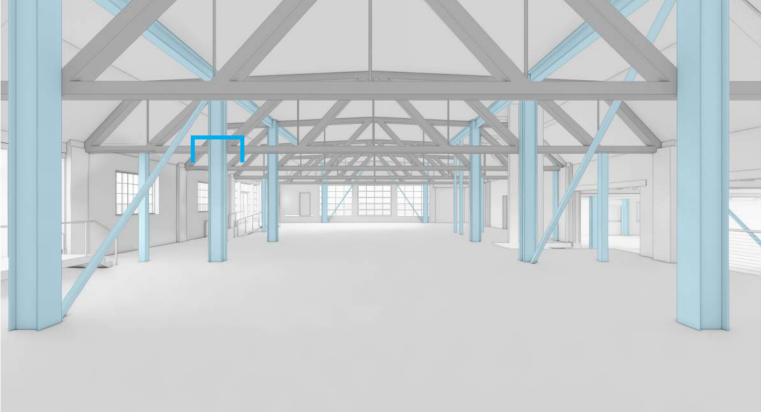
ALTERNATE NORTH BUILDING

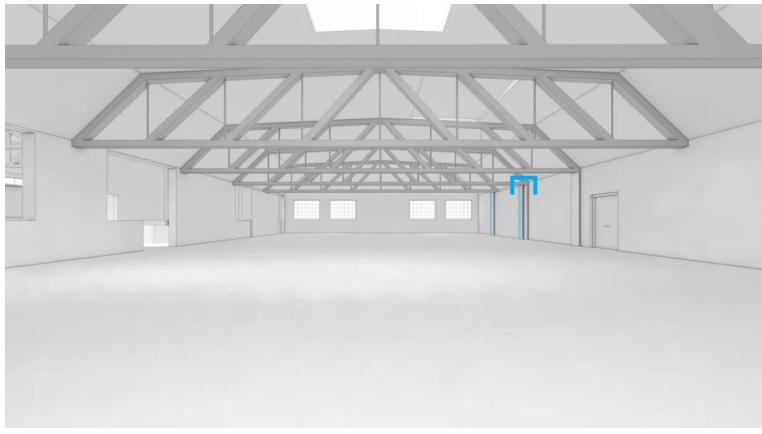
EXISTING SOUTH BUILDING

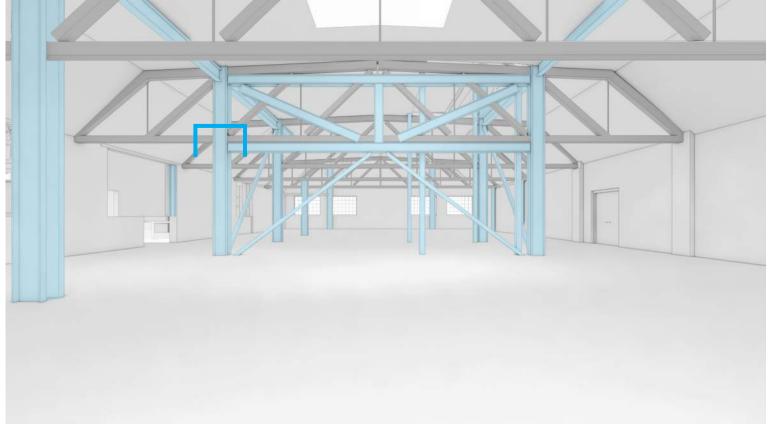
PREFERRED SOUTH BUILDING

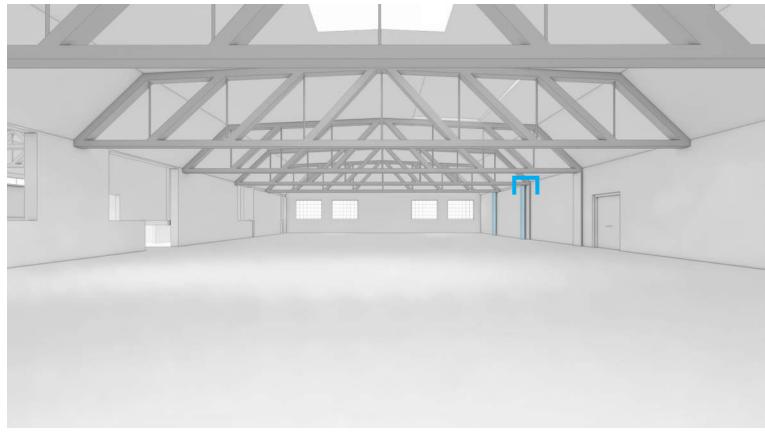
EXISTING SOUTH BUILDING

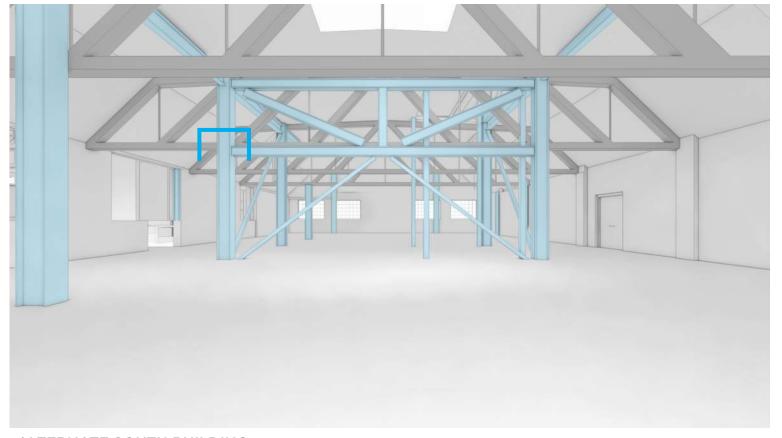
ALTERNATE SOUTH BUILDING
