## Carkeek Park Pedestrian Bridge

### Feasibility Study Report

RHC Engineering

March 12, 2021

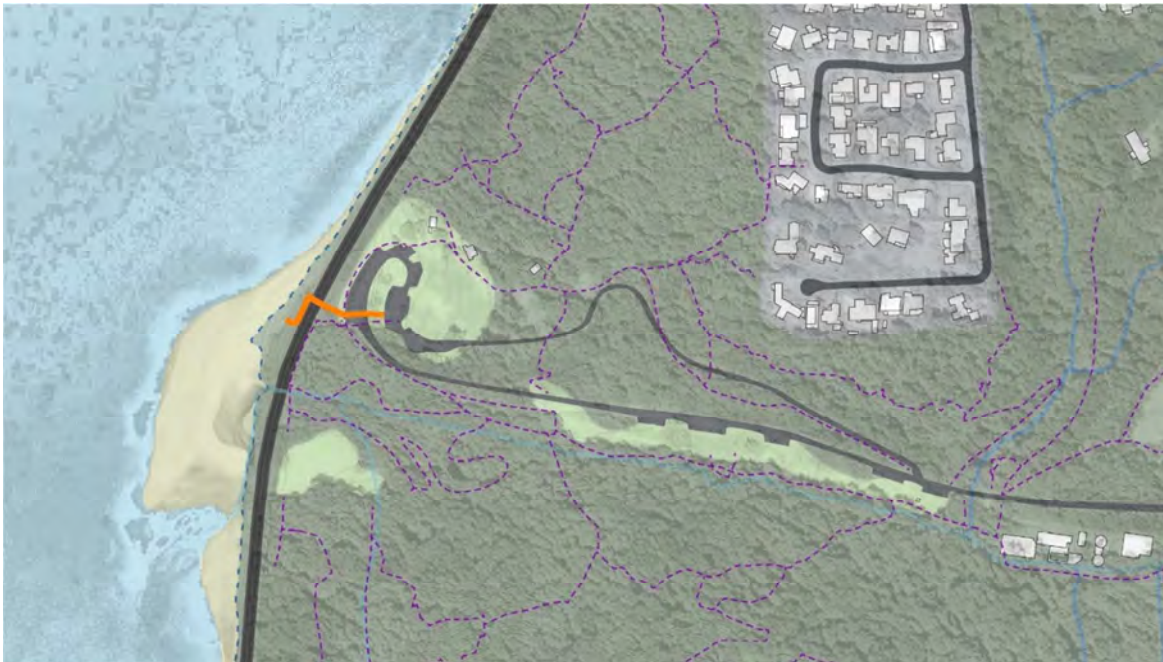
Figure 1 Park Context

Carkeek Park is a special place because of the many ecosystems it spans. Dark green in Figure 1 shows the forested areas, light green the lawn or meadow areas, tan or yellow area the beach, and blue the water. The rail tracks that separate the main body of the park from beach and water access are shown in dark grey. The project site is situated right at the convergence of the ecosystems and trails, and the orange line shows the alignment of the existing bridge over the trail tracks from the meadow to the beach.

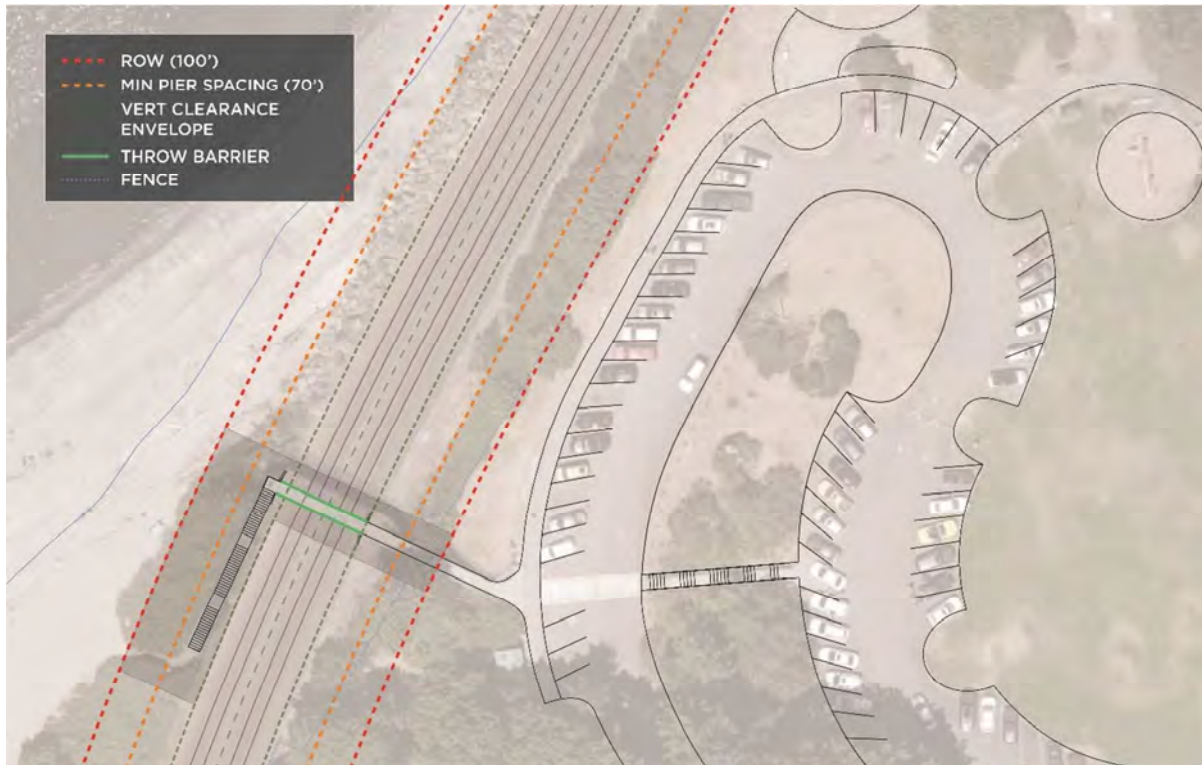
Figure 5 BNSF ROW Plan

Any portion of the new bridge occurring within the BNSF ROW needs to follow the BNSF Guidelines for Railroad Grade Separation Projects. A vertical clearance envelope of at least 23.5 feet, from the top of the track to the bottom of the structure must be maintained within nine feet of the nearest track centerline. A throw barrier, between 8 to 10 feet tall, must be placed on all portions of the bridge within 25 feet of the nearest track centerline or within the ROW. Any construction and maintenance of the bridge occurring within the BNSF ROW require the presence of a BNSF flagger at a cost of roughly \$1,200 per day.

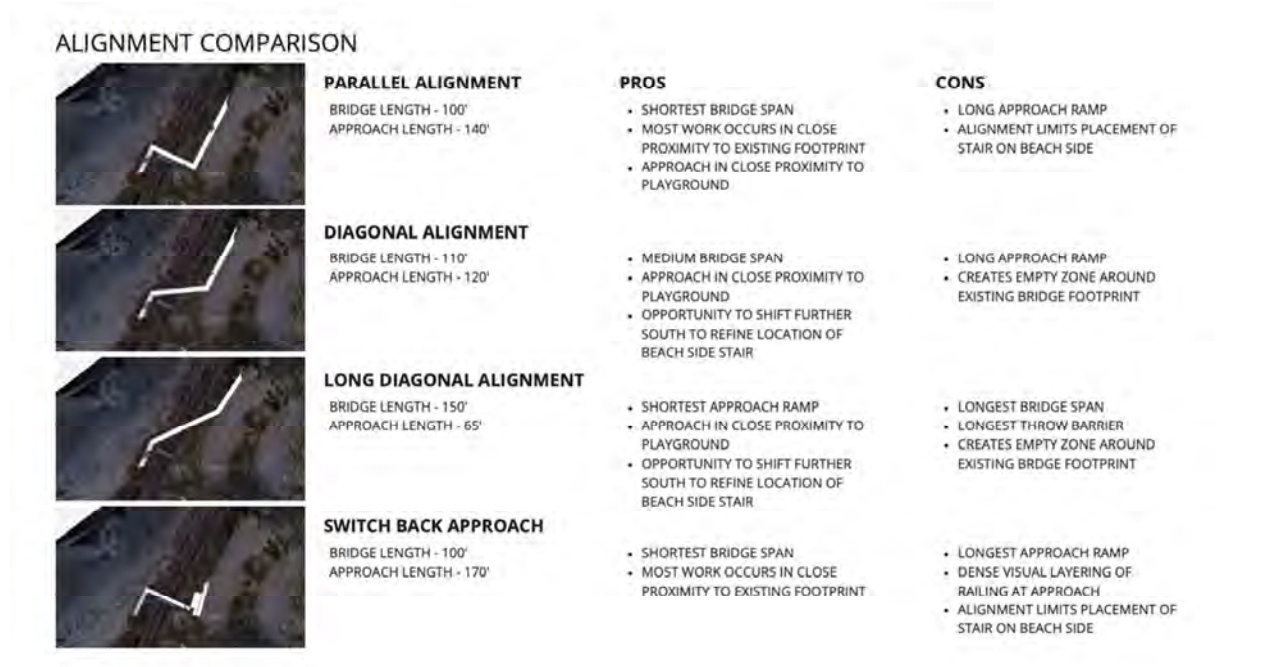
Figure 10 Alignment Study

Four alignments were compared to better understand how the east approach configurations would affect the bridge span and east approach length. In all cases, the west landing location remains consistent due to the limited options available on the west and the goal of retaining access across the existing bridge during construction of the new span.

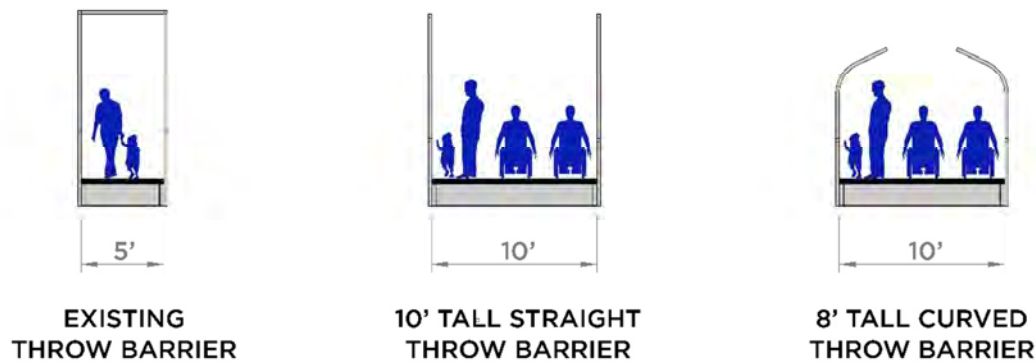
Figure 13 Throw Barrier

The existing throw barrier sections are eight feet tall and closed. For the new construction, BNSF requires either 10' straight or 8' curved shape. RHC recommends the 10-foot straight option for the sense of openness, simpler constructability, and reduced length compared to the 8' curved option. Figure 13 shows the three different throw barriers discussed.

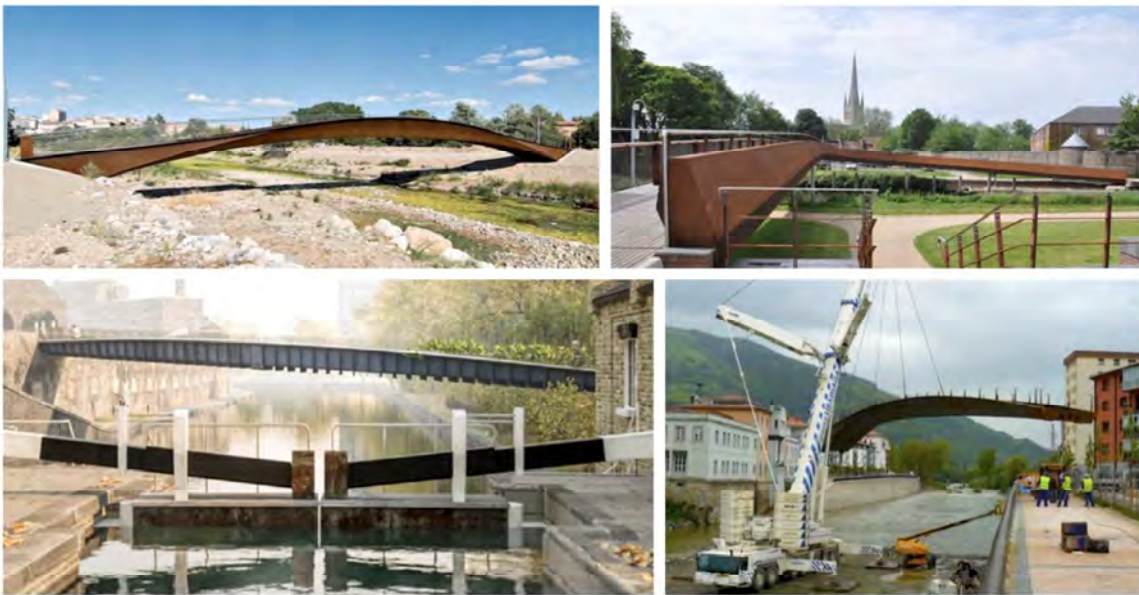
Figure 14 Girder Bridge Configurations

**Pros:** Conventional construction for better constructability and construction resources

**Cons:** Deck girder bridges require deeper depth which will trigger a longer landing ramp and park impact; half-through girder bridges require a deep profile that will block views for young children

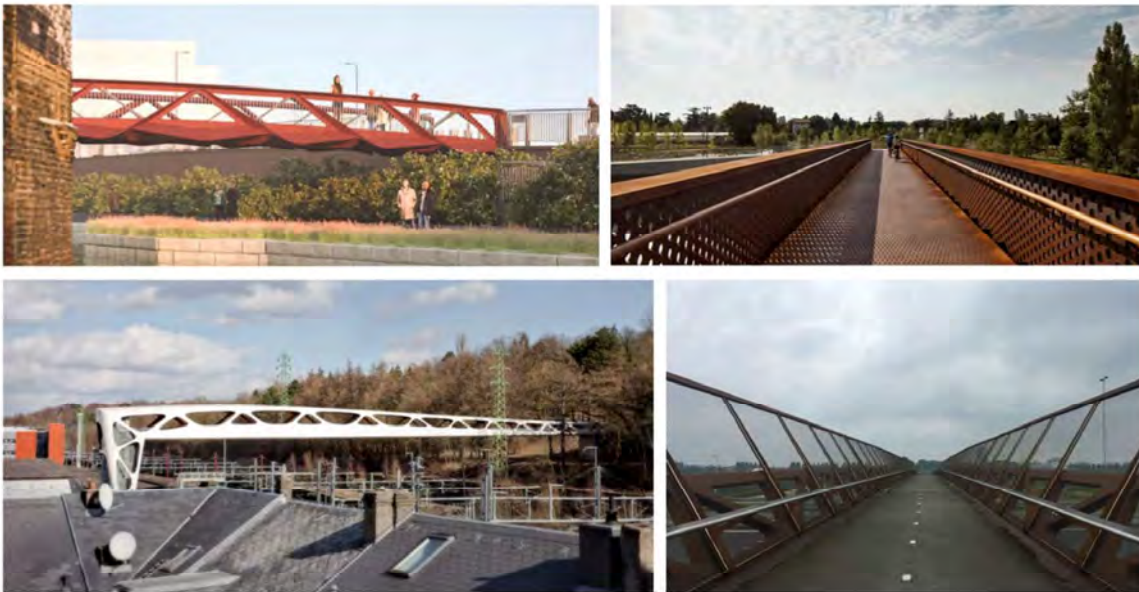
Figure 15 Truss Bridge Configurations

Traditional truss bridges consist of upper compression chords, lower compression chords, posts and diagonals to carry loads passed from the deck. The deck is typically near the bottom chord. Architectural appealing trusses, such as those shown in the Figure 15, have chord members in different shapes. Trusses can span longer with a low deck profile. Primarily built from steel, trusses are fracture critical structures that are sensitive to damage of one single chord.

**Cons:** Partial view blocking, constructability with site access constraints, bridge inspection access for taller upper chords, fracture critical structure that is also sensitive to lateral loads due to the height

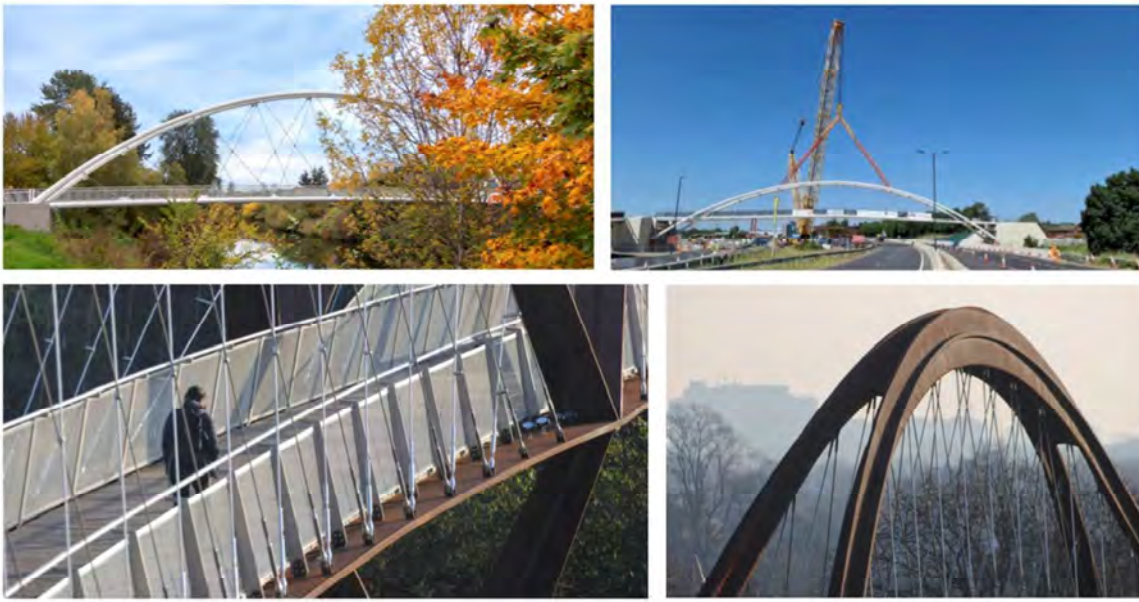
Figure 16 Arch Bridge Configurations

**Pros:** Span longer with low profile

**Cons:** Partial view blocking, constructability with site access constraints, bridge inspection access for taller upper chords

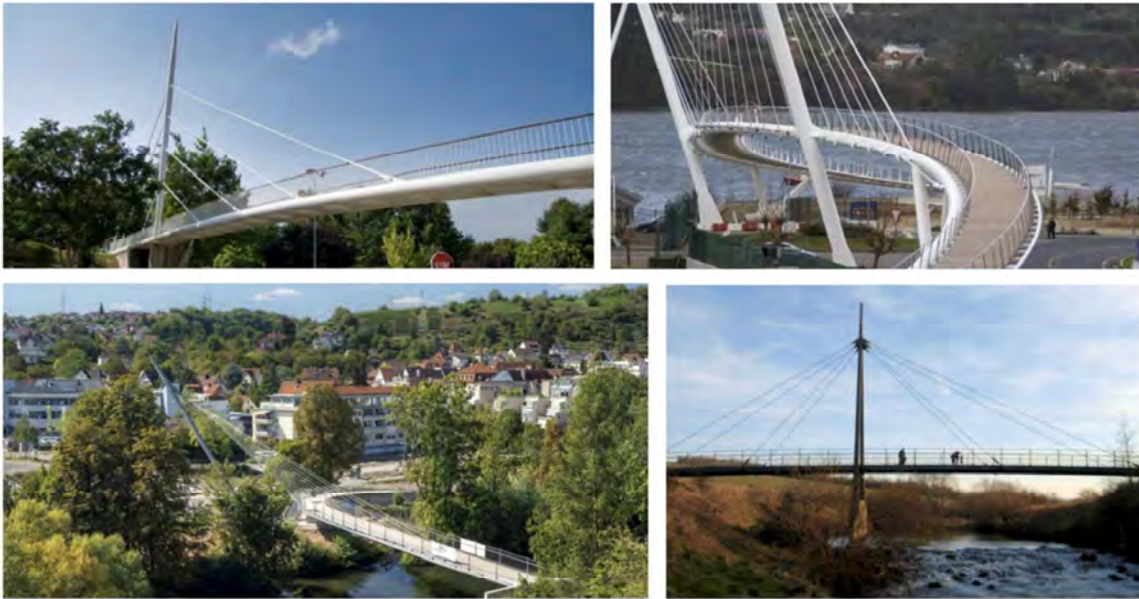
Figure 17 Cable-Stayed Bridge Configurations

Cable-stayed bridges include pylons and cables to support a shallow profile bridge deck. Foundations at the pylons carry larger loads and foundations at the bridge ends carry smaller loads. For the context of this project, the pylon and foundation can be constructed on the parking side. Figure 17 shows different configurations of cable-stayed bridges within similar sites as this bridge.

**Pros:** Span longer with low profile, iconic structure, fits the site condition and better constructability

**Cons:** Non-conventional structure to design and build

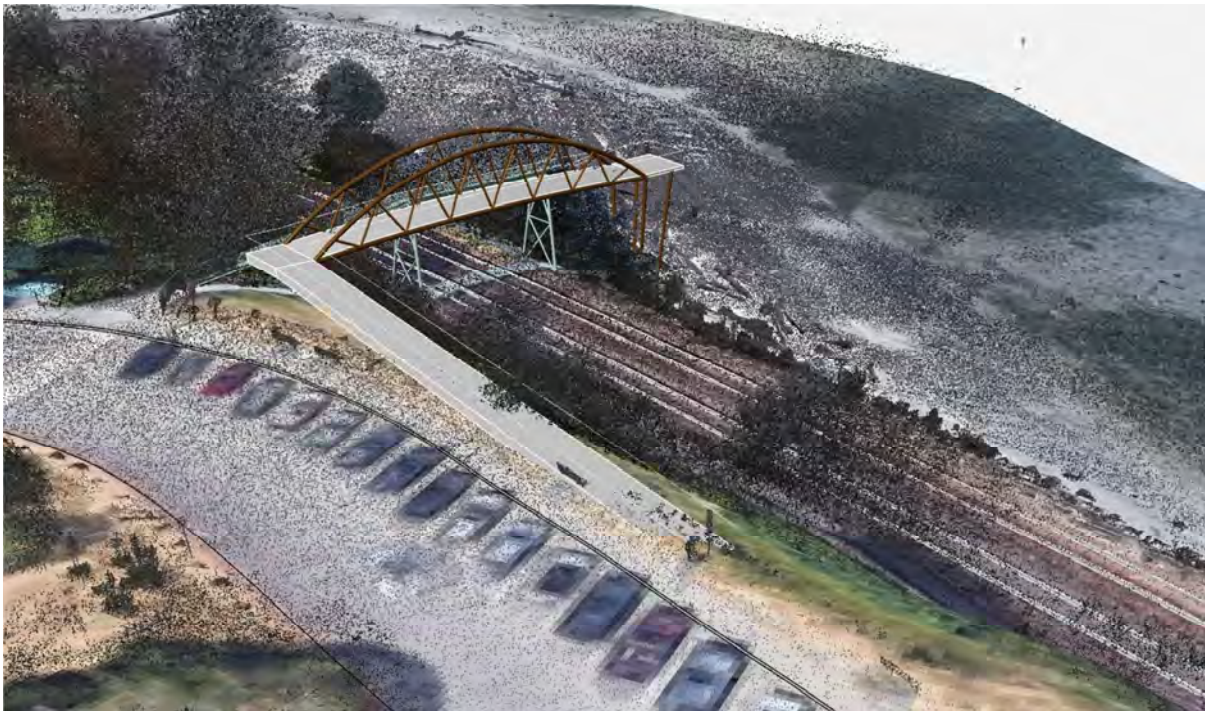
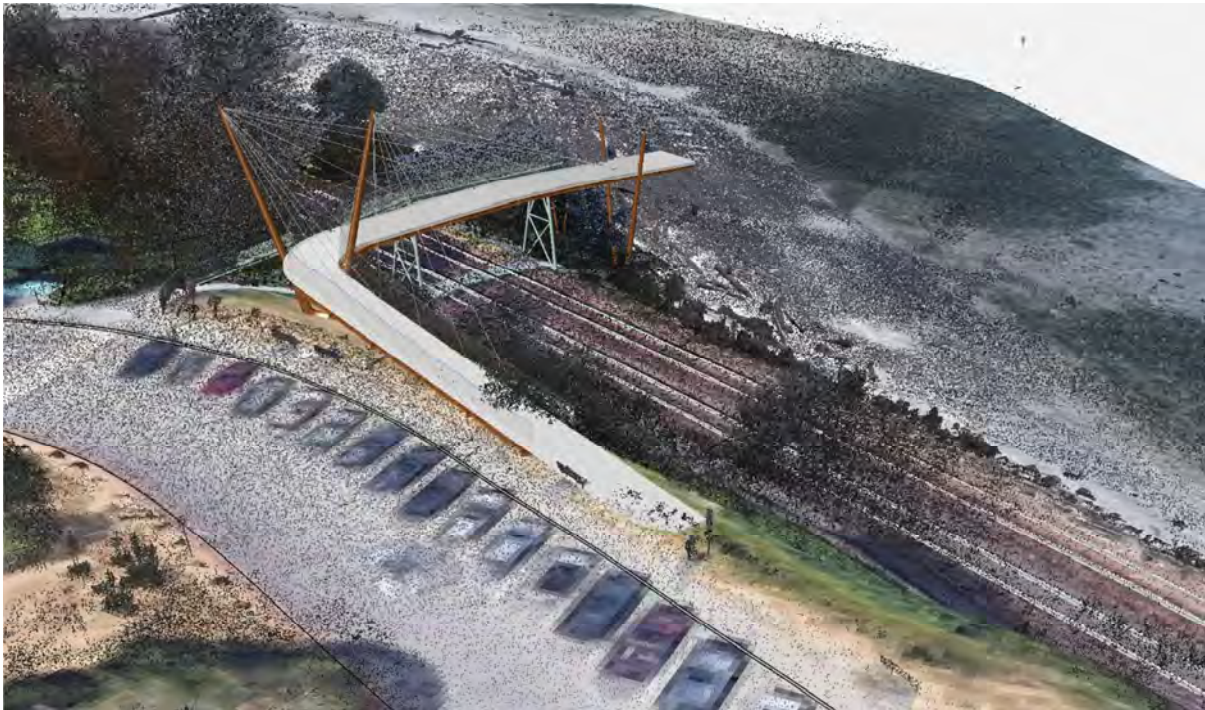
Figure 19 Truss and Cable-Stayed Bridge Rendering

Figure 18 shows a brief comparison of different bridge types. The truss option and the cable-stayed option fit the context of this bridge therefore they are advanced for further considerations, as shown in Figure 19. Table 2 is a comprehensive comparison of these two types of bridge as they apply to the unique bridge site. Both types have lower profile and have shorter overall bridge length.

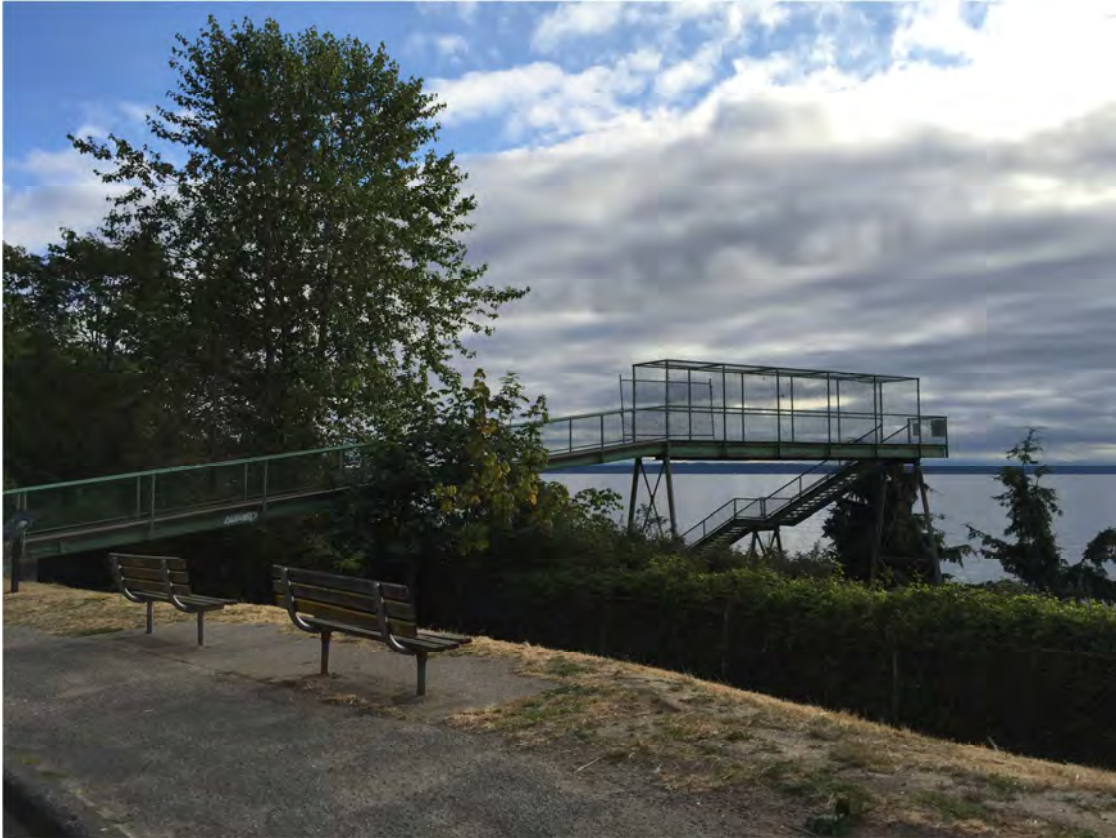
Figure 1 Bridge Overview

The bridge superstructure consists of steel plate girders and precast concrete deck panels. Hand rails and throw fences are on both sides of the bridge. The bridge substructure consists of braced steel pipes. The bridge foundation consists of reinforced concrete spread footing and pedestals to support the steel pipes. Figure 1 shows a view of the bridge from the sidewalk of the parking area.

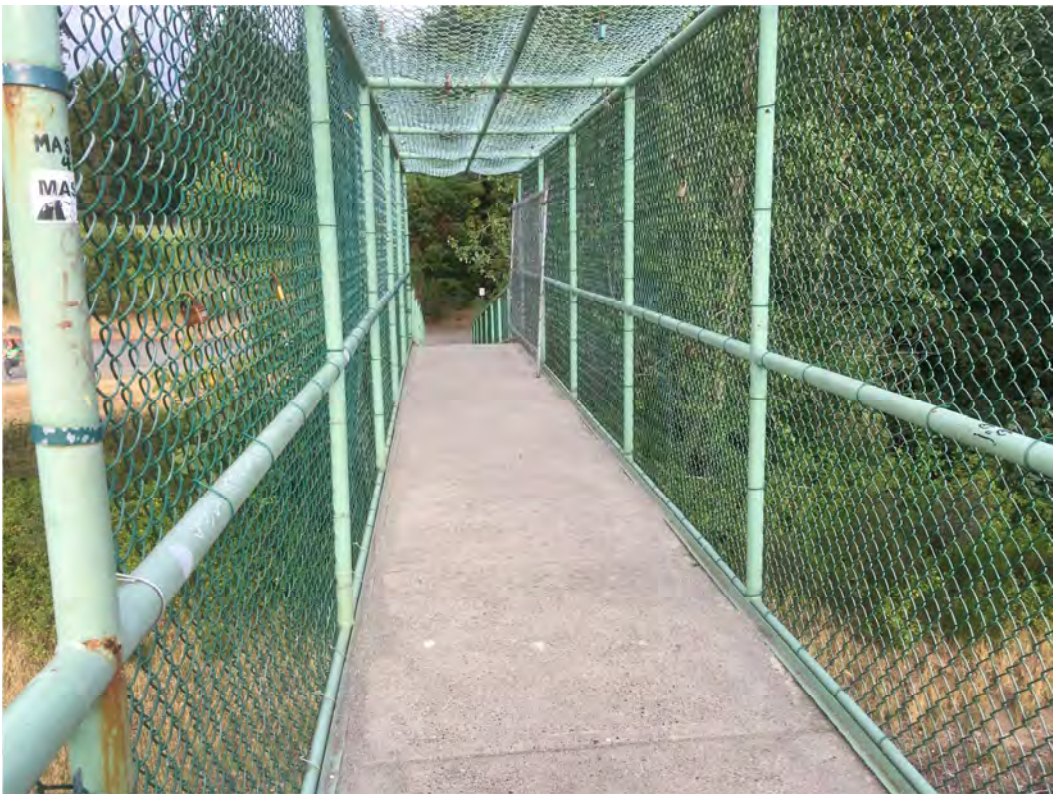
Figure 2 Deck and Fence

Bridge deterioration is the worst in the structural connections, where water penetration has caused significant corrosion at the concrete deck and steel beam interface, and at the steel welding between pier steel tubes and the connection plates. Figures 2 to 10 show some representative captured locations.

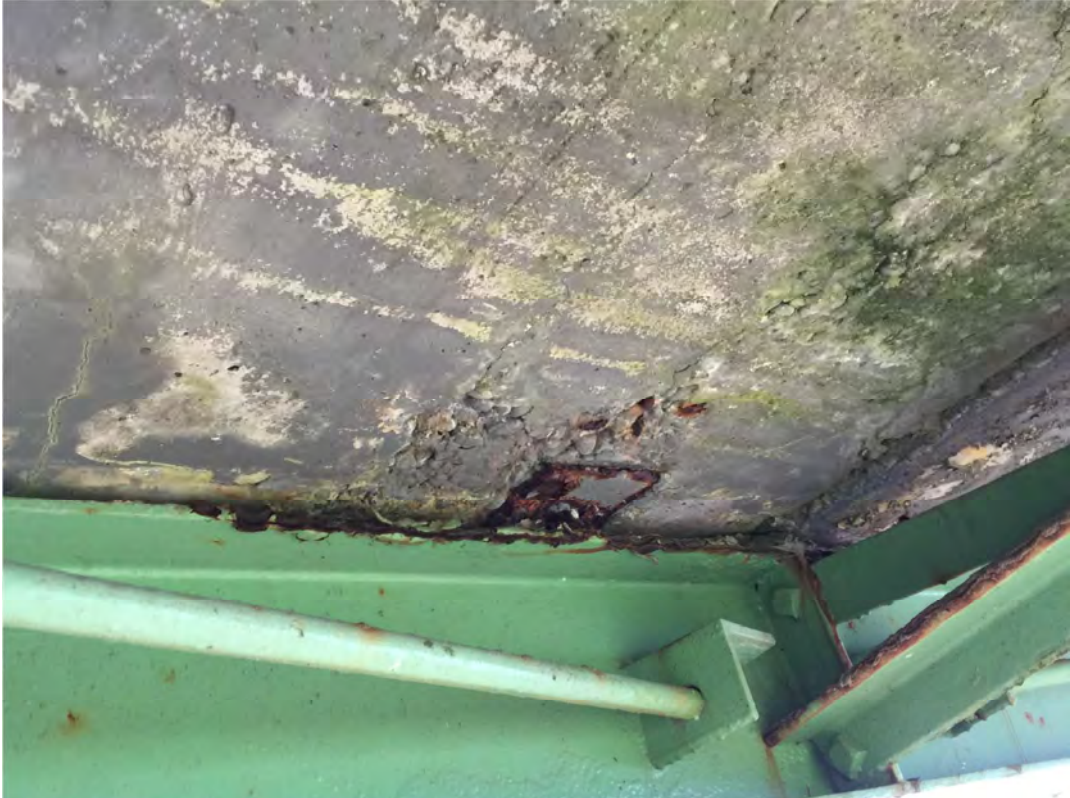
Figure 5 Corrosion and Spalling at Bolt Connection with Precast Slab

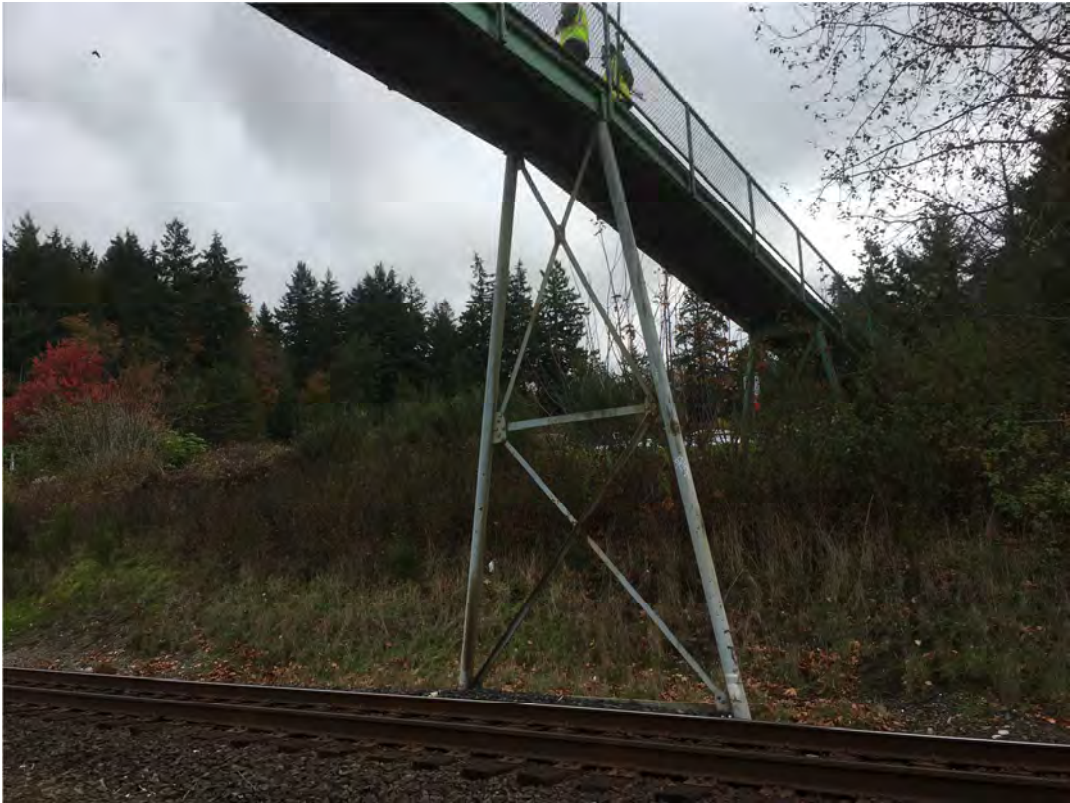
Figure 6 Pier with Corrosion Members at the Other Side of BNSF Tracks

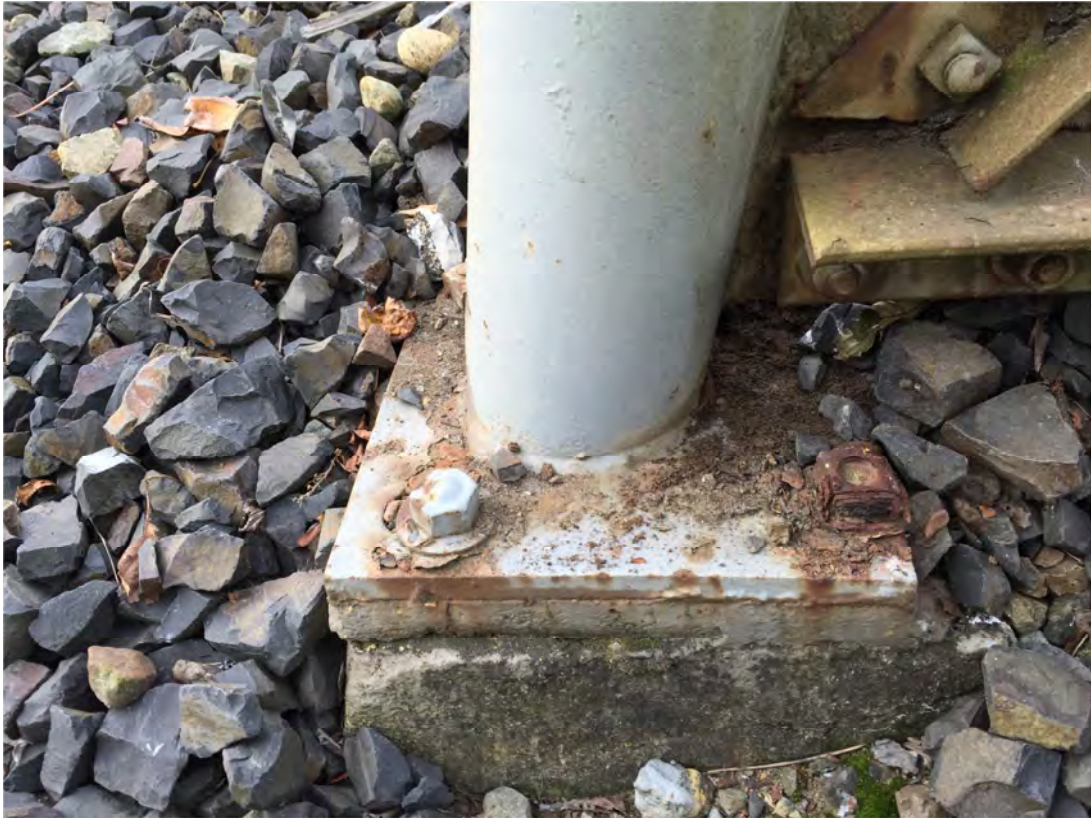
Figure 7 Corrosion at Pier Pipe Base Plate Anchor

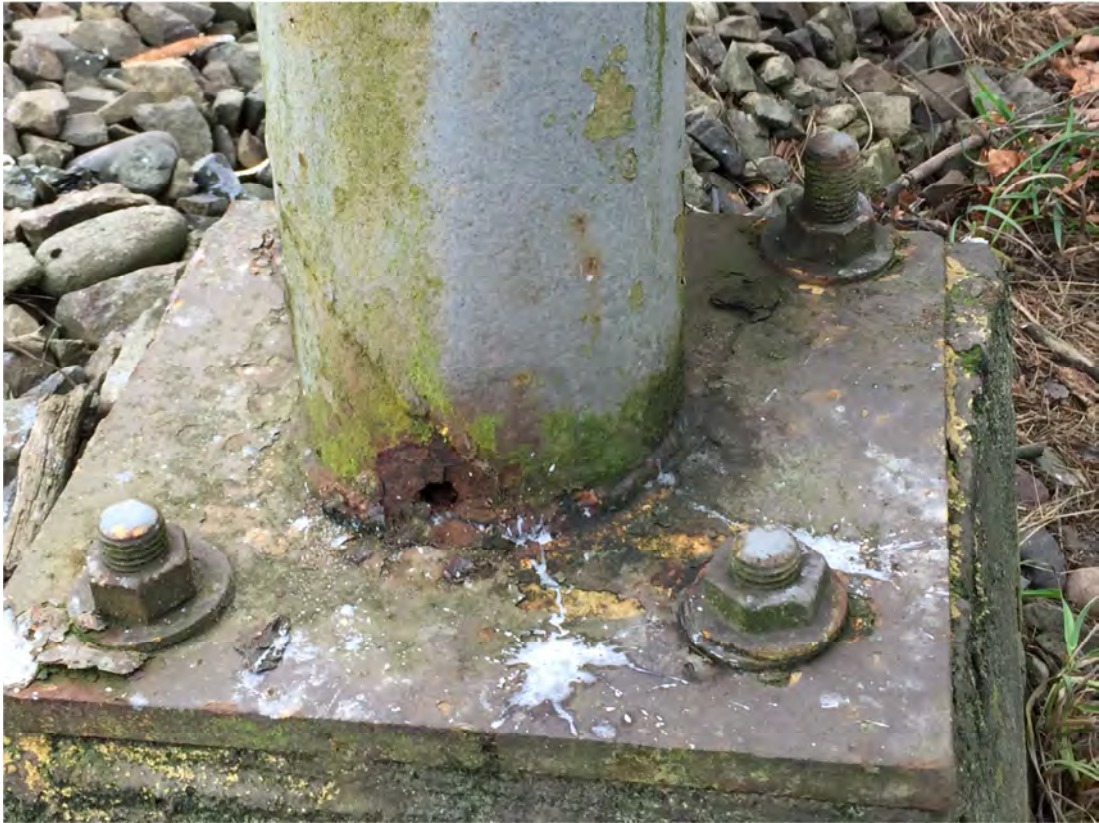
Figure 8 Corrosion at Pier Pipe Base with Visible hole

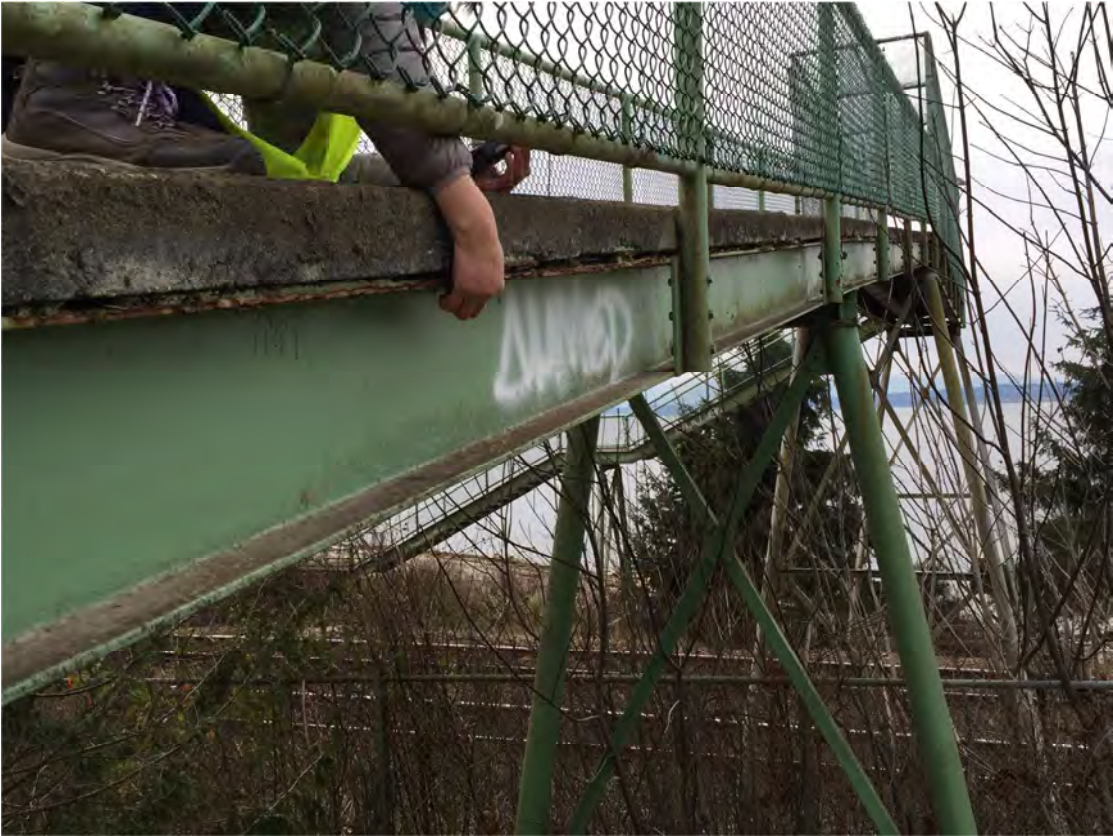
Figure 9 Corrosion at Steel Beam Top Flange

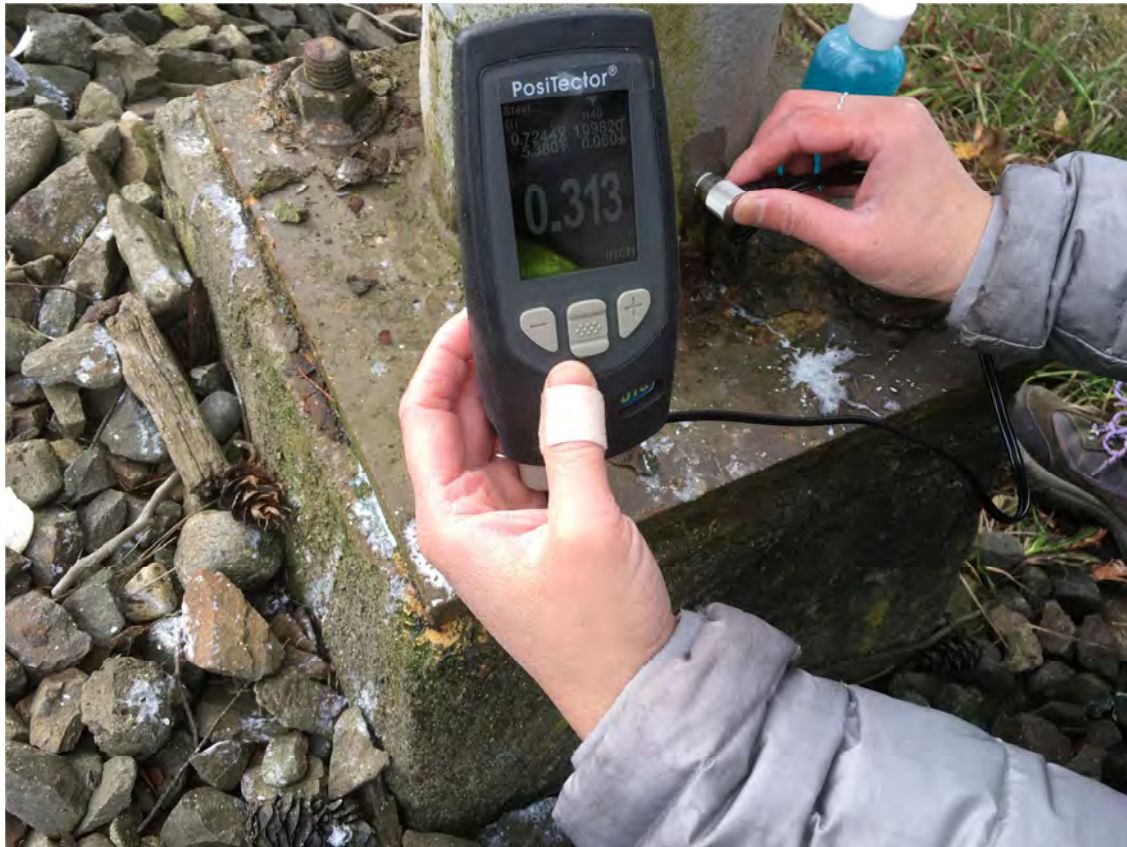
Figure 10 Field Measurement of Steel Thickness

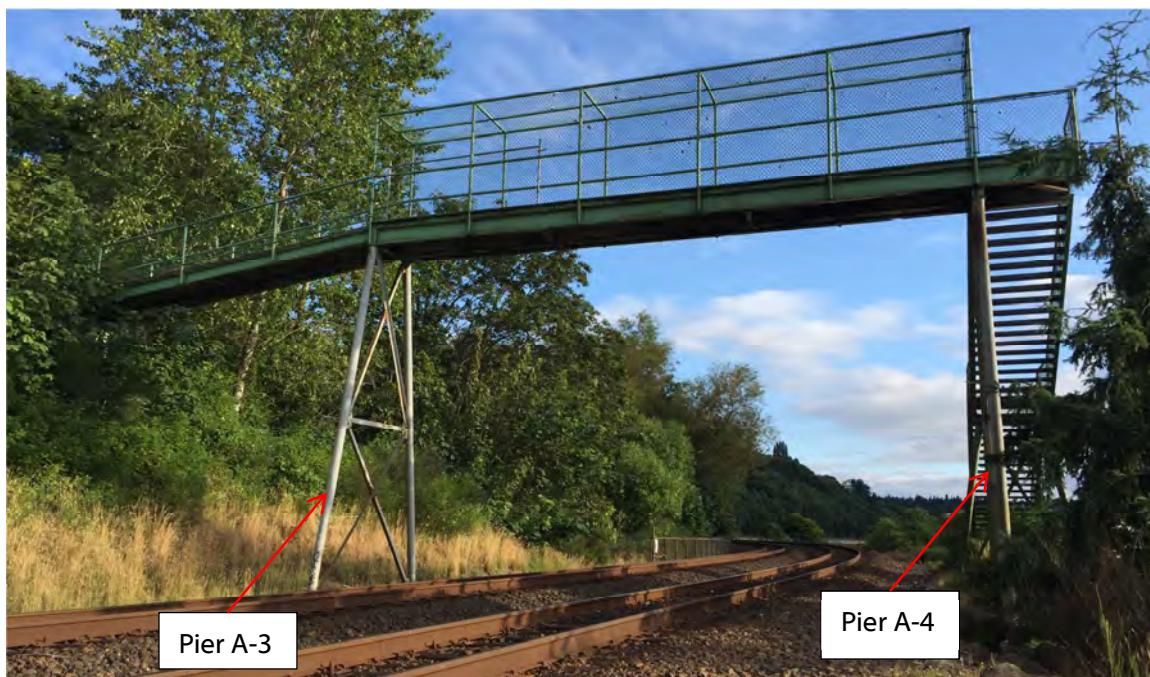
Figure 12 Existing Bridge Pier Locations

Based on the visibly deteriorated conditions at the structural members and connections, we recommend replacing the bridge within three years, although we have not found an immediate need to close the bridge. The Immediate work for safety includes Pier A-4 pipe base repair and load limitation posting at the parking side entrance.
