TECHNICAL MEMORANDUM 1

RN File No. 3193-001A

RE: Lowman Beach Park Feasibility Study – Geotechnical Evaluation

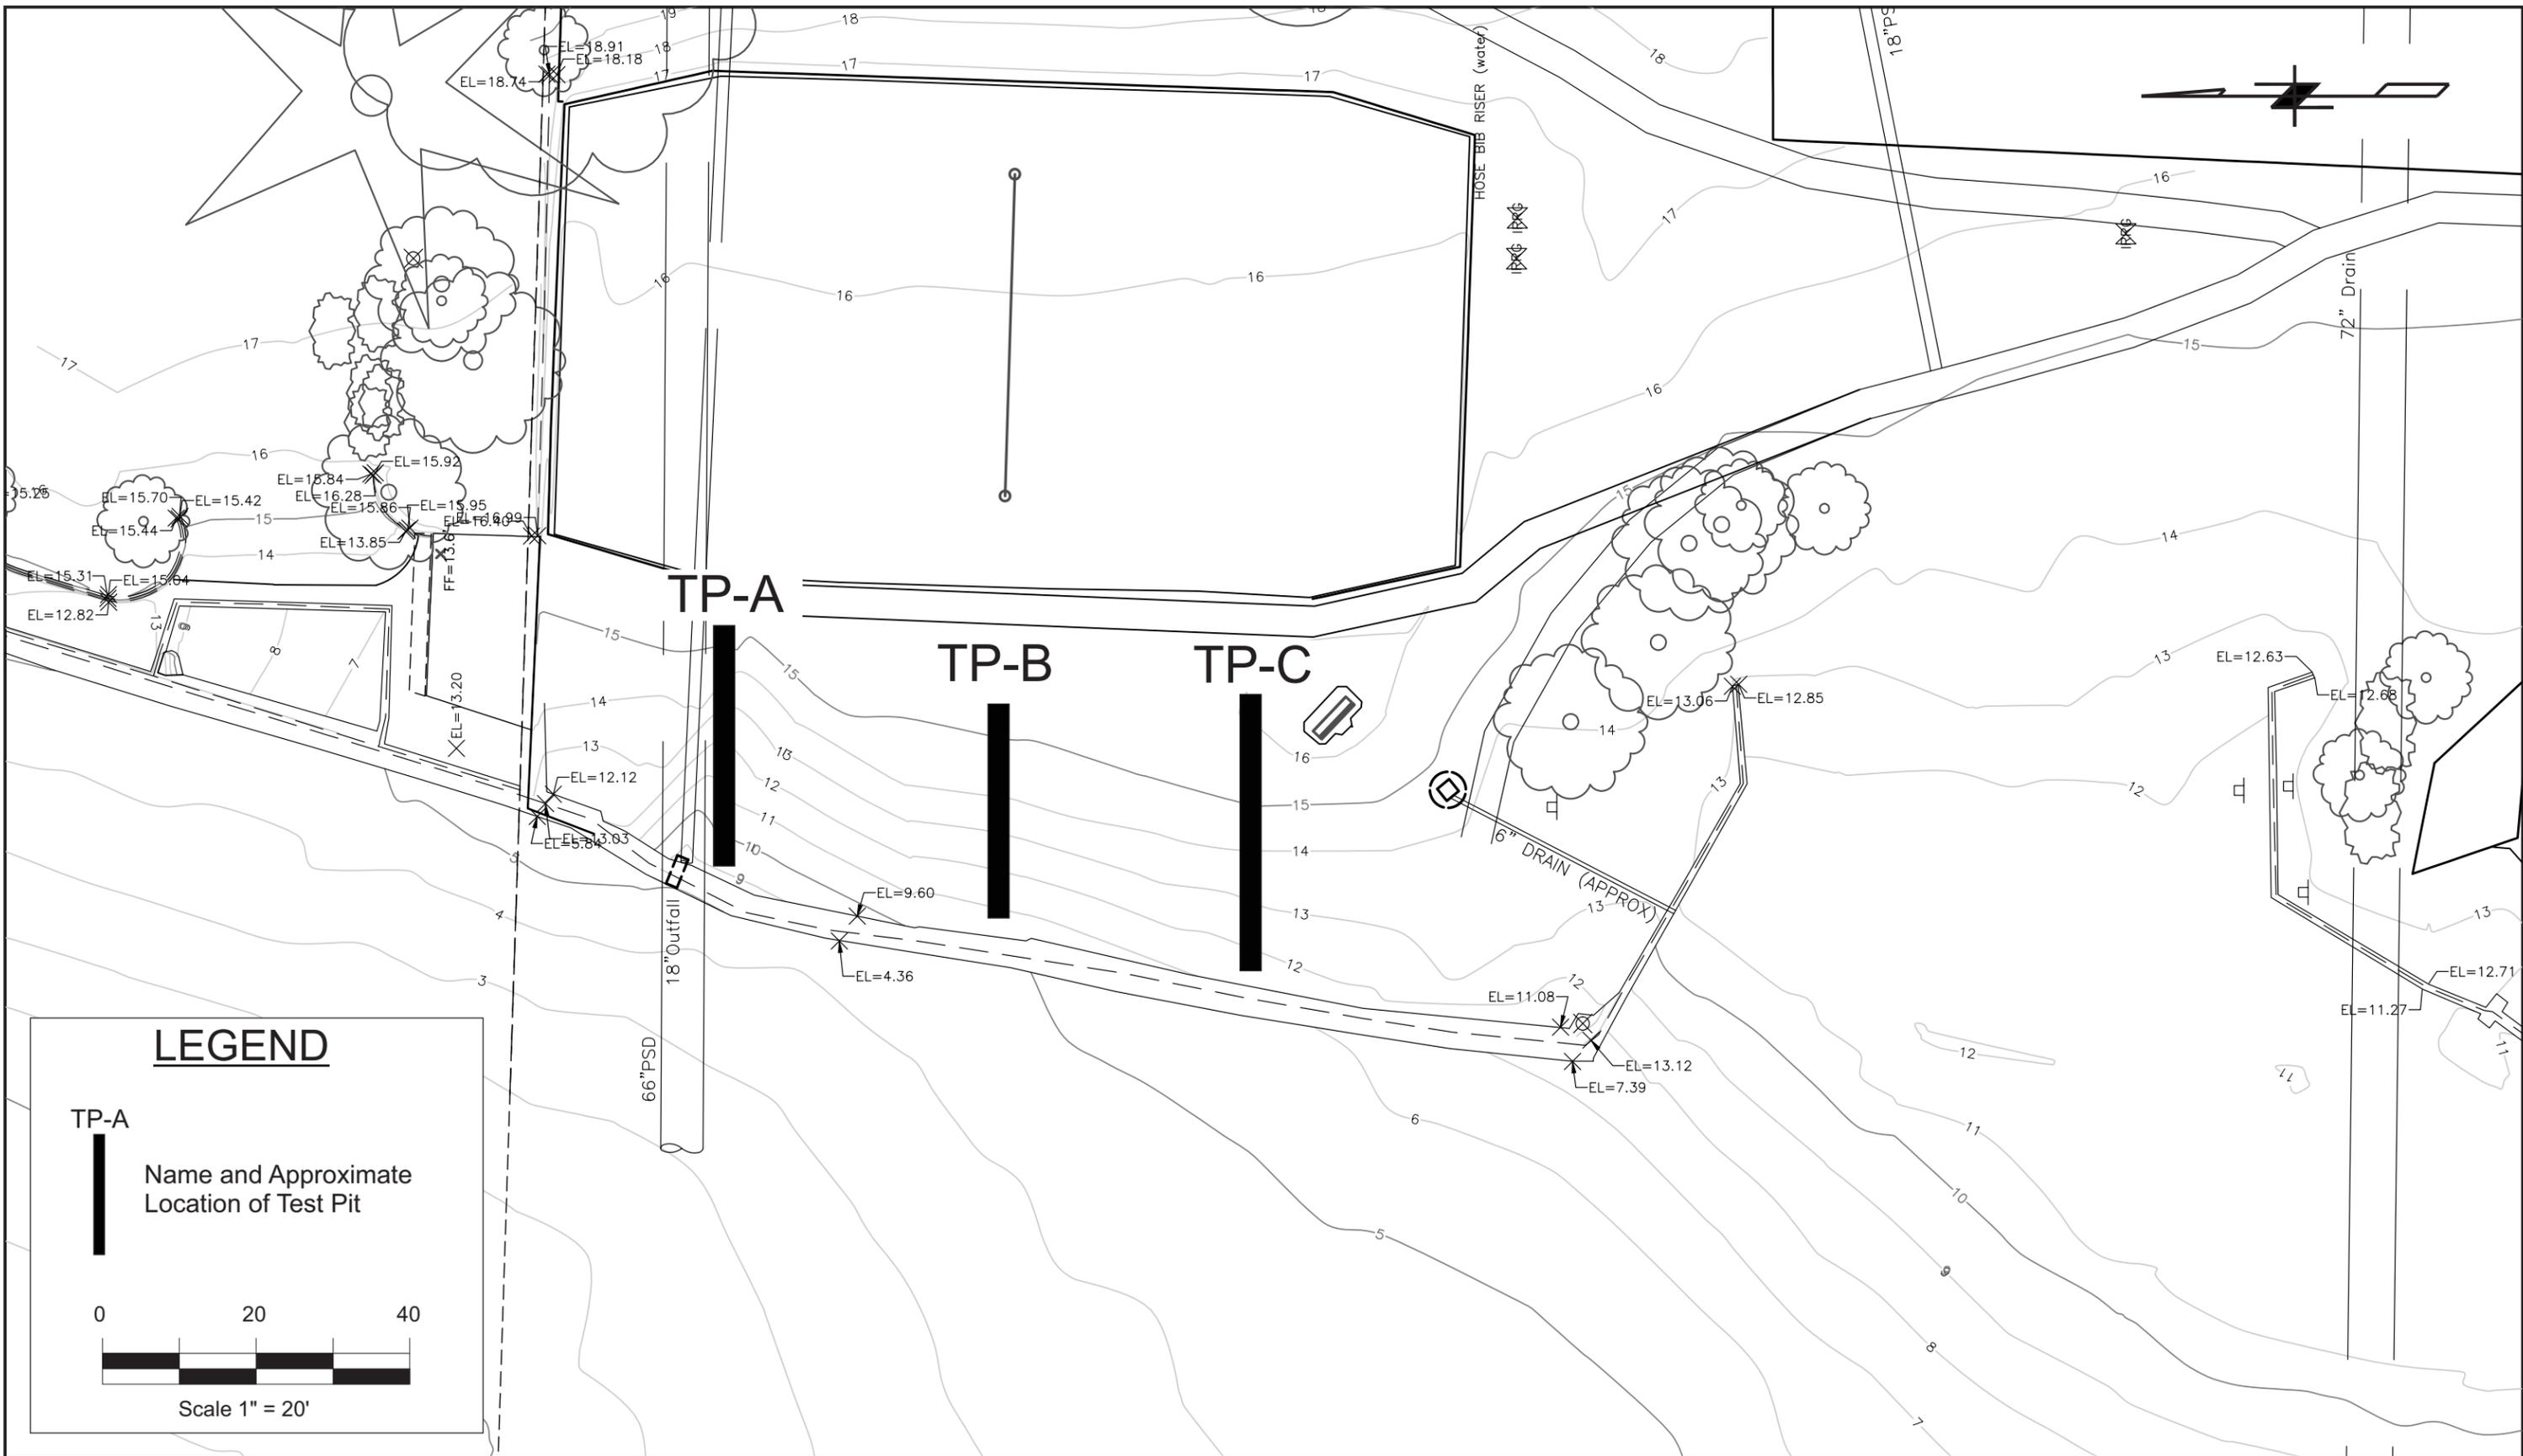
Figure 1
 Site Plan

We have performed geotechnical test pit explorations at the site to evaluate subsurface soil and water conditions in the area of the existing seawall. These explorations were performed on May 3, 2017. The explorations were performed by excavating three continuous trench test pits starting from the existing seawall on the western side of the property to the tennis courts to the east. The test pit locations are shown in Figure 1 and labeled Test Pits A, B and C. Cross Sections of the test pits are presented as Figures 2 through 4. The test pits were exca-

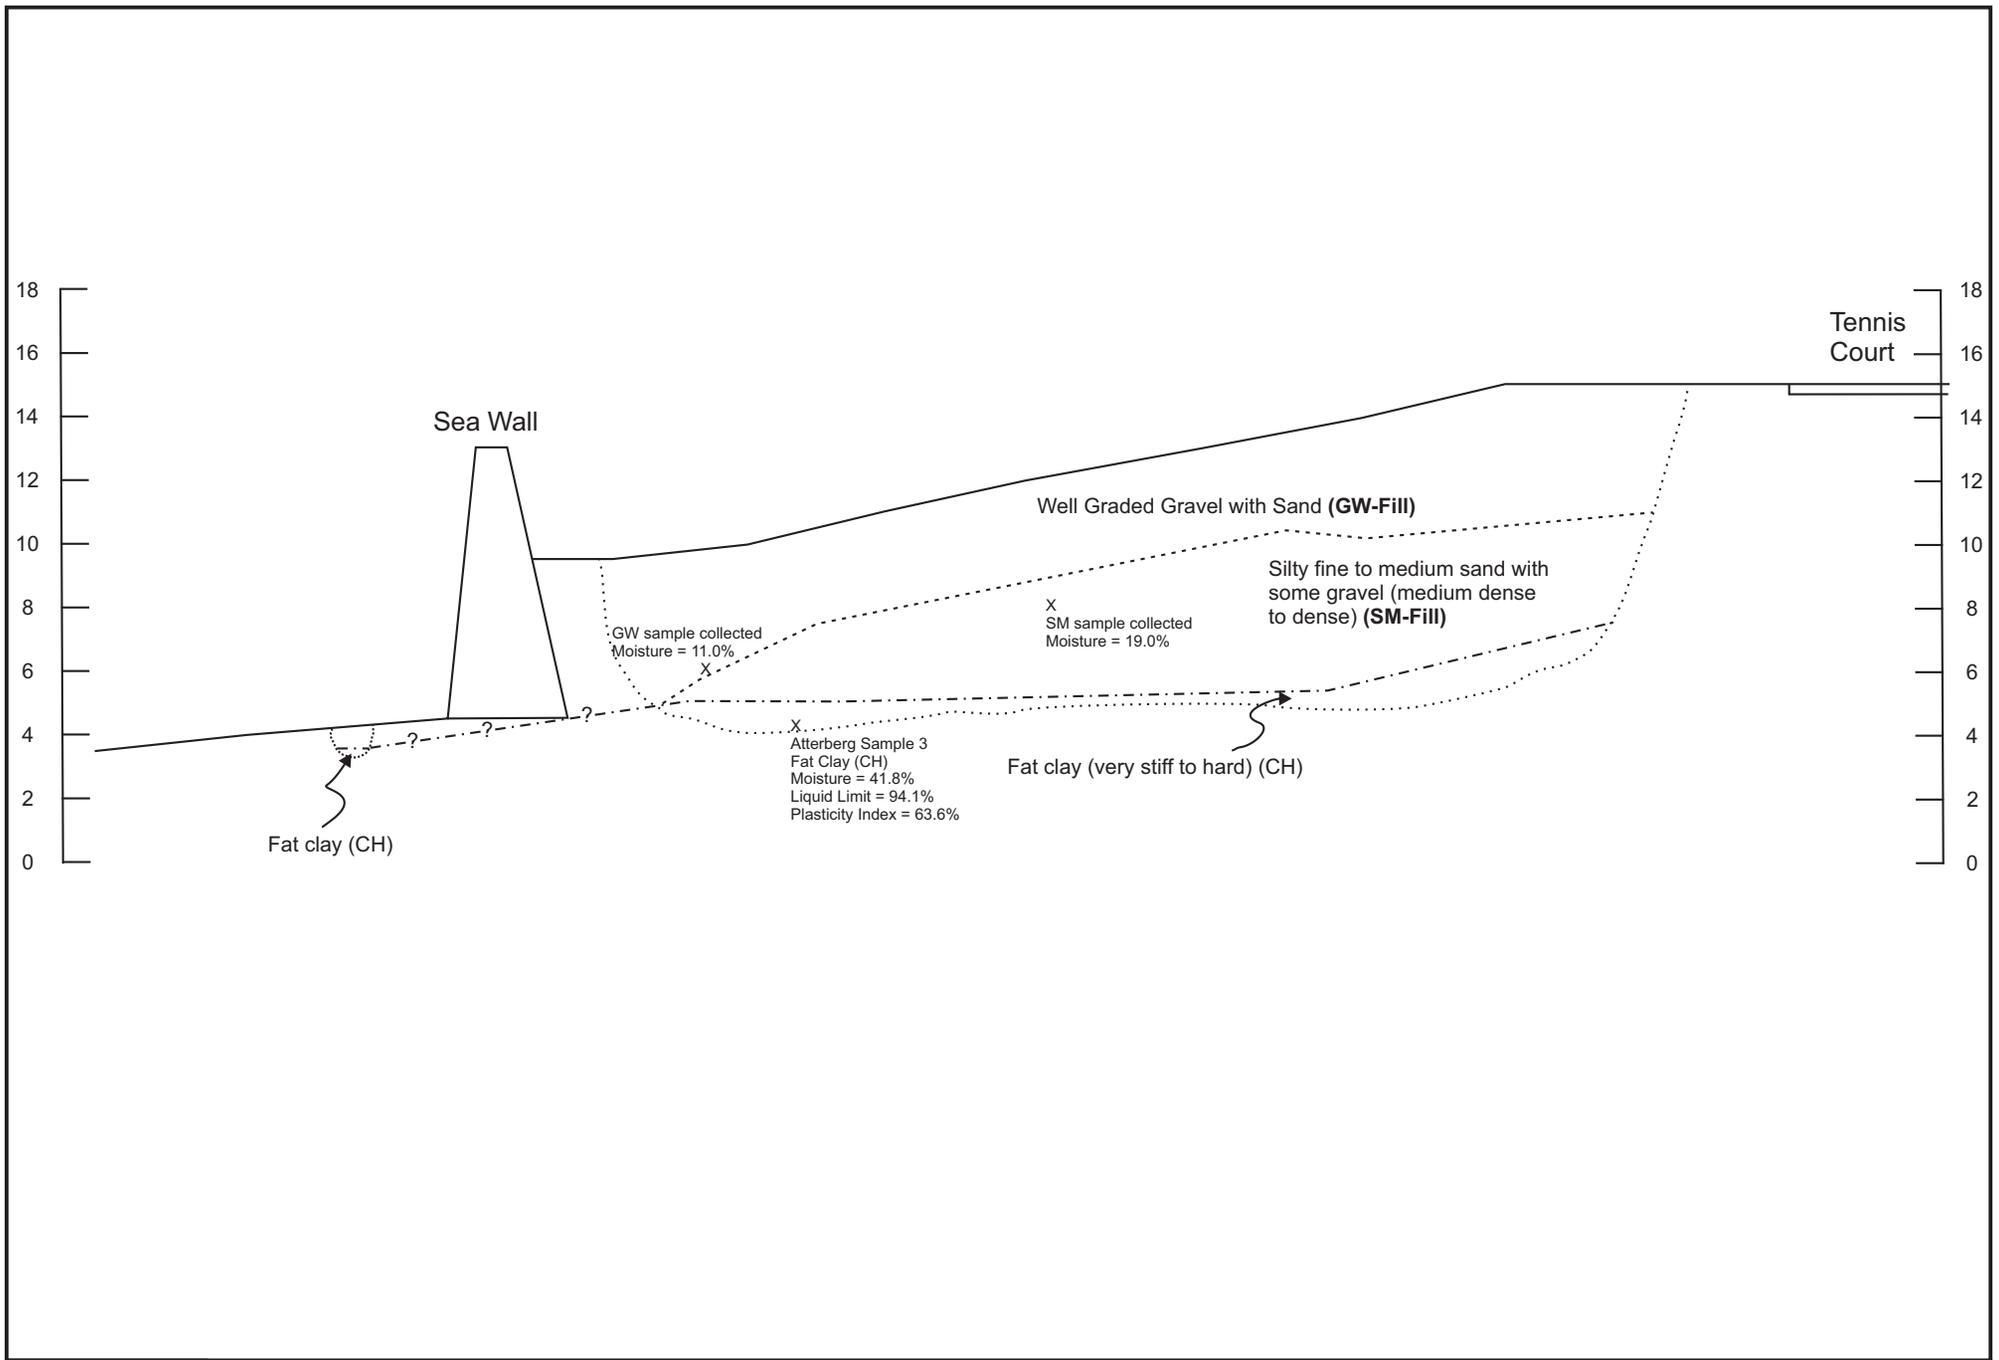
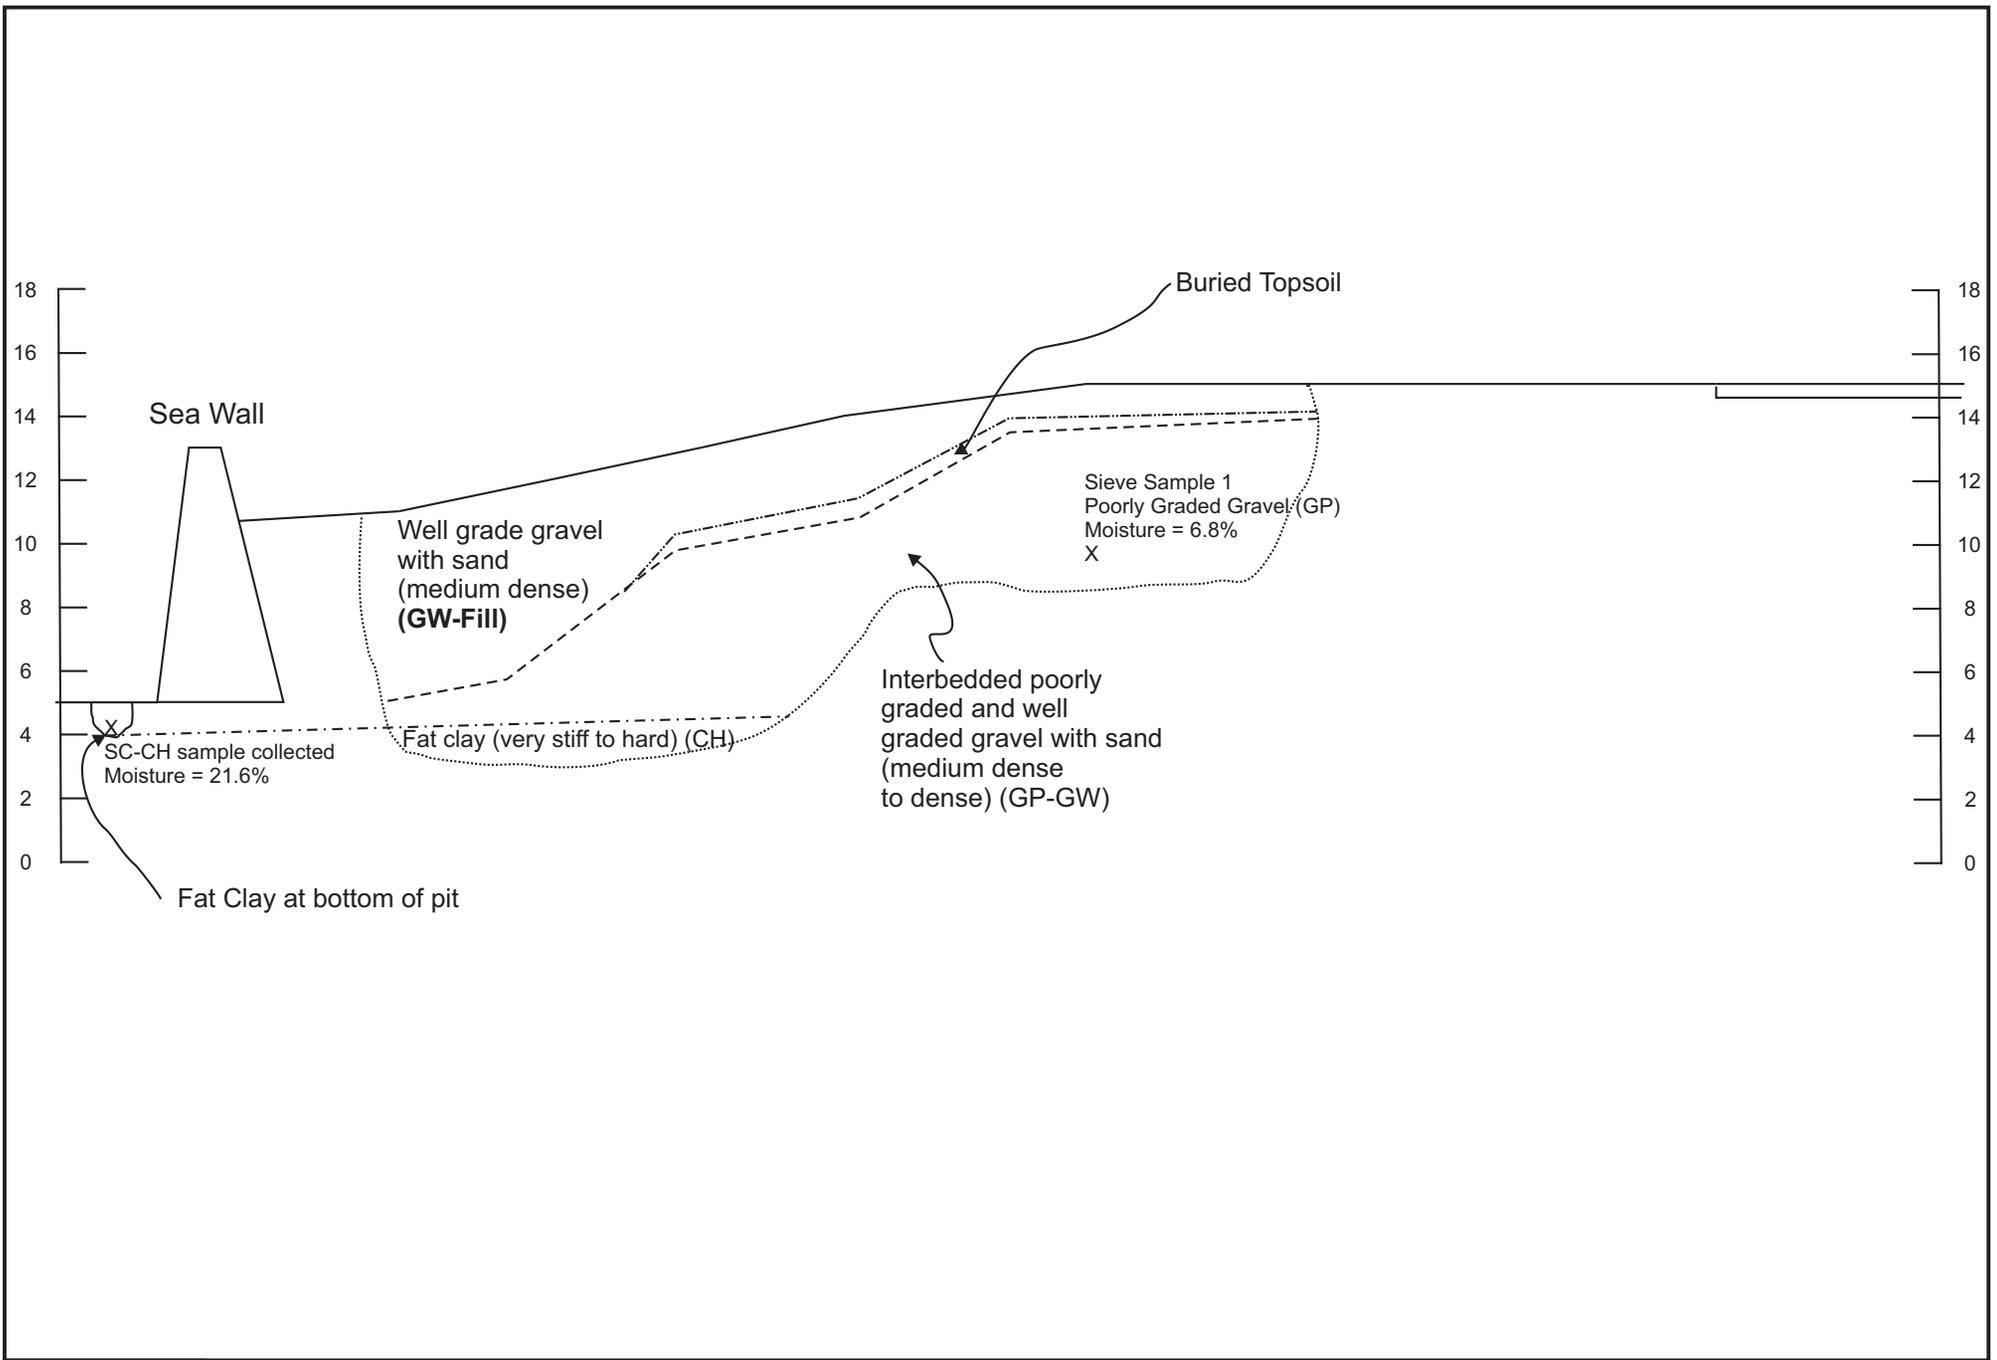
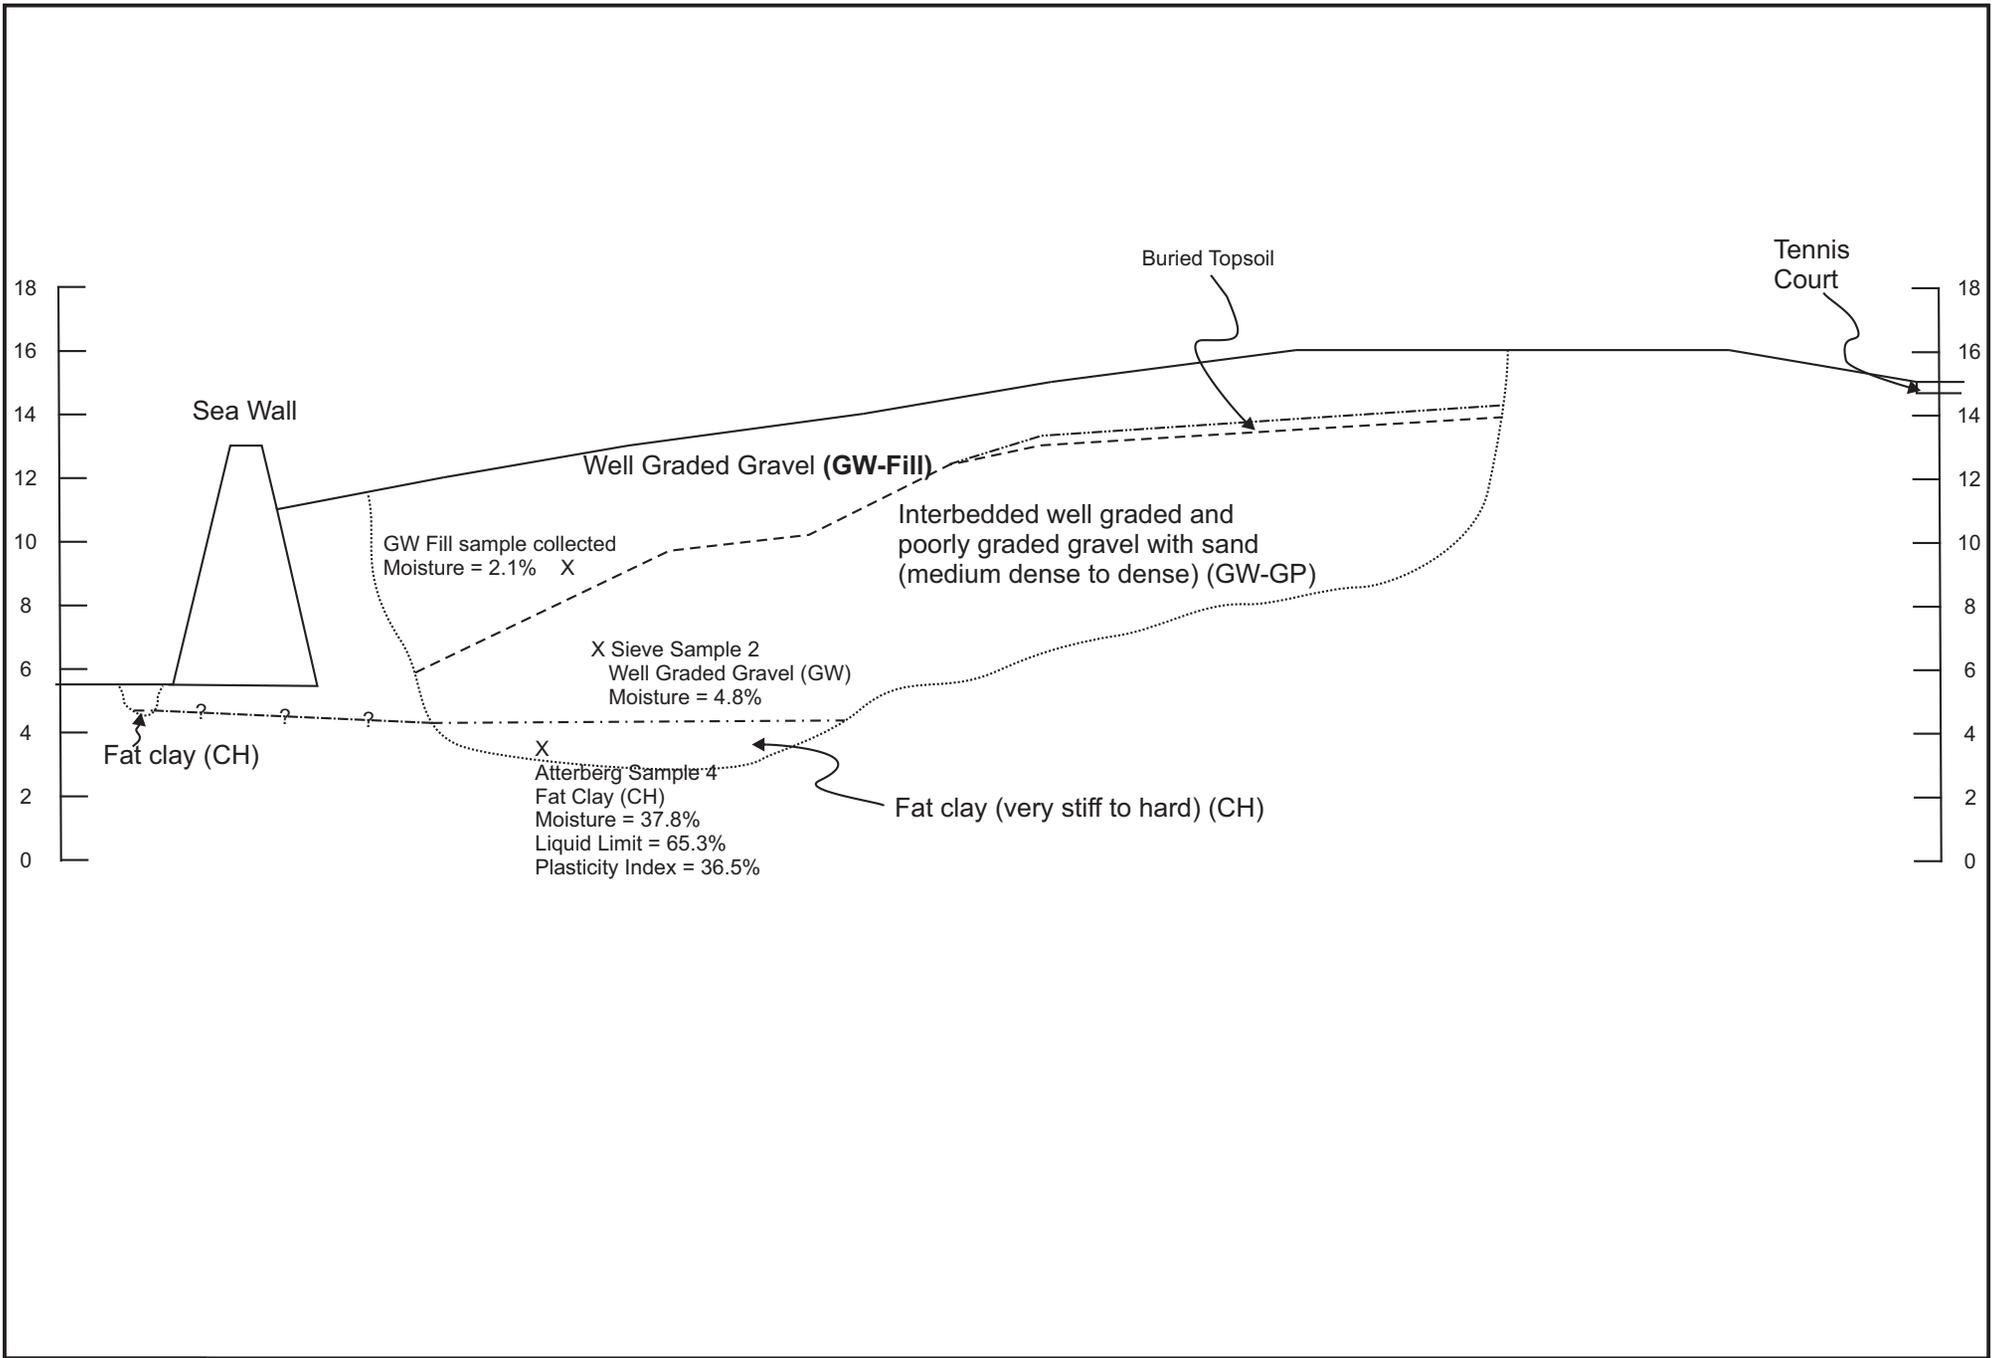
Test Pit A was completed in the northern region of the project site in the area of two known below grade storm pipes extending to Puget Sound. This test pit encountered well graded gravel with sand fill from the surface to approximately 3 to 5 feet below grade. The gravel fill material was underlain by silty sand with some gravel starting approximately 3 feet east of the seawall and extending towards the tennis court. This material was interpreted to be fill placed during the storm pipe installation. This fill was observed from approximately 3 to 9 feet below grade. The test pit was completed in stiff to hard clay. The clay was observed at approximately 6 feet below grade near the seawall and approximately 9 feet below grade near the tennis courts. On the beach side of the wall, beach deposits consisting of sandy gravel was observed to a depth of approximately 0.5 feet. Clay was observed below the beach deposits.

Test Pit B was performed in the central region of the project and roughly aligned with the tennis court net. The test pit was started approximately 3 feet east of the seawall and extended to the area of the tennis court. Near the seawall the test pit encountered medium dense gravel with sand at the surface to approximately 6 feet below grade. This material was interpreted to be fill and tapered to surface to depths of approximately 1 foot below grade near the tennis court. The fill was underlain by a thin layer of topsoil, approximately 2 to 6 inches in thickness, starting in the central region of the test pit trench at a depth of approximately 4 feet below grade and followed the surface grade upward to a depth of approximately 1 foot below grade near the tennis court. Native medium dense to dense outwash/beach deposits consisting of interbedded well graded and poorly graded gravel with sand were observed beneath fill/topsoil. The native material was observed towards the base of the seawall in the eastern region of the trench starting at a depth of approximately 6 feet below grade, and observed approximately 1 foot below grade near the tennis court. The native gravel soils were underlain by stiff to hard clay at depths of 7 feet below grade near the seawall and 10 feet below grade near the tennis court. On the beach side of the seawall, sandy clay was observed to approximately 1 foot below grade before encountering clay.

Test Pit C was performed in the southern region of the project area and encountered similar conditions to those of Test Pit B. Well-graded gravel fill with brick and construction debris was observed in the area of the seawall from the surface to near the base of the seawall at approximately 5 feet below grade. The fill tapered upwards towards the tennis court and was observed approximately 2 feet below grade at the east end of the test pit. The fill was underlain by a thin strip of buried topsoil in the central region of the test pit. The topsoil was observed at approximately 2 feet below grade. Native medium dense to dense interbedded well graded and poorly graded gravel with sand was observed below the fill and buried topsoil. This material was observed beginning at the base of the seawall and tapered up to near surface at the

tennis courts. Clay was observed at the base of the test pit and at the base of the seawall. The clay was observed to be approximately 6 feet below grade at the seawall and interpreted to be approximately 10 feet below grade near the tennis court. The clay was observed to be approximately 0.5 feet below grade on the beach and on the west side of the seawall.

We completed moisture content, grain size testing and Atterberg limits on selected samples from our explorations. The moisture contents are shown on the test pit cross sections. We completed two grain size tests on samples that we felt would represent on-site native granular soil composition. The results of the grain size tests are shown on Figures 5 and 6. Two Atterberg limit tests were performed on fine grain soils encountered at the base of our explorations to identify plasticity characteristics of those soils. The results of the Atterberg tests are shown on Figures 7 and 8.

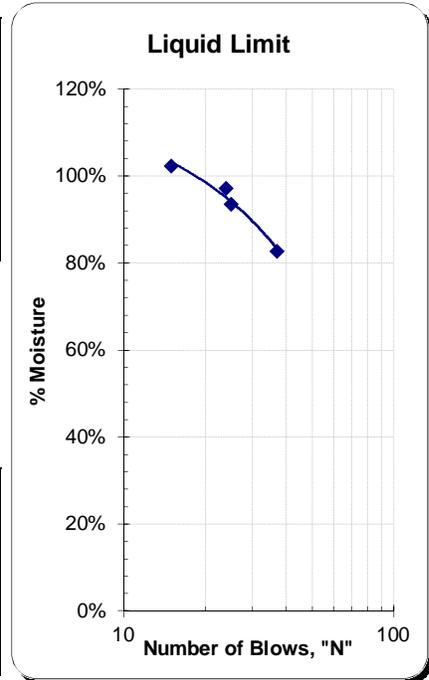
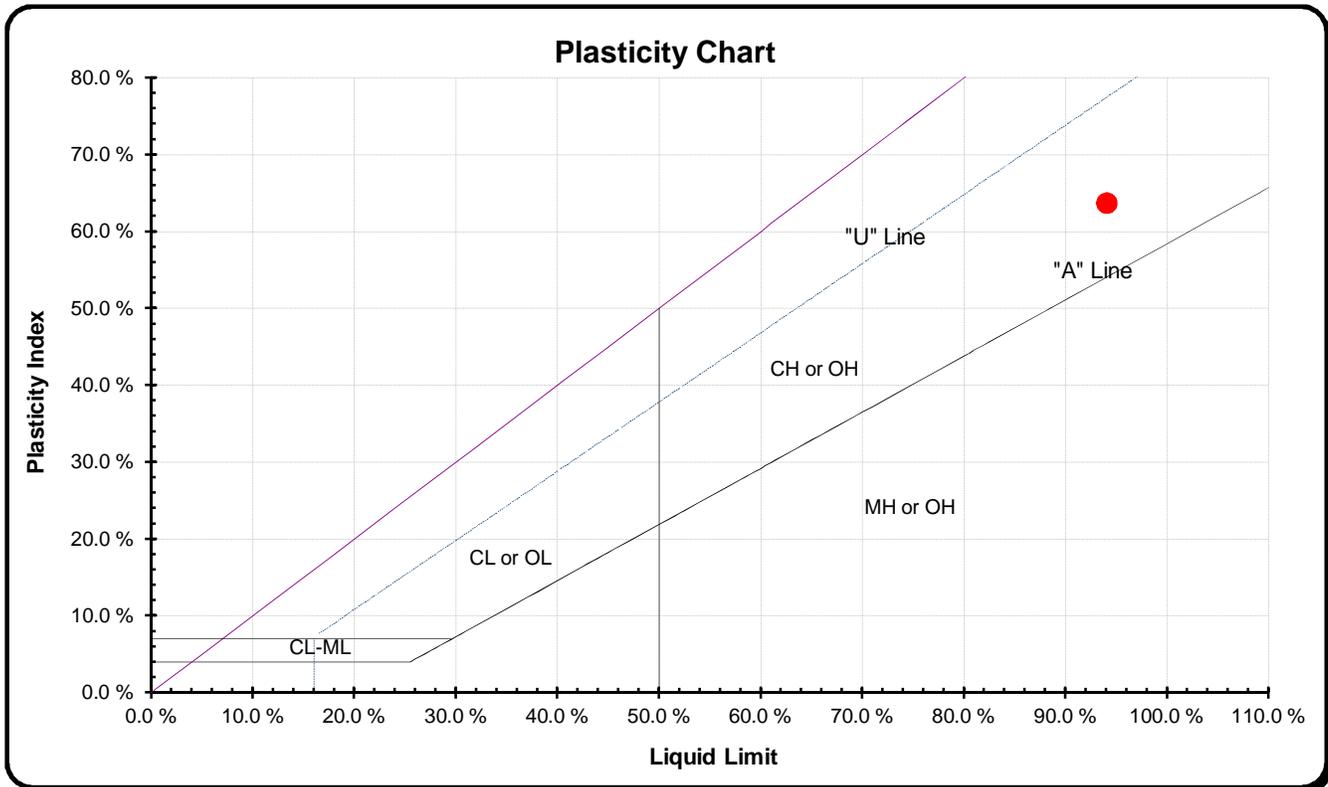
Atterberg Limits

Source: Test Pit A

Depth: 6.1'

Liquid Limit @ 25 Blows: 94.1 %

Plastic Limit: 30.5 %

Plasticity Index, I_p: 63.6 %

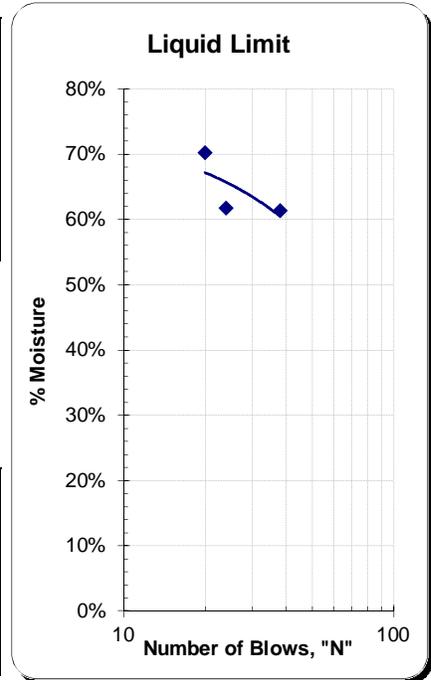
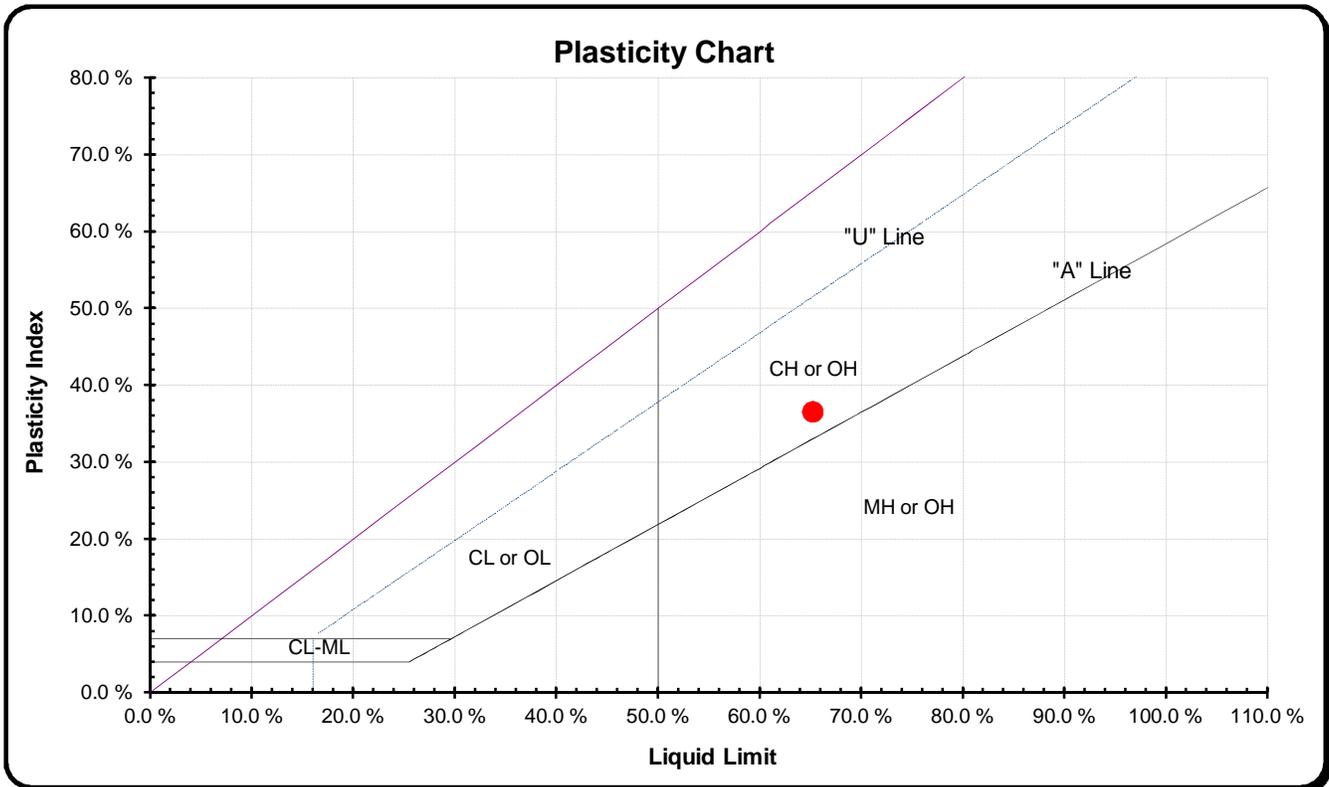
Atterberg Limits

Source: Test Pit C

Depth: 9.0'

Liquid Limit @ 25 Blows: 65.3 %

Plastic Limit: 28.8 %

Plasticity Index, I_p: 36.5 %
