SEATTLE DEPARTMENT OF TRANSPORTATION

CLIENT	Seattle Department of Transportation
DKS Project	24798-000
Project Name	S Holgate St Crossing Study
Document Name	Existing Conditions
Date Document Issued	August 15, 2025

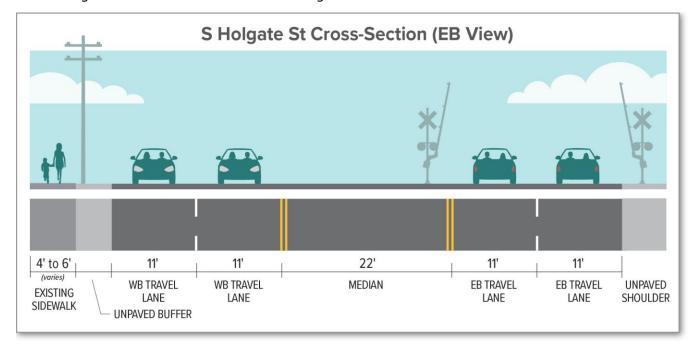
FIGURE 4: S HOLGATE ST CROSS-SECTION

The project area on S Holgate St features a four-lane cross section from Occidental Ave S to 3rd Ave S with two eastbound travel lanes and two westbound travel lanes, each approximately 11 feet wide. A median approximately 22 feet wide, with paved and unpaved segments, separates the eastbound and westbound traffic and is used for equipment staging. The south side of the roadway has an unpaved shoulder, and the north side has an inconsistently paved buffer adjacent to a paved sidewalk varying between 4 to 6 feet wide. The total right-of-way for S Holgate St is 130 ft. The S Holgate St cross section is shown in Figure 4.

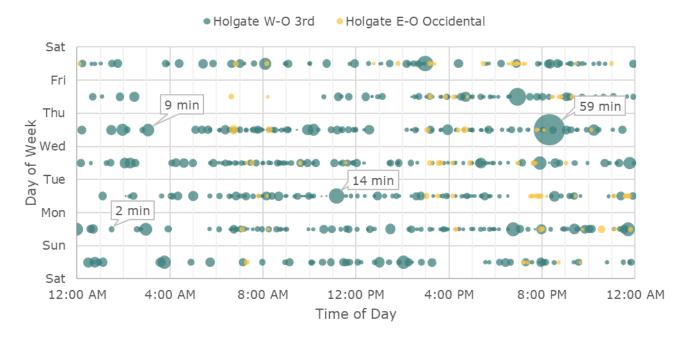
FIGURE 6: RAIL CROSSING "GATE DOWN" EVENTS ON S HOLGATE ST (927461X & 085583Y)

During the AM commuting peak between 6:00 AM and 10:00 AM, Figure 6 shows train activity remains high and is likely to cause frequent disruption to drivers, who may divert to Edgar Martinez Dr S or S Lander St to continue over the tracks. Longer train blockages (10 minutes or more at a time) seem to take place more during midday or in the early evening after the afternoon commuting peak. On average, S Holgate St is blocked for over three hours a day due to rail crossings between Occidental Ave S and 3rd Ave S. A previous study done for the S Holgate St rail crossing showed that in 2009 S Holgate St was blocked around 20% of the time throughout the day³; in comparison, the data collected for this study had a lower blockage rate, between 13% during the PM peak and 16% during the AM peak.

Recorded Gate Down Times and Duration - S Holgate Street Counted April 20-26, 2025

Congestion along S Holgate St is highly dependent on the length and frequency of unpredictable train crossing events (see Figure 6 and Table 3). This causes a wide distribution of delay experienced at each intersection and excessive delay resulting in LOS E-F when crossing events last greater than 1 minute (LOS E begins at 55 seconds of incurred delay). Intersection LOS on the corridor ranges from A-F. The intersections closest to the rail crossings gates (Sound Transit LRT tracks east of 4th Ave S (adjacent to the SODO Busway), BNSF mainline tracks west of 3rd Ave S (DOT#927461X), and Amtrak maintenance facility tracks east of Occidental Ave S (DOT#085583Y) experience the greatest delay and worst LOS (F) rating in the study area. Through movements going eastbound and westbound are prioritized on the corridor resulting in LOS F for many side street and turning movements. For example, the left turning movements at S Holgate St and 4th Ave S exceeds 5 minutes of delay going northbound, southbound, and westbound due to the congestion on S Holgate St, signal operations during preemption, and minimal green time allocated to the movements. Figure 15 displays intersection LOS; Table 9 and Table 10 include intersection delay and LOS for the AM and PM peak periods, respectively.

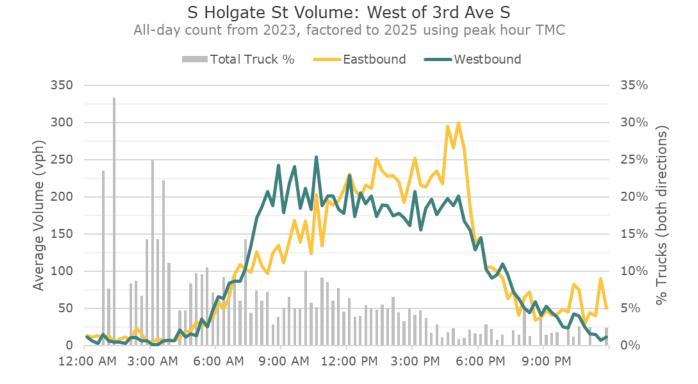
FIGURE 8: S HOLGATE ST TRAFFIC VOLUMES WEST OF 3RD AVE S

Existing traffic volumes on the S Holgate St rail crossing are shown in Figure 8. They were developed through all-day counts taken in November 2023 and factored up by 10% to match a recent May 2025 turning movement count that was done for the AM and PM peak periods. These counts showed an Average Daily Traffic (ADT) volume of **5,120 vehicles/day**, a decline from historical volumes on the corridor and reflective of completed large projects such as the Alaskan Way Viaduct Replacement and the S Lander St Bridge that have changed travel patterns in SODO. Travel patterns vary by direction: westbound volumes peaks in the morning and gradually decreases through the afternoon peak, while eastbound volumes build towards the afternoon peak with no pronounced drop in volume during midday. Heavy vehicles are up to 10% of the total volume during the AM peak and 5-10% in the late morning, but this share drops off through the afternoon. Overnight truck percentages are higher but reflect low overall traffic volumes during that period.

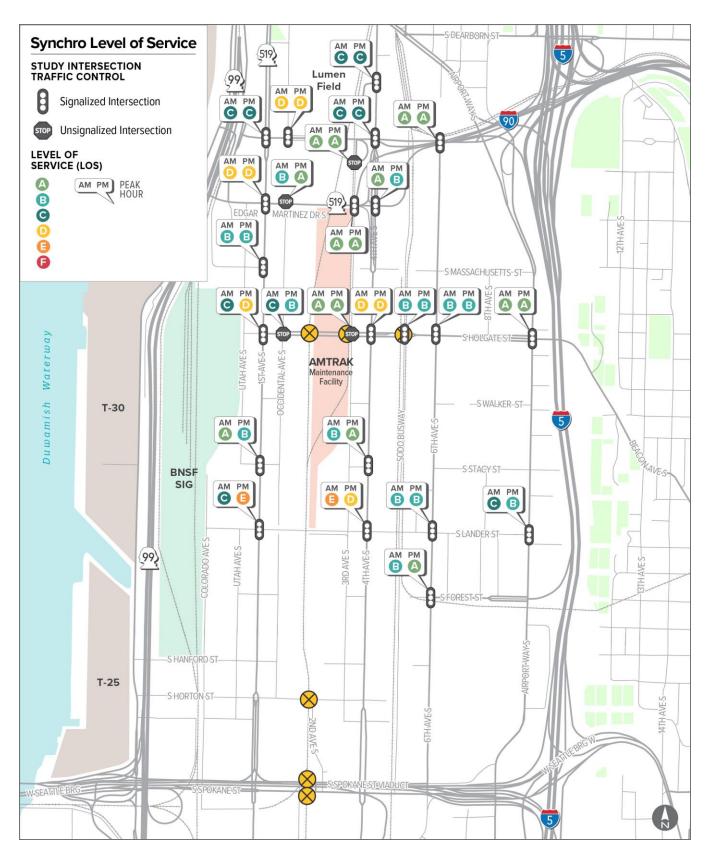
FIGURE 11: AM AND PM PEAK HOUR LOS RESULTS - SYNCHRO

This section summarizes the technical results of the Synchro analysis for a network of 25 intersections, including S Holgate St and surrounding intersections. The goal of this analysis was to assess intersection operations during the AM and PM peak periods using Synchro 12. The model was developed to reflect observed conditions, including signal timing, roadway geometry, and traffic volumes. Measures of effectiveness focused on intersection delay and volume-to-capacity (v/c) ratios. All analyses followed WSDOT's Synchro and SimTraffic Protocol. Figure 11 displays intersection level of service (LOS) and Table 5 includes intersection delay, LOS and v/c ratios for the AM and PM peak periods.

4th & Stacy	Signal	10.2	В	0.44	3.3	А	0.41
4th & Lander	Signal	58.9	Е	0.67	50.5	D	0.72
SODO Busway & Holgate	Signal	13.0	В	0.22	13.6	В	0.21
6th & Royal Brougham	Signal	7.7	А	0.19	6.5	А	0.20
6th & Holgate	Signal	17.7	В	0.35	18.9	В	0.34
6th & Lander	Signal	14.2	В	0.37	15.4	В	0.40
6th & Forest	Signal	12.1	В	0.50	8.3	А	0.37
Airport & Holgate	Signal	6.1	А	0.36	9.8	А	0.57
Airport & Lander	Signal	20.7	С	0.63	18.0	В	0.62

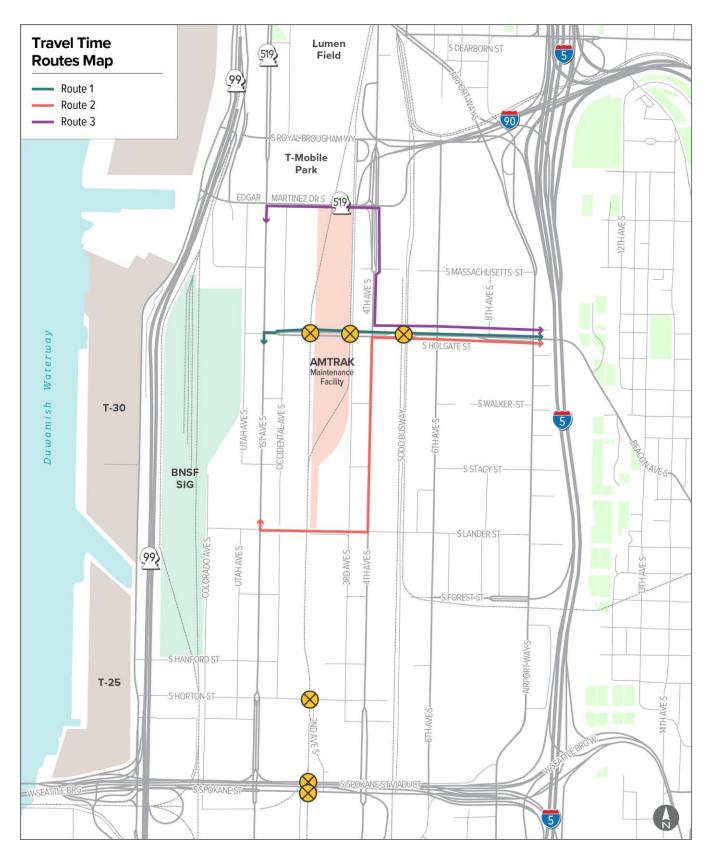
FIGURE 12: SYNCHRO TRAVEL TIME ROUTES

A travel time analysis was also conducted using the Synchro model for three routes using S Holgate St, S Lander St, and Edgar Martinez Dr S, as shown in Figure 12 (page 27). Because Synchro does not simulate individual vehicles, travel times were estimated by adding the delay at intersections to the time it takes to drive each segment at free-flow speed. Travel times for eastwest routes reflect the variation in route length with S Holgate St being the most direct. Travel times using S Lander St also reveal generally higher congestion levels near 1st Ave S and 4th Ave S. A summary of the findings of this travel time analysis is presented in Table 6 (page 28).

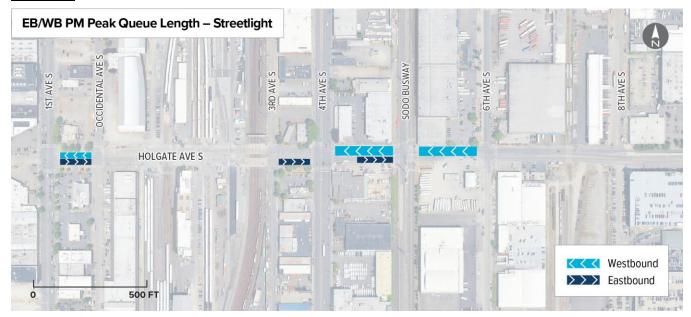
FIGURE 13: STREETLIGHT DATA PEAK PERIOD QUEUE LENGTHS

95th percentile and maximum queue lengths are reported for the AM and PM periods. In both periods, significant queuing occurred in the westbound direction caused by rail crossing events and matched the StreetLight Data analysis. Starting from the Sound Transit LRT rail crossing east of S Holgate St and 4th Ave S and ending at 6th Ave S, 95th percentile queue lengths exceeded storage capacity in the westbound direction, extending through and influencing queueing at the closely spaced upstream intersections. The Vissim queueing results showed longer westbound queues in the AM due to the distribution of gate down time and frequency. Eastbound queue lengths in the AM and PM periods are also closely related to rail crossing events and show patterns of queuing at

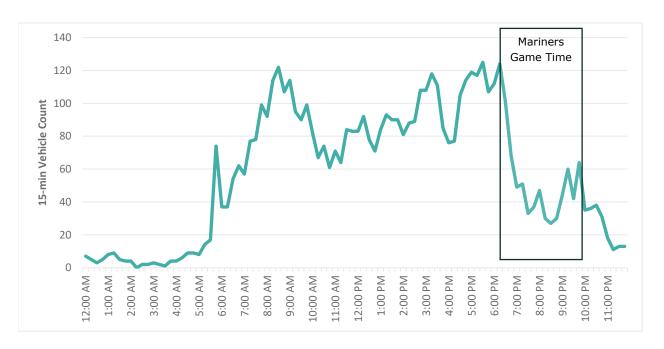
FIGURE 27: HOLGATE ST (EAST OF 1ST AVE S) TRAFFIC COUNT - 5/13/25

Figure 27 shows the 24-hour vehicle counts in 15-minute intervals along S Holgate St east of 1st Ave S on the game day. This figure illustrates a traffic pattern similar to that of a typical urban roadway with AM and PM rush hour peaks. However, while the AM peak occurs around the typical 8-9 AM timeframe, the PM peak extends from the typical 3 PM to as late as 6 PM. The prolonged PM peak correlates with Mariners game's start time of 6:40 PM, indicating that a portion of the PM peak traffic were event related. However, the event-related traffic along S Holgate St did not appear to significantly increase the PM peak hour volume. The data also reveals that heavy vehicles make up about 6.7% of all vehicular traffic on the game day.

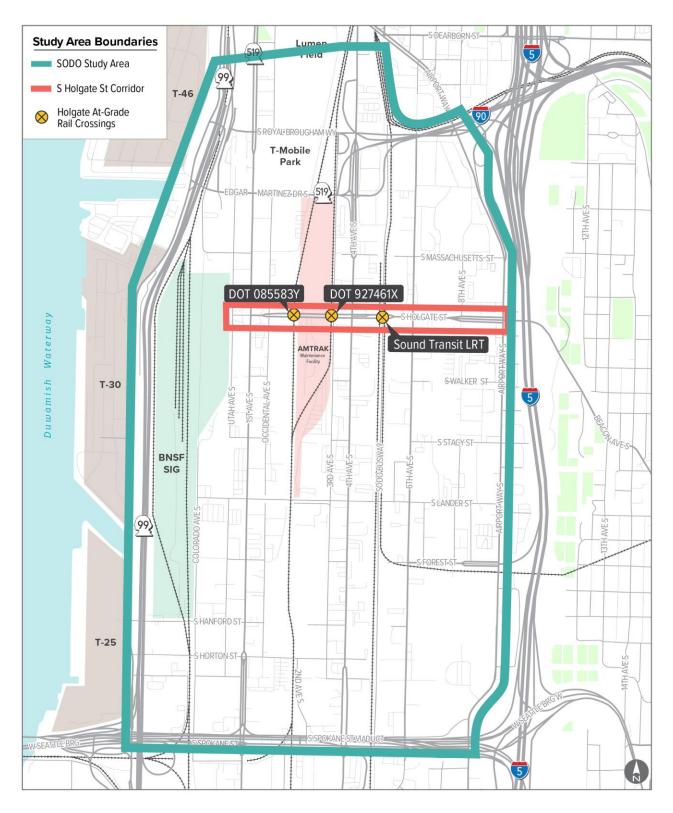
FIGURE 29: SAFETY STUDY AREA BOUNDARIES

Figure 29 provides a map of the study area boundaries.

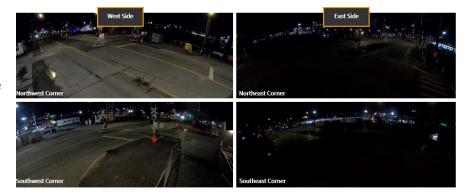
FIGURE 40: NIGHTTIME CONDITIONS AT S HOLGATE ST AND E RAILROAD CROSSING

Figure 40 shows the existing lighting conditions for each corner of the intersection. In particular, the northeast and southeast corners could have better visibility with improved lighting.

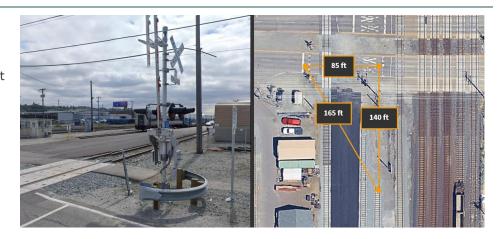
FIGURE 41: SIGHT DISTANCE LIMITATIONS ON THE NORTHBOUND TRAIN TRACK

Figure 41 shows there are trains regularly parked almost 200 feet from the crossing, which may obstruct the view of oncoming southbound trains around the corner.

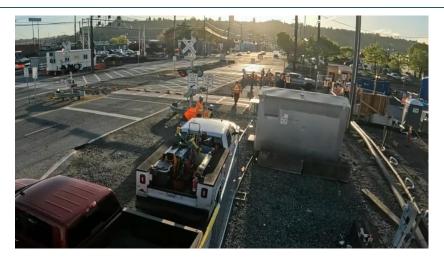
FIGURE 42: VIDEO CAPTURE OF AMTRAK WORKERS WALKING ACROSS THE TRACKS WHILE GATES ARE DOWN (APRIL 22, 2025)

The near miss analysis observed numerous Amtrak construction workers that were crossing the railroad tracks while gates were down. Figure 42 provides a screen capture of one of the incidents.

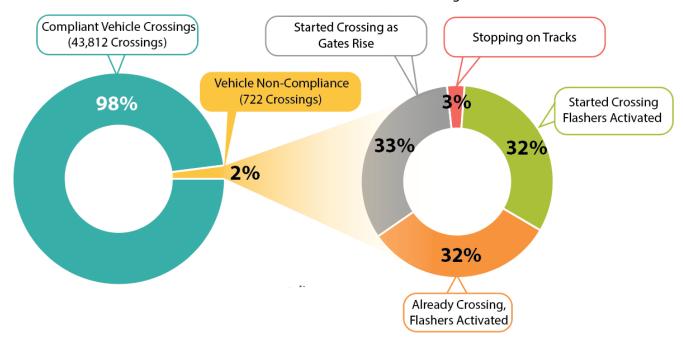
FIGURE 43: PROPORTION OF VEHICLE NON-COMPLIANCE WITH TRAIN CROSSING

For drivers, 98% of the observed vehicles complied with the gates flashing and stopped before entering the crossing. However, as shown in Figure 43, 230 vehicle drivers were observed to be crossing the intersection while the flashers were activated and 21 vehicles stopped on the tracks. Figure 44 provides a screenshot of the video capture where a truck driver ignored the activated flashers and was stuck under the gates. Furthermore, there were instances observed where vehicles would conduct U-turns at the intersection to avoid waiting for the train to cross.

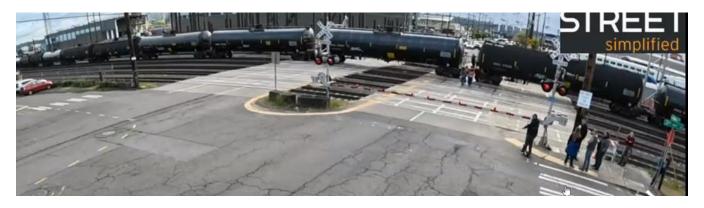
FIGURE 46: VIDEO CAPTURE OF PEDESTRIANS CROSSING OVER THE TRAIN WHILE GATES ARE FULLY LOWERED

Vulnerable road users (VRU) are individuals who walk or roll (scooter or bike). The S Holgate St crossing experiences higher pedestrian and VRU volumes during event days due to the proximity to major event stadiums located east of the corridor and transit connections to the west of the corridor. Analysis of near-miss incidents revealed that out of 25,220 observed VRU crossings, approximately 95% of users adhered to safety protocols—stopping in response to flashing signals and waiting for passing trains, as shown in Figure 45. However, 323 individuals were documented crossing the railroad tracks while the gates were fully lowered, disregarding both the visual and audible safety warnings, as shown in Figure 46.

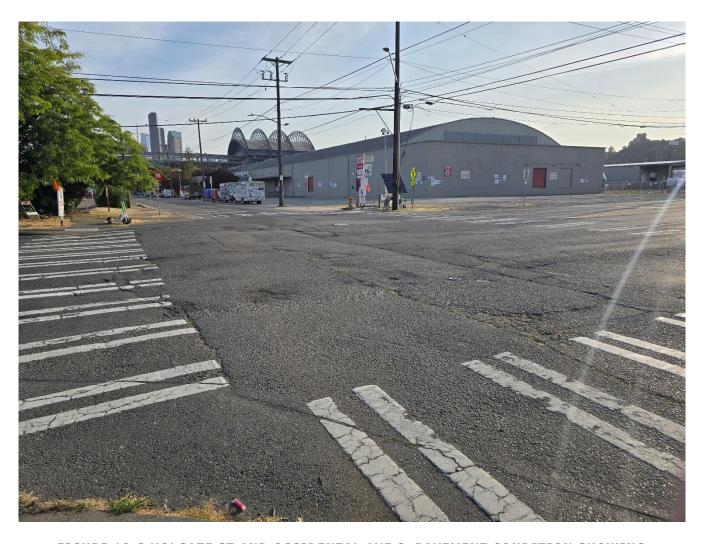
FIGURE 10-S HOLGATE ST AND OCCIDENTAL AVE S, PAVEMENT CONDITION SHOWING ALIGATORING AND CRACKING, SW CORNER LOOKING NE

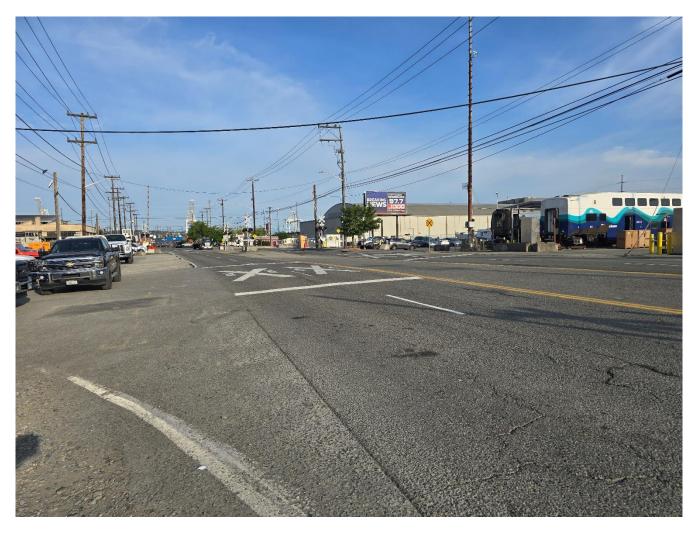
FIGURE 11-S HOLGATE ST AND DOT# 085583Y CROSSING, PAVEMENT CONDITION SHOWING ALIGATORING AND CRACKING, SW CORNER LOOKING NW

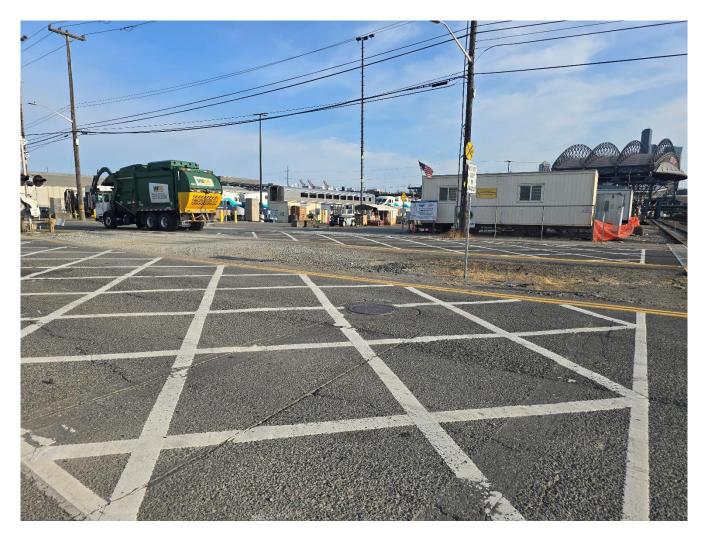
FIGURE 12-S HOLGATE ST BETWEEN DOT# 085583Y AND 927461X CROSSING, PAVEMENT CONDITION SHOWING ALIGATORING AND TRENCH REPAIR, SW CORNER LOOKING NW

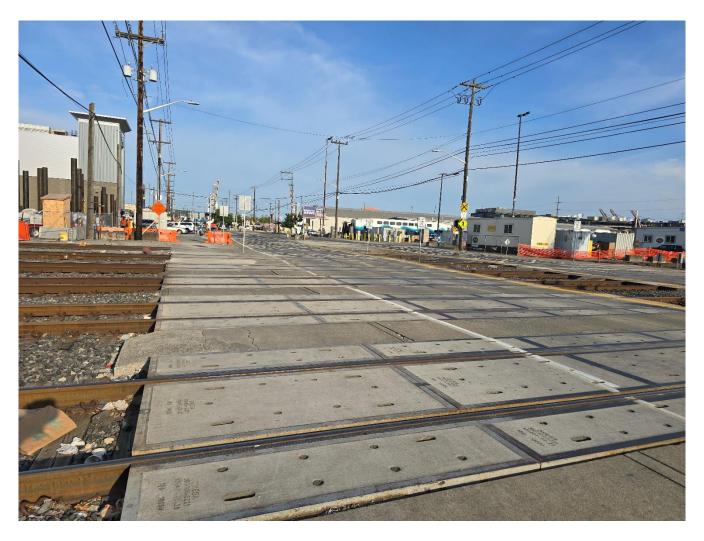
FIGURE 13-S HOLGATE ST AND DOT# 927461X CROSSING, PAVEMENT CONDITION SHOWING FAILURE OF PAVEMENT BETWEEN RAIL CROSSING, SE CORNER LOOKING NW

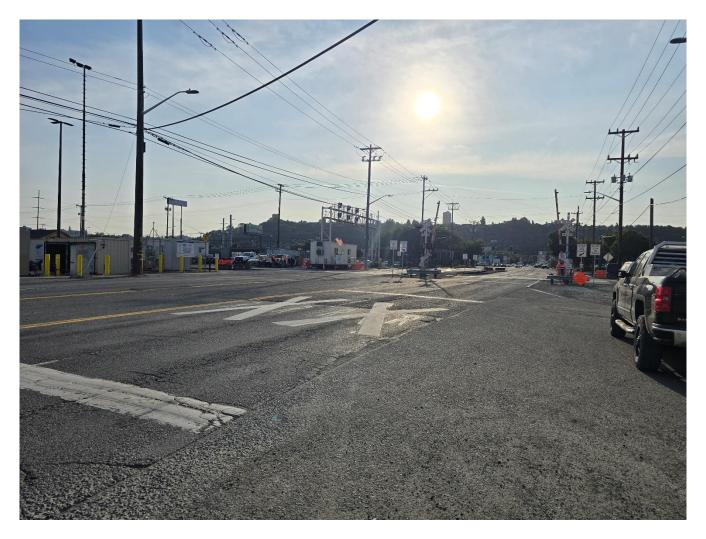
FIGURE 14-S HOLGATE ST AND DOT# 085583Y CROSSING, PAVEMENT CONDITION SHOWING ALLIGATORING OF PAVEMENT AND LATERAL CRACKING, SE CORNER LOOKING NE

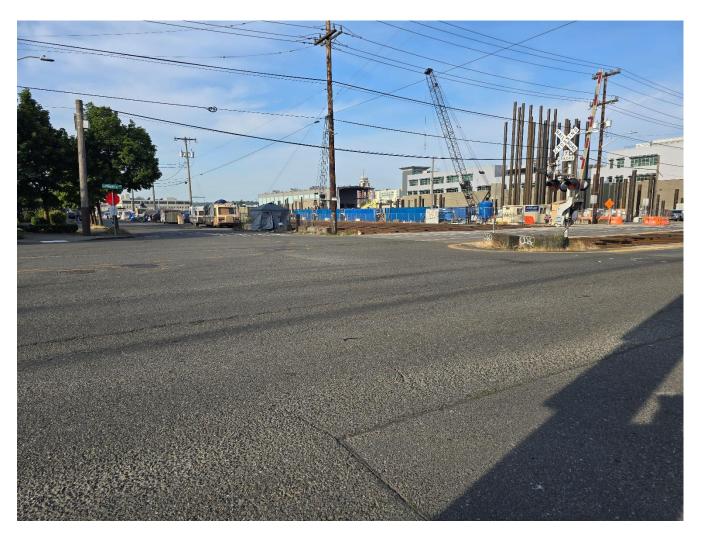
FIGURE 15-S HOLGATE ST AND 3^{RD} AVE S, NEAR DOT# 927461X, PAVEMENT CONDITION SHOWING LONGITUDINAL CRACKING AND PATCHING, NE CORNER LOOKING SW

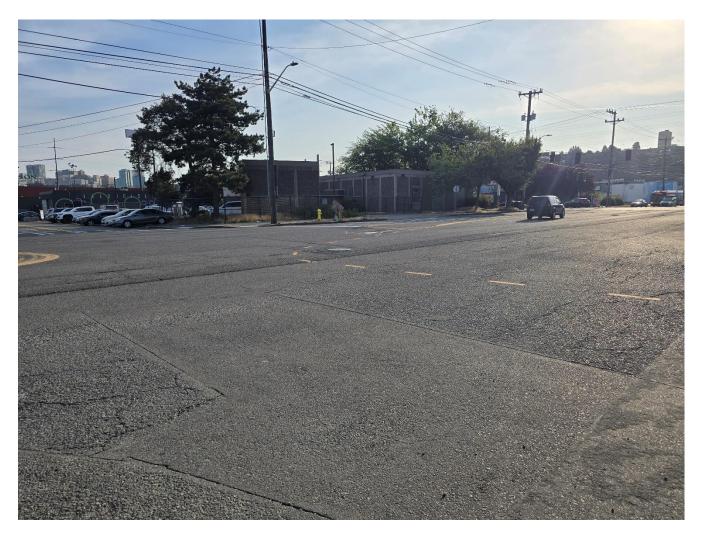
FIGURE 16-S HOLGATE ST AND 3RD AVE S, PAVEMENT CONDITION SHOWING ALLIGATOR CRACKING AND PATCHING, SW CORNER LOOKING NE

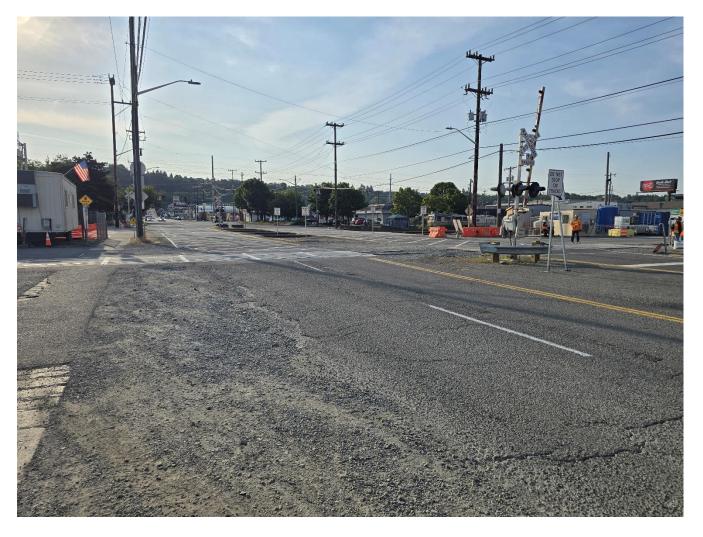
FIGURE 17-S HOLGATE ST AND DOT# 927461X, PAVEMENT CONDITION SHOWING ALLIGATORING, LONGITUDINAL AND LATERAL CRACKING, NW CORNER LOOKING SE

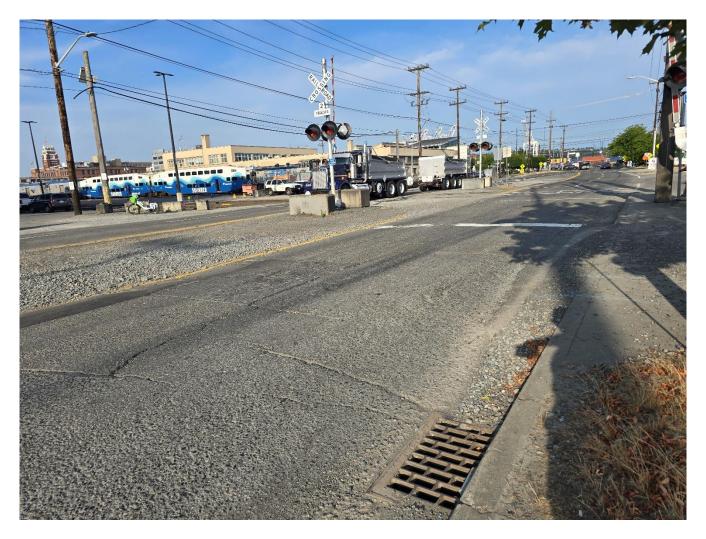
FIGURE 18-S HOLGATE ST AND DOT# 085583Y, ALLIGATORING, LONGITUDINAL AND LATERAL CRACKING, NE CORNER LOOKING SW

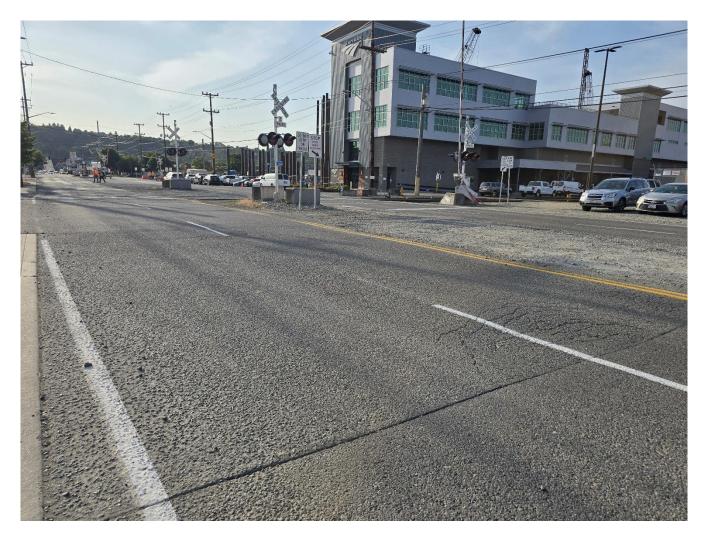
FIGURE 19- S HOLGATE ST AND DOT# 085583Y, ALLIGATORING, NW CORNER LOOKING SE

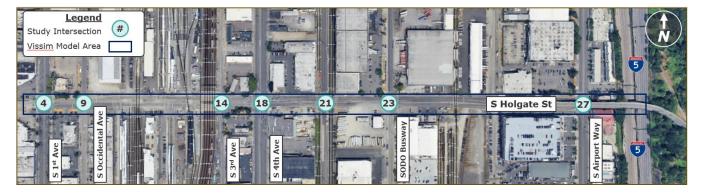
FIGURE 1. VISSIM STUDY AREA

The Vissim model extents for this study were along S Holgate St between 1st Ave S and Airport Way S as shown in Figure 1. All intersections are signalized except for S Holgate St and Occidental Ave S and S Holgate St and 3rd Ave S which are stop-controlled. Additionally, three active at-grade railway crossings were modeled which include the Sound Transit LRT tracks east of 4th Ave S (adjacent to the SODO Busway), BNSF mainline tracks west of 3rd Ave S (DOT#927461X), and Amtrak maintenance facility tracks east of Occidental Ave S (DOT#085583Y).

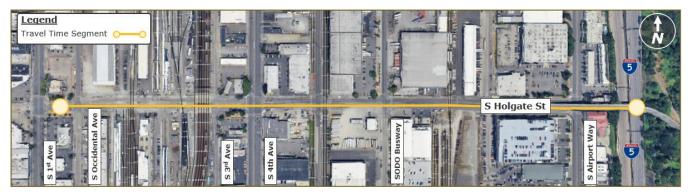
FIGURE 2. TRAVEL TIME SEGMENT EXTENT

Travel time data was retrieved from the Google Travel Time API. This method scrapes estimated travel time streamed throughout specified days from Google Maps in 5-minute increments. Travel time data was collected from Monday, June 9th to Thursday, June 12th, 2025, to represent typical weekday peak periods. Two travel time segments shown in Figure 2 were utilized to compare the Google Travel Time data to the Vissim Model:

- Westbound S Holgate St: From the Airport Way S Overpass to west of Occidental Ave S
- Eastbound S Holgate St: From west of Occidental Ave S to Airport Way S Overpass.

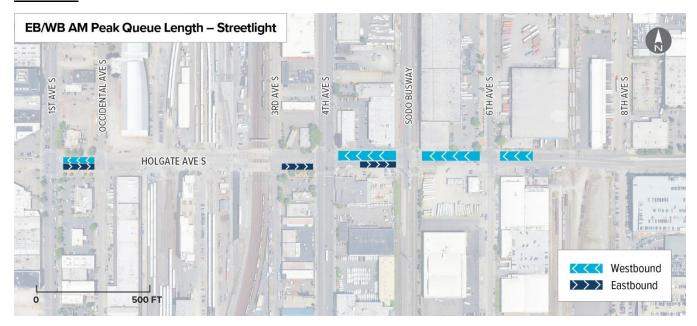
FIGURE 5: STREETLIGHT DATA PEAK PERIOD QUEUE LENGTHS

Queue lengths were compared to typical traffic data streamed from Google Maps API and a StreetLight Data Congested Segments analysis. The StreetLight Data analysis showed congestion associated with rail crossings in eastbound and westbound directions as shown Figure 5.

AM Peak
