# Section 6

## Environmental Baseline

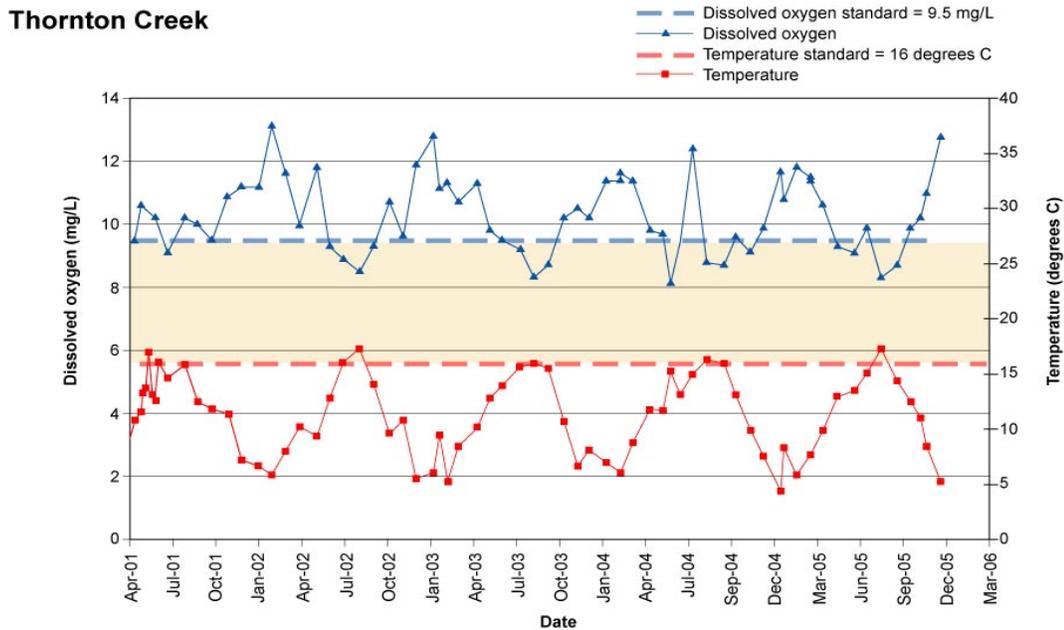
**Figure 7**

Dissolved oxygen and temperature in Thornton Creek

Station 0434. King County (undated).  
 Note: The areas between the two dashed lines show the samples that do not meet state water quality standards.

Metal concentrations within Thornton Creek are relatively low with the exception of mercury. Mercury was found to exceed the chronic toxicity criterion for aquatic life, but concentrations were below the laboratory reporting limit. Thornton Creek is a water of concern for mercury.

Nutrient levels in Thornton Creek are generally high and frequently exceed recommended water quality criteria. For example, total phosphorus concentrations in Thornton Creek (7-413 µg/L) frequently exceed the U.S. EPA (1976) water quality criterion (100 µg/L), which establishes a desired goal for the prevention of nuisance plant/algal growth in streams or other flowing waters not discharging directly to lakes or impoundments. In addition, total nitrogen concentrations in Thornton Creek (50-2,000 µg/L) frequently exceed U.S. EPA (2000) recommended nutrient criterion for streams in the western United States (340 µg/L for Ecoregion II). These criteria represent conditions in surface waters that are minimally impacted by human activities and are designed to prevent eutrophication and water quality problems associated with nutrient enrichment.

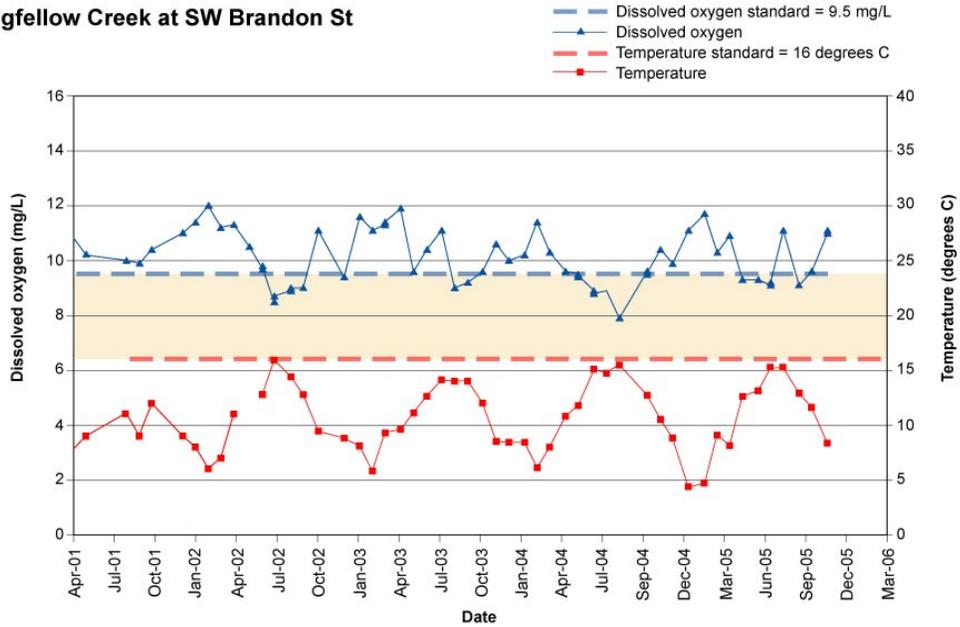
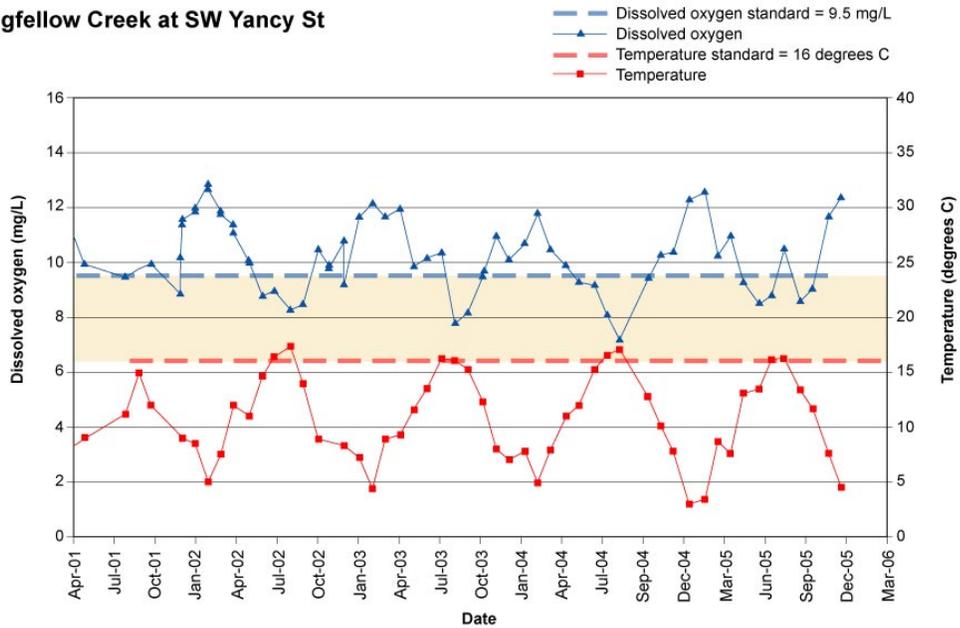
Dissolved oxygen and temperature in Longfellow Creek

**Longfellow Creek at SW Brandon St**

**Longfellow Creek at SW Yancy St**

Reference: Stations C370 and J370. King County (undated).

Note: The areas between the two dashed lines show the samples that do not meet state water quality standards.

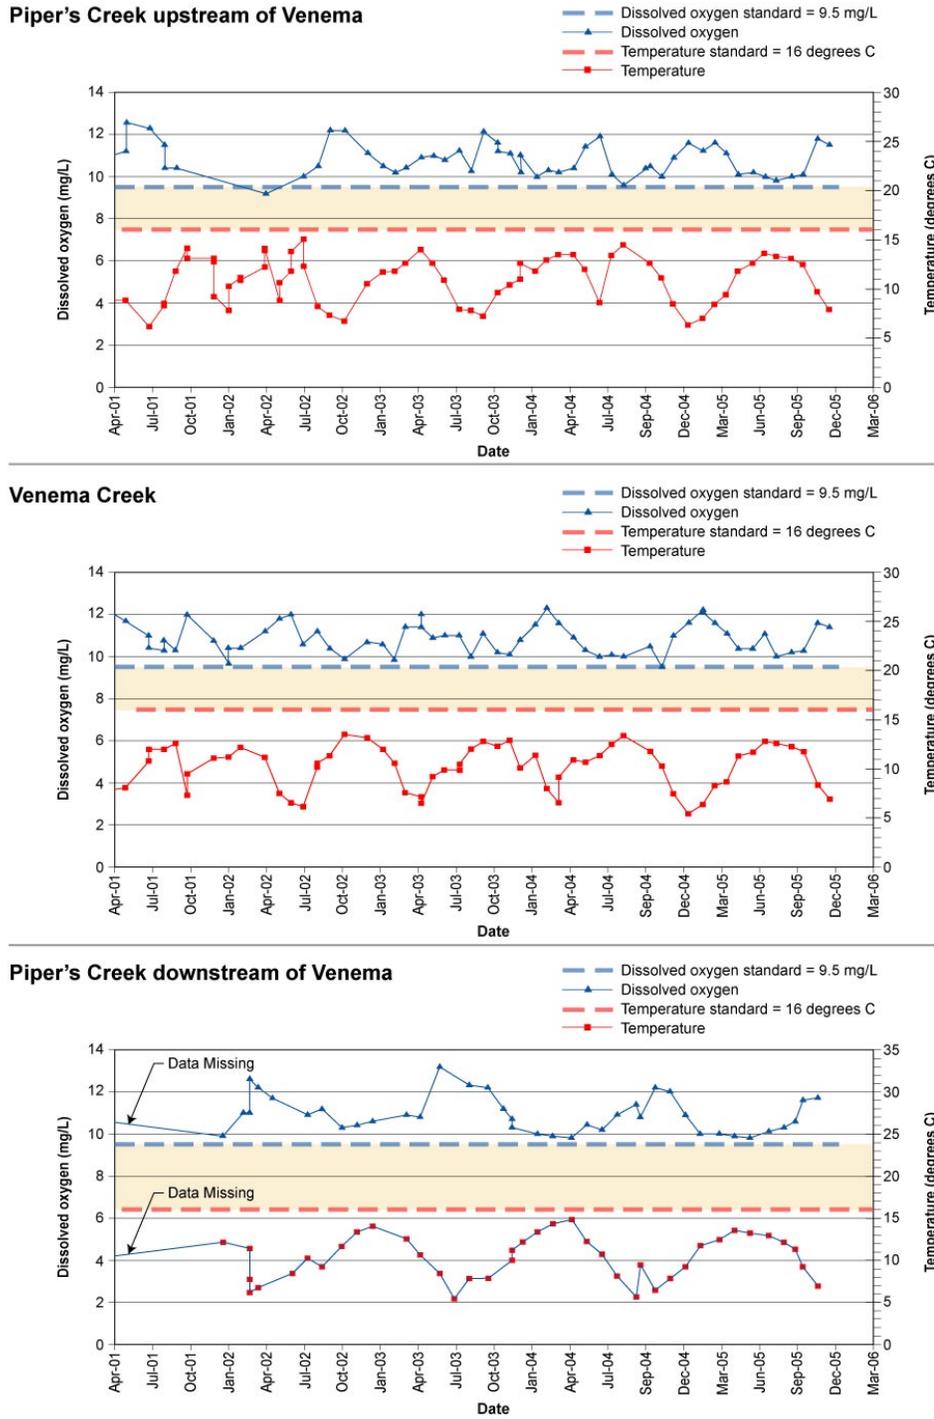
**Figure 13**

Dissolved oxygen and temperature in Piper's Creek

Reference: Stations KTAH02, KTAH03, and KSHZ06, King County (undated).  
 Note: The areas between the two dashed lines show the samples that do not meet state water quality standards.

Nutrient levels in Piper's Creek are generally high and exceed recommended water quality criteria. For example, total phosphorus concentrations in Piper's Creek (18 to 720 µg/L in non-storm samples and 3-990 µg/L in stormwater samples) frequently exceed the U.S. EPA water quality criterion (100 µg/L), which establishes a desired goal for the prevention of nuisance plant/algal growth in streams or other flowing waters not discharging directly to lakes or impoundments (USEPA 1976). In addition, total nitrogen concentrations in Piper's Creek (180 to 3,470 µg/L) frequently exceed the U.S. EPA (2000) recommended criterion for streams in the western United States. (340 µg/L for Ecoregion II). These criteria represent conditions in surface waters that are minimally impacted by human activities and are designed to prevent eutrophication and water quality problems associated with nutrient enrichment.
