Seattle Public Utilities Taylor Creek

Dead Horse Canyon Vegetation Assessment Summary Report

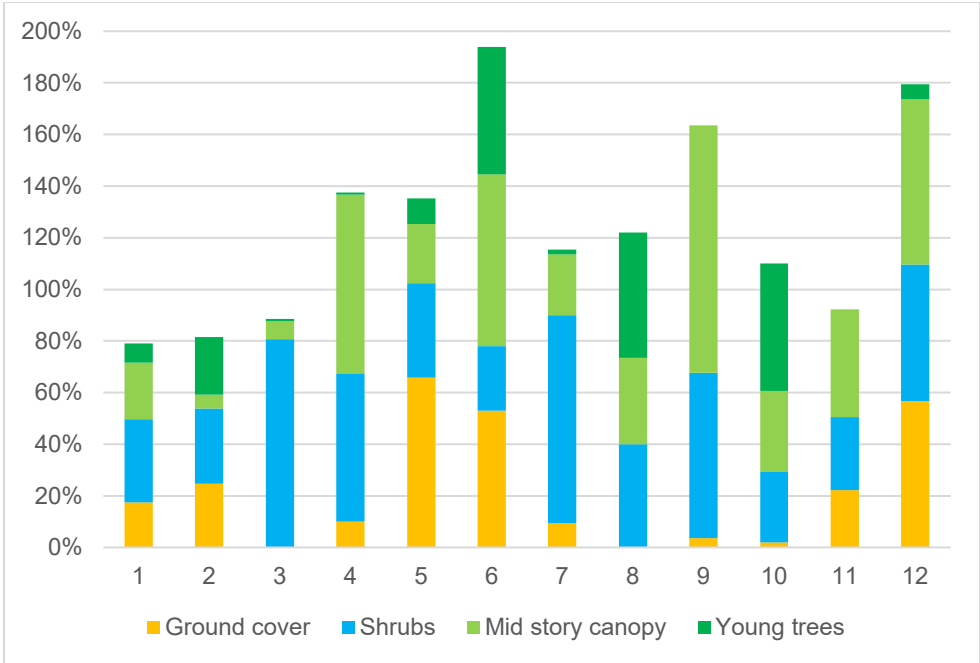
Table 2. Vegetation cover (absolute) per transect.

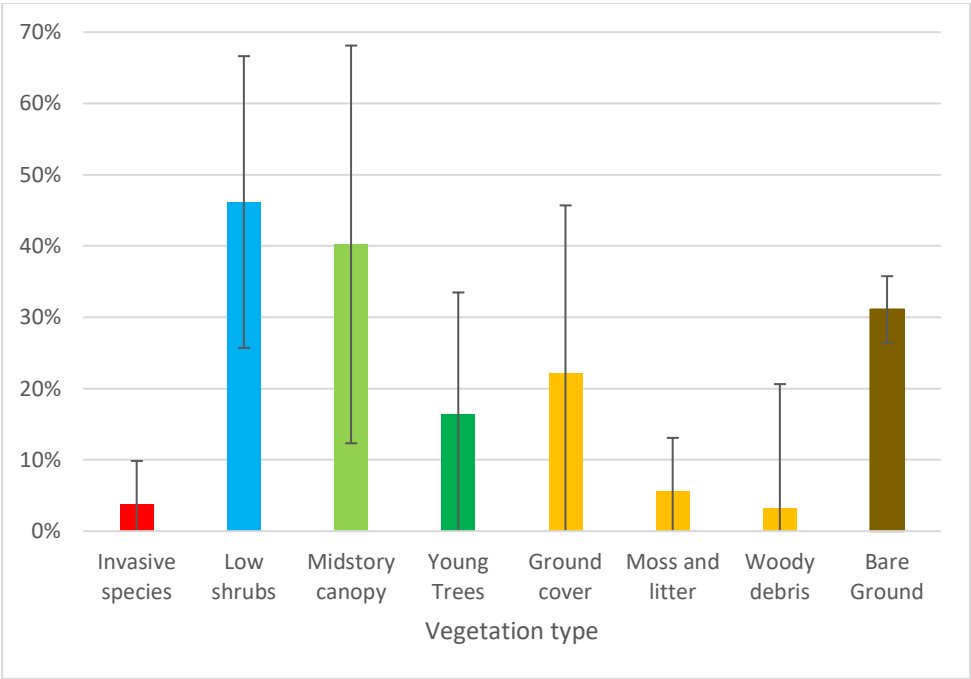
Table 3. Average vegetation cover by category

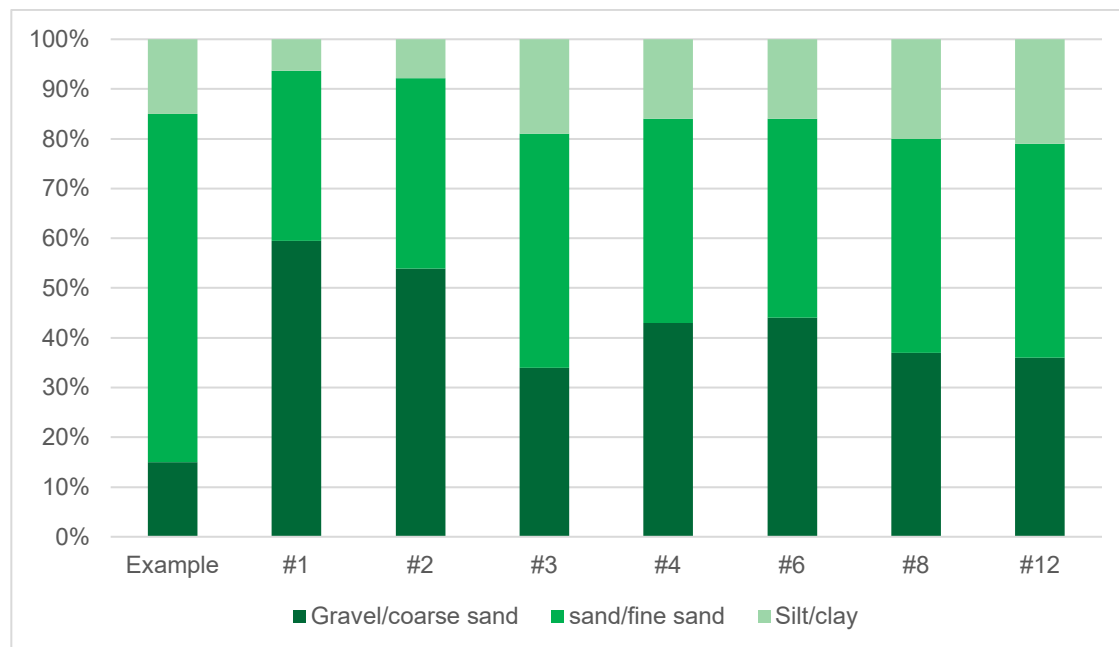
Figure 3. Soil Texture comparison between transects. The gravel component of these soils dominates the sand, silt and clay ratios.

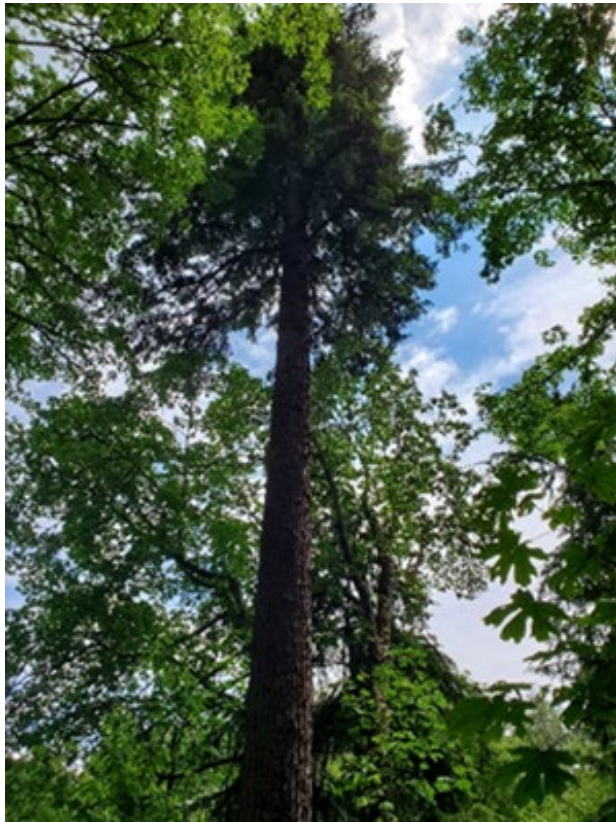
Canopy cover ranges from 80-100% Most of the canopy is deciduous. Allowing for ample winter light that will promote growth of evergreen understory shrubs. These gaps will increase in size with proposed construction.

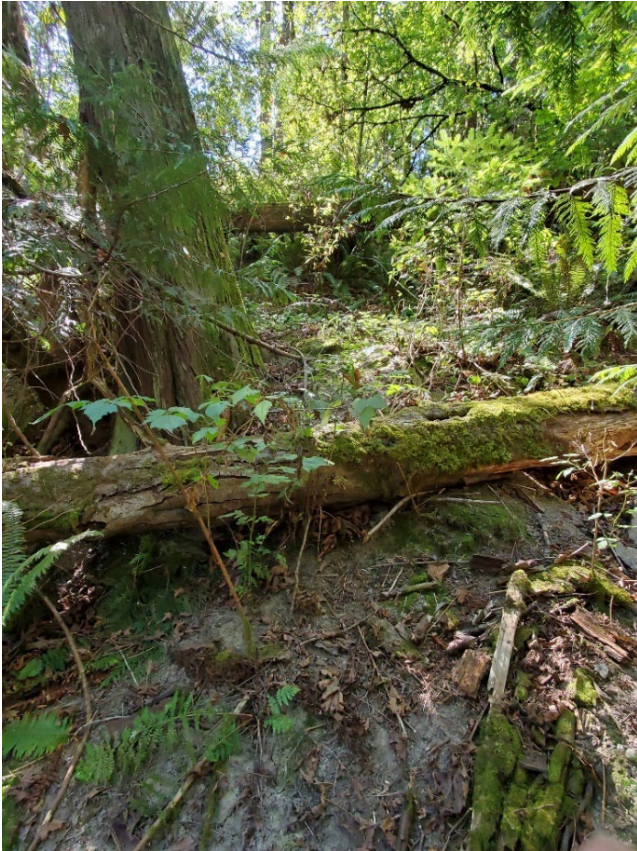
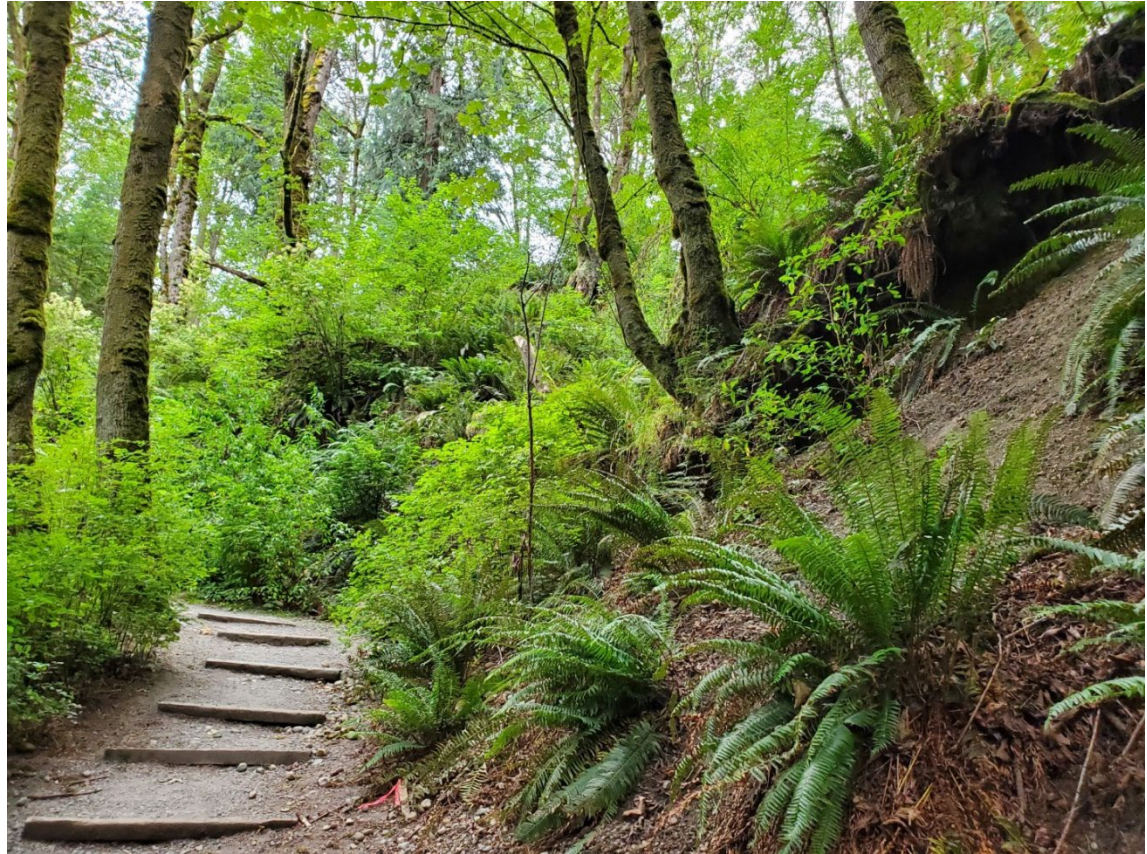
Some slopes have low vegetation cover and are actively eroding. Many areas have bare soil exposure with very little organic matter retention.

1. Large Woody Debris (LWD) should be secured perpendicular to the repaired slope through all impacted areas and overlap into the non-impacted edges of the forest.
2. Temporary soil erosion control is highly recommended on all exposed and repaired slopes before planting. Jute netting will likely be needed to hold wood chip mulch or temporary erosion control seed mixes on site.
3. Up to 4” of coarse wood chip mulch or hog fuel should be installed over netting. This may be raked or spread from preexisting tree and soil protection areas.
4. Consider biochar additions to soil before installing wood chip mulch as an experiment to improve long term soil biotic habitat.

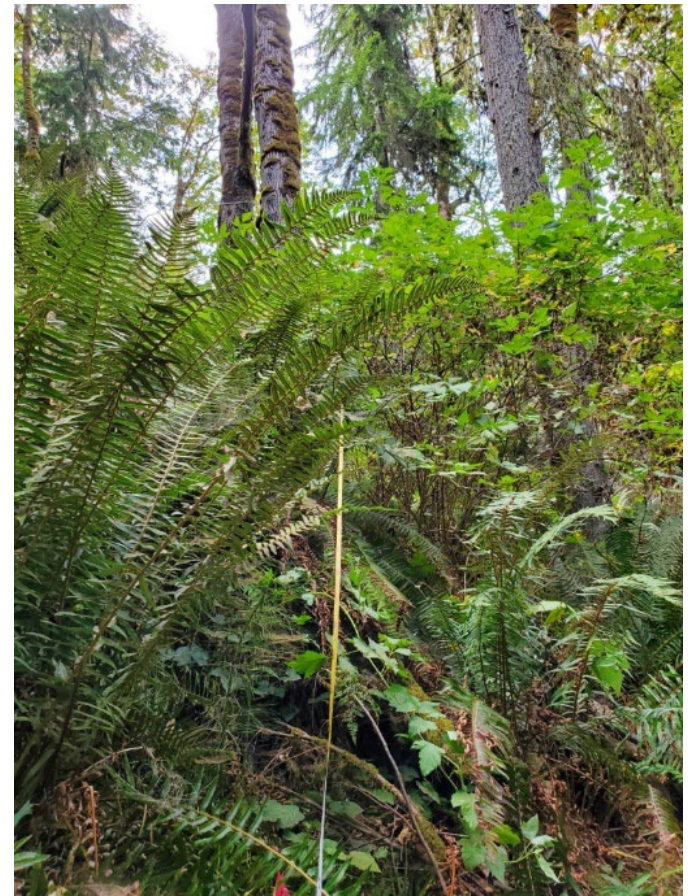
Many steep slopes have high vegetation cover. These slopes are still moving but do not seem to have the active surface erosion. Though woody debris is visible throughout the forest, the transect measurements did not indicate an abundance of debris.

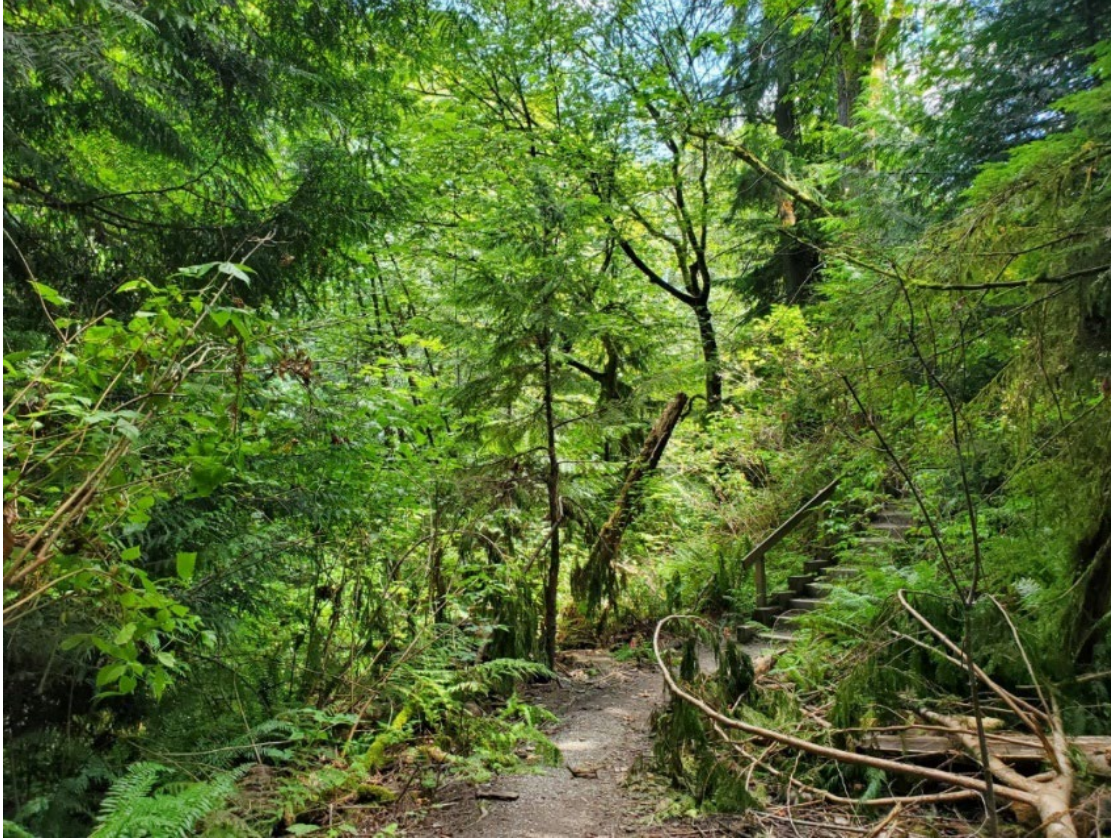
Midstory canopy creates a layer over 10 feet above the ground cover. This layering adds shade and complexity to the forest environment.
