I-5 Bark Beetle Infestation

WSDOT Northwest region
Arborist Services

Project overview

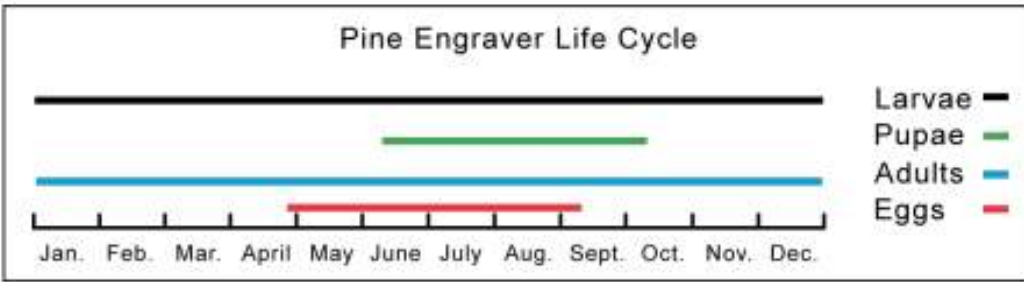
Figure 2. Life cycle of pine engraver beetles (from Johnson 1982).

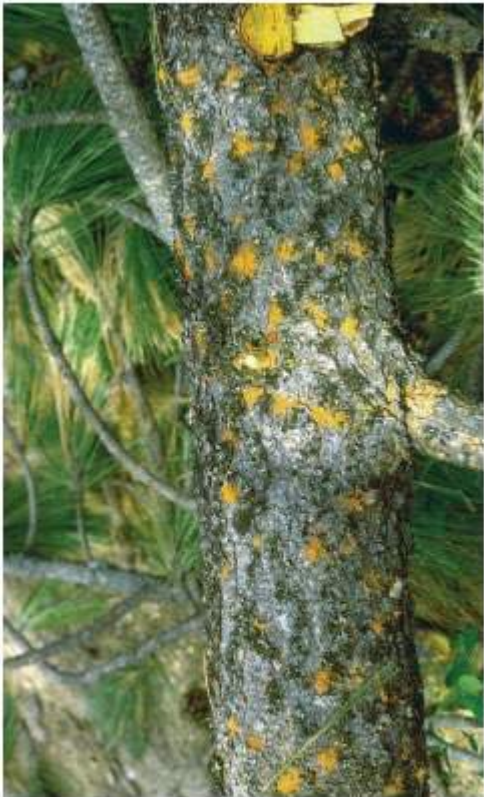
Figure 5. Boring dust on bark of pine attacked by pine engraver beetles. Photo: Kenneth E. Gibson, USDA Forest Service, Bugwood.org.

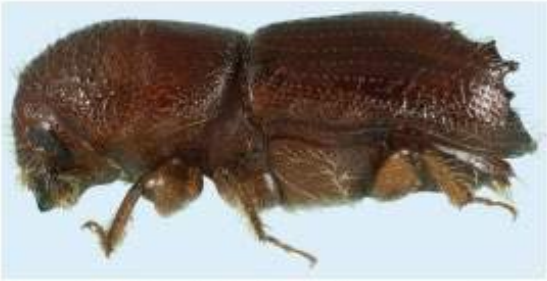
Figure 1. Adult *Ips pini* beetle with depression and spines on end of elytra. Photo: Natasha Wright, Florida Department of Agriculture and Consumer Services, Bugwood.org.

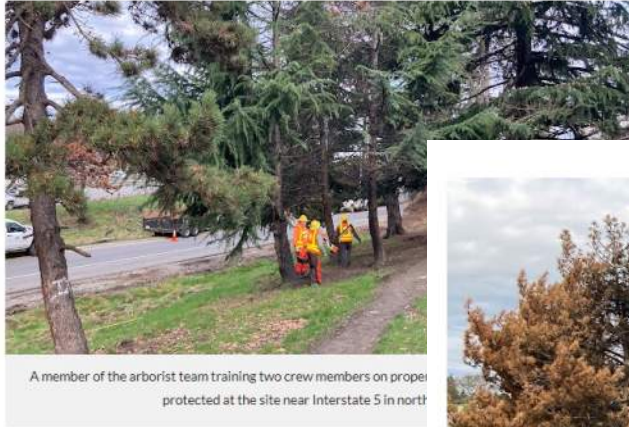
A member of the arborist team training two crew members on proper tree protection at the site near Interstate 5 in north Seattle.

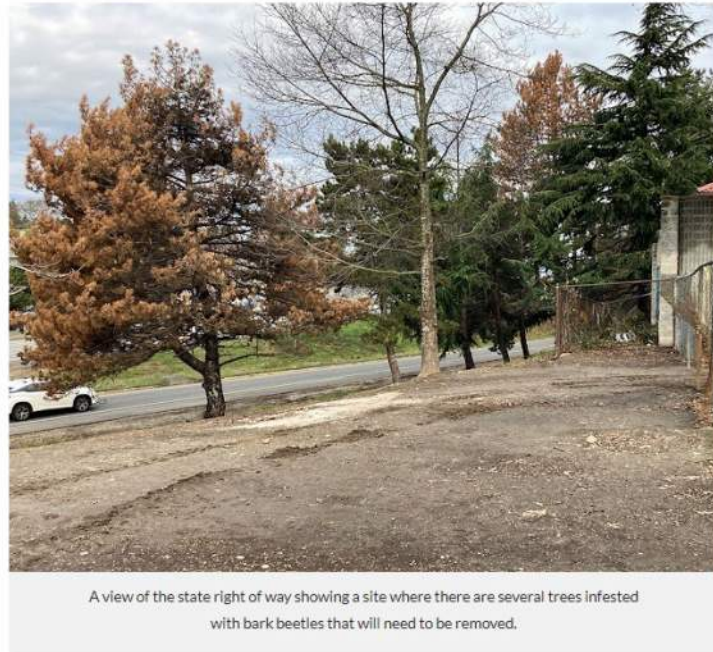
A view of the state right of way showing a site where there are several trees infested with bark beetles that will need to be removed.
