City of Seattle Parks & Recreation Department

# LOWMAN BEACH PARK SEAWALL CONDITION ASSESSMENT

Seattle, Washington

Nov 30, 2017  
ESA # D160292.00

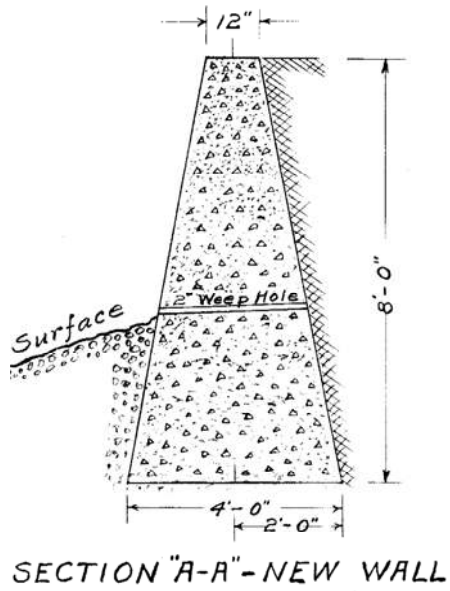
Figure 3. 1951 Seawall Design, Zones A-B through P-Q.

Structures of this type would typically be anticipated to have a thirty to fifty year design life. In the case of the Lowman Beach Seawall, the wall has aged beyond its anticipated service life. Drawings from 1951 show a few feet of beach material above the toe of the seawall which is now exposed, causing undermining at some locations. This undermining caused a loss of global stability and partial collapse. The portions of the seawall constructed around 1951 are beyond their anticipated service life, and if re-used as part of a seawall replacement project, they may have a service life less than the other new project elements.

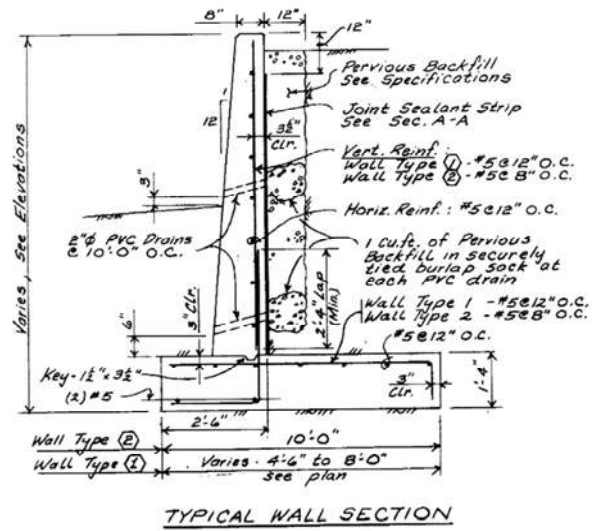
Figure 4. 1995 Seawall Design, Zone R-S.

A portion of the park was reconfigured in 1995, which replaced a portion of the seawall that was constructed around 1951. The drawings representing the current composition of the Seawall at Zone R-S are dated 1995, showing the new section of cantilevered seawall with a footing for stability (see Figure 4). The toe of the new section of seawall was cast as one piece and installed well below grade.

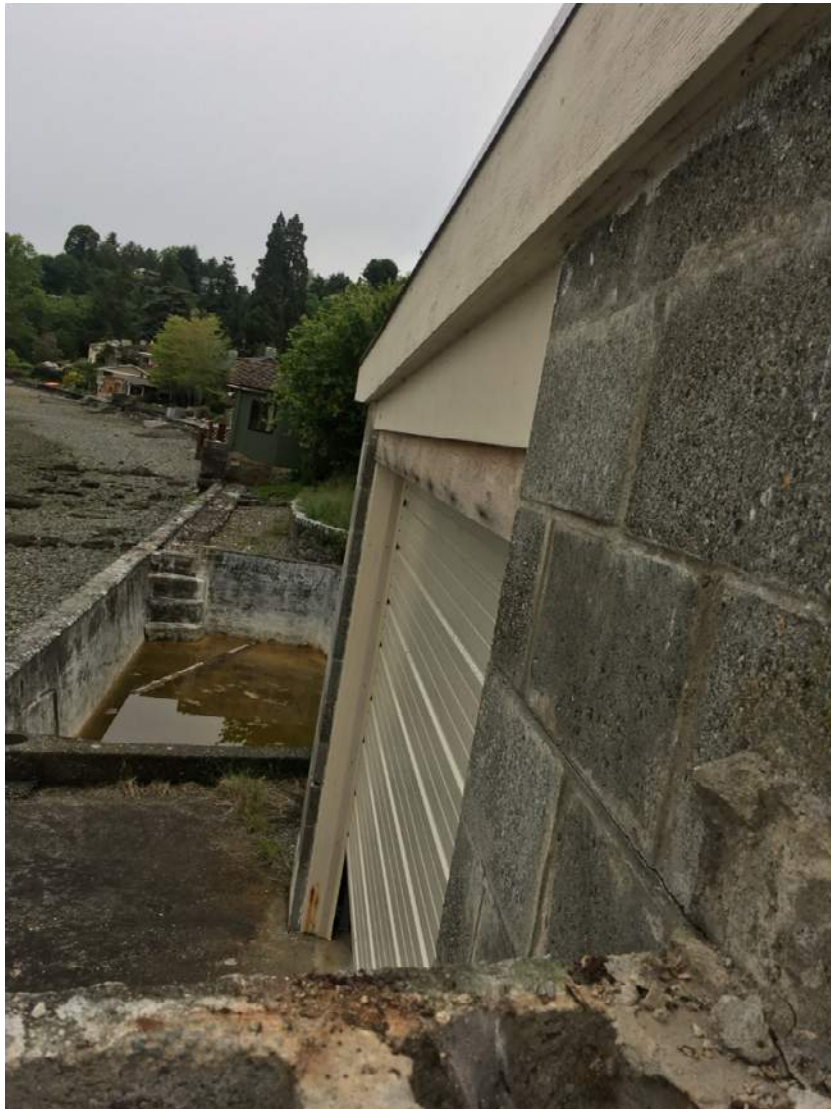
Photo 4. Adjacent Property to the North.  
Source: Reid Middleton Site Visit 10/18/2016

To the north of the Lowman Beach seawall is a private residence. There is a seawall protecting this private residence roughly in-line with the existing Lowman Beach Park seawall. This private seawall appears to be concrete construction, similar to the other walls in the vicinity and presumably subject to similar failure mechanisms as the Lowman Beach seawall.

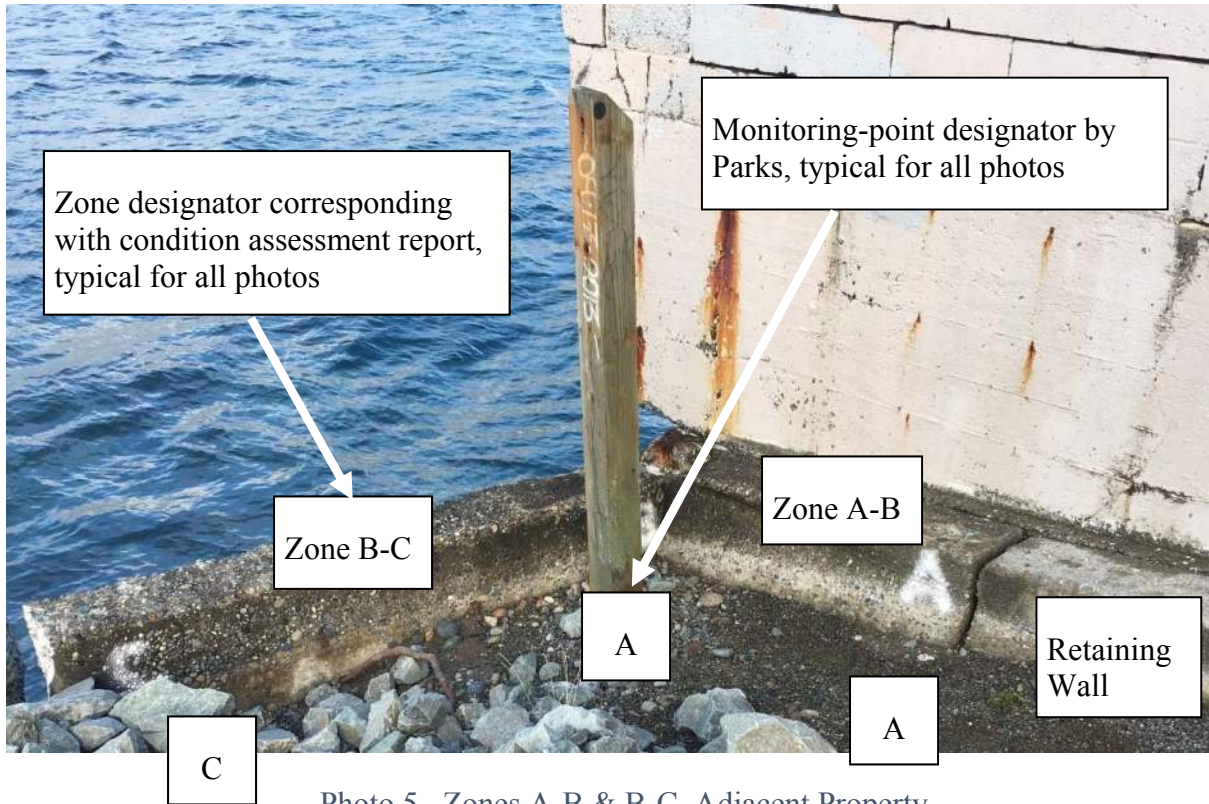
Photo 5. Zones A-B & B-C, Adjacent Property.  
 Source: Reid Middleton Site Visit 10/18/2016

ITEM	PHOTO	RATING	EXISTING CONDITION
North Retaining Wall Origin: Unknown, likely 1950's	5, 6	Fair	Structural: Not much visible, no damage notes. CMU privacy wall on top of retaining wall in serious condition. Length unknown, wall terminates underground Toe: N/A Rotation & Settlement: N/A
Zone A-B Length = 5'  Origin: 1950's	5, 6, 7, 8	Fair	Structural: Some spalling <sup>1</sup> at mudline where intersects Zone B-C. Toe: Exposed, material loss beginning, not protected. Rotation & Settlement: Minimal, has return portion perpendicular to shoreline that adds stability.
Zone B-C (8') Zone D-E (15') Zone F-G (8') Zone H-I (22') Zone J-K (15') Origin: 1950's	10 - 24	Critical	Structural: Cracking and spalling <sup>1</sup> . Original seawall segments have broken full-height into smaller segments. Toe: Exposed, material loss below wall, not protected. Rotation & Settlement: Segments appear to have rotated outwards and translated away from shore. Multiple segments broken full-height due to differential settlement.
