J&M HOTEL ANNEX DEMOLITION PACKET

Pioneer Square Preservation Board Briefing
July 10, 2025

Structural Engineer’s Report on the Condition of the Annex7

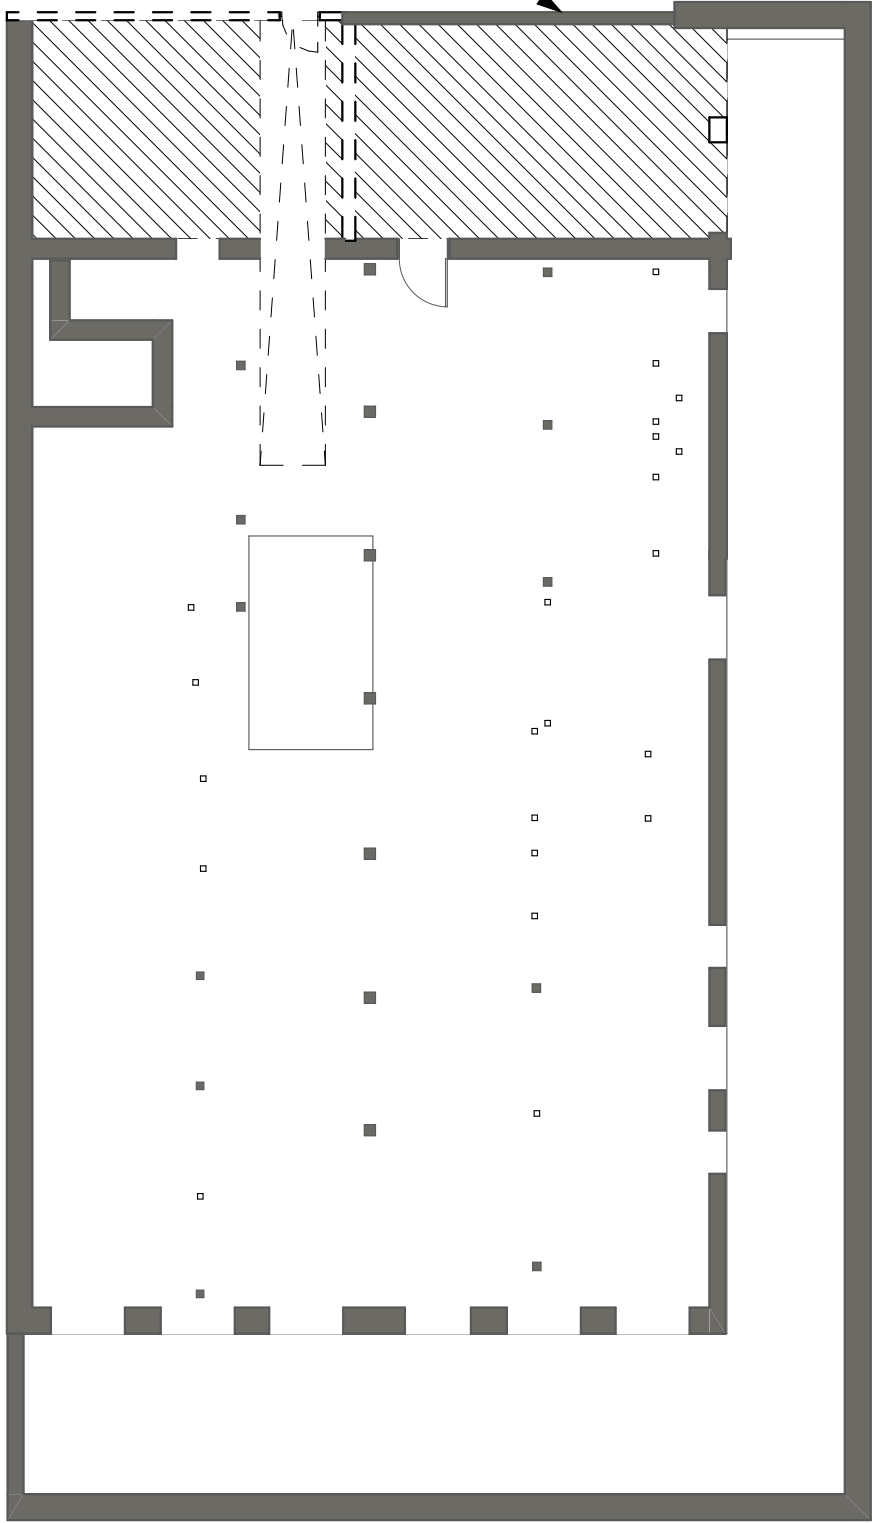
BASEMENT DEMOLITION PLAN

WALL TO REMAIN IN PLACE AND
BE BRACED UP TO ALLEY LEVEL

Following the demolition of the upper floors, the basement wall along the alley will be shored up and secured prior to the demolition of the first floor and the alley walls that extend from alley grade to the first floor. The footprint of the demolished area will serve as a staging area for interior demolition of the J&M Building.
