# Morrison Hotel

Certificate of Approval Application, Window Survey

509 Thrid Avenue South - Seattle, WA 98104

Survey conducted by SMR Architects in conjunction with DESC on the days of 07/09/2026, 07/10/2026, 7/23/2026.

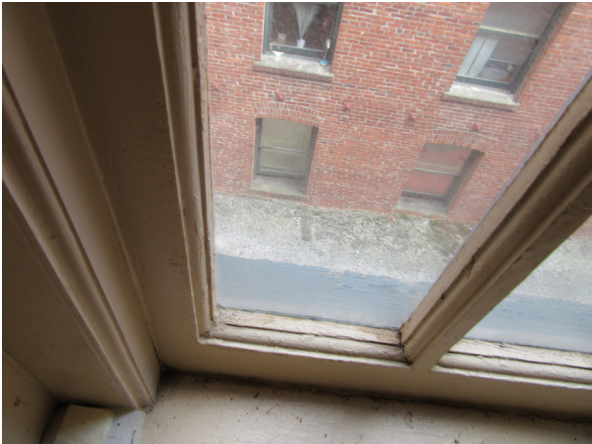
POOR Sill  
FAIR Single Glazing

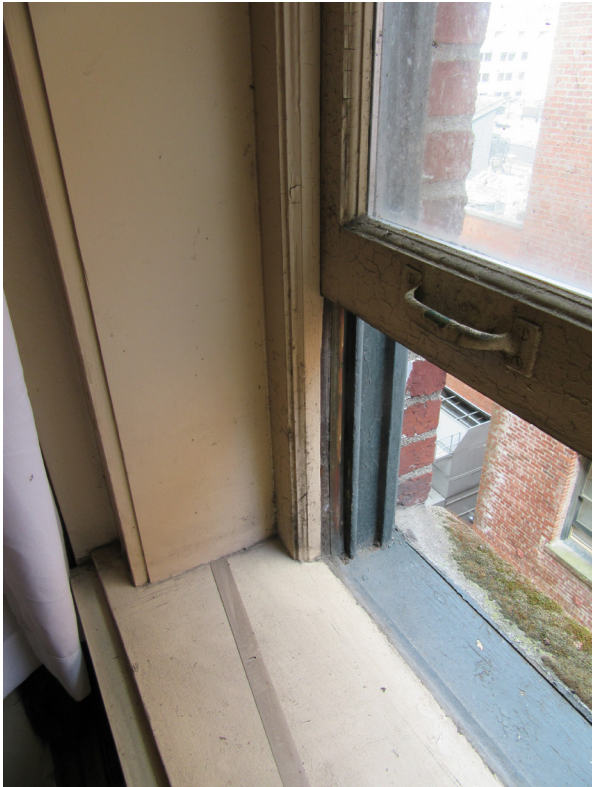
FAIR Sill, Frame, W. Stripping, Stool, Trim  
POOR Sash

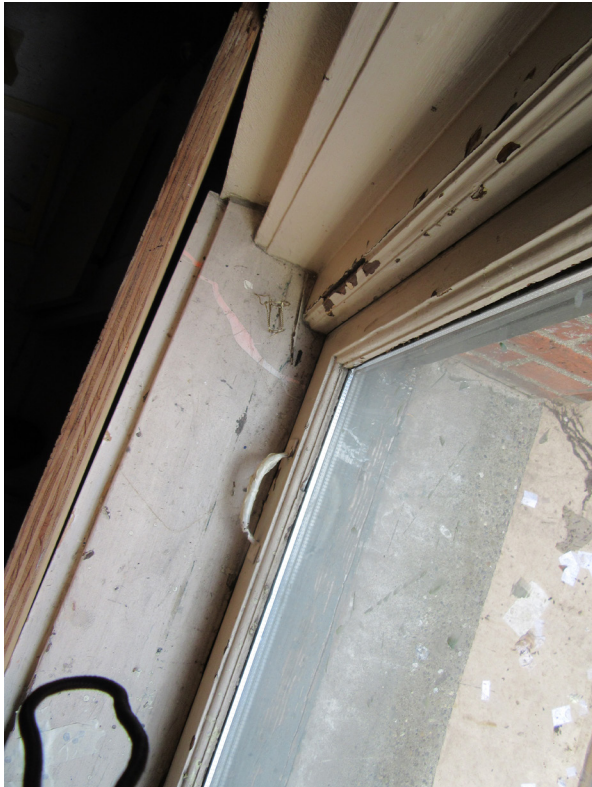
POOR Frame & Sill

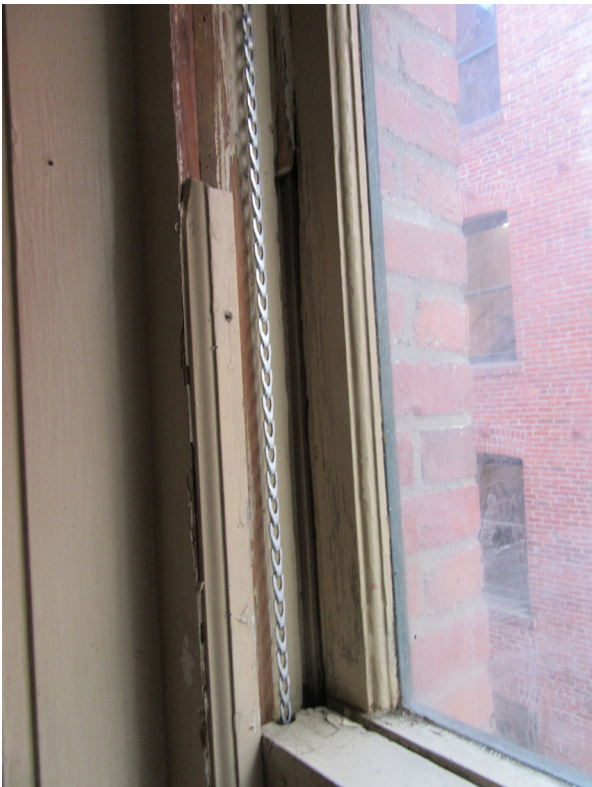
POOR Frame and W. Stripping

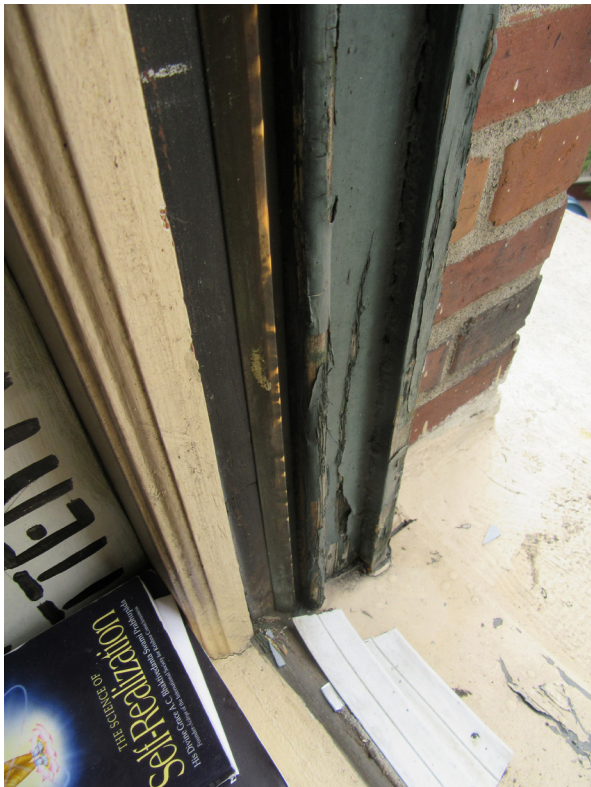
POOR Frame & Sill

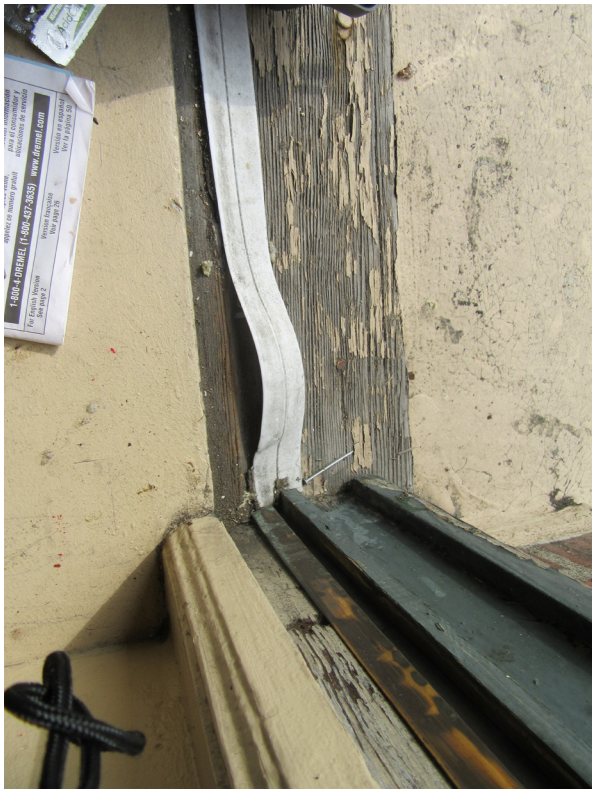
POOR W.Stripping & Frame

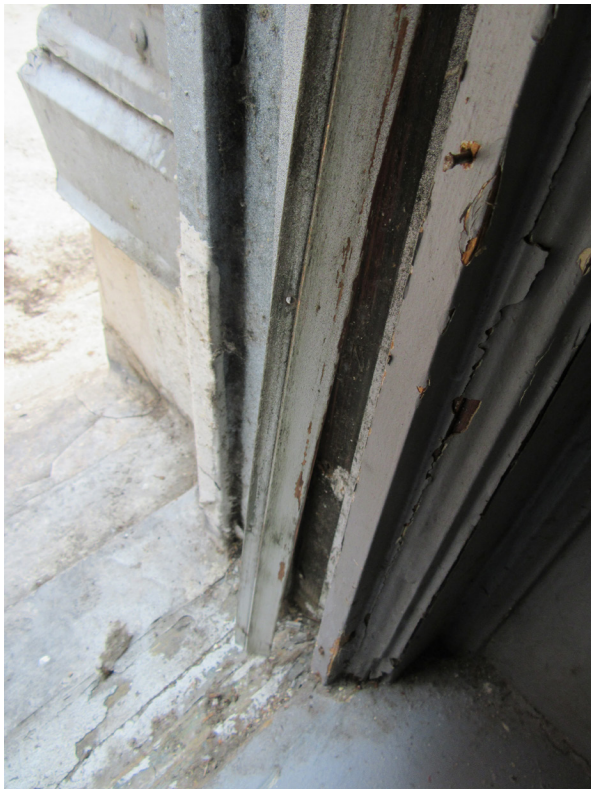
POOR Sill & Frame

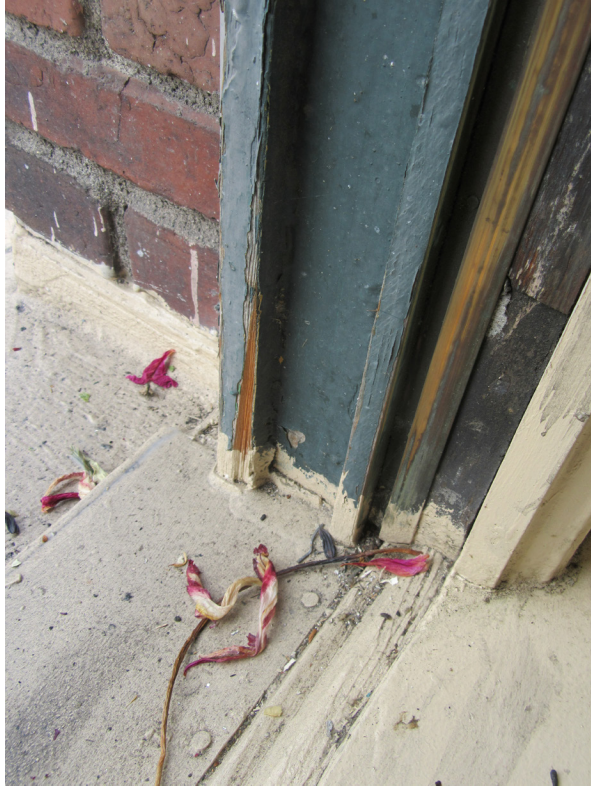
POOR Frame & Sill

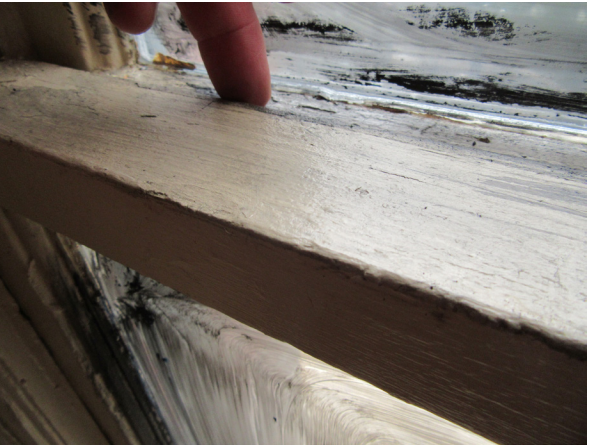
POOR cord & misaligned

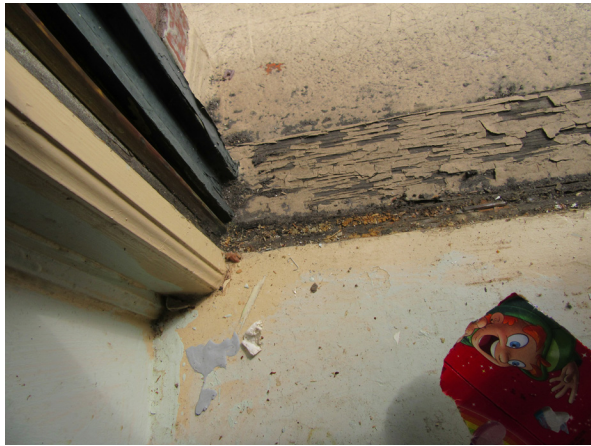
POOR Sill & Frame
