210 THIRD AVENUE SOUTH - WEST UNIT WINDOW SURVEY- FLOORS 2-5 AND WEST STOREFRONT ADDENDUM - FLOOR 1

Cross 2 Design Group for True North Construction Management, Inc.

The Lofts Window Survey

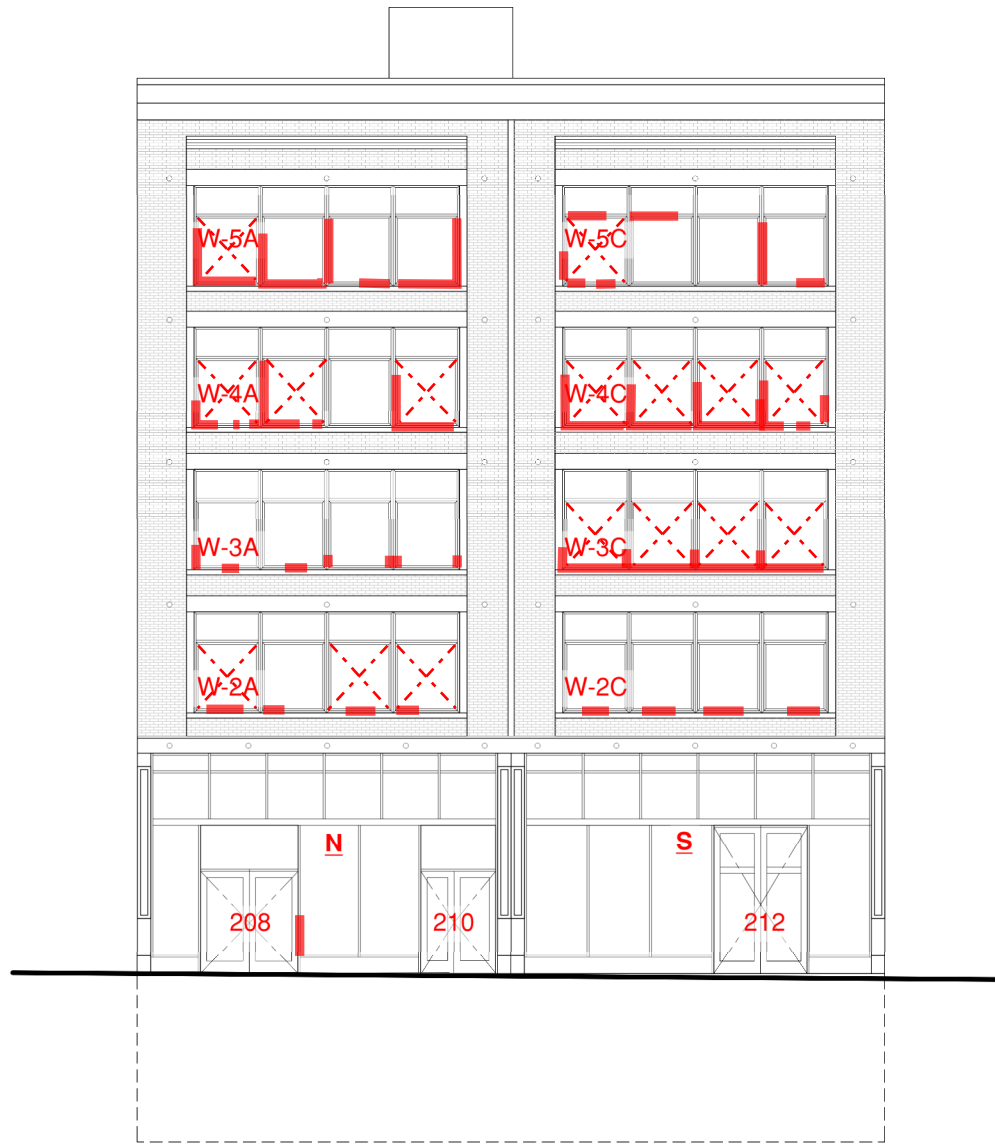
Diagram showing surveyed window locations on west elevation of 210 Third Avenue South.

- Area of rot / damage to frame or sash
- X Window Not Safely Operable
