Gatewood Elementary

Historic Wood Window Replacement

Seattle Public Schools

Seattle Department of Neighborhoods Historic Preservation & Landmarks

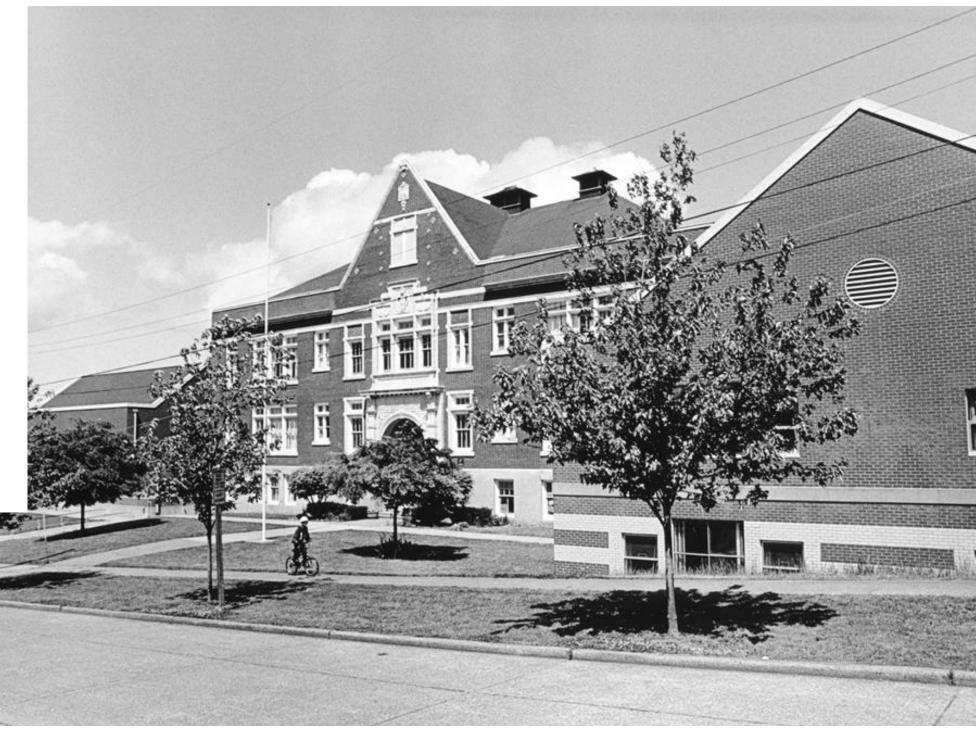
Based on their current condition, the majority of this schools historically landmarked wood windows are **no**longer viable candidates for effective refurbishment without replacement of many existing historic wood components.

Given the historic condition of the windows, and the need for widespread replacement existing wood components, Seattle Public Schools believes that the most responsible course of action is to selectively replace this school's historic windows with new high-quality historically matching, aluminum-clad wood window units.

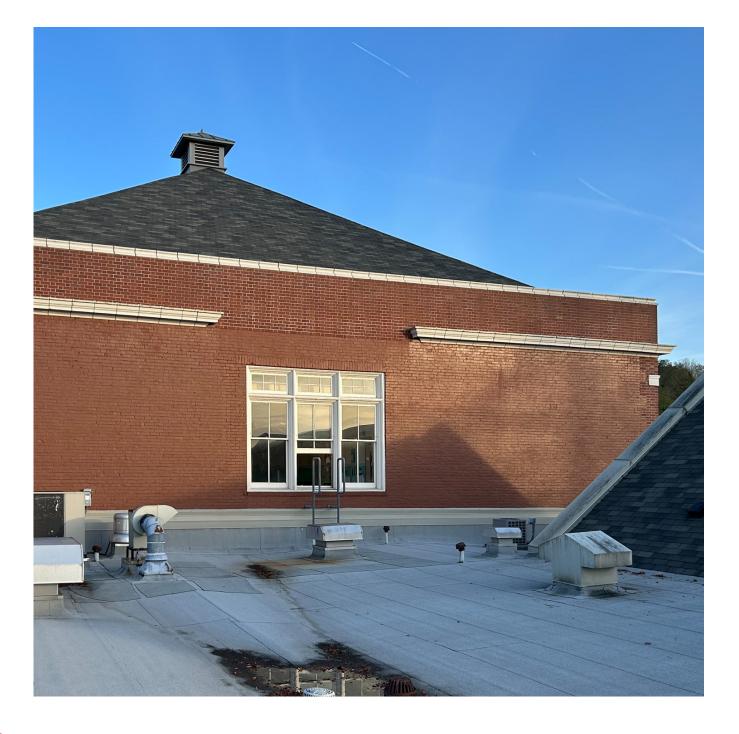
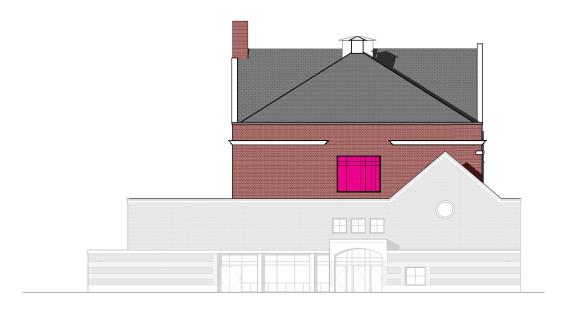
Location

Replacement of 6 windows at West end of level 3 hallway.

Replace and/or refurbish 3 existing operable wood windows + 3 existing fixed wood transom windows. Remove and refurbish existing wood exterior casings to be reinstalled at new windows

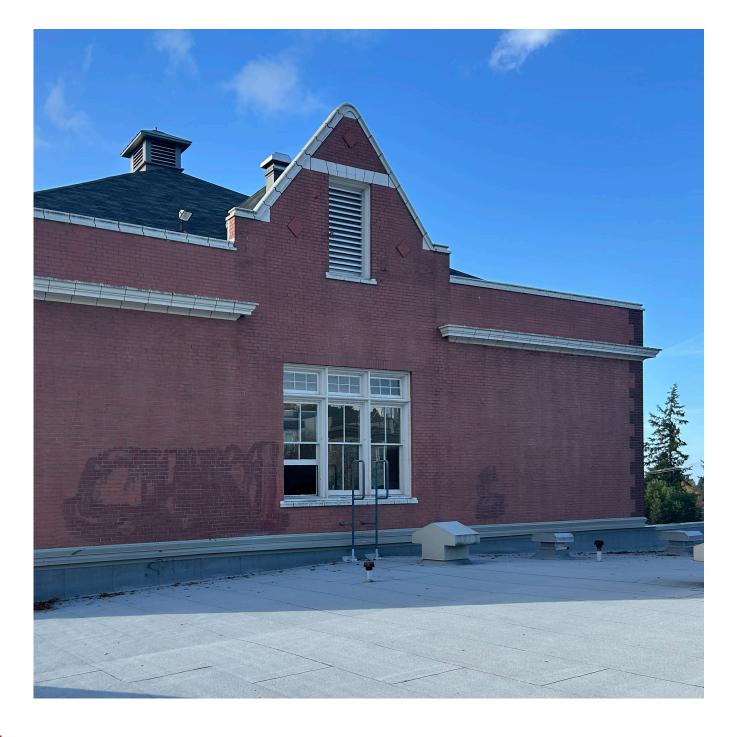
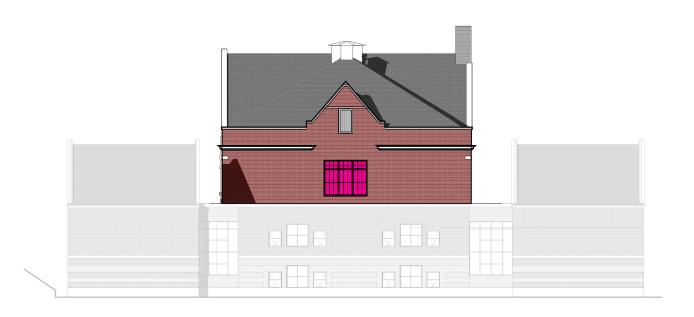
Location

Replacement of 6 windows at East end of level 3 hallway.

Replace and/or refurbish 3 existing operable wood windows + 3 existing fixed wood transom windows. Remove and refurbish existing wood exterior casings to be reinstalled at new windows

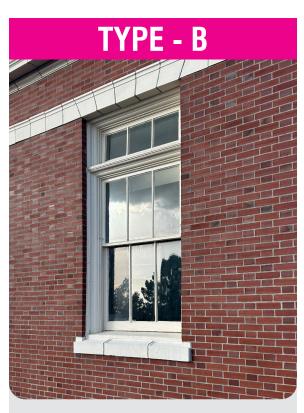
3.1 Wood Windows Brick

3rd Floor Hallway - West Elevation Damaged but not completely failing Rail to Stile connection.

3rd Floor Hallway - West Elevation Middle operable sashes, base of muntin cracked.

Classroom 9 - South Elevation Paint Failure at exterior

Classroom 17 - South Elevation
Parting Bead is failing - this is only window in bay that is still operable.

Classroom 9 - South Elevation
Complete Paint Failure at interior with areas of wood deterioration

Classroom 19 - South Elevation
Paint failure and wood deterioration at rail and muntin.

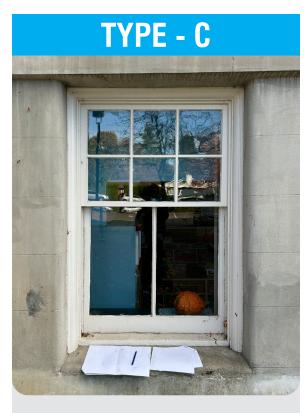
3.2 Wood Windows at Concrete

Paint Failure and extensive wood Deterioration

Classroom 1 - South Elevation
Paint Failure and extensive wood Deterioration
at upper sash bottom rail.

Classroom 1 - South Elevation
Paint Failure and extensive wood Deterioration
of exterior blind stop.

Classroom 2 - South Elevation
Window stile is cracked and has been repaired
with duct tape.

Paint Failure and extensive wood deterioration at window head.

Classroom 2 - South Elevation
Paint failure and wood deterioration typical at
Window Rails & Muntins.
