**Date:** March 24, 2026  
**To:** City of Seattle Landmarks Preservation Board  
**CC:** Erin Doherty, Landmarks Preservation Program Staff  
**From:** David Graves, AICP, Strategic Advisor  
**Subject:** Gas Works Park Cracking Towers – Pedestrian Appurtenance Removal Certificate of Approval Application

# GAS WORKS PARK "CRACKING TOWERS": EMERGENCY SELECTIVE DECONSTRUCTION

1901 N NORTHLAKE WAY 98103

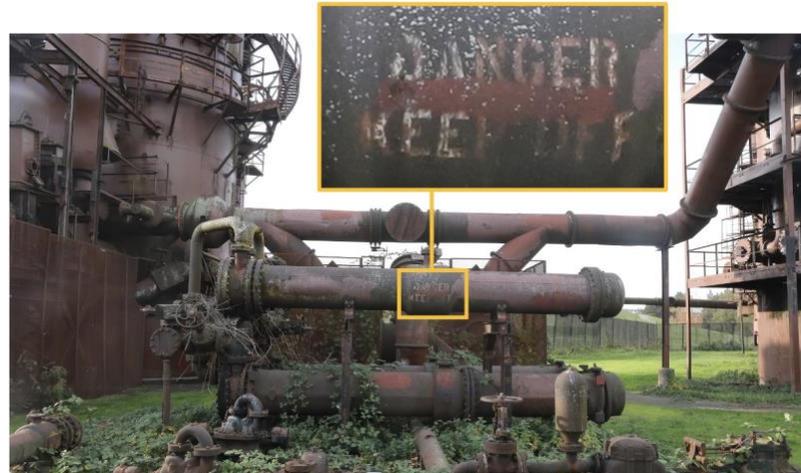
Finally, there are several areas on the subject structure (e.g., piping, tanks) that contain written text indicating “DANGER,” “KEEP OFF.” For example, Figure 4 depicts piping on the east side of the structure with this admonition.

**Figure 4.** A photograph taken during GEAR’s November 12, 2025, site inspection, depicting the text “DANGER,” “KEEP OFF” on a section of piping on the east side of the subject structure.

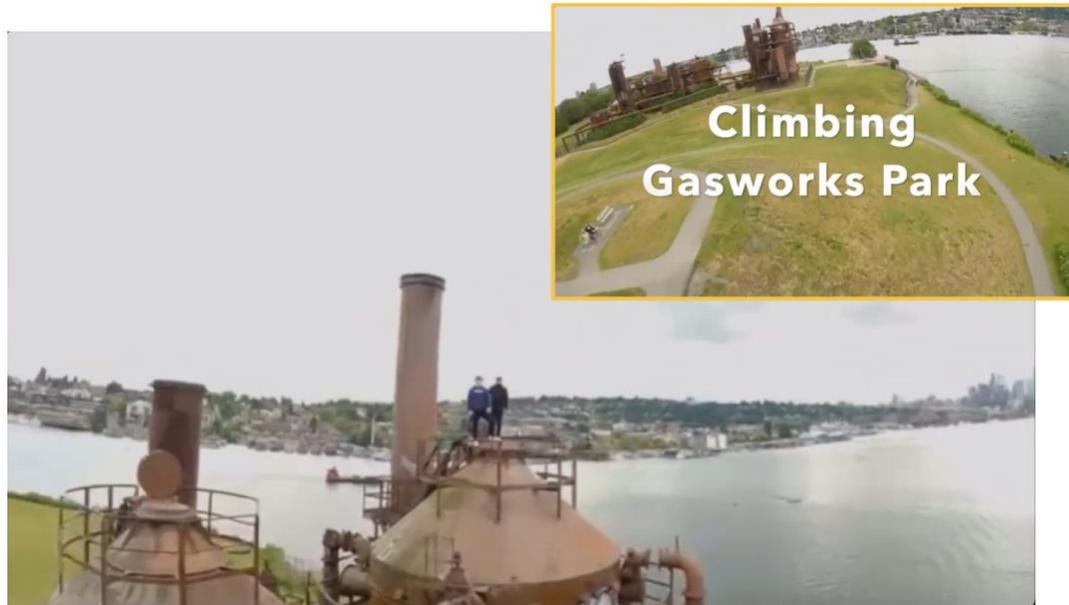
video from September of 2021 titled “Climbing Gasworks Park”<sup>4</sup> depicts (via body worn cameras) individuals approaching the fence perimeter, traversing through the interior of the perimeter, and climbing the structure: two individuals are depicted climbing the structure up to the top, with additional drone video of their ascension; see Figure 7.

**Figure 7.** Still captures from the “Climbing Gasworks Park” video (see inset of title screen) posted on YouTube. The video was taken with body worn cameras and a drone camera, and depicts two individuals approaching the fencing perimeter, traversing through the interior of the perimeter, and climbing the structure, with the still capture above depicting their ascension towards the end of the video.

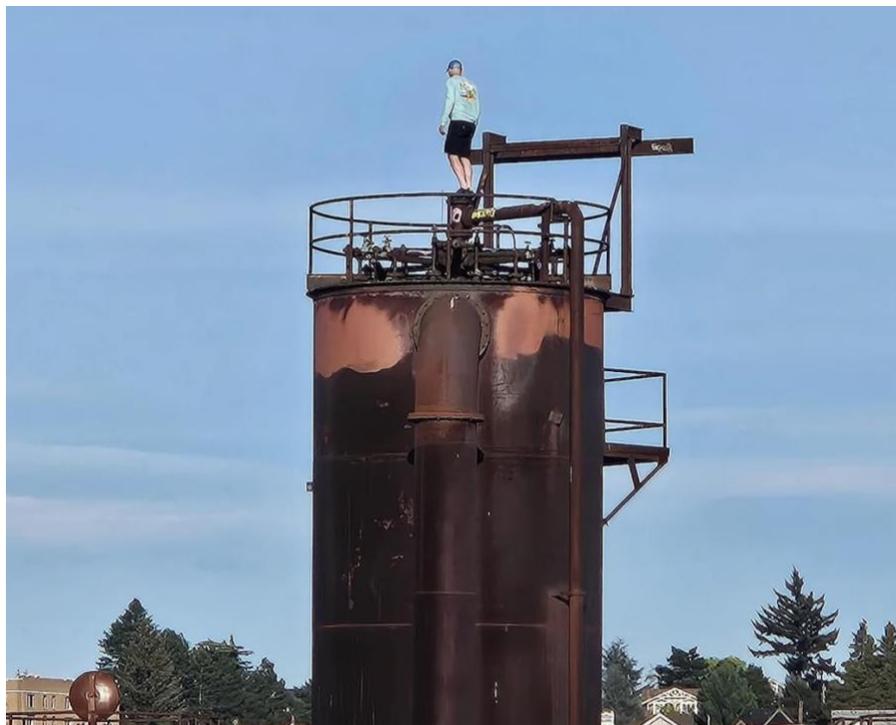
**Figure 8.** A photograph uploaded to a 2-year-old Reddit post titled “Guy climbed to the top of the Gas Works Park plant,” depicting an individual on top of one of the towers.

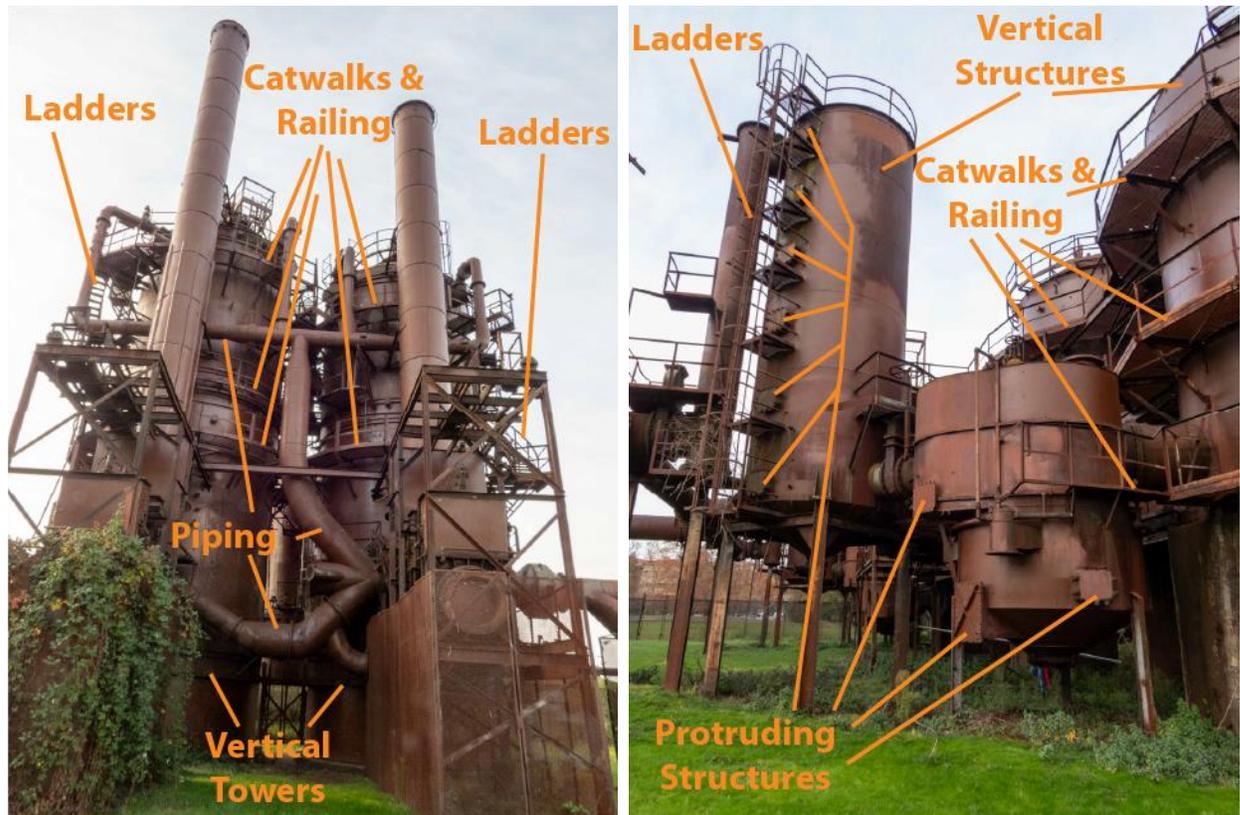
During the November 12, 2025, inspection, GEAR observed different types of structures at Gas Works Park. There were the main vertical towers and structures. There were also pedestrian appurtenances, such as, catwalks, ladders and railing (and the supporting structures for them); see Figure 10. There were also components such as piping and other protruding structures that were welded or bolted on to the vertical components and towers.

**Figure 10.** Photographs of the structures at Gas Works Park. There were the main vertical towers and structures. There were also pedestrian appurtenances such as catwalks, ladders and railing (and the supporting structures for them). There were also components such as piping and other protruding structures that were welded or bolted on to the vertical components and towers.

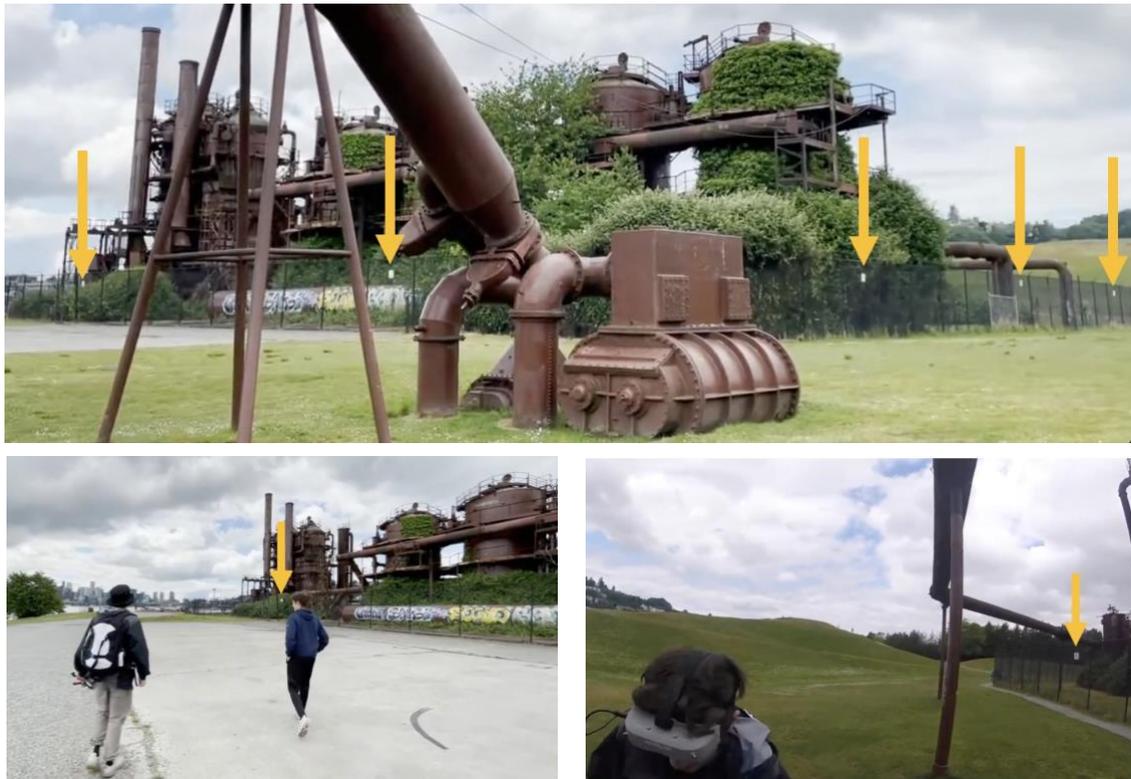
**Figure 13.** Still captures from the “Climbing Gasworks Park” YouTube video depicting the Gas Work Park structure (*top*), and individuals approaching the east fence (*bottom left*) and preparing their camera equipment near the west fence (*bottom right*). The orange arrow in each capture indicates what appears to be posted signs on the fence that is consistent in shape and appearance with the “NO TRESPASSING” signs.

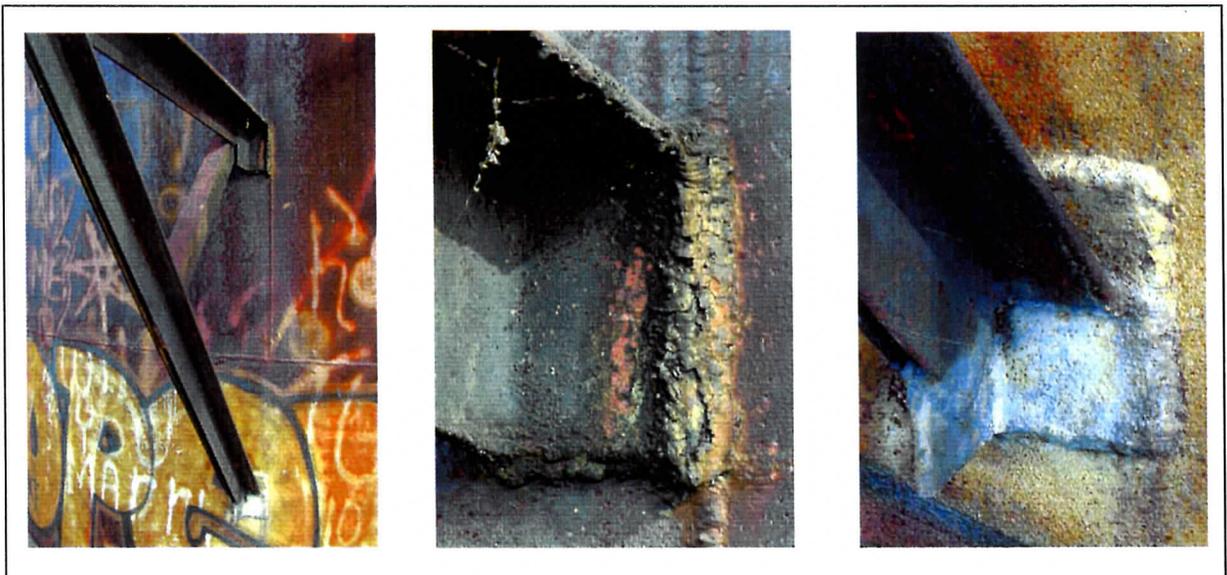
2. Typical stair support brace system.
