From: Aban, Eduardo <Eduardo.Aban@seattle.gov>
Sent: Thursday, June 6, 2024 2:16 PM
To: Graves, David <David.Graves@seattle.gov>
Cc: Jones, Carson <Carson.Jones@seattle.gov>; Stevens, Scott <Scott.Stevens@seattle.gov>
Subject: RE: Gas Works: Cracking Towers structure leaning
Importance: High

I conducted the inspection of the cracking tower structure at Gas Works. The following are my findings:

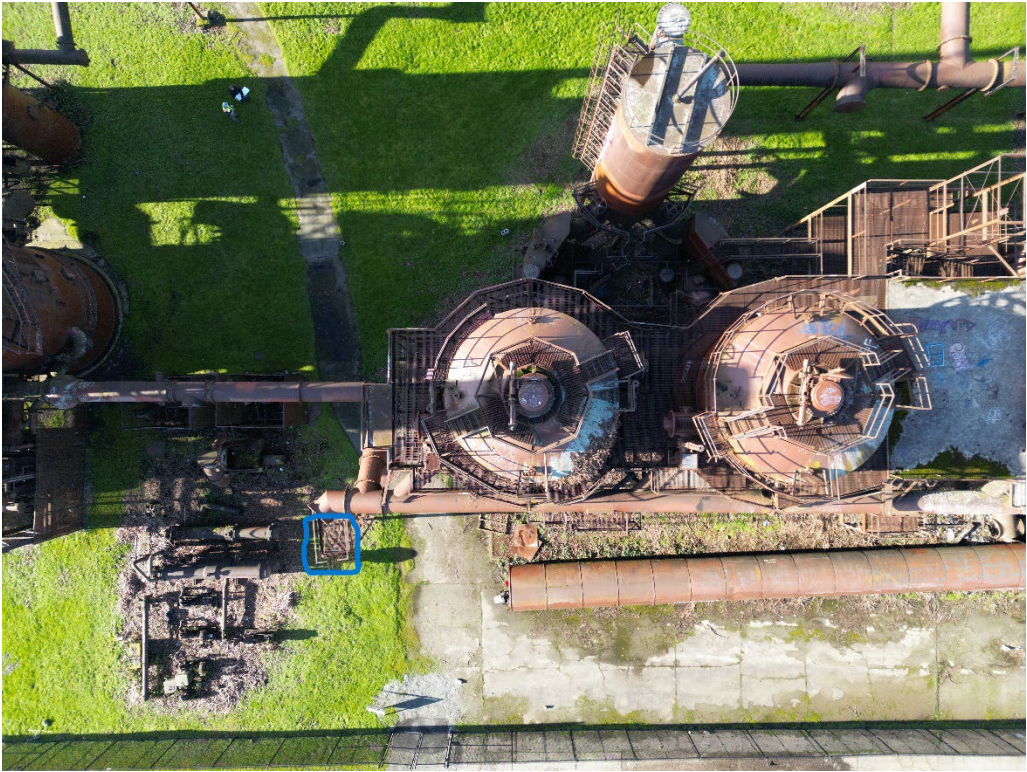
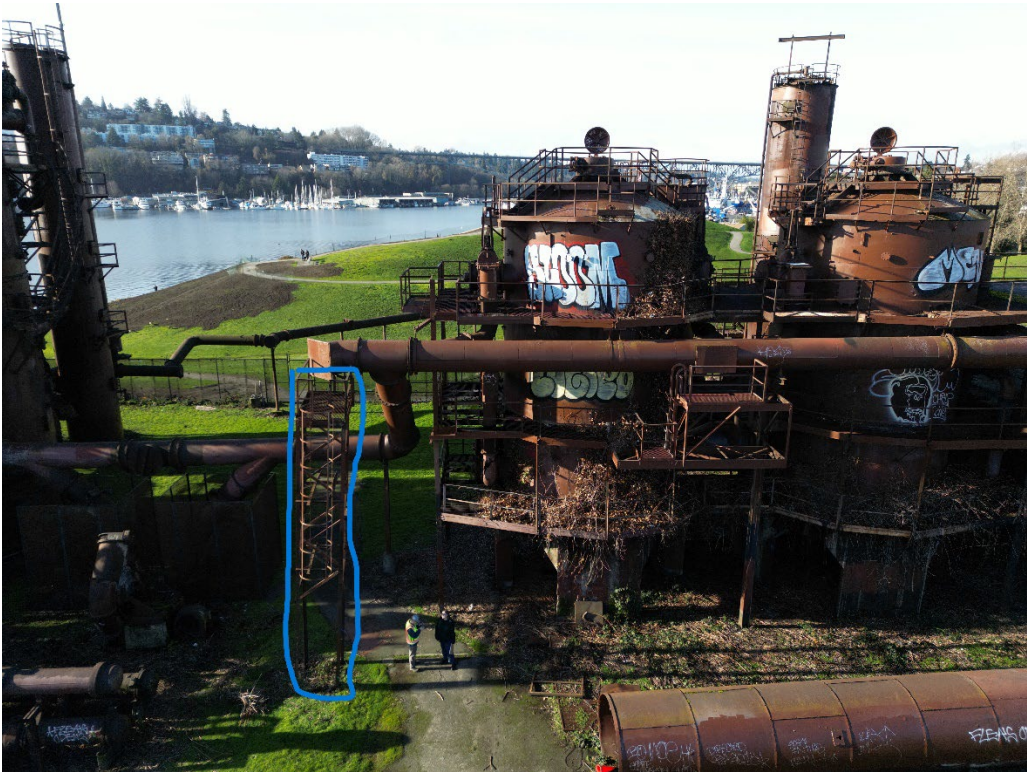
1. The southeast vertical support element of the structure is fractured at the base.

It is my recommendation that the tower structure be taken down. It is a failed structure that is unsafe to be left at its current condition/position. It is not recommended to be rebuilt or refurbished because its elements are deteriorated and badly corroded. The demolition of this tower must be done as soon as possible.
