TALARIS PROJECT RECAP

BUILDINGS A, B, C / EXISTING CONDITIONS AND BUILDING CHARACTERISTICS

BUILDING D / EXISTING CONDITIONS AND BUILDING CHARACTERISTICS

BUILDING F / EXISTING CONDITIONS AND BUILDING CHARACTERISTICS

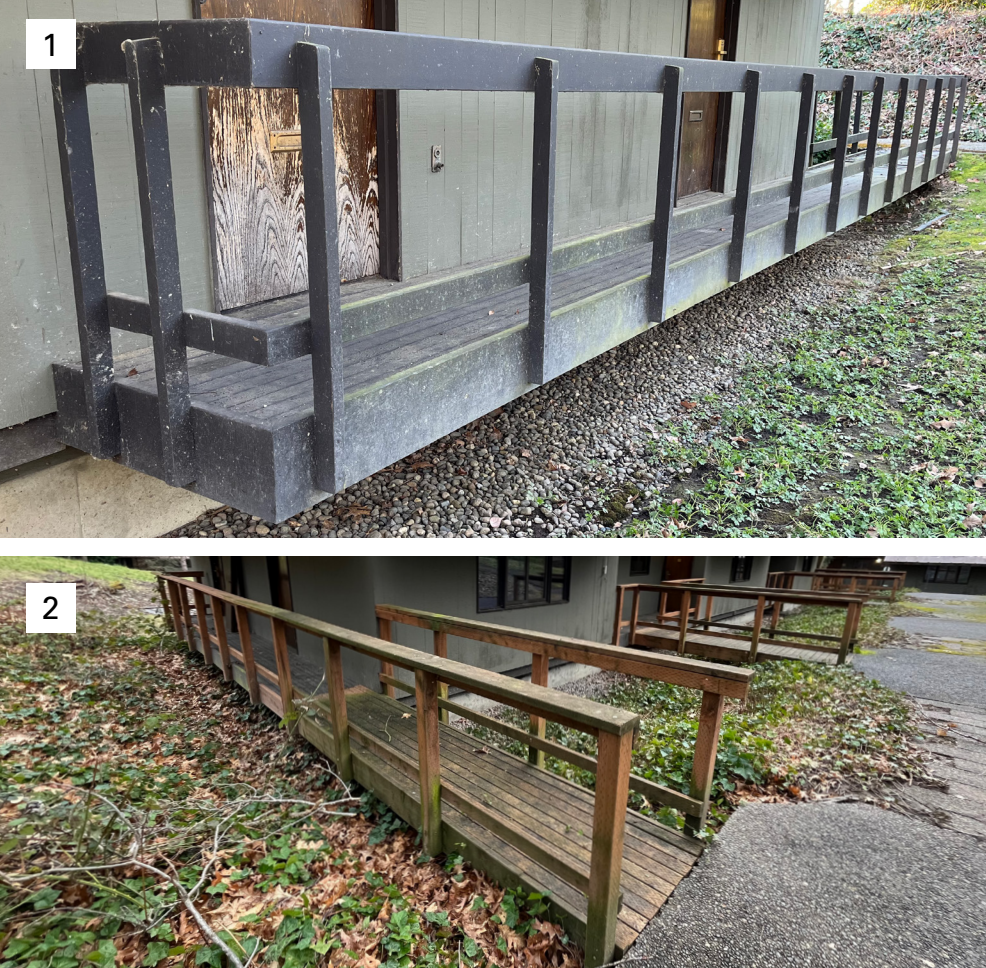
EXISTING

1. ORIGINAL DECKING:
5/4X4 BOARDS GAPPED 1/4" - 3/8" ON
2X10 FRAMING MEMBERS WITH 2X10 WOOD SKIRT BOARD
DARK BROWN PAINTED FINISH
1. ORIGINAL RAILING:
2X3 VERTICAL SUPPORTS @ 36"-48" O.C. TYP.
2X4 CONTINUOUS HORIZONTAL BOTTOM RAIL
2X6 CONTINUOUS HORIZONTAL TOP RAIL WITH EASED EDGES AT TOP
DARK BROWN PAINTED FINISH
2. REPLACEMENT DECKING SYSTEM:
5/4X4 OR 5/4 X 6 PRESSURE TREATED BOARDS GAPPED 3/8"-1/2" ON
2X10 PRESSURE TREATED FRAMING WITH 2X10 P.T. SKIRT BOARDS
UNFINISHED
2. REPLACEMENT RAILING SYSTEM:
4X4 P.T. VERTICAL SUPPORTS AT 36"-48" O.C. TYP.
2X4 CONTINUOUS P.T. HORIZONTAL BOTTOM RAIL
2X4 CONTINUOUS P.T. HORIZONTAL TOP RAIL WITH 2X6 P.T. CONT. CAP
UNFINISHED

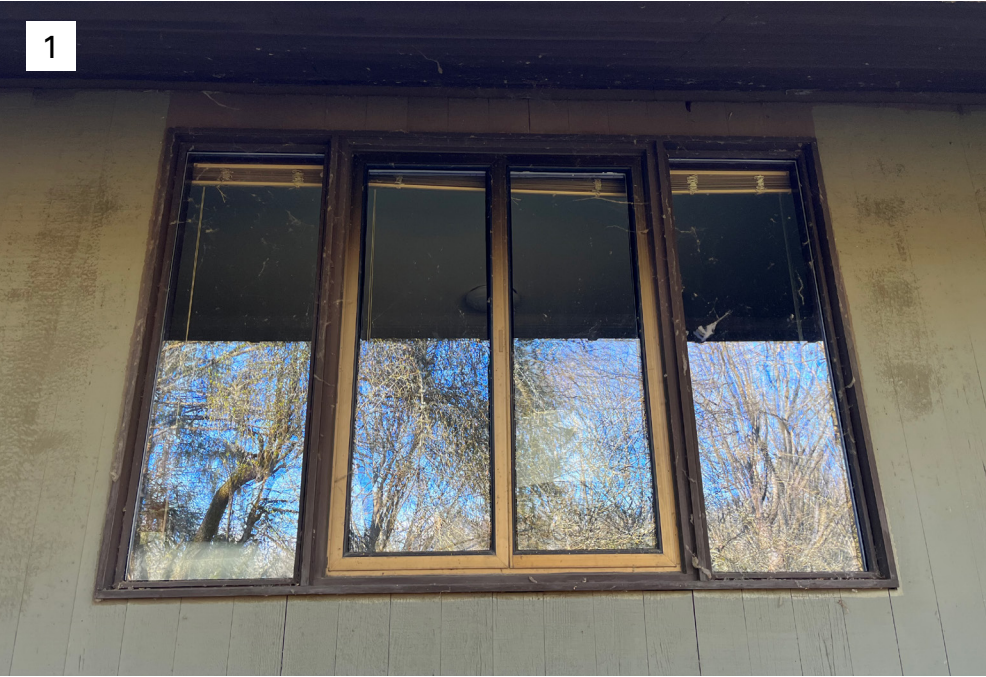
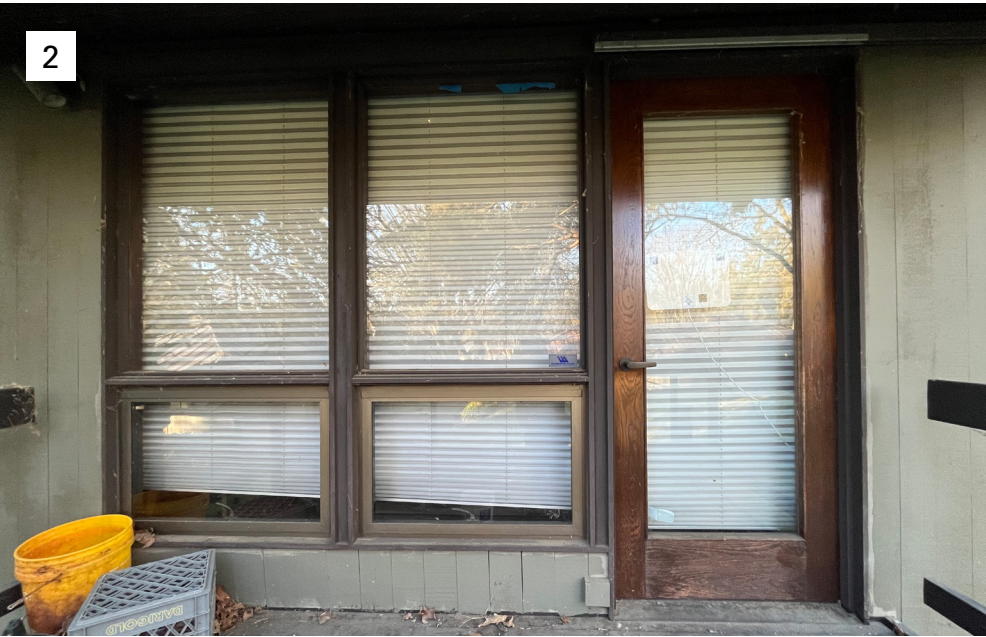
1. EXISTING WINDOWS ARE DOUBLE PANE GLASS IN WOOD FRAMES PAINTED DARK BROWNTO MATCH RAILINGS AND DOOR FRAMES.

2.THE OPERABLE CASEMENT WINDOWS AND AWNING WINDOWS ARE ALUMINUM FRAMED INSET IN PAINTED WOOD FRAMING.

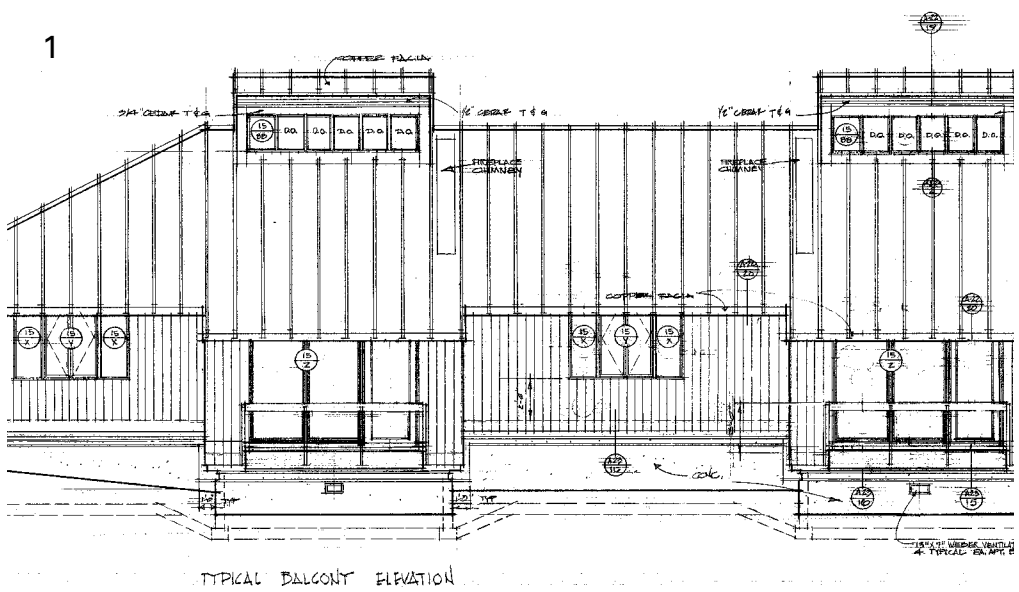
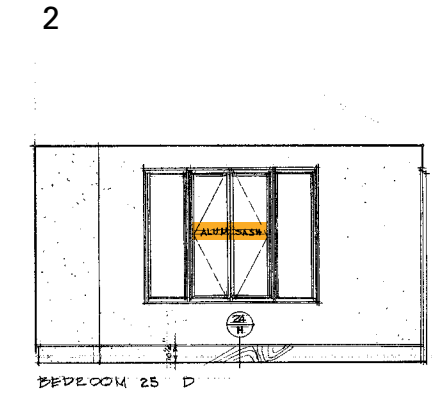
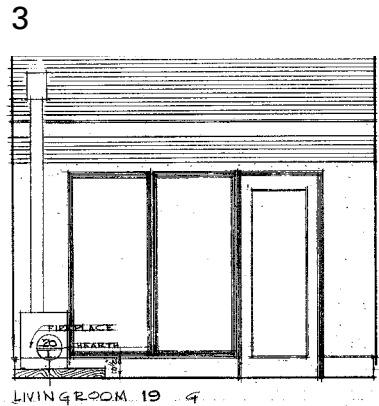
DESIGNED

1 & 2. THE ORIGINAL DESIGN SHOWS WOOD FRAMED FIXED WINDOWS AND ALUMINUM OPERABLE CASEMENT WINDOWS.

3. DOCUMENTS DO NOT SHOWTHE LOW BALCONY OPERABLE AWNING WINDOWS. THIS MAY HAVE BEEN ADDED DURING ORIGINAL CONSTRUCTION SINCE THEY APPEAR TO MATCHTHE OPERABLE CASEMENT WINDOWS.

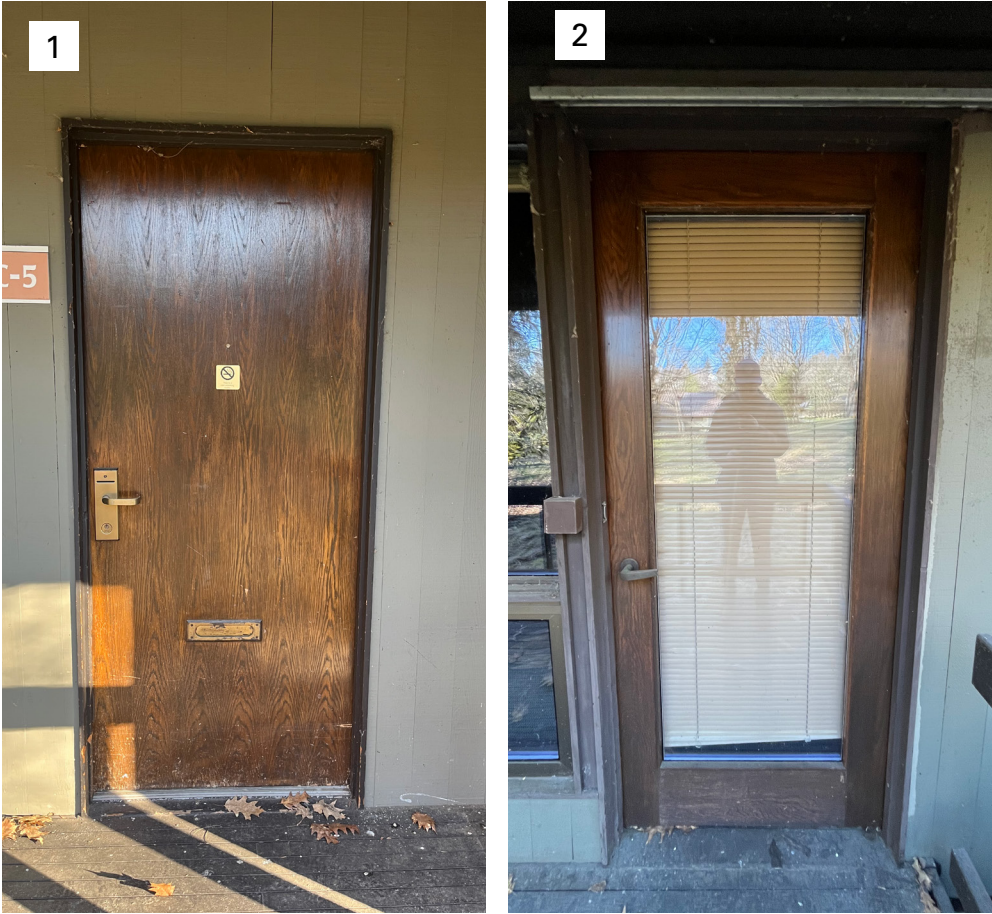
EXISTING

1. UNIT ENTRY DOORS:
FLUSH SOLID CORE DOORS WITH OAK VENEER AND STAIN FINISH
DOUBLE RABBIT WOOD FRAME WITH PAINT FINISH AND NO CASING TRIM.
2. DECK ACCESS DOORS:
OAK SILE AND RAIL FULL LIGHT GLASS DOORS WITH CHAMFERED
GLAZING STOP/ 5 1/2" VERTICAL STILES AND TOP RAIL; 11 1/2" BOTTOM
RAIL. DOUBLE RABBIT WOOD FRAME WITH PAINT FINISH AND NO
CASING TRIM.

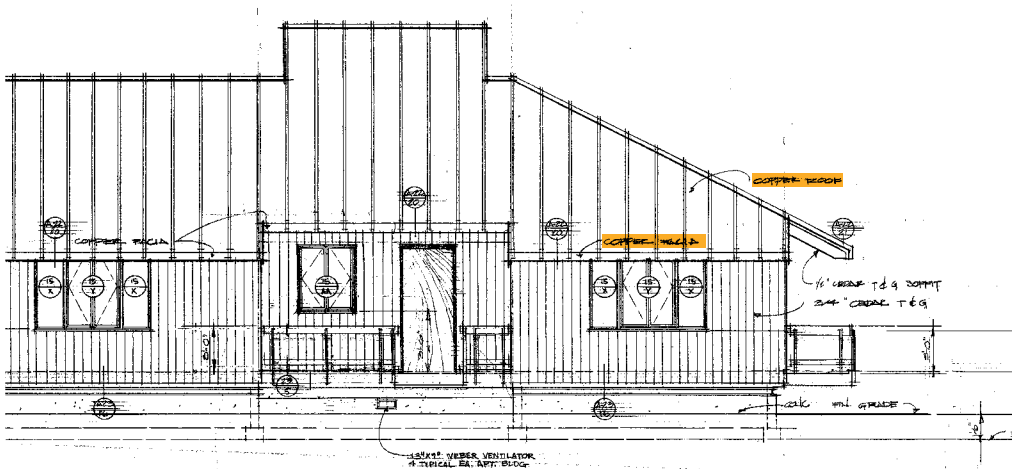
BRIEF HISTORY OF ROOFING/FLASHING MATERIALS

- ORIGINAL NBBJ OUTLINE SPECIFICATIONS NOTED ROOFING TO BE: COPPER, TERNE METAL OR TITANALLOY WITH STANDING SEAM.
- COPPER ROOFING AND FLASHING IS NOTED ON CONSTRUCTION DRAWINGS

- THE LANDMARK NOMINATION FORM NOTES COR-TEN STEEL WAS INSTALLED AS AN ALTERNATIVE TO MORE EXPENSIVE COPPER ROOFING.
- CORE-TEN ROOFING SYSTEM SUFFERED PRE-MATURE FAILURE DUE TO A MANUFACTURING ISSUE.

- REPLACEMENT OF THE ROOFING MATERIAL WITH A CONVENTIONAL PAINTED STANDING BATTEN SEAM SHEET METAL PRODUCT WAS COMPLETED AT SOME POINT.
- EXISTING ROOF SYSTEM IS A COATED GALVANIZED SHEET METAL BATTEN SEAM METAL ROOFING SYSTEM WITH PERIMETER SOFFIT AIR INTAKE STRIPS. EACH METAL PANEL INTERLOCKS IN THE FIELD WITH PERIMETER EAVE EDGE PANELS ENGAGED INTO A JOGGLE CLEAT.

- ROOFING PANEL FINISH IS IN FAIR TO POOR CONDITION WITH THE MULTIPLE LAYER SURFACE COATING BEGINNING TO FADE AND/OR CRACK AND PEEL DOWN TO PRIMER COAT LAYER IN VARIOUS LOCATIONS.

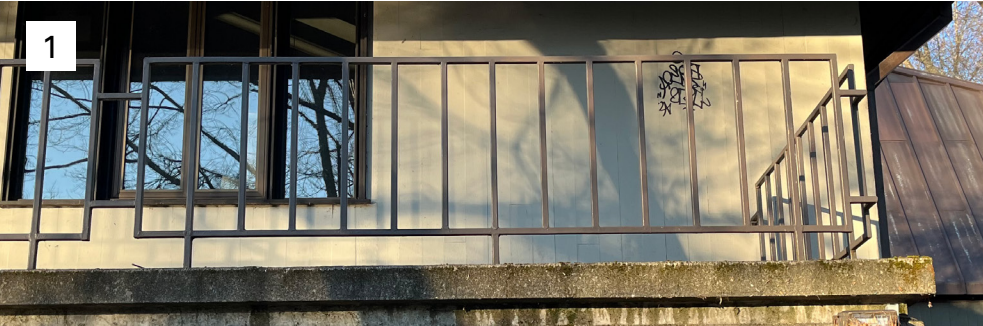
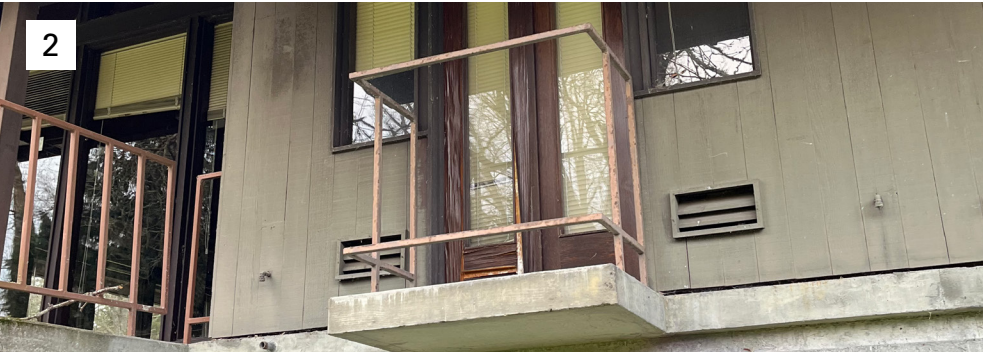
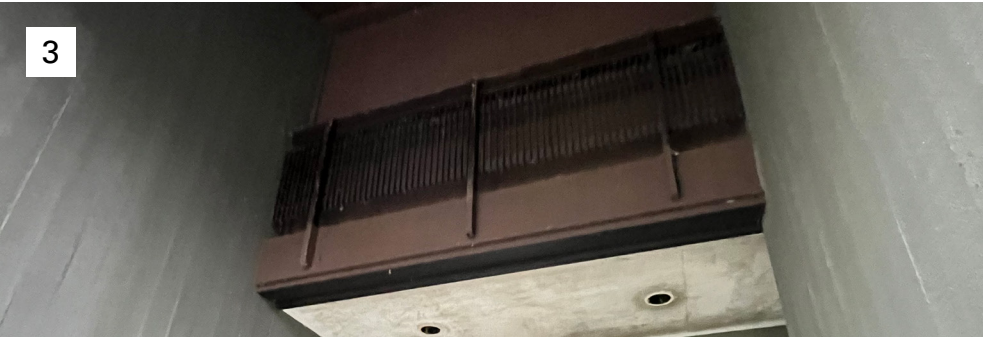
EXISTING

- 1. TYPICAL EXTERIOR METAL RAILINGS ARE PAINTED 1" SQUARE TUBES WITH A REPEATING PATTERN EVERY 10 FEET. PAINT FINISH IS FADED BUT APPEARS TO MATCH ROOFING IN COLOR.
- 2. SAME AS #1 BUT SPACE BETWEEN BALUSTERS IS WIDTH OF RAILING. LOCATION: CANTILEVERED BALCONIES.
- 3. AT WEST BREEZEWAY ENTRANCE, AN EXTERIOR BRIDGE WITH A WOOD RAILING HAS BEEN ENCLOSED. THE REMNANT RAILING APPEARS TO MATCH INTERIOR BUILDING D GUARD RAILINGS.

THREE OPTIONS: NEW GUARD RAIL DESIGN THAT MEETS CODE AND IS INSPIRED BY ORIGINAL DESIGN.

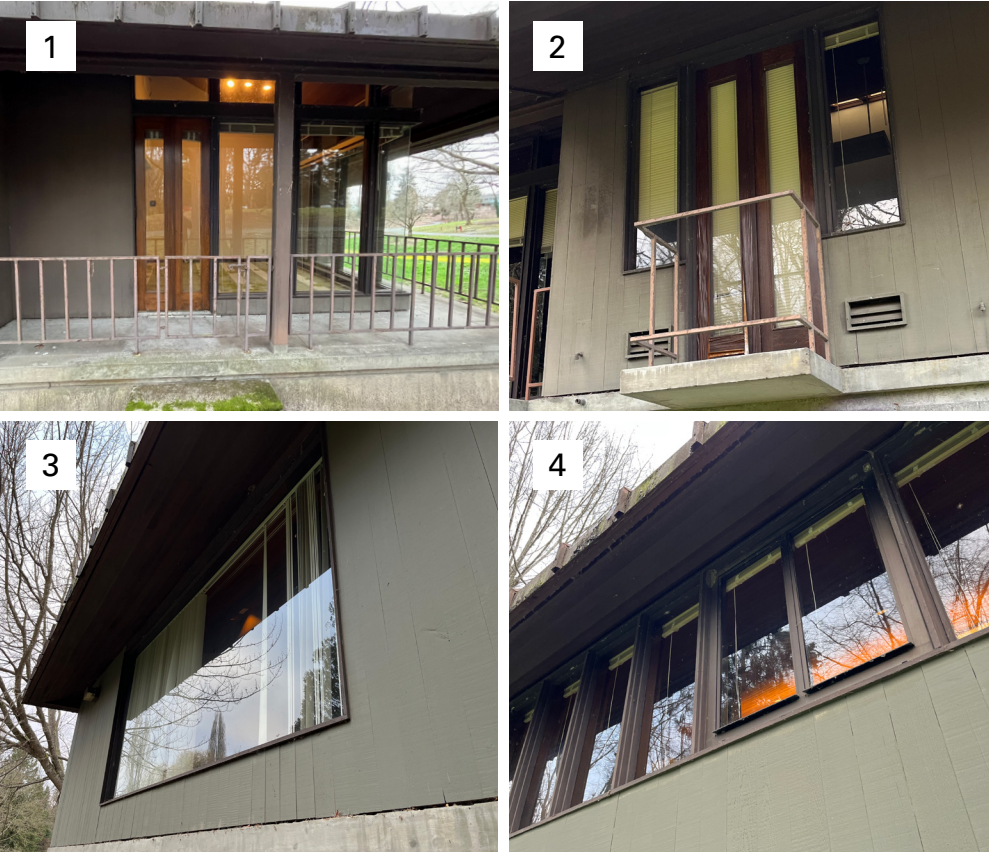
- 1. STOREFRONT GLAZING SYSTEM: WOOD FRAMED WITH FIXED GLASS, BUTT JOINTS AT OUTSIDE CORNERS. LOCATIONS: NE, NW, AND SW EXTERIOR DECKS; MAIN LOBBY ENTRANCE, MAIN CONFERENCE ROOM ENTRANCE
- 2. BALCONY DOOR SIDELIGHTS: WOOD FRAMED WITH FIXED GLASS. LOCATIONS: AT ALL RAISED BALCONIES WITH EXTERIOR PAIRS OF ACCESS DOORS.
- 3. TYPICAL EXTERIOR WINDOWS: ALUMINUM FRAMED, VERTICALLY ORIENTED WINDOWS IN A RIBBON PATTERN WITH INTERMITTENT CASEMENT OPERATORS. LOCATIONS: WEST WALL OFFICES, COURTYARD RECEPTION ROOM AND SECOND FLOOR OFFICES.
- 4. PICTURE WINDOWS: WOOD FRAMED FIXED GLASS WINDOW: LOCATIONS: MAIN CONFERENCE AND SEMINAR ROOM.

CASCADIA UNIVERSAL SERIES
THERMALLY BROKEN FIBERGLASS STOREFRONT FRAMES AND WINDOW UNITS WITH COLORS AND PROFILES SIMILAR TO EXISTING WINDOW UNITS

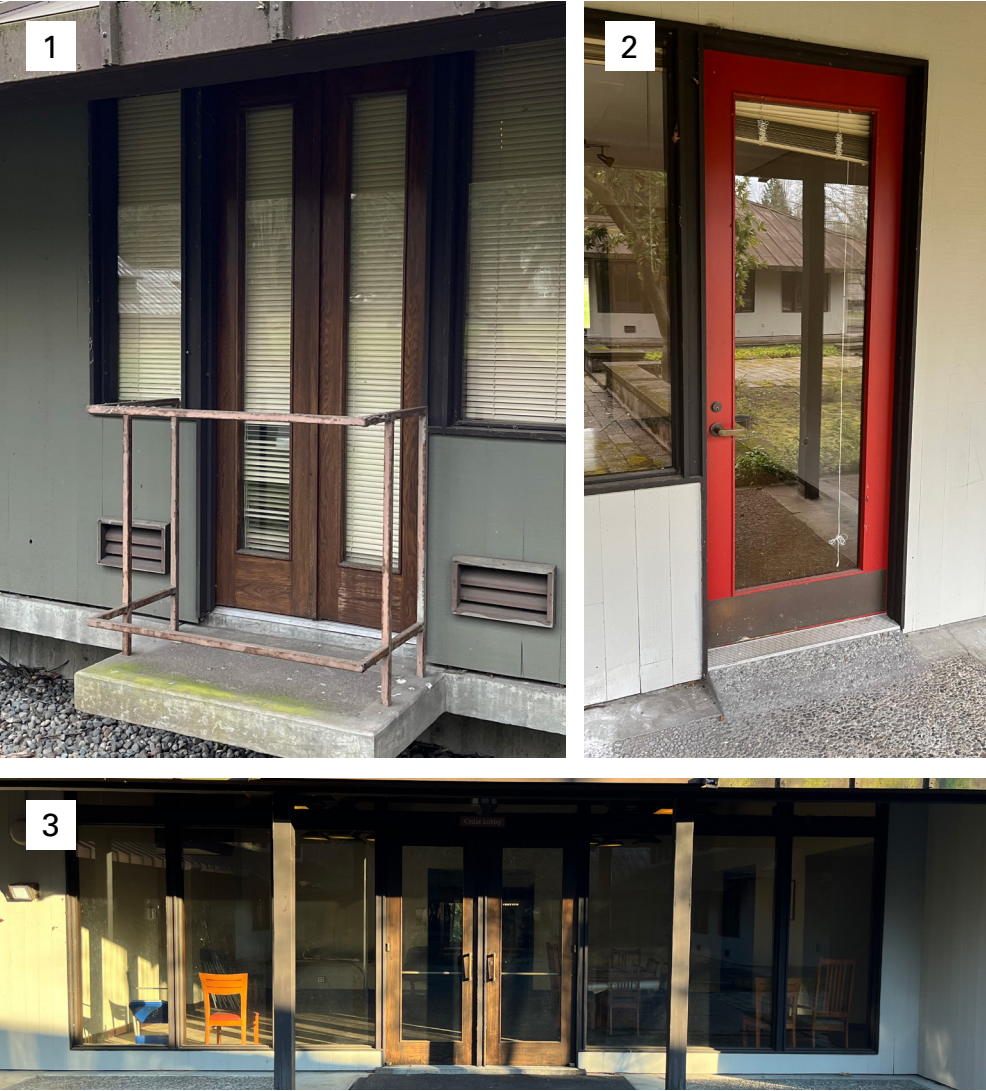
EXISTING

- 1. DOORS ARE WOOD WITH SINGLE PANE FULL LITES AND DARK HARDWARE THAT MATCHES THE COLOR OF THE WINDOW FRAMES. DOOR FRAMES ARE WOOD PAINTED DARK BROWN TO MATCH RAILINGS AND WOOD WINDOW FRAMES.
- 2. REPLACEMENT DOOR AT NORTH SIDE OF COURTYARD DOES NOT MATCH OTHER DOORS AT EXTERIOR
- 3. STOREFRONT ENTRY DOUBLE DOORS ARE WOOD WITH SINGLE PANE FULL LITES WITH PAINTED DARK WOOD FRAMES

- 1. NEW STILE AND RAIL DOORS SHALL BE SIMPSON MODEL 4976 OR SIMILAR IN WOOD VENEER WITH STAIN AND LACQUER FINISH.
- 2. NEW ENTRY DOORS SHALL BE SIMPSON MODEL 49900 OR SIMILAR WITH WOOD VENEER AND STAIN AND LACQUER OR PAINT FINISH.
- 3. BALCONY DOORS - NEW ENTRY DOORS SHALL BE SIMPSON MODEL 49908 OR SIMILAR WITH WOOD VENEER AND STAIN AND LACQUER OR PAINT FINISH.

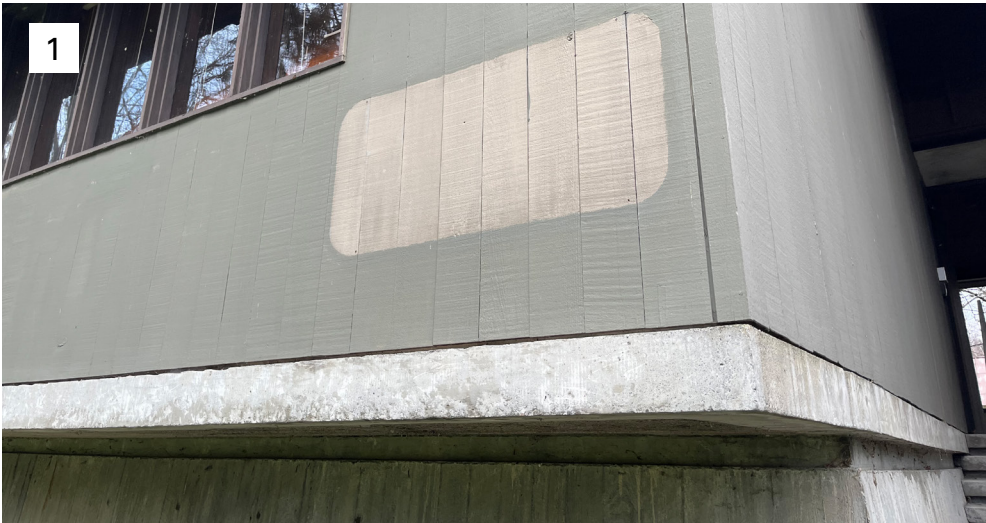
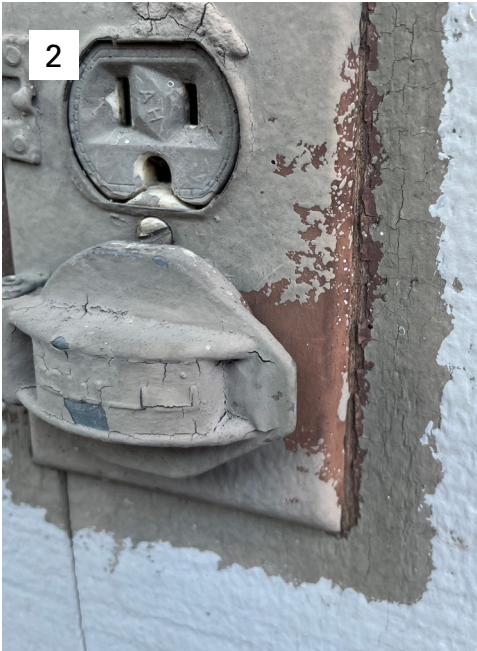
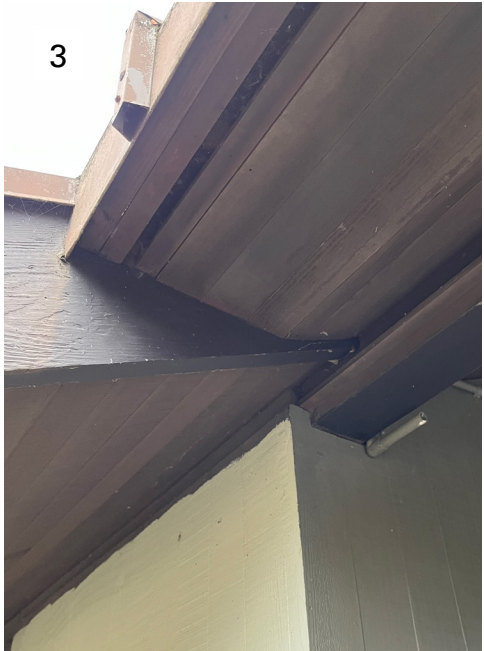
EXISTING

1&2. THE SIDING IS 3/4"X 5 1/2" TONGUE AND GROOVE CEDAR. BUILDINGS HAVE BEEN PAINTED MULTIPLE TIMES

SOME AREAS HAVE BEEN PAINTED ONCE, OTHER AREAS UP TO THREE TIMES. THE FIRST PAINT COLOR WAS MEDIUM GRAY/BEIGE. THE CURRENT COLOR FOR MOST OF THE BUILDINGS IS A DARK GREEN/GRAY COLOR

3. UNDERSIDE OF ROOF EAVE IS 3/4"X 5 1/2" TONGUE AND GROOVE CEDAR STAINED DARK BROWN.

3. DOORS TO BE WOOD VENEER AND STAIN AND LACQUER FINISH.

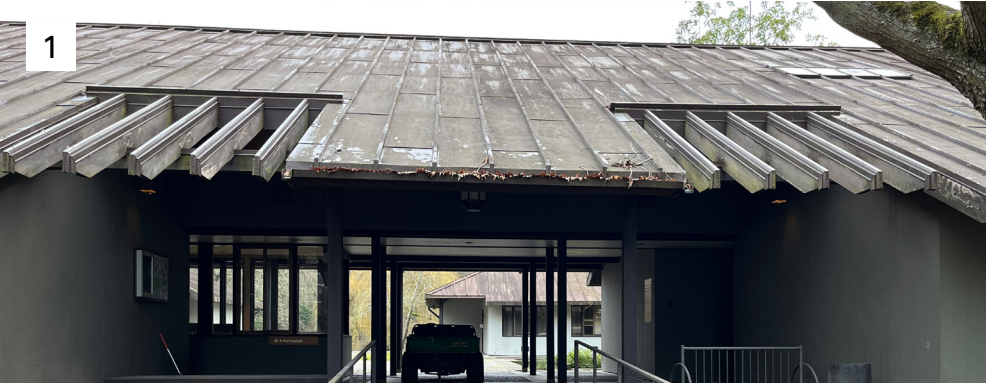
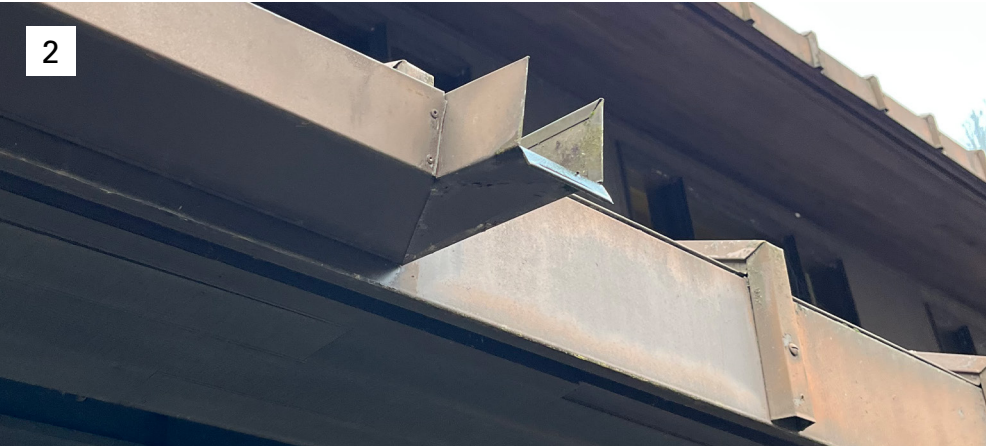
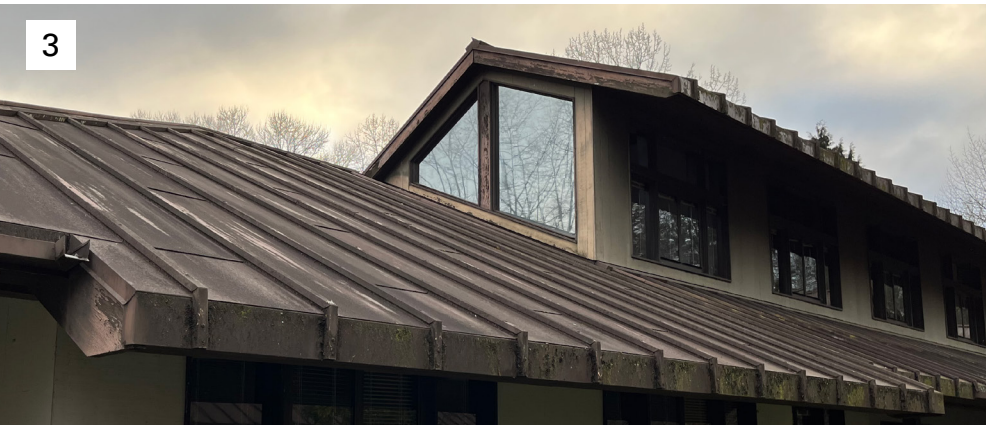
- 1. BATTEN METAL ROOFS ARE PAINTED WITH A DARK BROWN PAINT. THE PAINT IS PEELING IN MANY LOCATIONS.
- 2. GUTTERS ARE LOCATED AT WALKWAYS THAT PASS UNDER THE EAVES
- ROOF DRAINAGE TYPICALLY RUNS OFF ROOF EDGES AND FALLS TO PERIMETER GRAVEL SURFACED STORM SYSTEM.
- 3. UPPER ROOF EAVES ARE SIMILAR TO DEPTH AT FIRST LEVEL, RAKE OF ROOF DOES NOT HAVE A DEEP EAVE.

- THE LANDMARK NOMINATION FORM NOTES COR-TEN STEEL WAS INSTALLED AS AN ALTERNATIVE TO MORE EXPENSIVE COPPER ROOFING.
- CORE-TEN ROOFING SYSTEM SUFFERED PRE-MATURE FAILURE DUE TO A MANUFACTURING ISSUE.

- ROOFING PANEL FINISH IS IN FAIR TO POOR CONDITION WITH THE MULTIPLE LAYER SURFACE COATING BEGINNING TO FADE AND/OR CRACK AND PEEL DOWN TO PRIMER COAT LAYER IN VARIOUS LOCATIONS.

- 1. ATLAS ROOFING COMPANY PC WIDE BATTEN METAL PANEL ROOF SYSTEM, WITH 2" X 1 1/2" BATTEN SEAMS. COLOR TO BE SELECTED TO MATCH EXISTING MEDIUM BROWN.
- 2. METAL SALES BOX-BATTEN 1-1/2" X 1-1/2" METAL PANEL ROOF SYSTEM. COLOR TO BE SELECTED TO MATCH EXISTING MEDIUM BROWN.

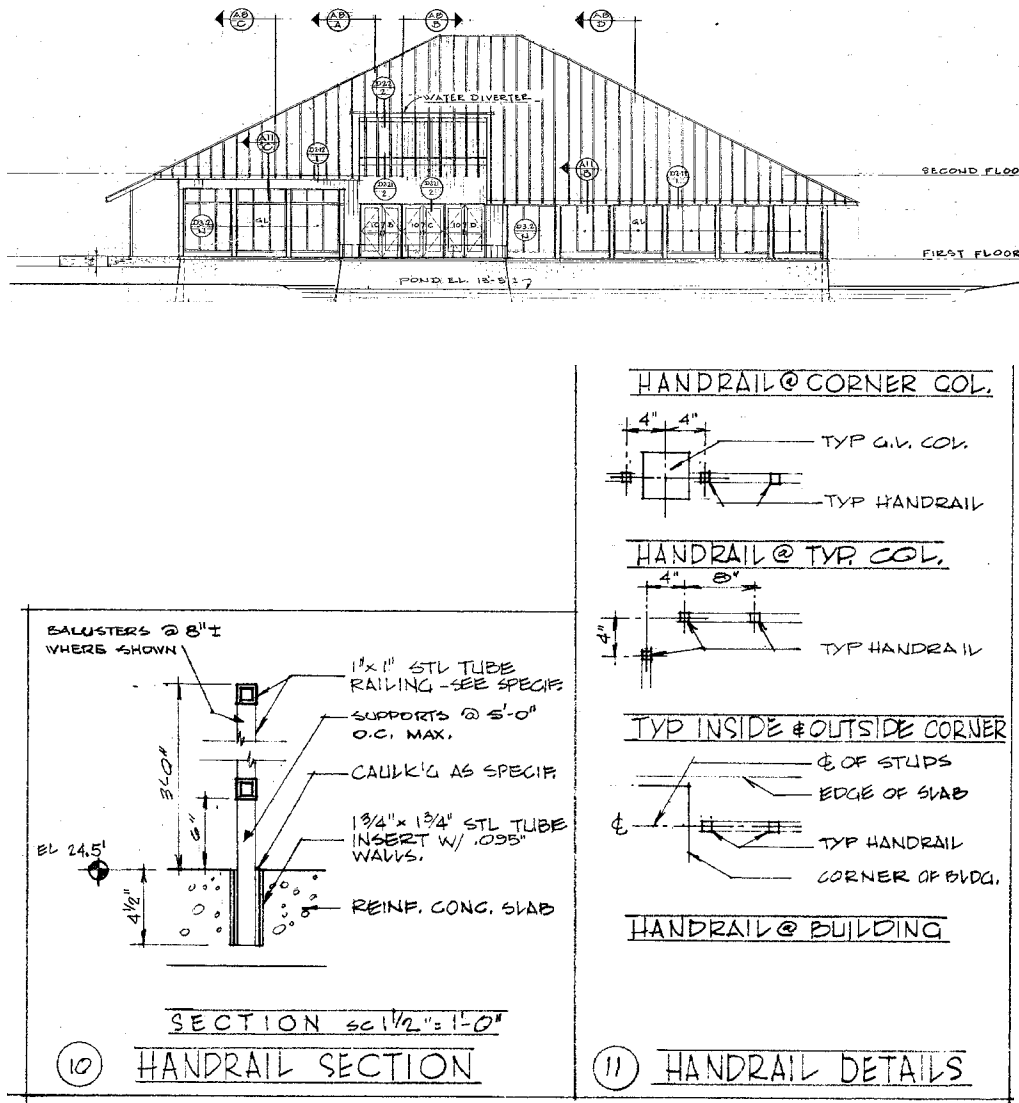
1. WEST ELEVATION SHOWING METAL HANDRAIL LOCATION
2. METAL HANDRAIL DETAILS

1. TYPICAL EXTERIOR METAL RAILINGS ARE PAINTED 1" SQUARE TUBES WITH A REPEATING PATTERN EVERY 10 FEET. PAINT FINISH IS FADED BUT APPEARS TO MATCH ROOFING IN COLOR.

THREE OPTIONS: NEW GUARD RAIL DESIGN THAT MEETS CODE AND IS INSPIRED BY ORIGINAL DESIGN.

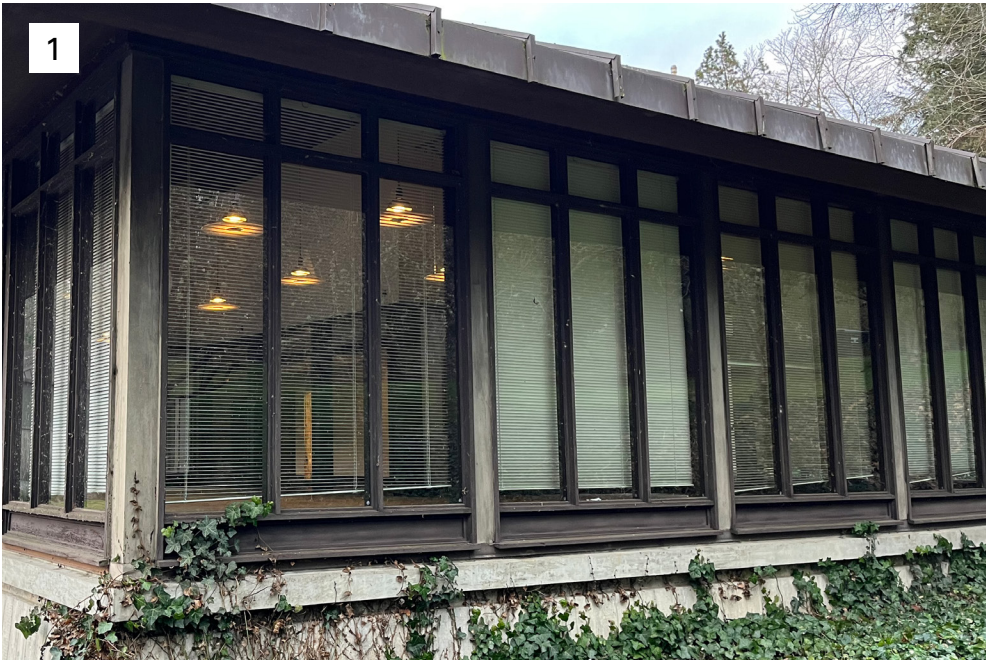
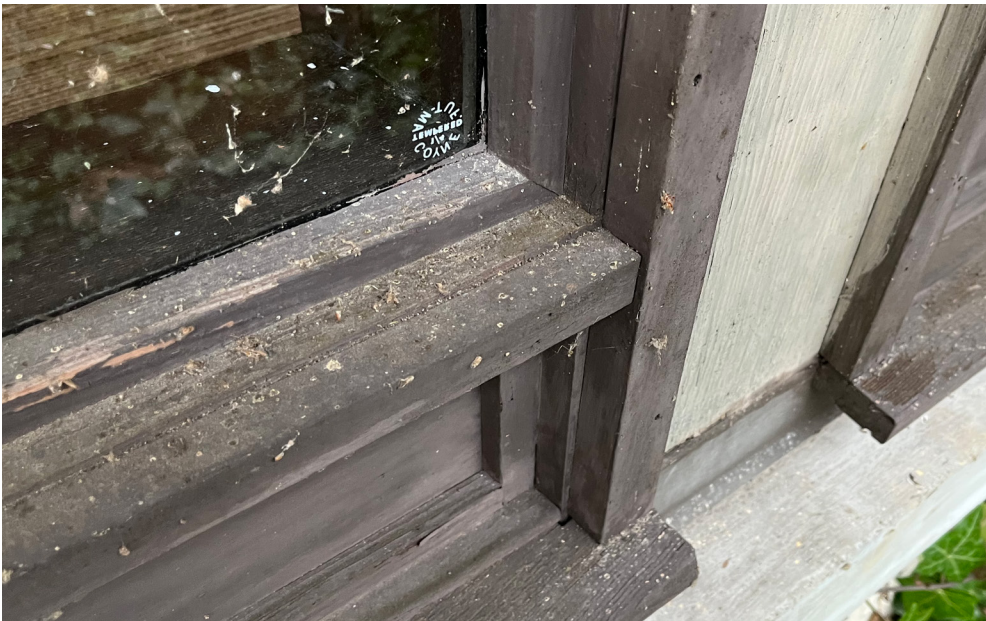
1. STOREFRONT GLAZING SYSTEM: WOOD FRAMED WITH FIXED SINGLE PANE GLASS, WINDOW GROUPING TYPICAL THROUGHOUT.

2.DETAIL OF SOUTH FACING WOOD STOREFRONT FRAME WITH SINGLE GLASS PANE

THERMALLY BROKEN FIBERGLASS STOREFRONT FRAMES AND WINDOW UNITS WITH COLORS AND PROFILES SIMILAR TO EXISTING WINDOW UNITS

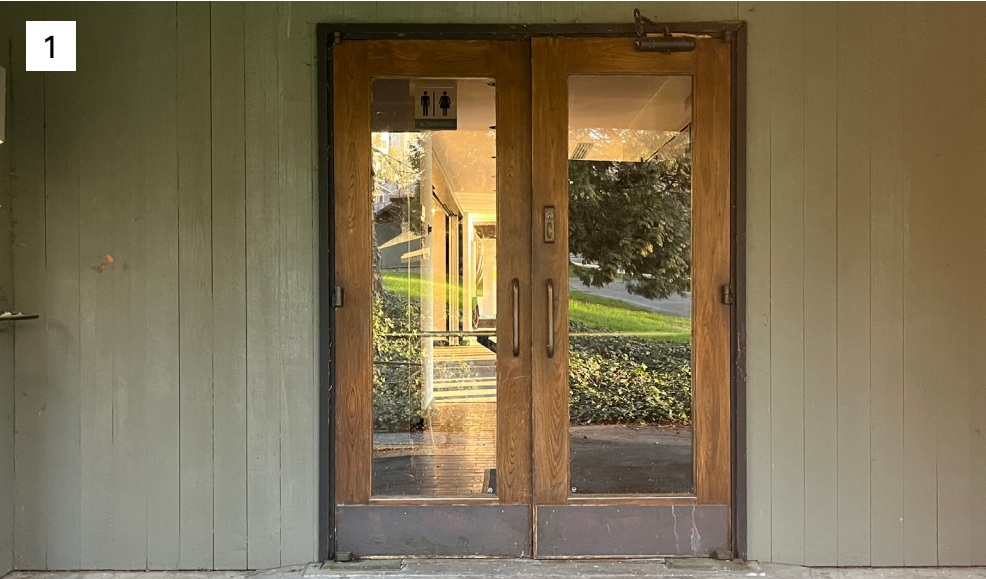
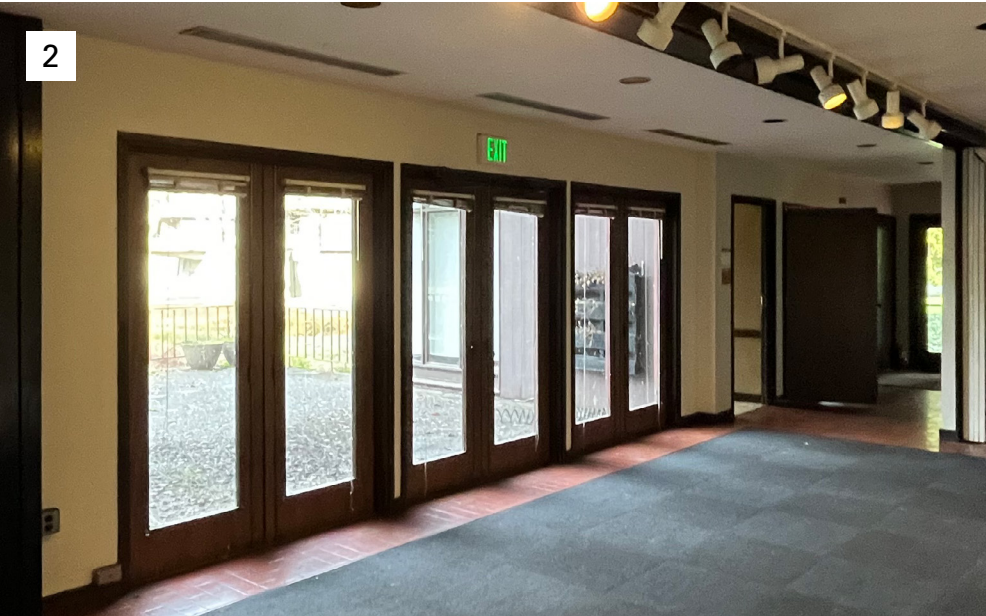
1&2. DOORS ARE WOOD WITH SINGLE PANE FULL LITES AND DARK HARDWARE THAT MATCHES THE COLOR OF THE WINDOW FRAMES. DOOR FRAMES ARE WOOD PAINTED DARK BROWN TO MATCH RAILINGS AND WOOD WINDOW FRAMES.

- 1. NEW STILE AND RAIL DOORS SHALL BE SIMPSON MODEL 4976 OR SIMILAR IN WOOD VENEER WITH STAIN AND LACQUER FINISH.
- 2. NEW ENTRY DOORS SHALL BE SIMPSON MODEL 49900 OR SIMILAR WITH WOOD VENEER AND STAIN AND LACQUER OR PAINT FINISH.

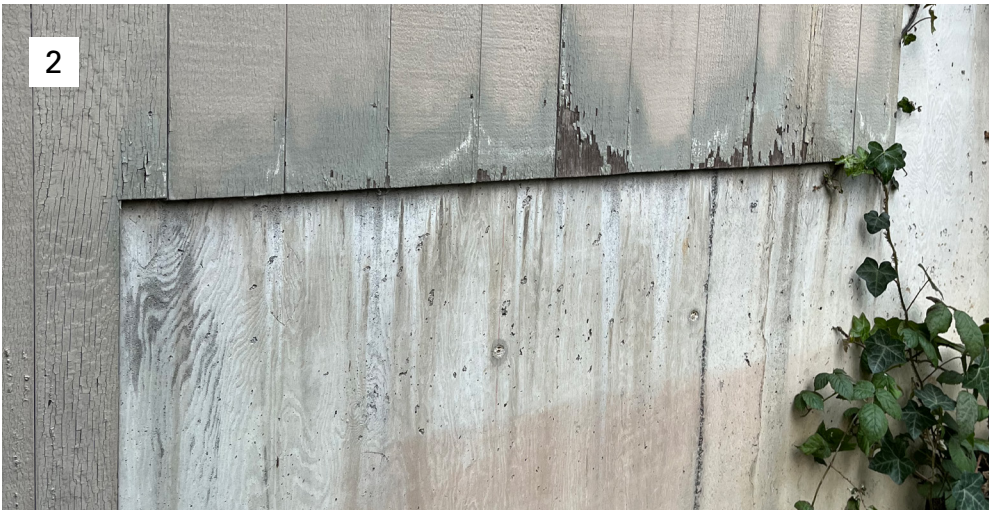
- 1. THE SIDING IS 3/4" X 5 1/2" TONGUE AND GROOVE CEDAR. BUILDINGS HAVE BEEN PAINTED MULTIPLE TIMES

SOME AREAS HAVE BEEN PAINTED ONCE, OTHER AREAS UP TO THREE TIMES. THE FIRST PAINT COLOR WAS MEDIUM GRAY/BEIGE. THE CURRENT COLOR FOR MOST OF THE BUILDINGS IS A DARK GREEN/GRAY COLOR
- 2. THE SOUTH FACADE SHOWS ORIGINAL PAINT COLOR FADED BY SUN AND WEATHERED ABOVE THE BOARD FORMED CONCRETE BASE.

- 1. CEDAR SIDING TO BE PAINTED TO MATCH FIRST LAYER OF GRAY/BEIGE PAINT ON CEDAR
- 2. RAILINGS, WINDOW AND DOOR TRIM, EXPOSED RAFTERS AND DECKING TO BE PAINTED TO MATCH DARK BROWN ON CEDAR.
- 3. DOORS TO BE WOOD VENEER AND STAIN AND LACQUER FINISH.
- 4. ROOFING/FLASHING TO MATCH EXISTING ROOF PAINT COLOR

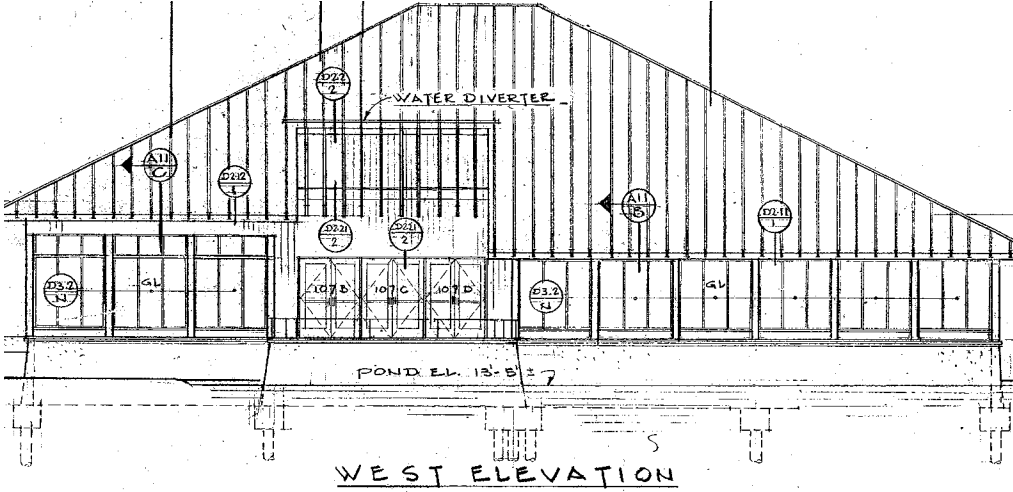
ROOF DRAINAGE TYPICALLY RUNS OFF ROOF EDGES AND FALLS TO GRADE.

BRIEF HISTORY OF ROOFING/FLASHING MATERIALS

- ORIGINAL NBBJ OUTLINE SPECIFICATIONS NOTED ROOFING TO BE: COPPER, TERNE METAL OR TITANALLOY WITH STANDING SEAM.
- COPPER ROOFING AND FLASHING IS NOTED ON CONSTRUCTION DRAWINGS

- THE LANDMARK NOMINATION FORM NOTES COR-TEN STEEL WAS INSTALLED AS AN ALTERNATIVE TO MORE EXPENSIVE COPPER ROOFING.
- CORE-TEN ROOFING SYSTEM SUFFERED PRE-MATURE FAILURE DUE TO A MANUFACTURING ISSUE.

- REPLACEMENT OF THE ROOFING MATERIAL WITH A CONVENTIONAL PAINTED STANDING BATTEN SEAM SHEET METAL PRODUCT WAS COMPLETED AT SOME POINT.
- EXISTING ROOF SYSTEM IS A COATED GALVANIZED SHEET METAL BATTEN SEAM METAL ROOFING SYSTEM WITH PERIMETER SOFFIT AIR INTAKE STRIPS. EACH METAL PANEL INTERLOCKS IN THE FIELD WITH PERIMETER EAVE EDGE PANELS ENGAGED INTO A JOGGLE CLEAT.

- ROOFING PANEL FINISH IS IN FAIR TO POOR CONDITION WITH THE MULTIPLE LAYER SURFACE COATING BEGINNING TO FADE AND/OR CRACK AND PEEL DOWN TO PRIMER COAT LAYER IN VARIOUS LOCATIONS.

1. ATLAS ROOFING COMPANY PC WIDE BATTEN METAL PANEL ROOF SYSTEM, WITH 2" X 1 1/2" BATTEN SEAMS. COLOR TO BE SELECTED TO MATCH EXISTING MEDIUM BROWN.
2. METAL SALES BOX-BATTEN 1-1/2" X 1-1/2" METAL PANEL ROOF SYSTEM. COLOR TO BE SELECTED TO MATCH EXISTING MEDIUM BROWN.
