PART 1 – PROJECT NARRATIVE

1.1. Nathan Eckstein Middle School description

PHOTOS OF EXISTING CONDITIONS

ECKSTEIN MIDDLE SCHOOL

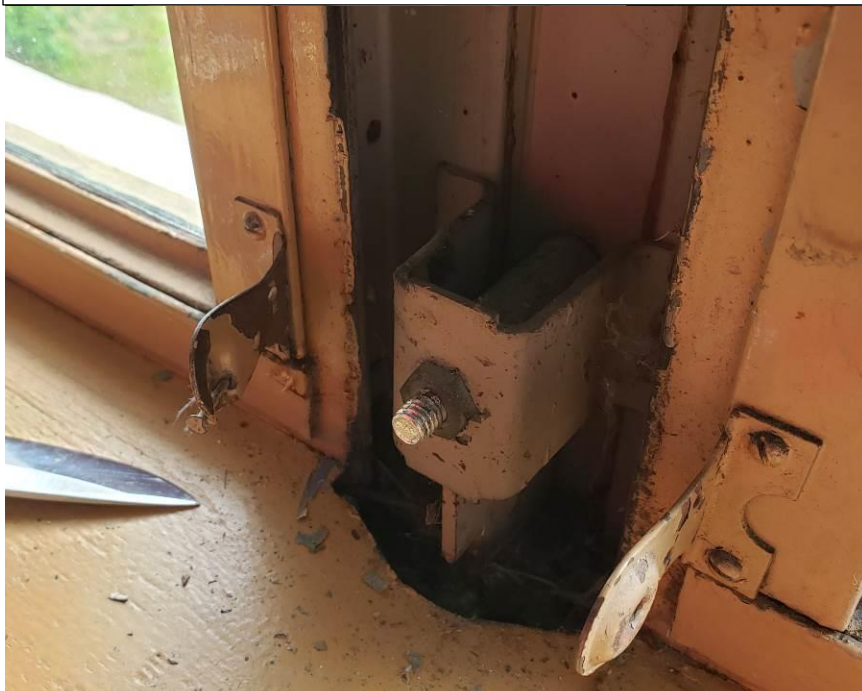
Photo-3 above depicts the concealed brackets used to connect the steel windows at the base of the existing jambs. Note: The brackets are secured to the building structure (embedded in concrete) at only the head and sill of the windows. Intermediate brackets between windows are also located every 16-to-20-inches running vertically between the windows.

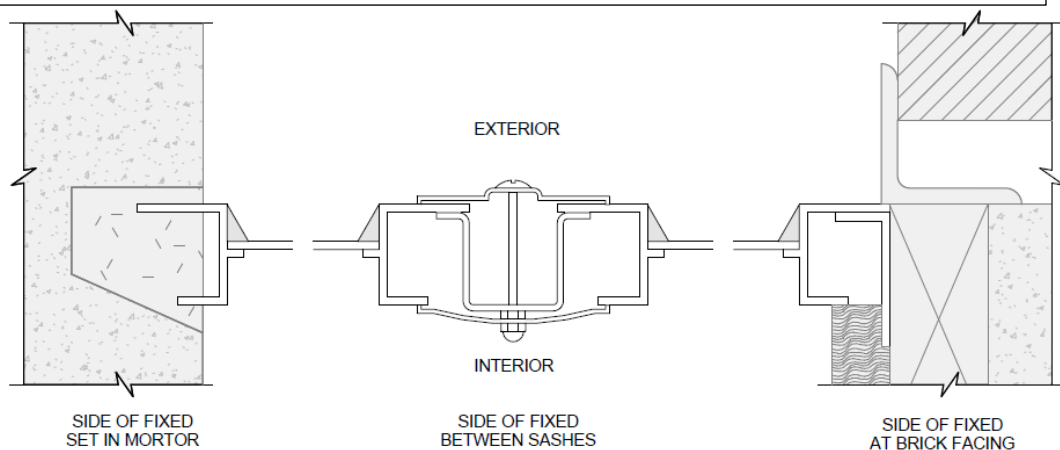
Sketch-1 below depicts the historic fixed window profiles at the two most common rough opening conditions at the window jambs.

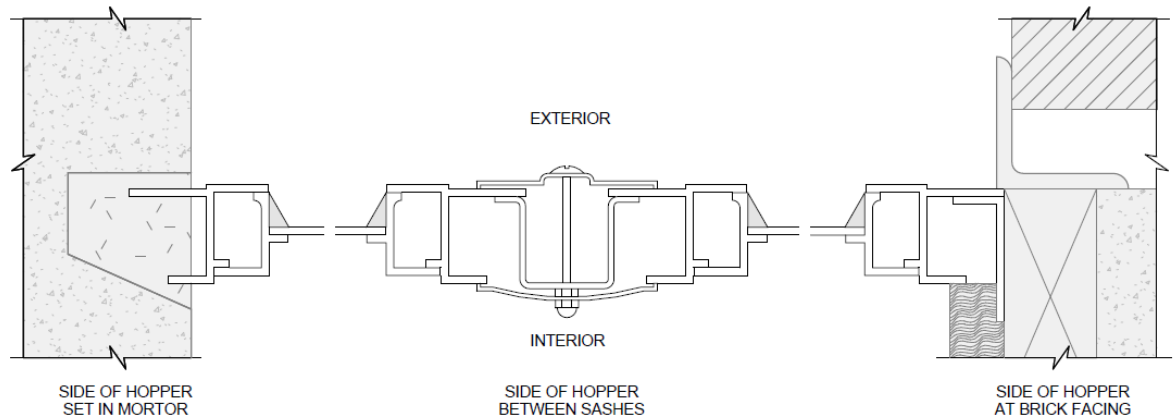
Sketch-2 below depicts the most common type of operable historic window profiles (in-swing hopper) at the two most common rough opening conditions at the window jambs.

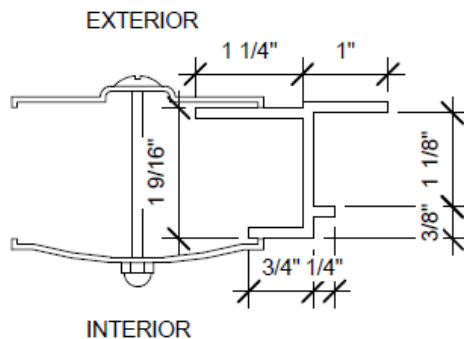
Sketch-3 below provides the field measurements of a historic window frame profile at an operable sash.

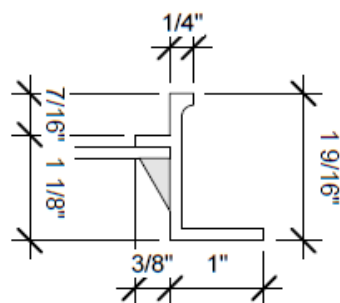
Sketch-5 below provides the field measurements of the historic fixed window frame.

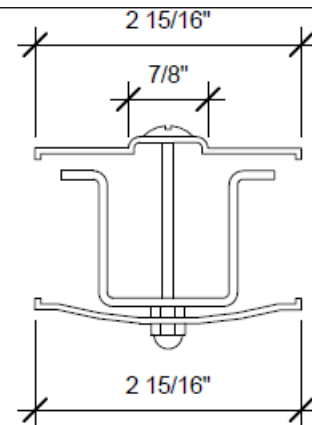
Sketch-4 below provides the field measurements of the most common historic interior and exterior 1/-16-inch thick steel mullion plates used as the typical means of securement at the window jambs.

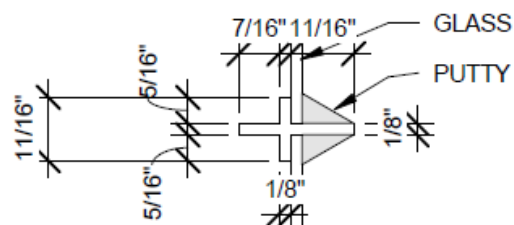
Sketch-6 below provides the field measurements of the historic muntins that exist on both fixed and operable windows.

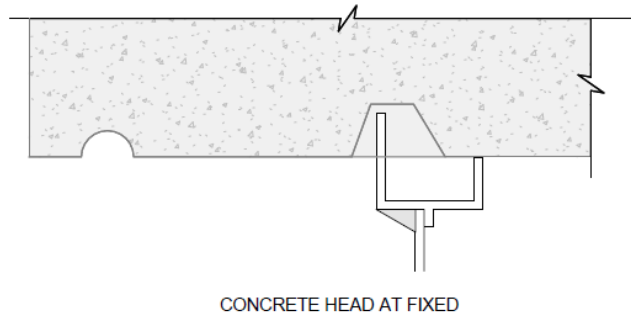
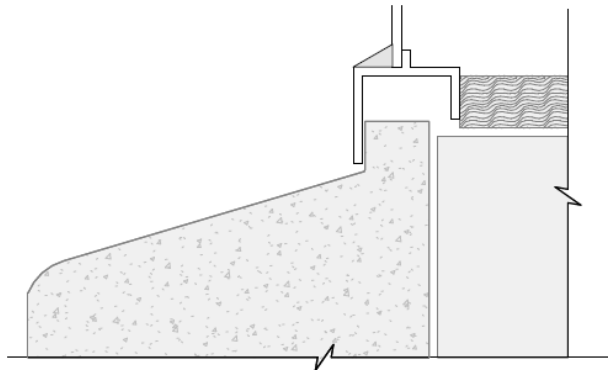
Sketch-7 below depicts the historic fixed window profiles at the most common head/sill rough opening conditions.

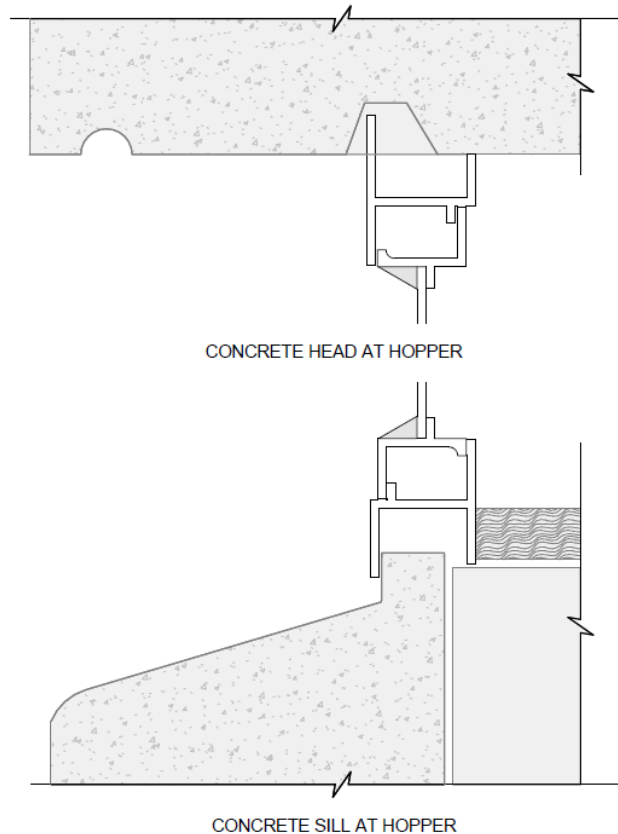
Sketch-8 below depicts the historic operable window profiles at the most common head/sill rough opening conditions.

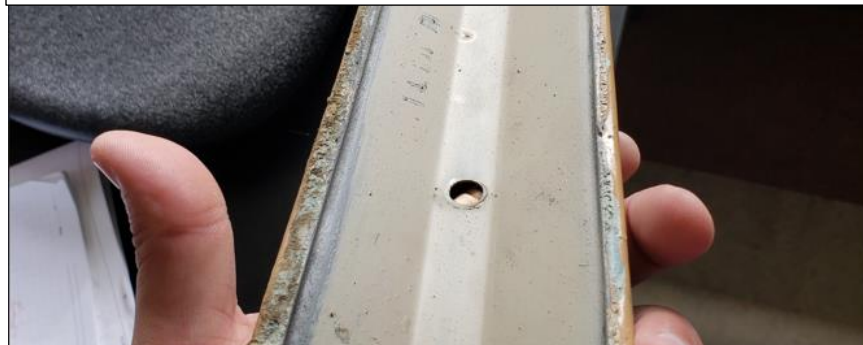
Photo-6 above depicts the back (concealed) side of the 1/16-inch thick formed steel mullion plates that are the typical method of securing the jambs of the original steel windows. The lighter “tan” paint visible on the backside appears to have been the original paint color and also appears to have been factory/shop applied. Sherwin Williams SW 6142 is the closest match to this color.

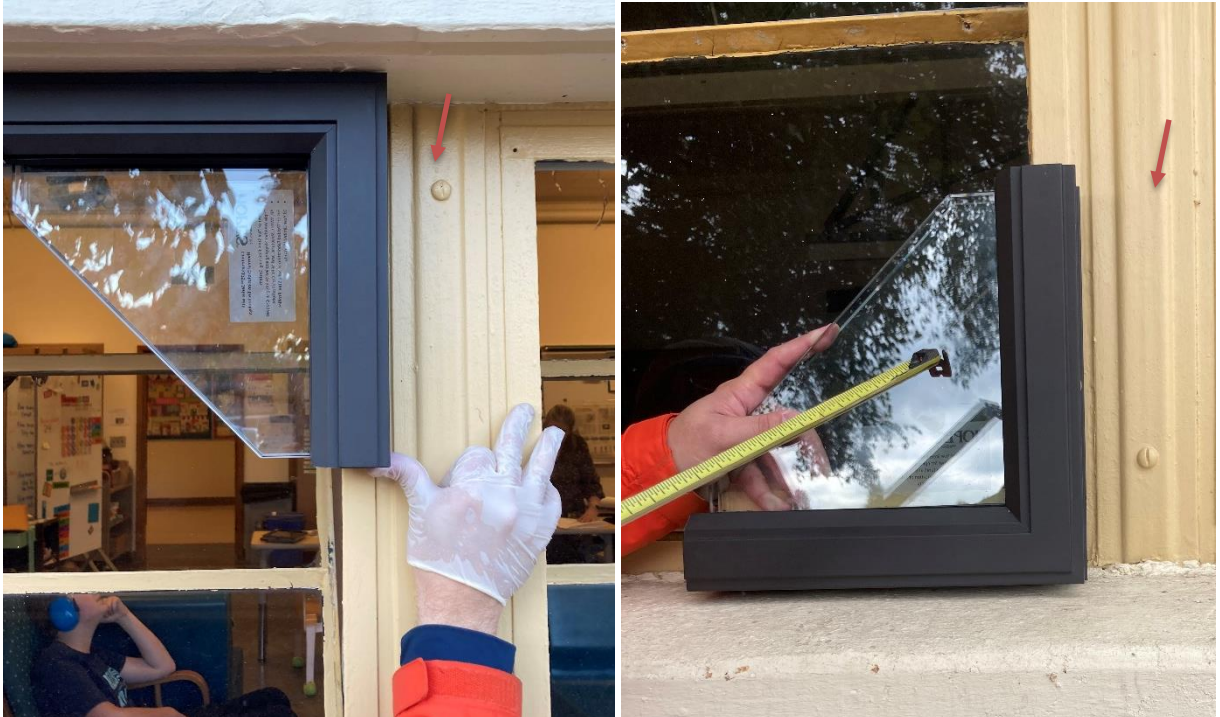
Photos above depict a Hope's Window sample, Landmarked 175 Series, inswing hopper next to the original historic steel frame/sashed windows. *Note: This sample lacks the 1-inch flange that would be specified as part of project and allow for securement behind the profiles steel bracket (red arrow).*

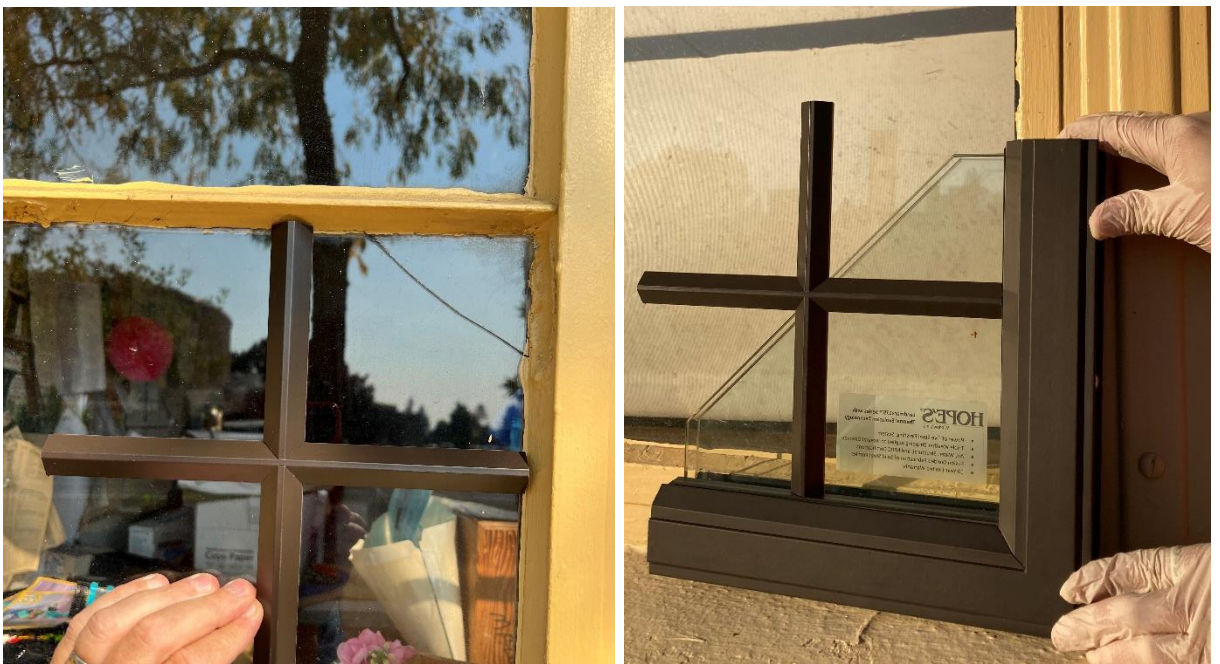
Photos above depict a Hope's Window sample "Simulated Divided Muntin", adjacent to historic muntins with glazing putty. *Note: The existing glazing putty varies in width slightly across building.*

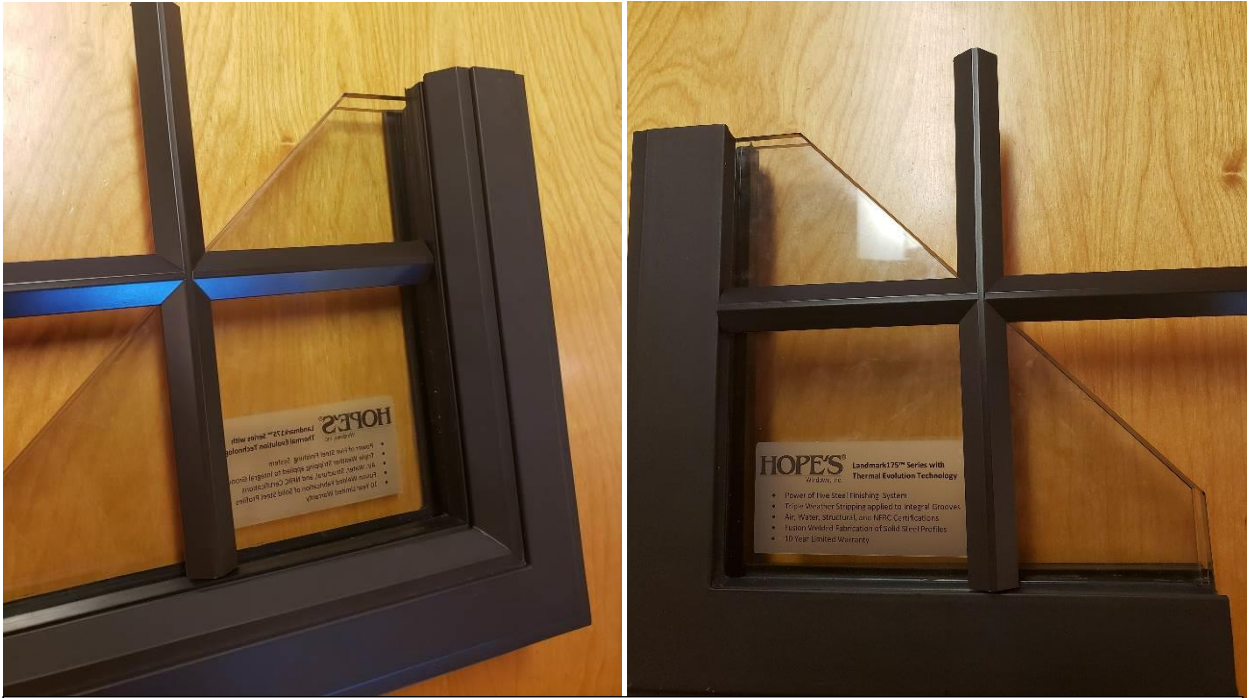
Photos above depict a Hope's "Simulated Divided Muntin", set in a Landmark 175 Series window sample. The photo on the left depicts the location of this muntin as it would be seen on the exterior face of an inswing operable hopper. The photo on the right depicts the location of the muntin as it would be seen on a fixed exterior window. *Note: For the proposed replacement windows, exterior "Simulated Divided Muntins" would only be installed on the outside face of the windows and will be custom milled to seat tightly against the window frames, sashes, and glazing sealants. For exterior fixed windows, the preferred option is to have the steel muntins welded and dressed seamlessly to the steel windows at the factory.*

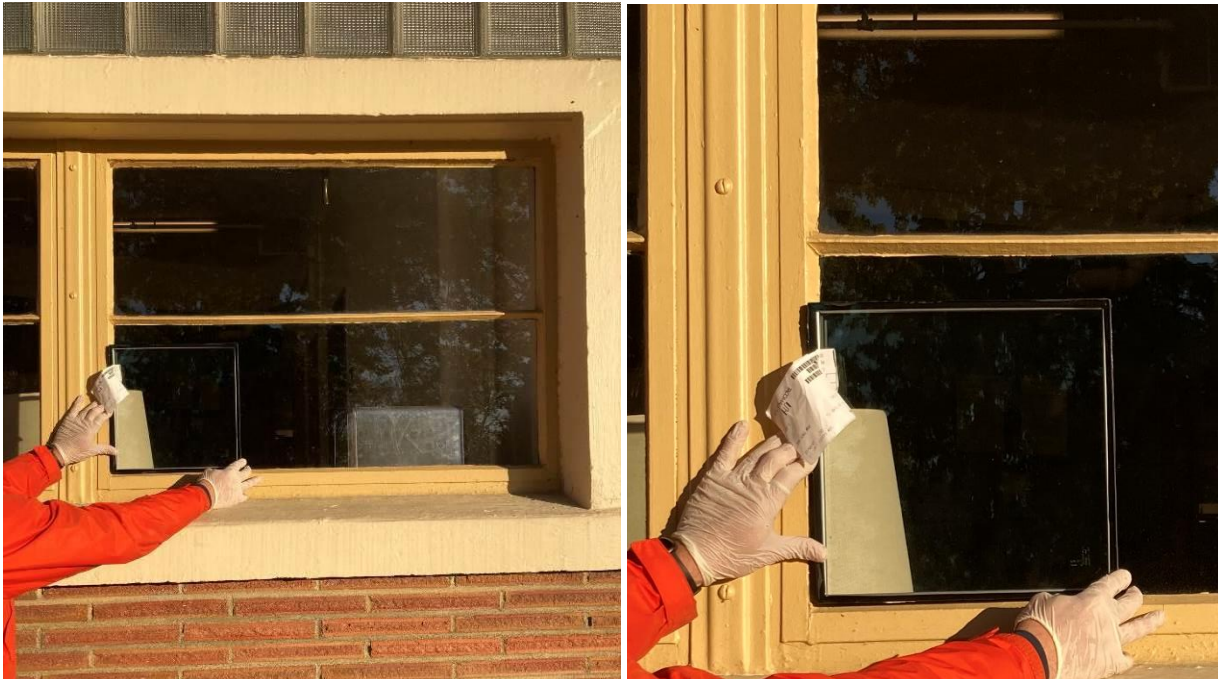
The photos above depict the preferred glass sample on a south facing classroom window in direct sunlight.

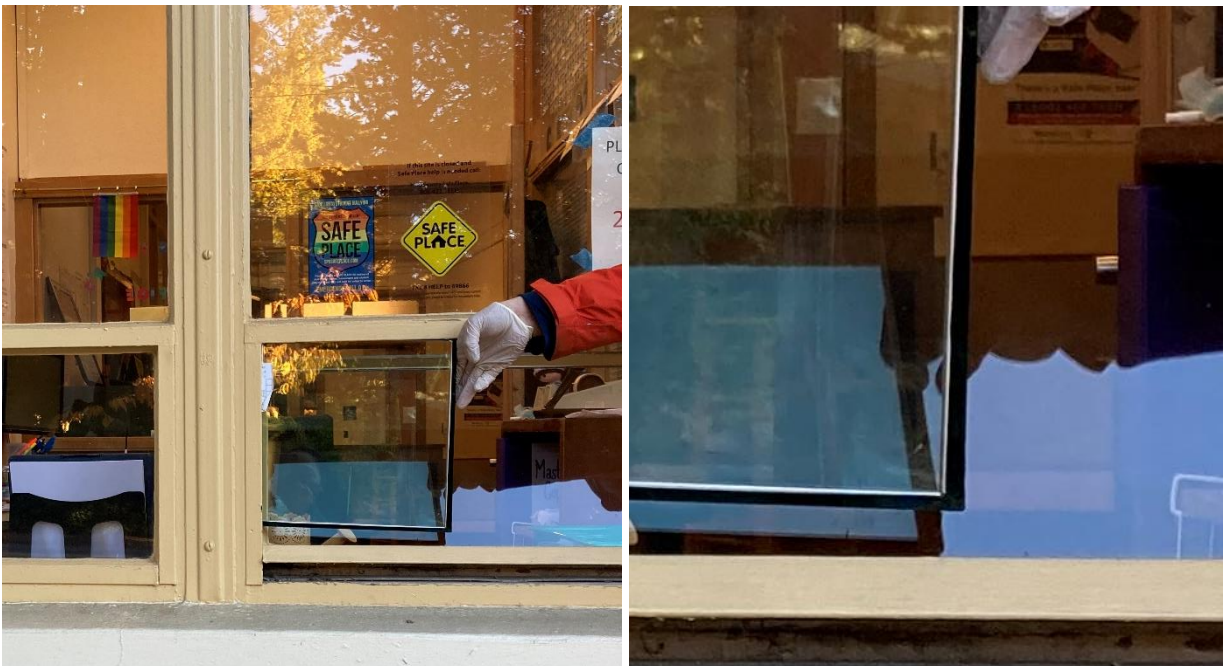
The photos above depict the preferred glass sample on a north facing office window in the shade.

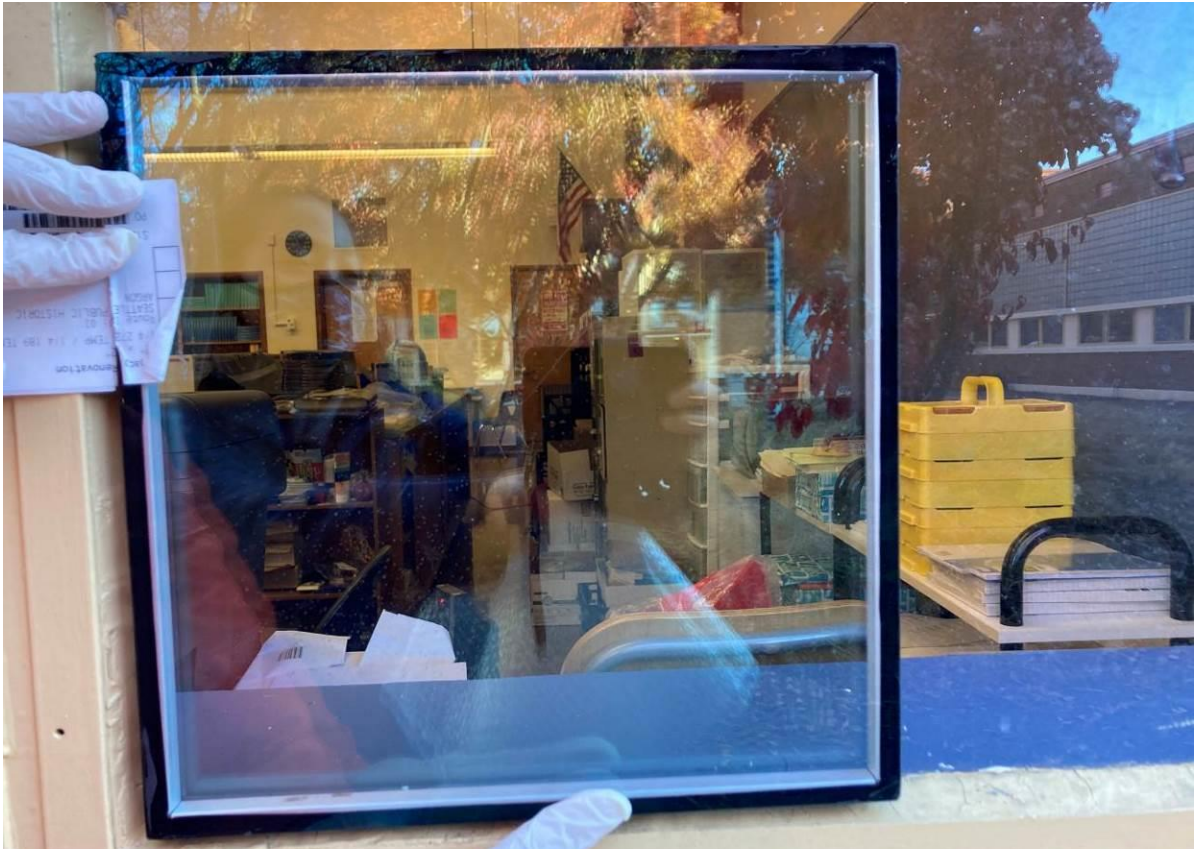
The photos above depict the preferred glass sample on a north facing classroom window in the shade.

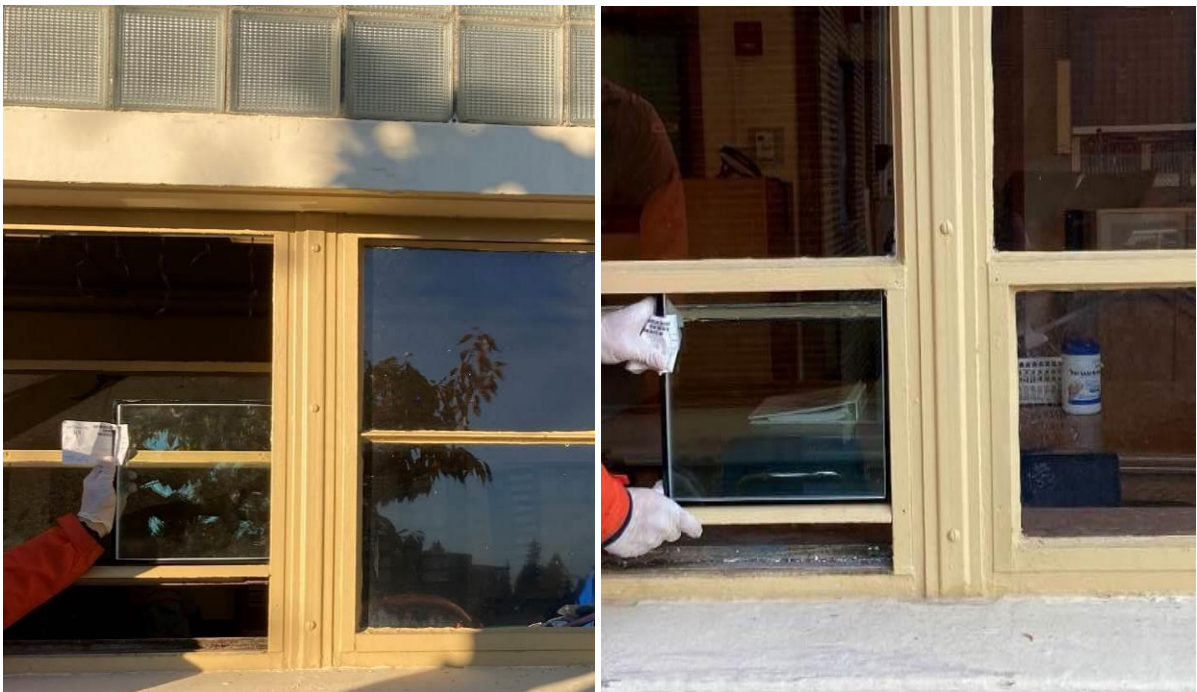
The photos above depict the preferred glass sample placed inside the frame of open operable window. The photo on the left is a classroom window in partial sun/shade. The photo on the right is a shop window in the shade.
