Nathan Eckstein Middle School Window Replacement

Landmark Preservation Board
Marc A. Tegen, Project Manager

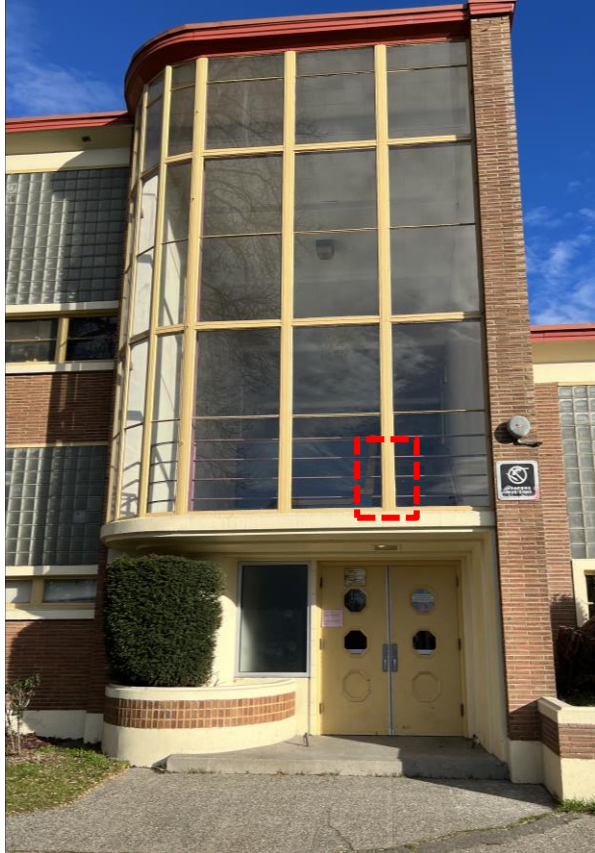
Fixed windows at stairwells

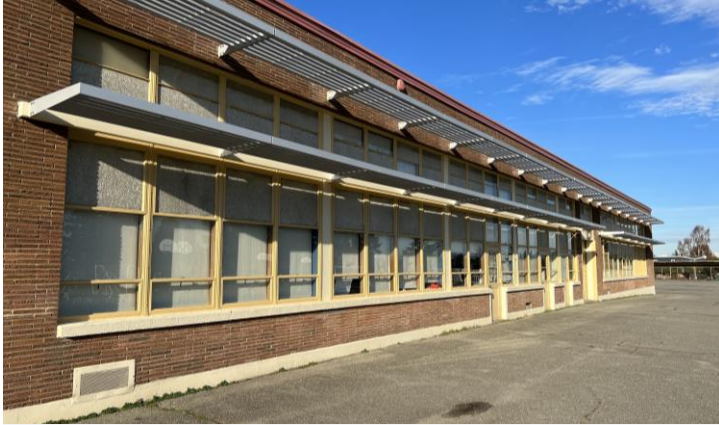
Shop windows and doors

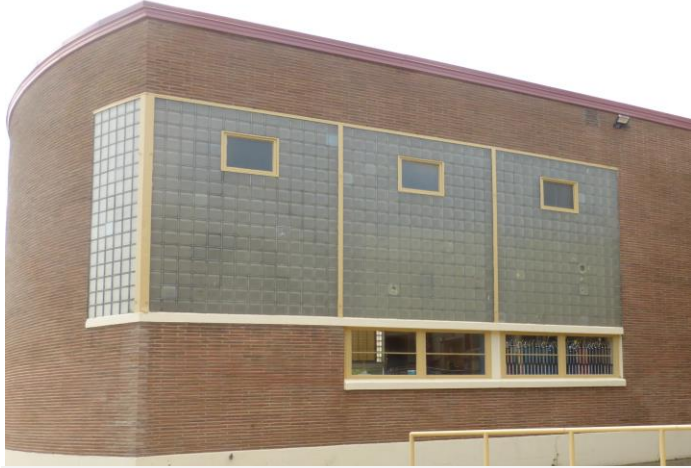
Fixed windows in glass block walls

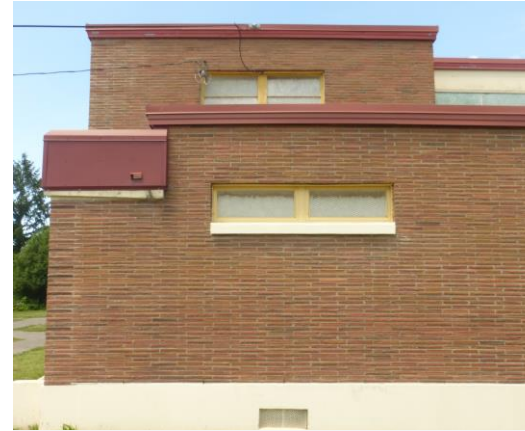
Narrow fixed windows
