## OVERVIEW

The stone paving in the Plaza in front of SAAM has deteriorated significantly within the primary vehicle drive areas. Seattle Department of Parks and Recreation is investigating repair alternatives and is seeking input from the Architectural Review Committee on the method of repairs.

## VOLUNTEER PARK DRIVE PLAZA PAVING

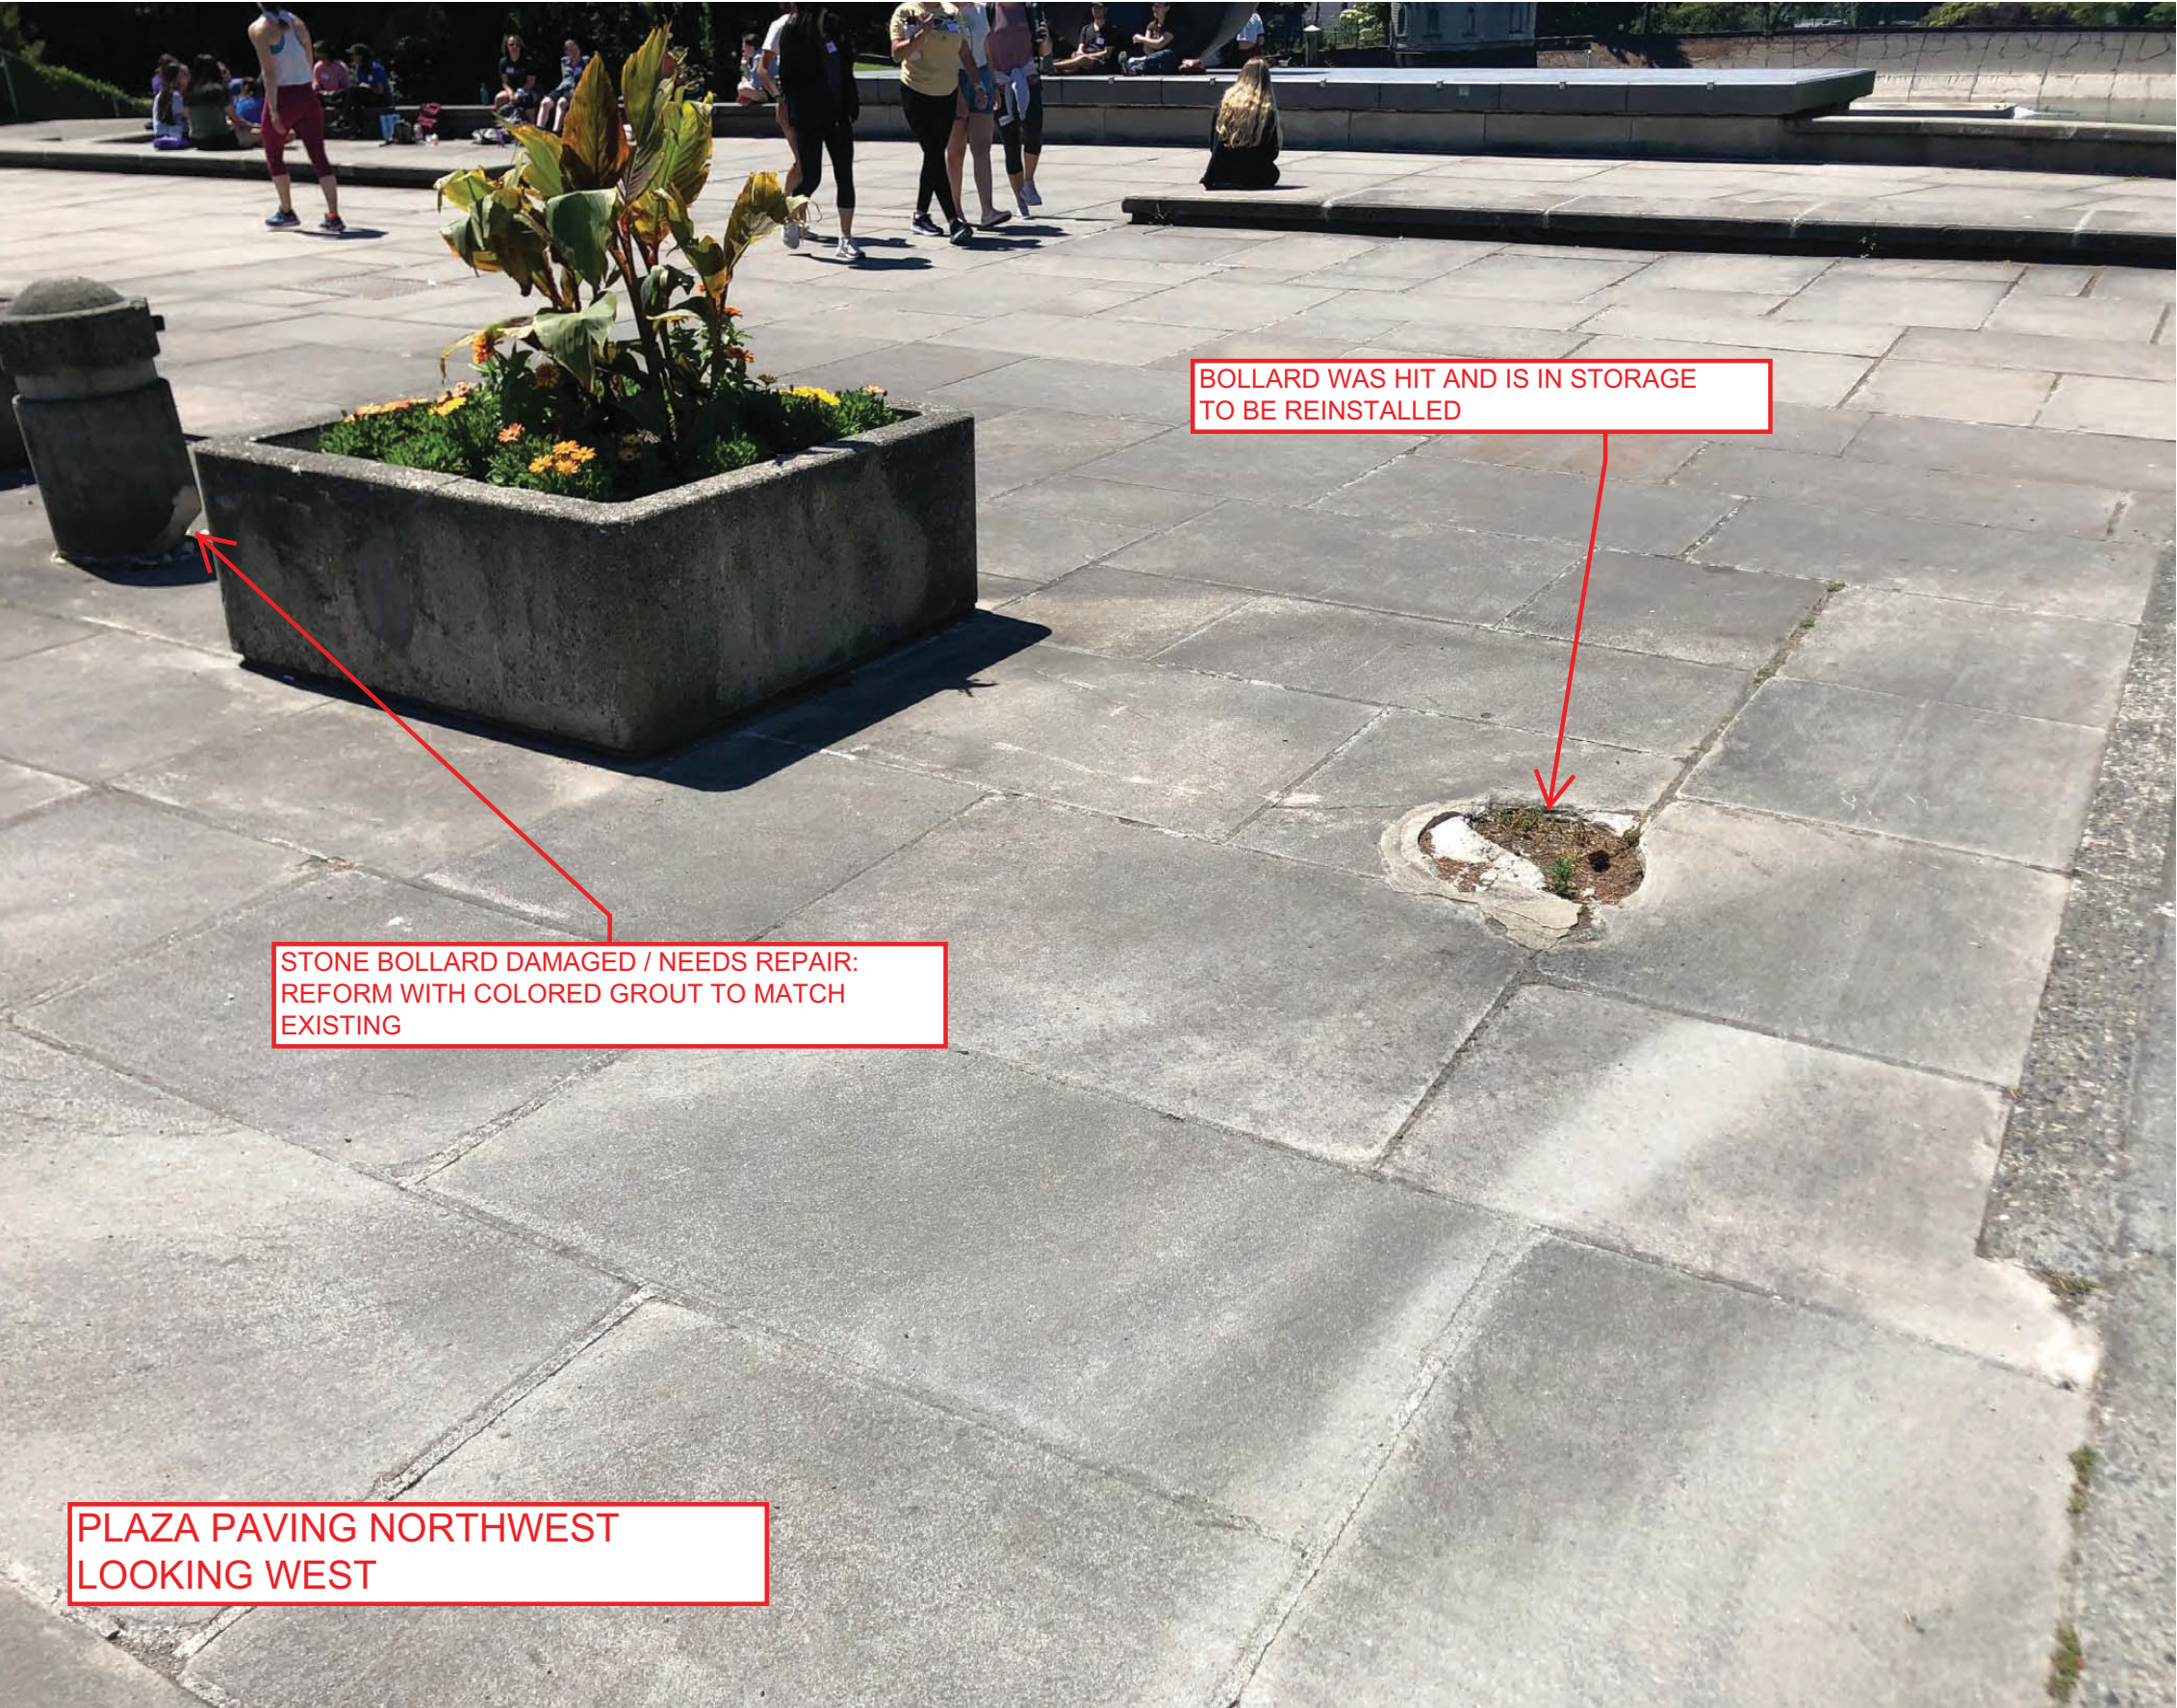
Red: stone needing replacement: 410 sf

Dark Blue: concrete needing replacement: 150sf

Light Blue: other concrete infills with no cracks: 80sf

## Notes Regarding Potential Repairs:

1) Pioneer Masonry, the contractor who recently completed repairs to the SAAM pedestrian paving indicated that the repairs to cracked stones, as implemented in the pedestrian paving areas, are not feasible within the vehicle drive areas. They advised that full replacement of damaged stones is the only repair they see as feasible given the high traffic use. They noted that the relatively soft Wilkeson stone, as well as potential matching replacement stone, are not typically recommended for vehicular roadways.

2) SPR is currently seeking pricing and samples from Select Stone in Montana to determine the cost of replacement of the failed stone with new stone. Replacement with concrete may also be explored if stone is infeasible due to costs, and given the poor performance of stone in the vehicle traffic areas.
