# SANDPOINT 18 & 41

## Building Condition Assessment

March 30, 2026

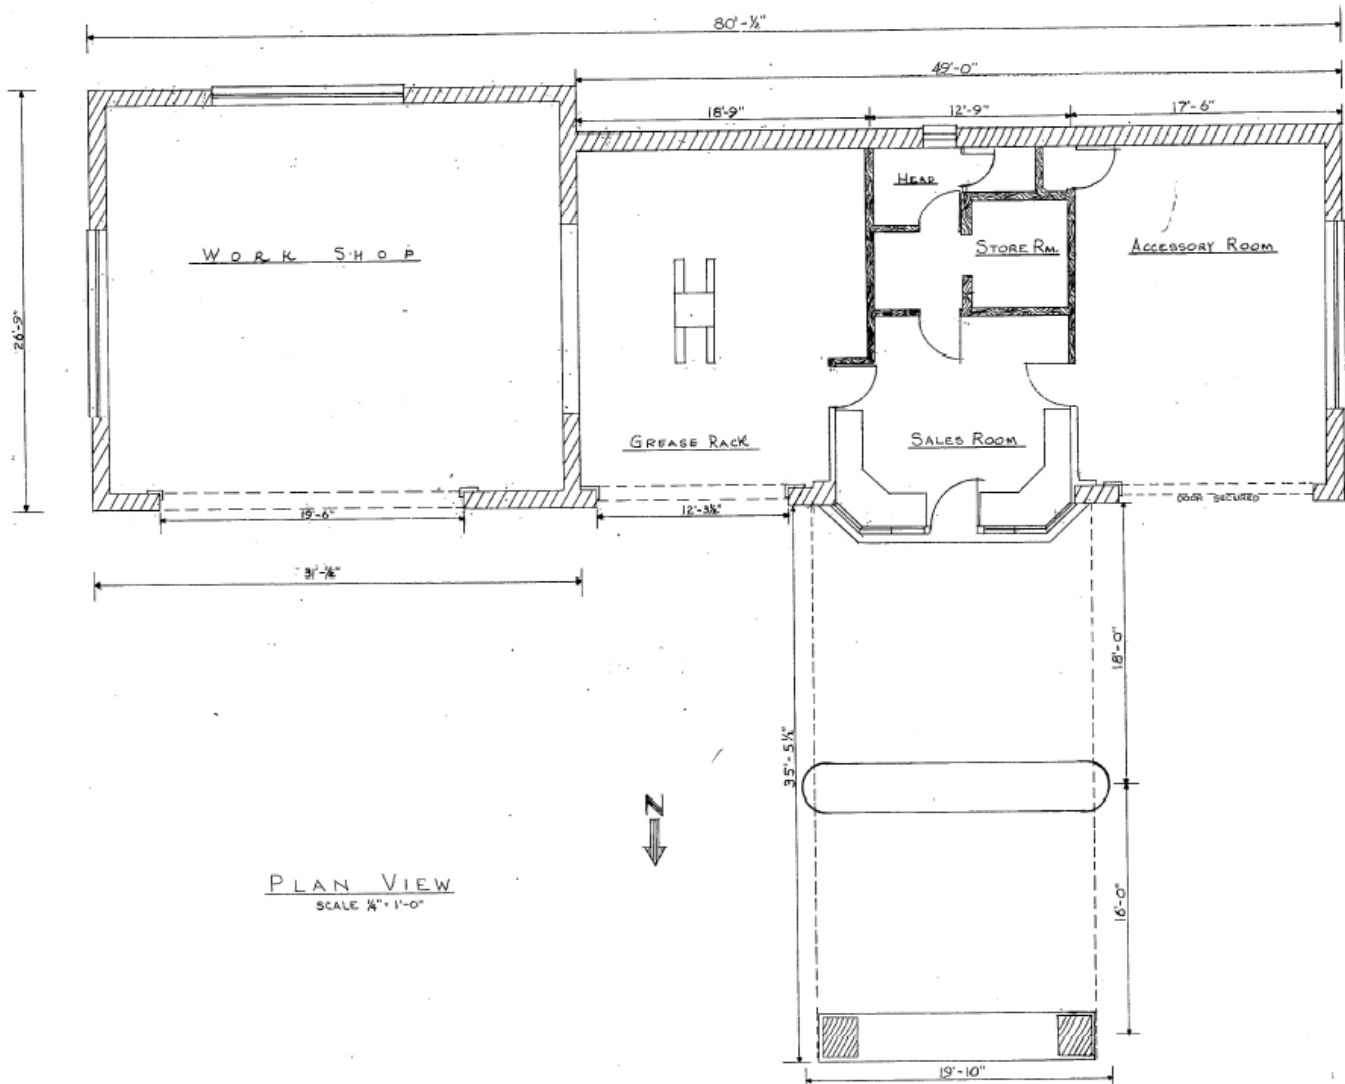
Building 41 was the base Gas Station. It was originally built in 1939 and has had a series of additions. It currently looks like it is in reasonable shape, and has a metal roof in relatively good condition. It has a bay on the west side, now used for storage, the office area, a single bay and a double bay, added at different times. There is an exterior canopy that used to be the gas pump area.

Floor elevation varies between the bays. It also has an exterior covered area, where the gas pumps were originally situated. The building was recently used by the Park's maintenance crews.

The building is basically sound, and appears to be in satisfactory condition. There is a good quality standing seam metal roof, which does not appear to be leaking.

There are miscellaneous "junk" items running on the surface of the building which should be removed, and the holes restored. Windows are all single-pane and should be replaced with similar insulated units. All the exterior wood on the building requires cleaning and painting. The Brick veneer looks to be in good condition and should be cleaned, pointed and sealed.
