Fairview Avenue N Bridge Replacement Project

Appendix B

Cultural Resources Discipline Report (Redacted Version)

Fairview Avenue North Bridge

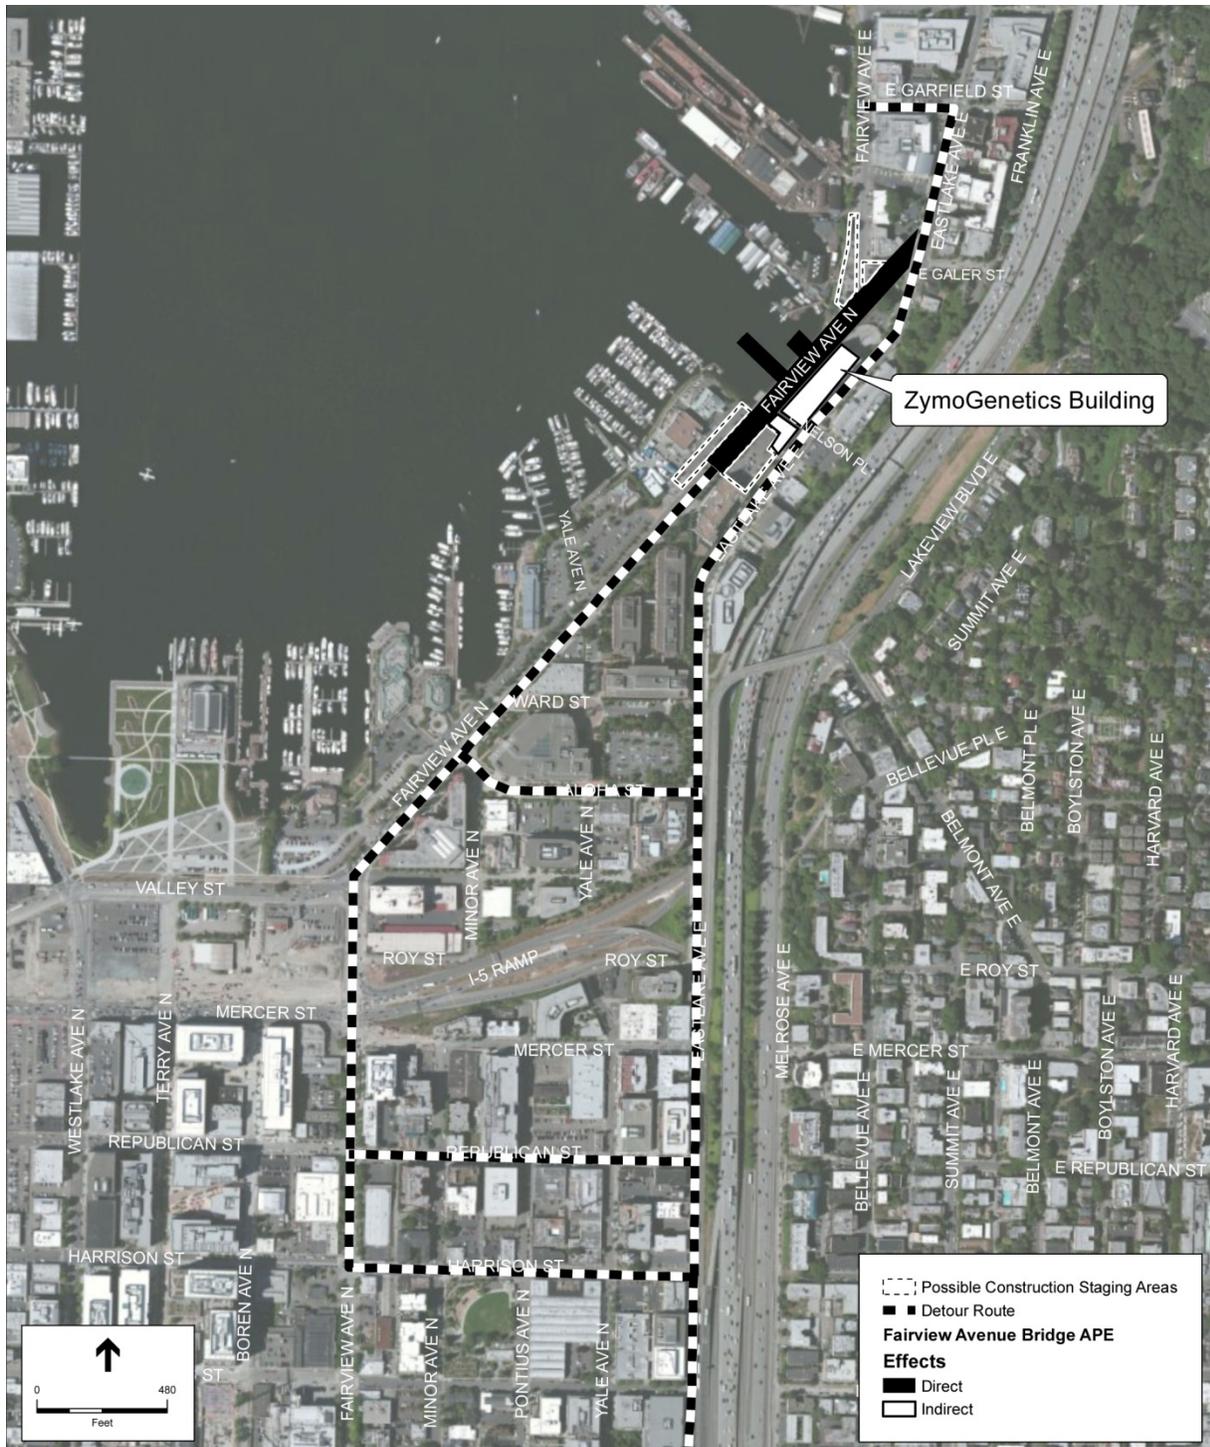
Figure 2. Fairview Avenue Bridge APE, possible staging areas, and detour route.

The location for construction staging has not been finalized. Several paved areas adjacent to the bridge approaches have been identified as possible staging areas (Figure 2).

The Area of Potential Effect (APE) includes direct effects related to construction and indirect effects to two historic buildings immediately adjacent to the bridge. The APE for direct effects is the footprint of the bridge replacement including the bridge approaches, the location of the abandoned pier, and construction staging areas (Figures 1 and 2). The depth of disturbance for bridge piling drill shafts is up to 120 feet; the depth of disturbance for the bridge approaches and utilities is up to 12 feet. The location for construction staging has not been finalized. Several paved areas adjacent to the bridge have been identified as possible staging areas. Four potential staging areas are currently included in the APE though not all are expected to be utilized. The APE for indirect effects includes the Lake Union Steam Plant Building (Zymogenetics) and the Washington Laundry Building. Indirect effects are expected to include noise and vibration during bridge construction.

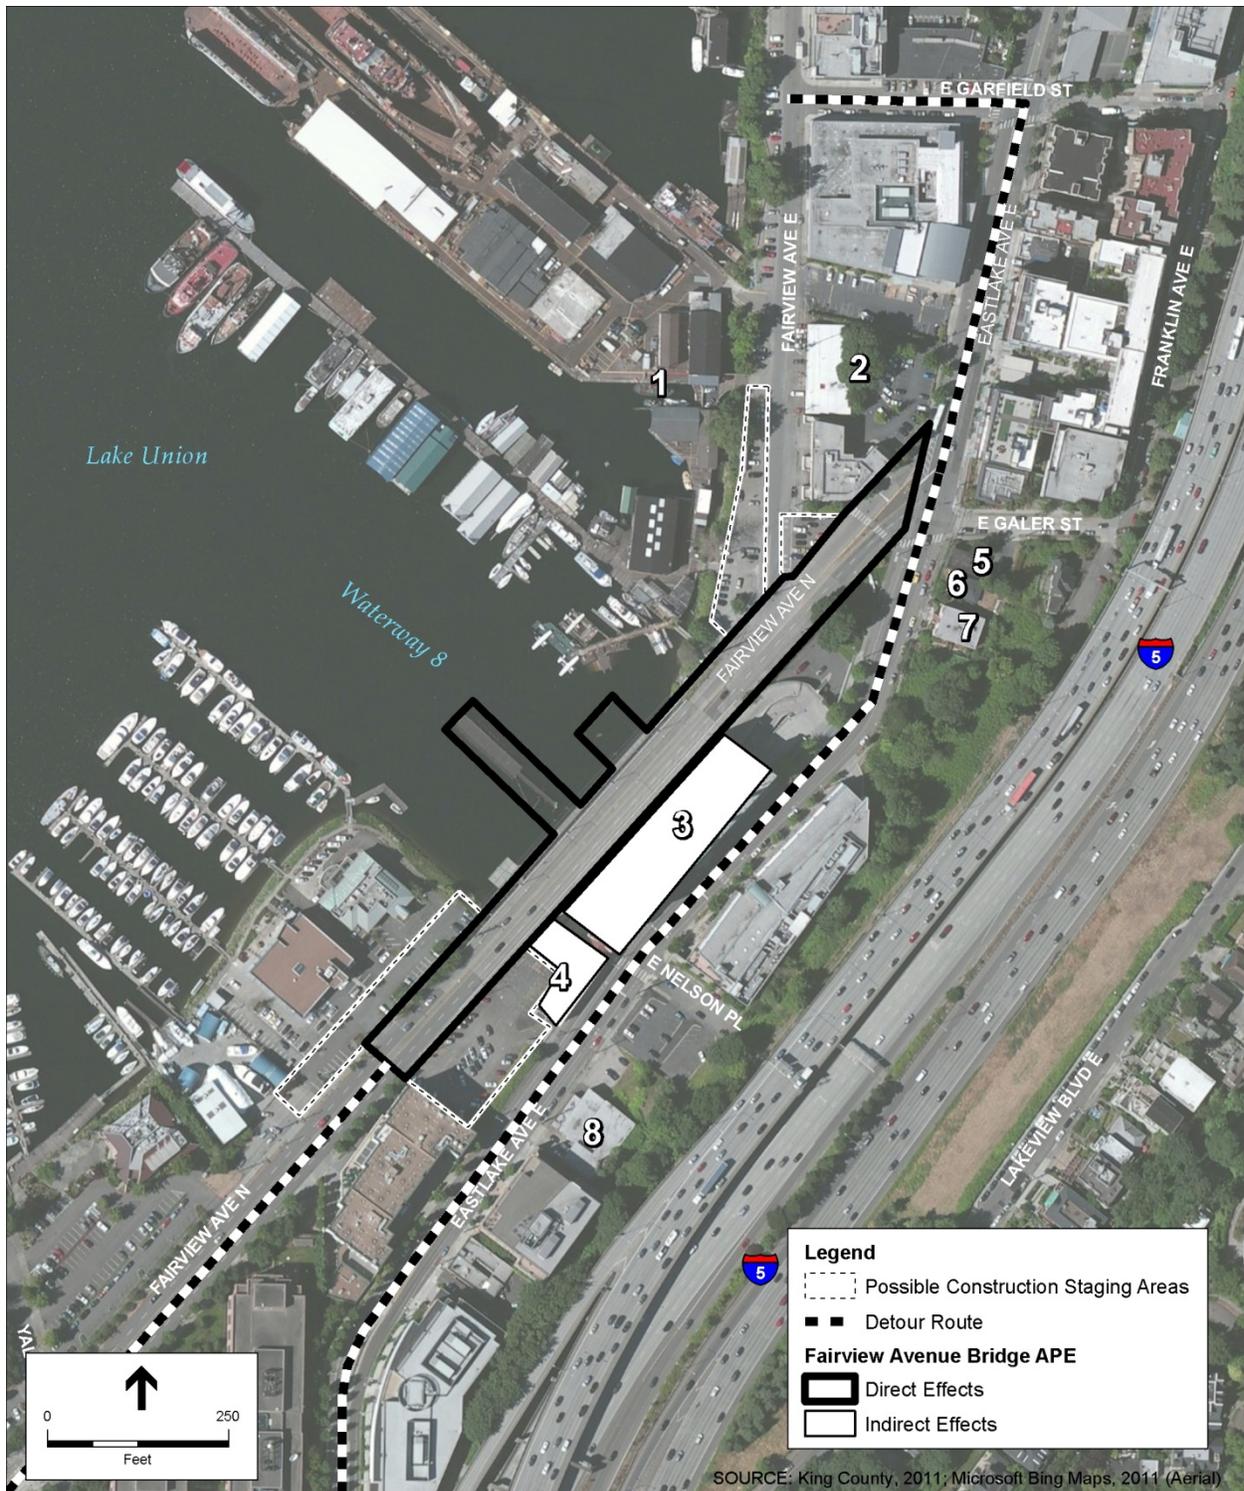
Figure 3. Recorded Historic Properties in Immediate Vicinity of APE. Numbers refer to properties listed in Table 5.

Eight structures built 1909-1963 were inventoried at the reconnaissance level as part of the historic property survey (Table 5, Figure 3). Photographs of the buildings were taken from the public right-of-way and HPIs were prepared (Appendix B).

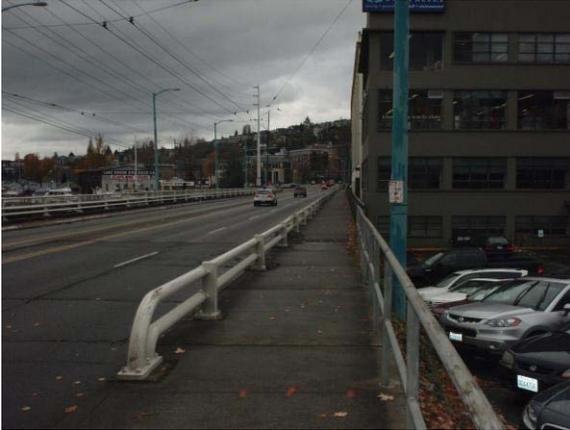
Photo 1. The wider-gauge traffic guardrail on the west side of the sidewalk is from the 1988 improvements. This southernmost portion of the handrail on the east side of the sidewalk is also part of the 1988 improvements. View to the north, showing the two northbound lanes of the East Bridge and raised sidewalk.
2011

In 1962-1963 the existing eastern wooden piling bridge was removed and the current concrete piling bridge was built in its place (Photos 7, 8). Engineering plans for the 1963 East Bridge were drawn by W. T. Robertson with Carl M. West as supervising bridge engineer. During construction, the wooden handrails on the east side of the sidewalk were replaced with a metal handrail along the length of the bridge, but not at the approaches. The handrails at the approaches were eventually replaced in 1988 with the current steel pipe handrails (Photos 1, 3). The current metal traffic guardrail was also installed in 1988, replacing the wooden traffic curb along the west side of the sidewalk (Photo 1). In 1993-1995 the East Bridge underwent seismic retrofitting.

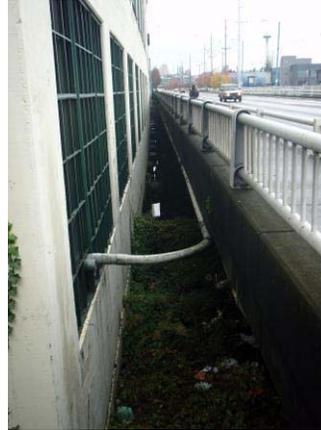
Photo 2. Note the reflection on the water below and pipes leading from the Steam Plant. The sidewalk handrail seen here is from the 1963 design and is based on Standard Bridge Railing Type 3-A. View to the south, showing the proximity to the Steam Plant.
2011

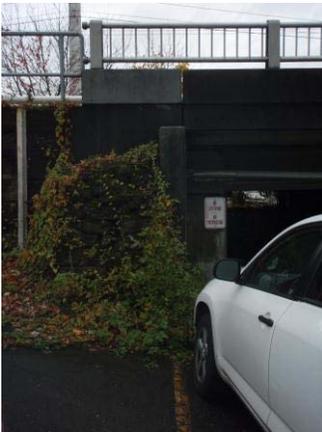
Photo 3. The southern portion (left frame) dates to the 1988 improvements, while the northern portion (right frame) dates to the 1963 design. View to the west, showing the east sidewalk railing of the East Bridge.
2011

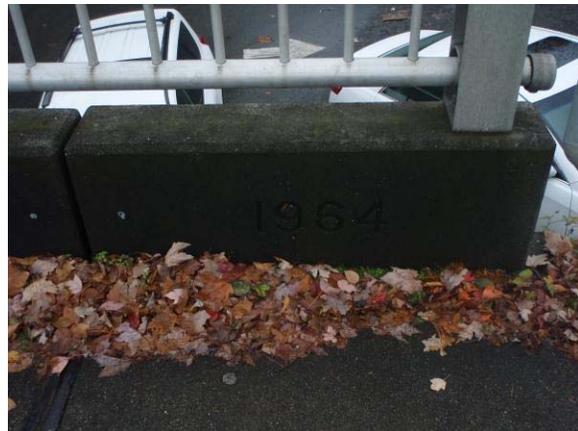
Photo 4. Detail of date inscription (1964) on south end of sidewalk (east side); this sidewalk handrail style is part of the 1963 design and is based on Standard Bridge Railing Type 3-A. View to the east from sidewalk.
2011

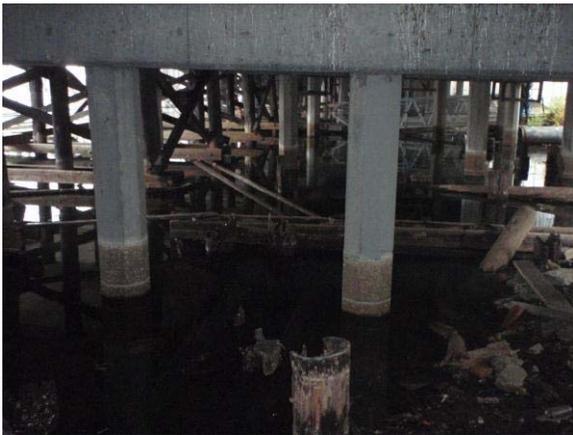
Photo 5. The concrete supports from the 1963 bridge and sawed timber piles from the previous (c. 1917) bridge. View to the north under the East Bridge.

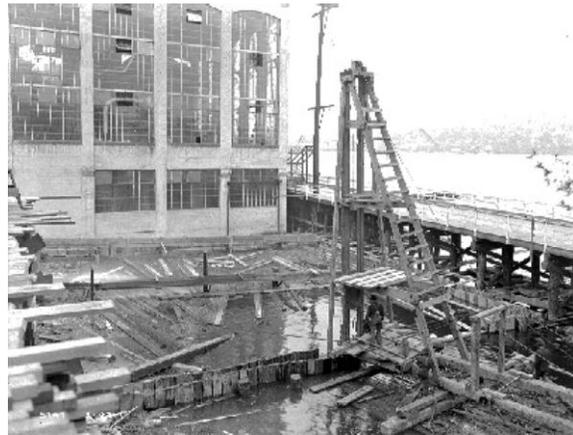
Photo 6. This shows the pilings and cross-beam supports for the original East Bridge (Seattle Municipal Archives Photograph No. 1364).

View to the southwest during expansion of the Steam Plant. 1917

By 1923 two wooden piling trestle bridges were located along Fairview Avenue North, built in parallel with a 3' wide gap between (Photo 6). Engineering plans improvements to the 1924 West Bridge were drawn by W. S. Joseph of the Seattle Engineering Department and show the addition of planking on the approaches and resurfacing with asphalt concrete. In 1948 the West Bridge was improved upon again, however these improvements essentially resulted in the removal and rebuilding of many of the bridge's defining elements. The improved 1948 bridge was also a timber trestle design with supports consisting of five pilings and cross-braces per bent (Photos 7-9). Plans for the 1948 improvements were drawn by "H.T.D." who is assumed to have been a staff engineer with the City of Seattle. Later improvements to the West Bridge include replacement of the handrail/bicycle rail in 1988 and seismic retrofitting in 1993-1995. The original wooden guardrails were removed from the western (Lake Union) side and replaced by the current pipe railings.

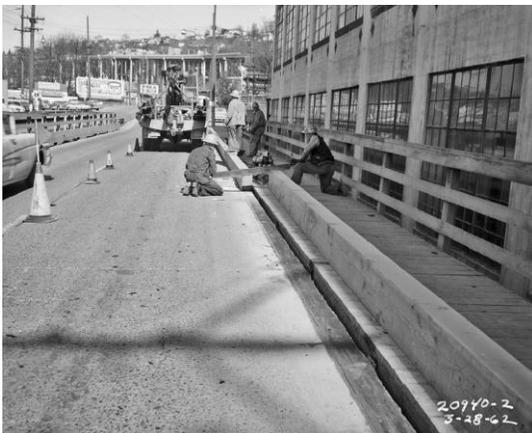
Photo 7. The wooden handrail and traffic curb date to the earlier (c.1917) bridge at this location. This handrail was replaced in 1963 except at the approaches. The traffic curb was replaced in 1988 (Seattle Municipal Archives Photograph No. 70915).

View to the north of the East Bridge sidewalk and traffic curb in 1962 during construction.

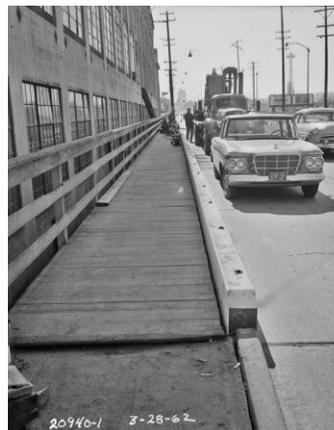
Photo 8. The wooden handrail and traffic curb date to the earlier (c.1917) bridge at this location. This handrail was replaced in 1963 except at the approaches. The traffic curb was replaced in 1988 (Seattle Municipal Archives Photograph No. 70916).

View to the south of the East Bridge sidewalk in 1962 during construction.

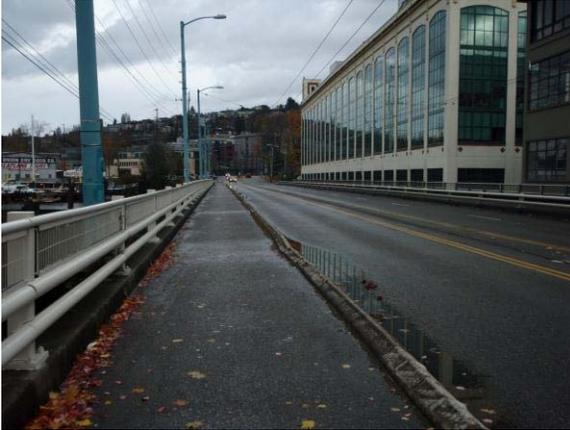
Photo 1. Building on the far right is the Lake Union Steam Plant. Railing on the left is from the 1988 improvements. View to the north, showing the pedestrian/bicycle lane and single vehicle lane of the West Bridge (left) and double vehicle lanes of the East Bridge (right).
2011

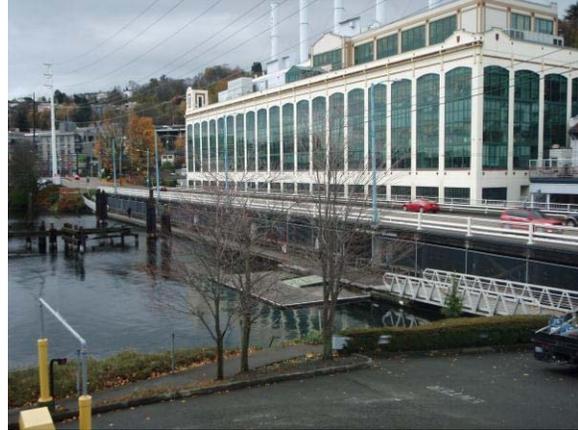
Photo 2. Note the West Bridge's timber piling supports behind the chain-link fence. View to the north, showing the bridge in relationship to Lake Union.
2011

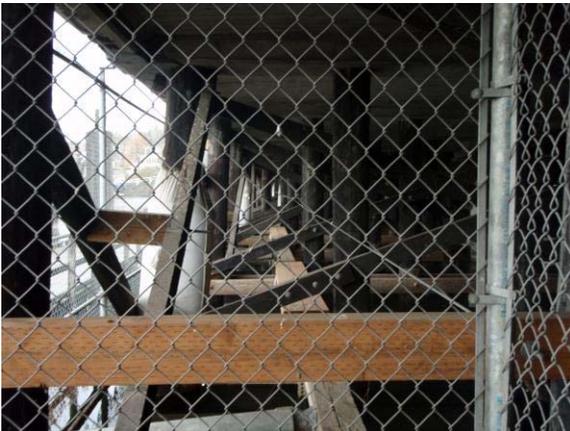
Photo 3. View to the north, showing the cross beams and timber piling supports of the West Bridge.
2011

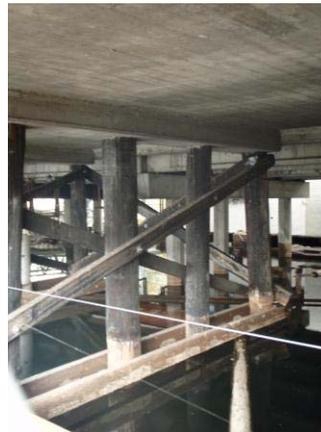
Photo 4. Note the timber pilings and cross-bracing; concrete piling bents for the East Bridge are visible in the background. View to the east showing a typical bent of the West Bridge.
2011

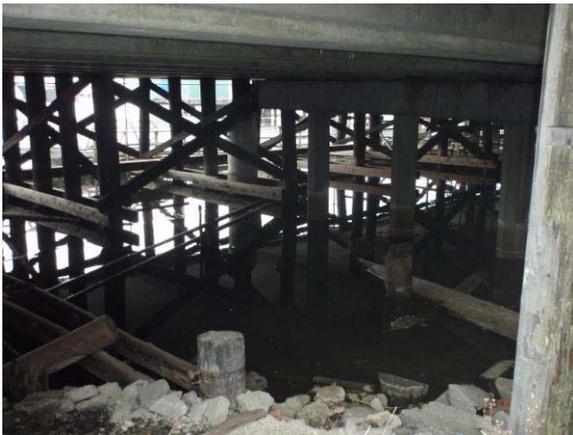
Photo 5. View to the north showing the timber piling supports for the West Bridge; a concrete support for the East Bridge is visible in the foreground.
2011

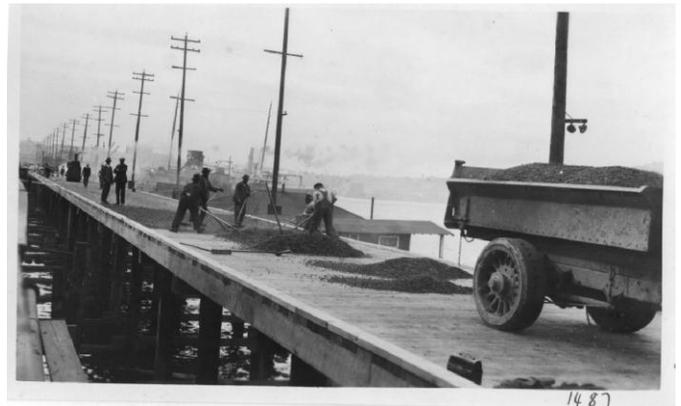
Photo 6. Note the original timber trestle supports and the gap between the West and East Bridges (Seattle Municipal Archives Photograph No. 57503).
View to the south showing paving of the original West Bridge in 1924.
1924

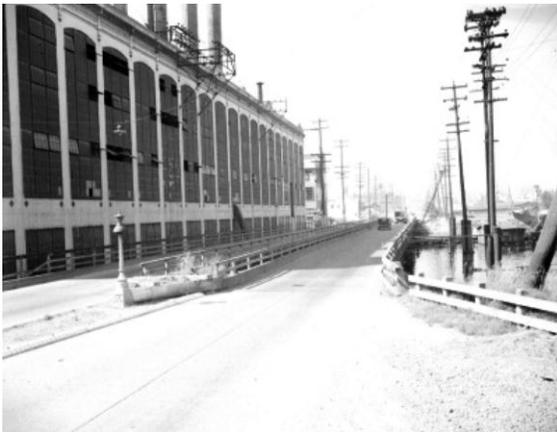
Photo 7. Note original wooden guardrails.
View to the south of the East and West Fairview Avenue Bridges (Seattle Municipal Archives Photograph No. 41303).
1948

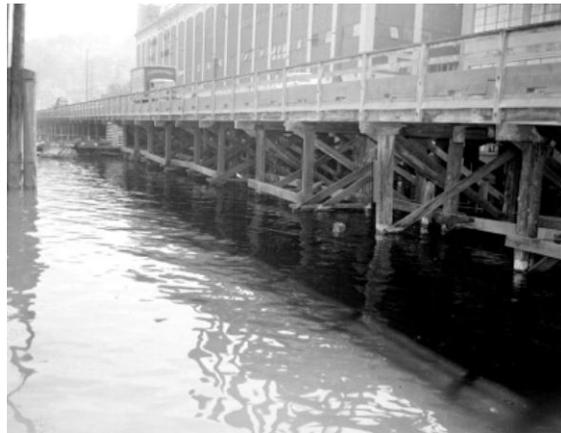
Photo 8. View to the north; note original wooden guardrail and timber supports (Seattle Municipal Archives Photograph No. 41304).
1948

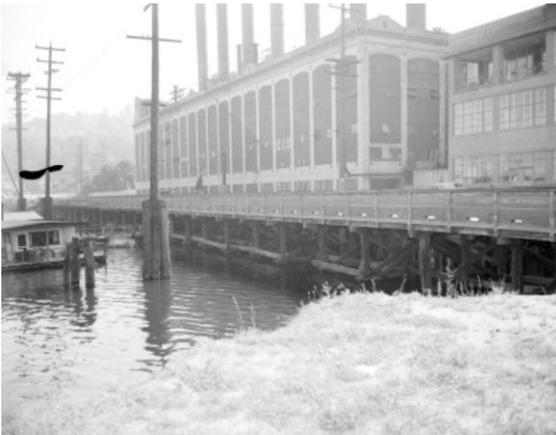
Photo 9. View to the north, note timber supports (Seattle Municipal Archives Photograph No. 41305).
1948

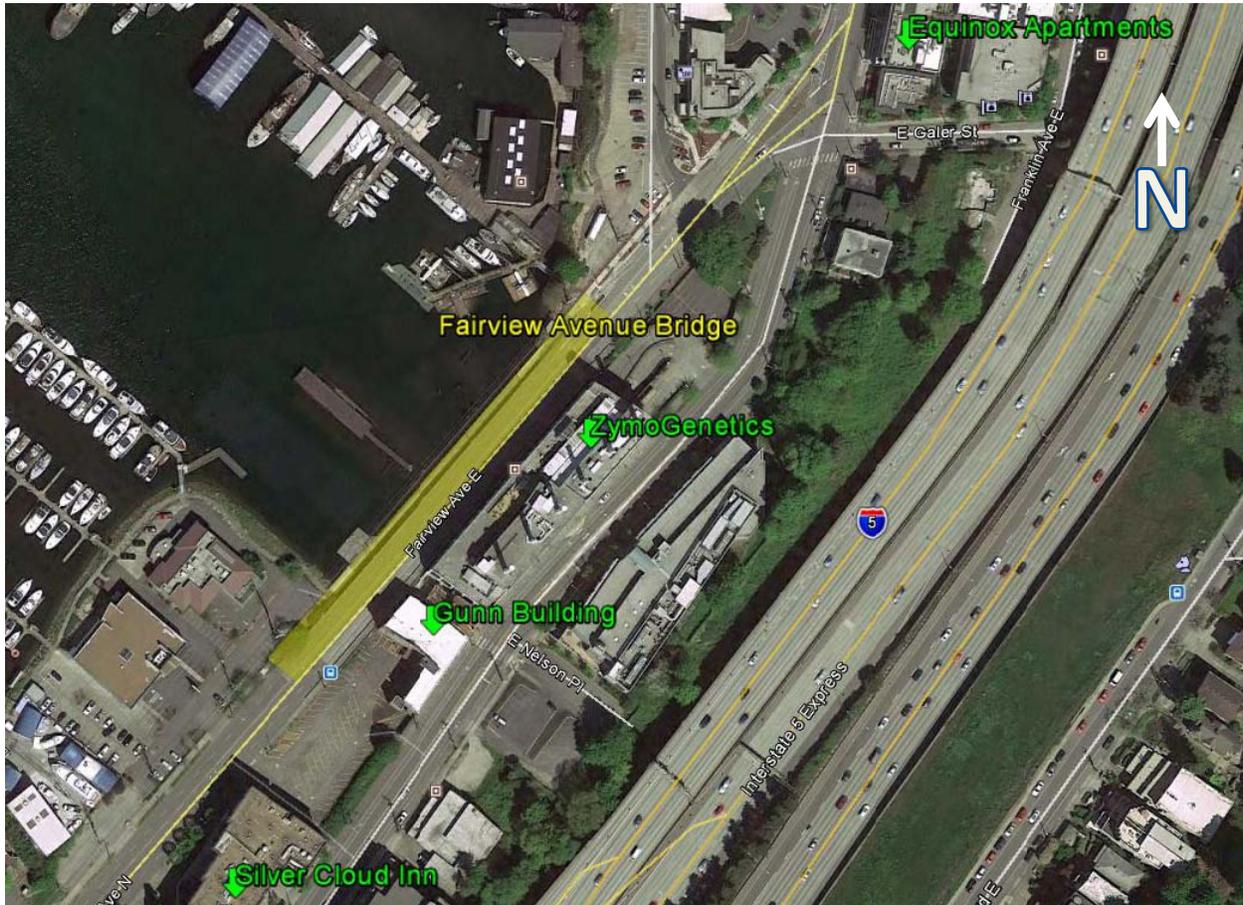
Figure 2 – Representative Noise Sensitive Receivers

Traffic noise levels from the Project are not anticipated to present any impacts to nearby receivers, therefore noise abatement is not required. Construction noise emissions are expected to impact the closest buildings, ZymoGenetics and the Gunn Building (see Figure 2). However, identified noise impacts are moderate and mitigation of these impacts is feasible. Construction sound levels are expected to exceed nighttime City of Seattle Code limits, which would warrant a pursuit of a construction noise variance for nighttime work.

The three representative noise sensitive receivers were identified near the construction area. ZymoGenetics was selected due to its proximity to the Site, elevated level of sensitivity during daytime hours, and sensitivity of testing equipment used in their business. Equinox Apartments and Silver Cloud Inn were selected based on their nighttime noise sensitivity as well as proximity to the construction area. A map of the selected noise sensitive receivers is presented in Figure 2 and Photos 1, 2, and 3.

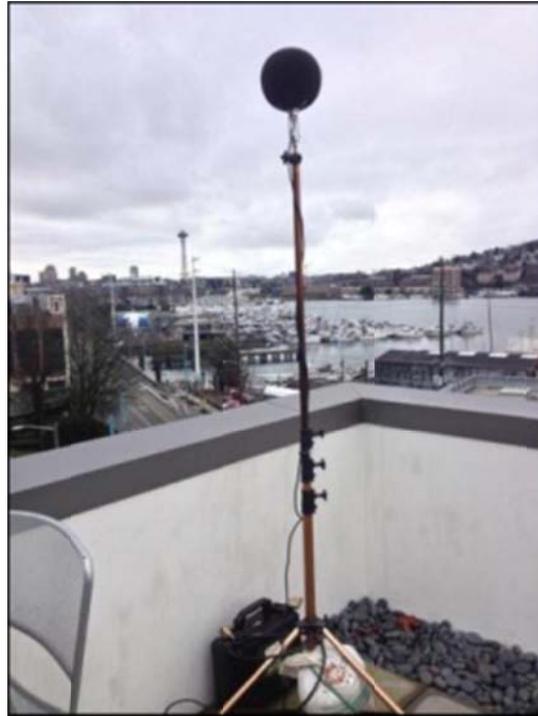
Photo 4 – Typical Ambient Noise Monitoring Station

The following equipment was used during measurements of existing ambient noise and vibration, typical equipment setups are shown in Photos 4 and 5. All equipment was laboratory calibrated within 1 year of the measurement date. Field calibrations were also performed before and verified immediately after the measurements.

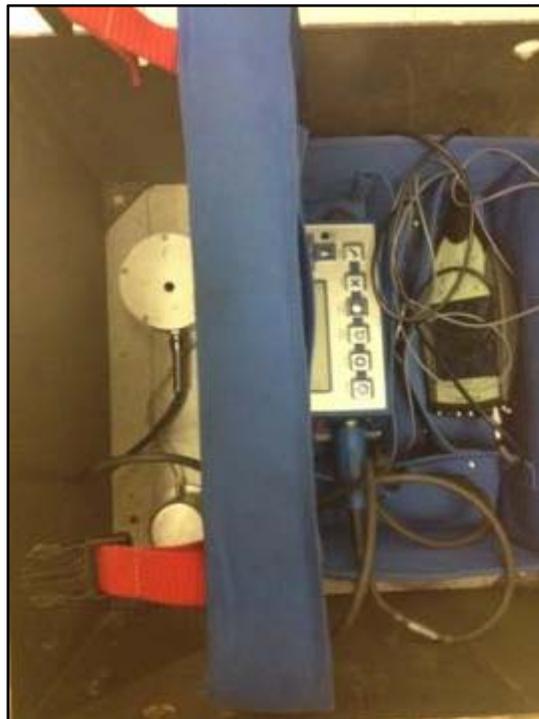
Photo 5 – Typical Ambient Vibration Monitoring Station

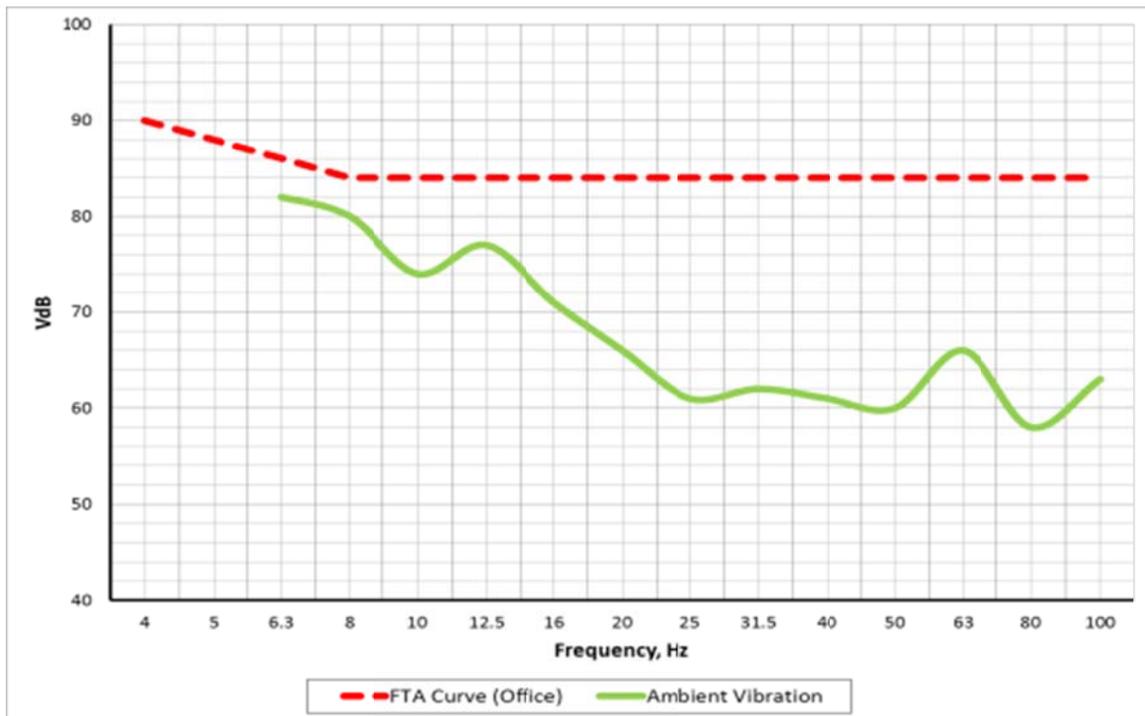
Figure 3 – ZymoGenetics Floor 1

Based on information ZymoGenetics provided the design team, equipment currently installed would fall under the vibration sensitivity classification of VC-A, which is defined with limits of 72 VdB at a frequency of 4 Hz and 66 VdB at 8 Hz and above. Other nearby structures with less sensitive uses, would be assigned less stringent annoyance criteria. Table 15 describes impact assessment criteria throughout ZymoGenetics based on understood vibration sensitivity of each floor. However, it's important to note that existing vibration levels within ZymoGenetics occasionally exceed the proposed impact assessment criteria. Comparisons of these impact criteria and ambient conditions are presented in Figures 3 – 7.

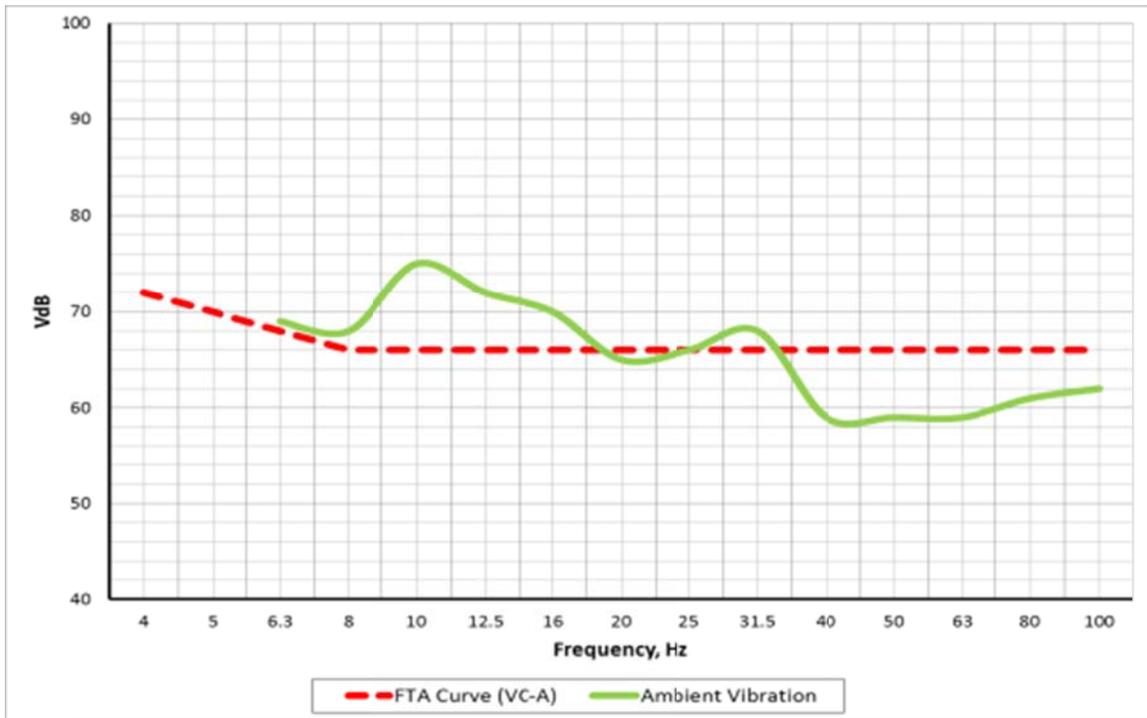
Figure 4 – ZymoGenetics Floor 2

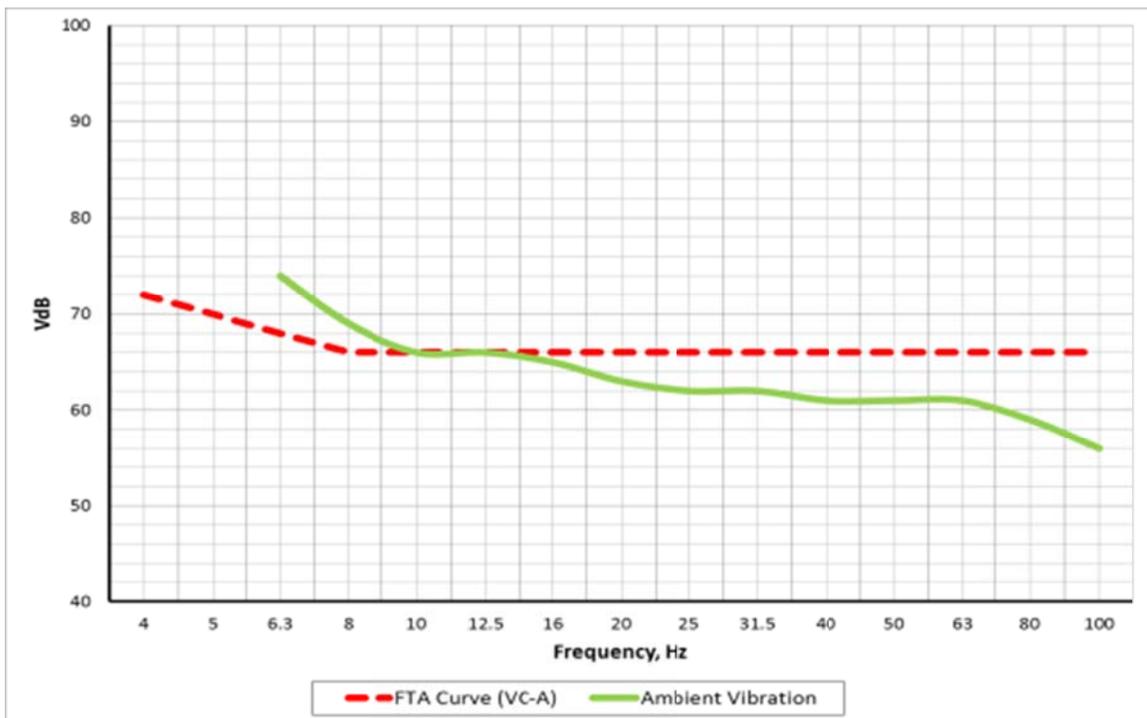
Figure 5 – ZymoGenetics Floor 3

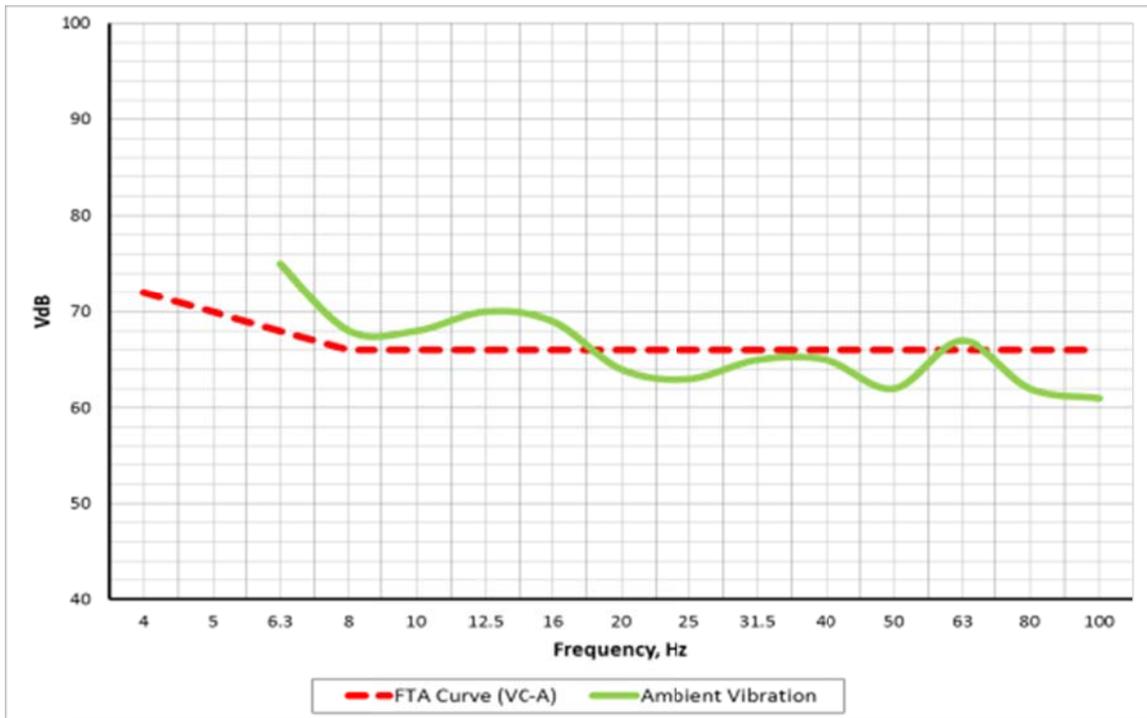
Figure 6 – ZymoGenetics Floor 4

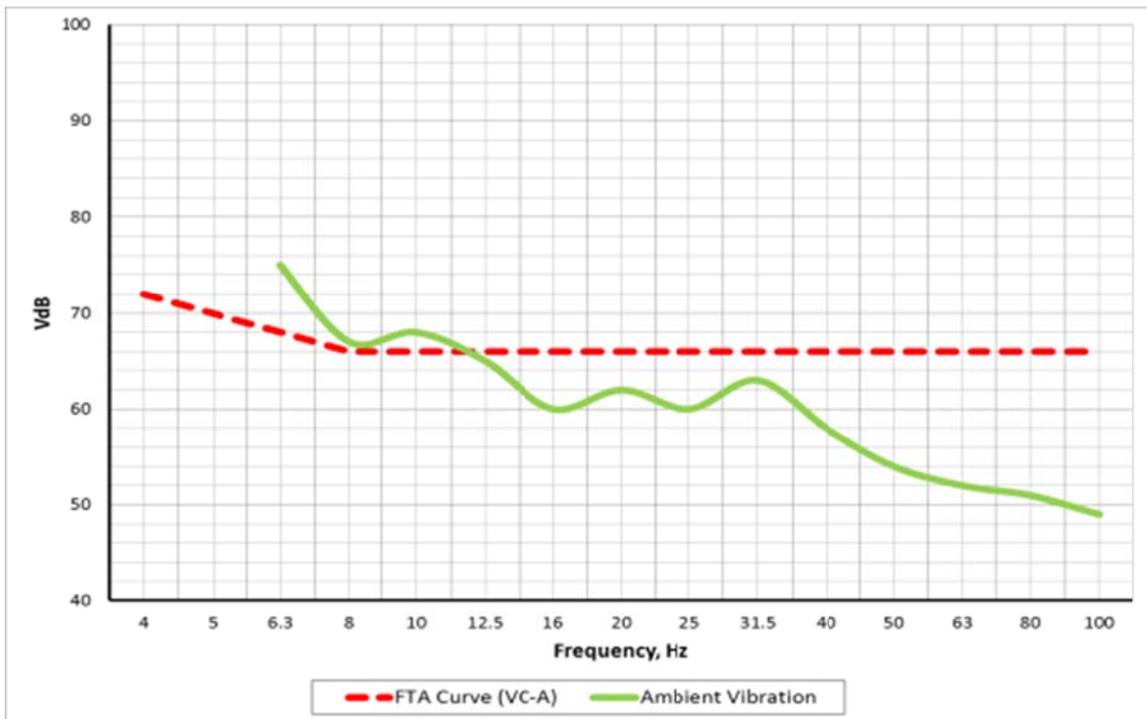
Figure 7 – ZymoGenetics Floor 5

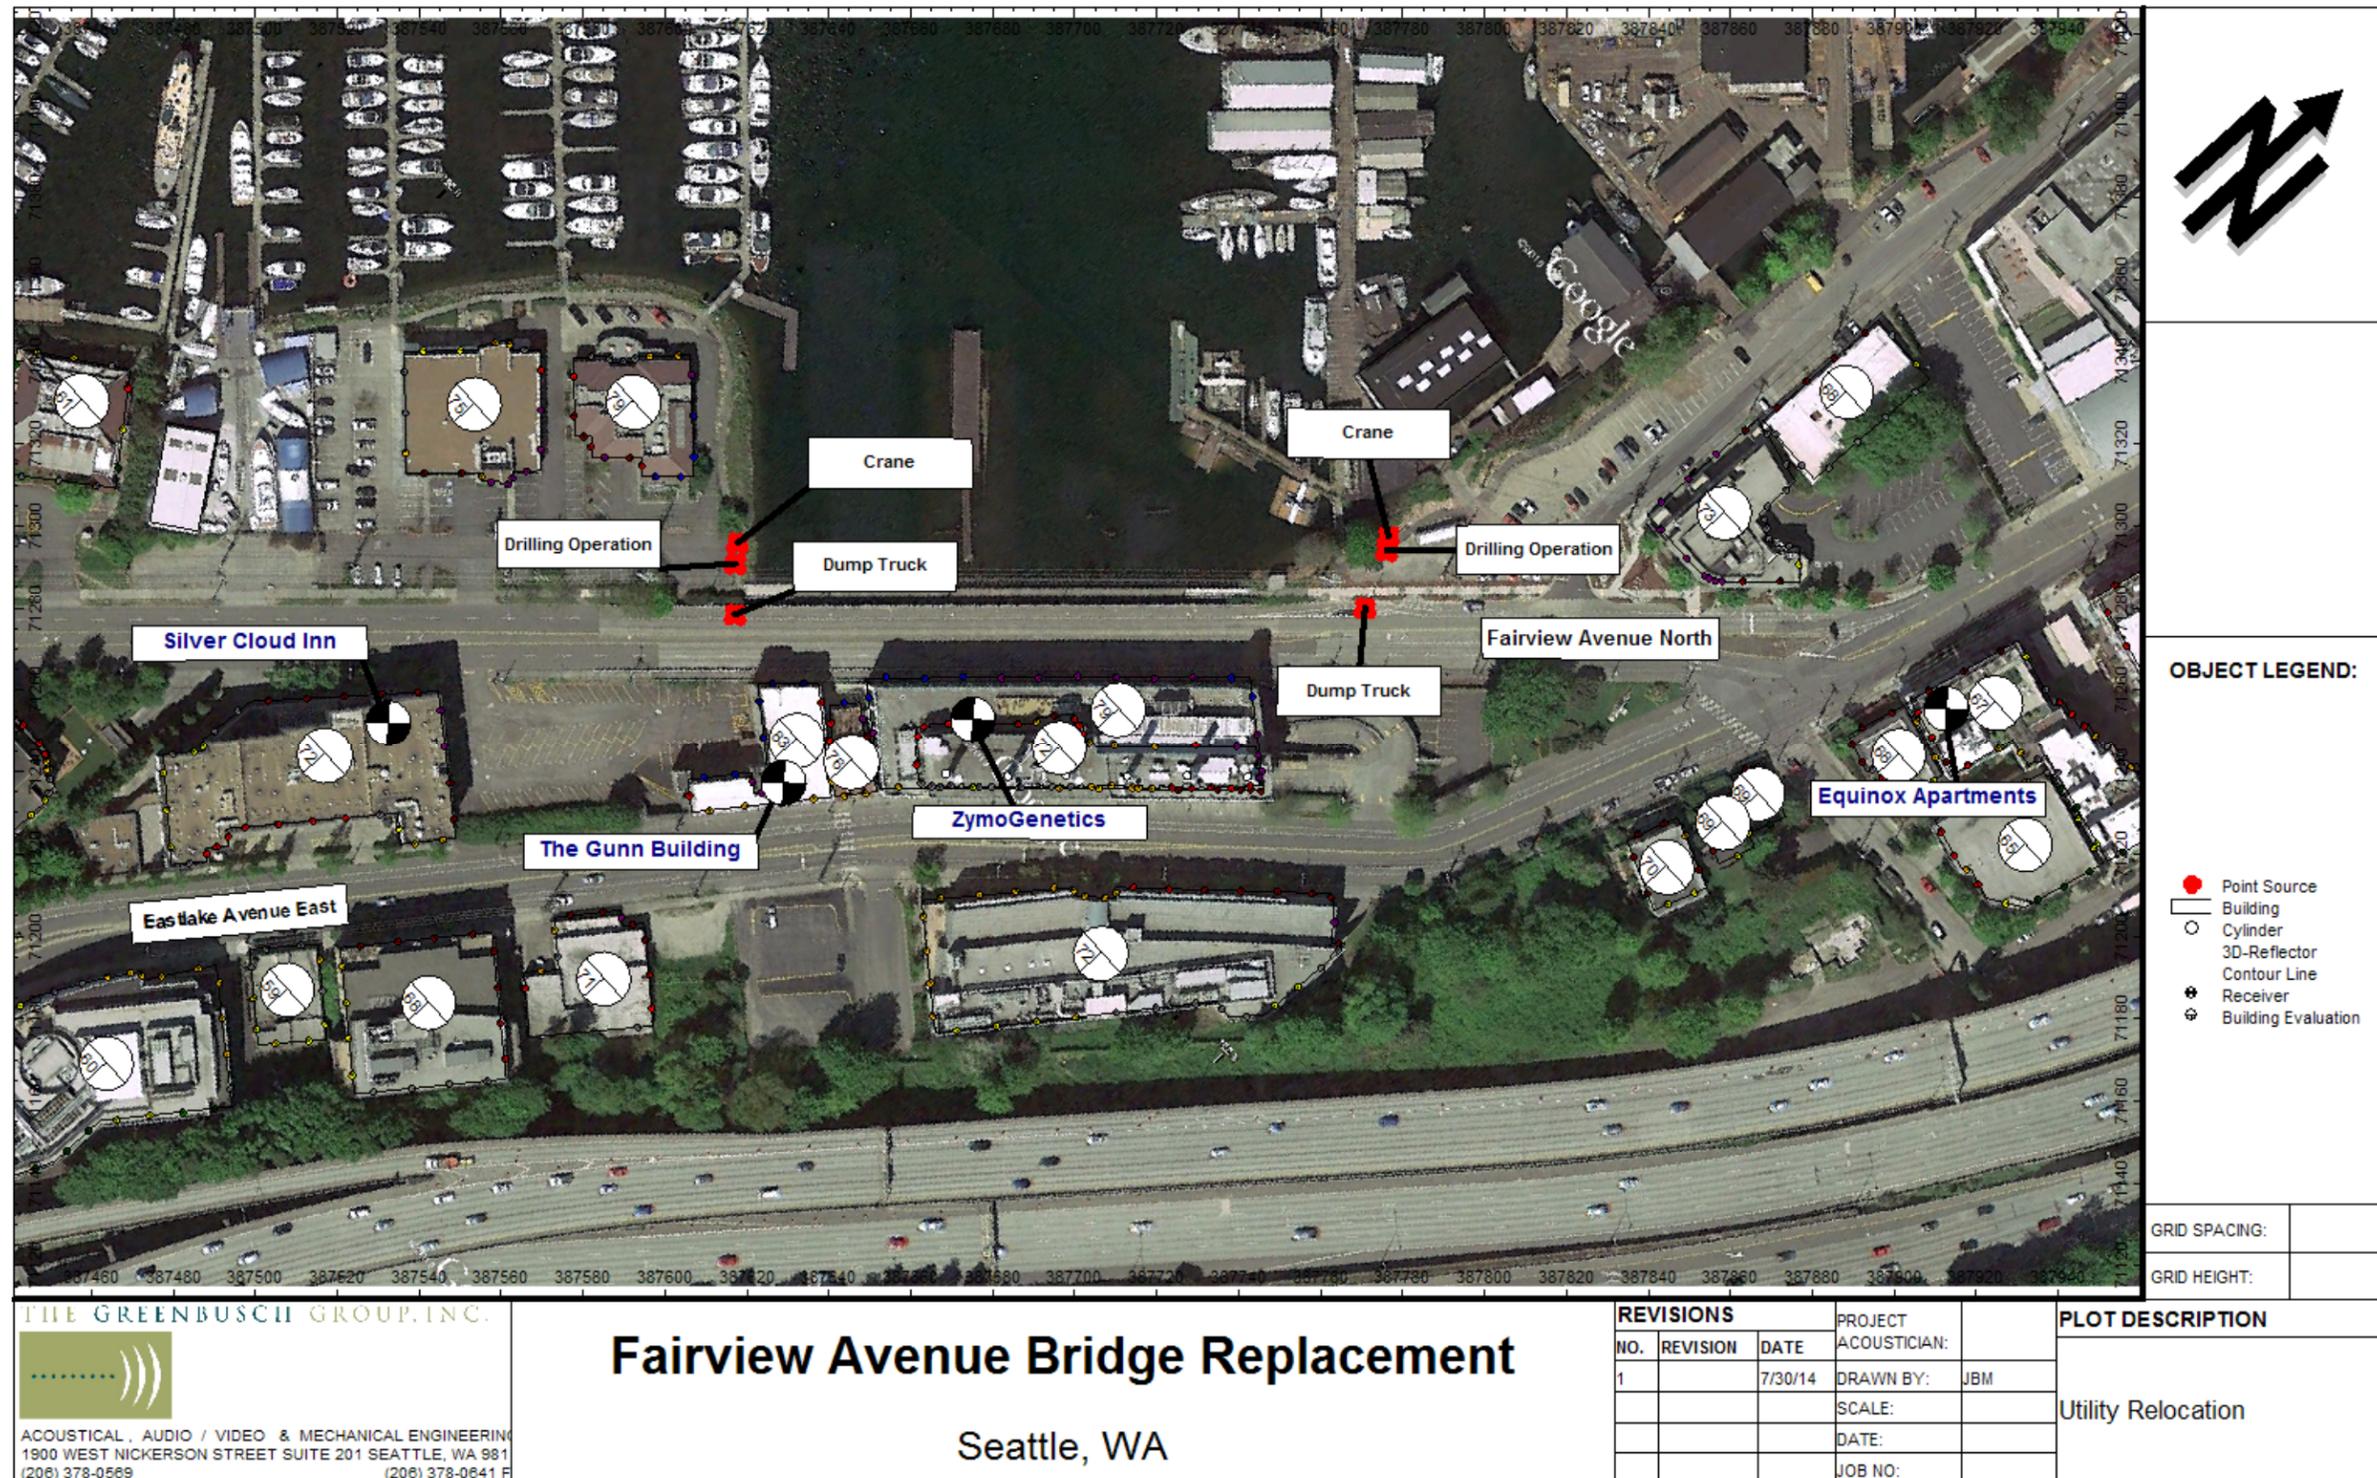
Figure A-1 Utility Relocation Construction Noise Model

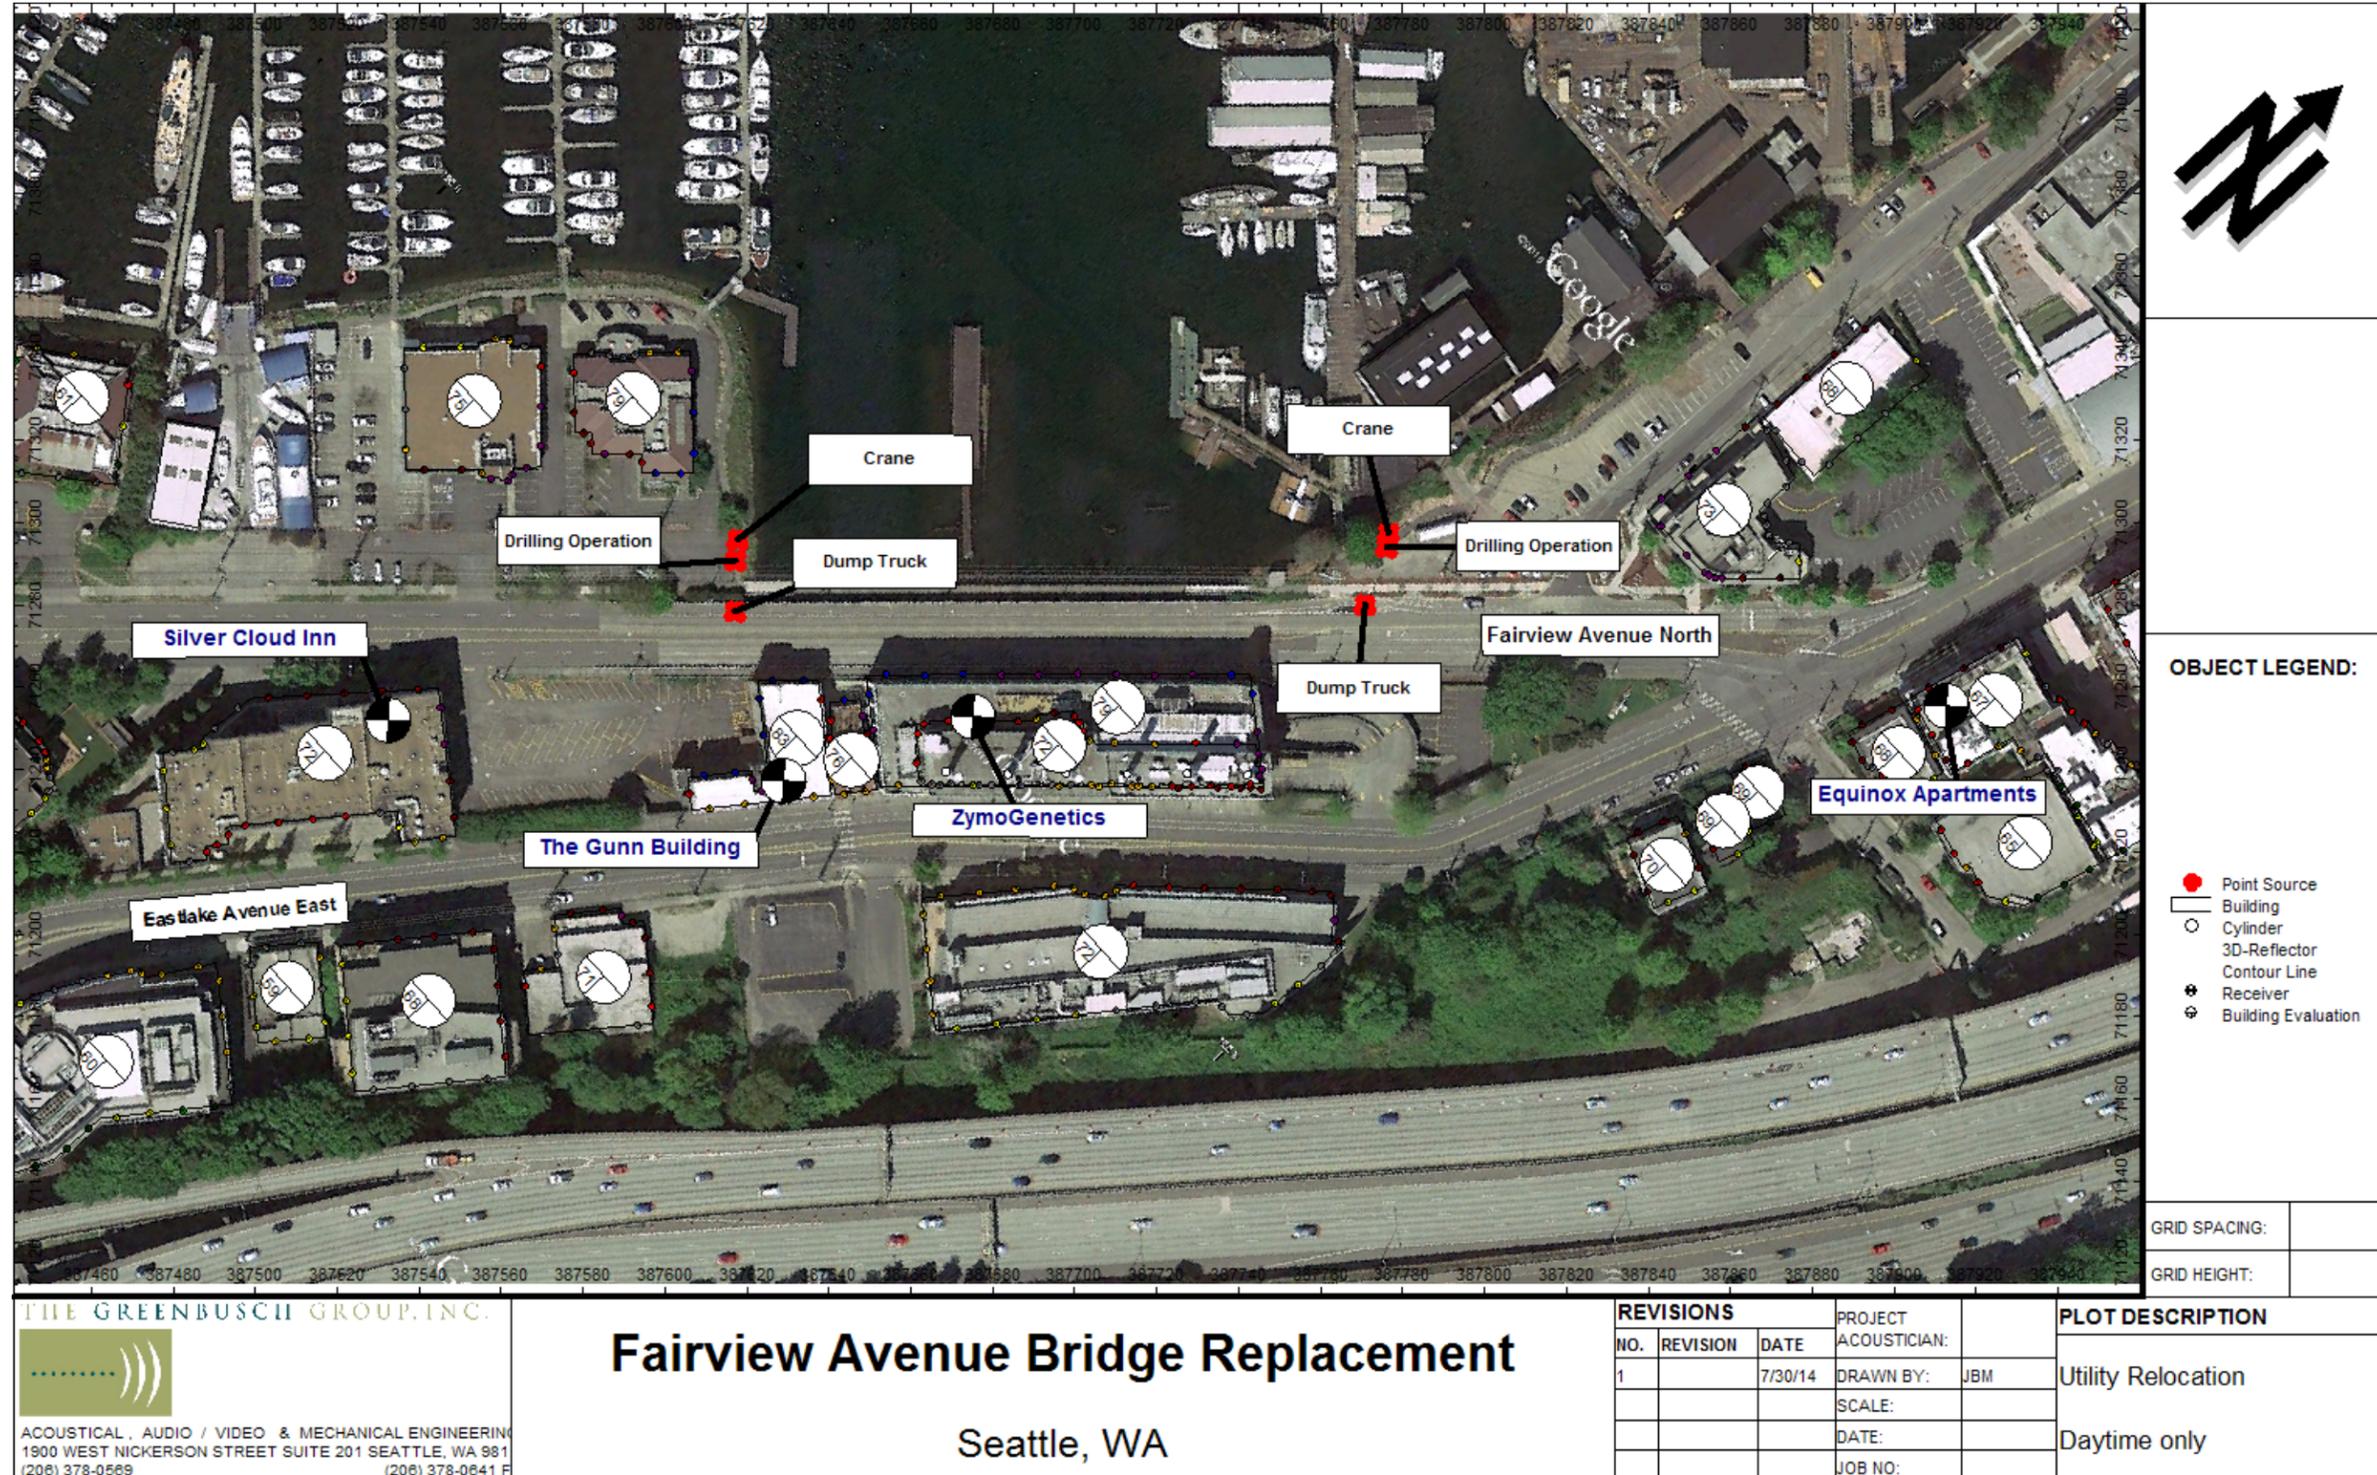
Figure A-2 Phase I.I Construction Noise Model
