Fairview Avenue N Bridge Replacement Project

Appendix B

Cultural Resources Discipline Report (Redacted Version)

Fairview Avenue North Bridge

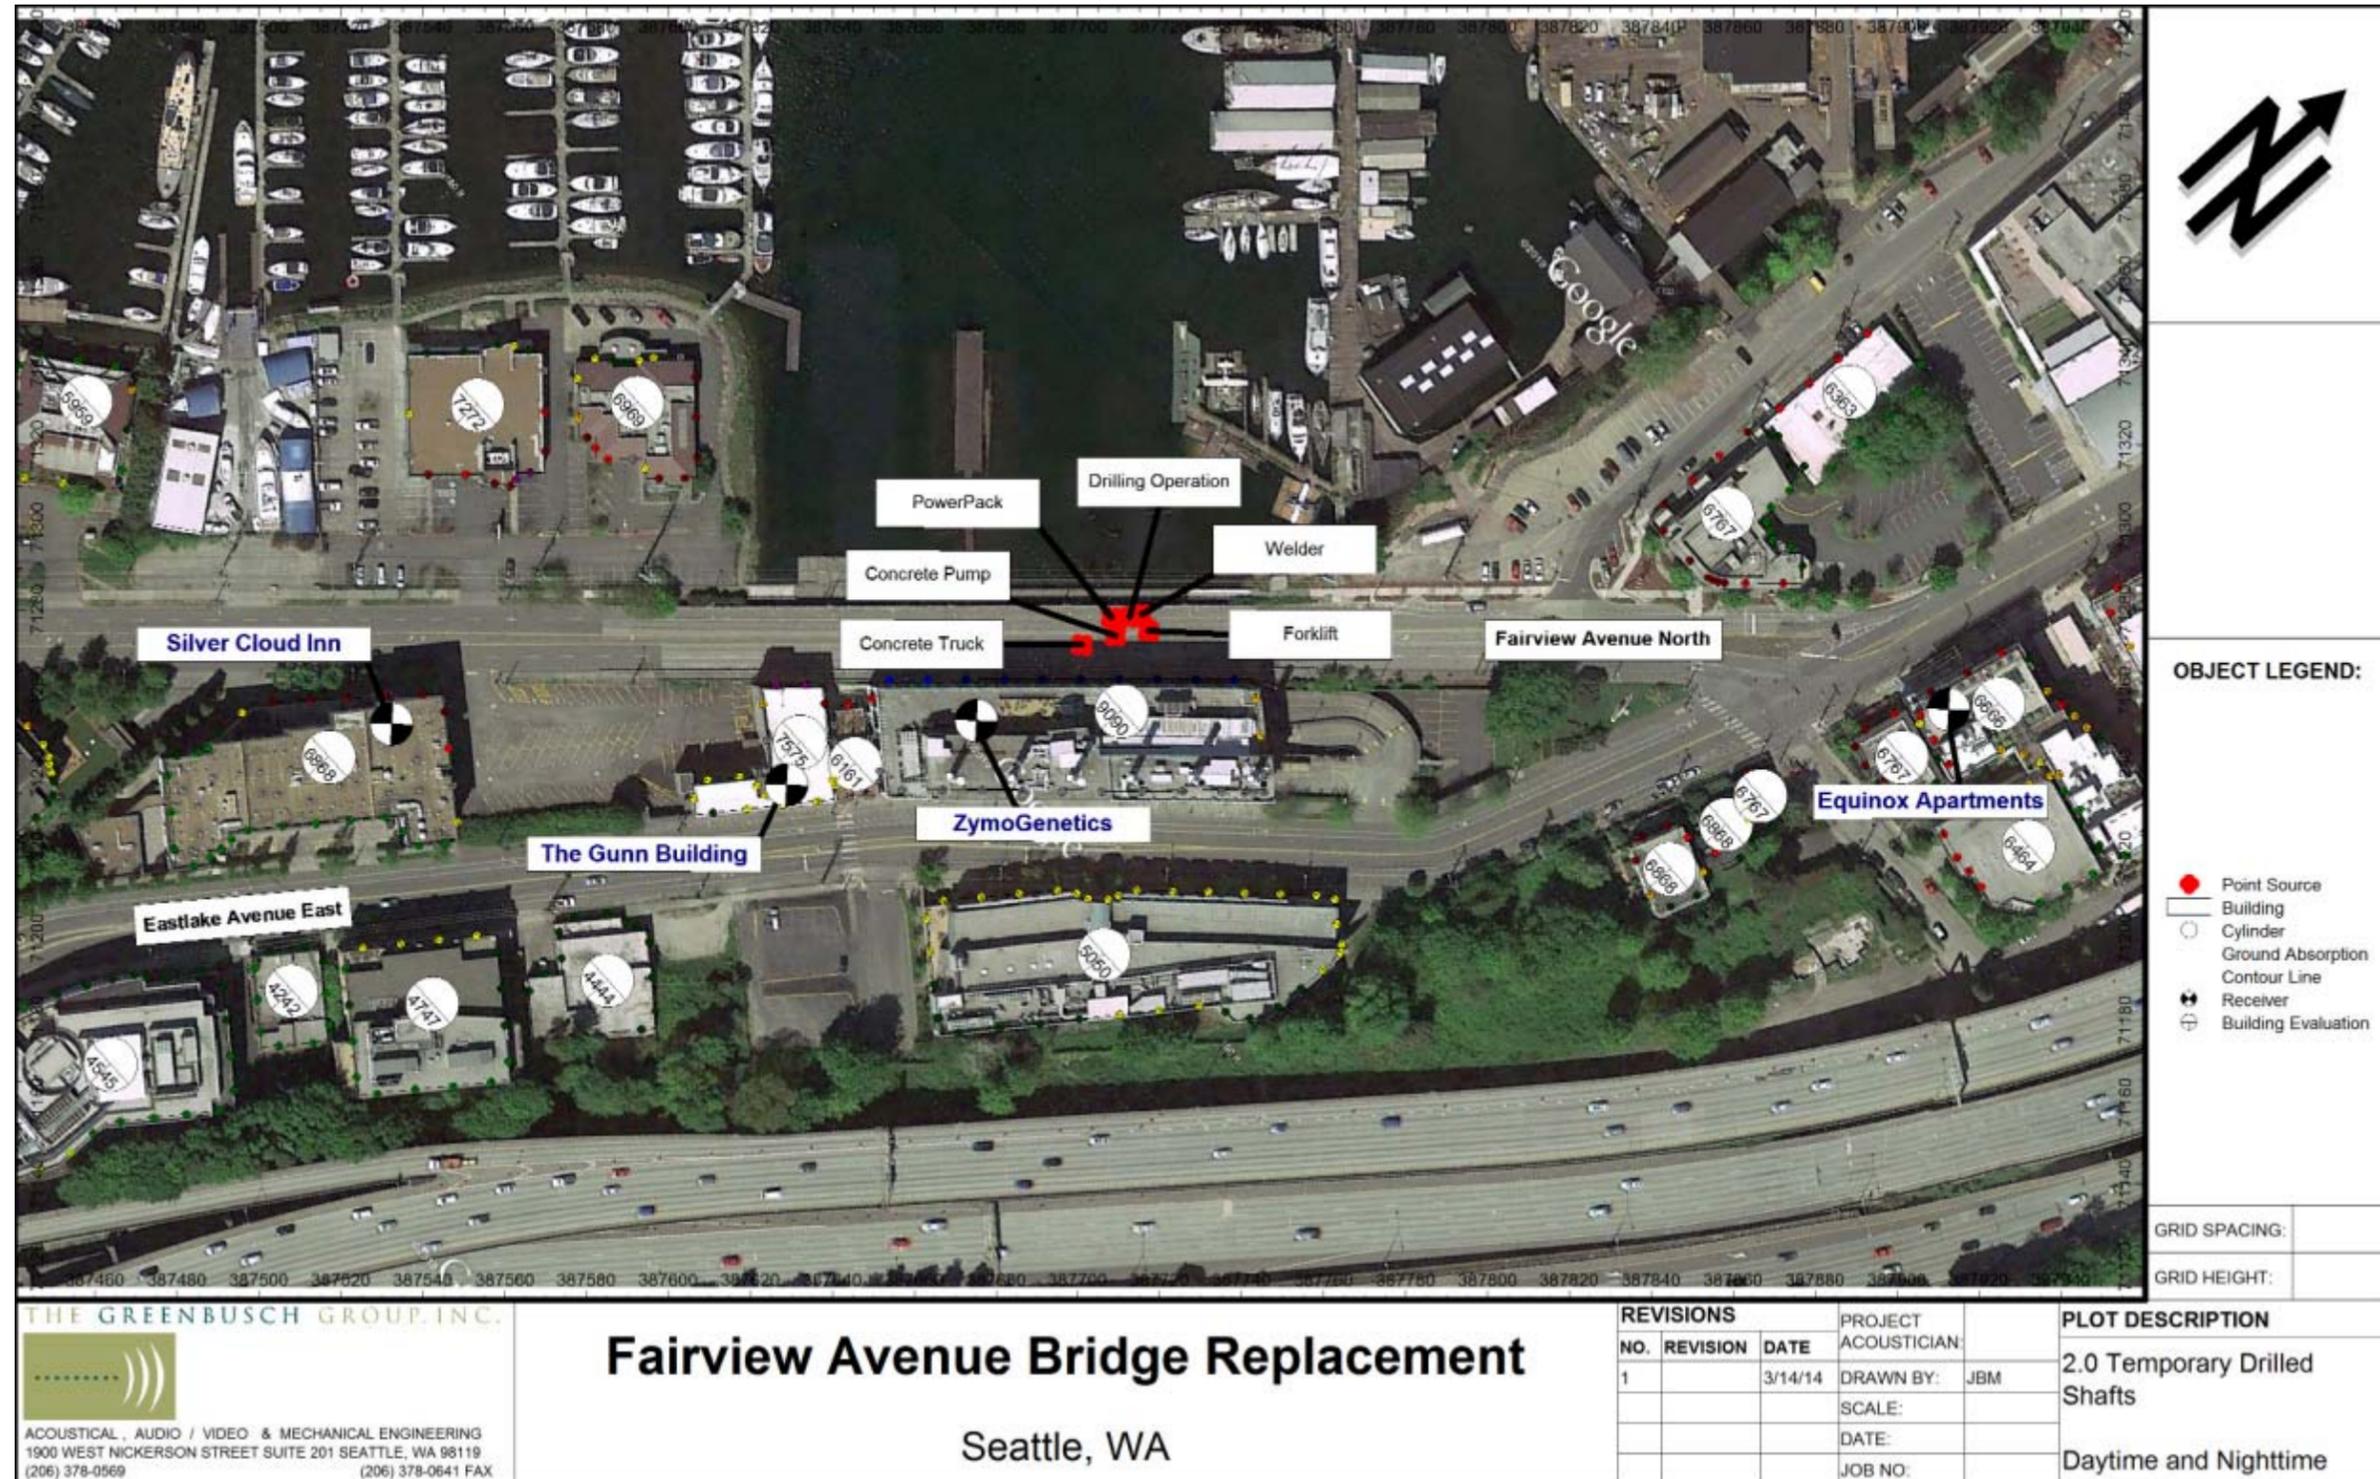
Figure A-3 Phase 2 Construction Noise Model

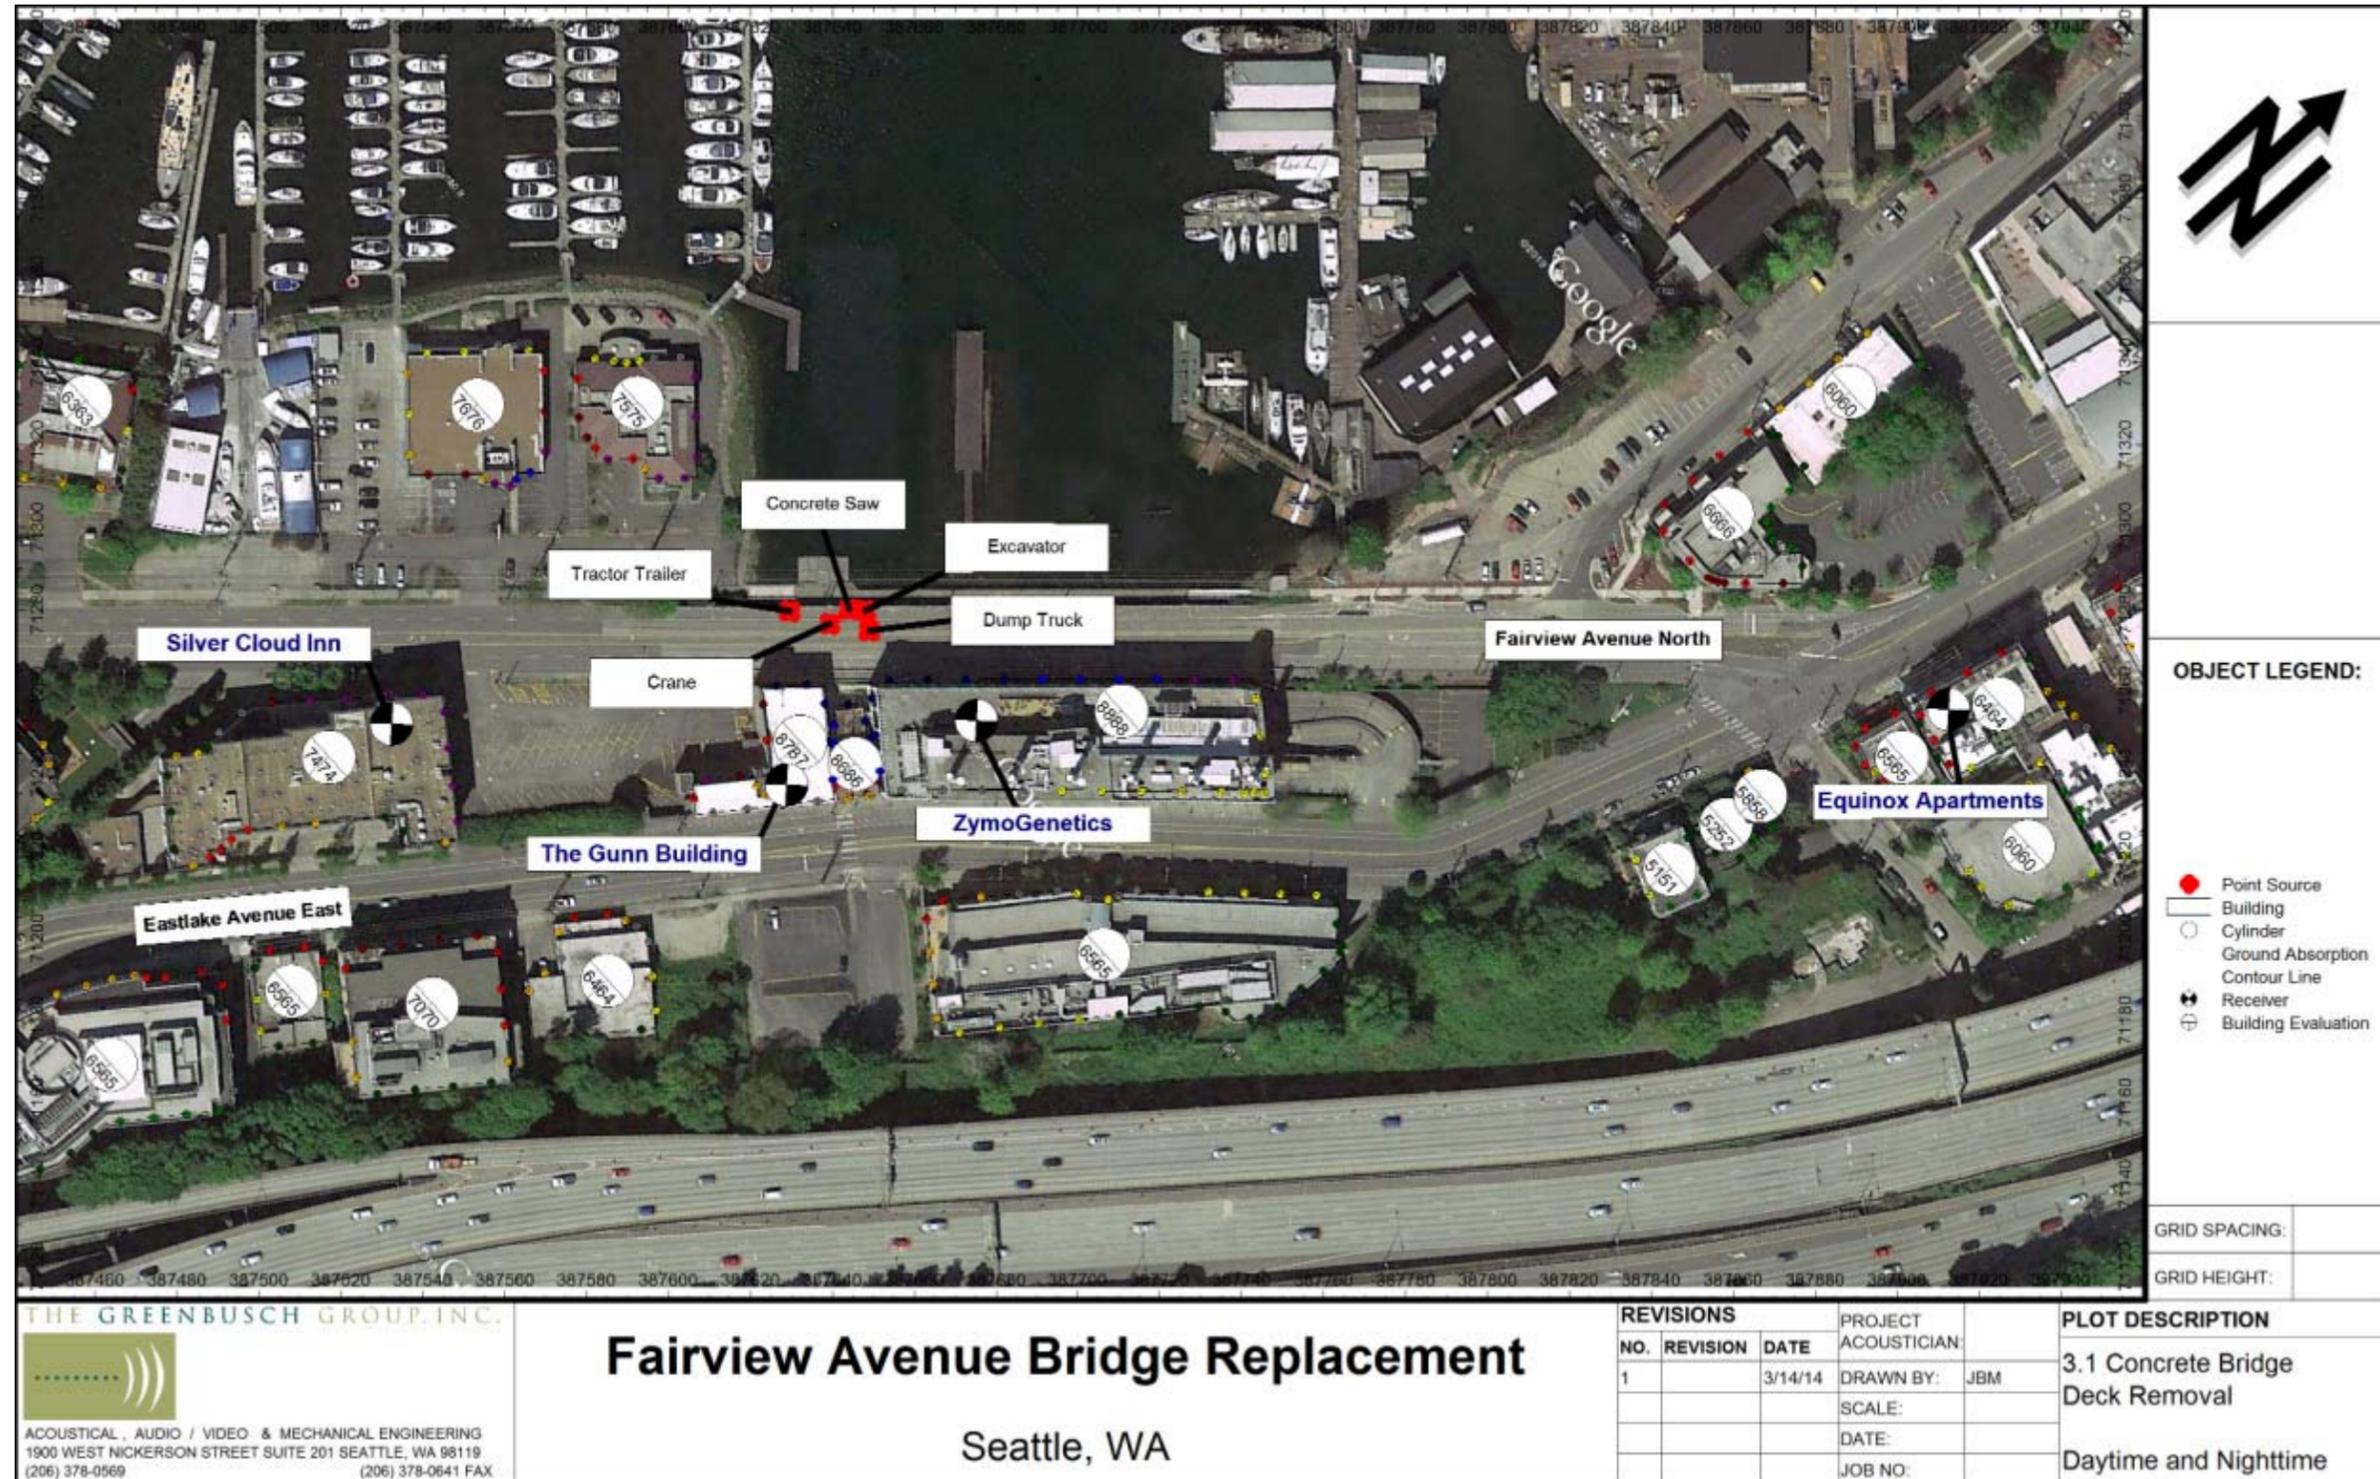
Figure A-4 Phase 3.1 Construction Noise Model

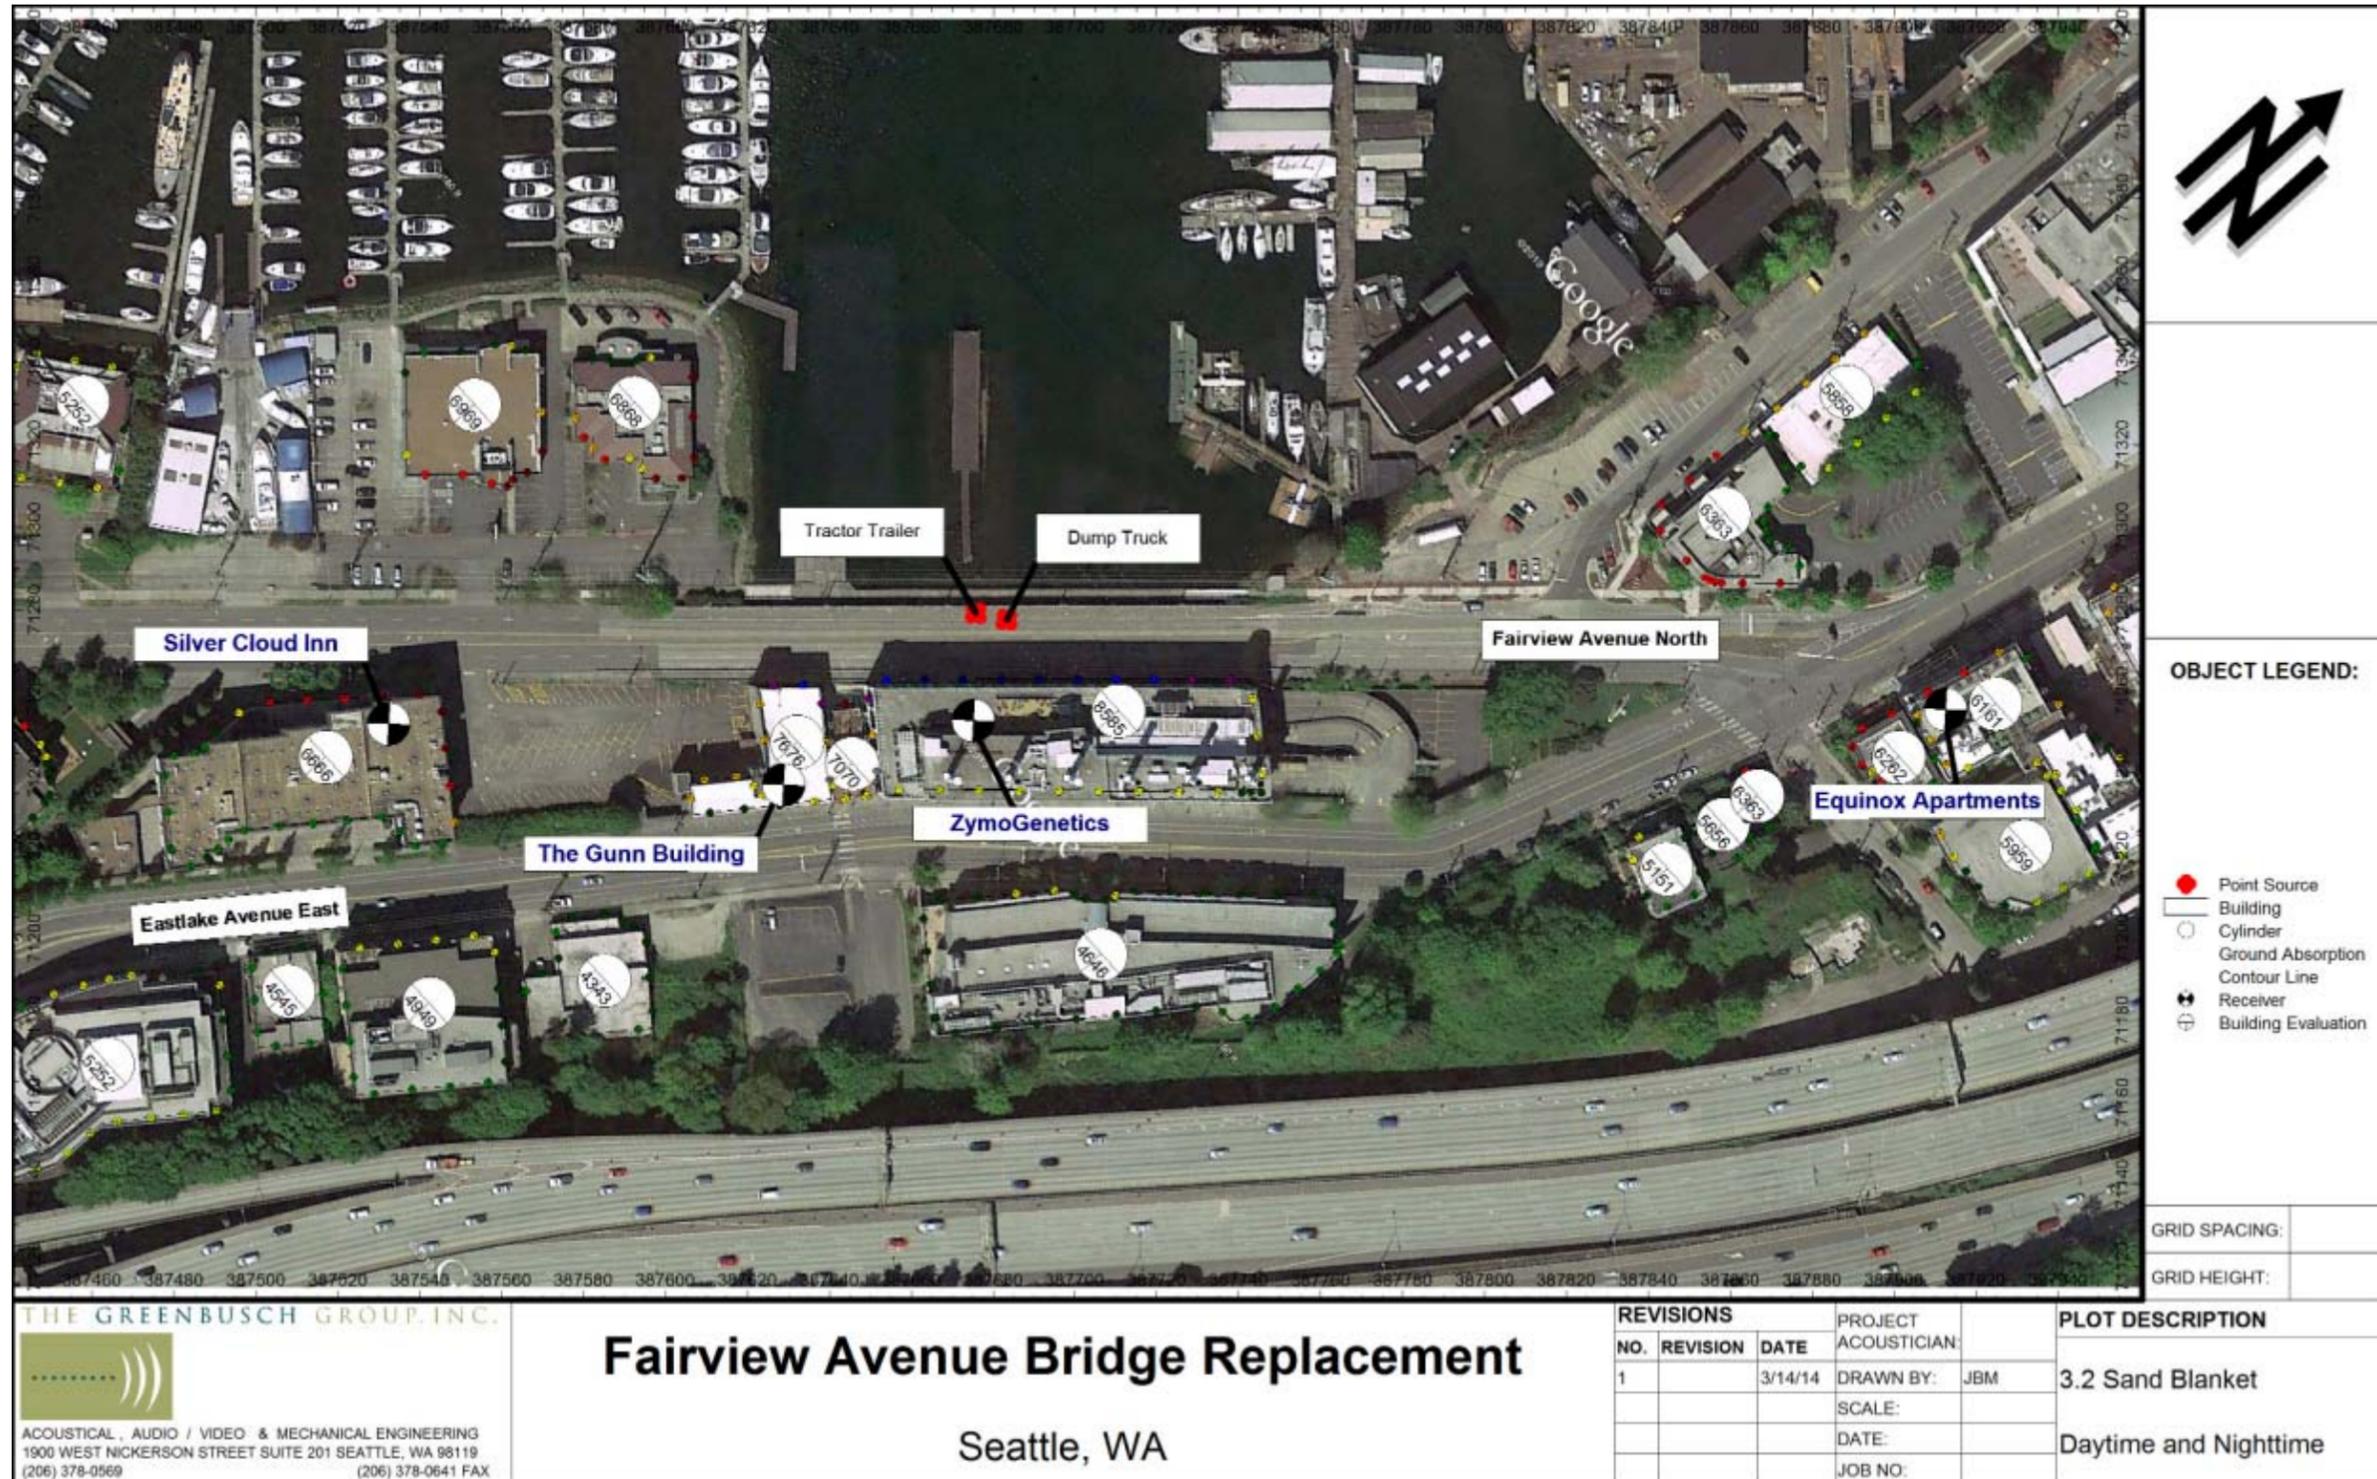
Figure A-5 Phase 3.2 Construction Noise Model

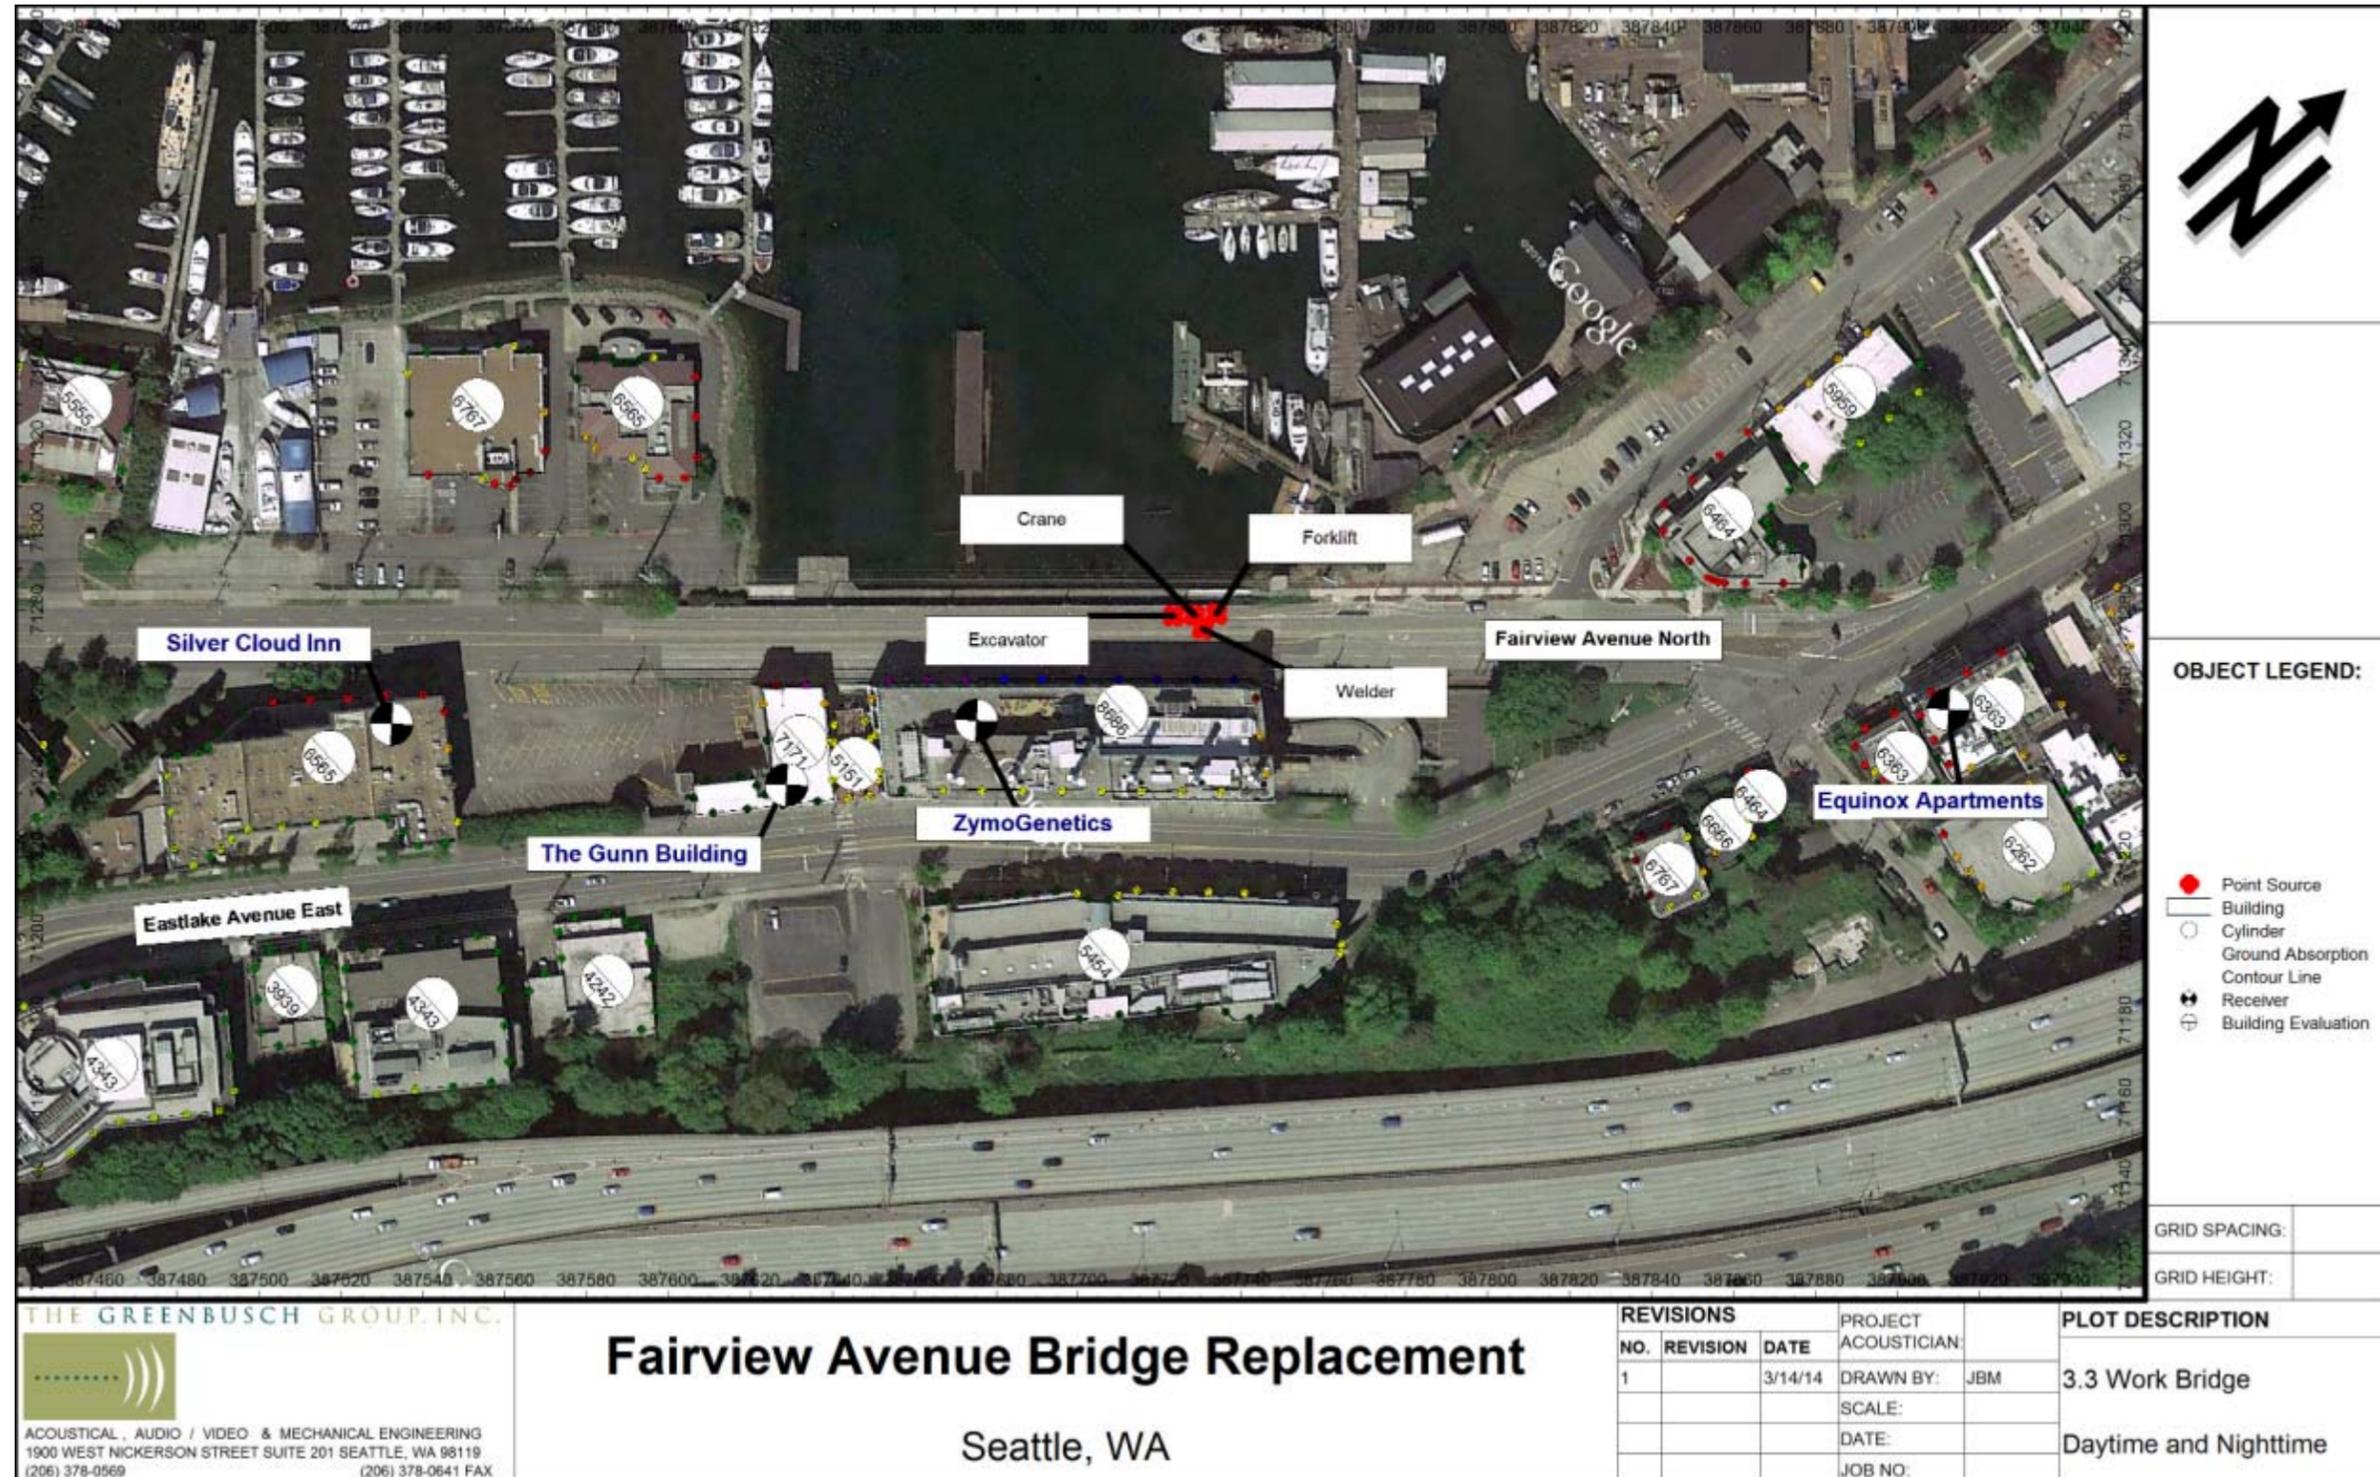
Figure A-6 Phase 3.3 Construction Noise Model

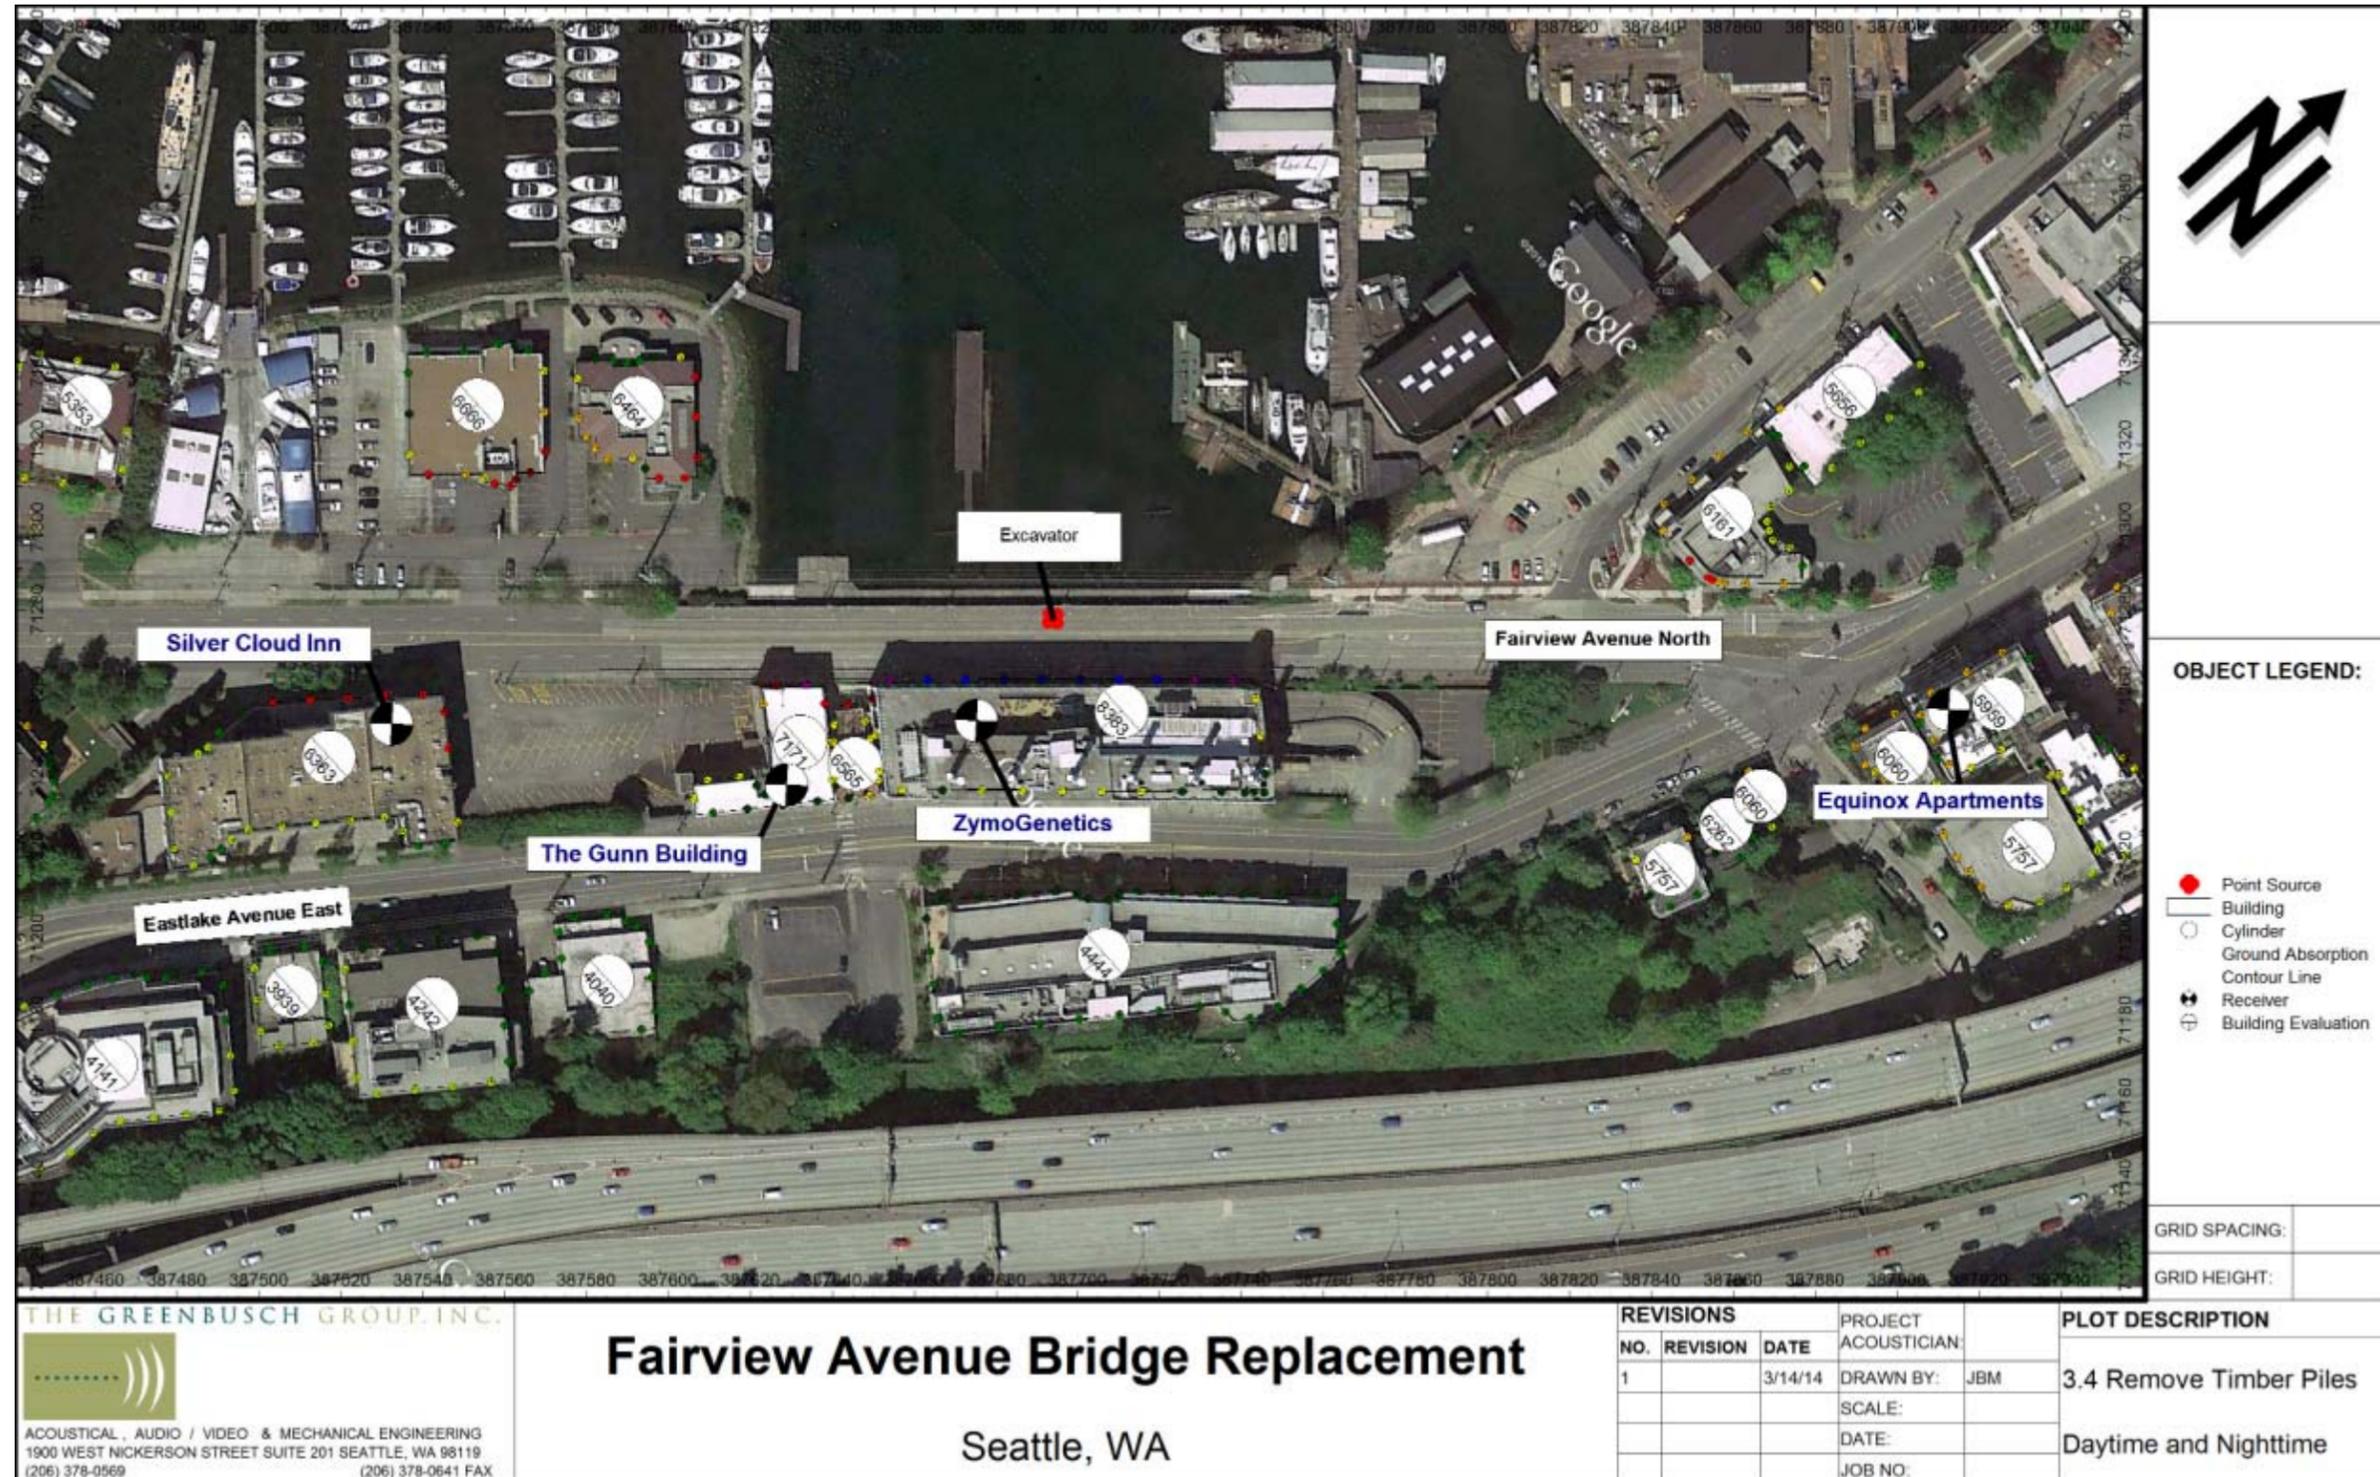
Figure A-7 Phase 3.4 Construction Noise Model

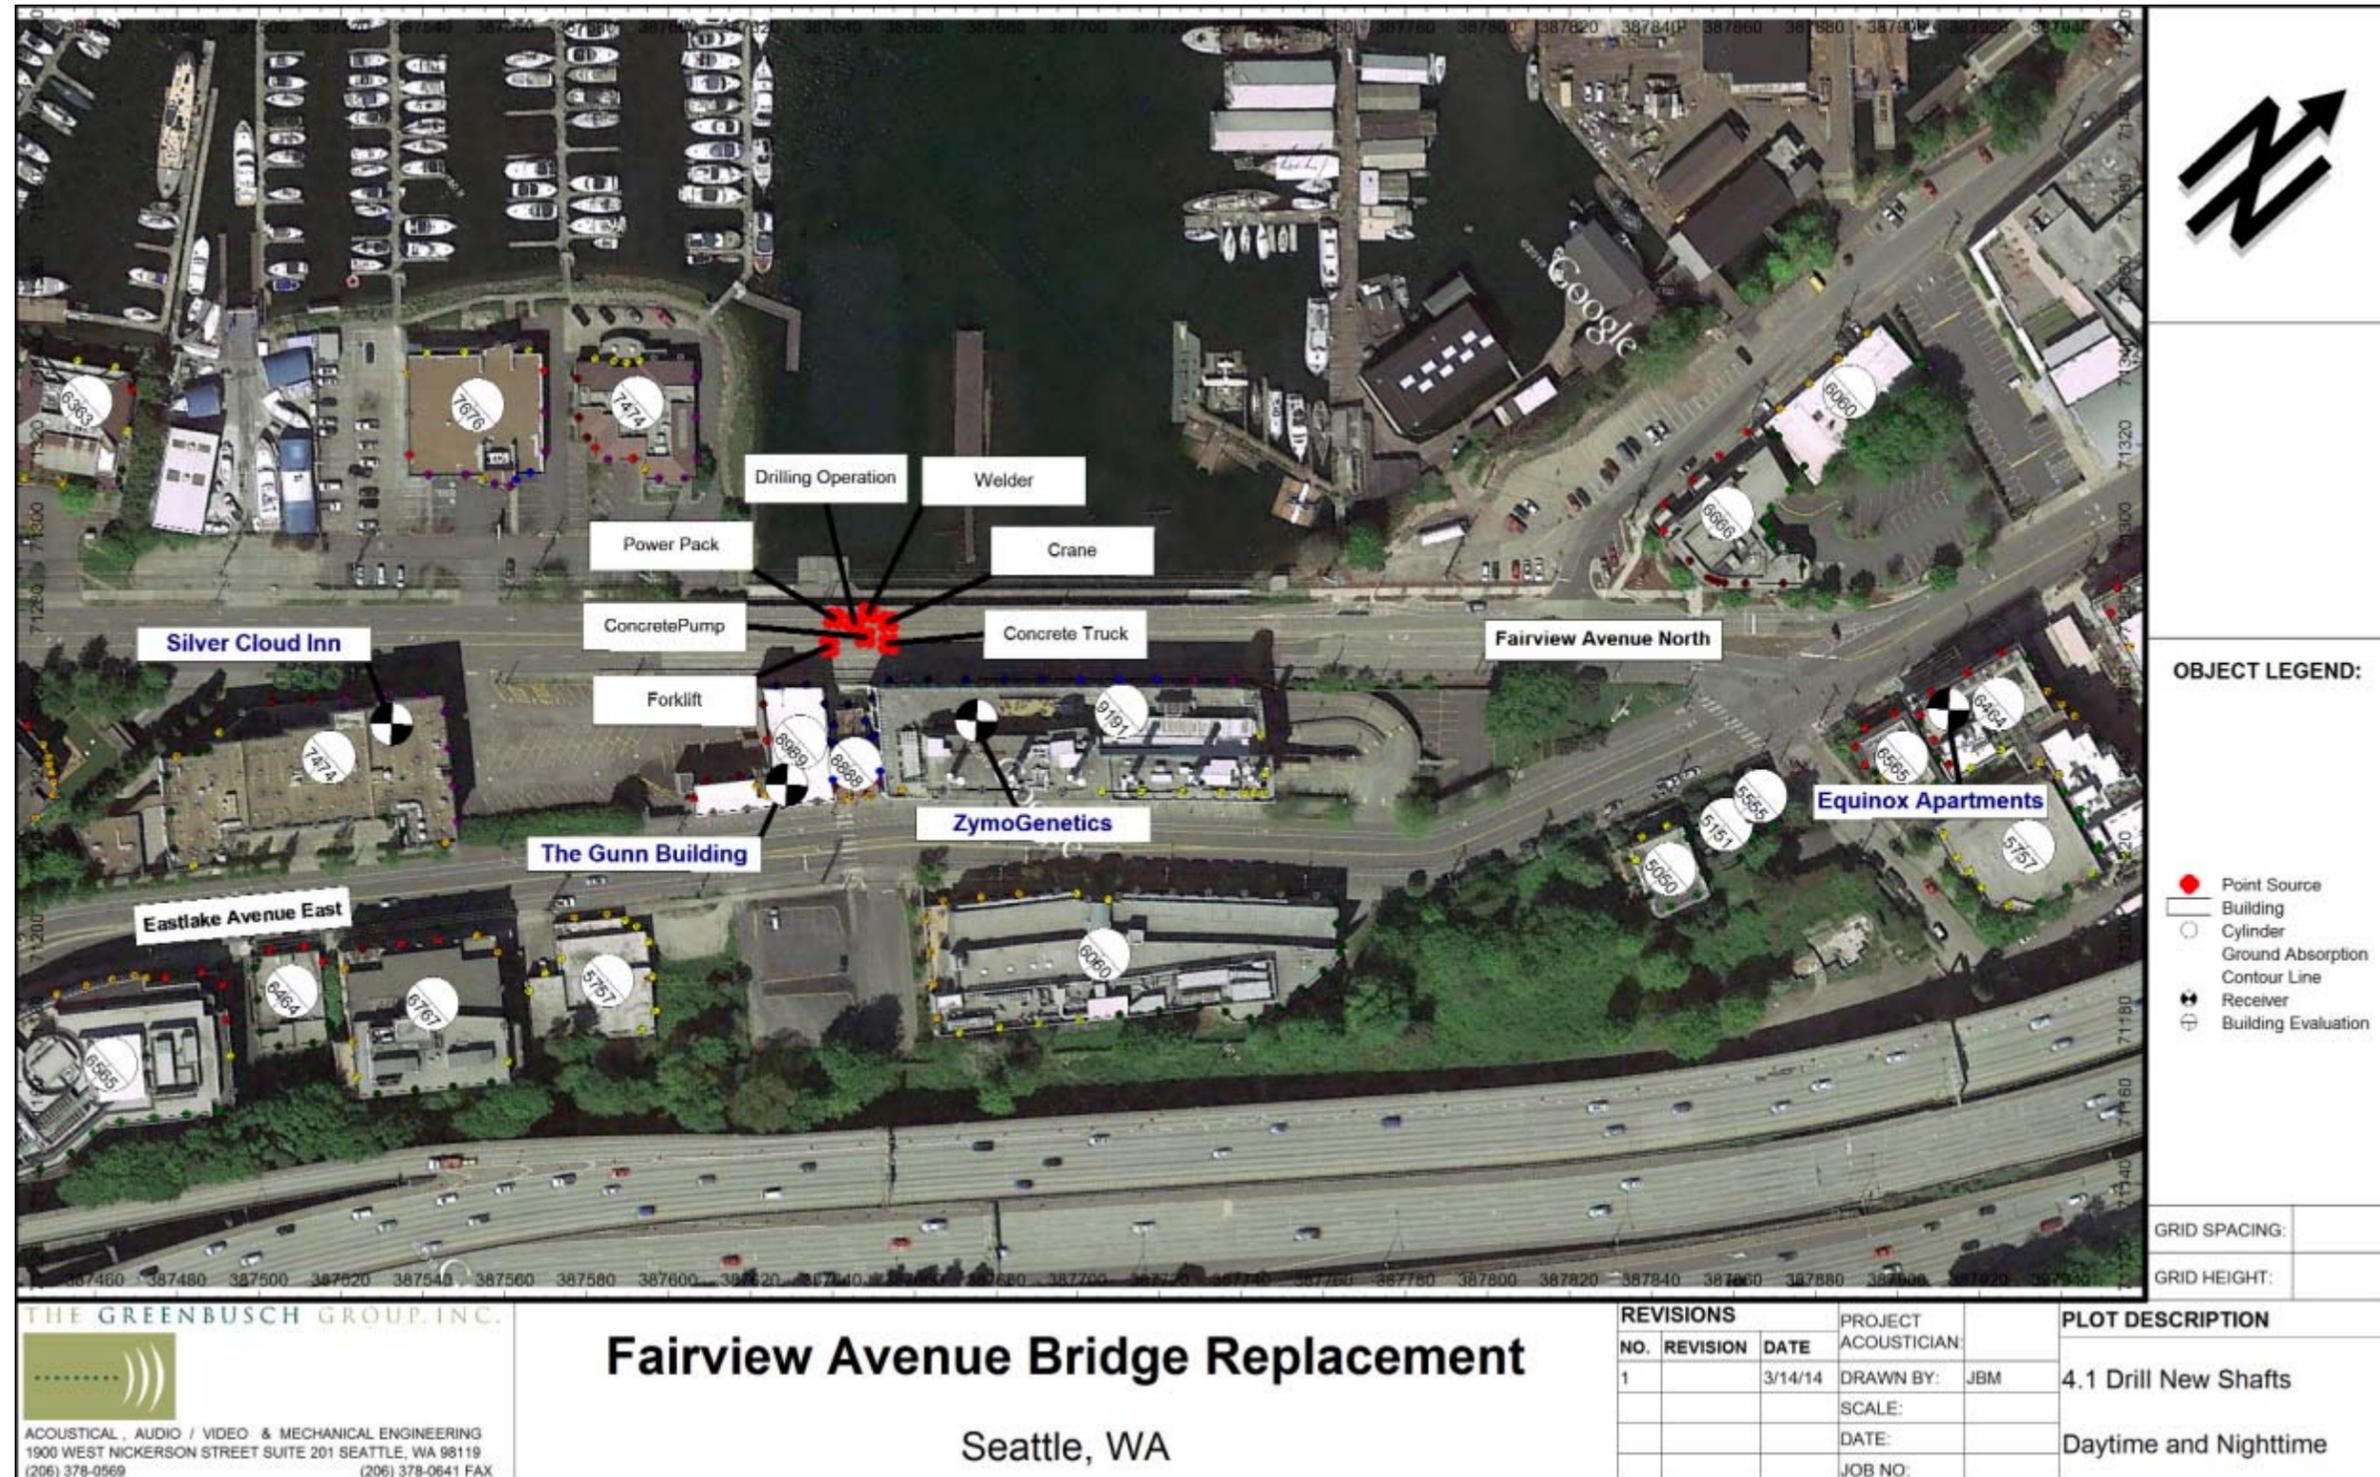
Figure A-8 Phase 4.1 Construction Noise Model
