Fairview Avenue N Bridge Replacement Project

Appendix B

Cultural Resources Discipline Report (Redacted Version)

Fairview Avenue North Bridge

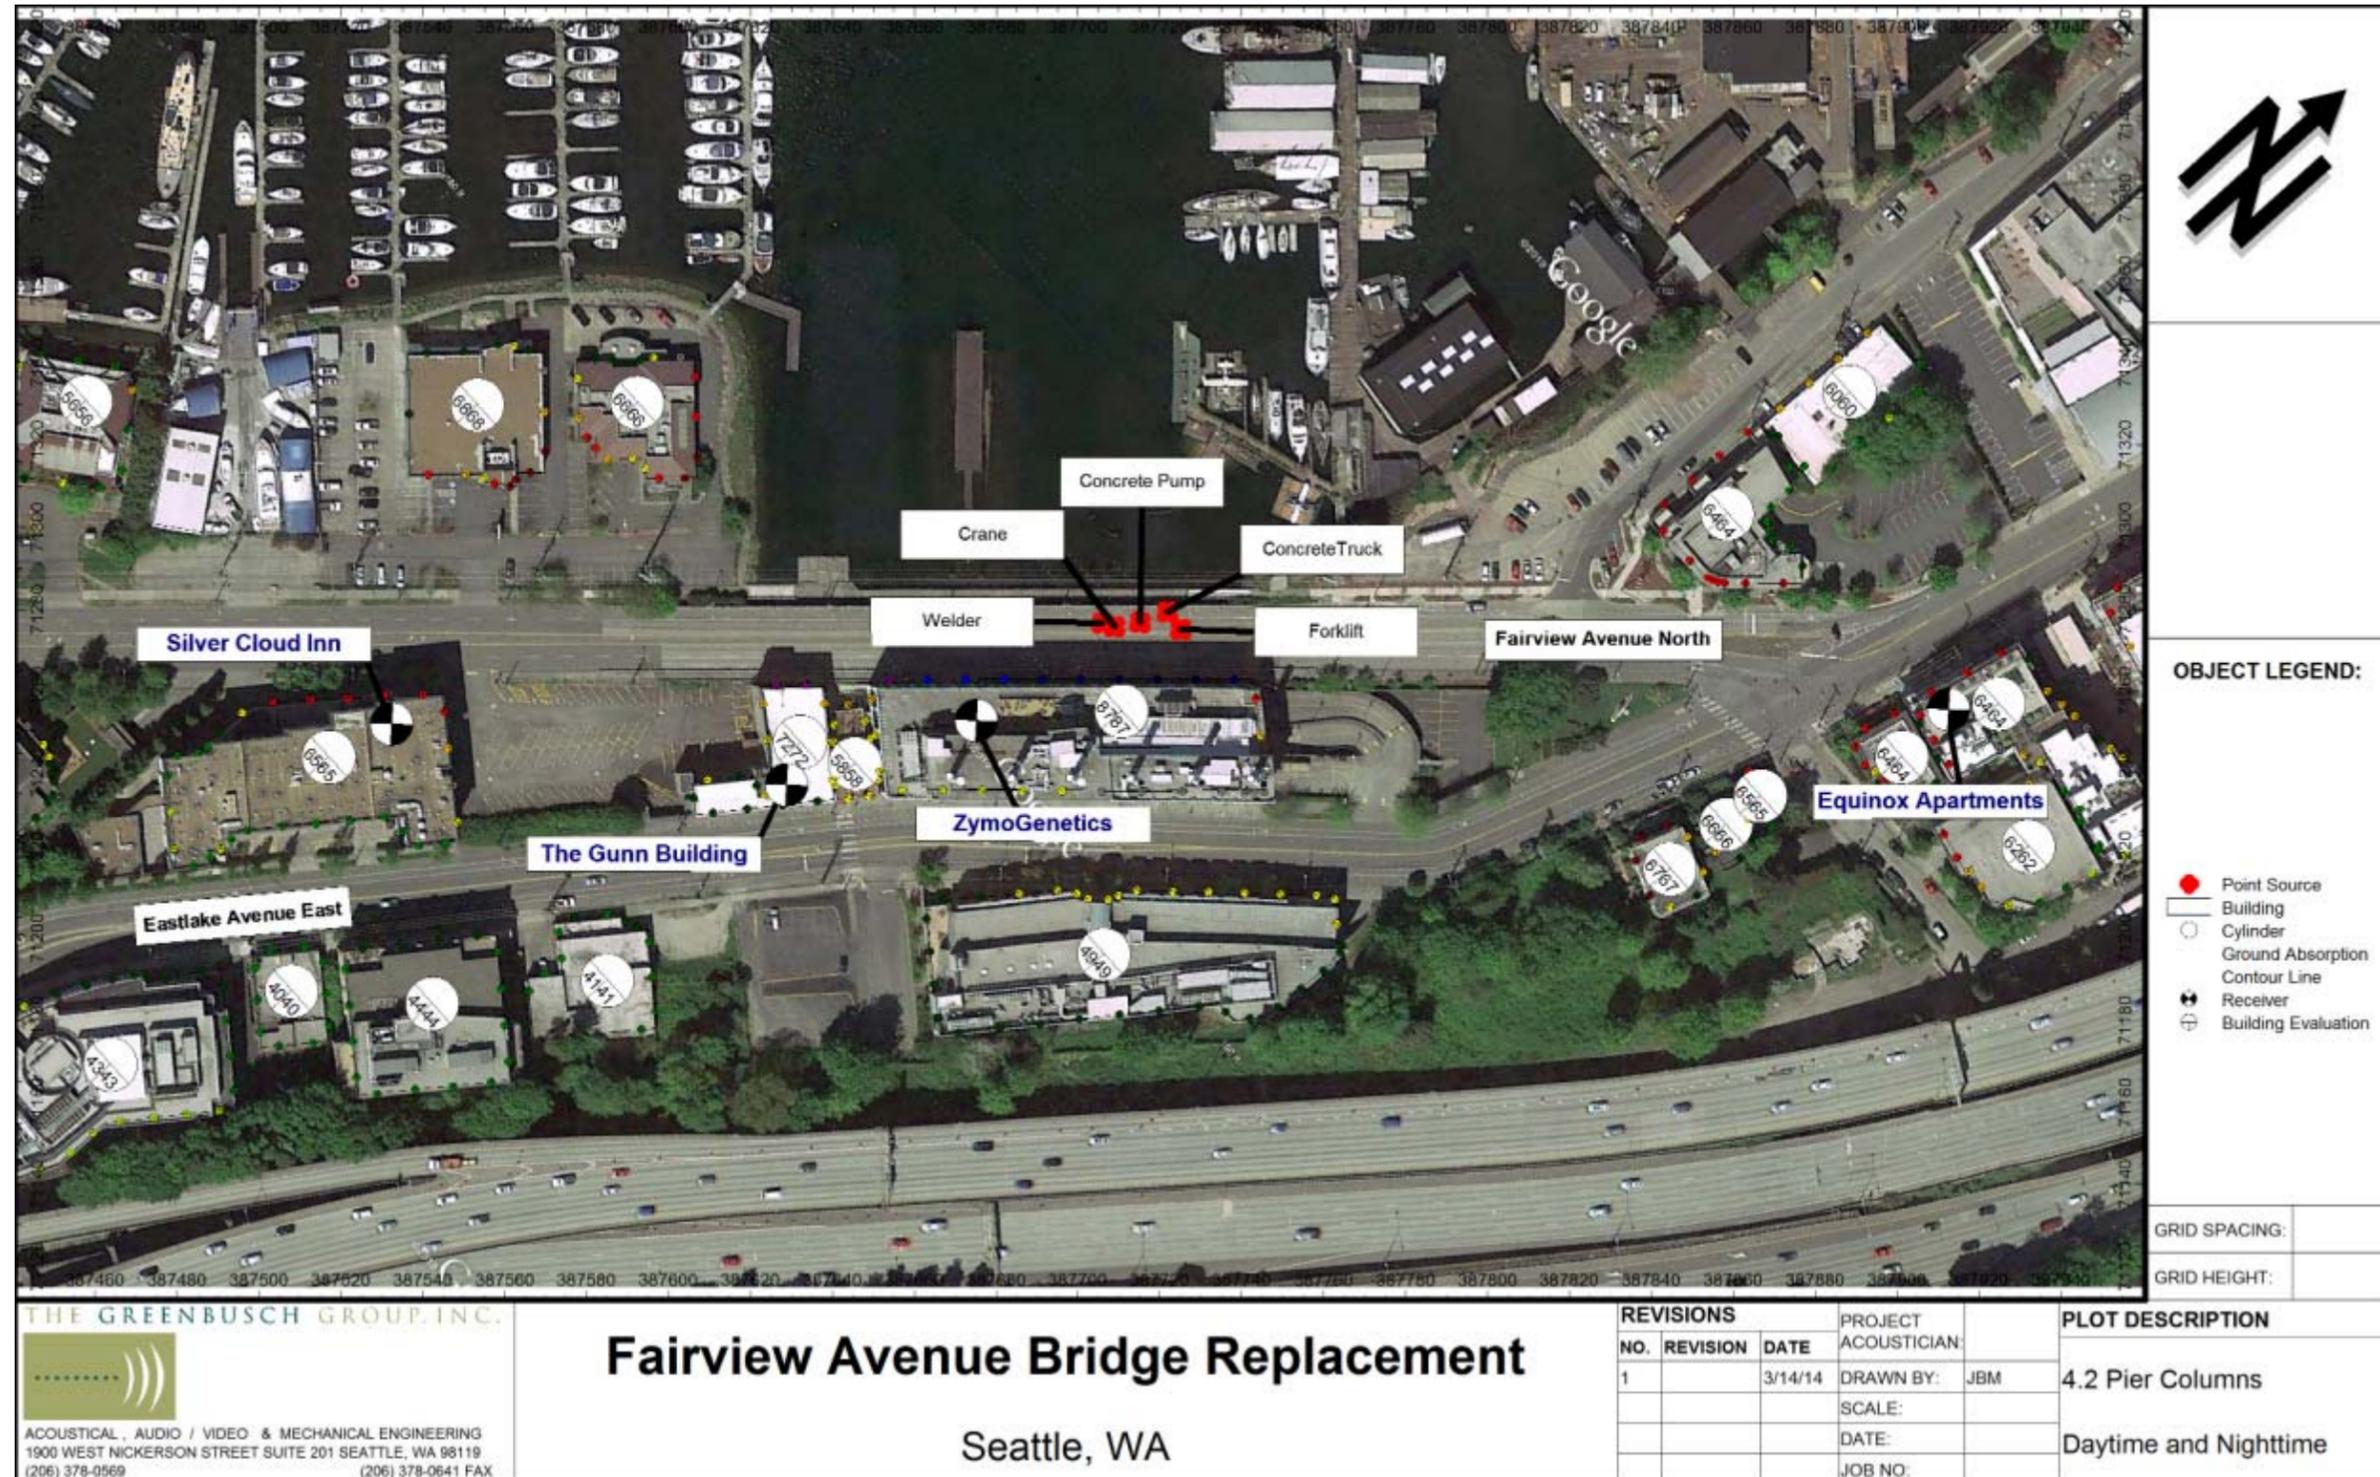
Figure A-9 Phase 4.2 Construction Noise Model

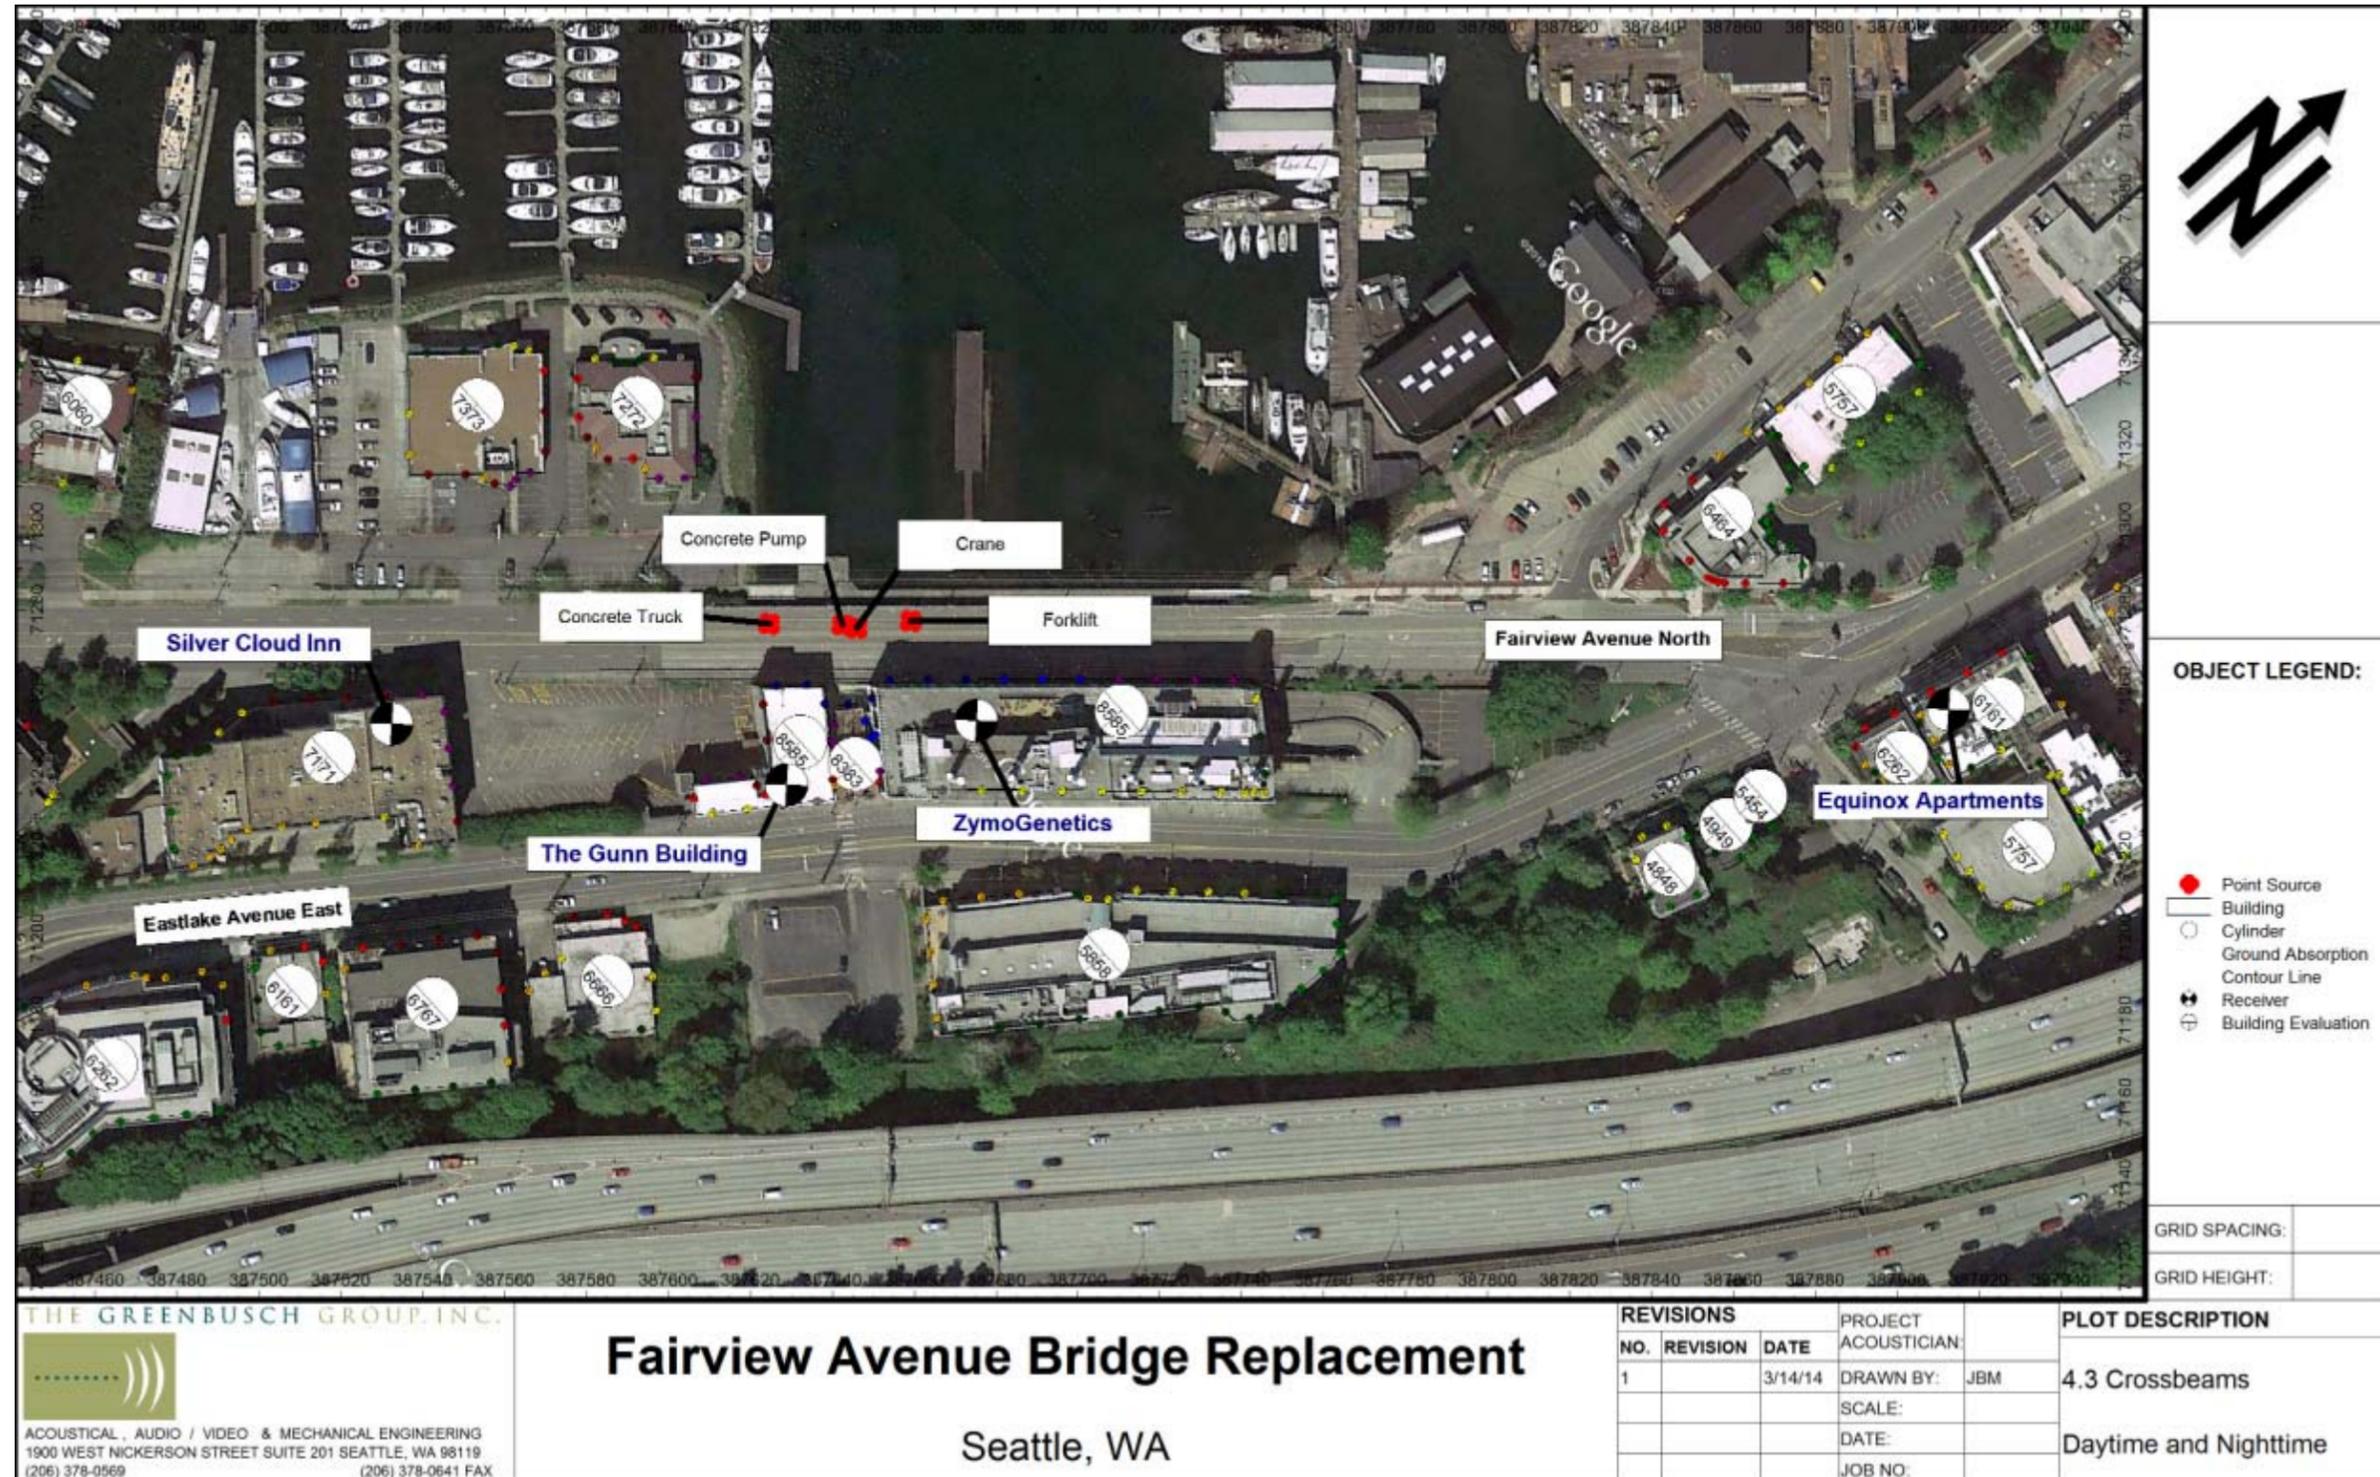
Figure A-10 Phase 4.3 Construction Noise Model

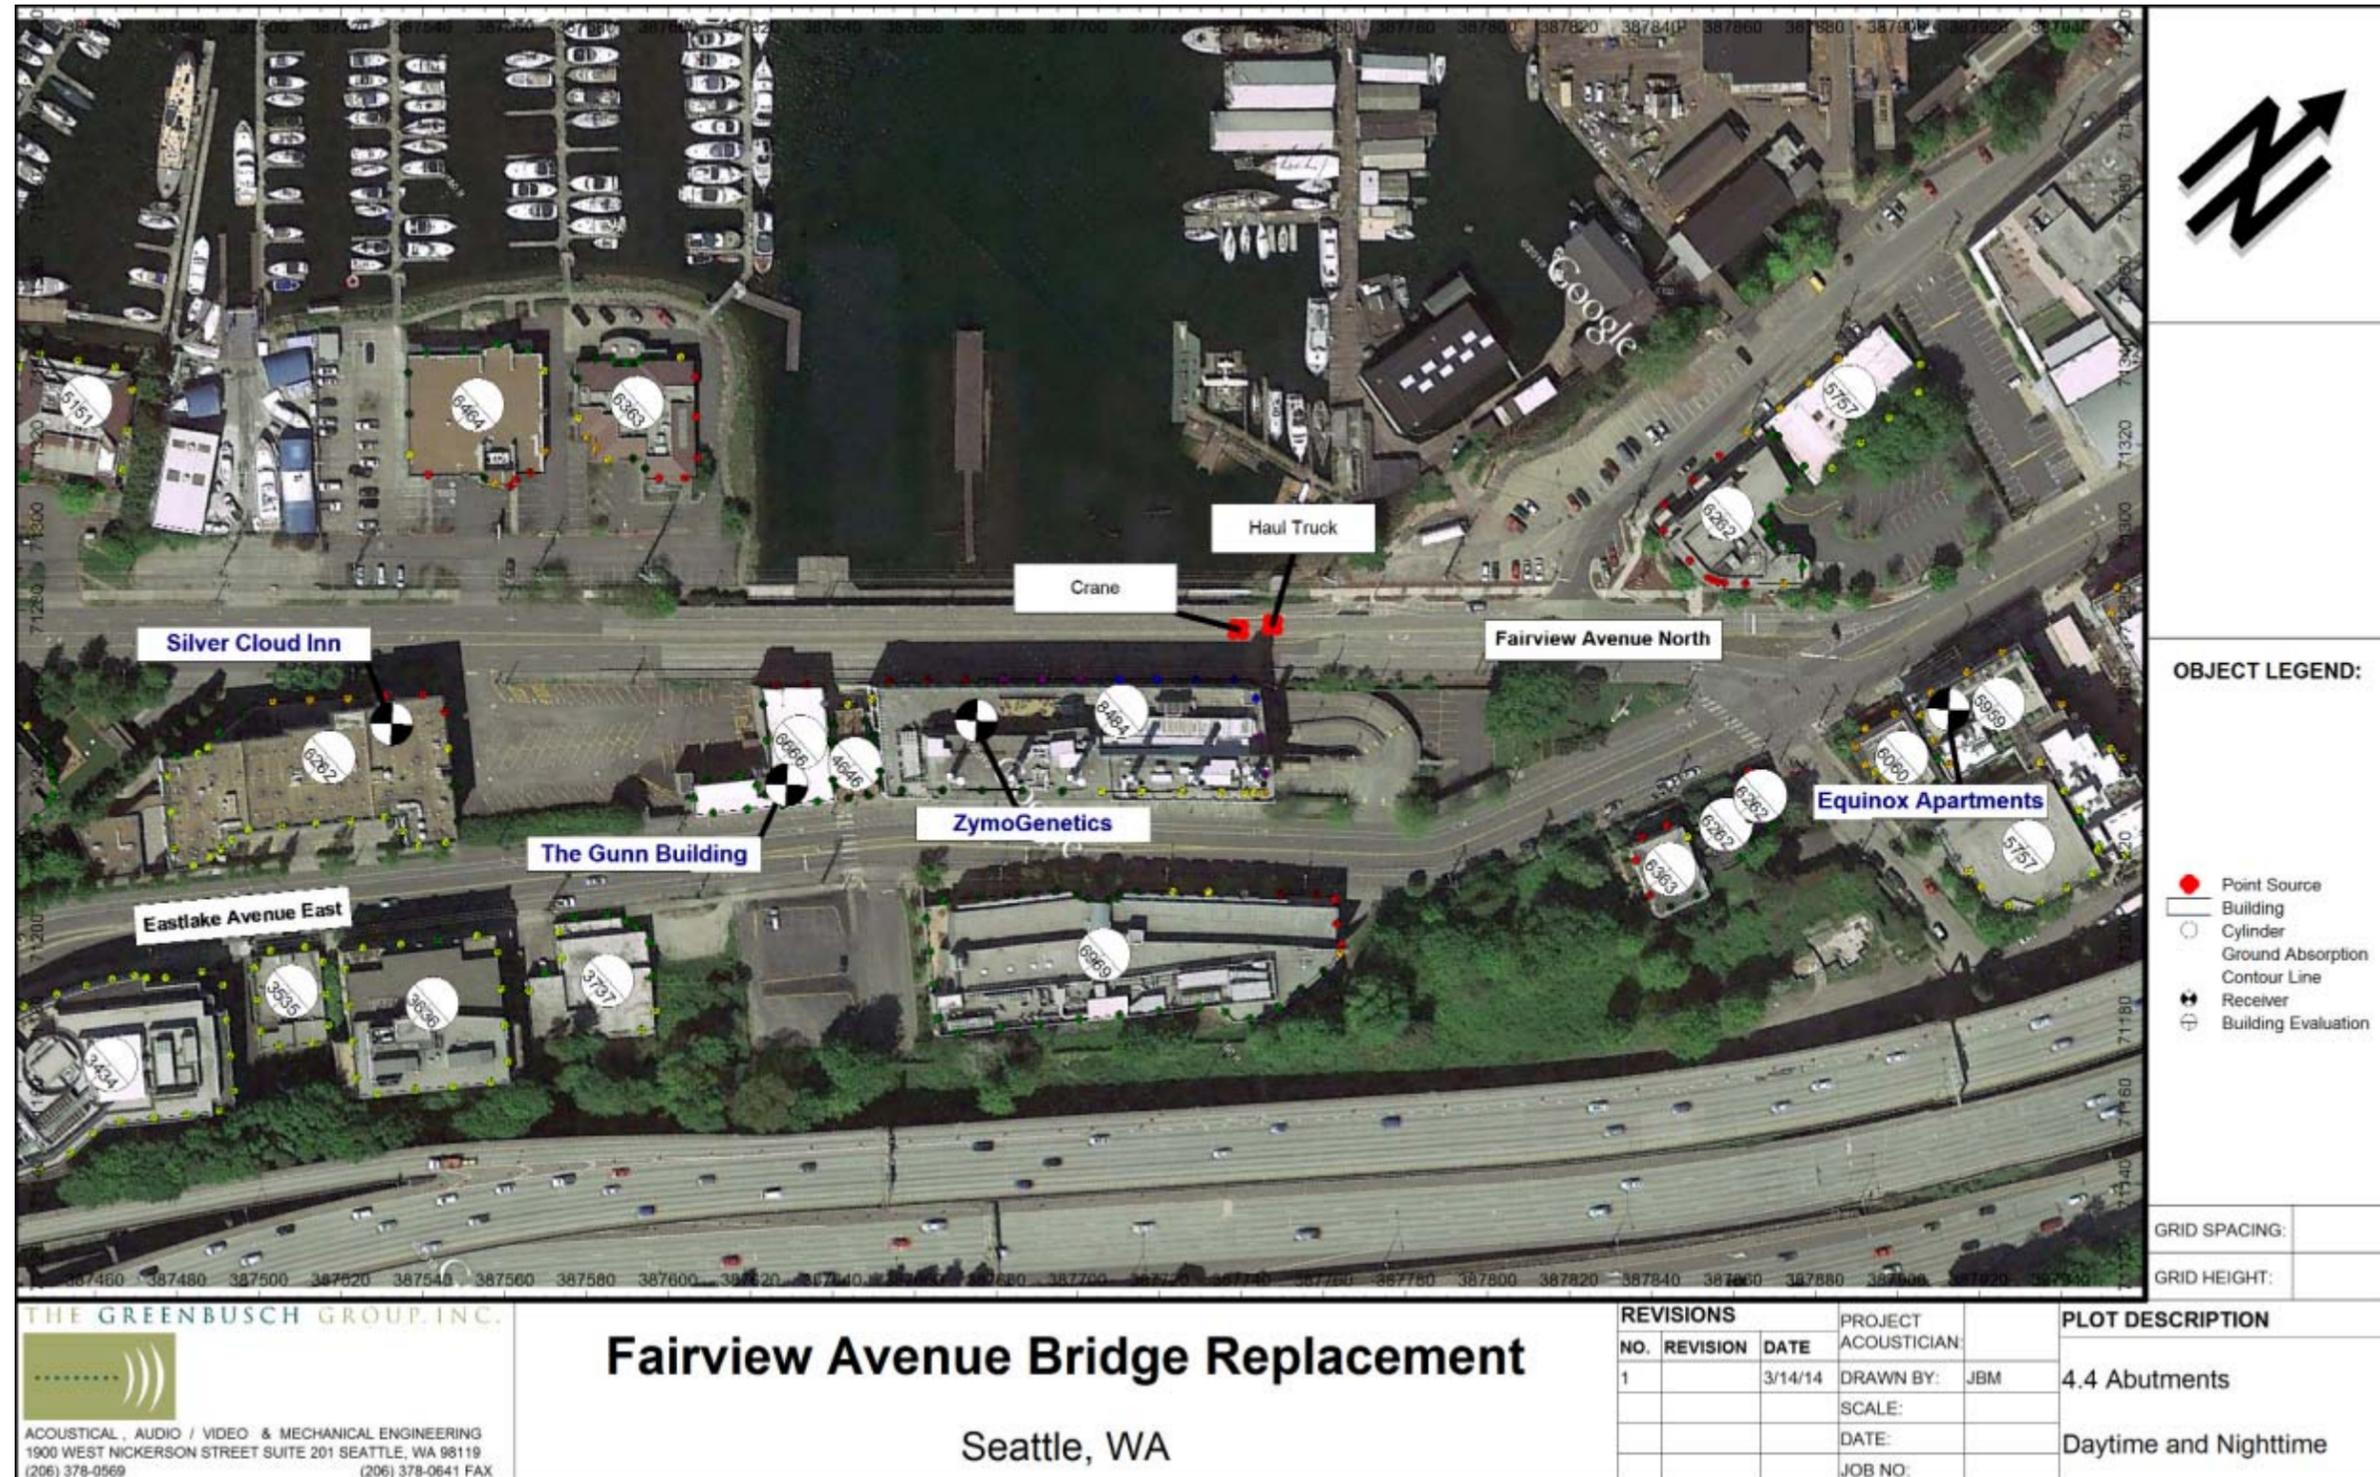
Figure A-11 Phase 4.4 Construction Noise Model

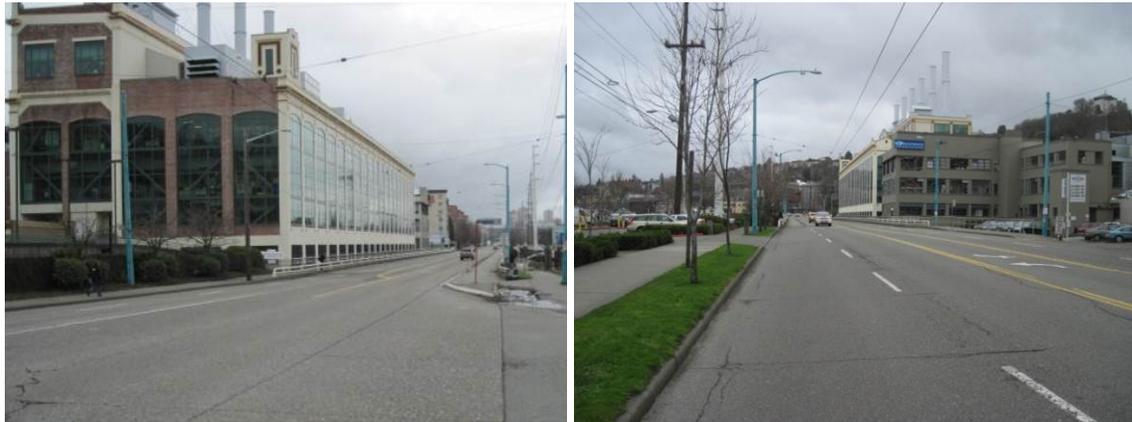
Figure 2 – Fairview Avenue North

The East Bridge was built in 1963 and carries two lanes of northbound traffic and one raised 8-foot-wide sidewalk for pedestrians. The East Bridge has a prestressed concrete girder superstructure supported on prestressed concrete piles.

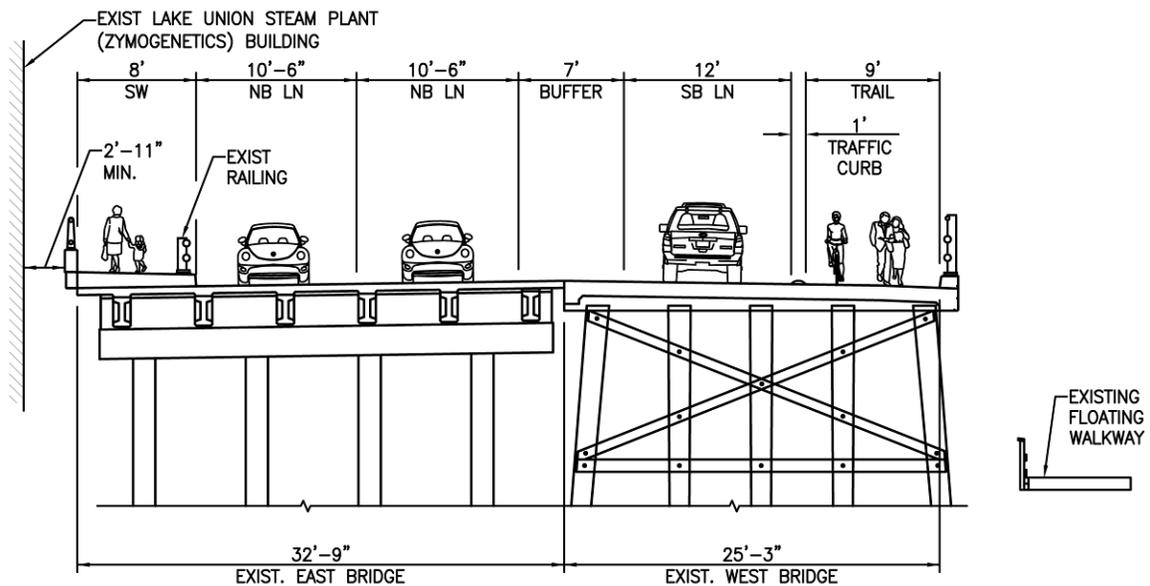
Figure 3 – Existing Typical Section

Principal Arterial, Regional Connector and a Minor Transit Street by the City of Seattle. The posted speed is 30 miles per hour (mph). The roadway across the bridge consists of two 10.5-foot-wide lanes northbound and a 12-foot-wide lane southbound separated by a 7-foot-wide striped median. There is an 8-foot-wide raised concrete sidewalk on the east side and a 9-foot-wide bicycle/pedestrian path on the west side separated from the roadway by a 12-inch-wide traffic curb (see Figure 3).

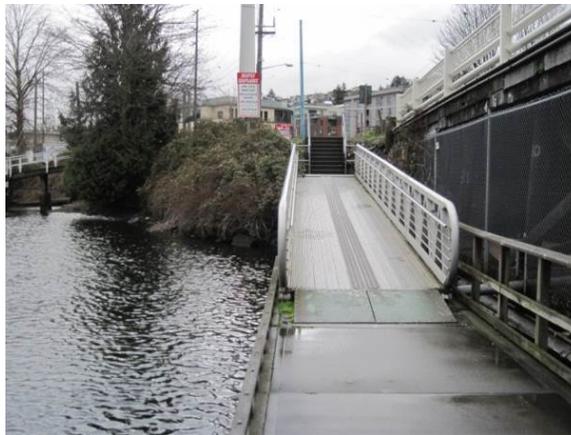
Figure 4 – Stairway/Ramp access to Floating Walkway

The Cheshiahud Trail is operated by the City of Seattle Parks Department as a recreational loop around Lake Union. The trail is classified as an Urban Trail by the City. In the area of the Fairview Avenue North Bridge, the trail consists of an 8-foot-wide floating walkway on the west side of the bridge. The floating walkway is accessed by stairs and ramps on the north and south ends of the bridge.

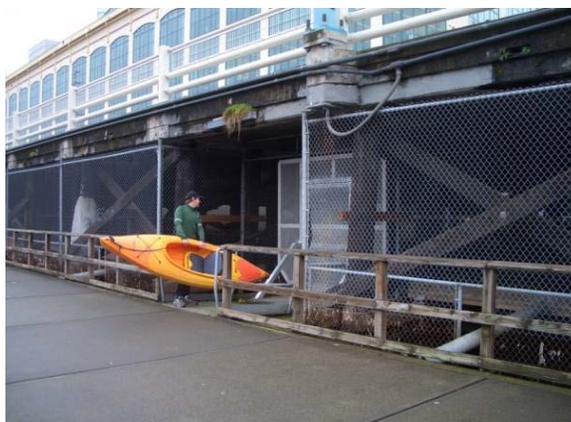
Figure 5 – ZymoGenetics Kayak Access

In addition to the Cheshiahud trail and the bicycle/pedestrian facilities on the bridge, there is a private-pedestrian access under the Fairview Avenue North Bridge. The access was created as part of the redevelopment of the Lake Union Steam Plant building to the east of the bridge. The gated access allows ZymoGenetics employees to use the Cheshiahud trail and provides kayak access to Lake Union.

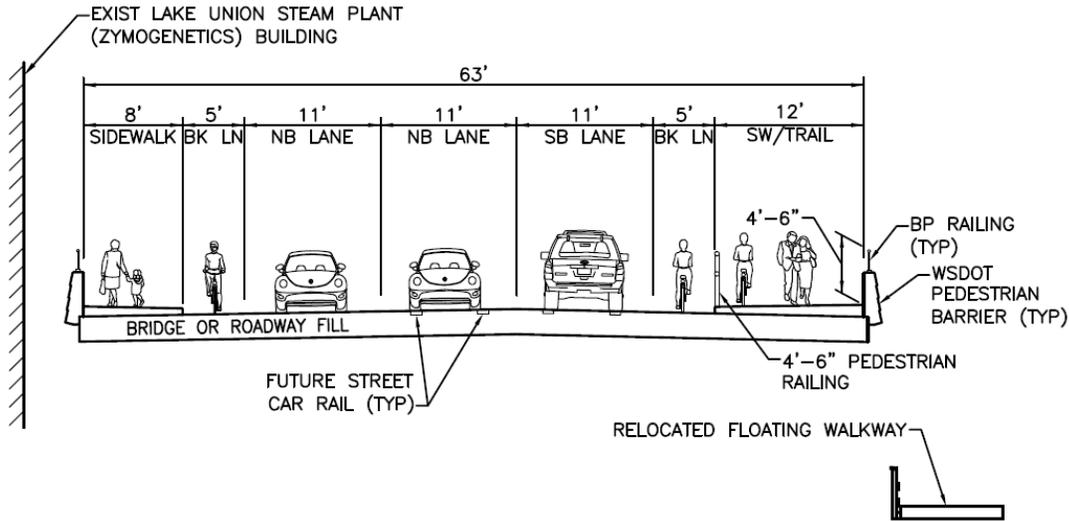
The proposed roadway section includes three 11-foot-wide lanes (two northbound and one southbound), one 5-foot-wide bike lane in each direction, an 8-foot-wide sidewalk on the east side and a 12-foot-wide mixed-use trail on the west side. The project would either replace or relocate the existing floating pedestrian walkway to the west of the bridge that is part of the Cheshiahud Trail.

Four alternative roadway sections were developed and presented to City staff. With feedback from City staff, the preferred alternative in Figure 8 – Proposed Roadway Section was developed for use in evaluating bridge replacement alternatives.

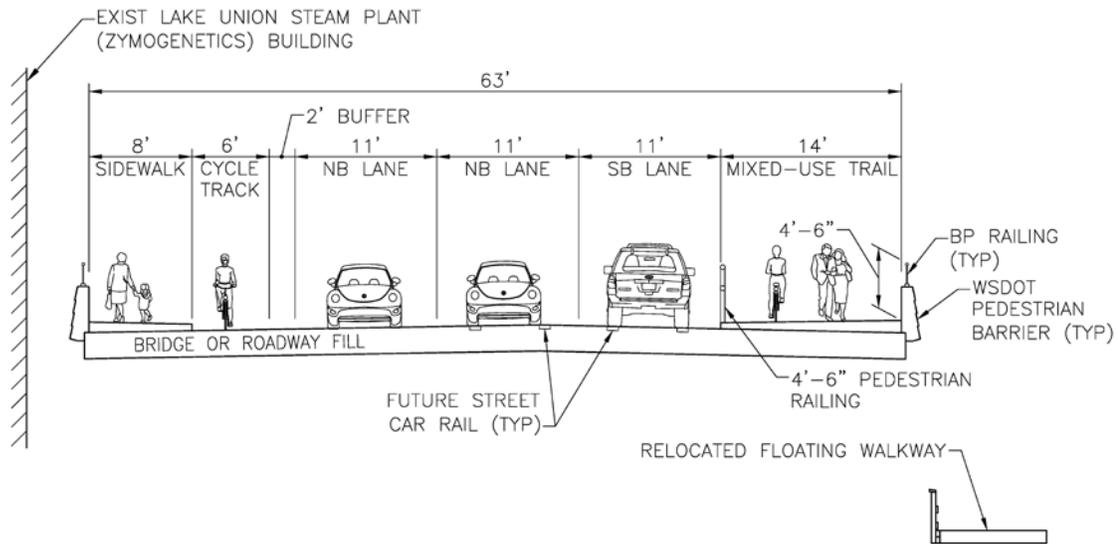
Figure 9 – Proposed Roadway Section with Cycle Track

Subsequent to the selection of a preferred roadway section and the evaluation of the bridge alternatives, Fairview Avenue North was identified by the City as a possible route for a cycle track. Figure 9 was developed to show that the current proposed width of 63-feet does not preclude the addition of a cycle track across the bridge. The proposed roadway section with the cycle track includes three 11-foot-wide lanes (two northbound and one southbound), a 6-foot wide northbound (east side) cycle track separated by a 2-foot wide buffer, an 8-foot-wide sidewalk on the east side and a 14-foot-wide mixed-use trail on the west side.

The impact of the cycle track and how it would tie-in to the roadway north and south of the bridge has not been evaluated at this time. While fatal flaws are not expected, it will likely require the modification of the intersection at Eastlake north of the bridge, as well as roadway and sidewalk modifications extending south of the bridge. The discussions under the Bridge Replacement Alternative Evaluation section are based on Figure 8. All three alternatives can accommodate Figure 9; however, Alternative R4 would require a wider section.

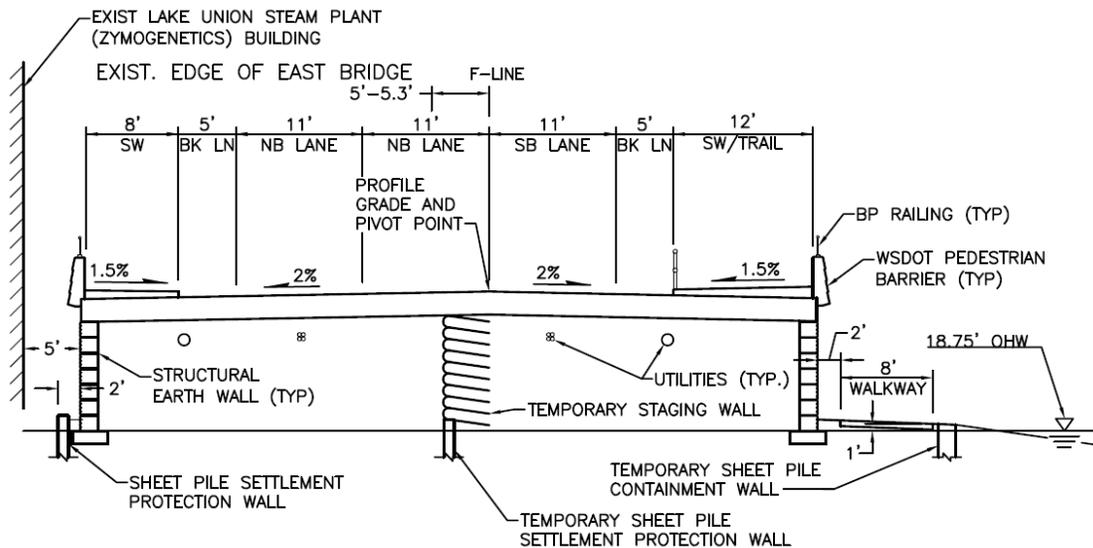
Figure 10 – Alternative F1 Typical Section

Alternative F1 would completely replace the existing East and West Fairview Avenue North Bridges (Bridge No. 069 & 070) with a roadway fill section that would place an extensive amount of fill in the lake and a small structure to maintain the existing private-pedestrian walkway. The roadway fill would completely replace the bridges and would extend into Lake Union approximately 175 feet. Fill above the ordinary high water mark would be retained using structural earth walls. A preliminary typical section can be seen in Figure 10. A preliminary layout for Alternative F1 can be seen in Appendix D.

The roadway section would be shifted west to facilitate the staging needed to maintain two lanes of traffic and one sidewalk during construction. For reference the 8-foot east sidewalk would be shifted 3½-feet west. The wider roadway section will impact the Cheshiahud Trail at the ends of the existing West Bridge. The bottom of the floating walkway could be replaced with a trail on fill set a minimum 1-foot above the ordinary high water line. This would provide opportunities to improve ADA accessibility to the lakeside trail by replacing the stairway with ADA accessible trail profile.

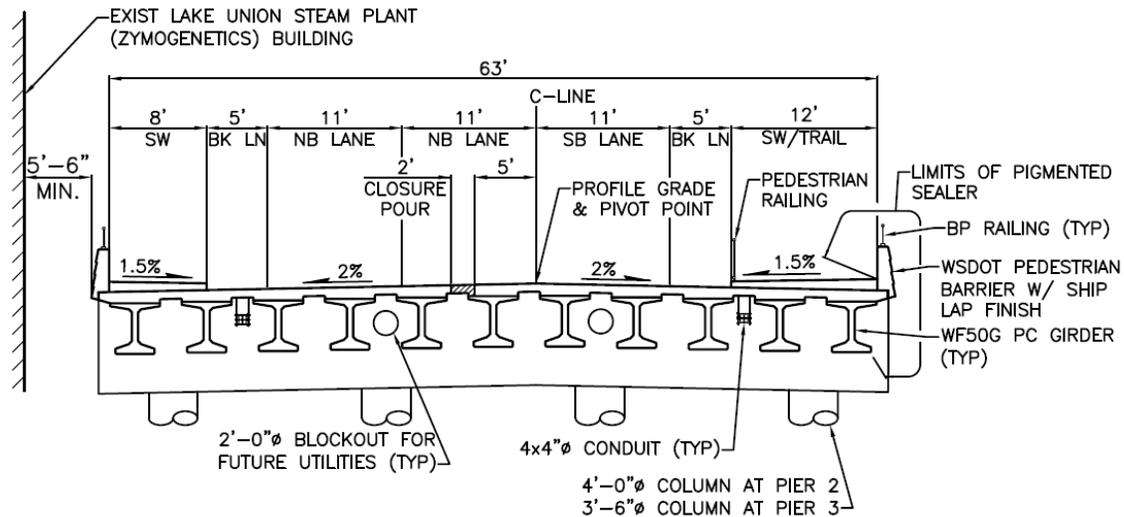
Figure 11 – Alternative C5 Typical Section

Alternative C5 would completely replace the existing East and West Fairview Avenue North Bridges (Bridge No. 069 & 070) with a single bridge. The replacement bridge would have a length of 410 feet, a width of 66 feet, and consist of three 135-foot-long spans with the northern abutment located at the northern end of the existing bridges. The new southern abutment would be north of the existing East and West Bridge abutments by approximately 72 feet and 91 feet respectively. This would result in placing fill below the ordinary-high-water mark at the southern end of the replacement bridge. A typical section of Alternative C5 can be seen in Figure 11. A preliminary layout and typical section for Alternative C5 can be seen in Appendix D

The roadway section would be shifted west to facilitate the staging needed to maintain two lanes of traffic and one sidewalk during construction. For reference the 8-foot east sidewalk would be shifted 3½-feet west. The wider bridge would impact the Cheshiahud Trail at the ends of the existing West Bridge and would require relocation of the floating walkway. This would provide opportunities to improve ADA accessibility to the floating walkway. The bridge would include three 11-foot wide traffic lanes, two 5-foot wide bike lanes, one 8-foot wide sidewalk, and one 12-foot wide shared-use path. A raised bridge profile would provide positive stormwater drainage to the ends of the bridge via gutter flow and enable the existing private-pedestrian walkway to remain under the bridge.

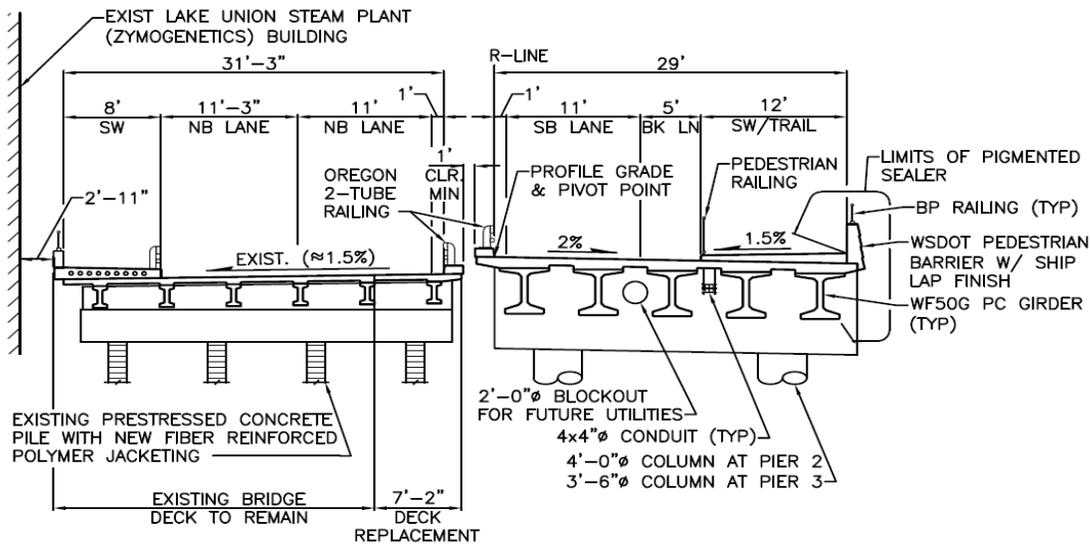
Figure 12 – Alternative R4 Typical Section

Alternative R4 would replace only the existing West Bridge (Bridge No. 070). The bridge configuration and layout would be nearly identical to Alternative C5 except that only the first phase of the bridge would be constructed during this project and would have a width of 32 feet. The second phase could be constructed at later date when it becomes necessary to replace the existing East Bridge. This would be required if the South Lake Union Streetcar line were extended across the bridge because the existing East Bridge is not capable of supporting the streetcar loading. A typical section of Alternative R4 can be seen in Figure 12. A preliminary layout, typical section, and construction staging for Alternative R4 can be found in Appendix D.

The key difference between Phase 1 of Alternative C5 and Alternative R4 would be the placement of median barriers on the new West Bridge and the existing East Bridge due to the raised profile of the new West Bridge. A portion of the East Bridge deck would need to be reconstructed to support the barrier. In addition to this change, the existing East Bridge would be evaluated during final design for strengthening and seismic retrofit which could include jacketing of the existing prestressed pile supports.

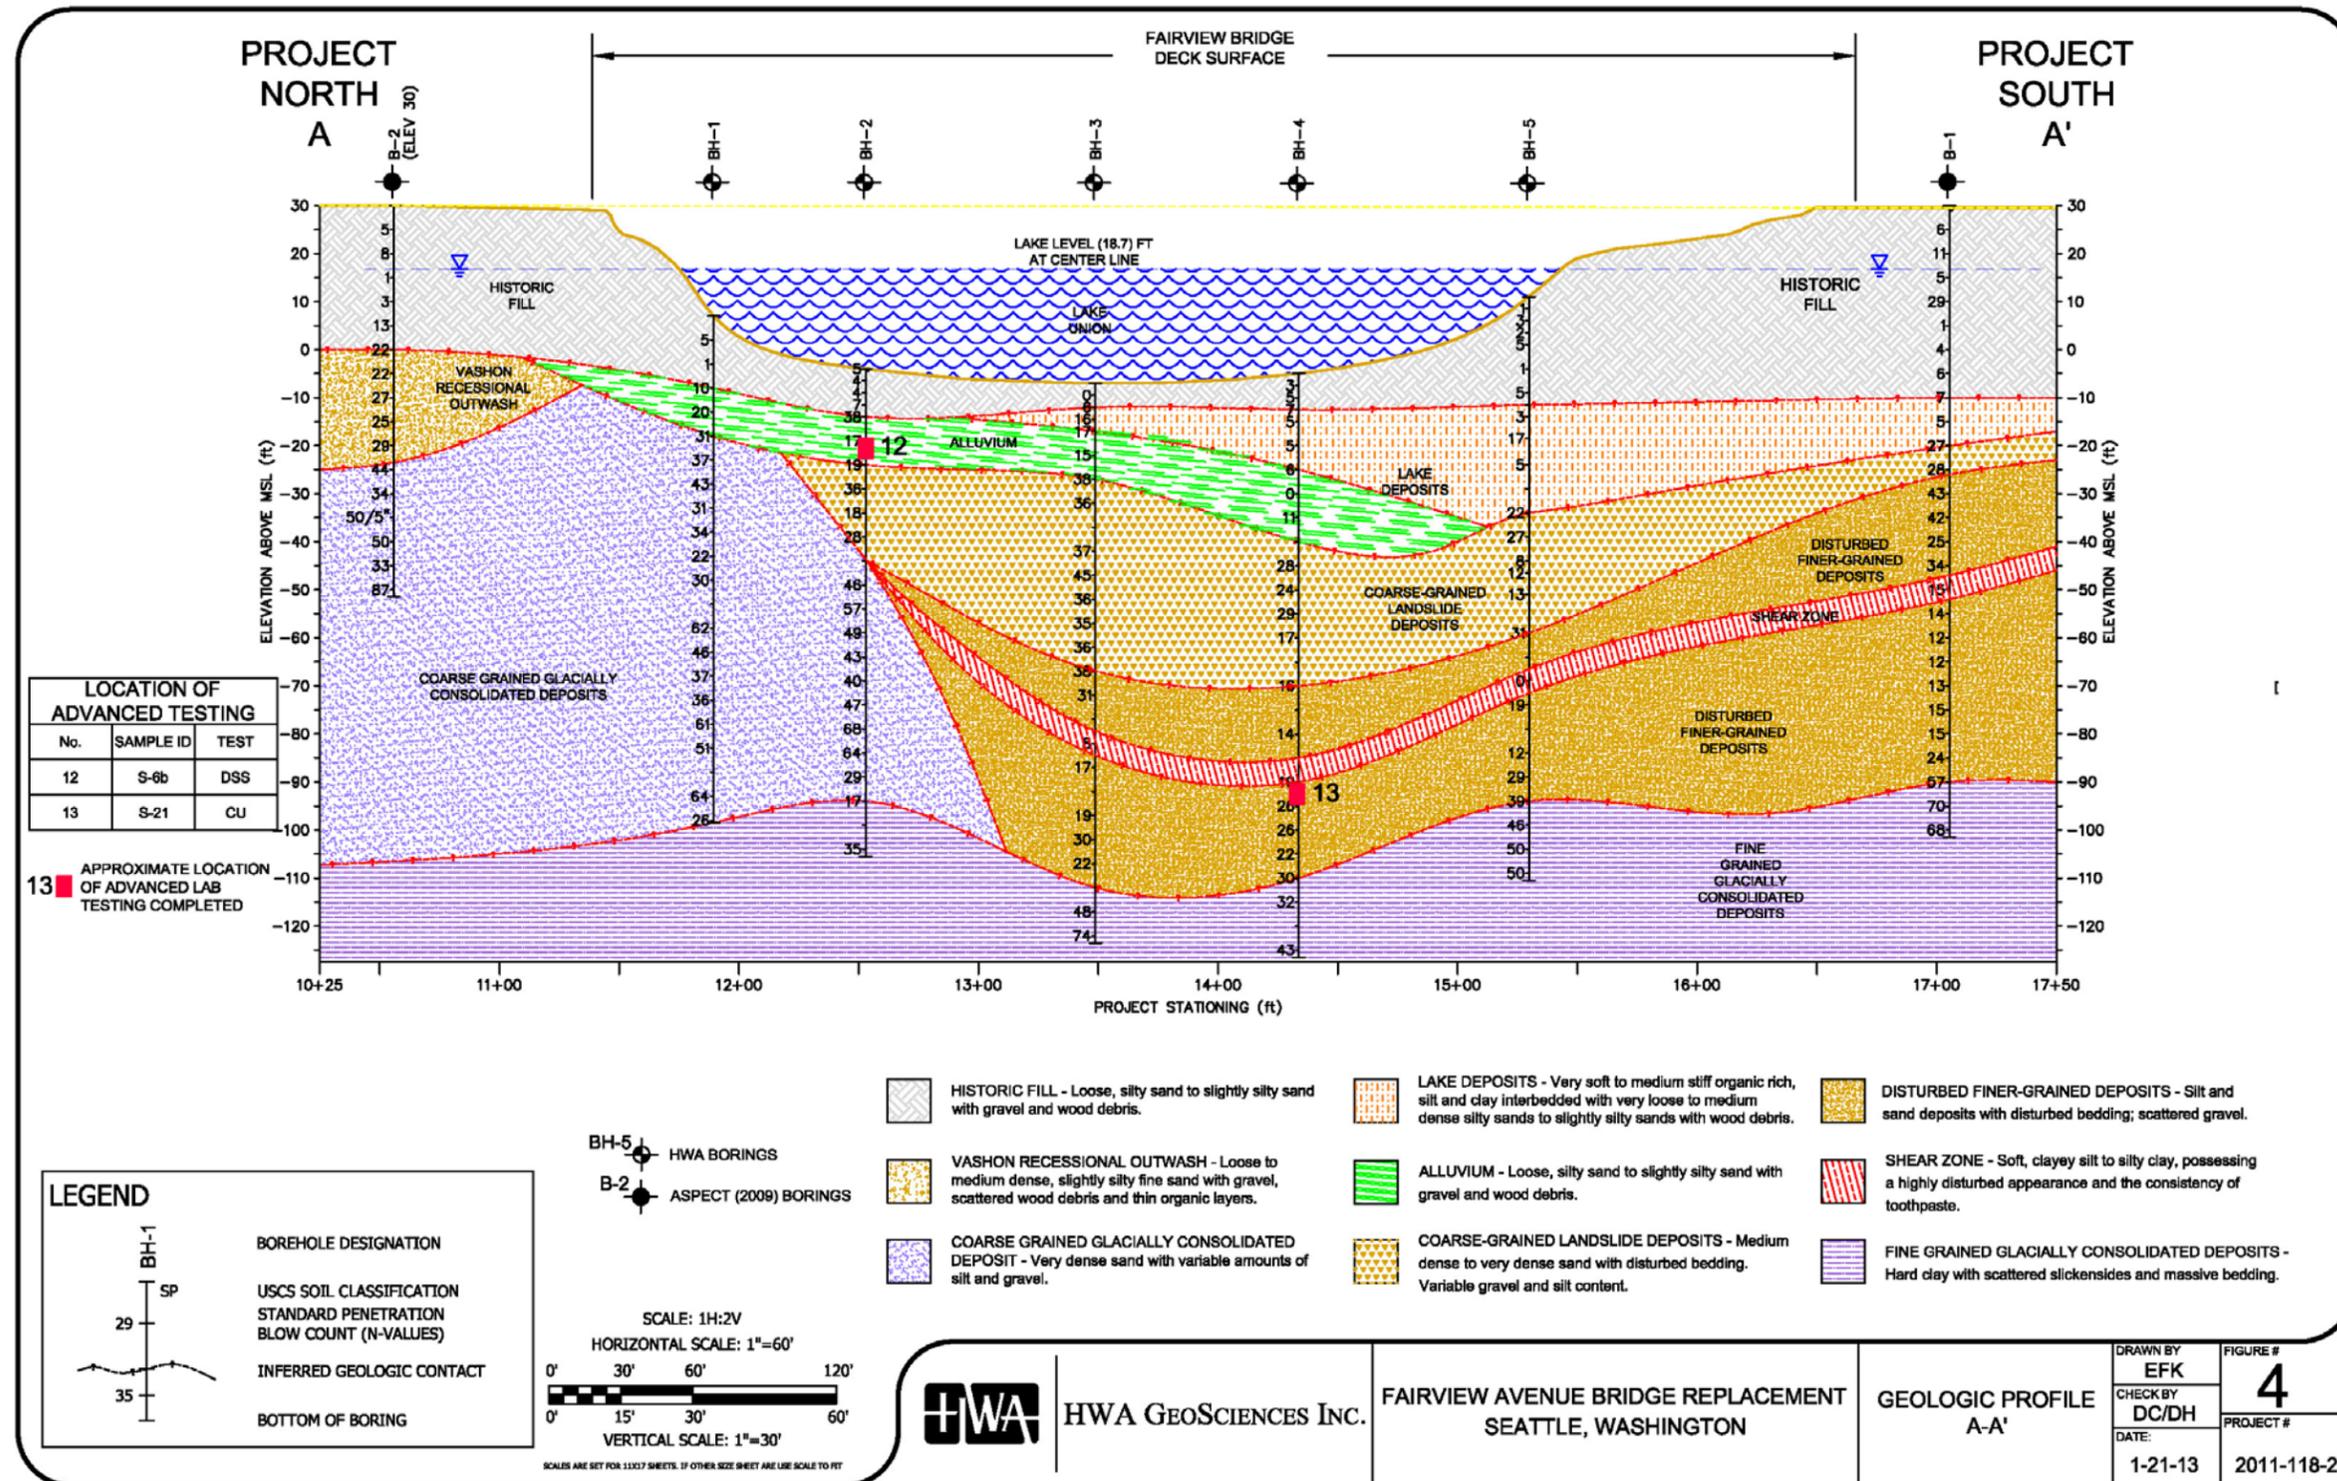
Figure 13 – North-South Geologic Profile

Construction of the fill alternative would result in applying additional load to the driving side of the underlying landslide mass. The application of this load would result in a reduction in the stability of the slope with respect to the current condition. According to the Final Geotechnical Report, with the fill alternative, potential ground movement associated with re-mobilization of the deep-seated failure plane would not represent a life-safety issue (See Appendix F). The fill would move and deform along with the surrounding ground, whereas a bridge would need to resist such deformation. However, global stability mitigation measured would be required to offset the reduction in stability associated with construction of the fill alternative. Two large diameter cylindrical pile walls with 8-foot diameter shafts on 16-foot centers are considered an appropriate global stability mitigation option if the fill alternative is chosen.
