Fairview Avenue N Bridge Replacement Project

Appendix B

Cultural Resources Discipline Report (Redacted Version)

Fairview Avenue North Bridge

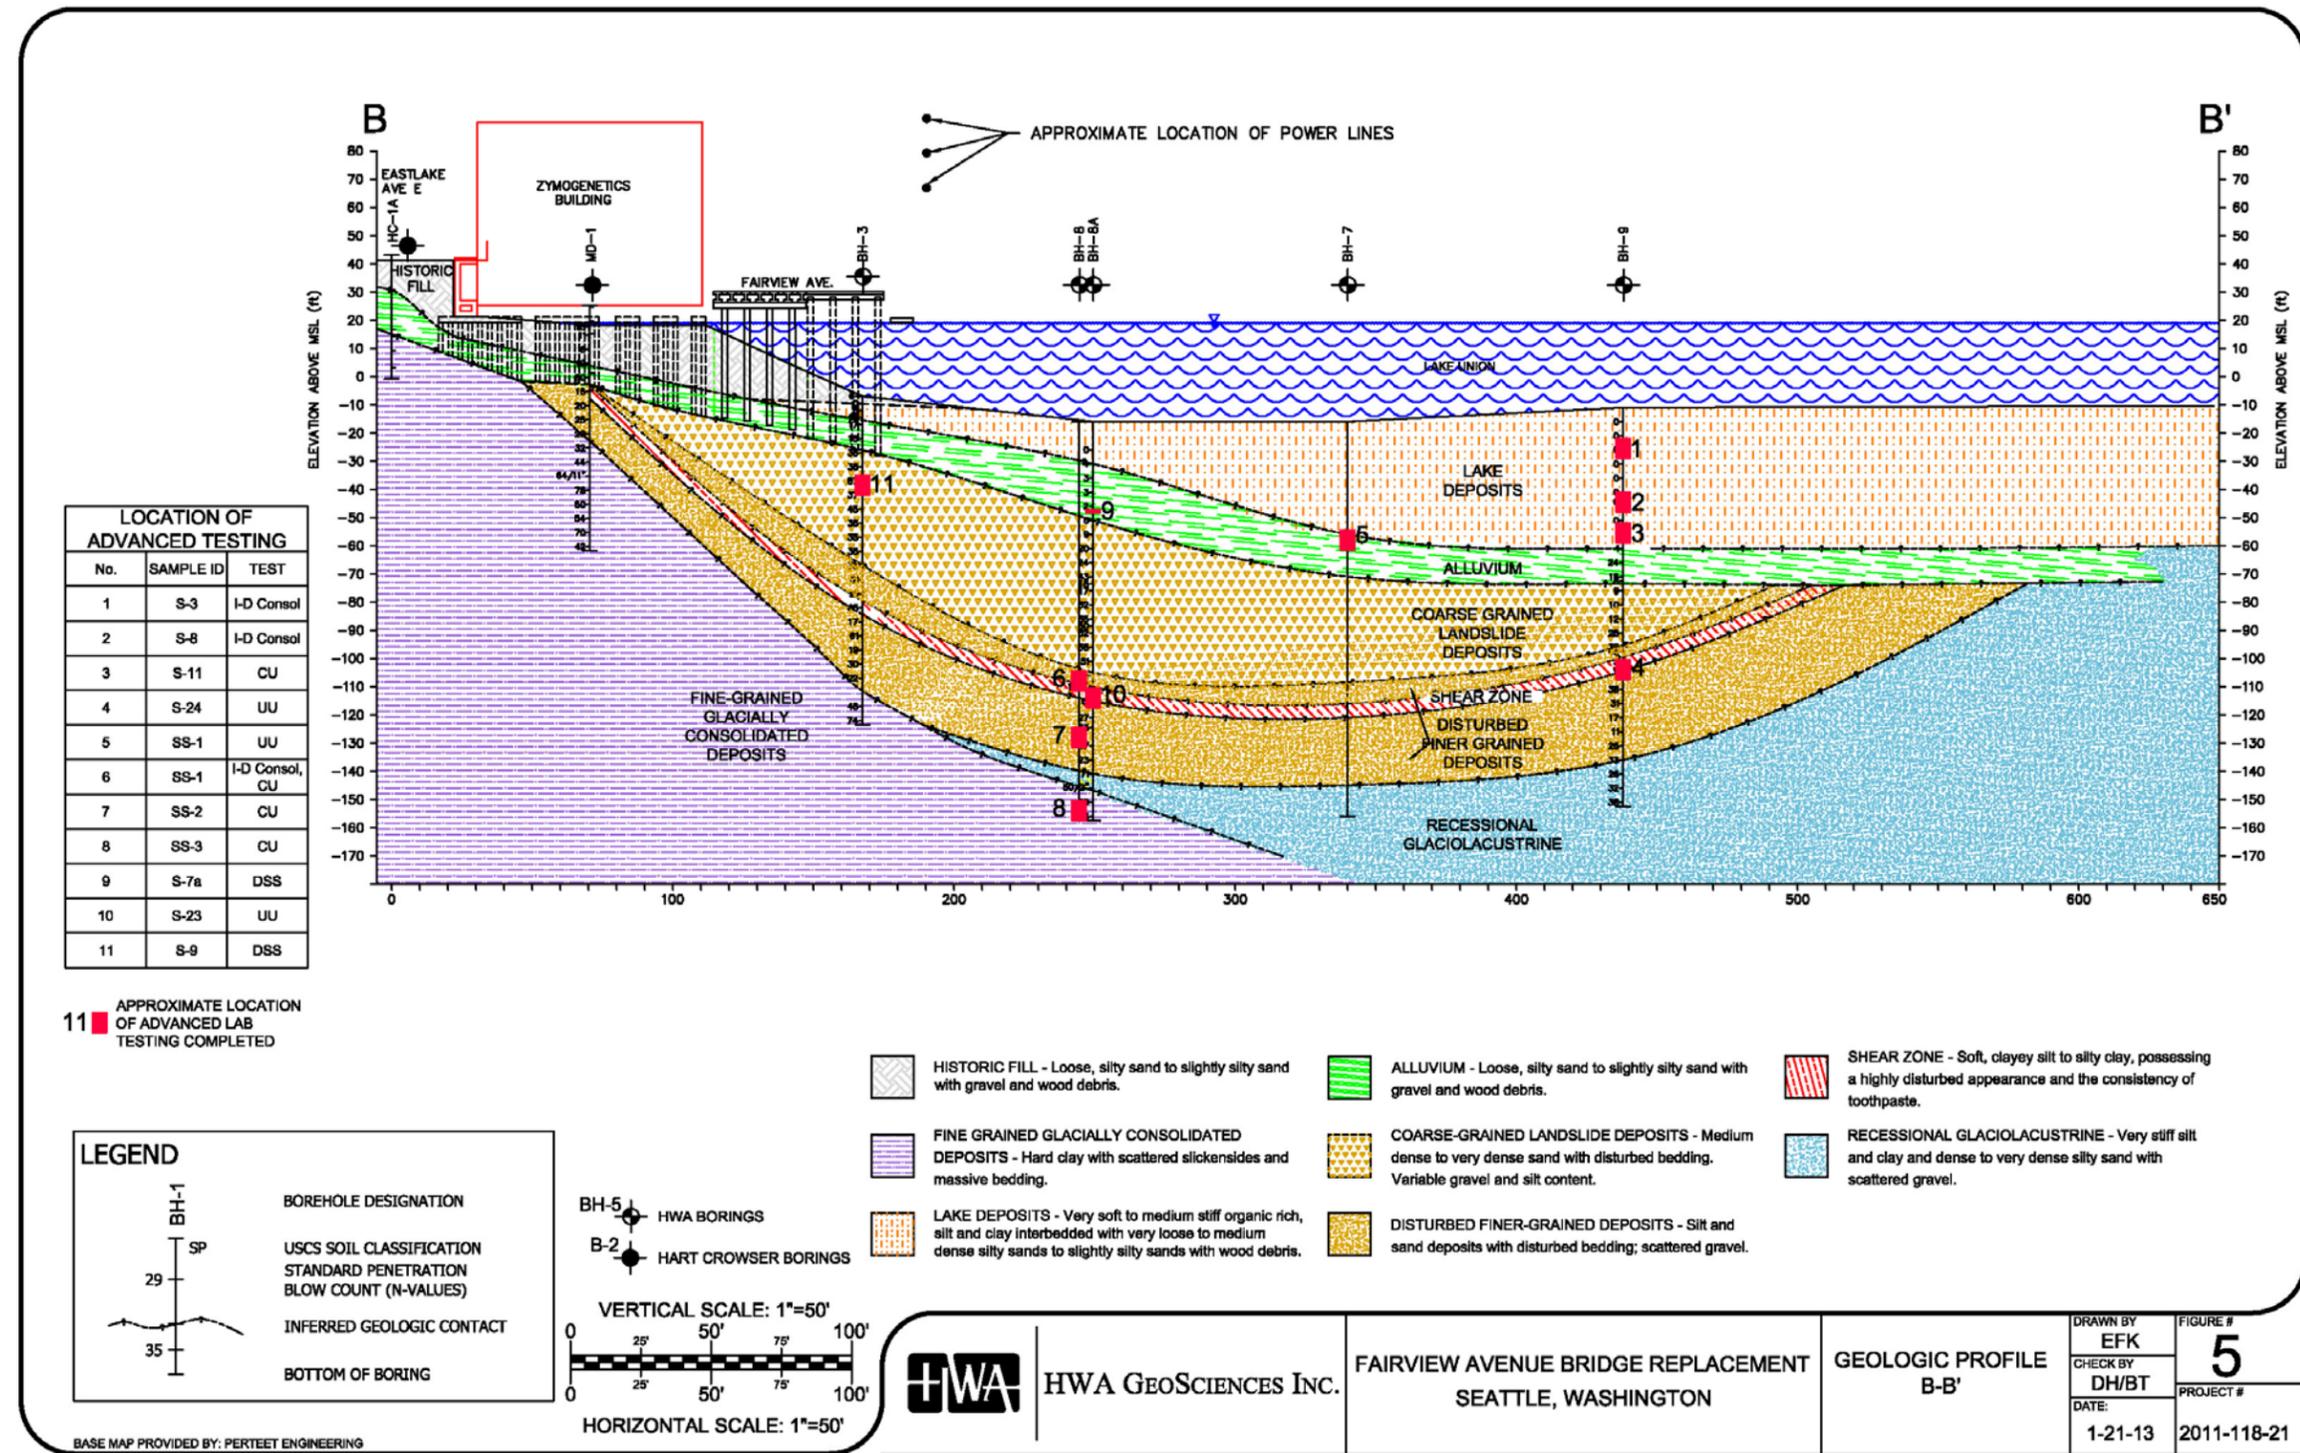
Figure 14 – East-West Geologic Profile

In addition, with the F1 alternative, a settlement protection wall would be required along the ZymoGenetics building. This could be a sheet pile wall, installed by vibratory or push-in methods, to depths at or below the existing timber piles supporting the ZymoGenetics building. Push-in methods will produce the least amount of vibration and impact to ZymoGenetics. However, there is a high likelihood of encountering obstructions at this site (in the form of old bridge and construction piling) and it may be necessary to vibrate or drive the sheet pile through the obstruction. This wall would reduce or eliminate the potential for consolidation settlement in the disturbed deposits below the ZymoGenetics building. With staged construction, a settlement protection wall could also be required along the centerline of the roadway to protect the eastern bridge during construction.

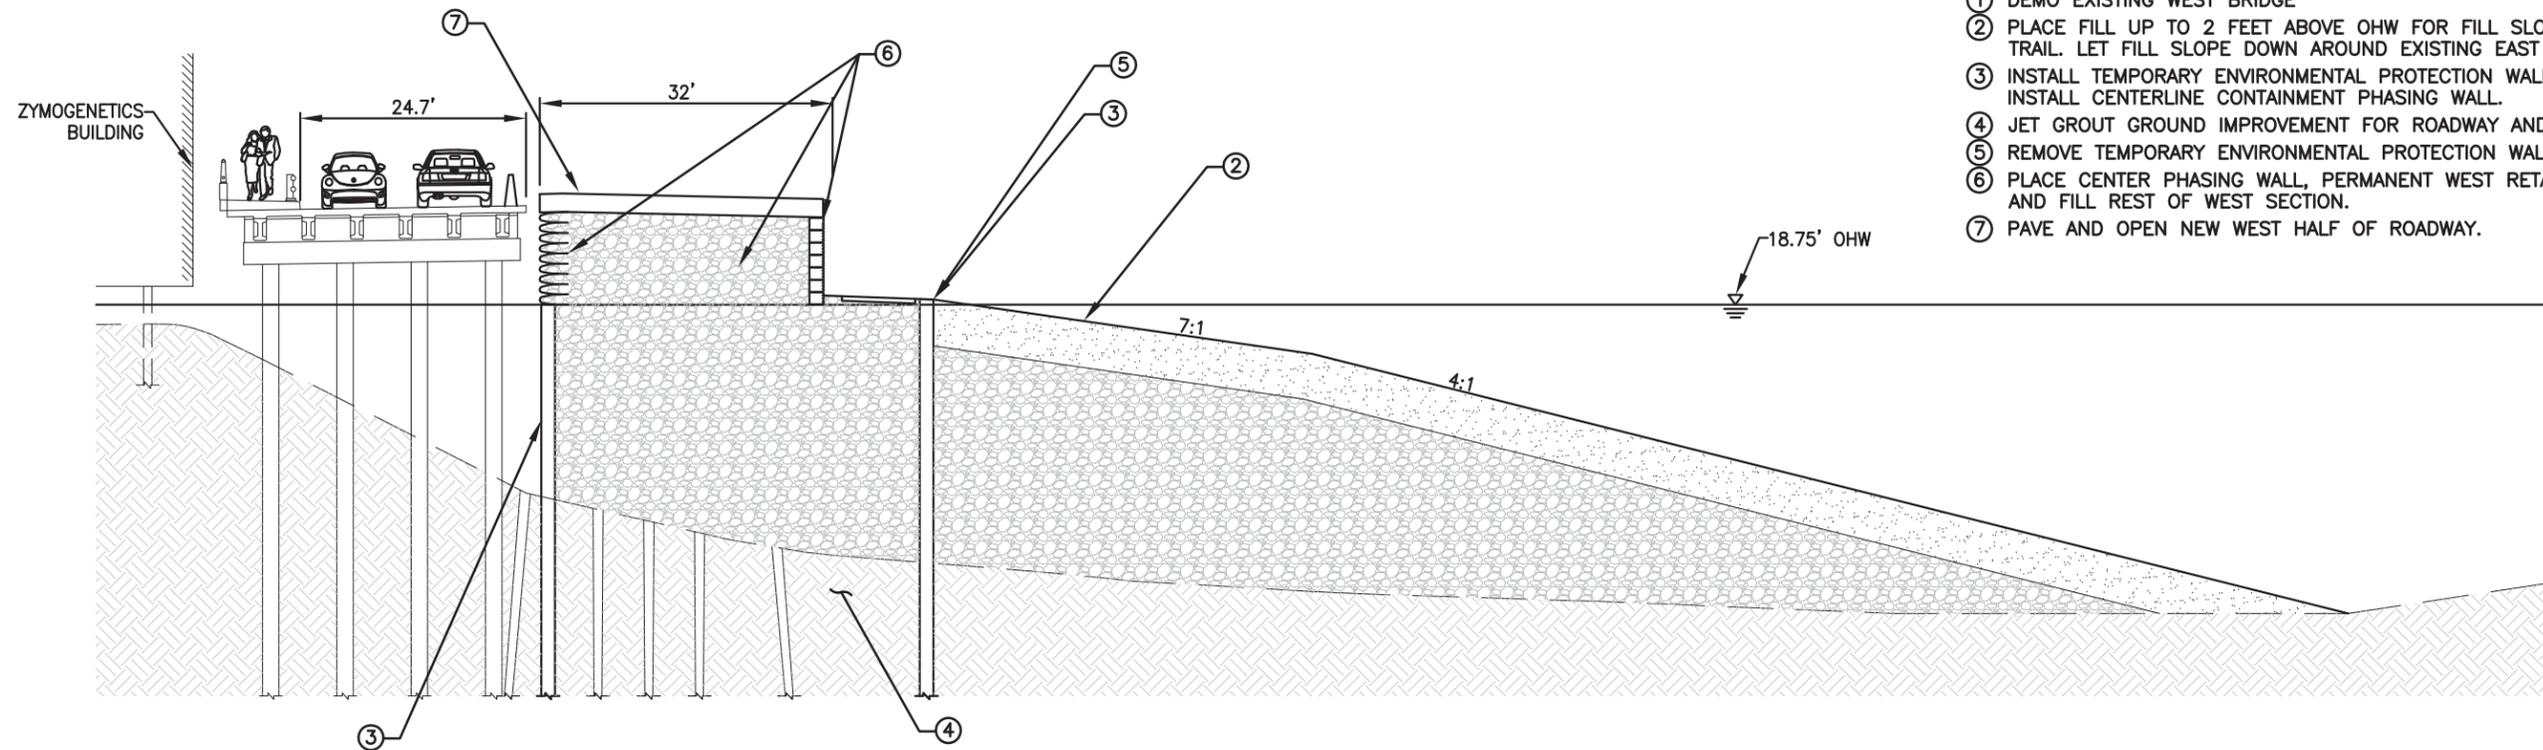
WEST FILL

- ① DEMO EXISTING WEST BRIDGE
- ② PLACE FILL UP TO 2 FEET ABOVE OHW FOR FILL SLOPE AND LAKESIDE TRAIL. LET FILL SLOPE DOWN AROUND EXISTING EAST BRIDGE PILING.
- ③ INSTALL TEMPORARY ENVIRONMENTAL PROTECTION WALL. INSTALL CENTERLINE CONTAINMENT PHASING WALL.
- ④ JET GROUT GROUND IMPROVEMENT FOR ROADWAY AND TRAIL FOOTPRINT.
- ⑤ REMOVE TEMPORARY ENVIRONMENTAL PROTECTION WALL.
- ⑥ PLACE CENTER PHASING WALL, PERMANENT WEST RETAINING WALL, AND FILL REST OF WEST SECTION.
- ⑦ PAVE AND OPEN NEW WEST HALF OF ROADWAY.

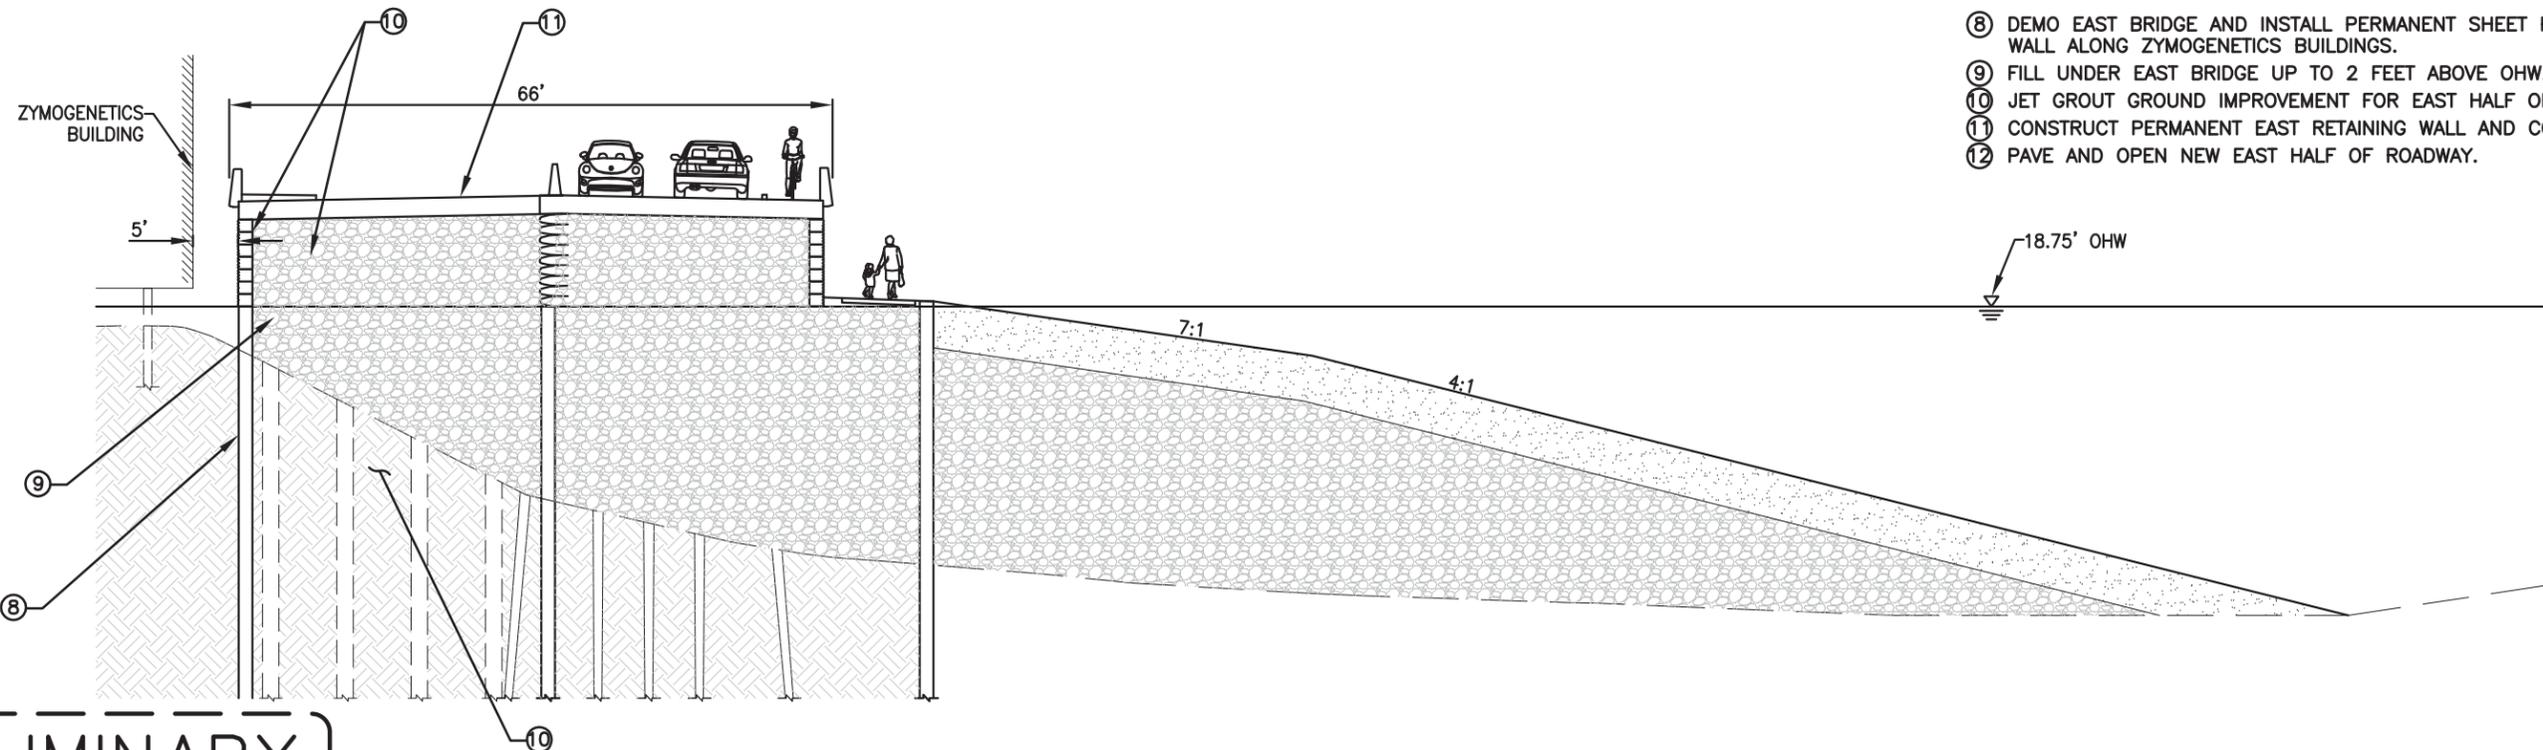
EAST FILL

- ⑧ DEMO EAST BRIDGE AND INSTALL PERMANENT SHEET PILE ISOLATION WALL ALONG ZYMOGENETICS BUILDINGS.
- ⑨ FILL UNDER EAST BRIDGE UP TO 2 FEET ABOVE OHW.
- ⑩ JET GROUT GROUND IMPROVEMENT FOR EAST HALF OF ROADWAY.
- ⑪ CONSTRUCT PERMANENT EAST RETAINING WALL AND COMPLETE FILL.
- ⑫ PAVE AND OPEN NEW EAST HALF OF ROADWAY.

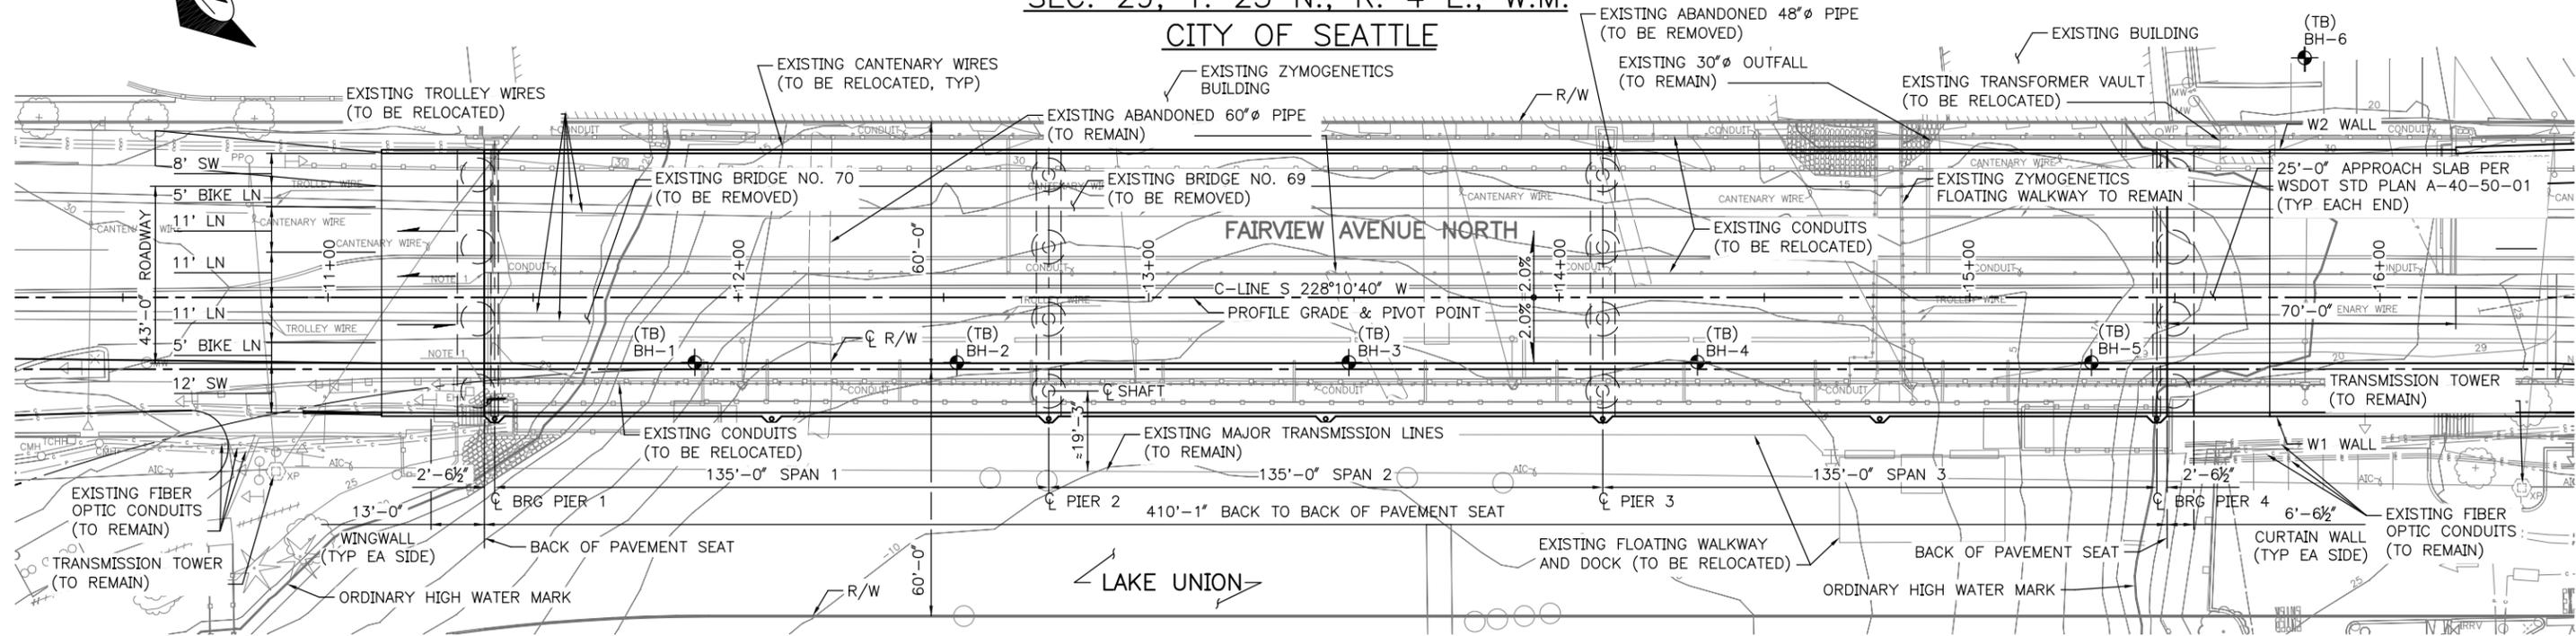
PLAN

(BEARING OF ALL PIERS ARE NORMAL TO C-LINE)

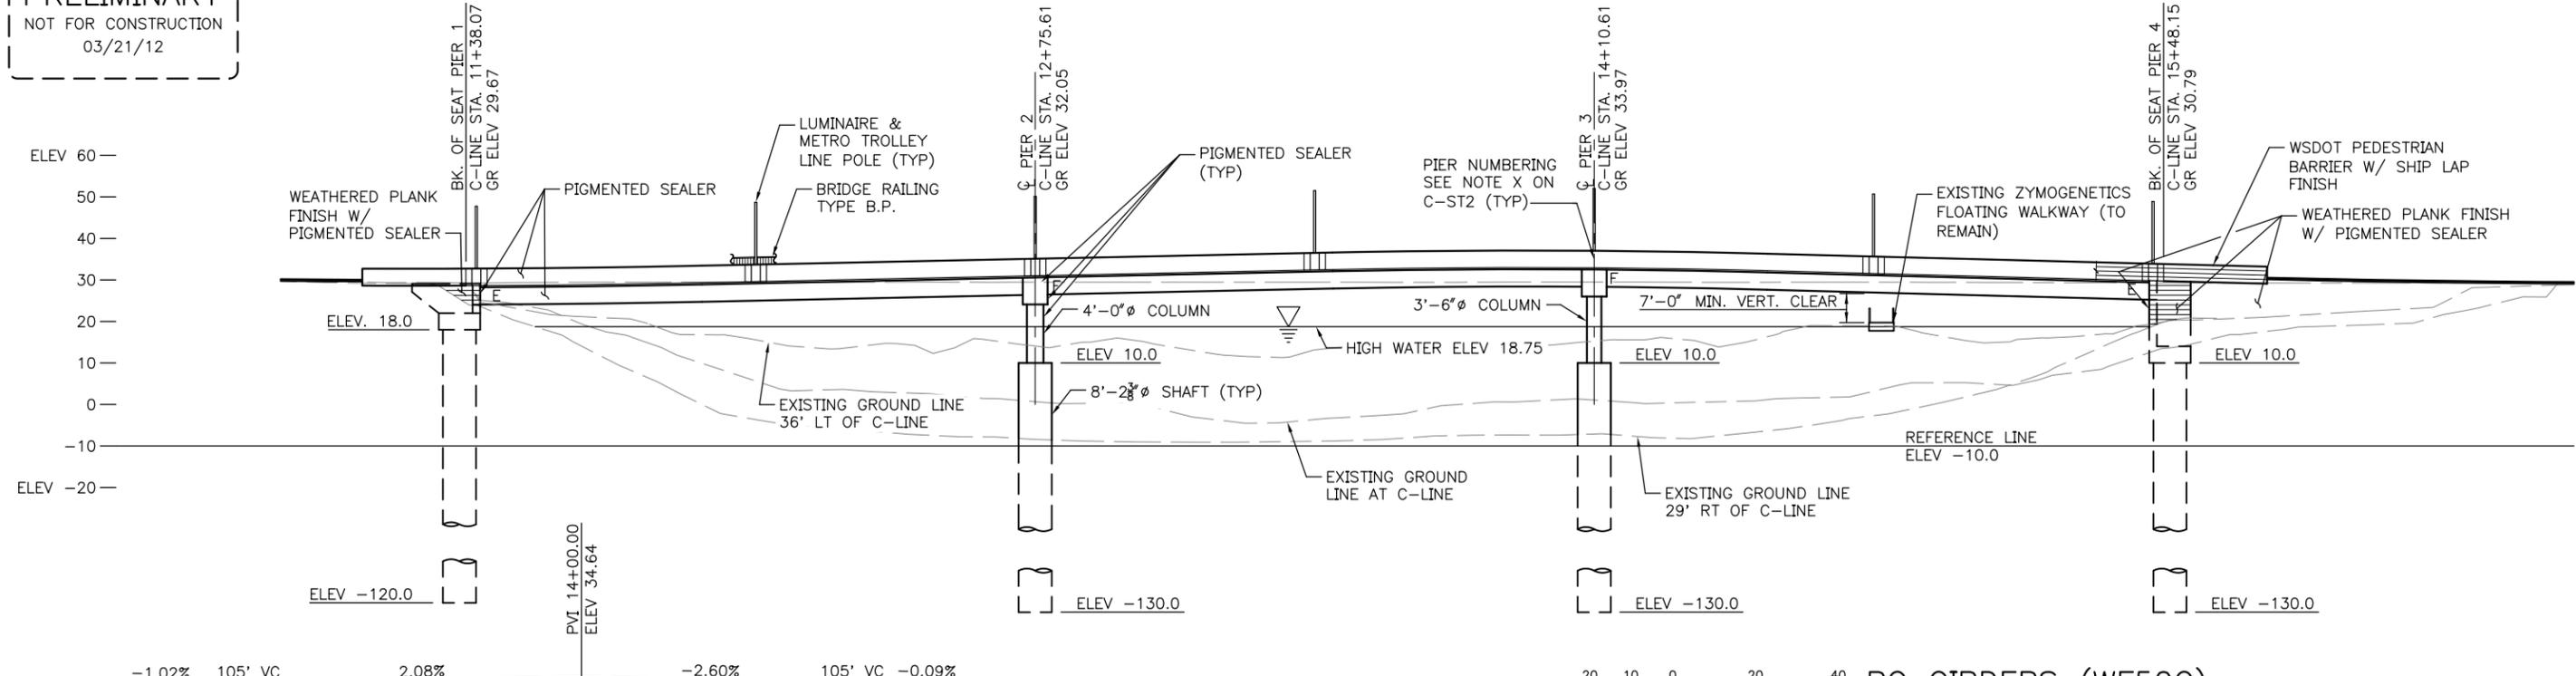
ELEVATION

GRADE ELEVATIONS SHOWN ARE FINNISH GRADE AT TOP OF ROADWAY SLAB ON C-LINE AND ARE EQUAL TO PROFILE GRADE.

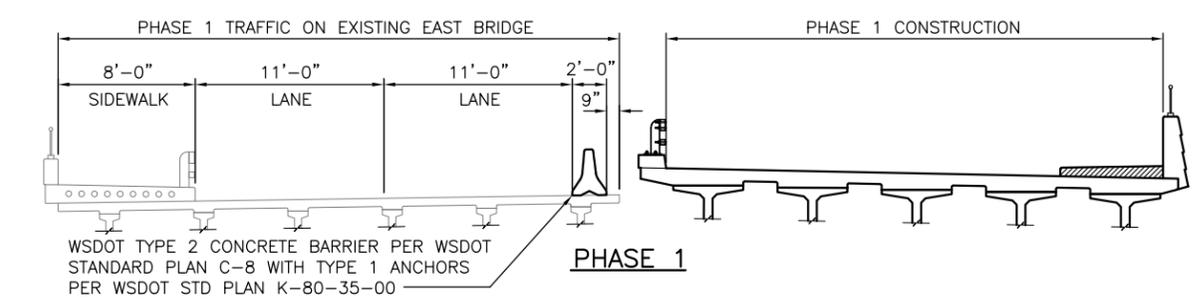
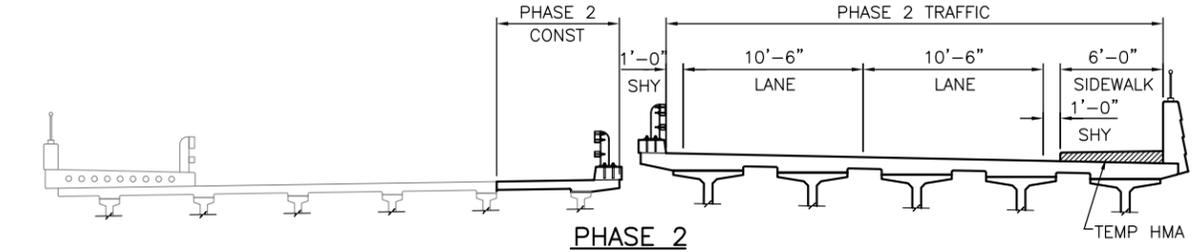
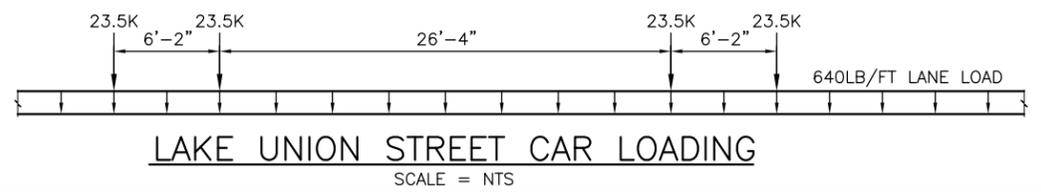
DECK REPLACEMENT
TYPICAL SECTION
 SCALE 3/8" = 1'-0"

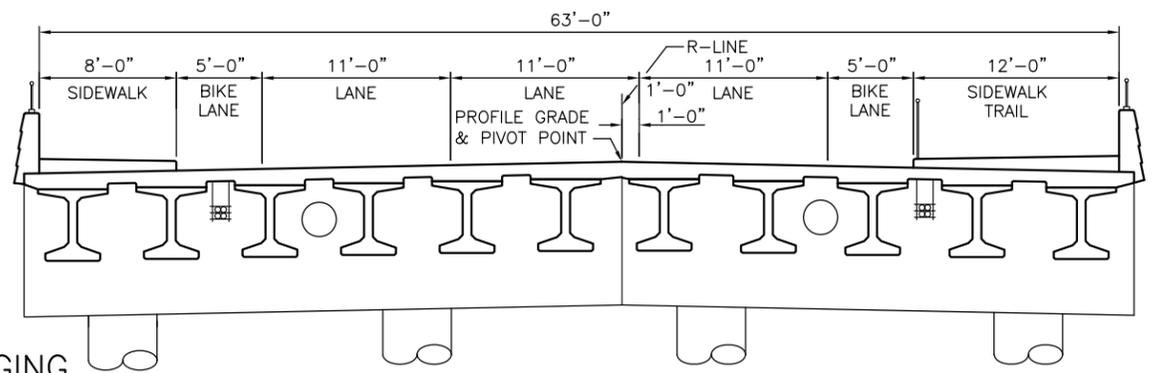
FUTURE PHASE

FUTURE TYPICAL SECTION

CONSTRUCTION STAGING
 SCALE 3/16" = 1'-0"
