Triangle Hotel and Bar (Flatiron Building)

Pioneer Square Preservation Board Briefing 2

March 25, 2024

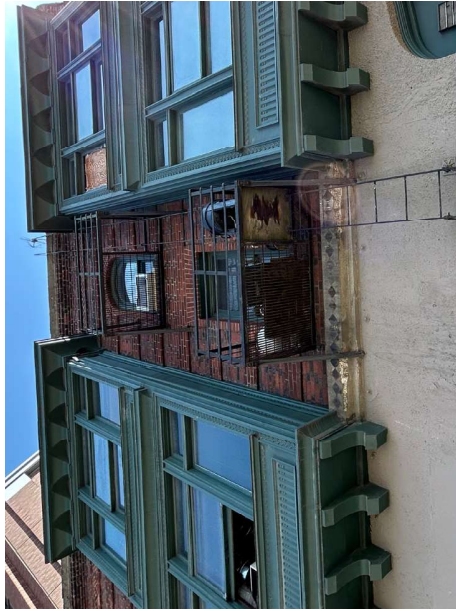
1. EXISTING FIRE ESCAPE

- The eight rooms on the upper levels were demolished and the spaces were remodeled into studio apartments.
- The ground level west entry has been infilled and restrooms were constructed on this floor.
- A fire escape was added to the west side of the building servicing the apartments.

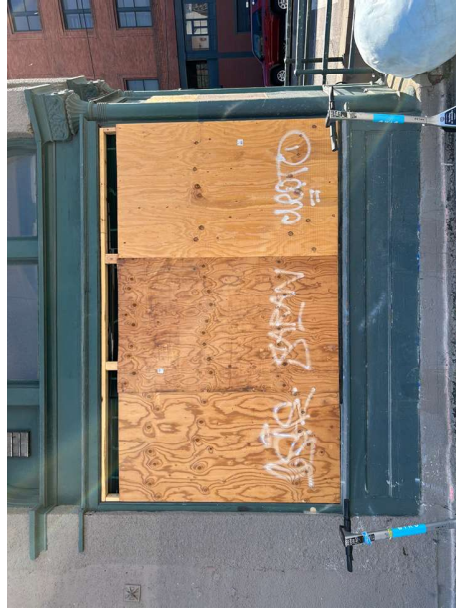
2. DAMAGED AND ROTTING STOREFRONT AT WEST ELEVATION

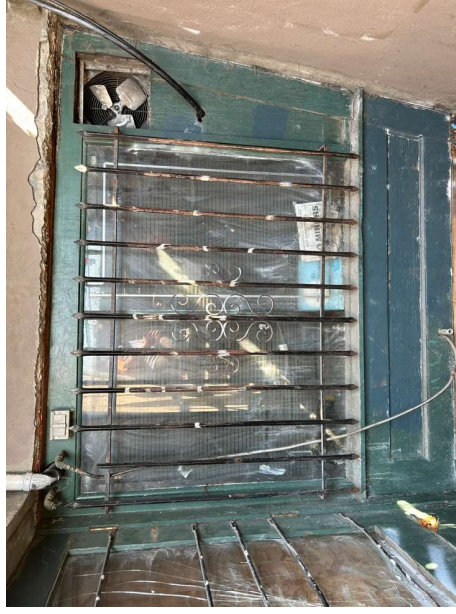
DOOR AND WINDOW WALL AT BOTTOM OF STEPS AT AREAWAY

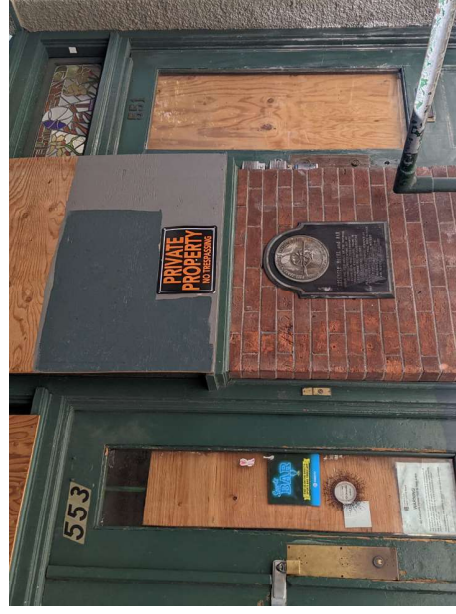
ENTRY TO PUB (LEFT) AND RESIDENCES (RIGHT) WITH STAINED GLASS TRANSOM

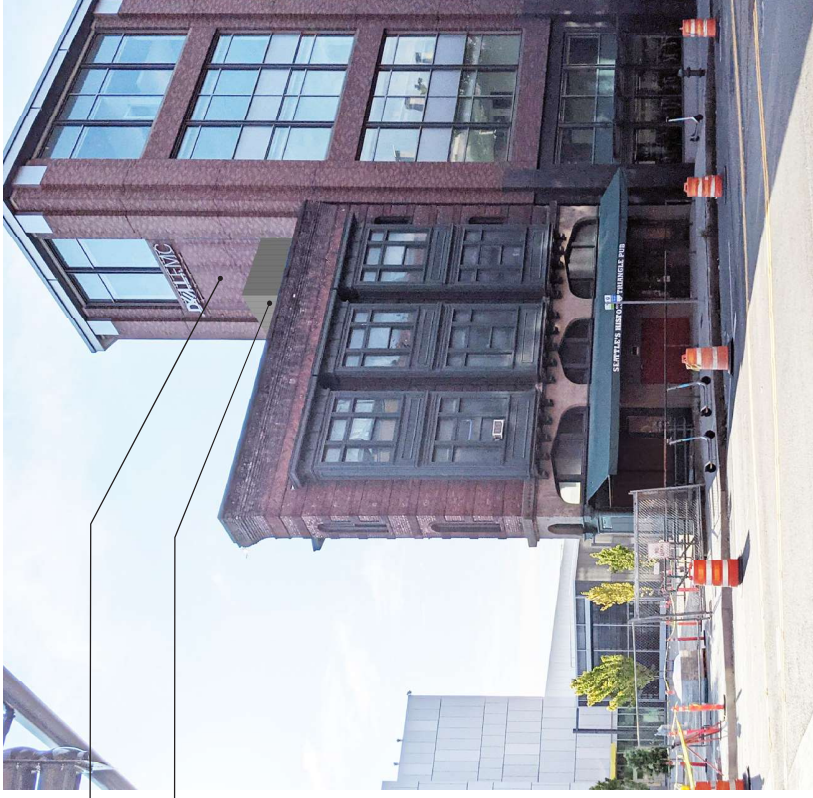
PROPOSED STAIR ENCLOSURE AT ROOF

BRICK INFILL OF WINDOWS
TO BE COMPLETED BY
NEIGHBORING BUILDING

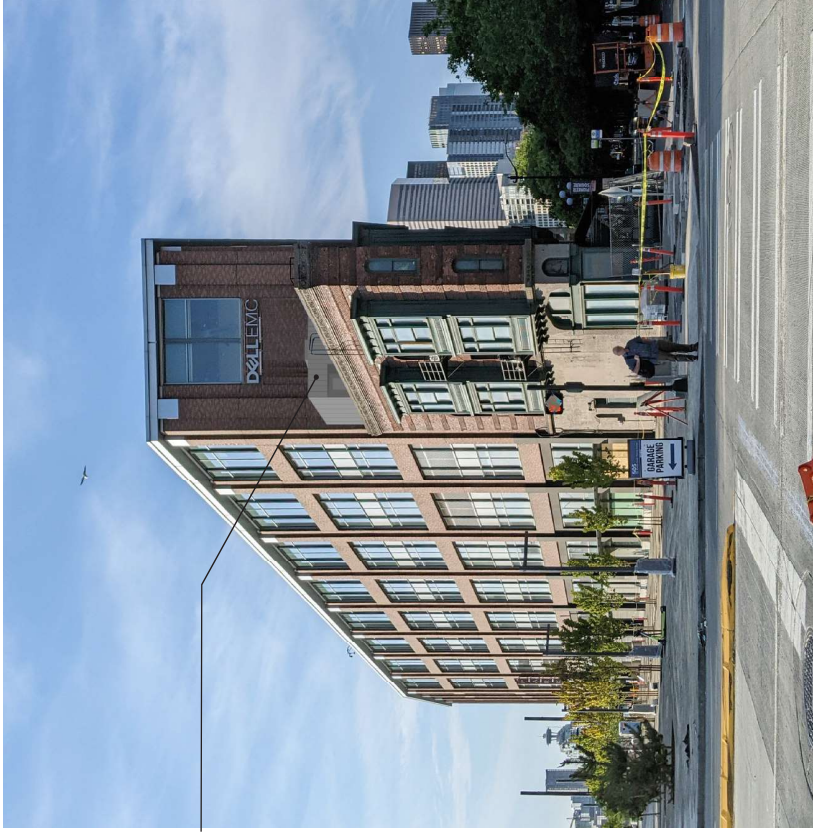
PROPOSED STAIR ENCLOSURE

PROPOSED STAIR ENCLOSURE AT ROOF

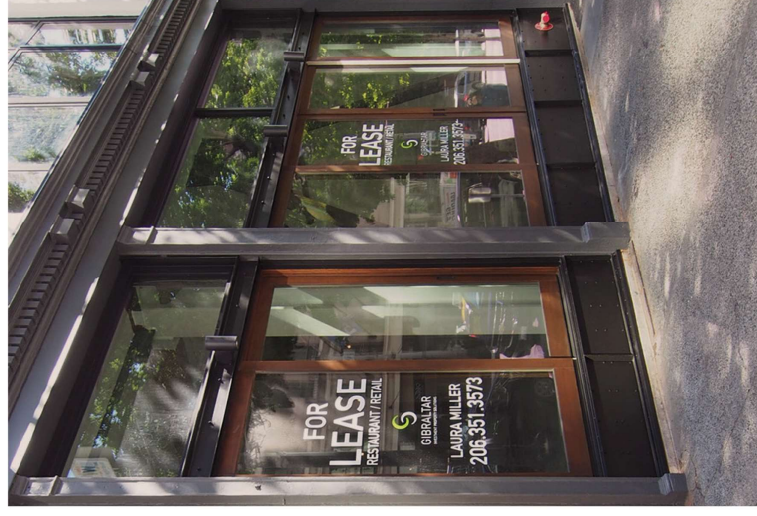
SIMILAR INSTALLATION OF PRODUCT IN SEATTLE - TO BE PAINTED TO MATCH EXISTING
