PSPB COA PROPOSAL - CORRECTIONS

GRAND CENTRAL BLOCK

BRUNSWICK-BALKE-COLLENDER CO + GOTTSTEIN + SQUIRE LATIMER

200 S 1ST ST, Seattle, WA 98104

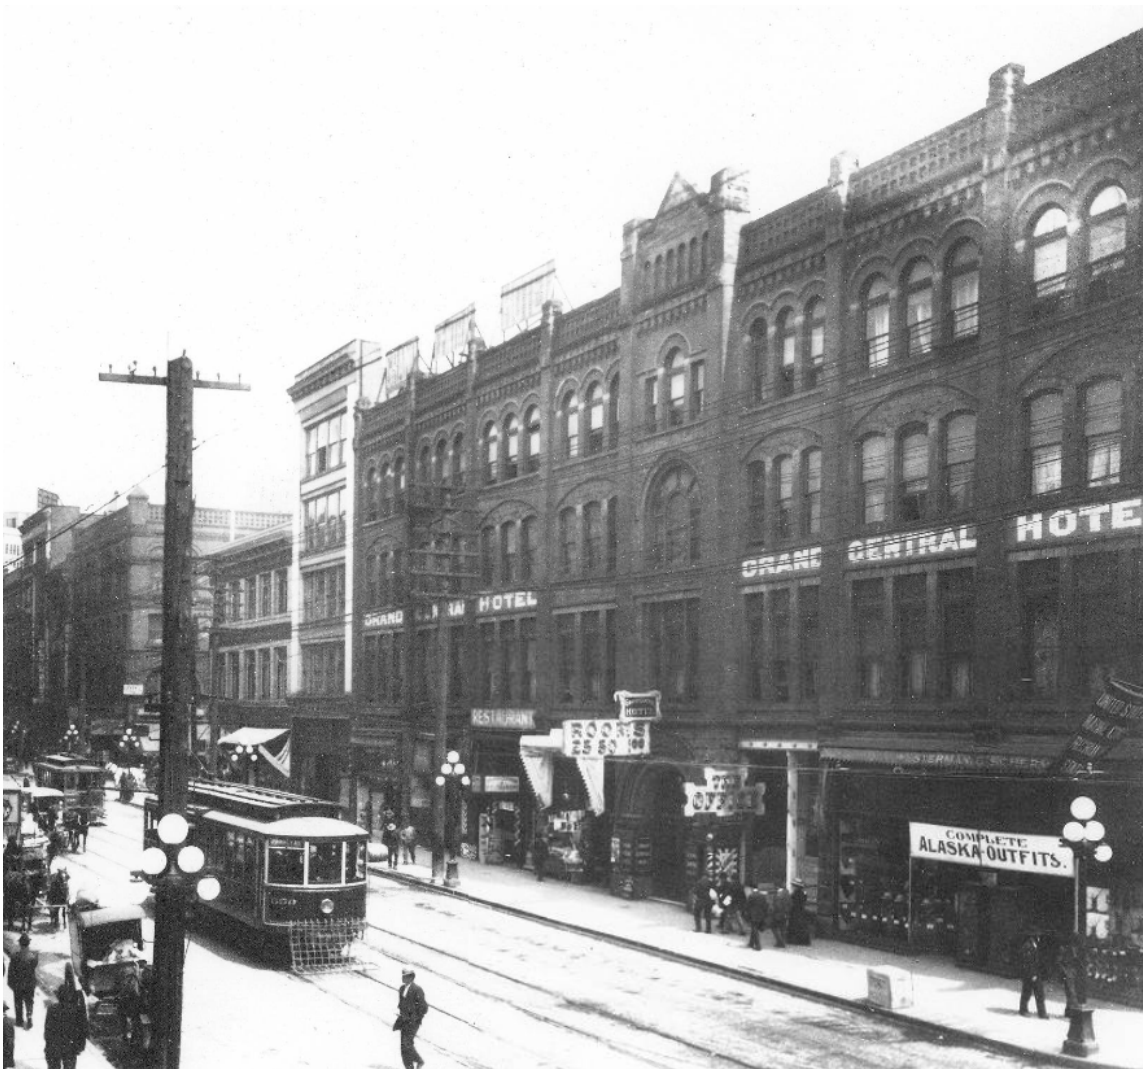
WEST VIEW OF THE BLOCK SHOWING ALL 3 BUILDINGS - 1909

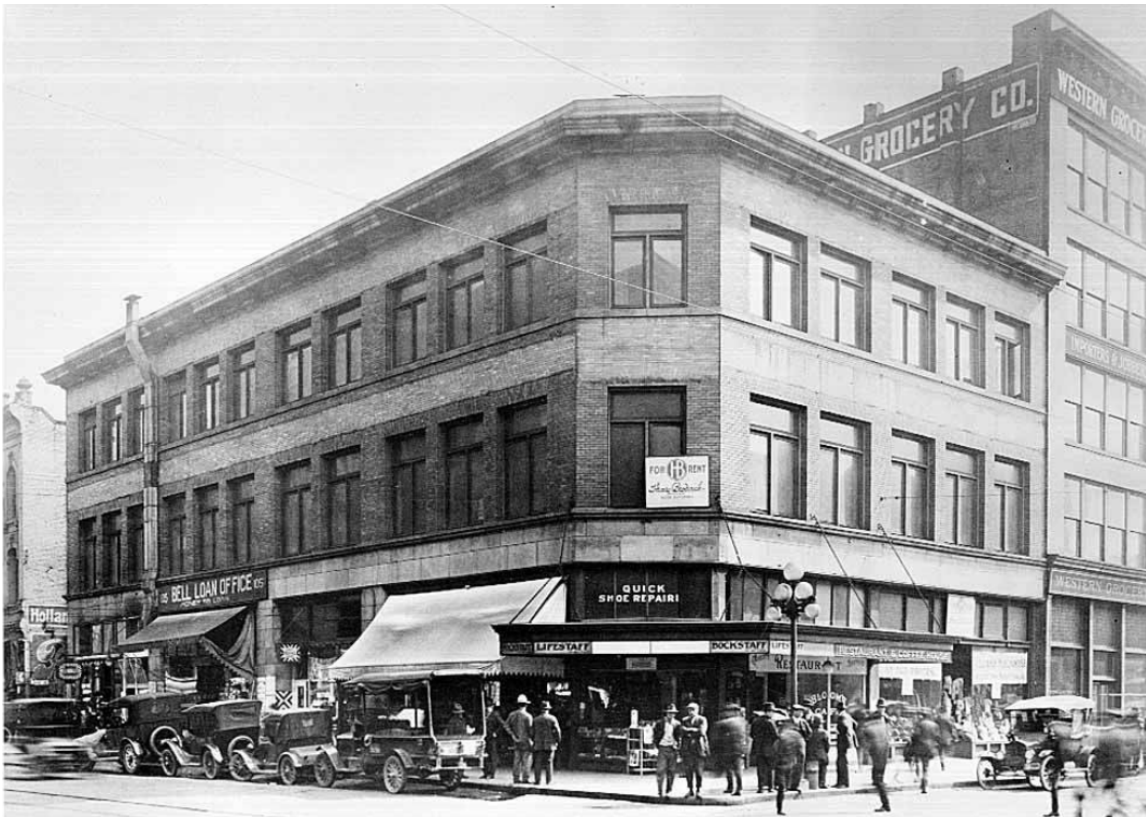
NORTHWEST CORNER OF BUTTNICK - 1915

- Exterior load bearing URM walls
- Chamfered entrance on the northwest corner
- Rectangular 1:2 windows
- Sandstone string courses and sills

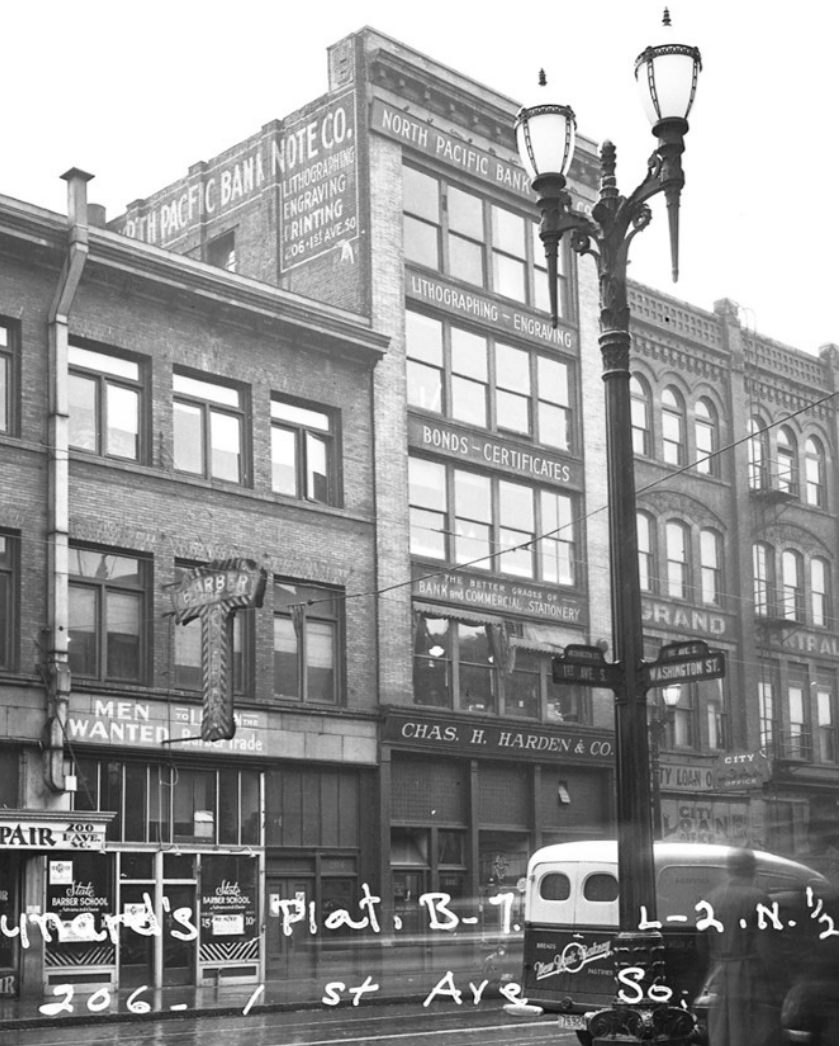
WEST ELEVATION OF CITY LOAN - 1937

- Exterior load bearing URM walls with sandstone and light gray brick on the West facade and red brick on the remaining facades
- Storefront with cast iron header and wood support columns
- Large window bays with cast iron lintels and sandstone sills on the west facade of floors 2-5
- Small double hung windows on the east facade of floors 2-5
- Exterior metal fire escape at alley elevation

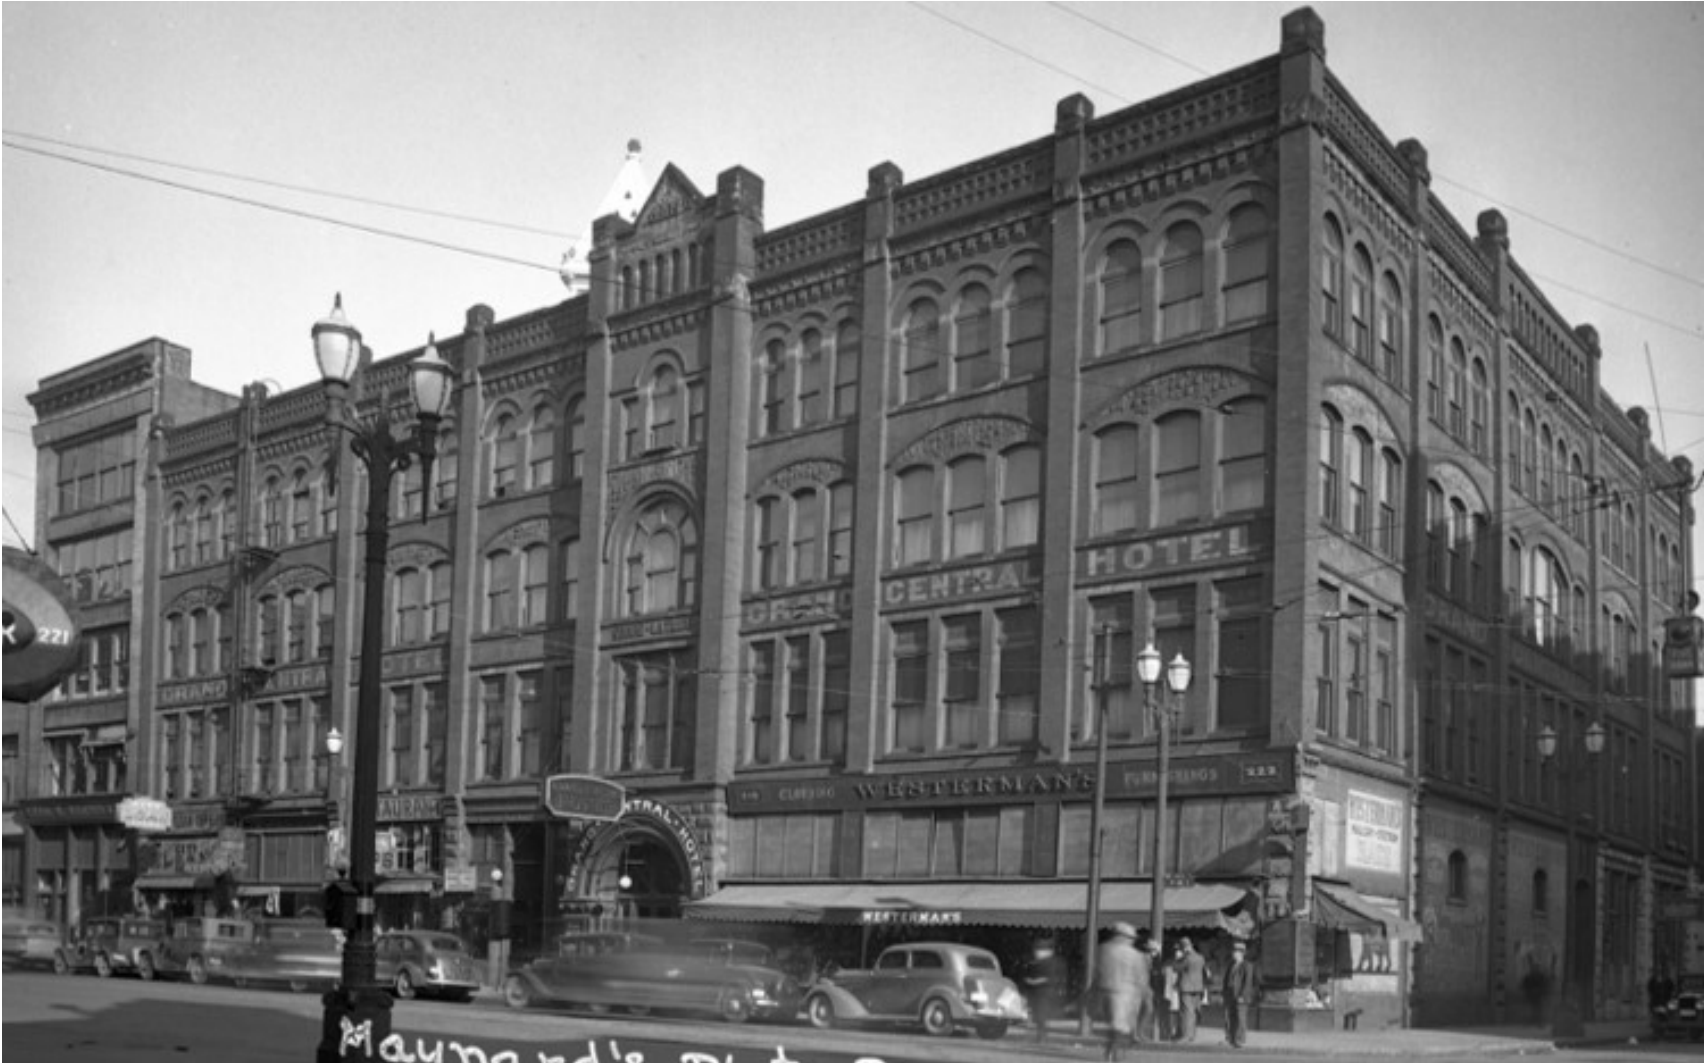
SOUTHWEST CORNER OF GRAND CENTRAL -1937

- Exterior load bearing URM walls
- Slightly asymmetrical primary facades
- Main arched stone entry w/ deeply recessed doorway and stone detailing
- Pilasters (rusticated stone at ground level and brick above)
- Storefronts with cast iron columns and lintels
- Window shape and rhythm: rectangular w/ stained glass at 2nd floor, low arch at 3rd floor, rounded arch at 4th floor; Unique windows at the West entry bay and South center bay
- Sandstone sills, string courses, and other detailing
- Entry lobby with wood staircase around an elevator shaft
- Interior light wells from 2nd to 4th floor

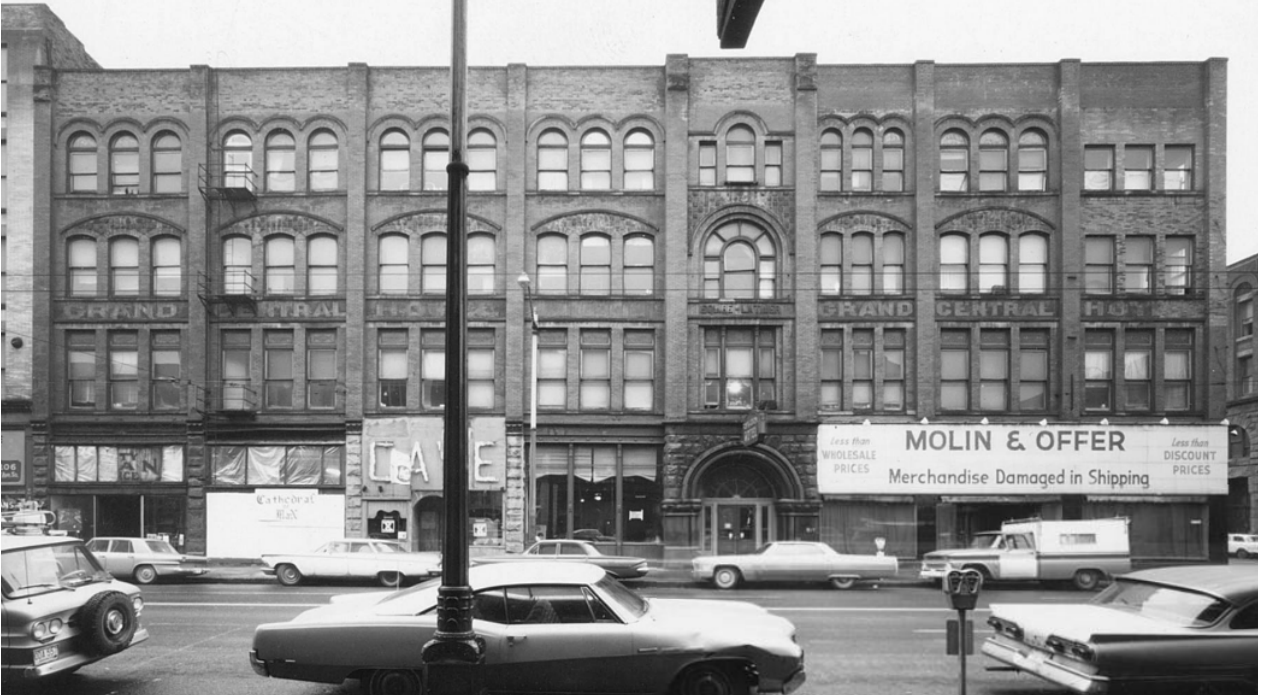
WEST ELEVATION OF GRAND CENTRAL - 1969

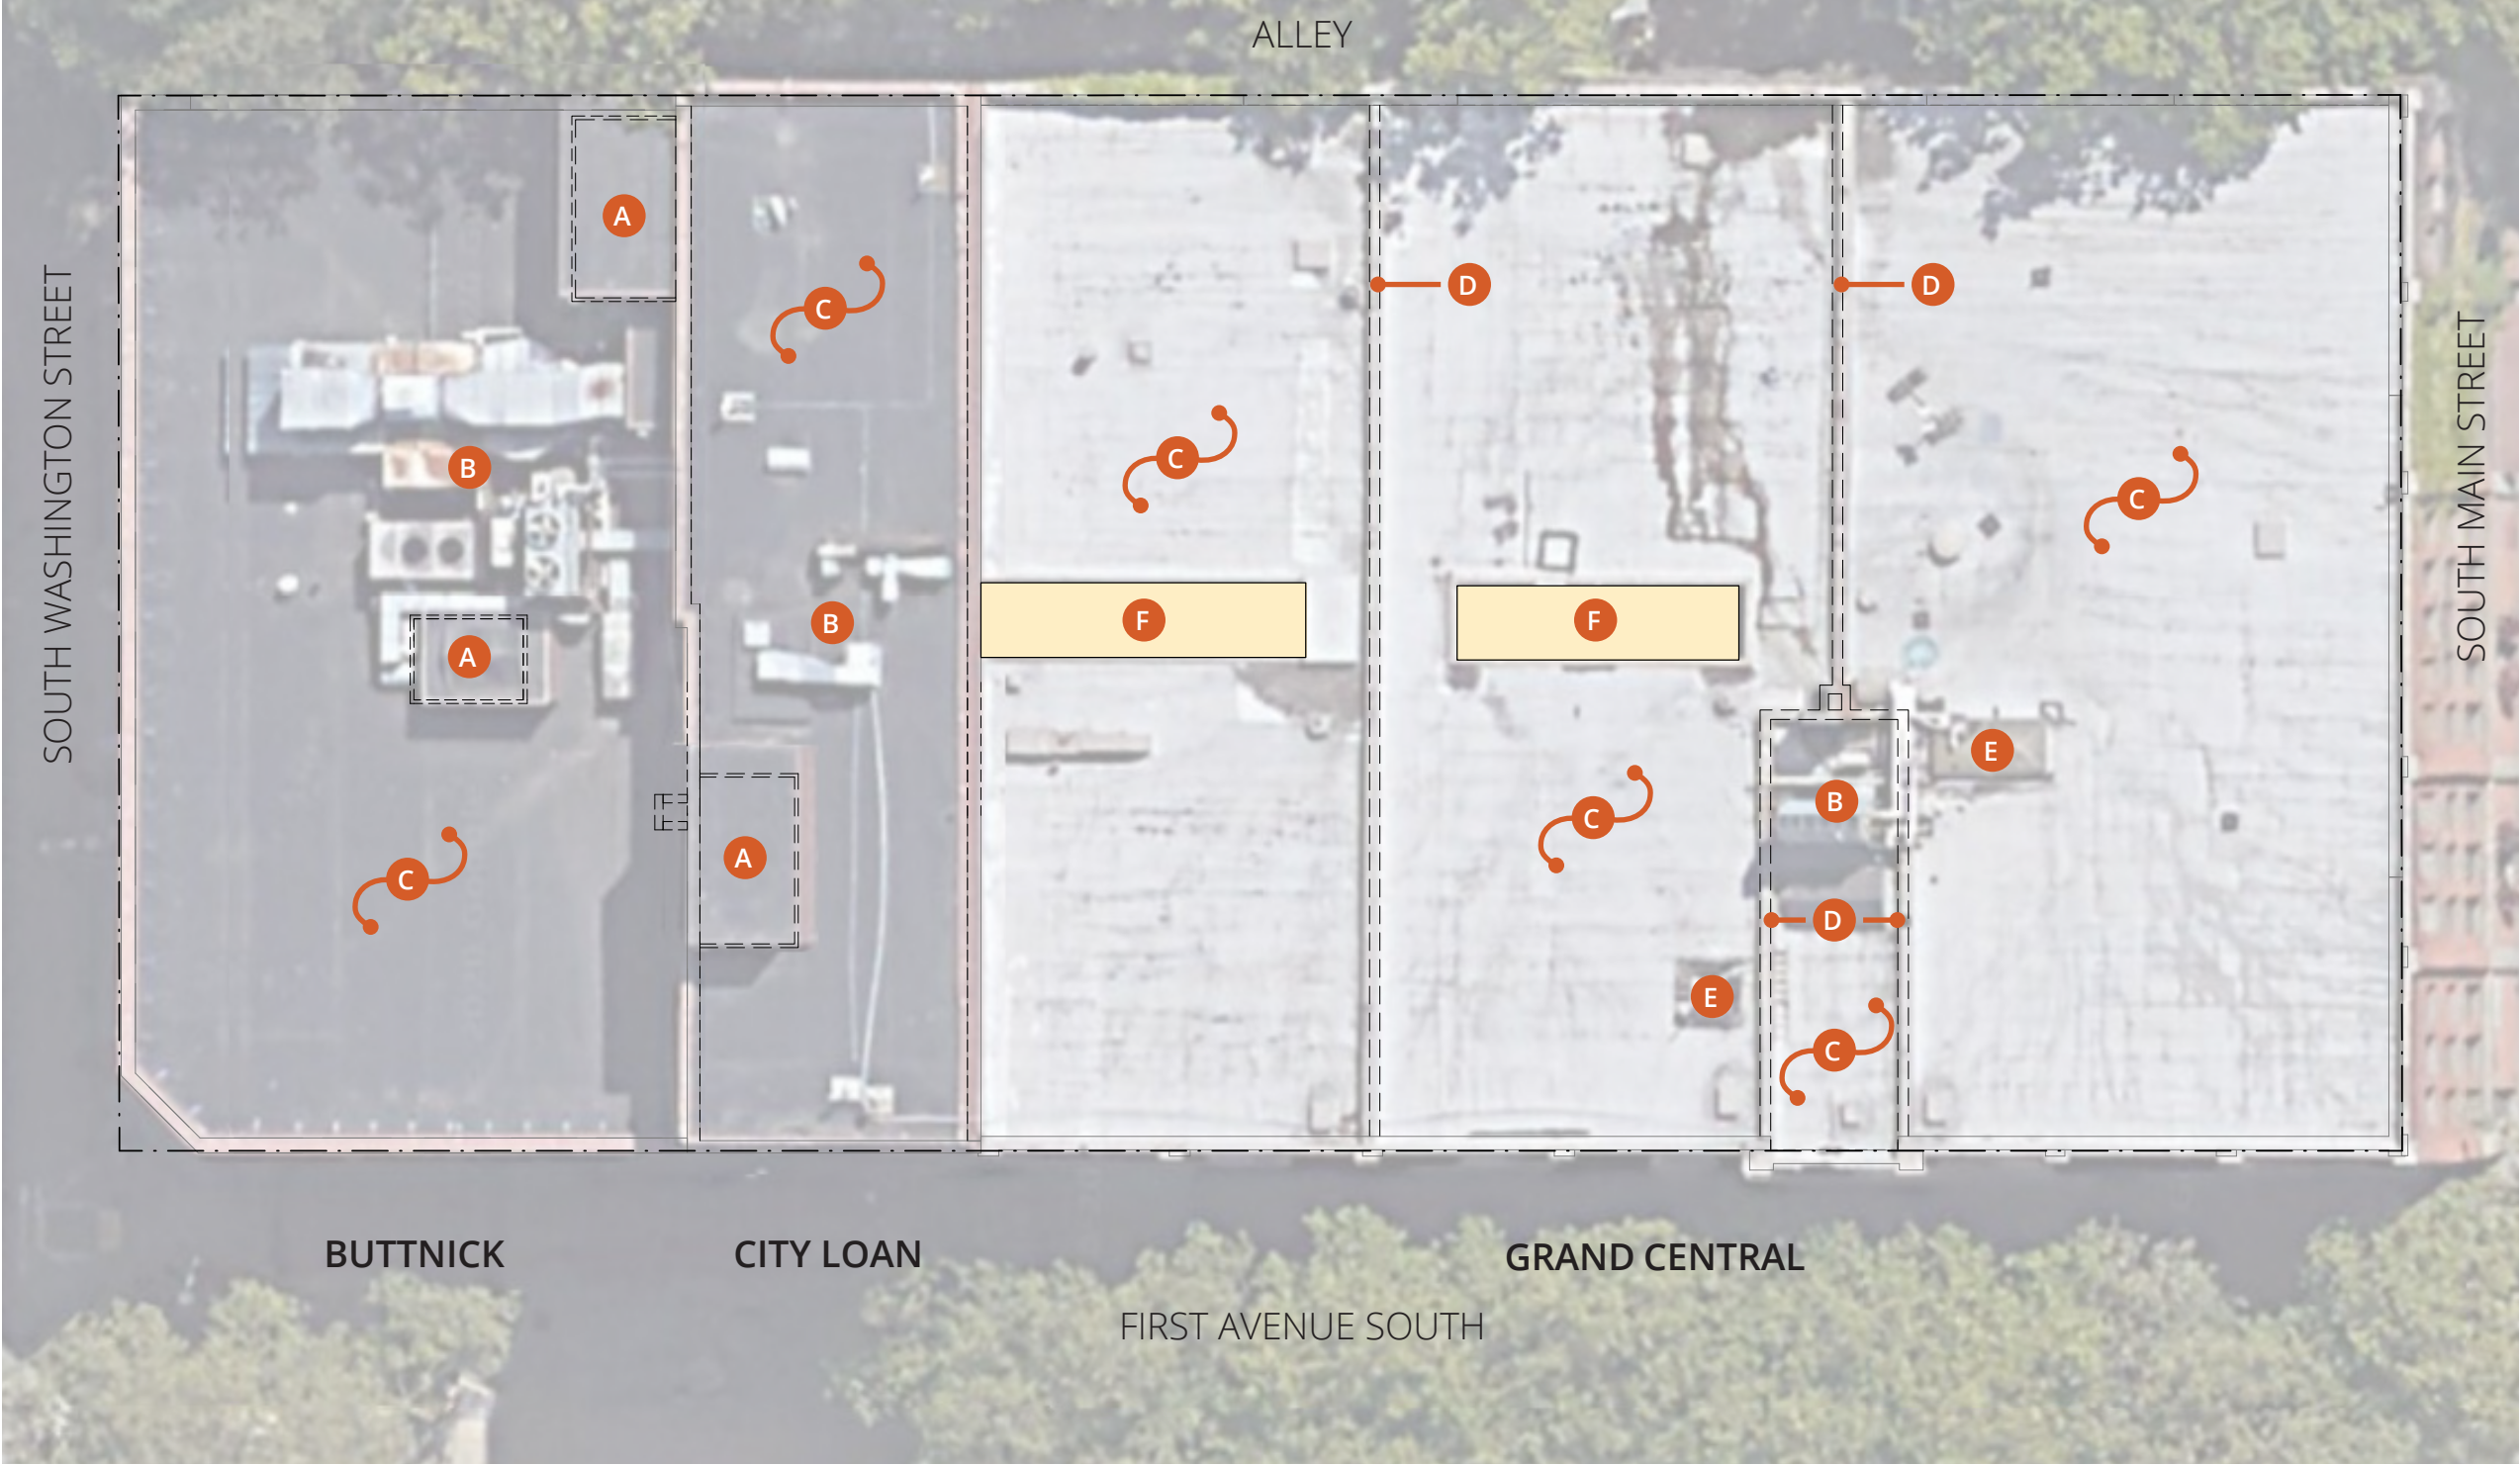
ROOF - SELECTIVE REMOVAL

- A** Remove stair
- B** Remove equipment
- C** Remove roof + structure
- D** Lower fire wall
- E** Remove skylight
- F** Light well to remain

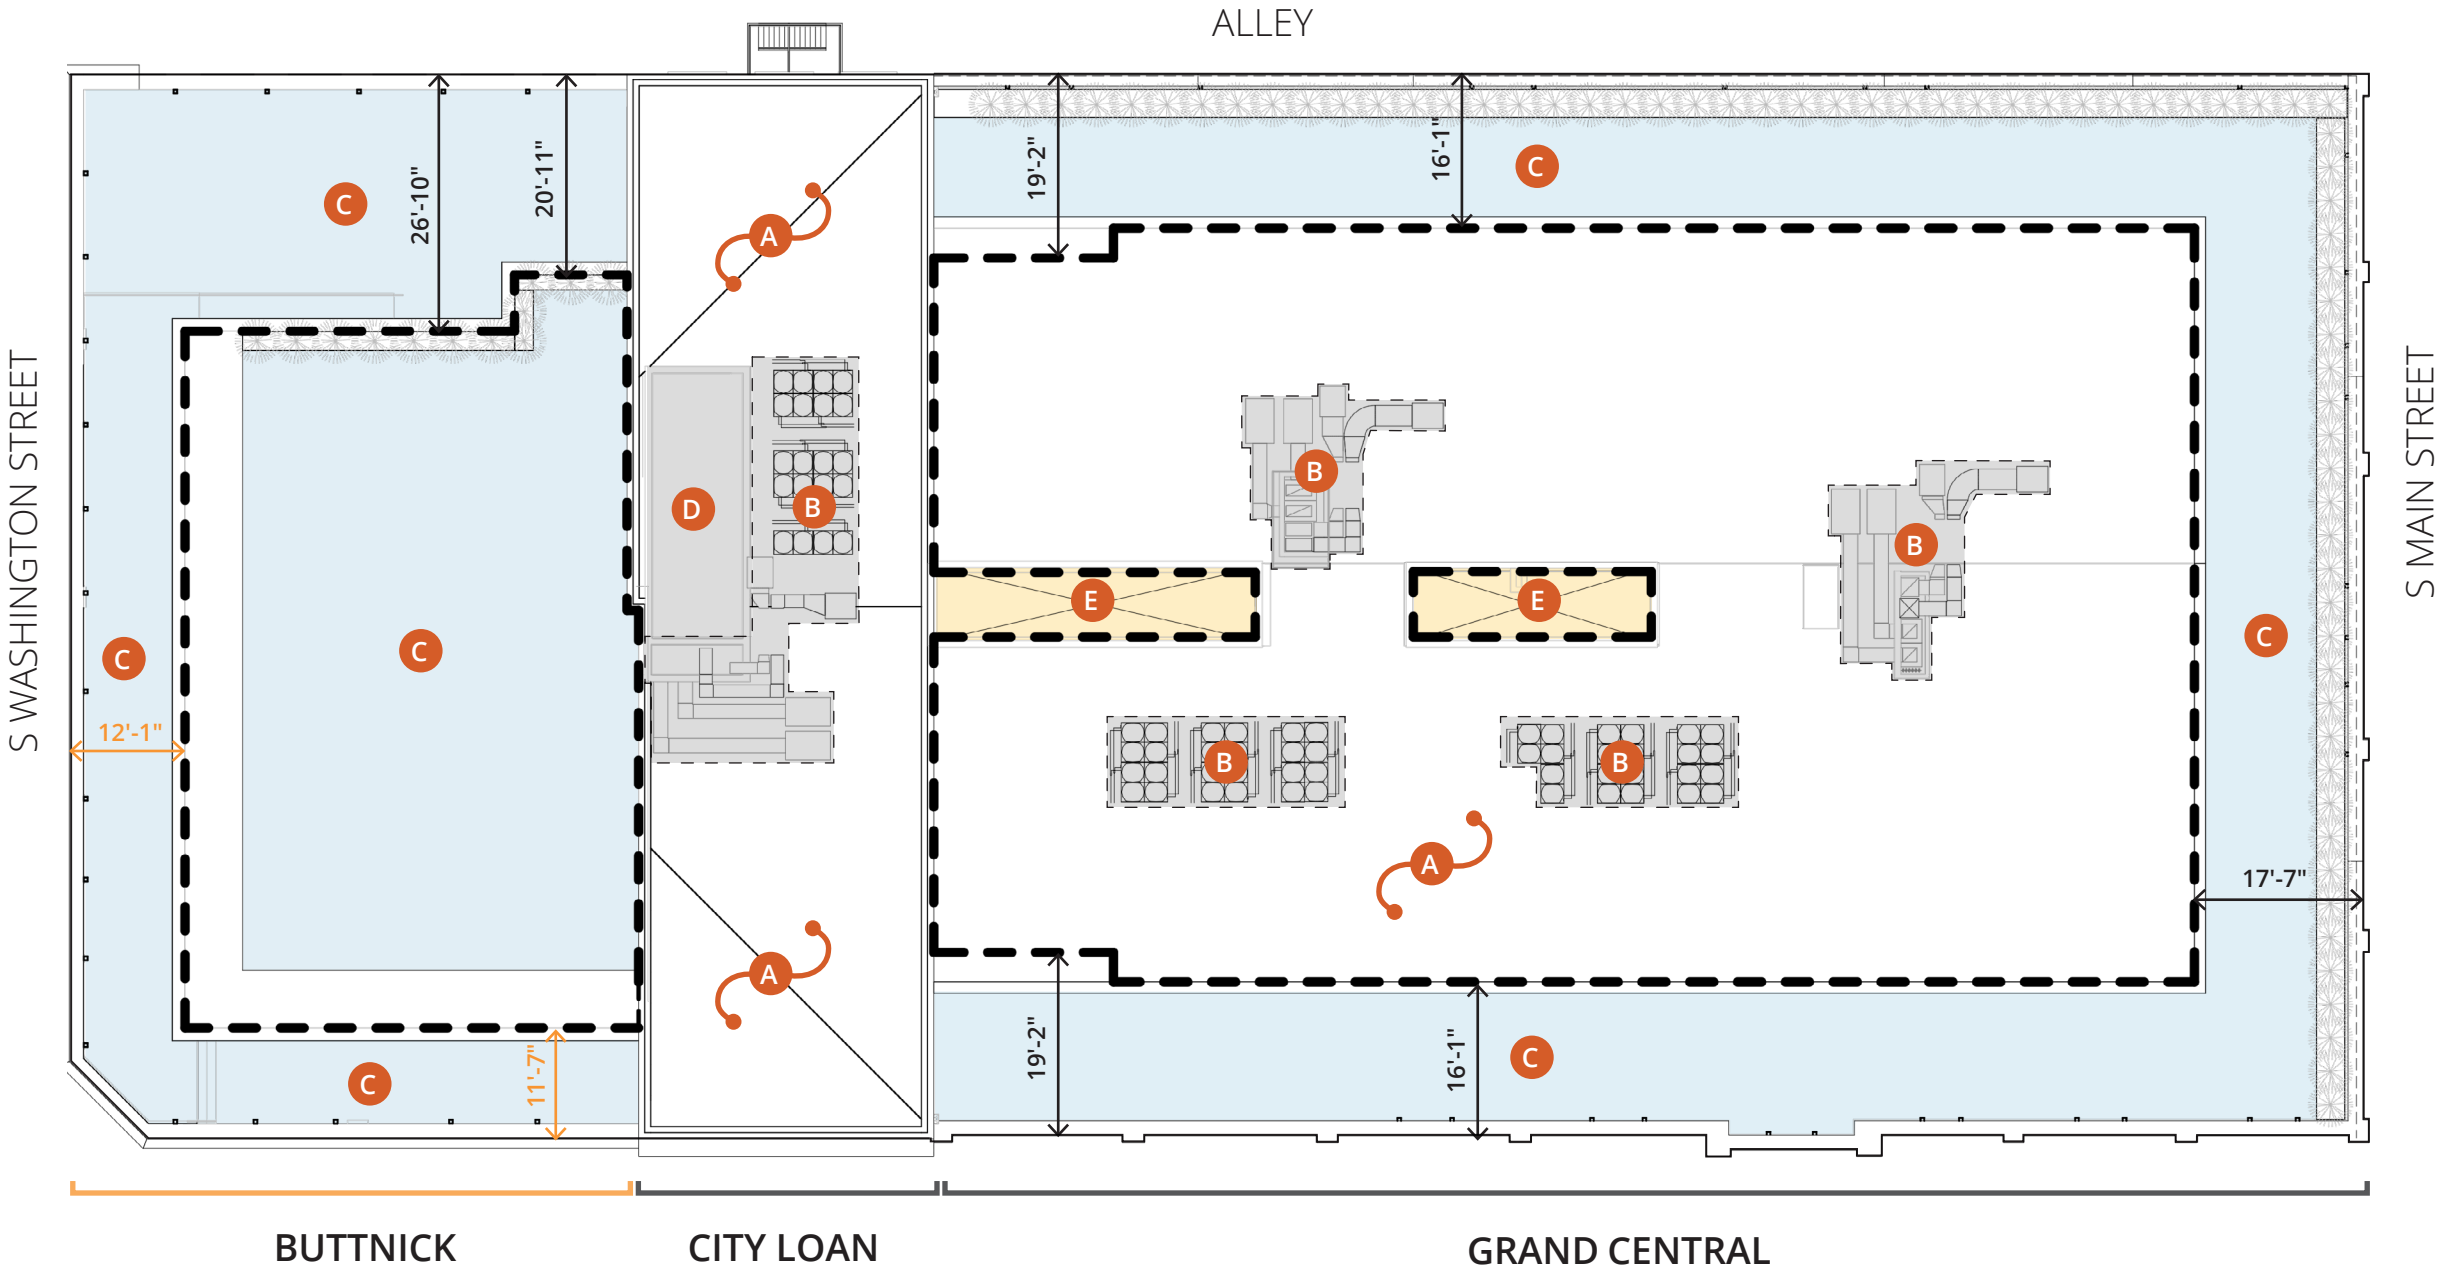
ROOF PLAN

- A Light gray TPO roof
- B Mechanical
- C Occupied roof deck
- D Elevator overrun
- E Light well to remain

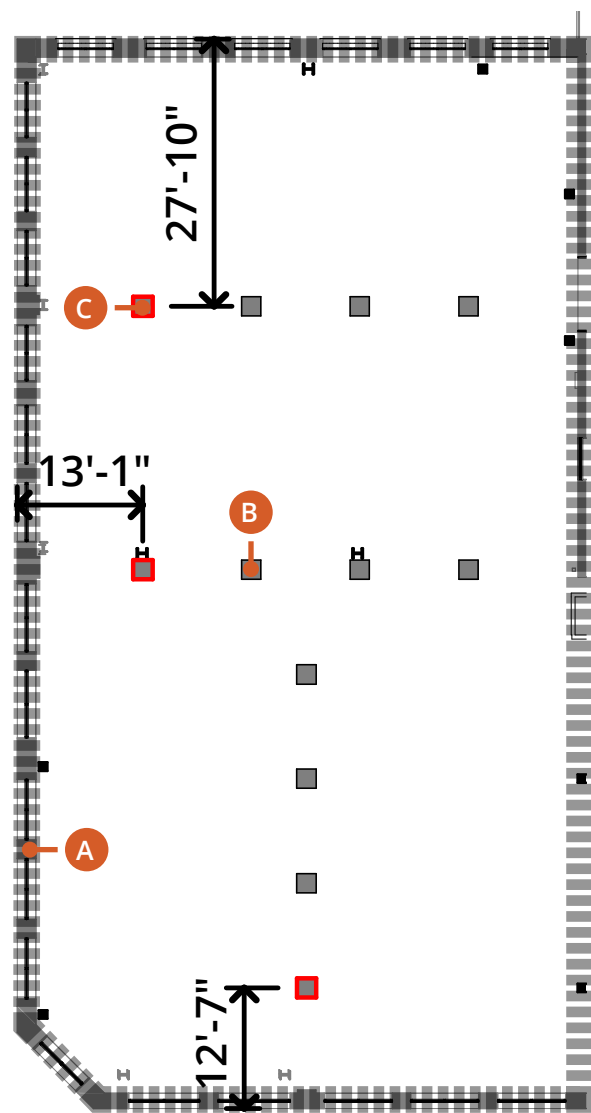
SECOND FLOOR - EXISTING STRUCTURE DIAGRAM

- A** Existing URM walls
- B** Existing column
- C** Existing column aligned to edge of penthouse

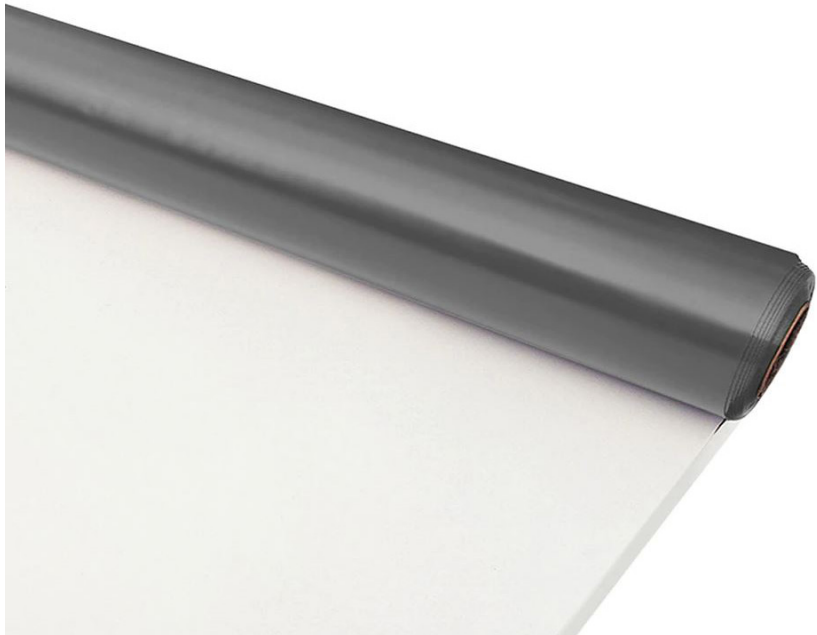
GAF Everguard TPO roofing in light gray color

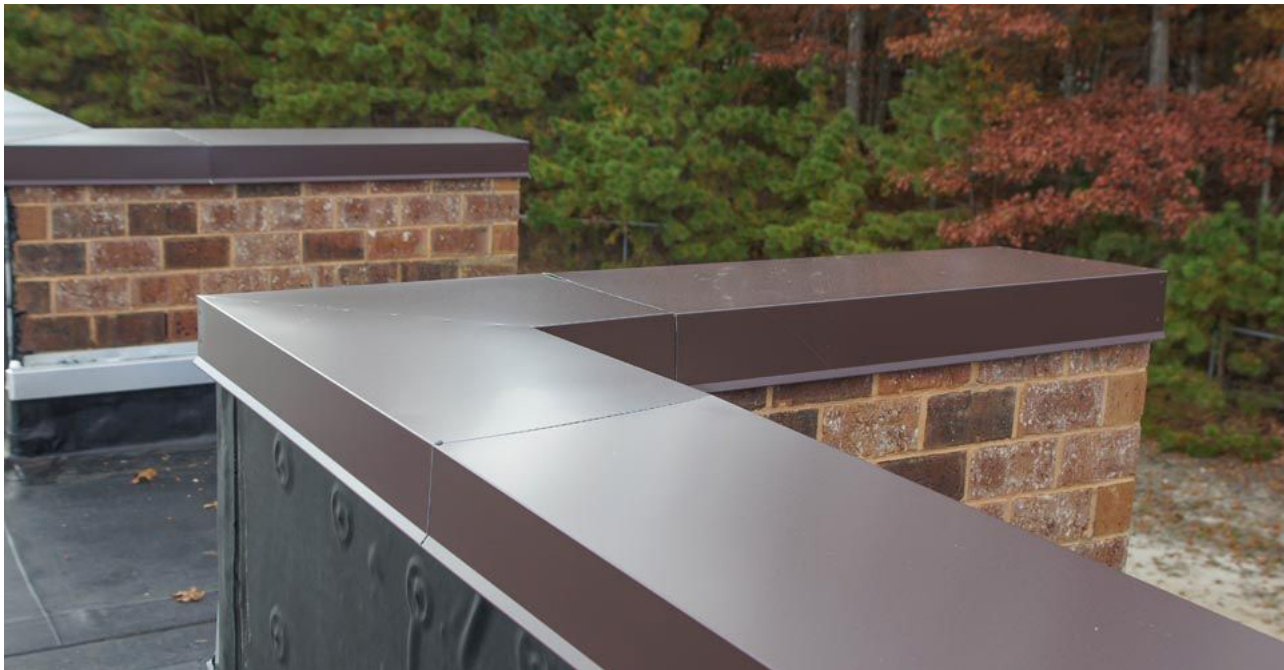
AEP Span cap flashing to be similar to existing brick color

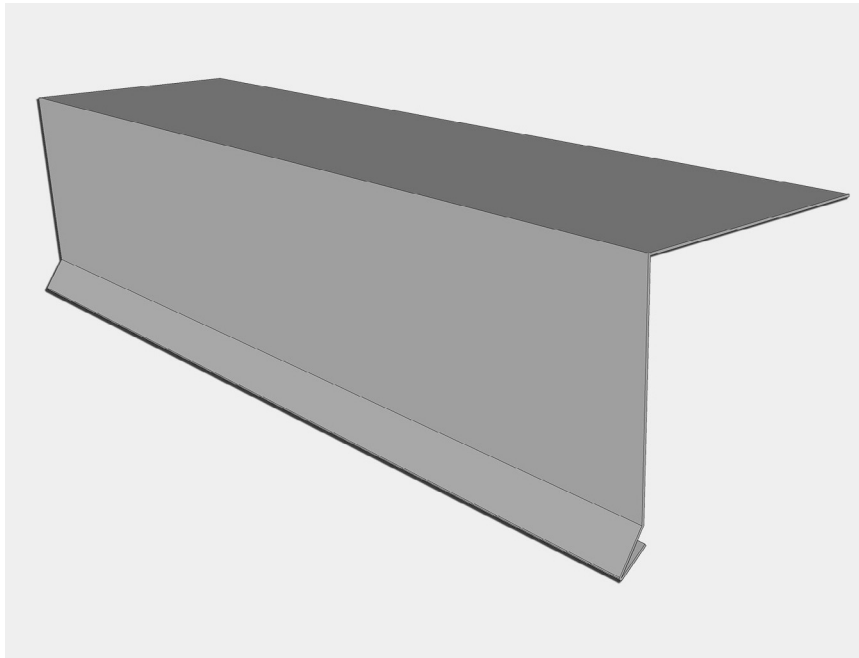
AEP Span drip edge in gunmetal gray finish

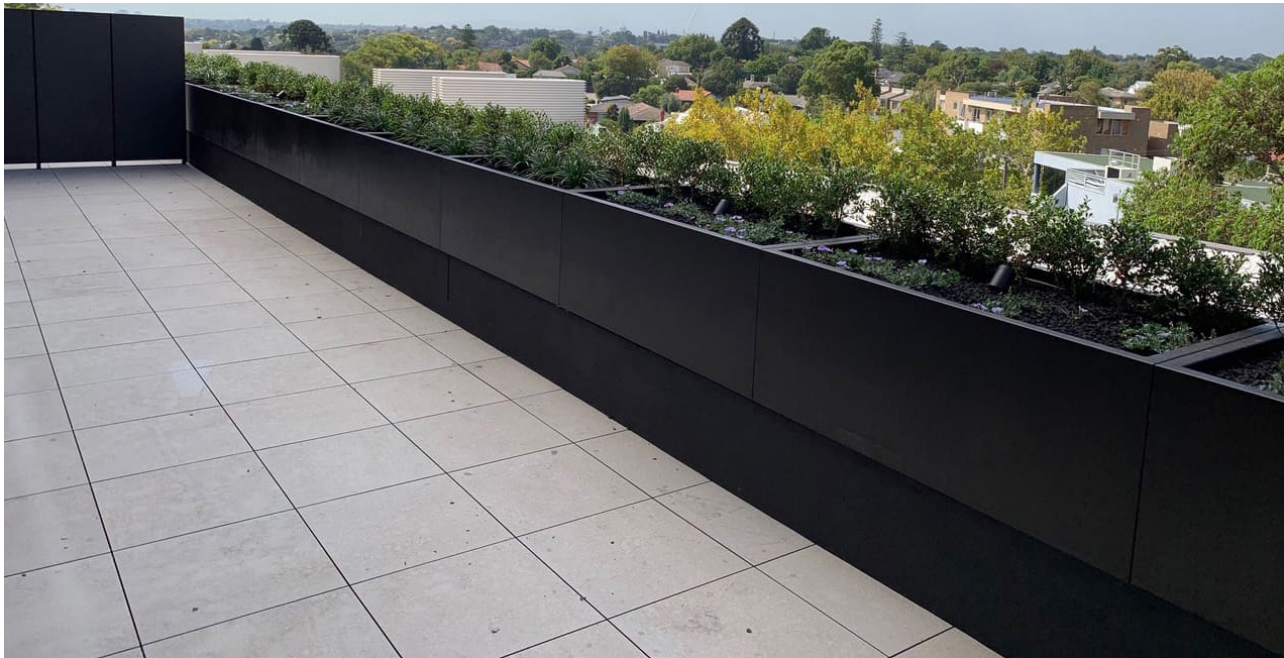
Concrete pedestal pavers at occupied roof decks. 36" tall continuous planters in lieu of guardrails

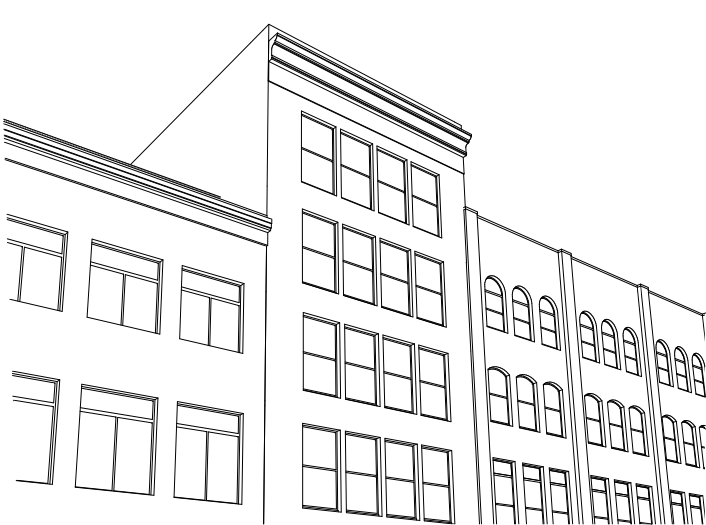
PROPOSED

Replication of the dentils is not proposed. The proposed version is simplified similar to the Buttnick cornice.

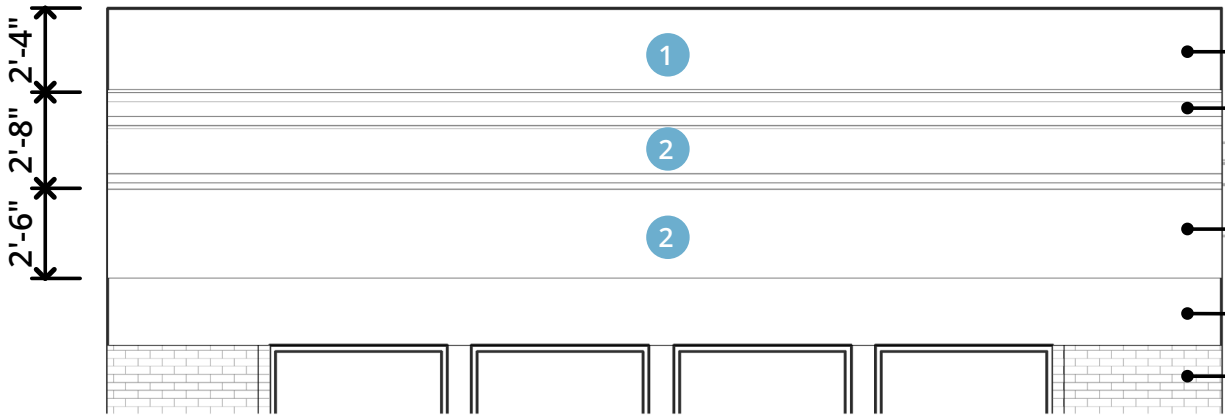
CORNICE ELEVATION

- FLAT METAL TO CAP
- DECORATIVE CORNICE, ENDS DO NOT WRAP, FINISH FLAT
- FLAT METAL OVER RED BRICK
- EXISTING CONCRETE FINISH
- EXISTING WHITE BRICK

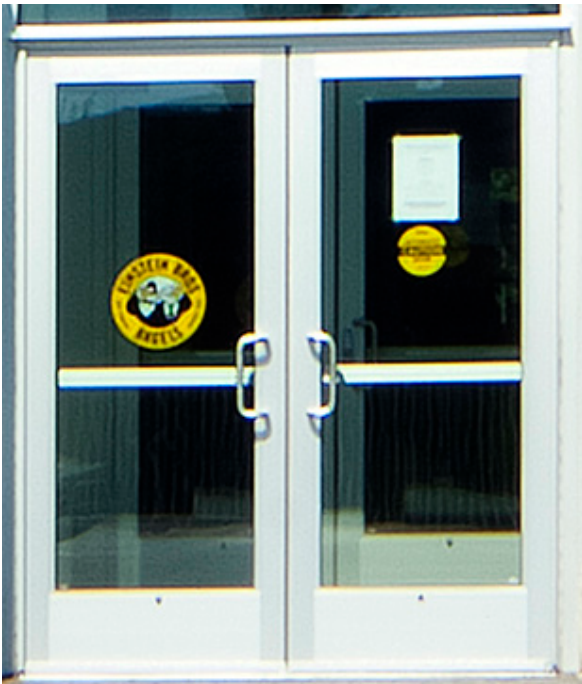
EFCO SERIES D300 ENTERANCE DOORS

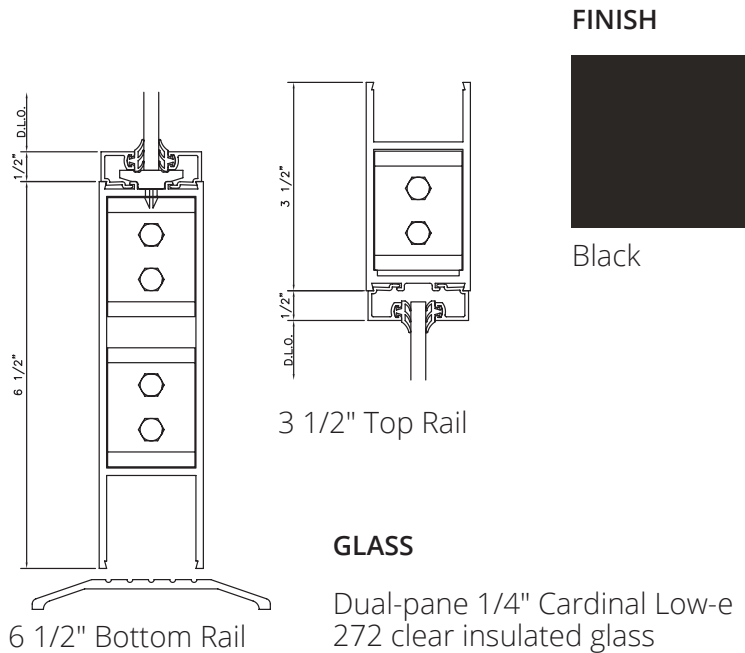
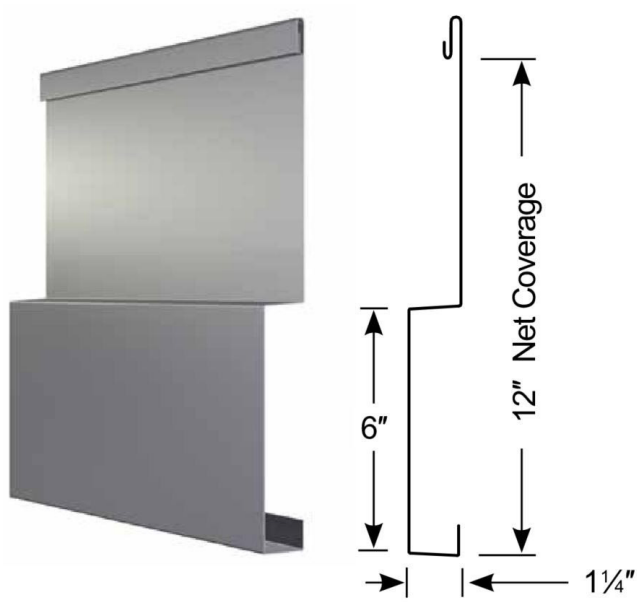
AEP Span Flex Series 1.2FX30-12

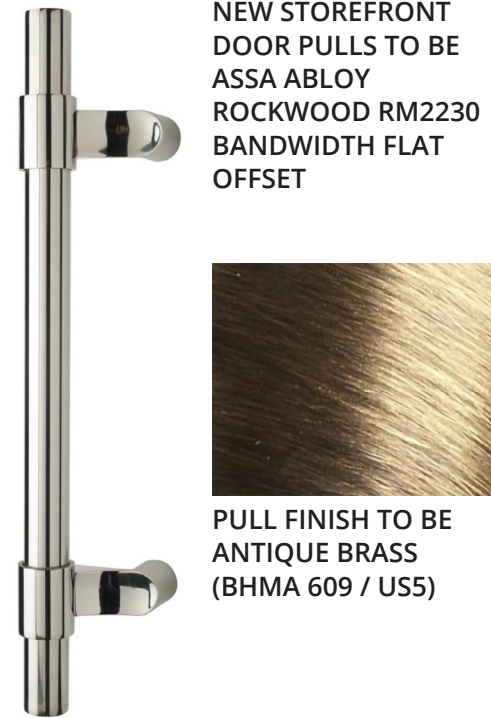
NEW STOREFRONT
DOOR PULLS TO BE
ASSA ABLOY
ROCKWOOD RM2230
BANDWIDTH FLAT
OFFSET

PULL FINISH TO BE
ANTIQUÉ BRASS
(BHMA 609 / US5)

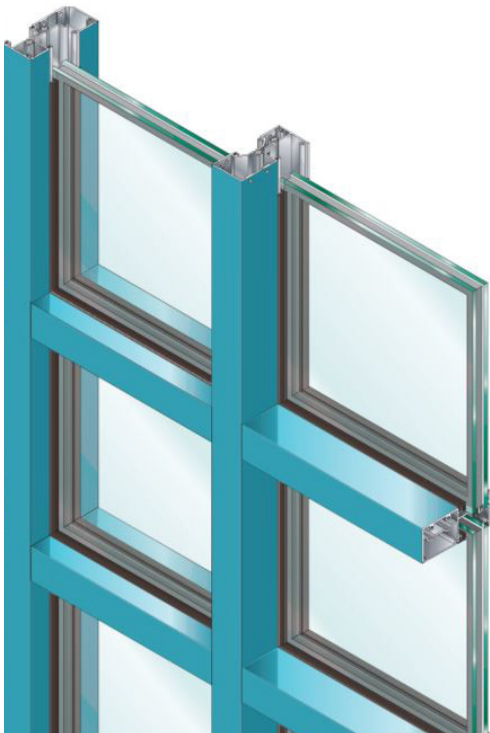
**EFCO SERRIERS 433
STOREFRONT SYSTEM**

- 2" sightline
- 4 1/2" deep
- Thermally broken frames
- Front glazed configuration

Dual-pane 1/4" Cardinal Low-e 272 clear insulated glass

- Standard features:
- 2" sightline
 - 4 1/2" deep
 - Thermally broken frames
 - Front glazed configuration

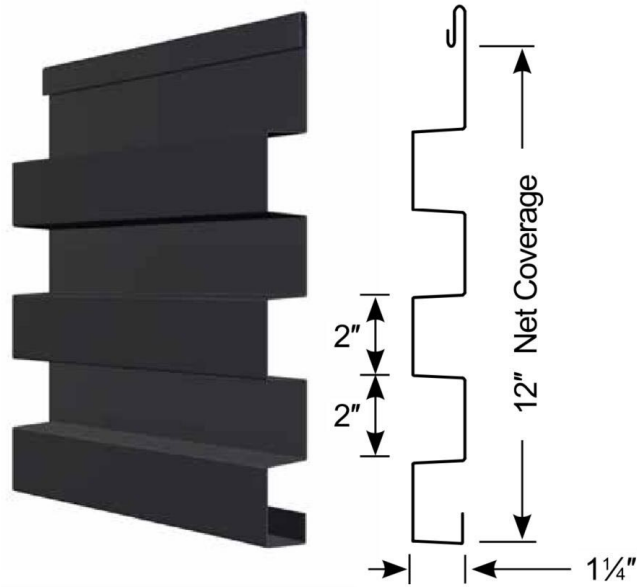
AEP Span Flex Series 1.2FX10-12

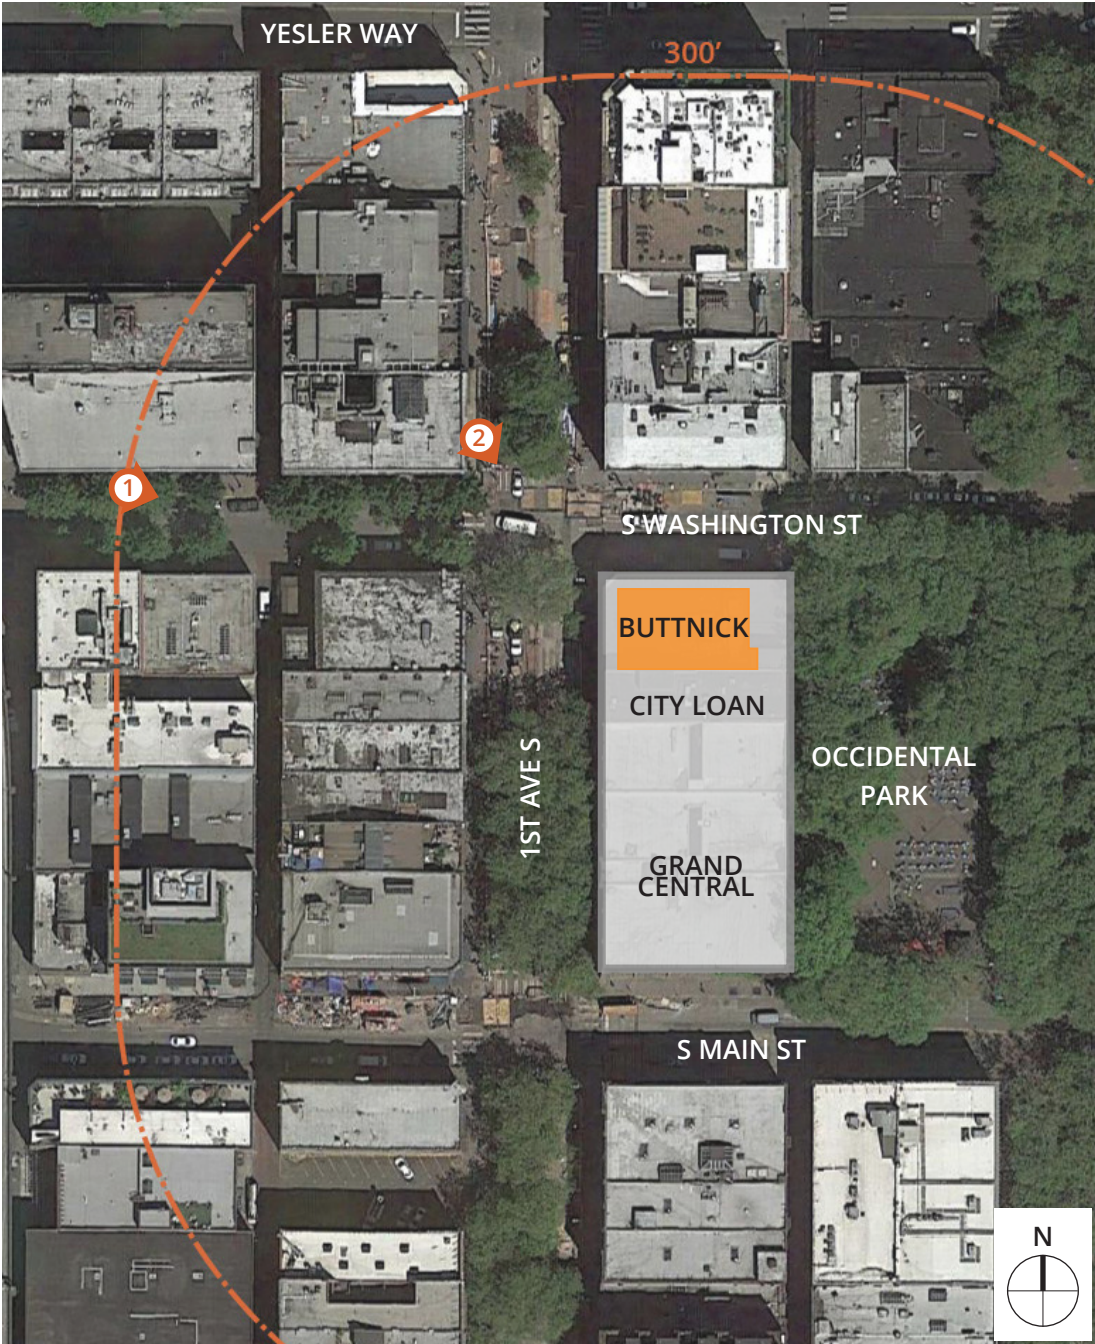
BUTTNICK ARIEL VIEW

Photos are from the penthouse mockup performed in March 2021. The penthouse height and footprint shown are a reduction compared to the previous Board Briefing.

KEY: --- 300 ft from Building

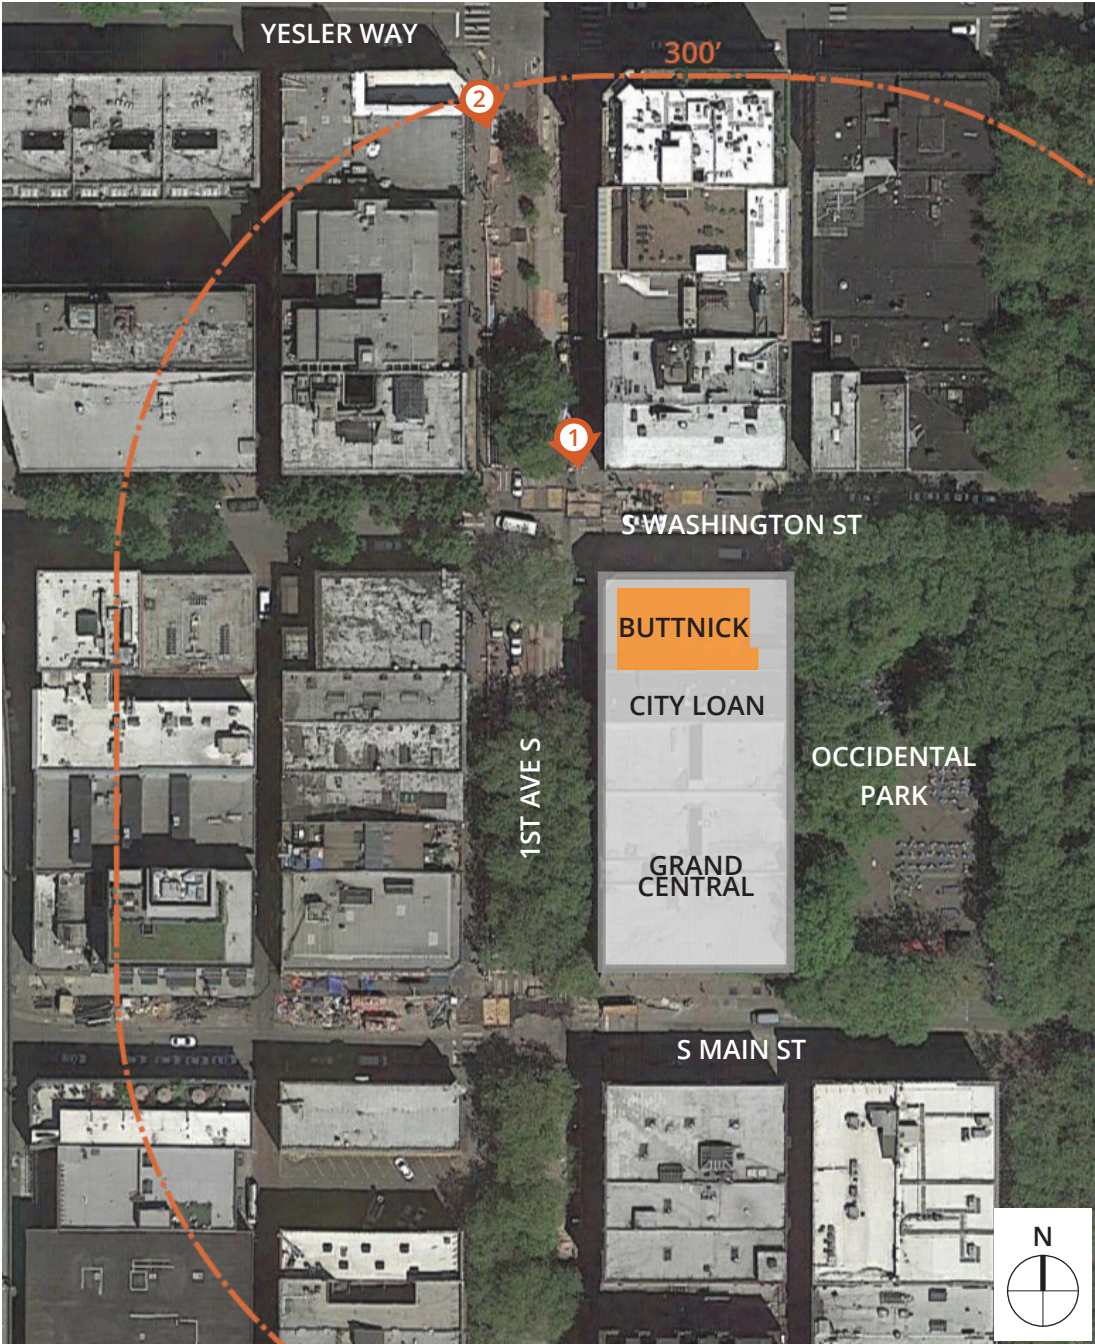
BUTTNICK ARIEL VIEW

Photos are from the penthouse mockup performed in March 2021. The penthouse height and footprint shown are a reduction compared to the previous Board Briefing.

KEY: — 300 ft from Building
