PSPB COA PROPOSAL - CORRECTIONS

GRAND CENTRAL BLOCK

BRUNSWICK-BALKE-COLLENDER CO + GOTTSTEIN + SQUIRE LATIMER

200 S 1ST ST, Seattle, WA 98104

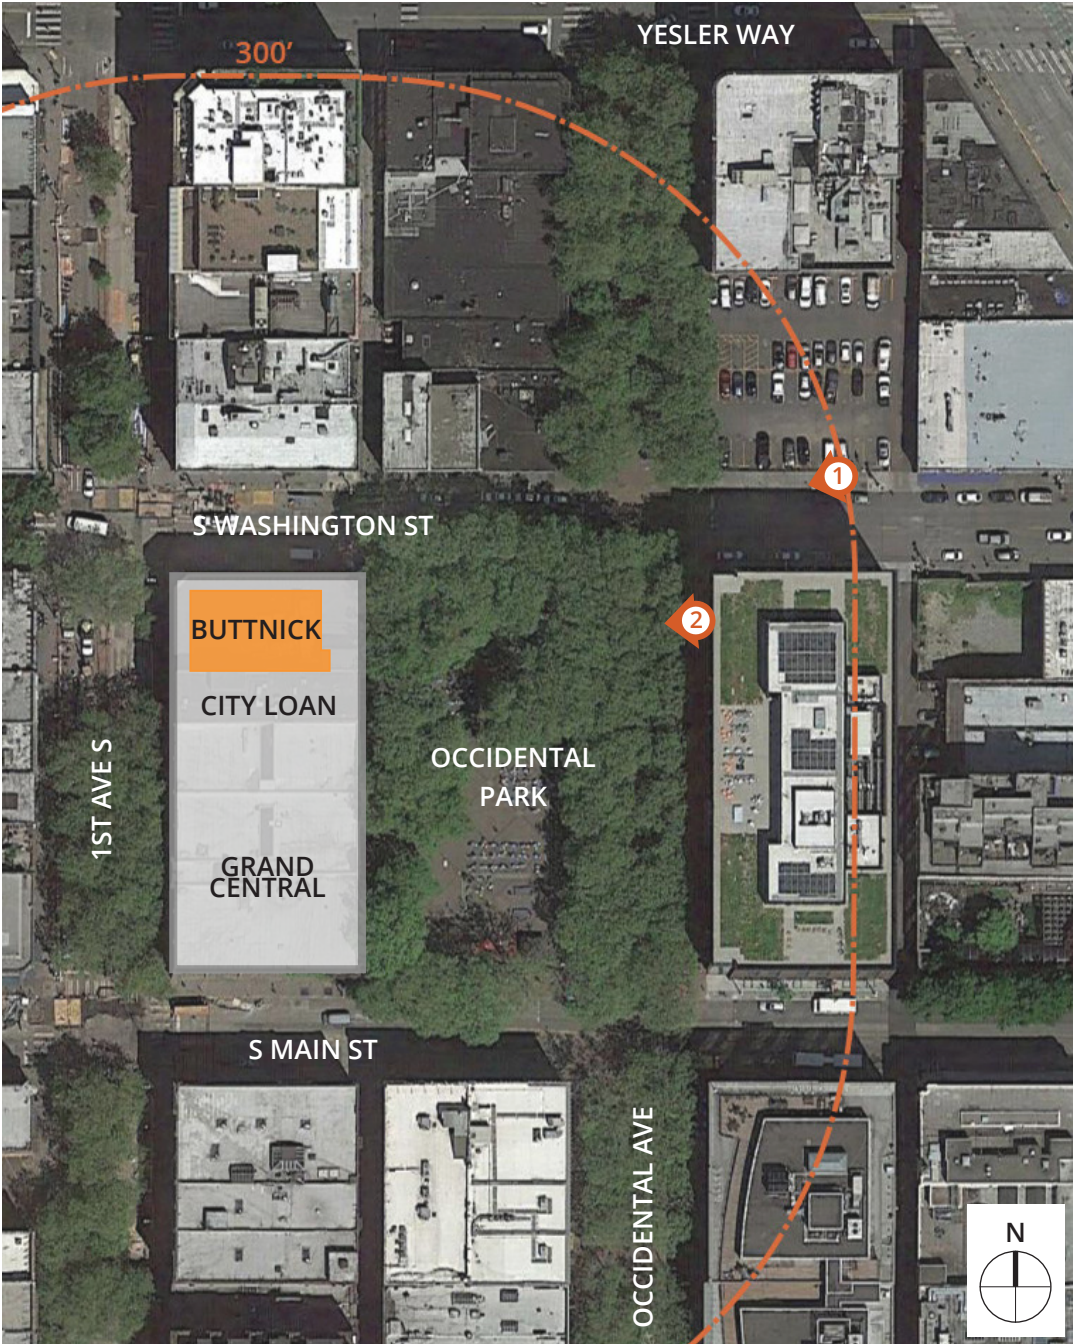
GRAND CENTRAL ARIEL VIEW

Photos are from the penthouse mockup performed in March 2021. The penthouse height and footprint shown are a reduction compared to the previous Board Briefing.

KEY: - - - 300 ft from Building

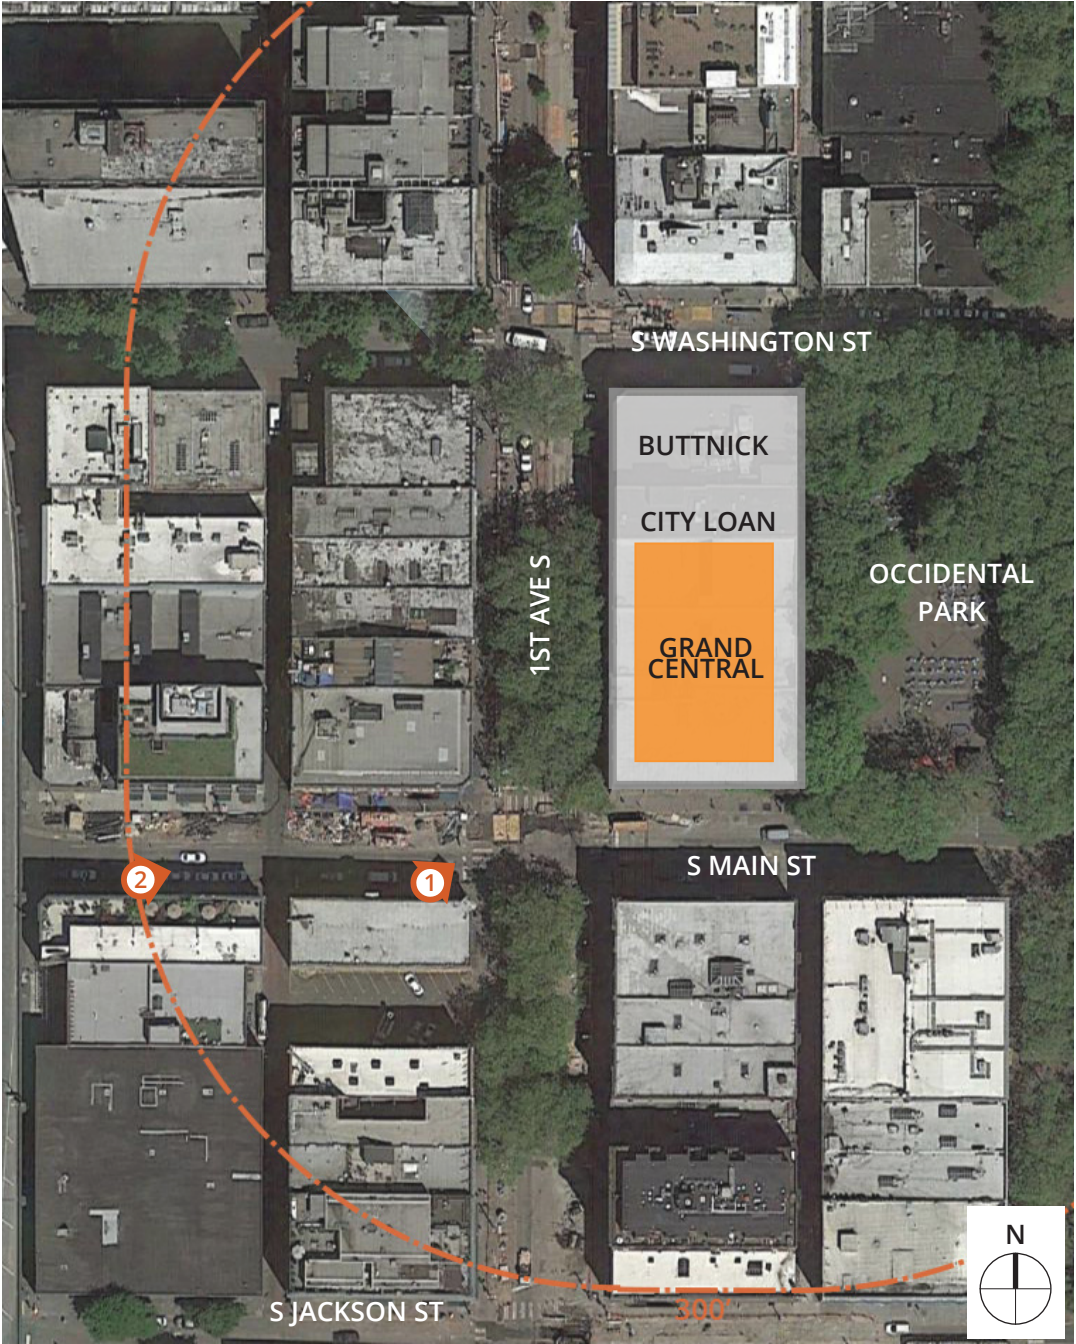
GRAND CENTRAL ARIEL VIEW

Photos are from the penthouse mockup performed in March 2021. The penthouse height and footprint shown are a reduction compared to the previous Board Briefing.

KEY: --- 300 ft from Building

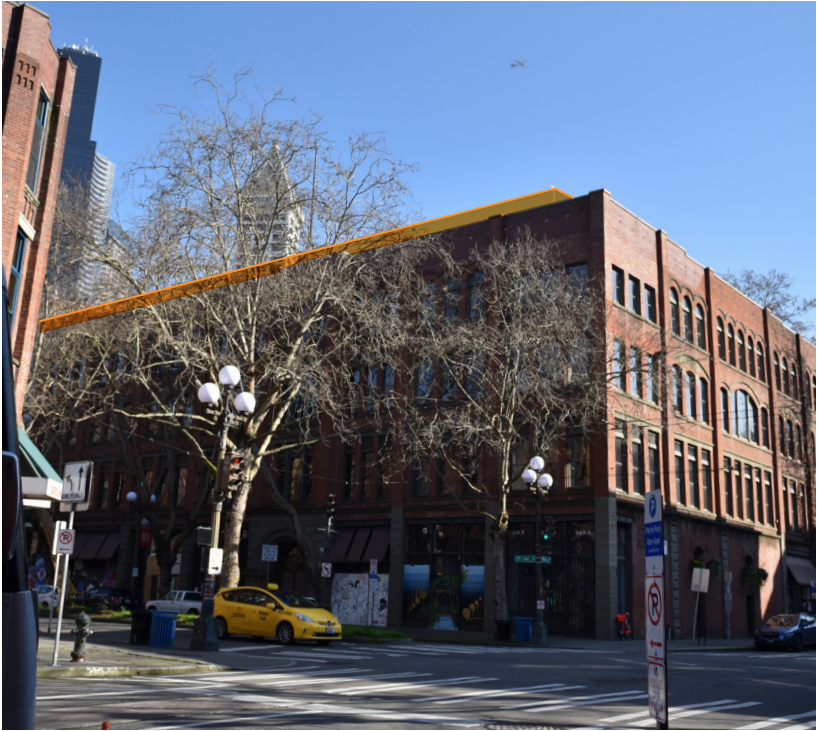
1 S MAIN ST - PENTHOUSE VISIBLE

The Board would first have to determine if the penthouse is minimally visible from 300 feet. It appears visible in what is provided. (Staff Report 8/5/2020)

Photos are from the penthouse mockup performed in March 2021. The penthouse height and footprint shown are a reduction compared to the previous Board Briefing.

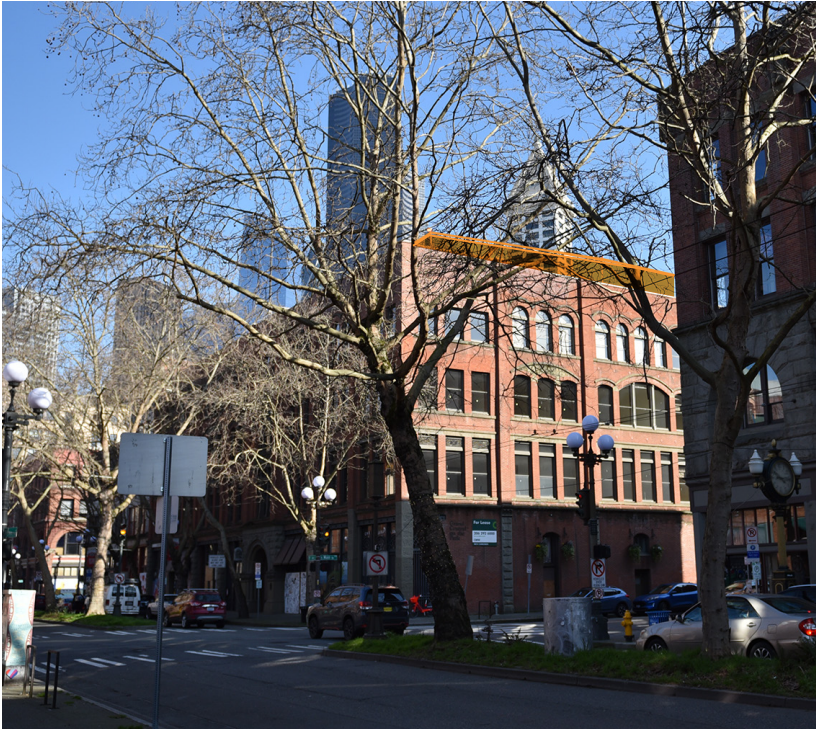
1 1ST AVE S - PENTHOUSE VISIBLE

The Board would first have to determine if the penthouse is minimally visible from 300 feet. It appears visible in what is provided. (Staff Report 8/5/2020)

Photos are from the penthouse mockup performed in March 2021. The penthouse height and footprint shown are a reduction compared to the previous Board Briefing.

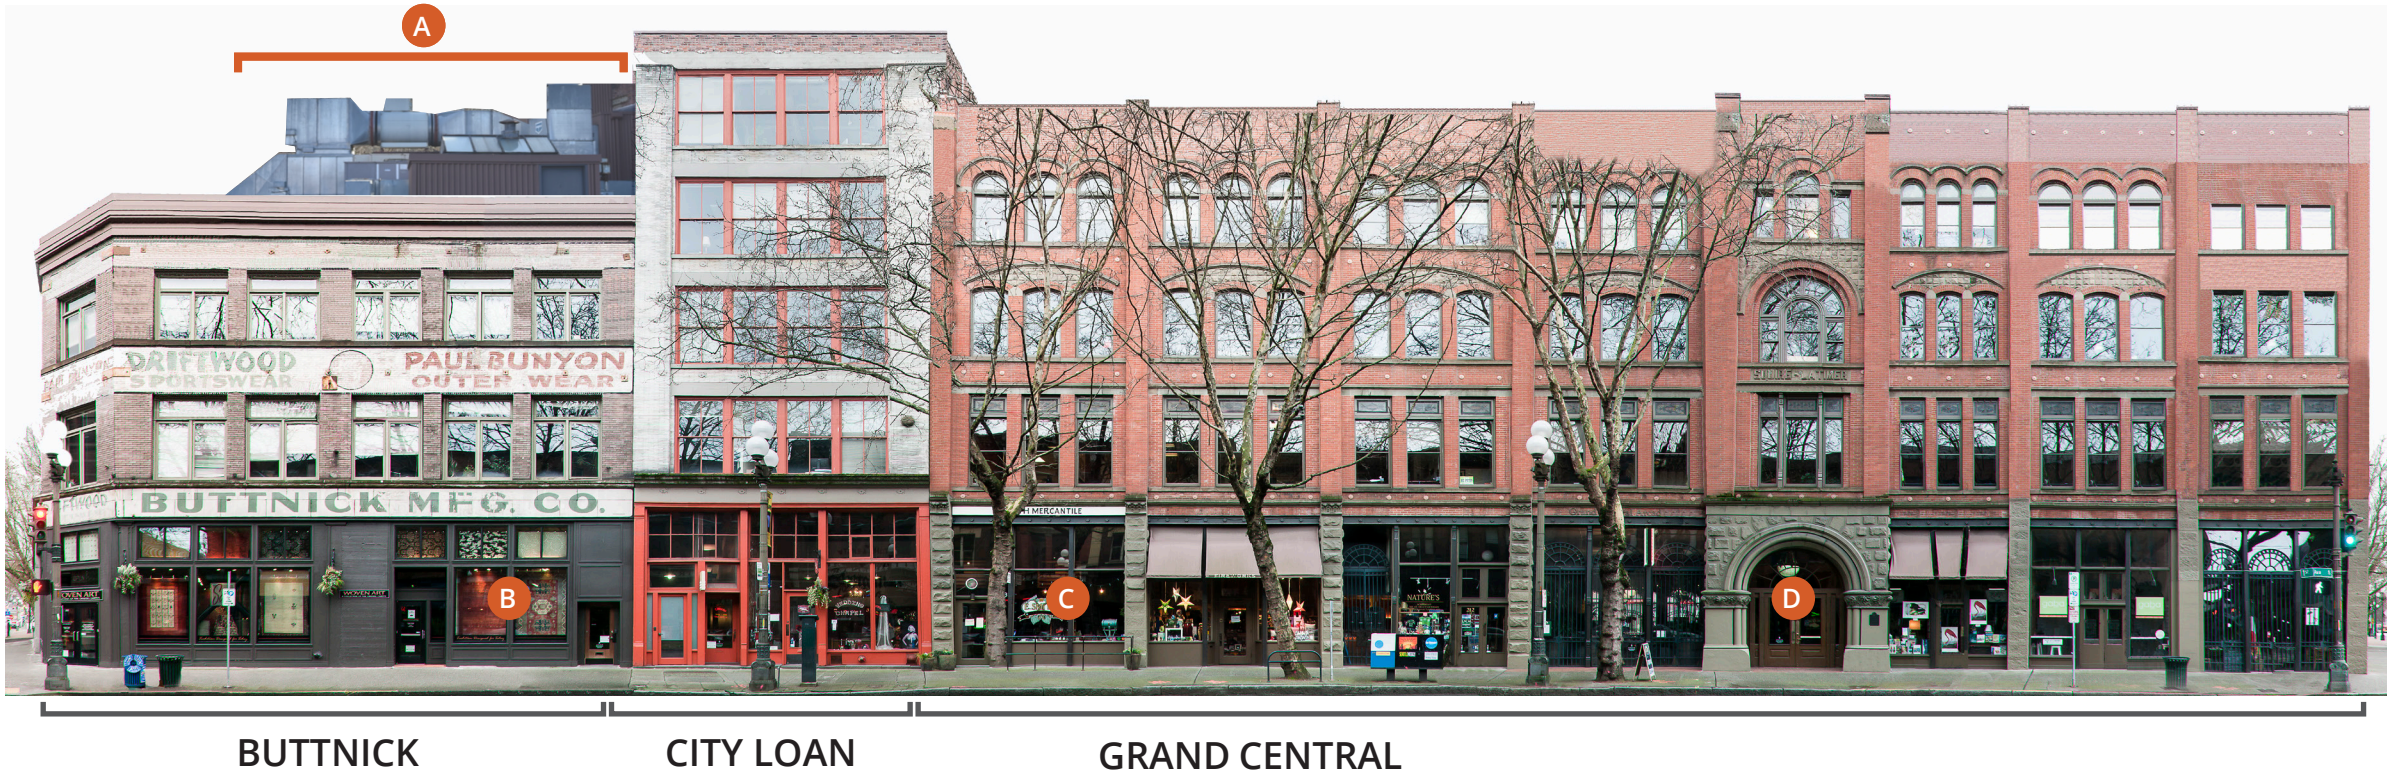
West Elevation - Exterior View From First Avenue South

EXISTING EXTERIOR ELEVATION

- A** Remove mechanical equipment (See photo)
- B** Protect existing storefront typ. at Buttnick
- C** Remove existing storefront. Protect existing cast iron columns, typ. at all openings
- D** Protect existing doors / frames / fan window

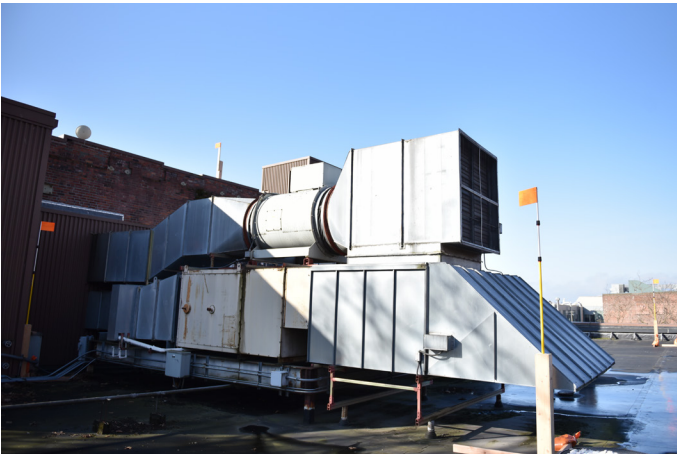
Existing mechanical equipment shown next to flags identifying height at boundary of proposed new Buttnick penthouse

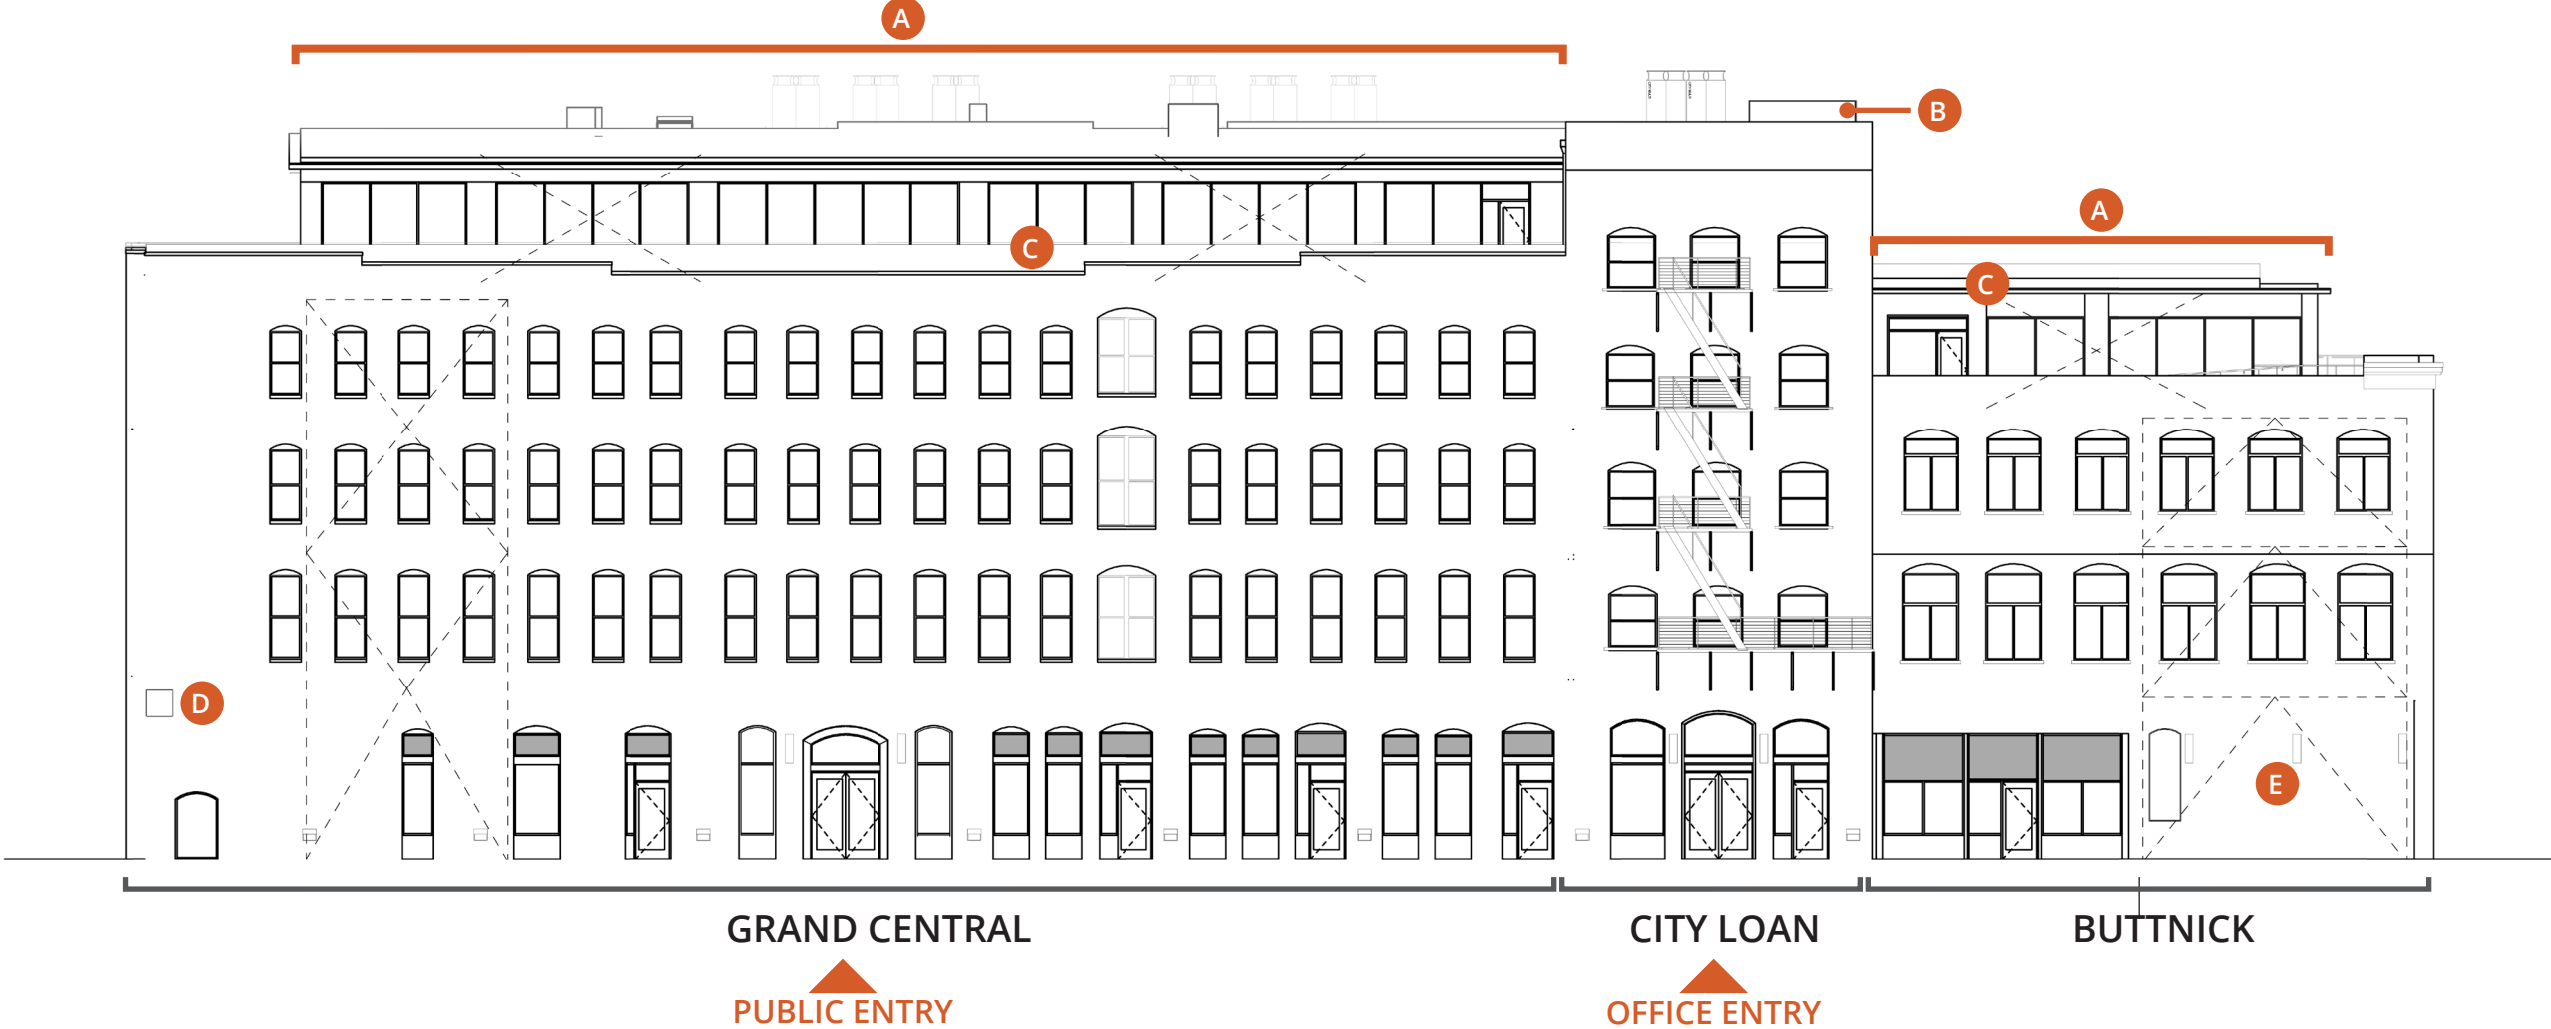
East Elevation - Exterior View From Occidental Square

PROPOSED EXTERIOR ELEVATION

- A** New office penthouse
- B** New elevator overrun
- C** Planters at new roof deck
- D** Vault vent louver
- E** Protect historic mural

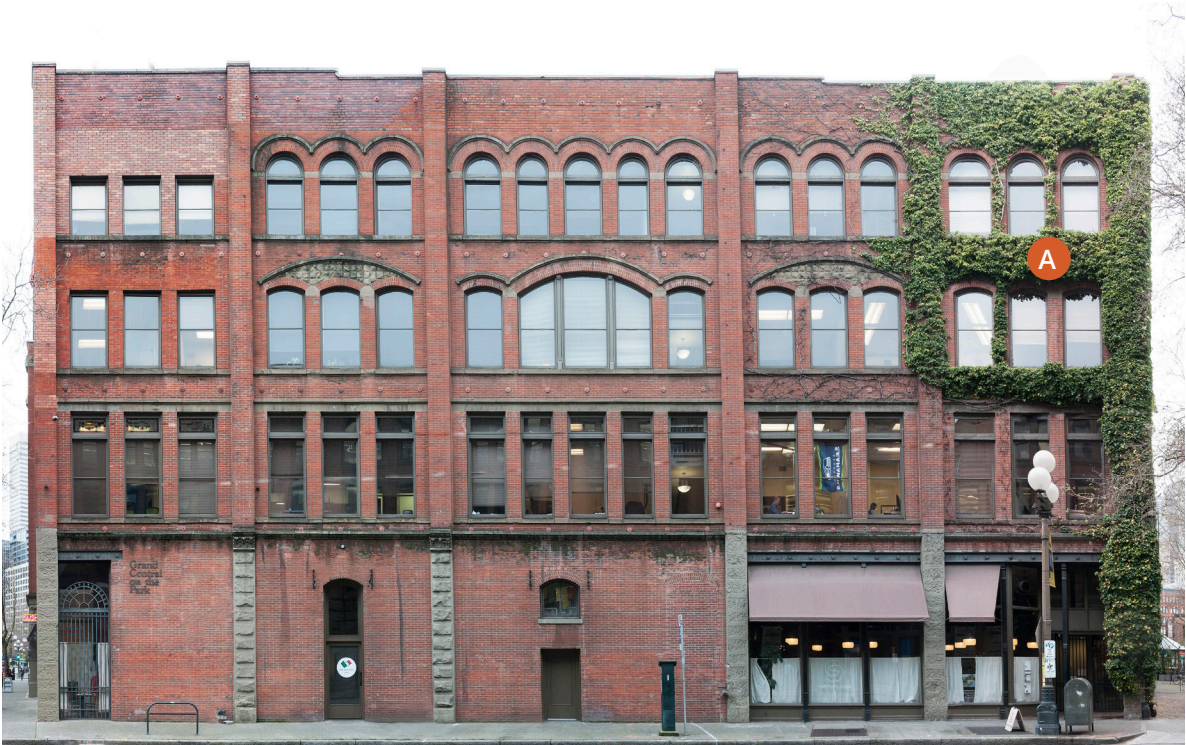
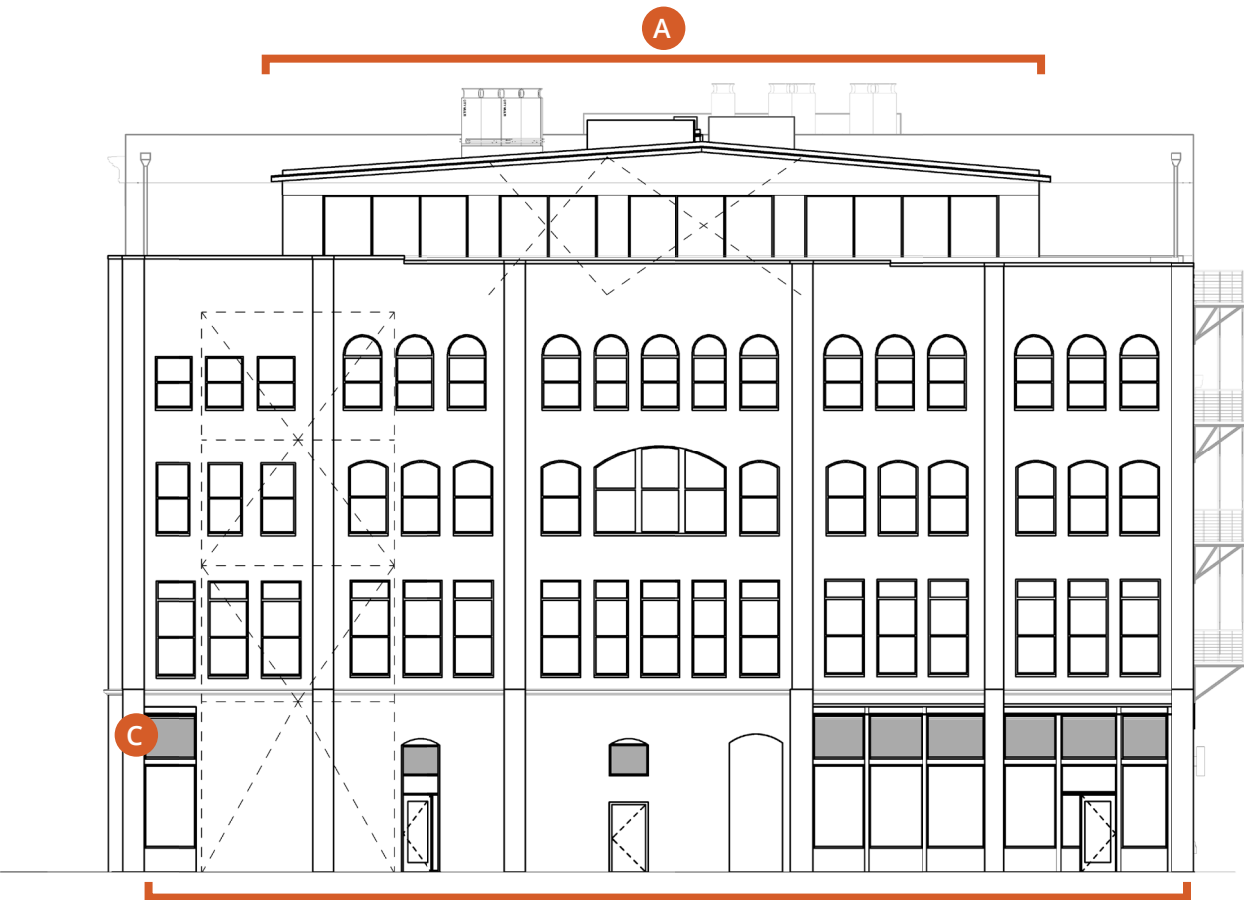
South Elevation - Exterior View From S Main St

EXISTING AND PROPOSED EXTERIOR ELEVATIONS

- A Remove Ivy and repair brick underneath

- A New office penthouse
- B New storefront
- C Louvers typical

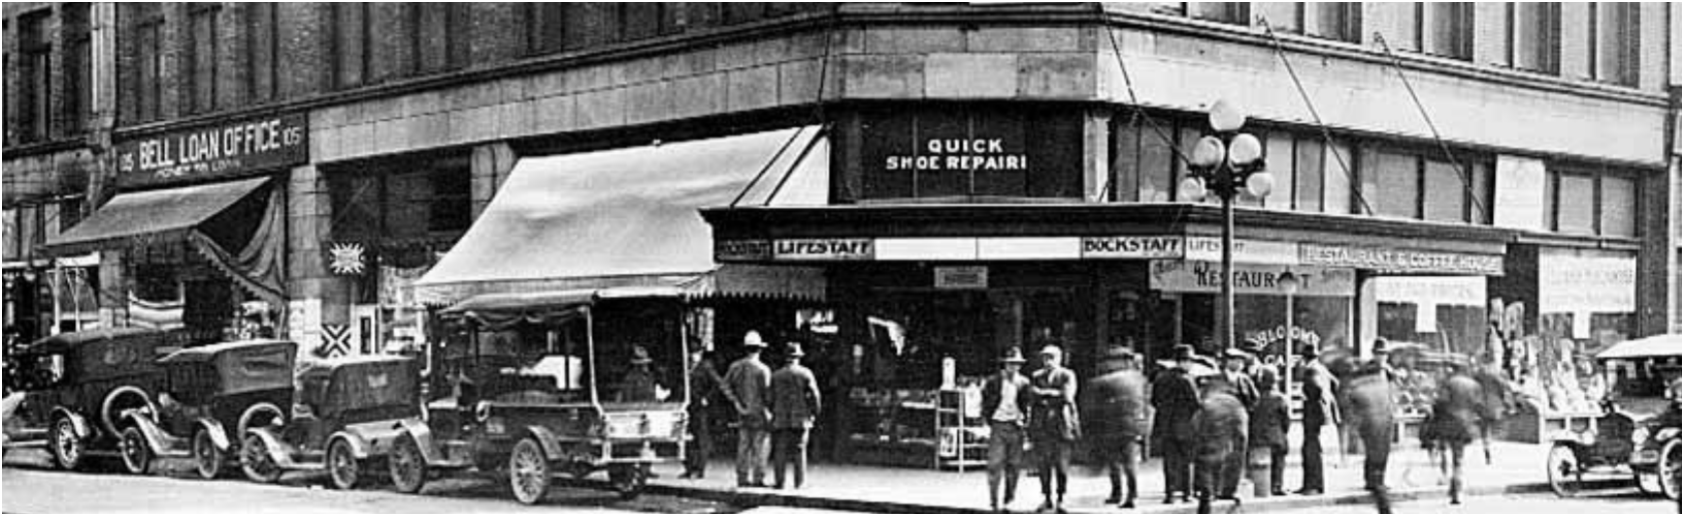
1915 First photo of Buttnick storefront. Assumed close to original condition.

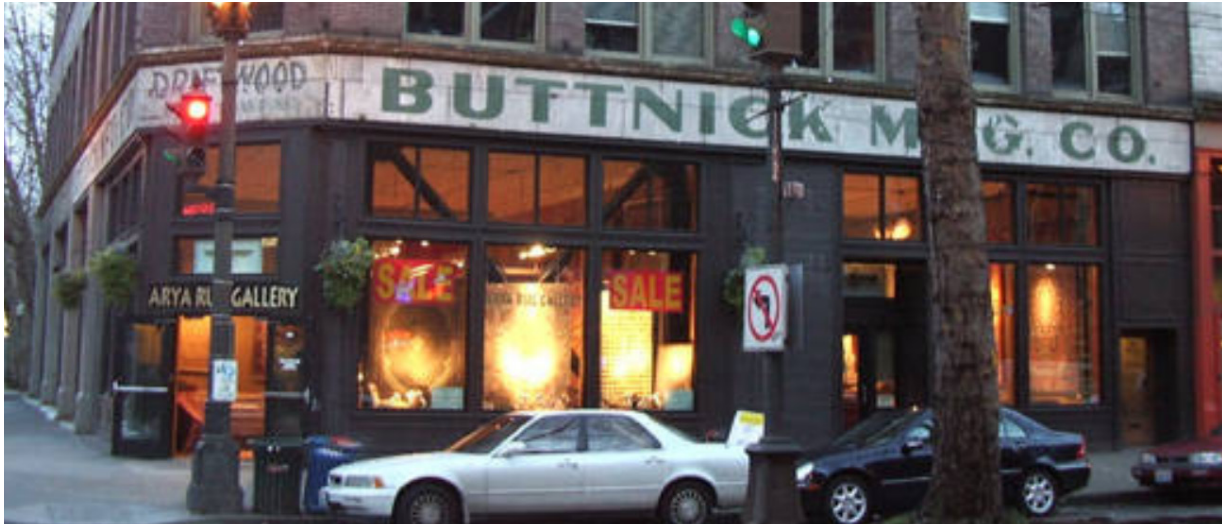
2003 Shows storefront reconstructed to better approximate the original condition as part of the 2002 renovation project.

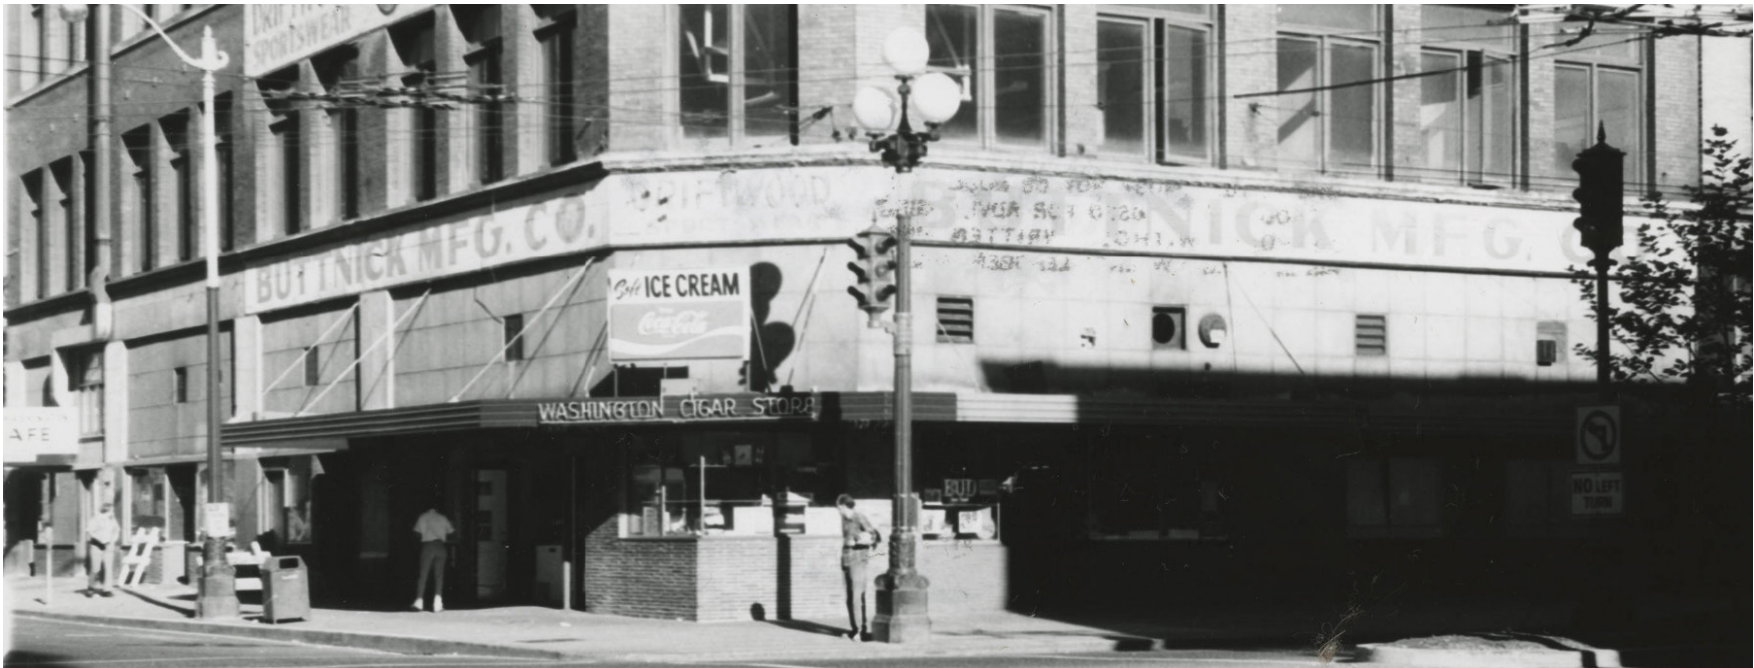
1974 Show the storefront rebuilt in a modern design following the 1950 gas explosion. No original storefront exists for the building.

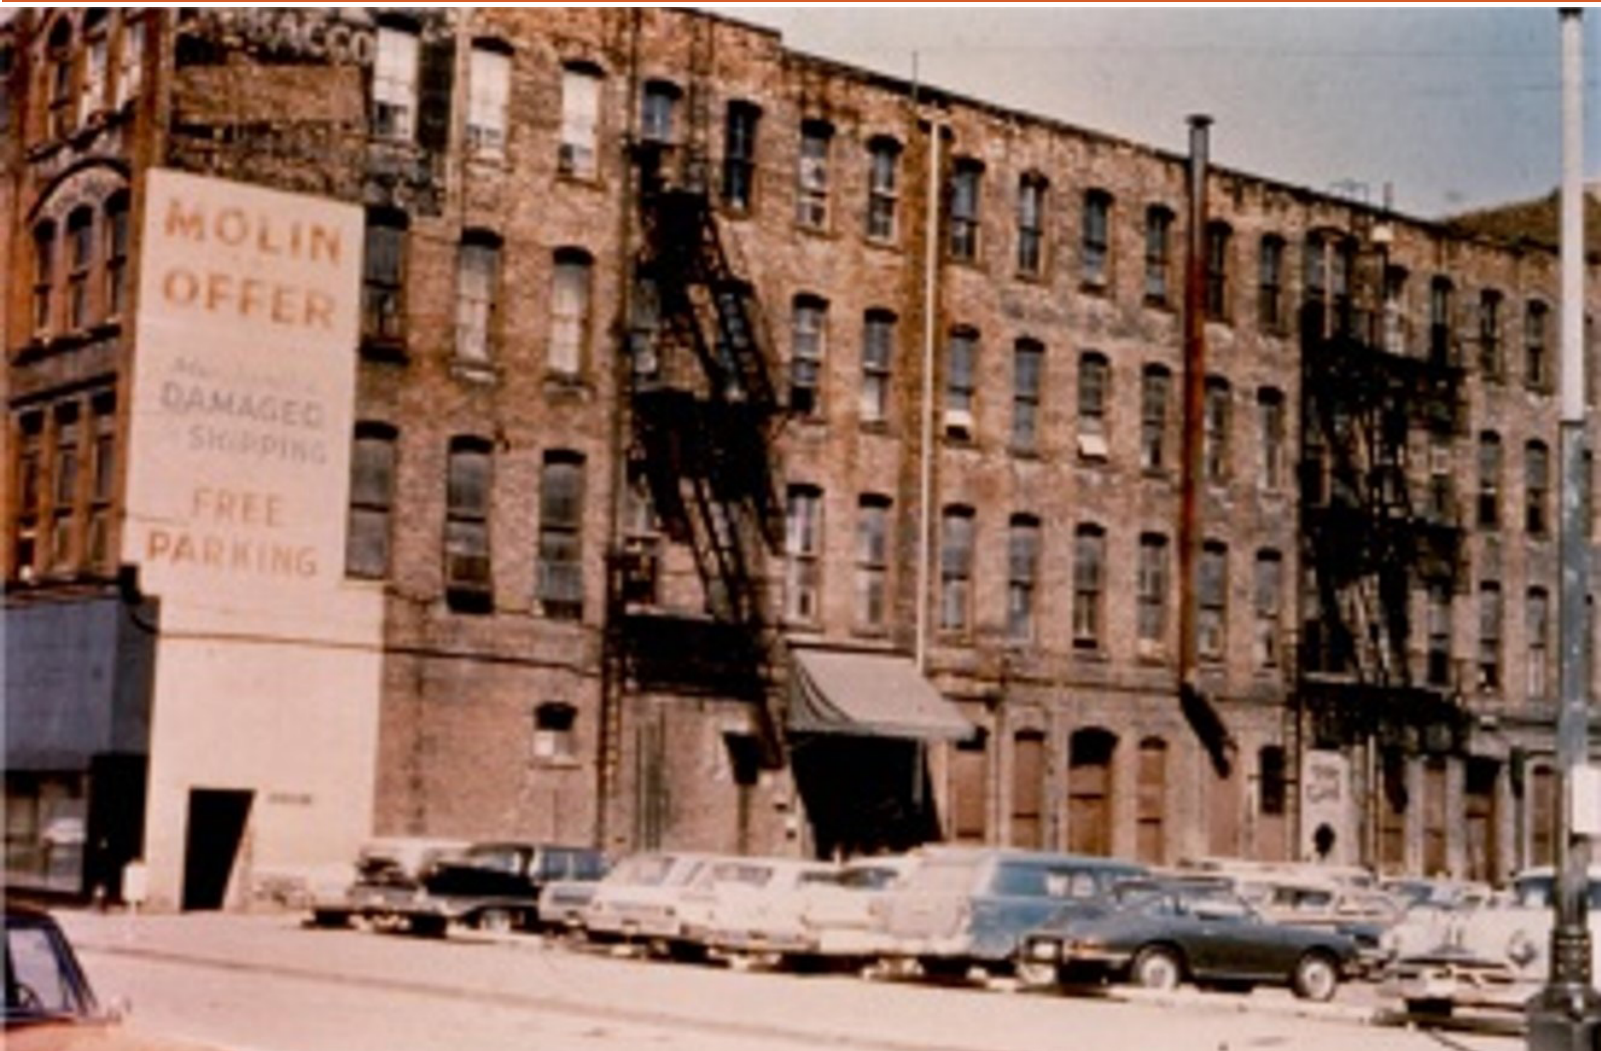
1970 Alley condition prior to 1972 building renovation.

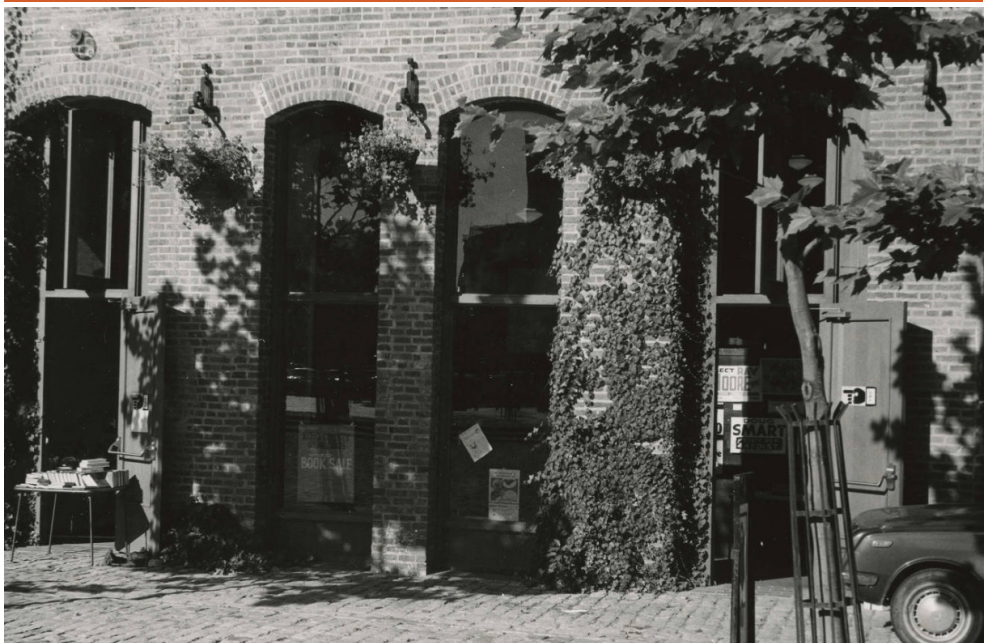
1974 Closeup of new alley storefront added during 1972 building renovation.

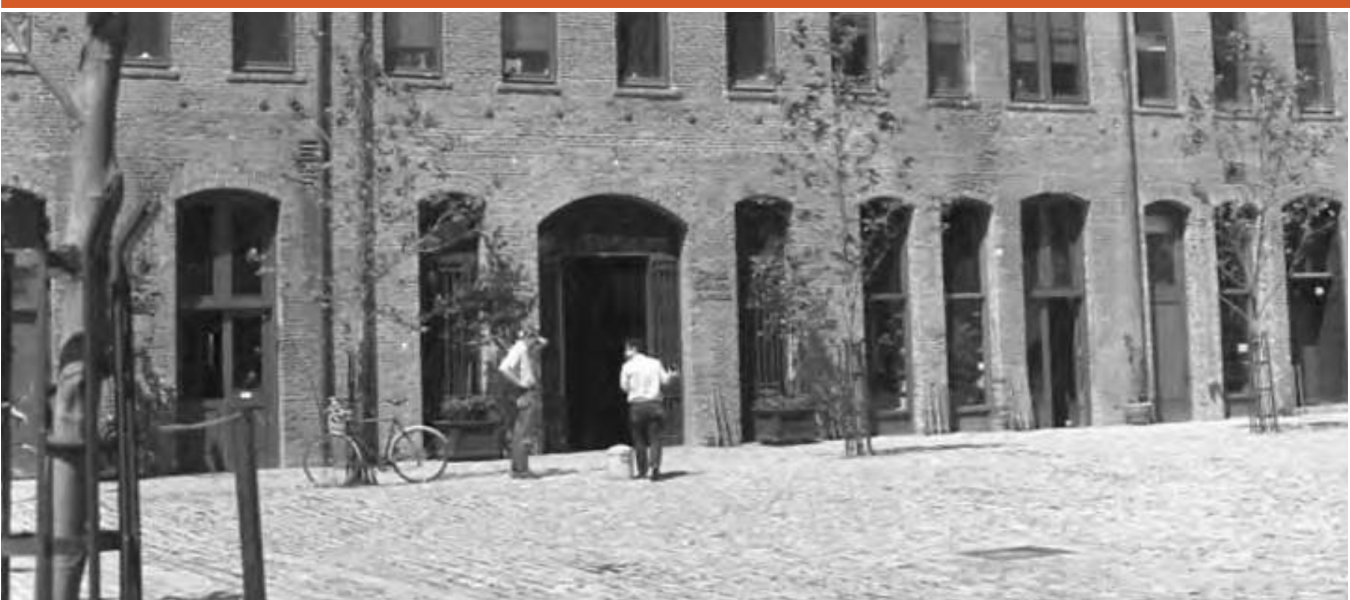
1973 New alley storefront added during 1972 building renovation.

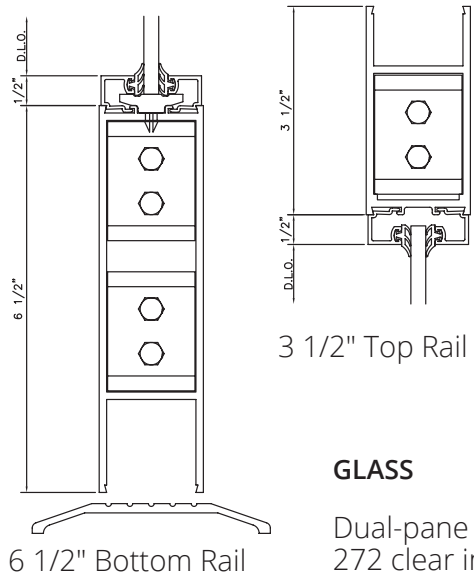
EFCO SERIES D300 ENTERANCE DOORS

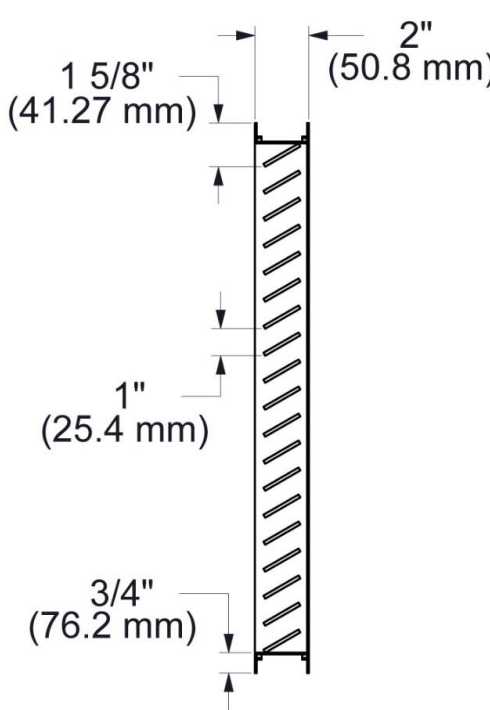
INDUSTRIAL LOUVERS, INC.
MODEL 150 THIN LINE
STOREFRONT LOUVER

- Standard features:
- Extruded aluminum
 - 2" deep
 - 2" blades
 - 1" blade spacing

FINISH

Dark bronze to match
EFCO storefront

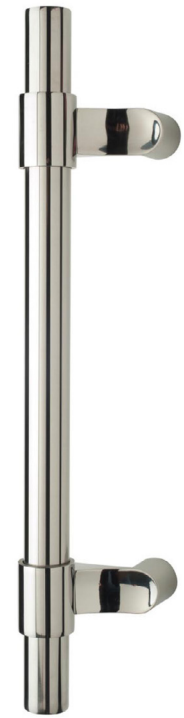
NEW STOREFRONT
DOOR PULLS TO BE
ASSA ABLOY
ROCKWOOD RM2230
BANDWIDTH FLAT
OFFSET

PULL FINISH TO BE
ANTIQUÉ BRASS
(BHMA 609 / US5)

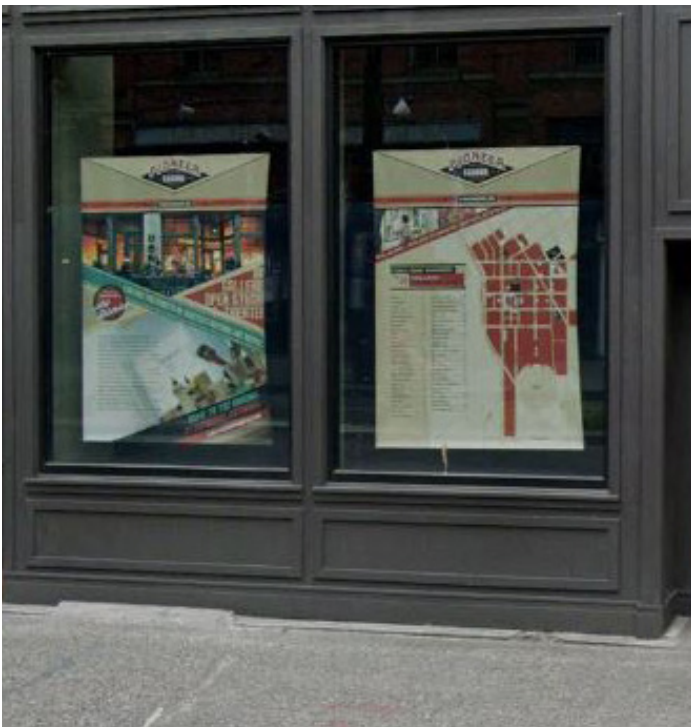
EXISTING PONY WALL

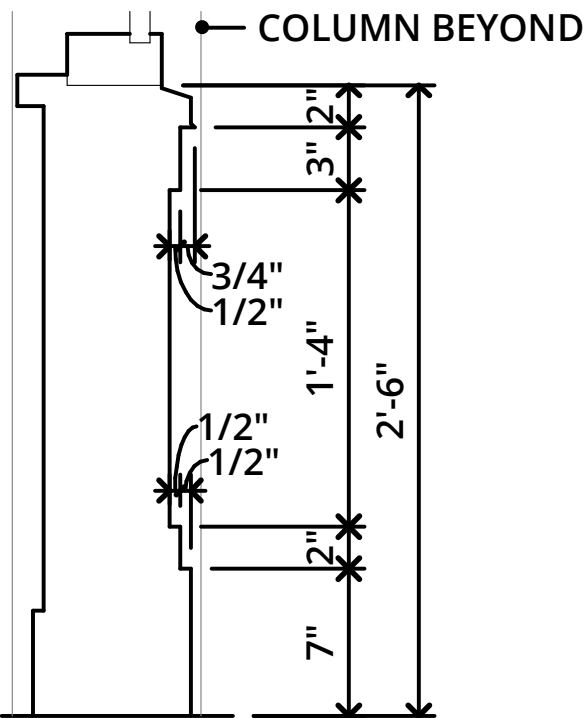
PROPOSED PONY WALL SECTION

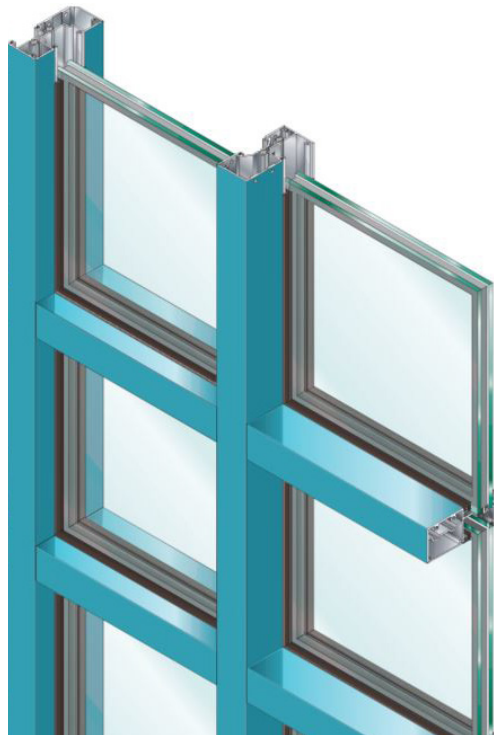
EFCO SERRIERS 433
STOREFRONT SYSTEM

- Standard features:
- 2" sightline
 - 4 1/2" deep
 - Thermally broken frames
 - Front glazed configuration

- 2" sightline
- 4 1/2" deep
- Thermally broken frames
- Front glazed configuration

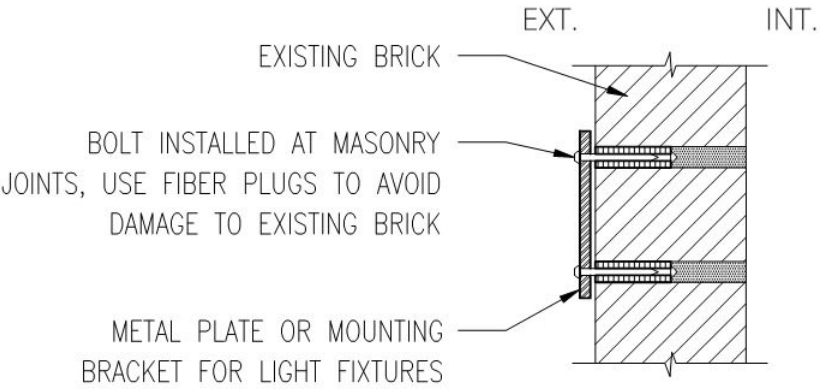
EXTERIOR LIGHTING MOUNTING DETAIL

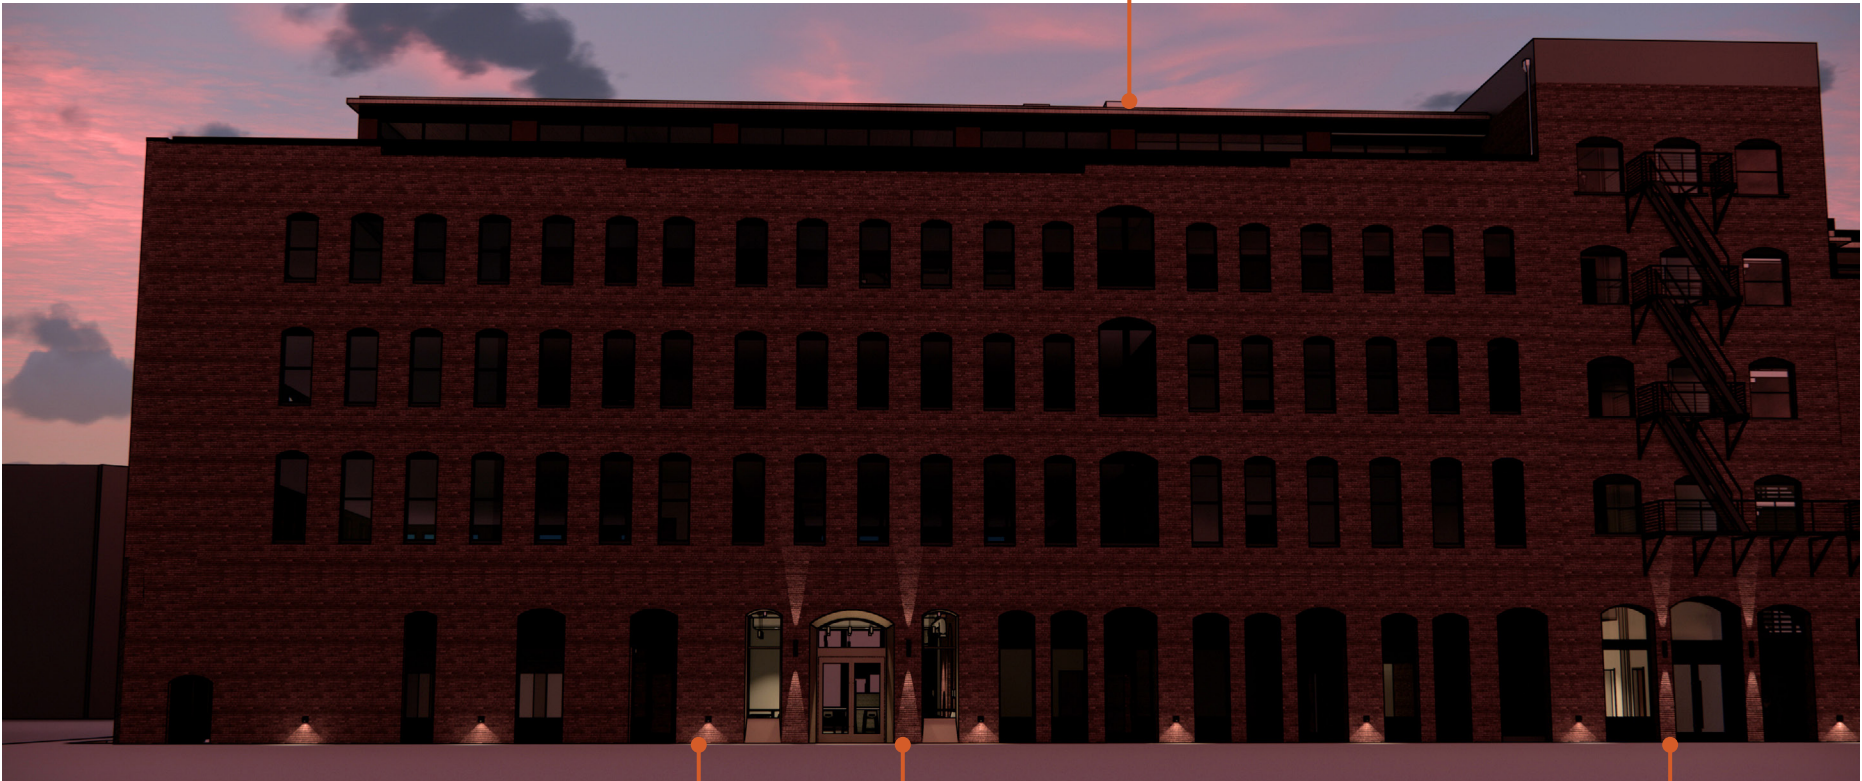
EAST ELEVATION LIGHTING RENDERING

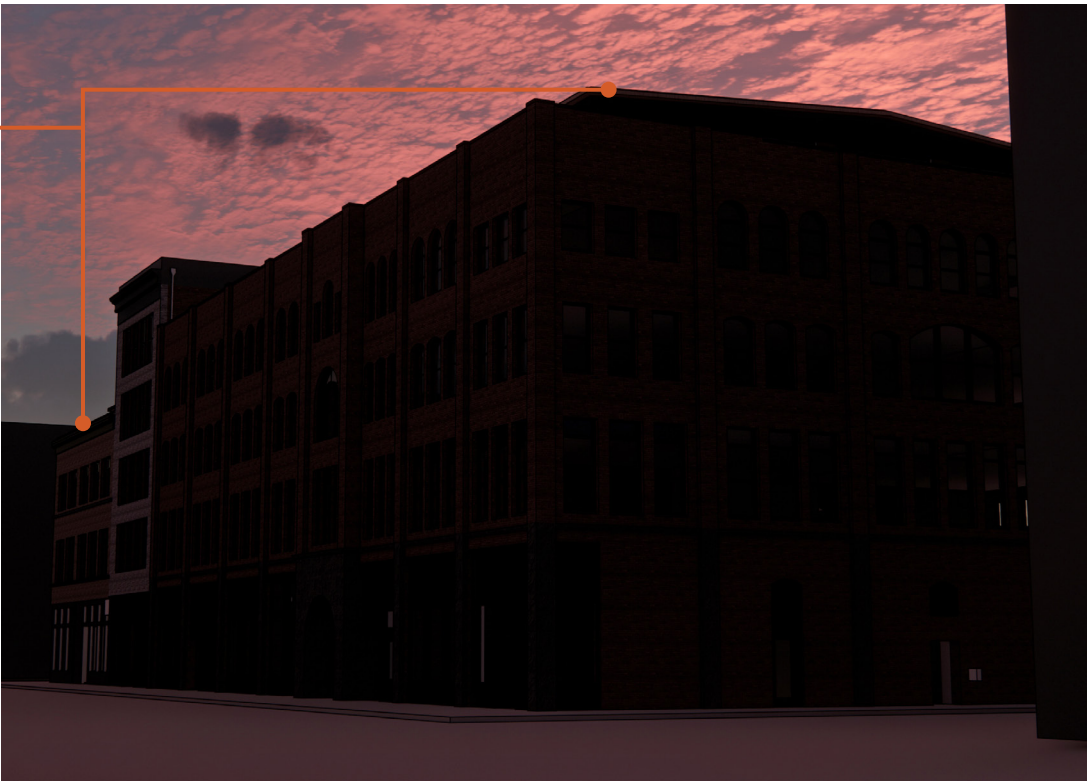
SOUTHWEST ELEVATION LIGHTING RENDERING - PENTHOUSE EXTERIOR FIXTURES NOT VISIBLE

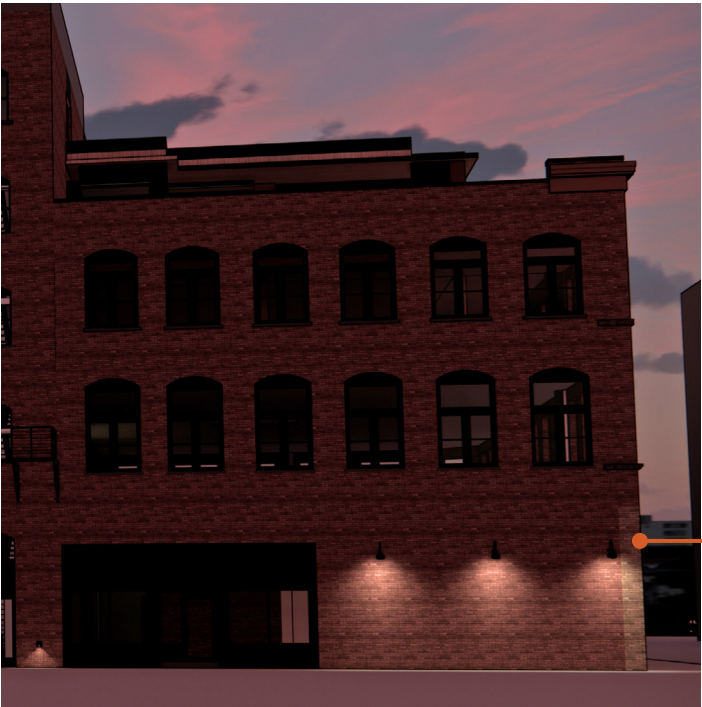
EAST ELEVATION AT BUTTNICK LIGHTING RENDERING
