PSPB COA PROPOSAL - CORRECTIONS

GRAND CENTRAL BLOCK

BRUNSWICK-BALKE-COLLENDER CO + GOTTSTEIN + SQUIRE LATIMER

200 S 1ST ST, Seattle, WA 98104

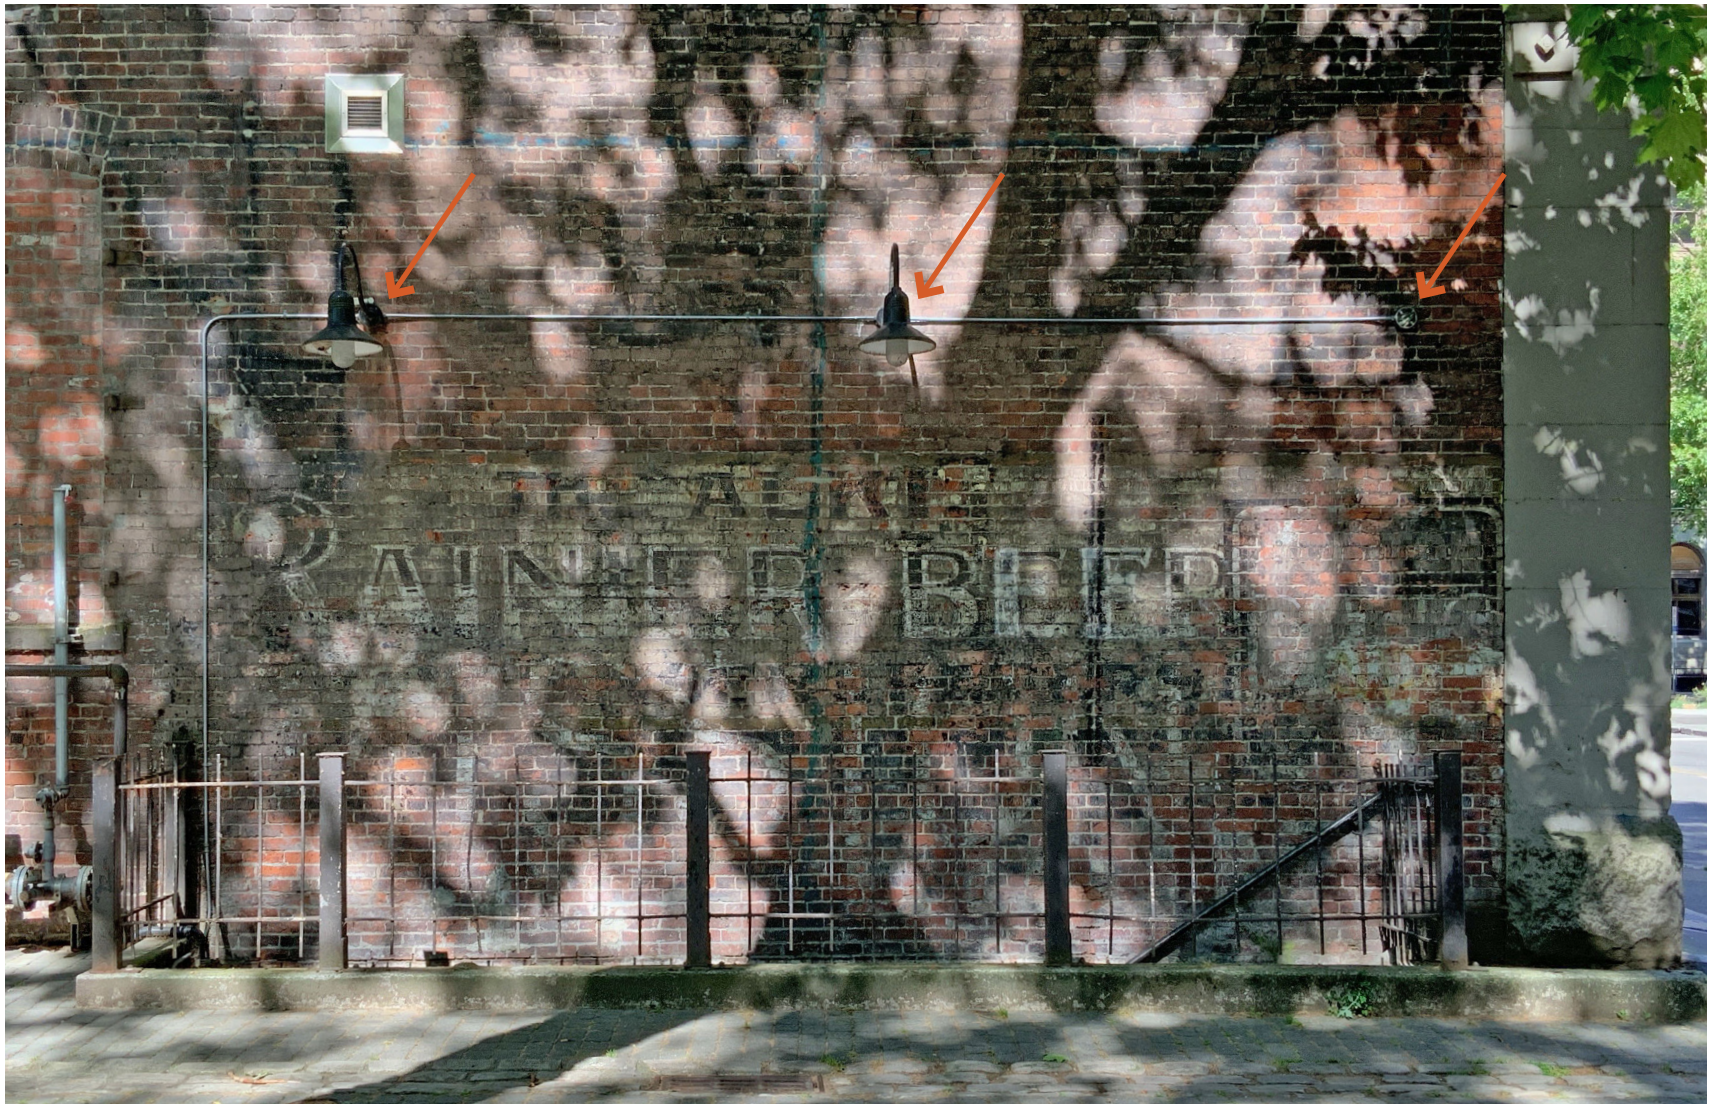
EXISTING GHOST SIGN

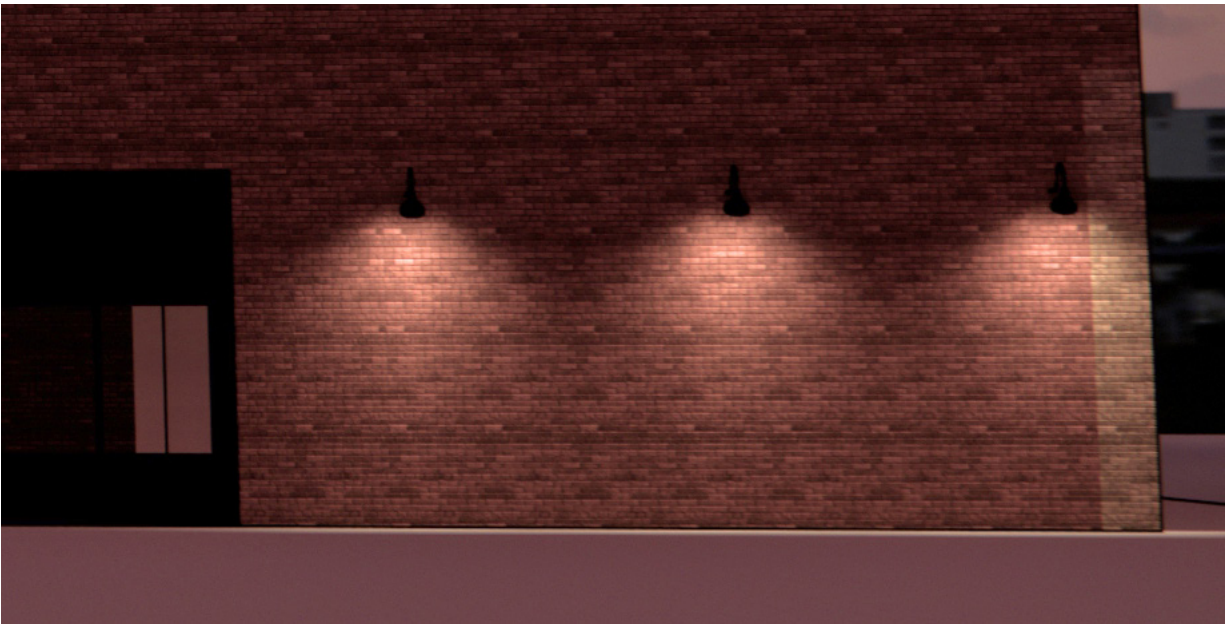
LIGHTING RENDERING FOR GHOST SIGN LOCATION

LIGHTING LOCATIONS

- Three existing light fixture locations exist at the ghost sign on the North end of the Alley.
- The existing J-box locations will be reused for the new lighting fixtures.
- No new lighting locations are proposed for the ghost sign.

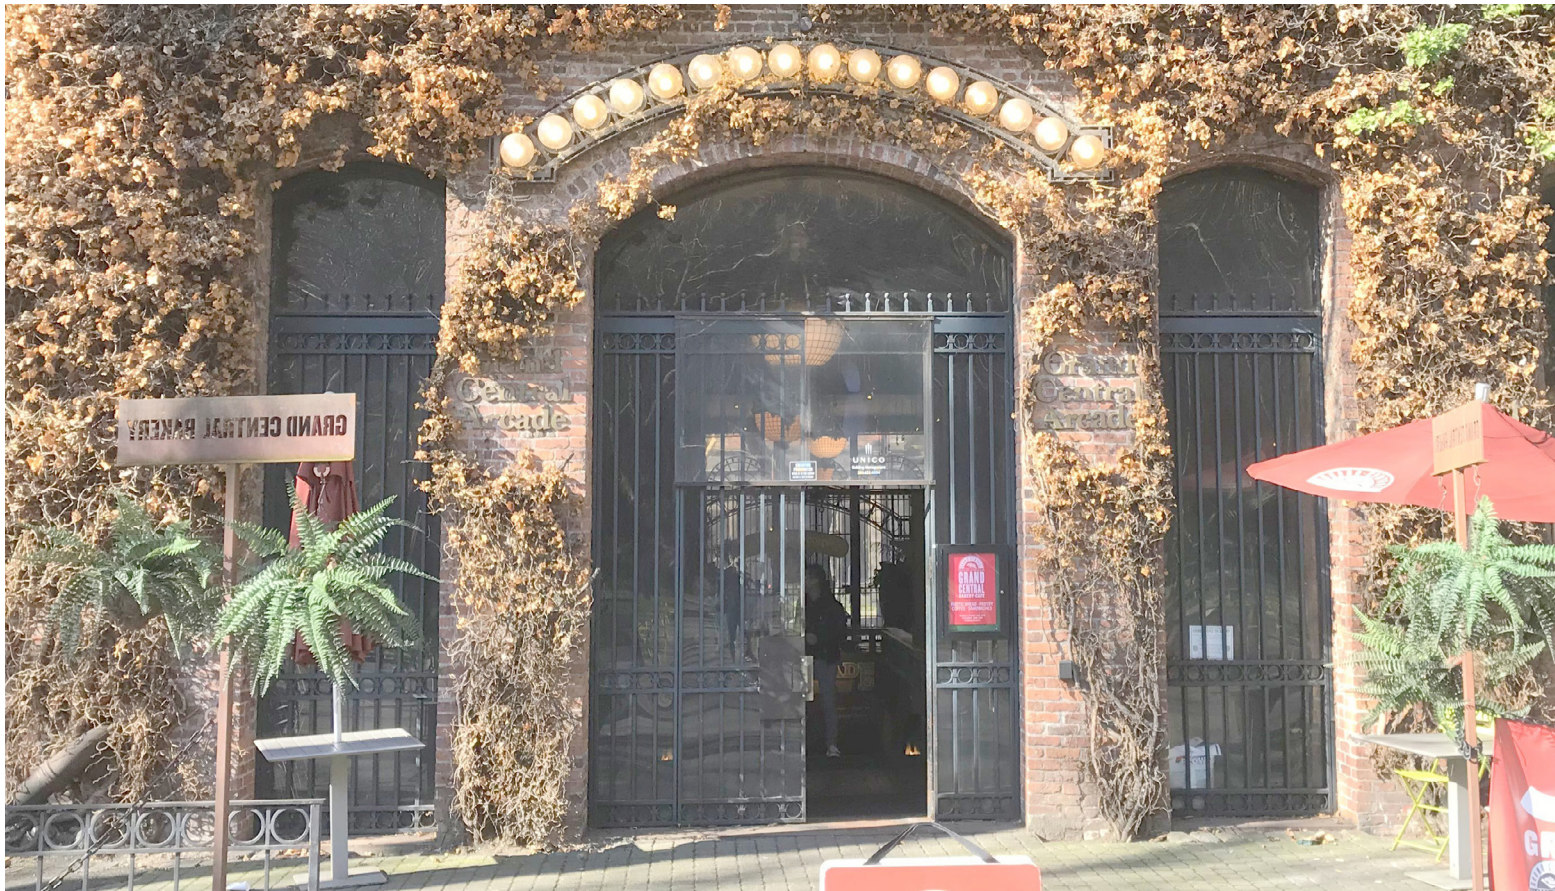
EXISTING GRAND CENTRAL PUBLIC ENTRY

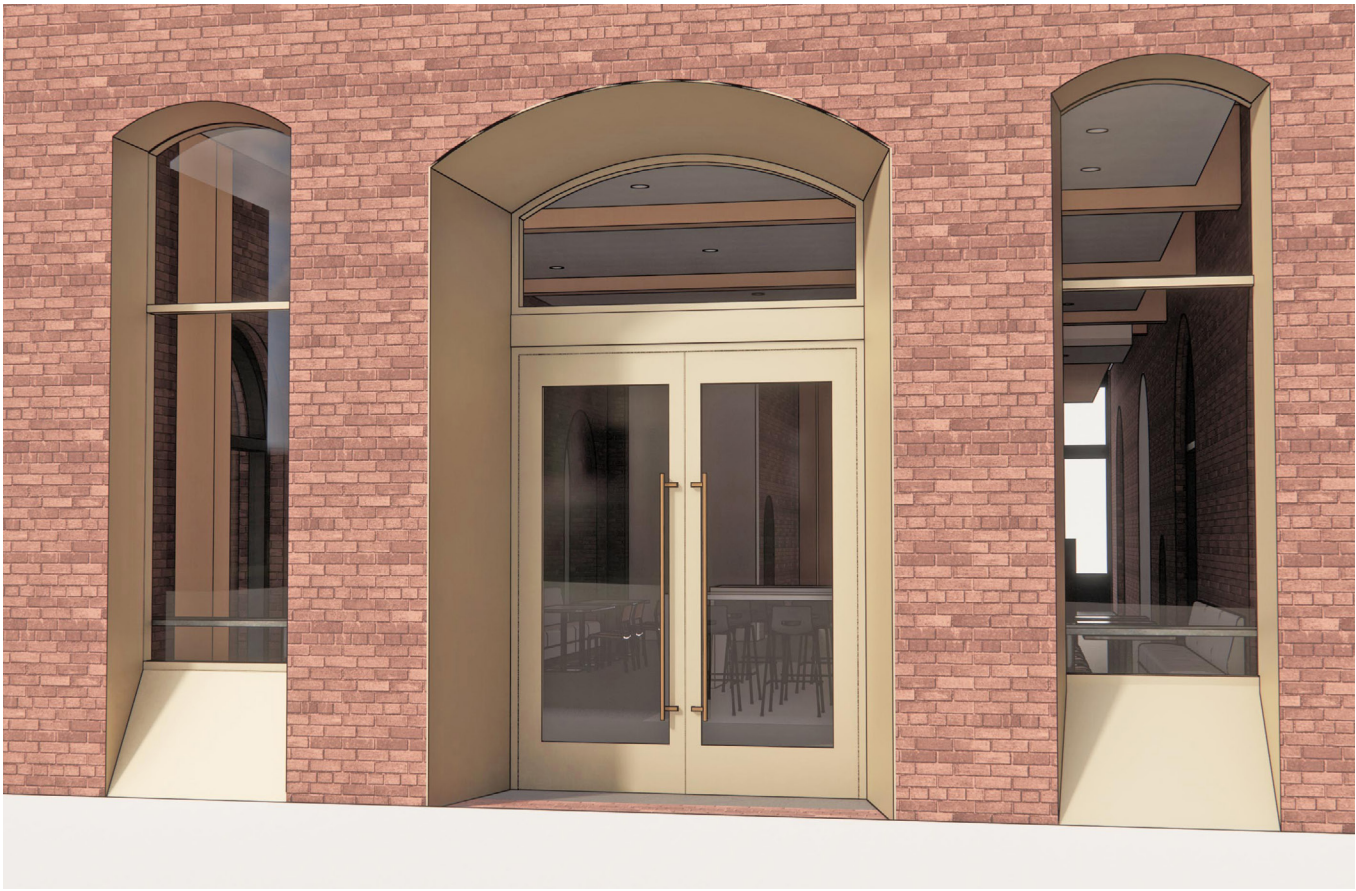
PROPOSED GRAND CENTRAL PUBLIC ENTRY

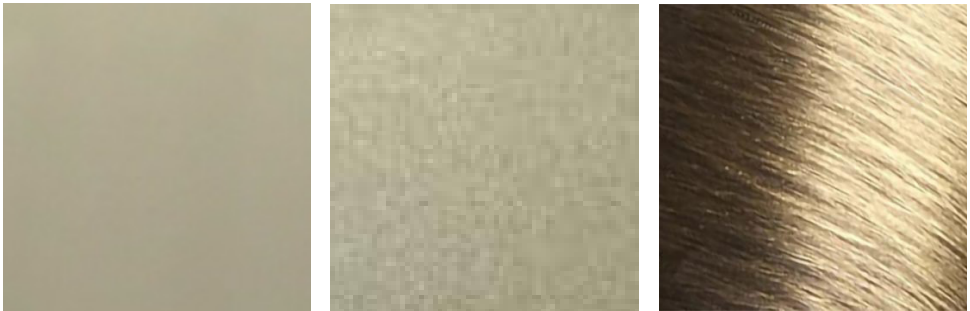
EXTERIOR MATERIALS

- 1 Champagne (EFCO Standard Finish)
- 2 Metallic Champagne (AEP Span)
- 3 Door Hardware Pull - Antique Brass (BHMA 609 / US5)

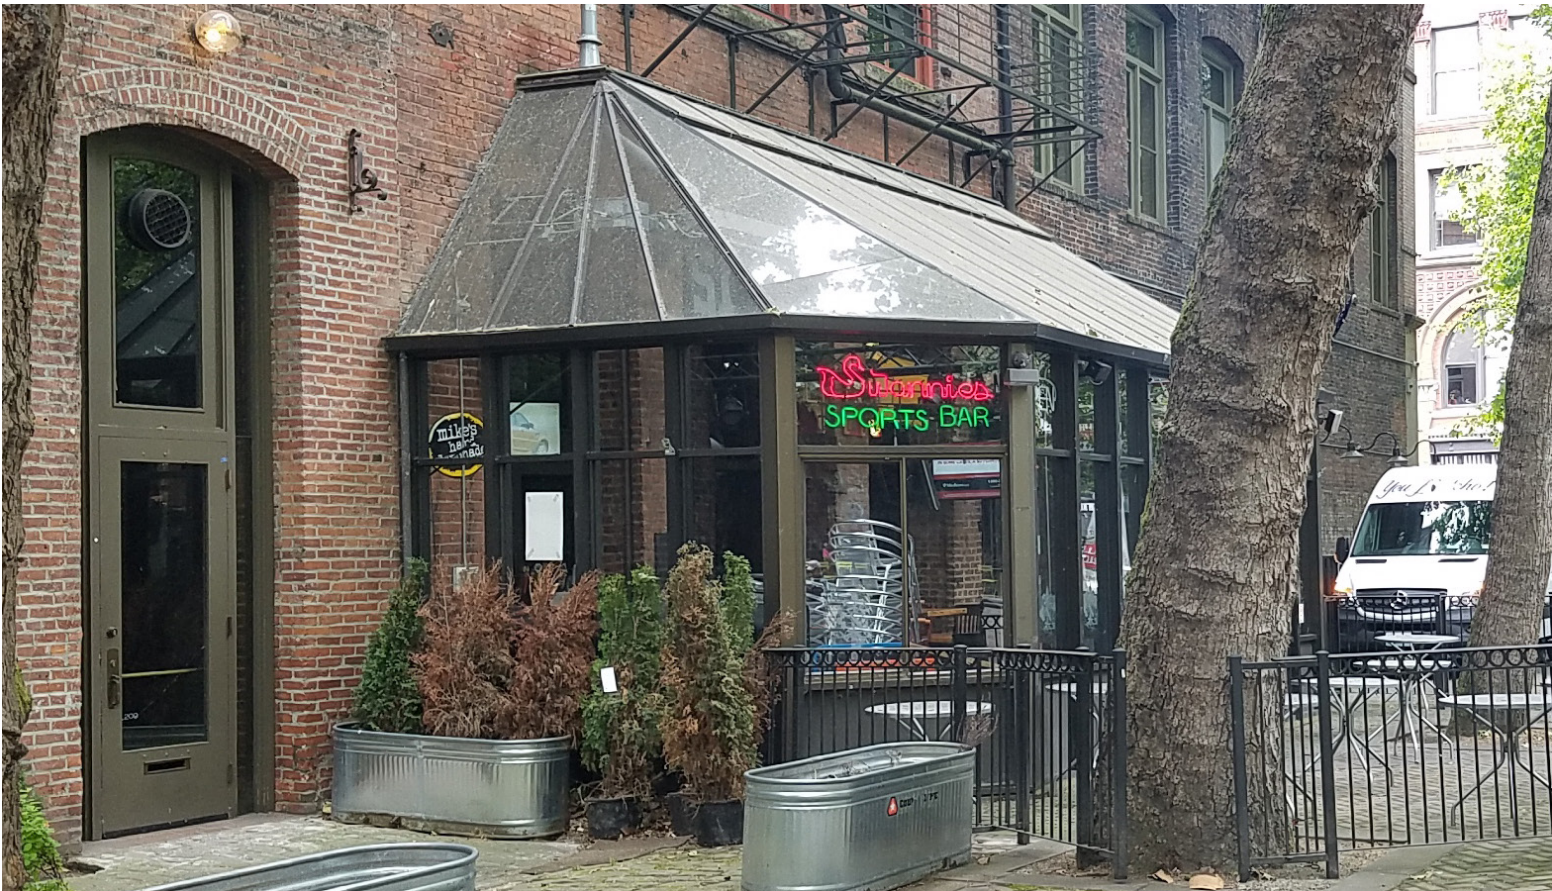
EXISTING CITY LOAN GREEN HOUSE SEATING AREA

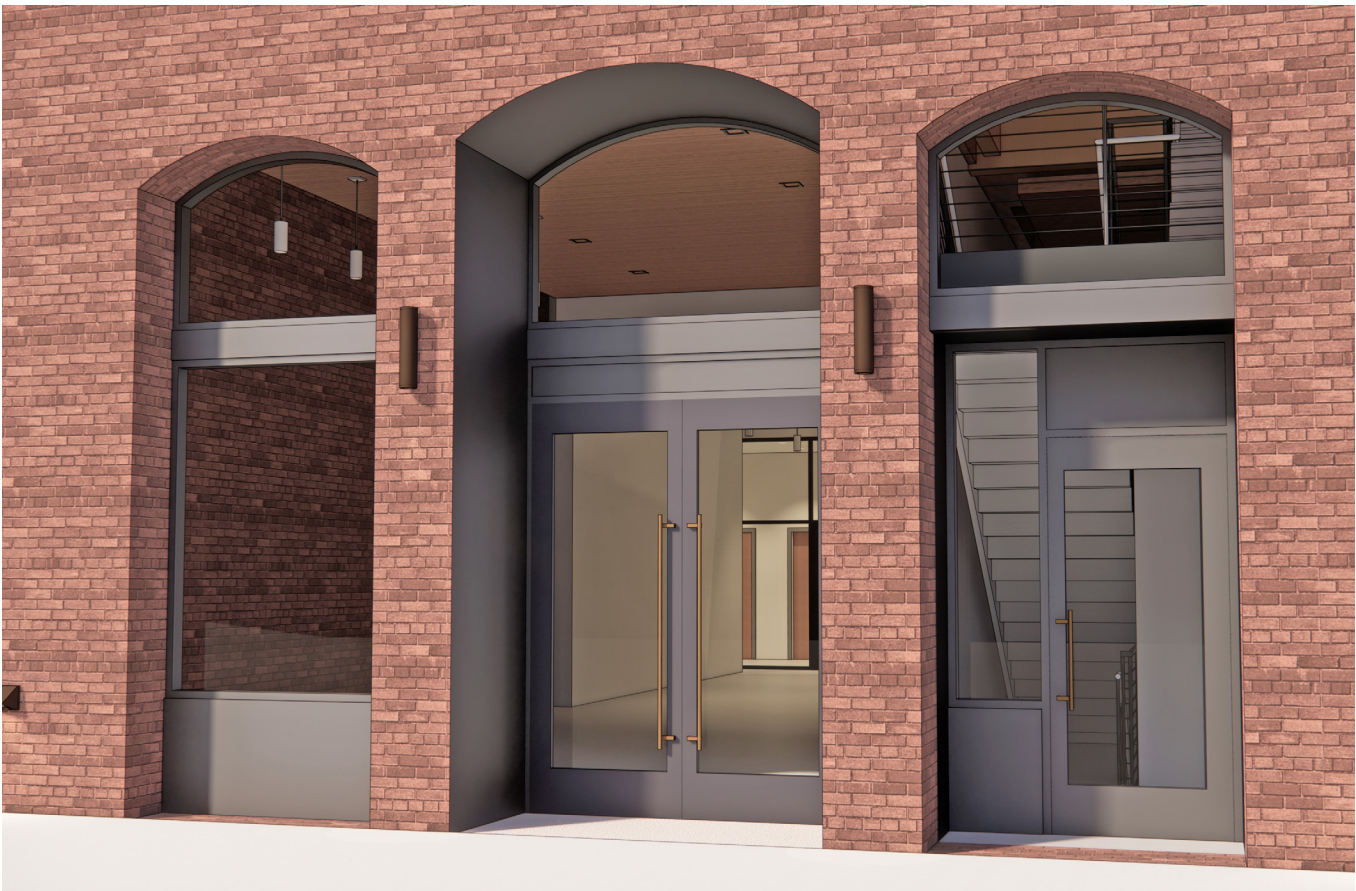
PROPOSED CITY LOAN OFFICE ENTRY

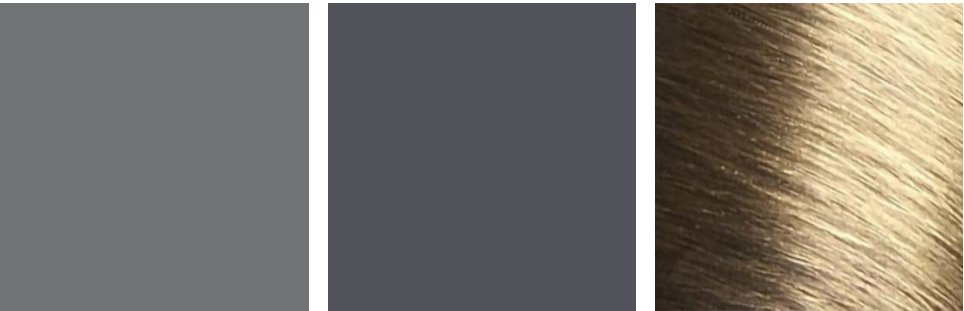
EXTERIOR MATERIALS

- 1 Old Town Gray (EFCO frame to match AEP Span color)
- 2 Slate Gray (EFCO door to match AEP Span color)
- 3 Door Hardware Pull - Antique Brass (BHMA 609 / US5)

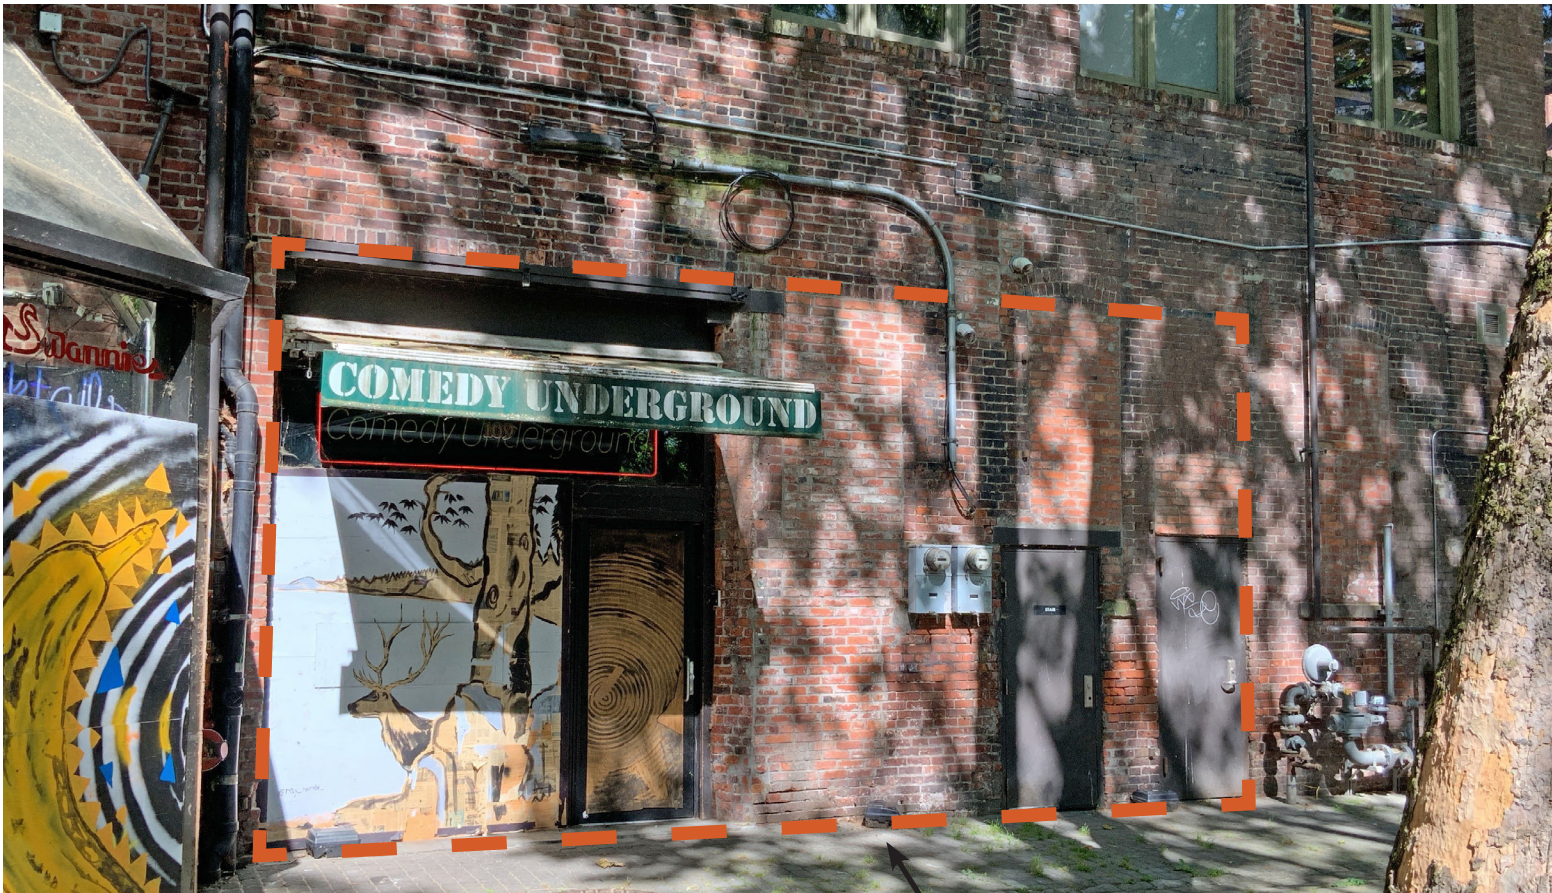
EXISTING BUTTNICK MASONRY OPENINGS

EXISTING MASONRY
AND OPENINGS TO
BE REMOVED

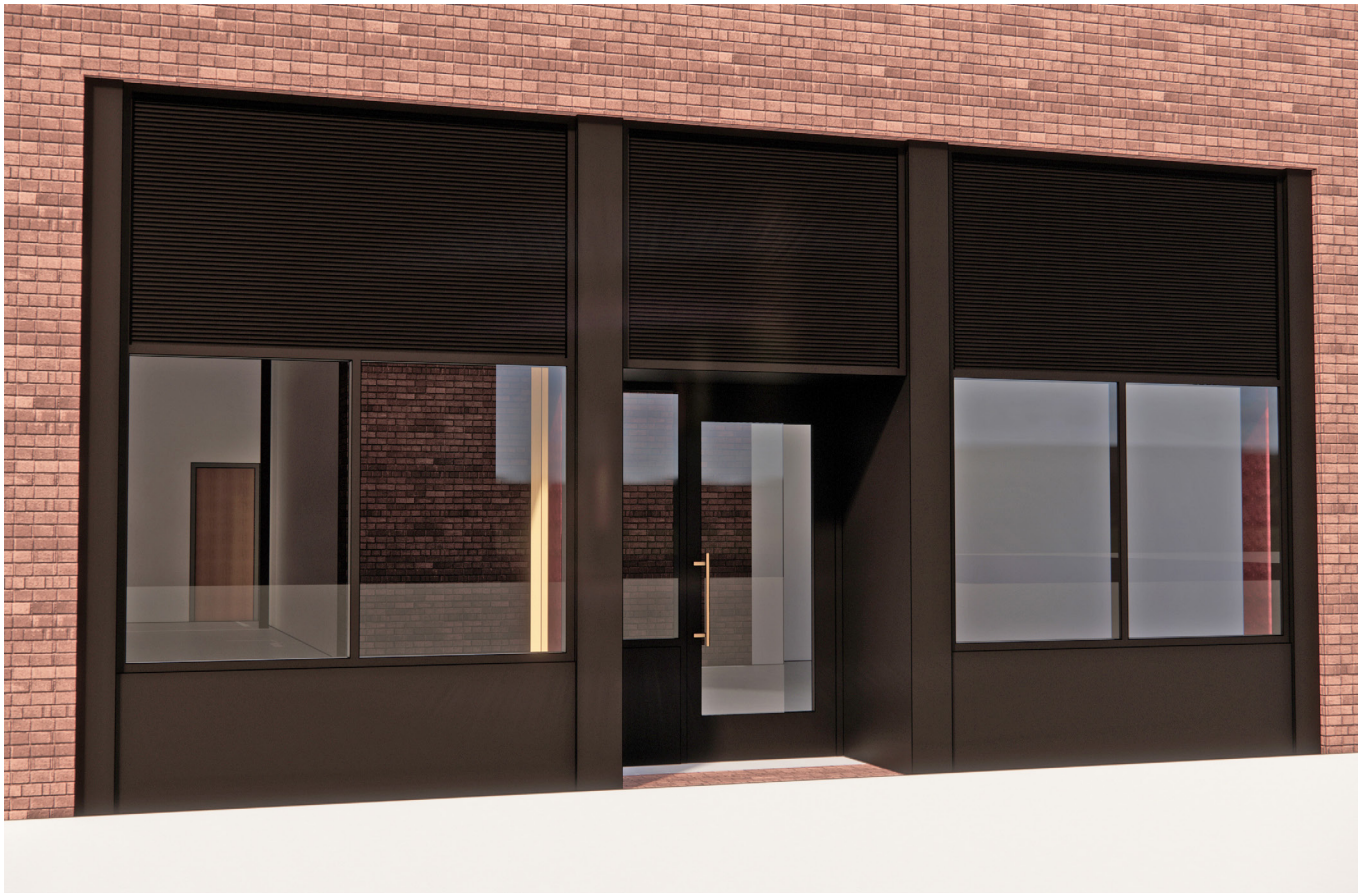
PROPOSED BUTTNICK STOREFRONT IN MASONRY OPENING

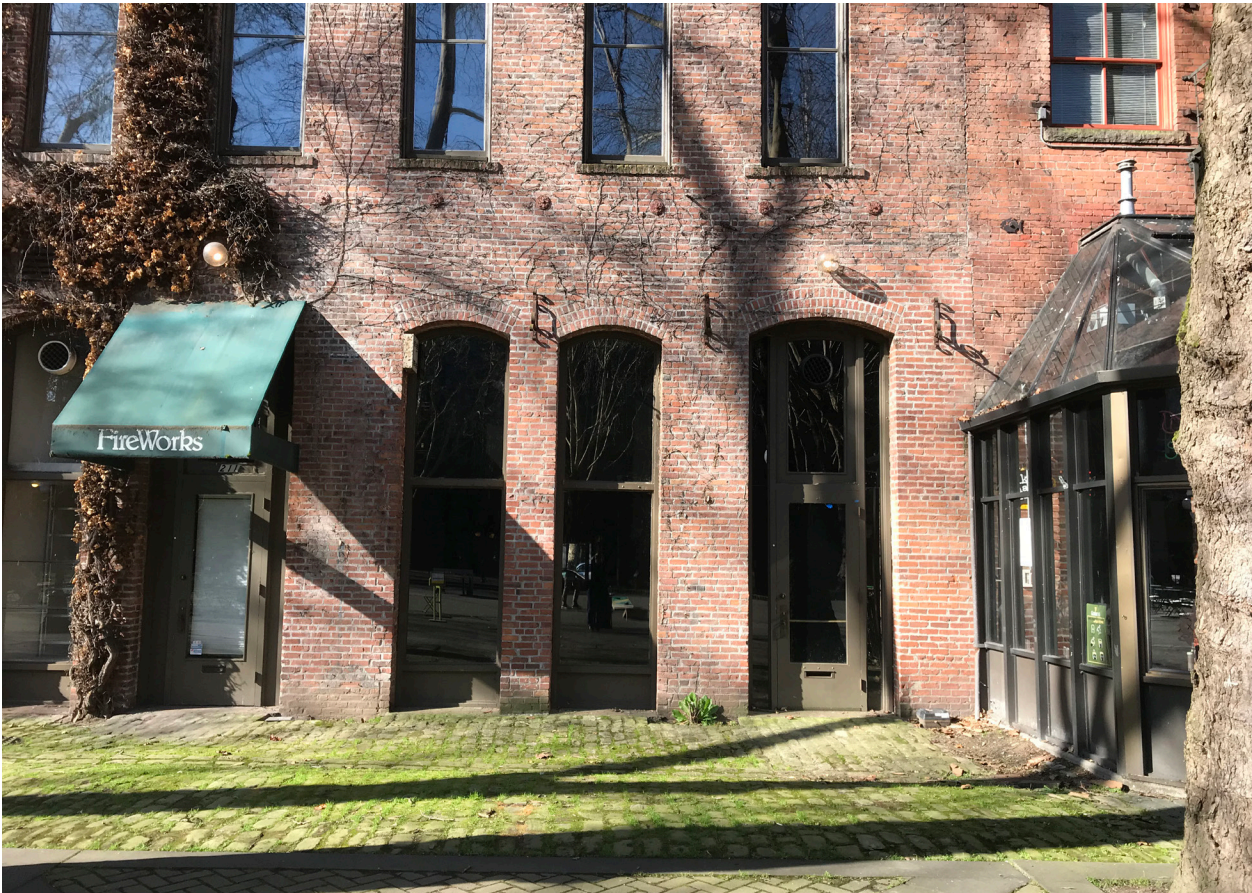
EXISTING TYPICAL TENANT STOREFRONT AT ALLEY

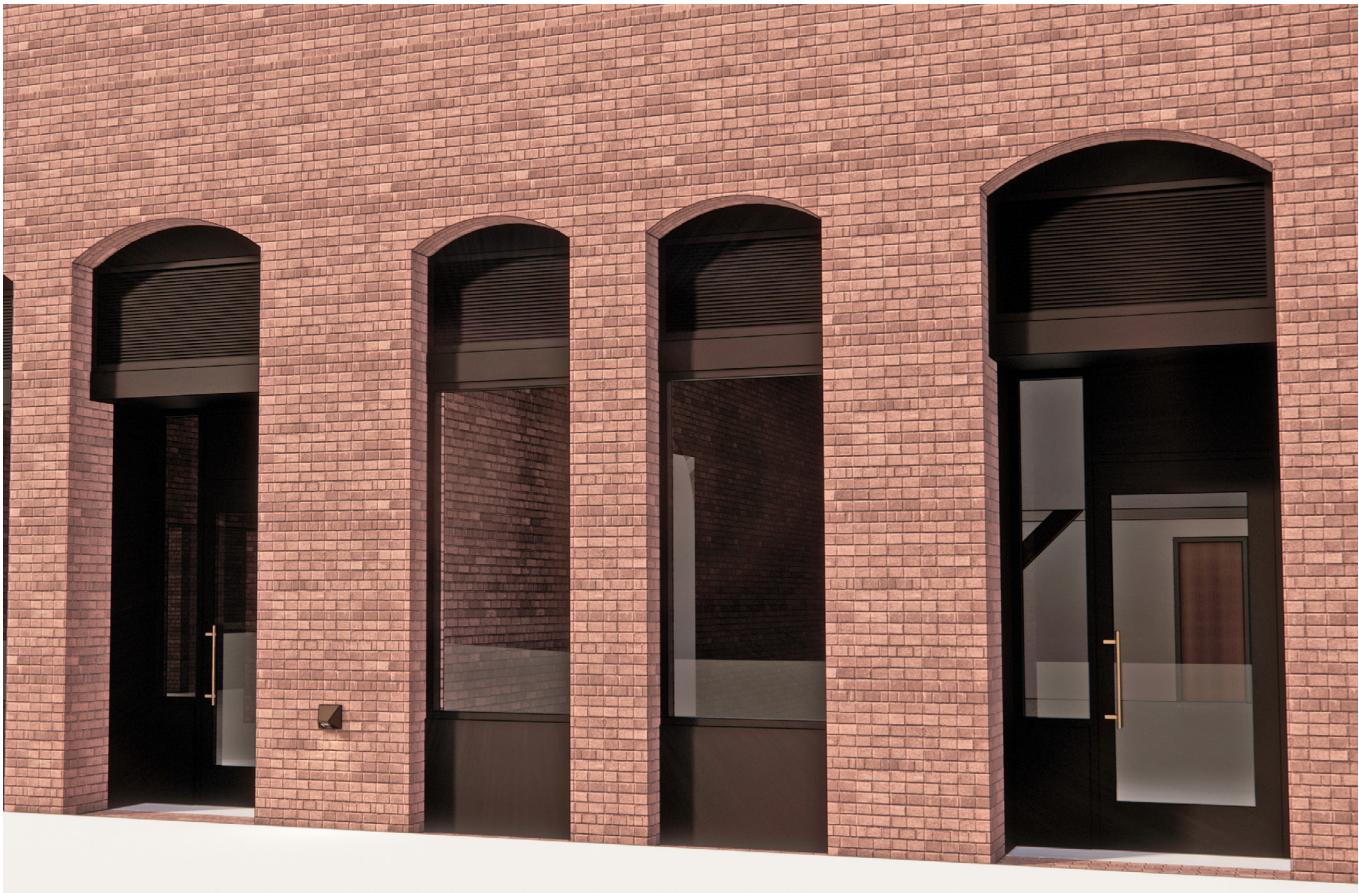
PROPOSED TYPICAL TENANT STOREFRONT AT ALLEY

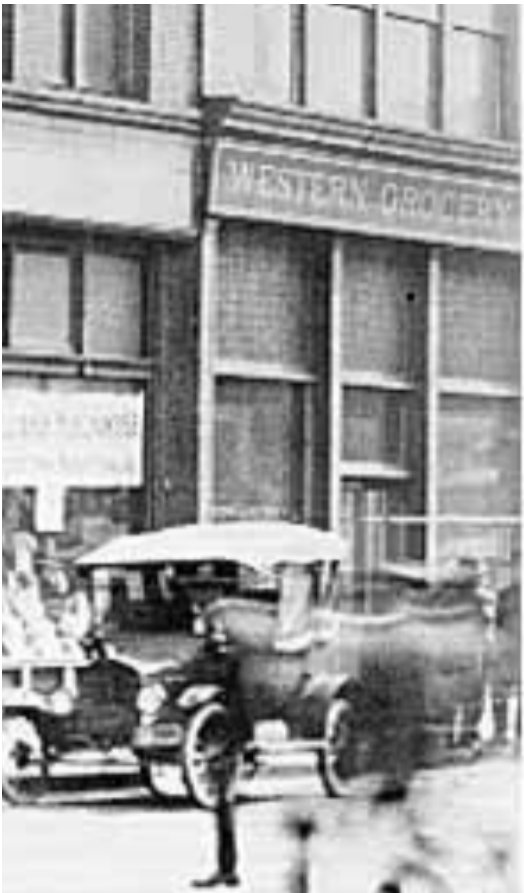
HISTORIC PHOTO FROM 1915

1915 First photo of Buttnick storefront. Assumed close to original condition.

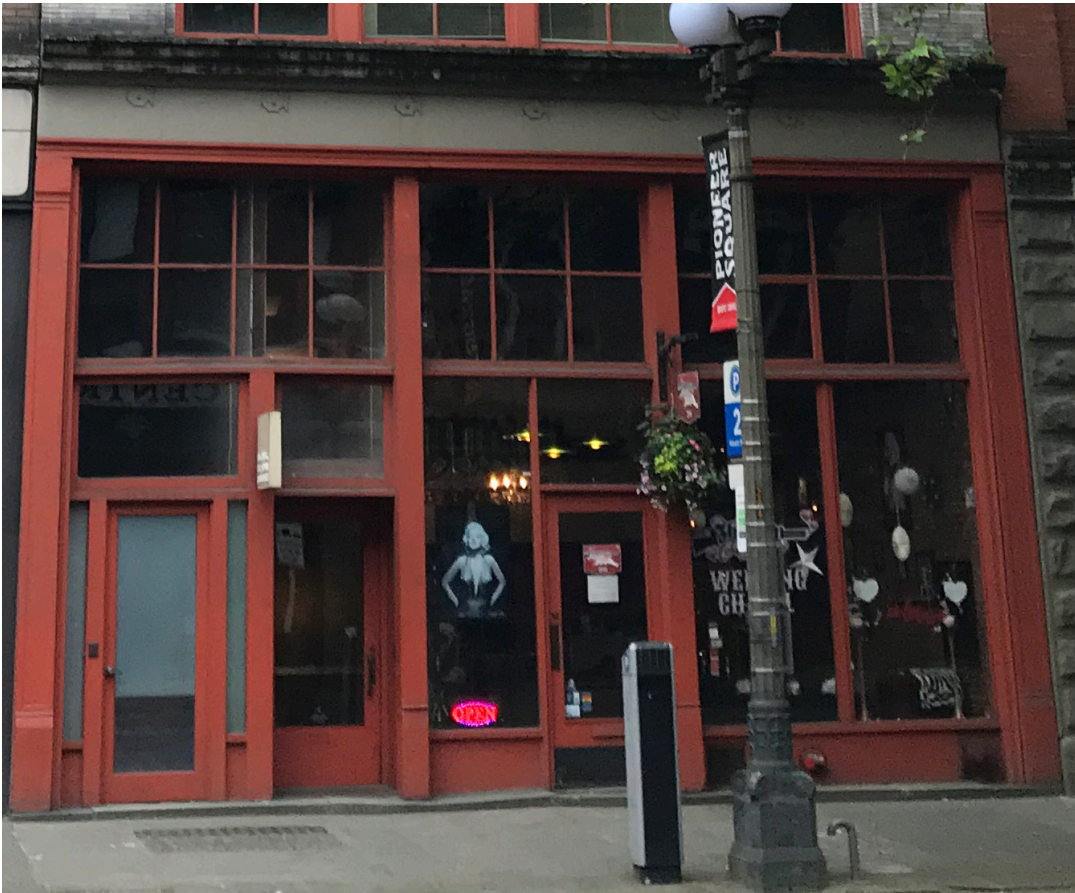
EXISTING WEST STOREFRONT

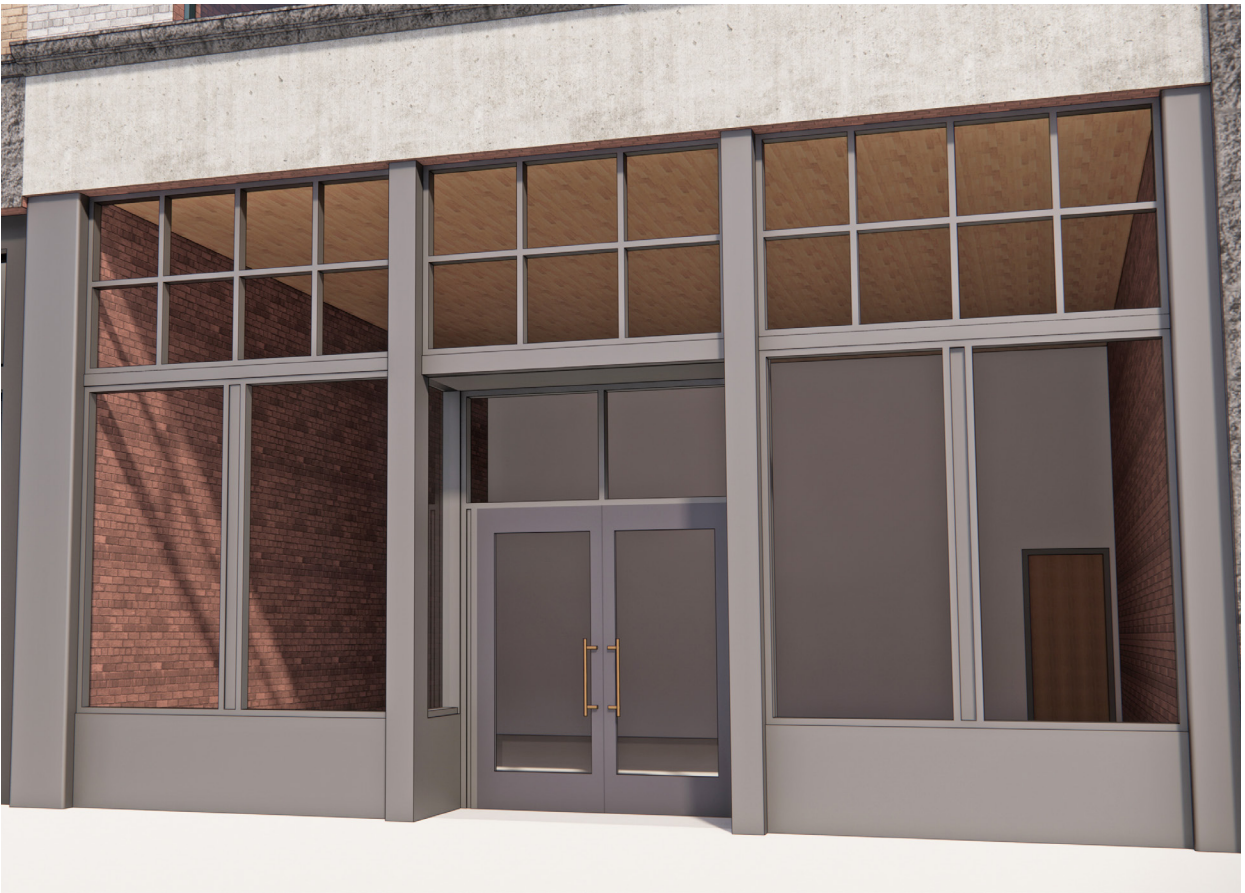
PROPOSED WEST STOREFRONT

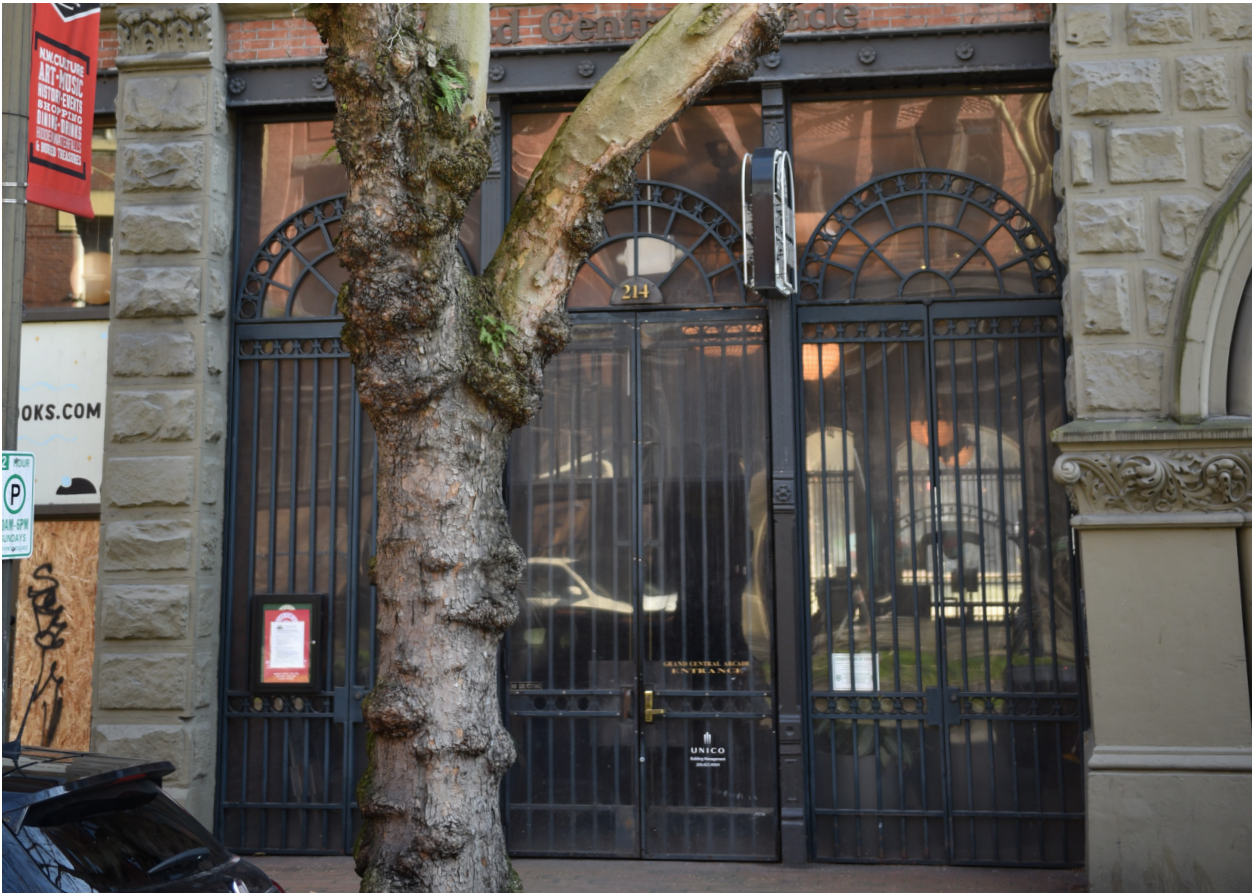
EXISTING GRAND CENTRAL PUBLIC ENTRY

1. Existing iron bars at Grand Central entries were added as part of the 1972 Anderson renovation and are not from the historic period of significance.

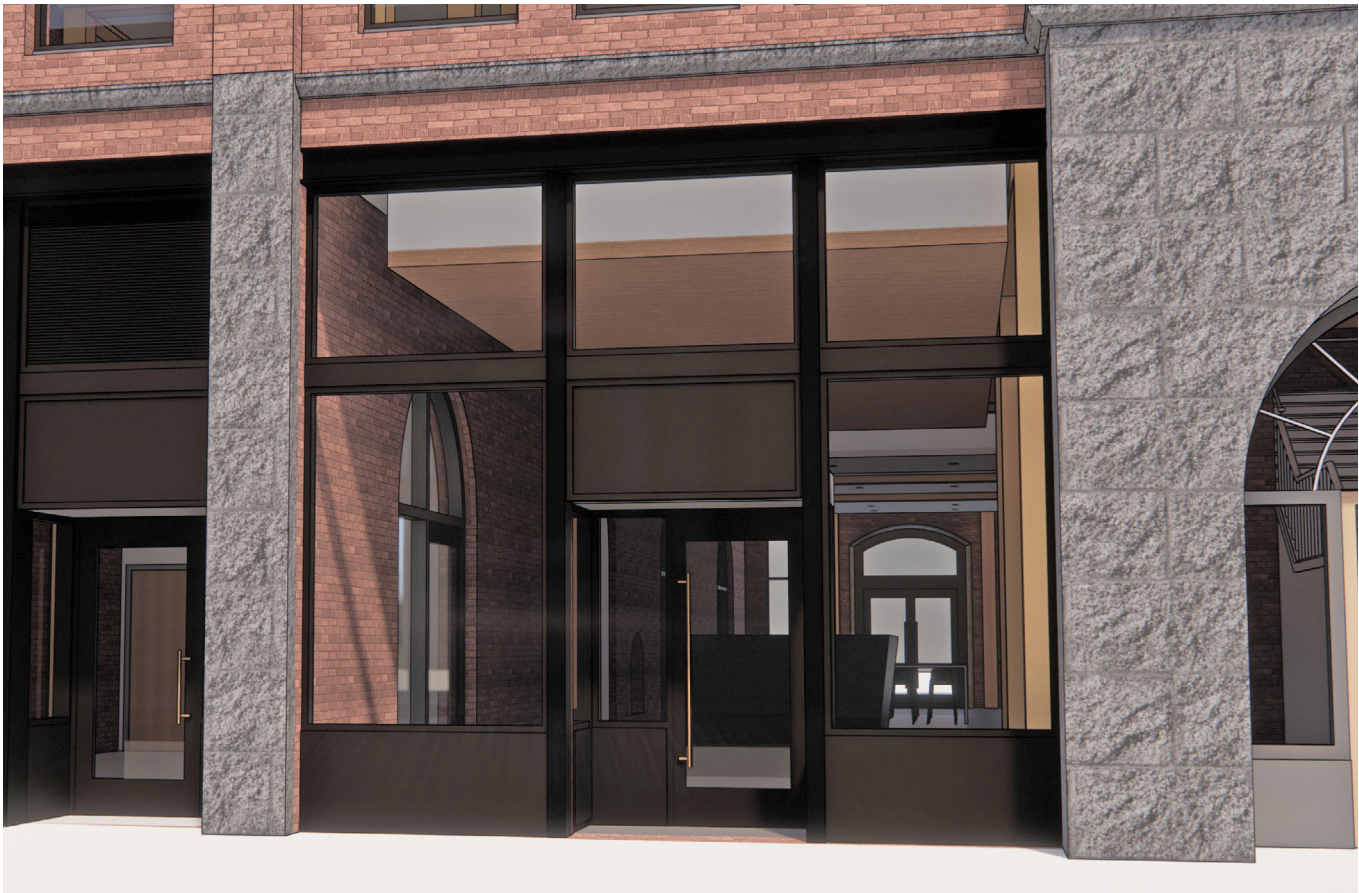
PROPOSED GRAND CENTRAL PUBLIC ENTRY

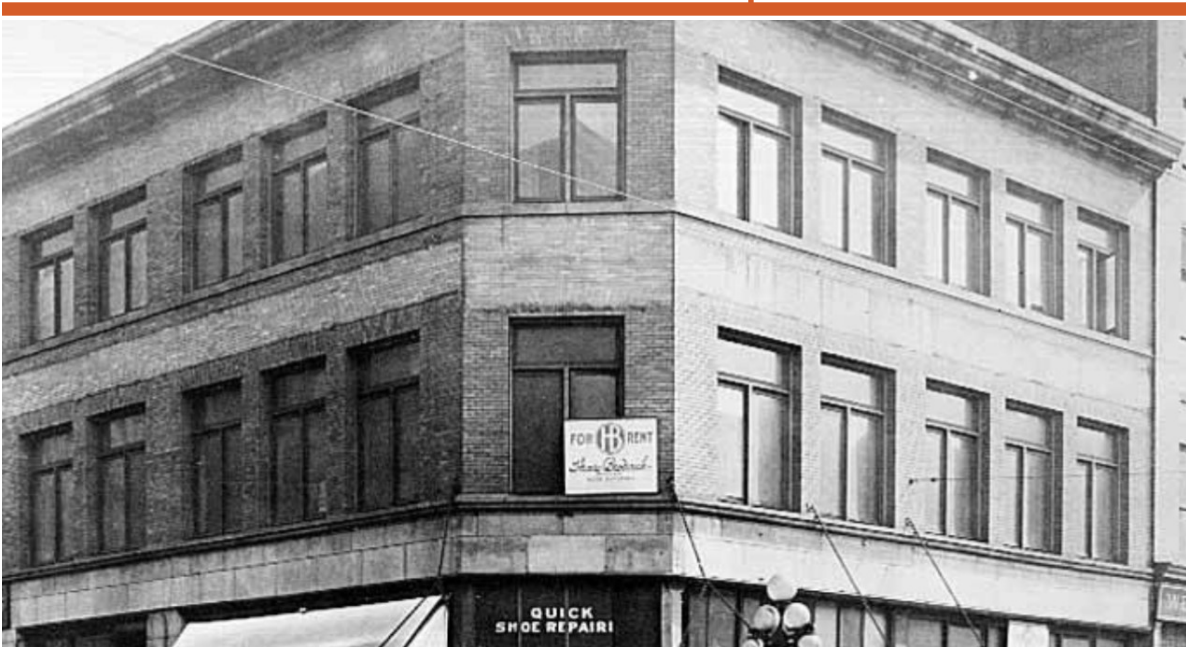
1915 First photo of Buttnick windows. Assumed original condition

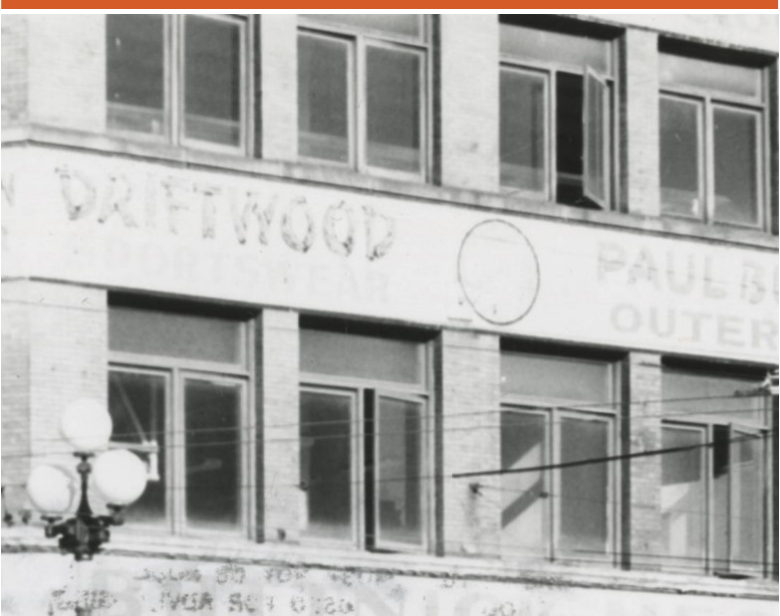
1974 Shows some windows modified to casement condition instead of pivot.

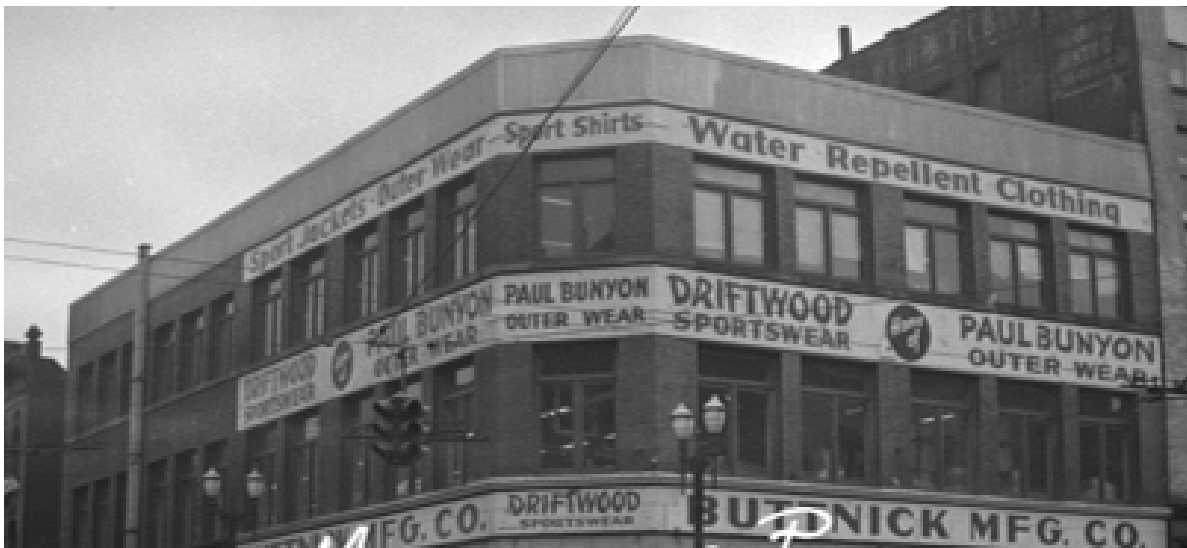
1952 Reconstructed Buttnick windows after the 1950 gas explosion in basement and associated upper floor fire.

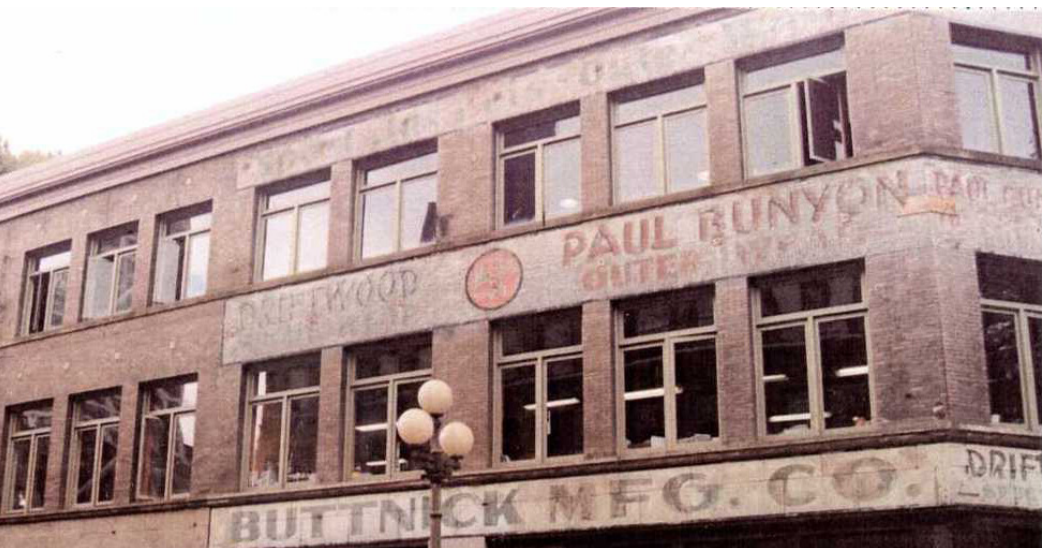
2003 Shows windows that were modified in the 2002 renovation project.

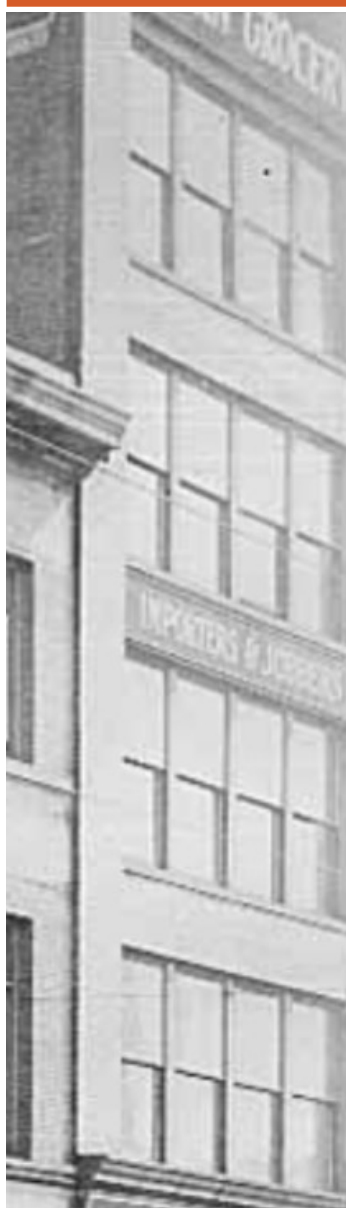
1915 Original windows with no muntins.

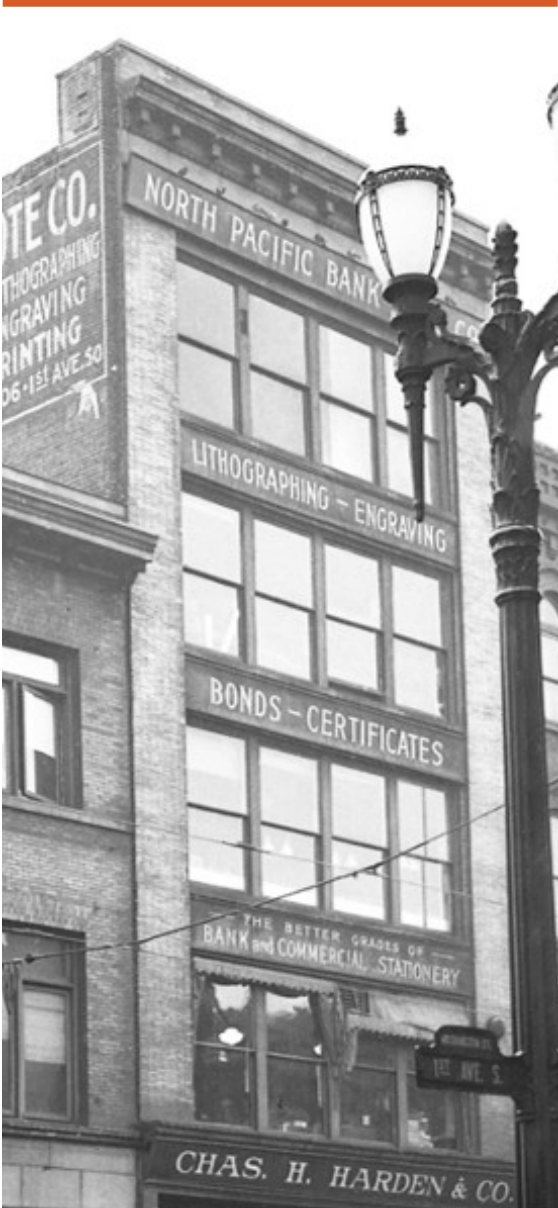
1937 Windows have begun being modified as seen in the bottom right window.

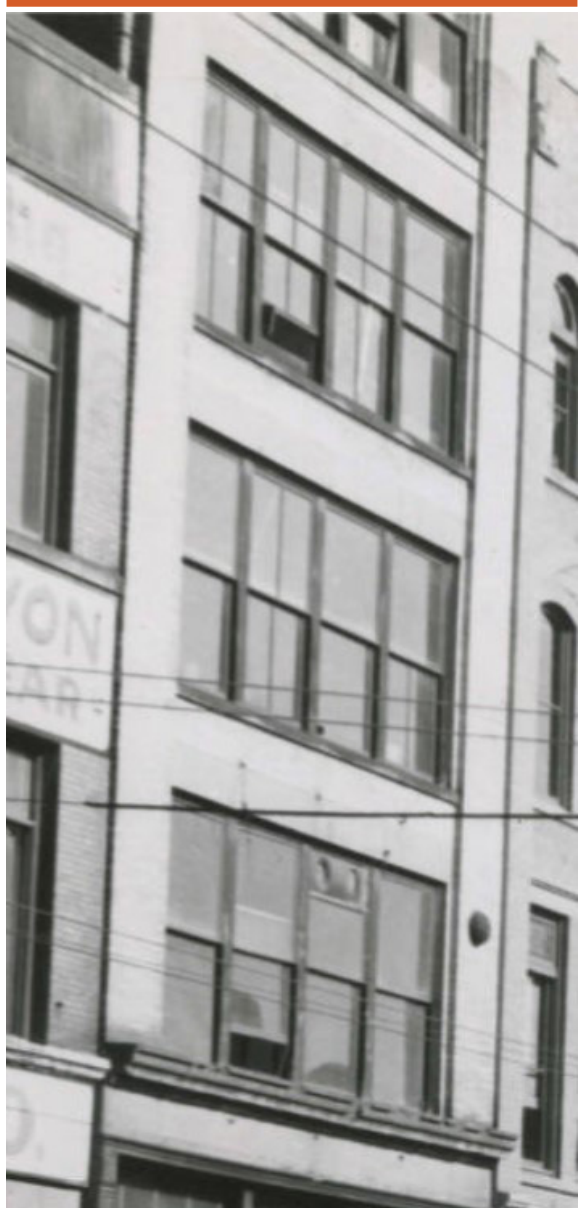
1974 Multiple windows with muntins, but no complete replacement
