PSPB COA PROPOSAL - CORRECTIONS

GRAND CENTRAL BLOCK

BRUNSWICK-BALKE-COLLENDER CO + GOTTSTEIN + SQUIRE LATIMER

200 S 1ST ST, Seattle, WA 98104

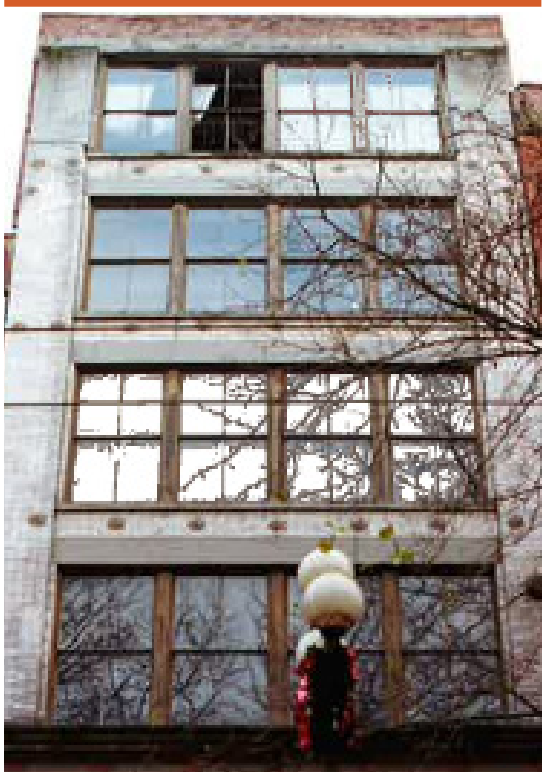
2001 All windows have been replaced by this time with 2:2 double hung windows. Assumed replacement date is 1970s

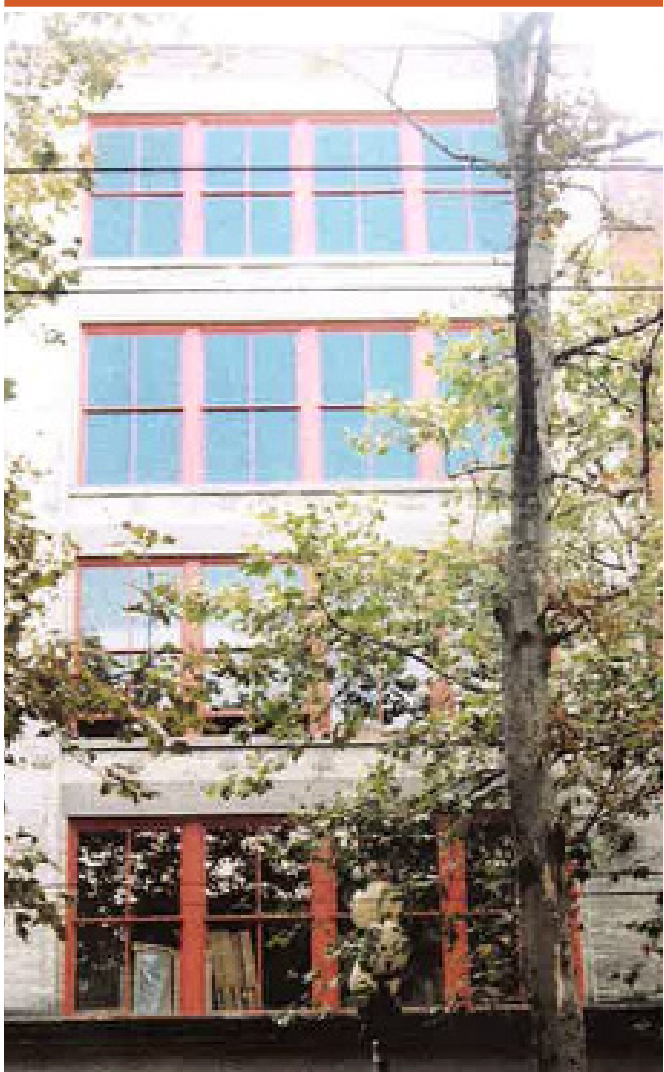
2003 Shows windows modified and restored in the 2002 renovation project.

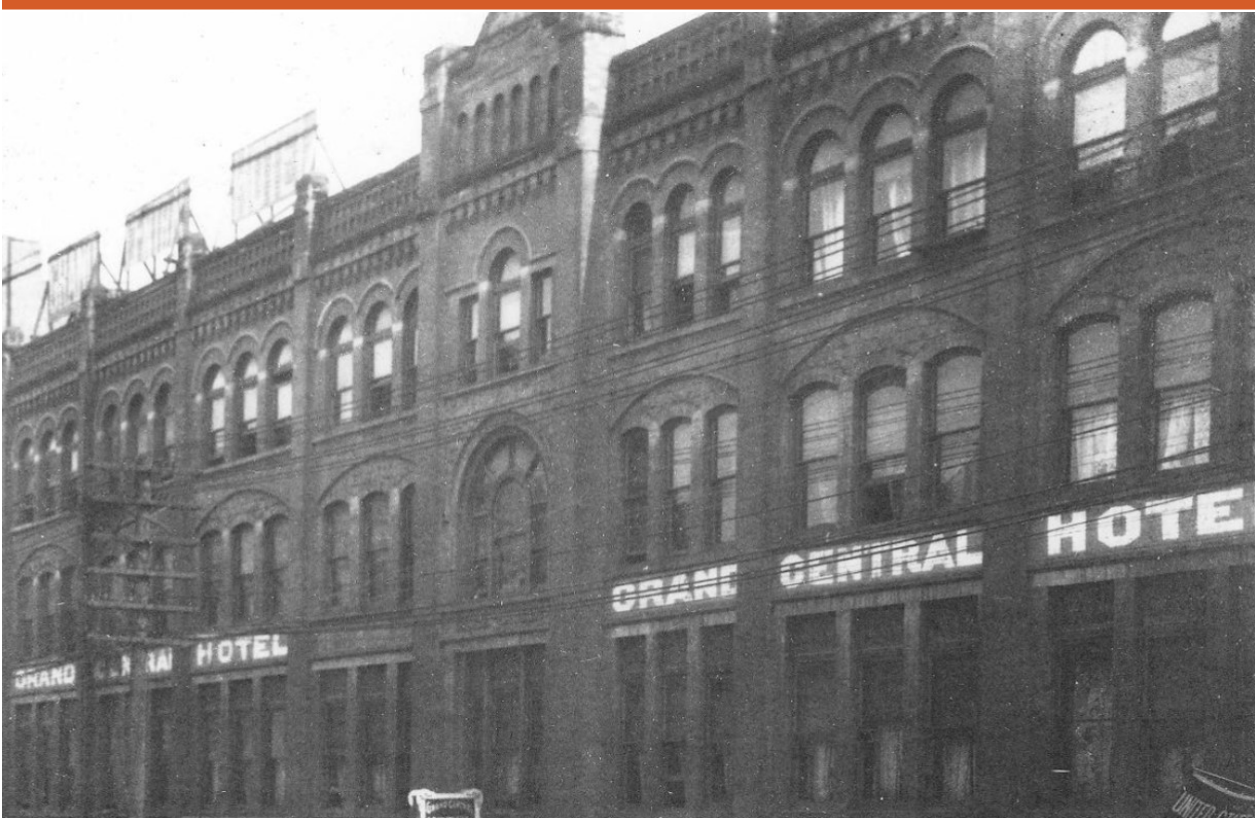
1909 Double hung original windows with arches on South bay.

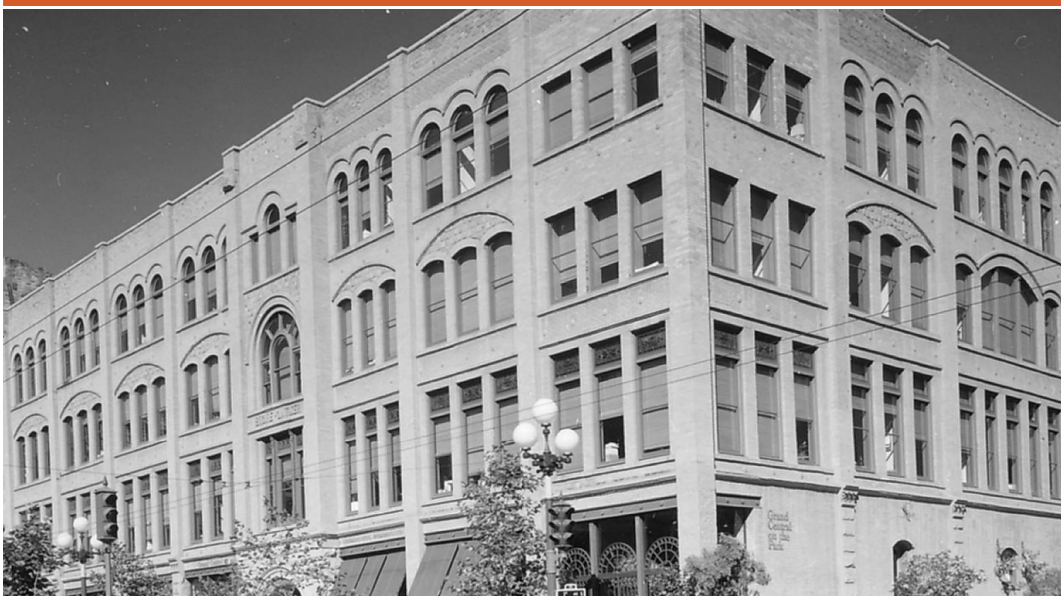
1974 Shows windows modified and sashes replaced with stationary 1:1 single sash during 1972 building renovation.

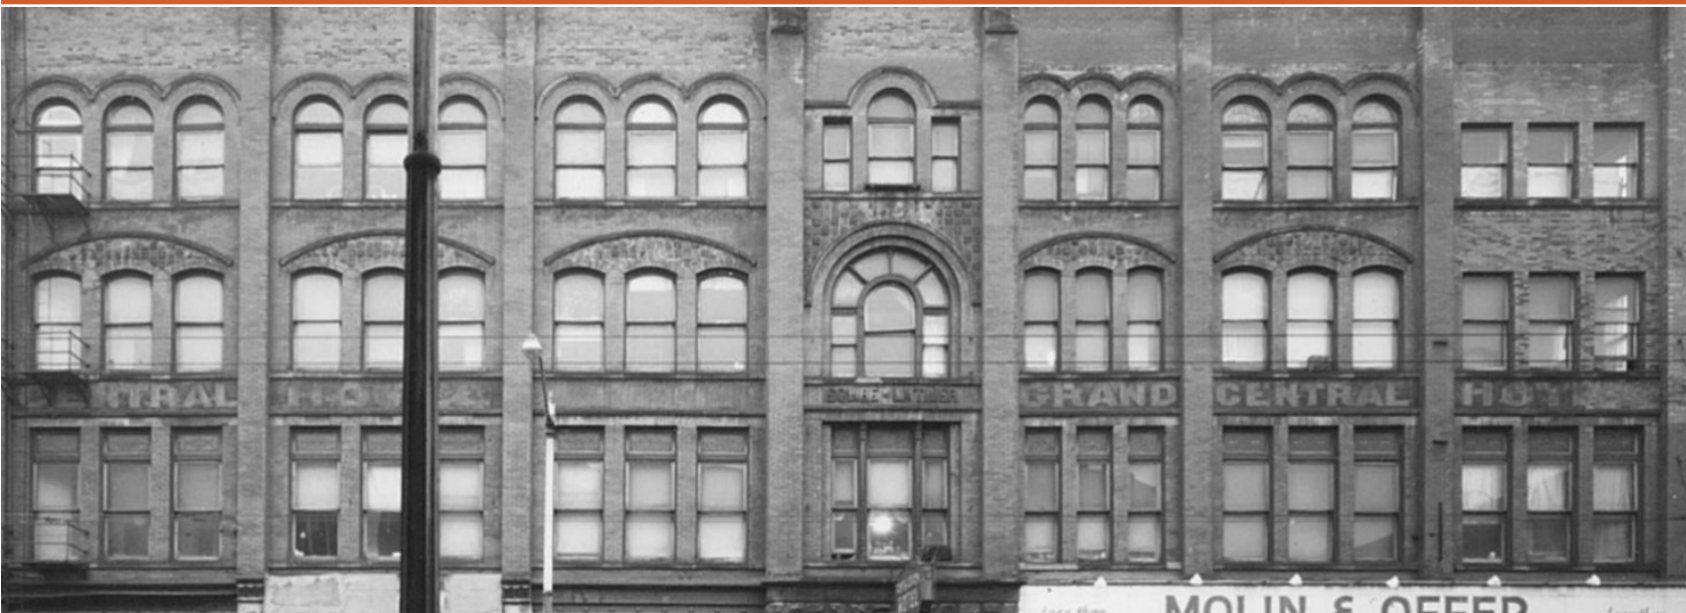
1969 Double hung windows in poor condition with crooked sashes and arches missing on South bay.

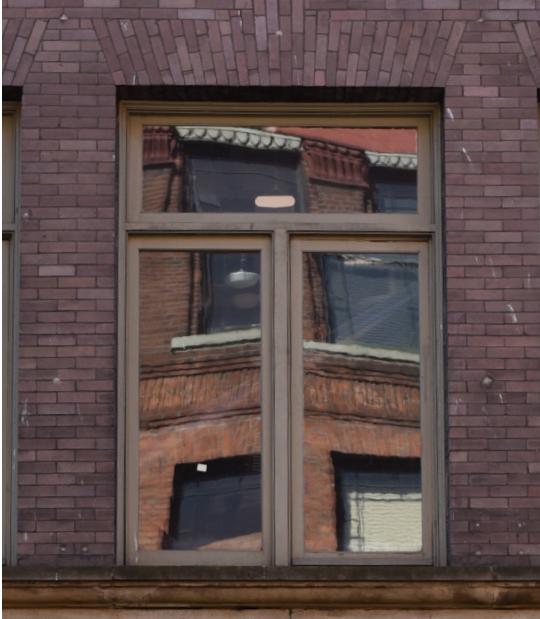
EXISTING - PHOTOGRAPH

EXISTING
MATERIAL	WOOD
GLASS TYPE	SINGLE, CLEAR
FUNCTION	PIVOT/CASEMENT, FIXED TRANSOM
TRIM	WOOD
MULLIONS	WOOD
TRANSOM BAR	WOOD
MUNTINS	NONE
COMMENTS	NONE

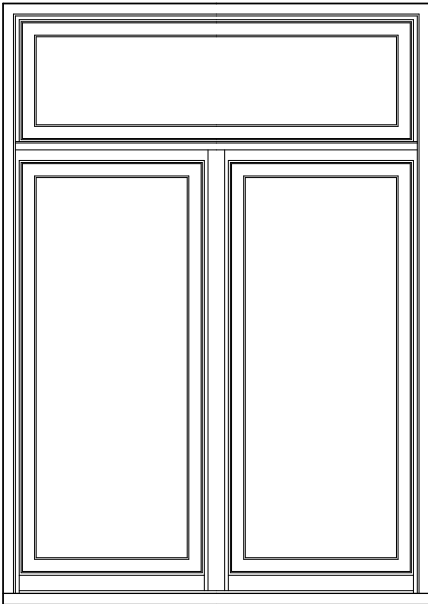
PROPOSED - ELEVATION

PROPOSED
MATERIAL	ALUM CLAD WOOD
GLASS TYPE	CLEAR, DOUBLE, LOW-E
FUNCTION	FIXED PIVOT, FIXED TRANSOM
TRIM	ALUM
MULLIONS	ALUM CLAD WOOD
TRANSOM BAR	ALUM CLAD WOOD
MUNTINS	NONE
FINISH	PEBBLE TAN

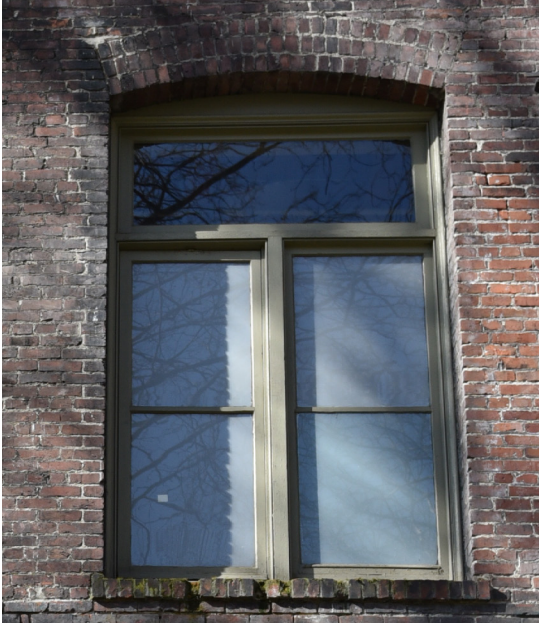
EXISTING - PHOTOGRAPH

EXISTING
MATERIAL	WOOD
GLASS TYPE	SINGLE, CLEAR
FUNCTION	FIXED PIVOT, FIXED TRANSOM
TRIM	WOOD
MULLIONS	WOOD
TRANSOM BAR	WOOD
MUNTINS	WOOD
COMMENTS	NONE

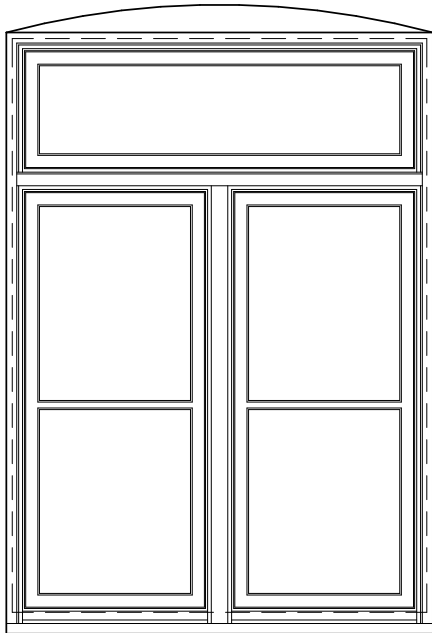
PROPOSED - ELEVATION

PROPOSED
MATERIAL	ALUM CLAD WOOD
GLASS TYPE	CLEAR, DOUBLE, LOW-E
FUNCTION	FIXED PIVOT, FIXED TRANSOM
TRIM	ALUM
MULLIONS	ALUM CLAD WOOD
TRANSOM BAR	ALUM CLAD WOOD
MUNTINS	ALUM CLAD WOOD FDL
FINISH	PEBBLE TAN

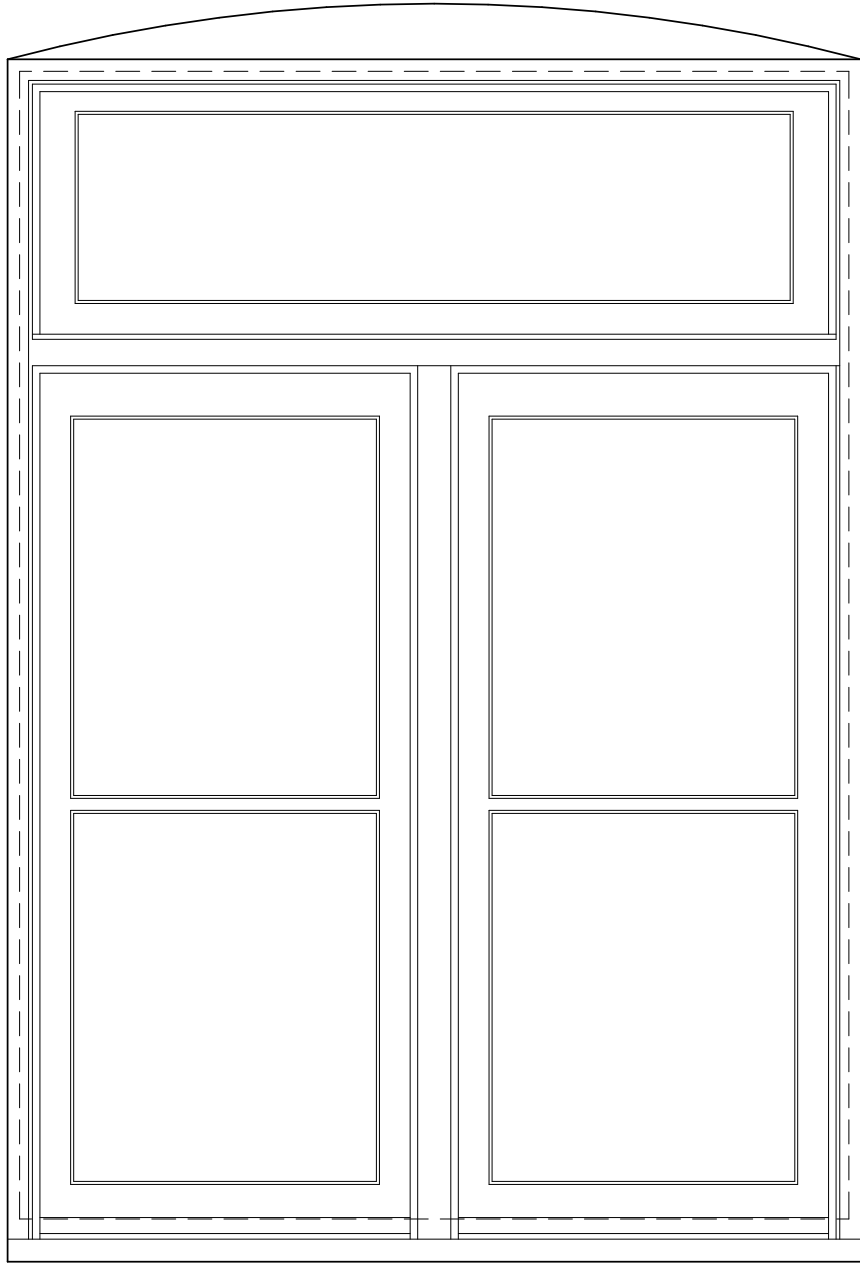
EXISTING ELEVATION

TYPE: WB

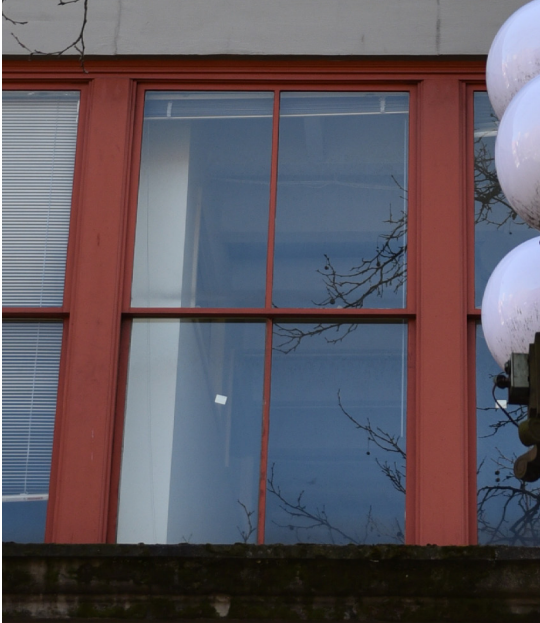
EXISTING - PHOTOGRAPH

EXISTING
MATERIAL	WOOD
GLASS TYPE	SINGLE, CLEAR
FUNCTION	SINGLE HUNG
TRIM	WOOD
MULLIONS	WOOD
TRANSOM BAR	NONE
MUNTINS	WOOD
COMMENTS	NONE

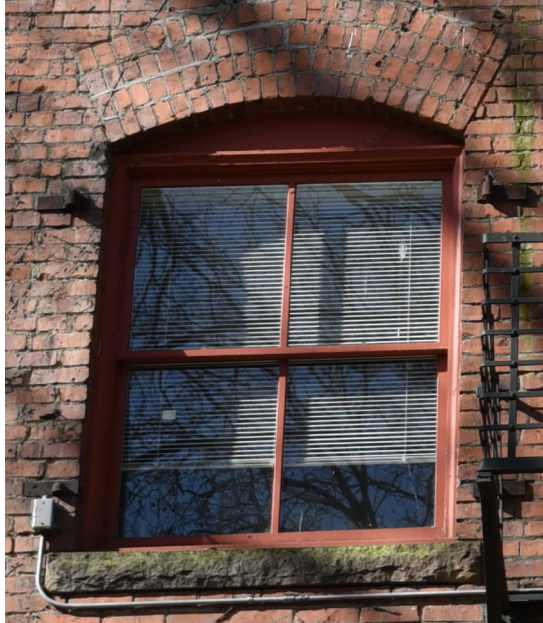
EXISTING - PHOTOGRAPH

EXISTING
MATERIAL	WOOD
GLASS TYPE	SINGLE, CLEAR
FUNCTION	SINGLE HUNG
TRIM	WOOD
MULLIONS	NONE
TRANSOM BAR	NONE
MUNTINS	WOOD
COMMENTS	NONE

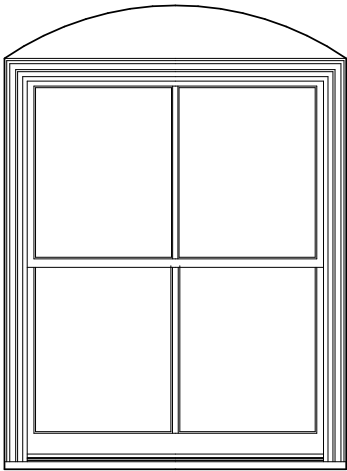
PROPOSED - ELEVATION

PROPOSED
MATERIAL	ALUM CLAD WOOD
GLASS TYPE	CLEAR, DOUBLE, LOW-E
FUNCTION	SINGLE HUNG
TRIM	ALUM
MULLIONS	NONE
TRANSOM BAR	NONE
MUNTINS	ALUM CLAD WOOD FDL
FINISH	YORKTOWN PEWTER

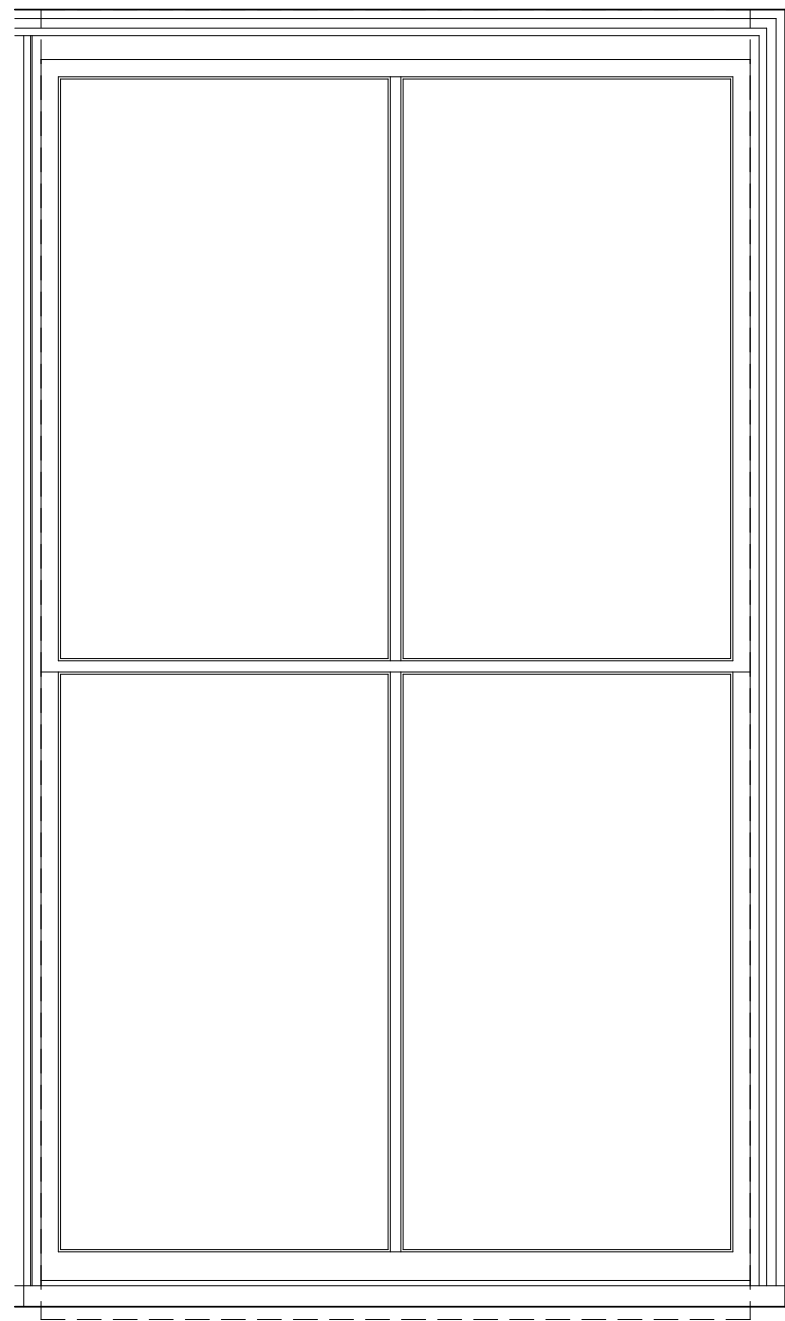
EXISTING ELEVATION

TYPE: WC

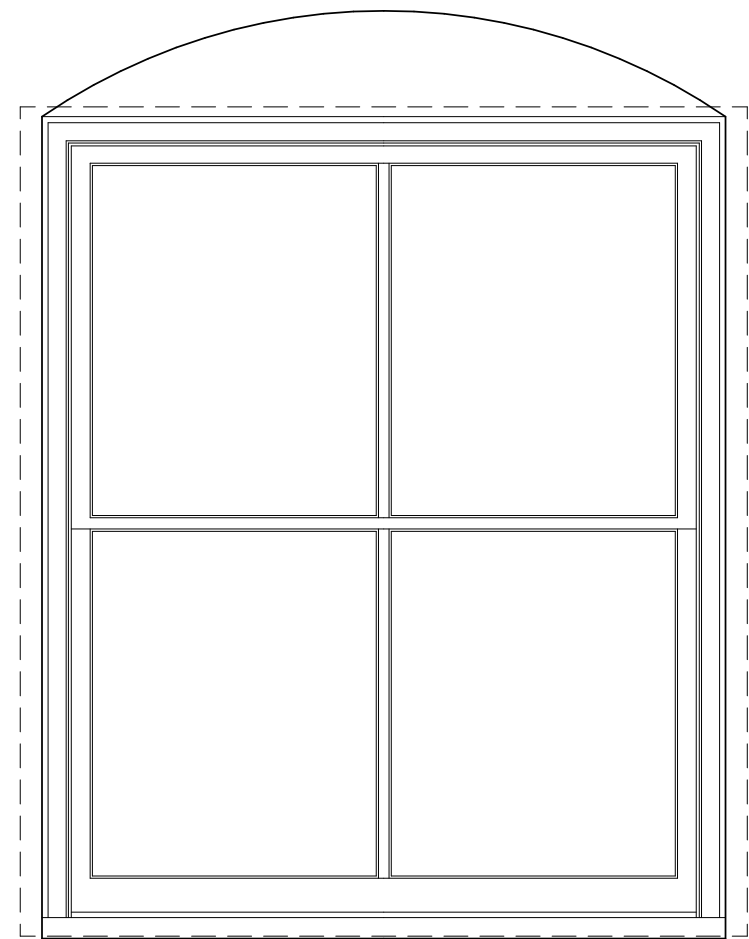
EXISTING ELEVATION

TYPE: WD

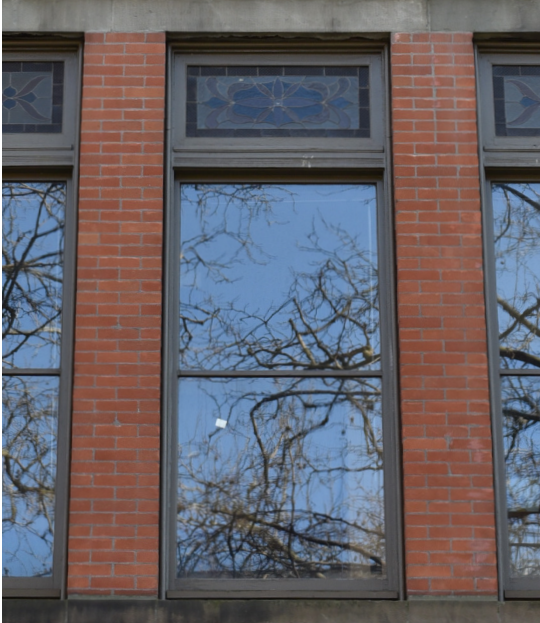
EXISTING - PHOTOGRAPH

EXISTING
MATERIAL	WOOD
GLASS TYPE	SINGLE, CLEAR; STAINED GLASS
FUNCTION	FIXED PICTURE, FIXED TRANSOM
TRIM	WOOD
MULLIONS	NONE
TRANSOM BAR	WOOD
MUNTINS	WOOD
COMMENTS	NONE

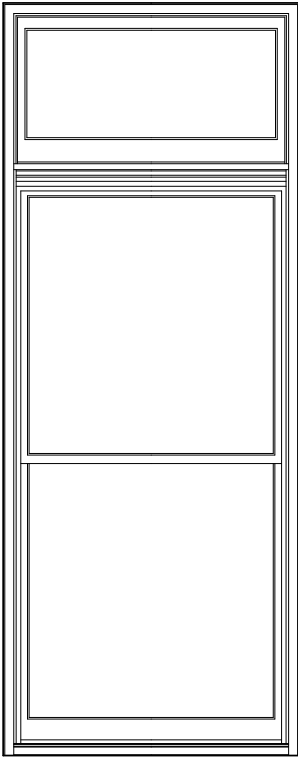
PROPOSED - ELEVATION

PROPOSED
MATERIAL	ALUM CLAD WOOD
GLASS TYPE	CLEAR DOUBLE, LOW-E; STAINED GLASS
FUNCTION	SINGLE HUNG (INOPERABLE), FIXED TRANSOM
TRIM	ALUM
MULLIONS	NONE
TRANSOM BAR	WOOD & ALUM CLAD WOOD
MUNTINS	NONE
FINISH	SIERRA BRONZE & PAINT TO MATCH

COMMENTS	RETAIN STAINED GLASS TRANSOM W/ NEW WINDOW BELOW AND NEW BRICK MOLD TRIM

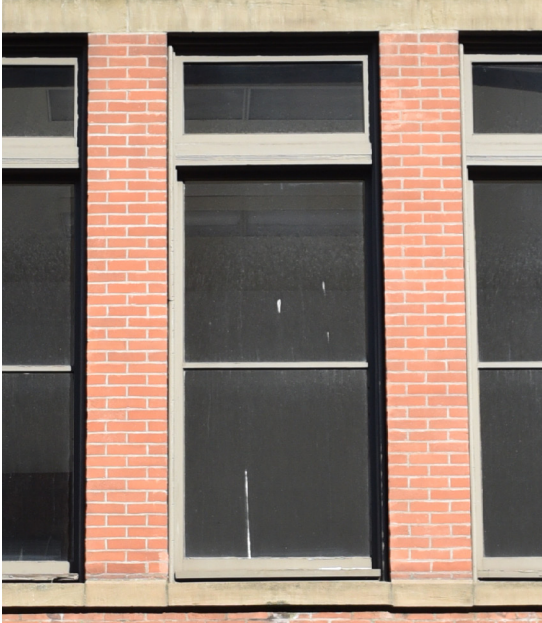
EXISTING - PHOTOGRAPH

EXISTING
MATERIAL	WOOD
GLASS TYPE	SINGLE, CLEAR
FUNCTION	FIXED PICTURE, FIXED TRANSOM
TRIM	WOOD
MULLIONS	NONE
TRANSOM BAR	WOOD
MUNTINS	WOOD
COMMENTS	NONE

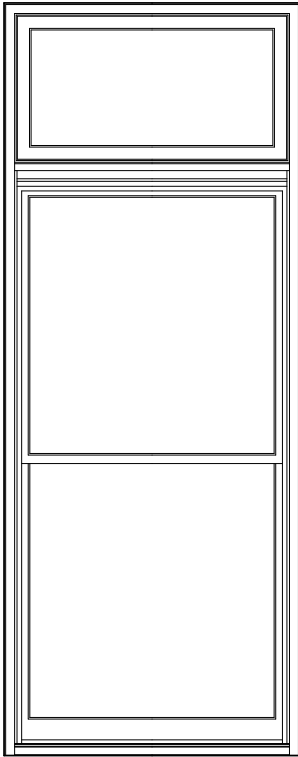
PROPOSED - ELEVATION

PROPOSED
MATERIAL	ALUM CLAD WOOD
GLASS TYPE	CLEAR DOUBLE, LOW-E
FUNCTION	SINGLE HUNG (INOPERABLE), FIXED TRANSOM
TRIM	ALUM
MULLIONS	NONE
TRANSOM BAR	ALUM CLAD WOOD
MUNTINS	NONE
FINISH	SIERRA BRONZE

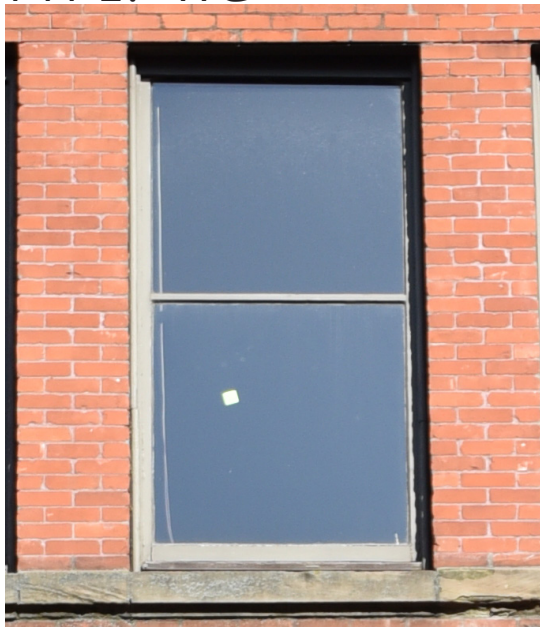
EXISTING - PHOTOGRAPH

EXISTING
MATERIAL	WOOD
GLASS TYPE	SINGLE, CLEAR
FUNCTION	FIXED PICTURE
TRIM	WOOD
MULLIONS	NONE
TRANSOM BAR	NONE
MUNTINS	WOOD
COMMENTS	WINDOWS ARE MODIFIED VERSIONS OF WH & WJ WITH BRICK ARCHES AT EXTERIOR MODIFIED TO BE FLAT WITH STEEL LINTELS. INTERIOR IS SIMILAR TO ORIGINAL TYPE.

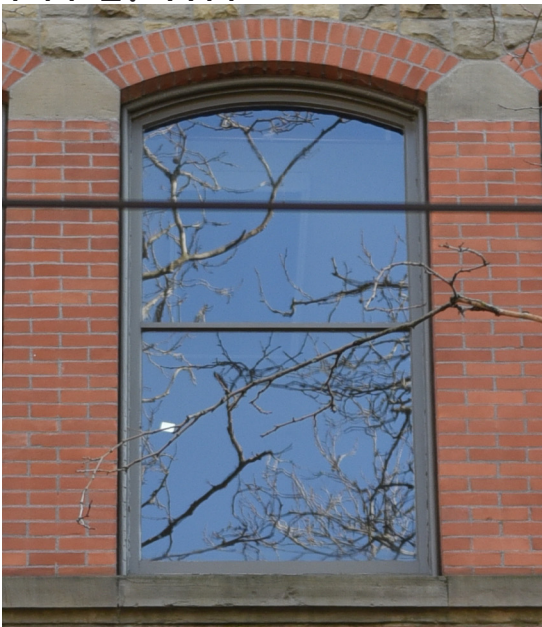
EXISTING - PHOTOGRAPH

EXISTING
MATERIAL	WOOD
GLASS TYPE	SINGLE, CLEAR
FUNCTION	FIXED PICTURE
TRIM	WOOD
MULLIONS	NONE
TRANSOM BAR	NONE
MUNTINS	WOOD
COMMENTS	NONE

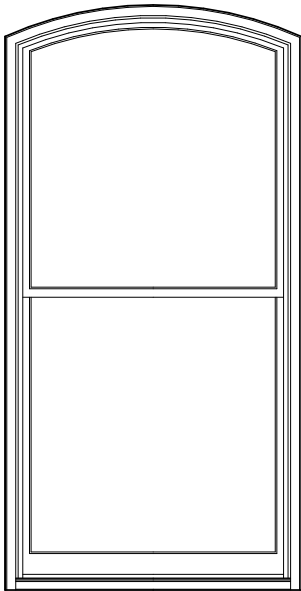
PROPOSED - ELEVATION

PROPOSED
MATERIAL	ALUM CLAD WOOD
GLASS TYPE	CLEAR, DOUBLE, LOW-E
FUNCTION	SINGLE HUNG (INOPERABLE)
TRIM	ALUM
MULLIONS	NONE
TRANSOM BAR	NONE
MUNTINS	NONE
FINISH	SIERRA BRONZE <div></div>
COMMENTS	NONE

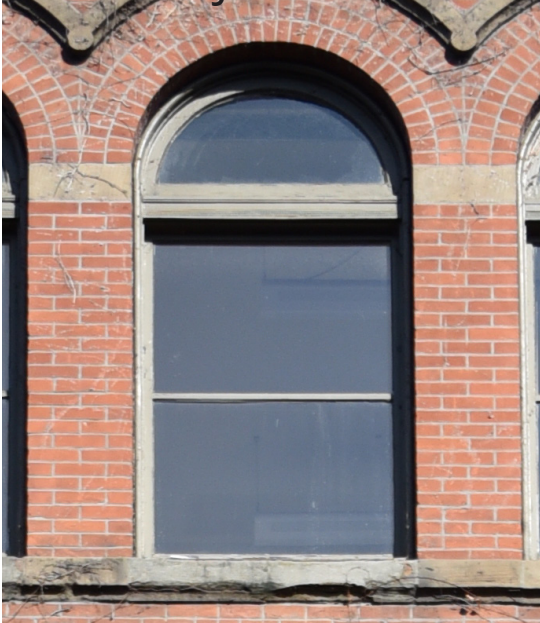
EXISTING - PHOTOGRAPH

EXISTING
MATERIAL	WOOD
GLASS TYPE	SINGLE, CLEAR
FUNCTION	FIXED PICTURE, FIXED TRANSOM
TRIM	WOOD
MULLIONS	NONE
TRANSOM BAR	WOOD
MUNTINS	WOOD
COMMENTS	NONE

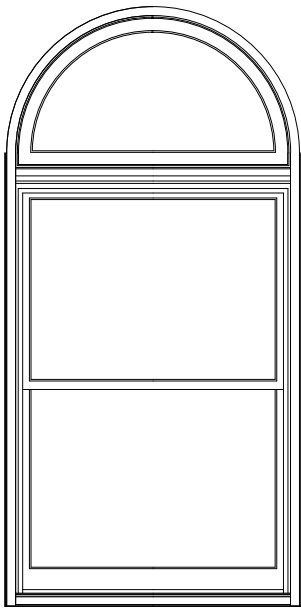
PROPOSED - ELEVATION

PROPOSED
MATERIAL	ALUM CLAD WOOD
GLASS TYPE	CLEAR, DOUBLE, LOW-E
FUNCTION	SINGLE HUNG (INOPERABLE), FIXED TRANSOM
TRIM	ALUM
MULLIONS	NONE
TRANSOM BAR	ALUM CLAD WOOD
MUNTINS	NONE
FINISH	SIERRA BRONZE

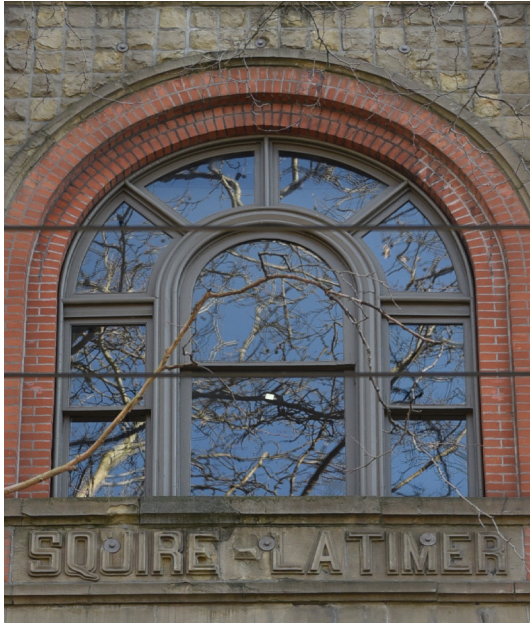
EXISTING - PHOTOGRAPH

EXISTING
MATERIAL	WOOD
GLASS TYPE	SINGLE, CLEAR
FUNCTION	DOUBLE HUNG (INOPERABLE), FIXED PICTURE
TRIM	WOOD
MULLIONS	WOOD
TRANSOM BAR	WOOD
MUNTINS	WOOD
COMMENTS	DOUBLE HUNG WINDOWS (3) WERE MODIFIED TO MAKE INOPERABLE DURING 1972 RENOVATION

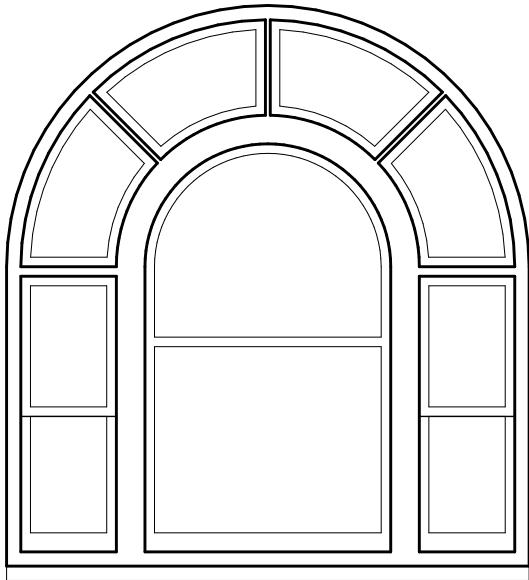
PROPOSED - ELEVATION

PROPOSED
MATERIAL	WOOD
GLASS TYPE	SINGLE, CLEAR
FUNCTION	DOUBLE HUNG (INOPERABLE), FIXED PICTURE
TRIM	WOOD
MULLIONS	WOOD
TRANSOM BAR	WOOD
MUNTINS	WOOD
FINISH	PAINT TO MATCH SIERRA BRONZE

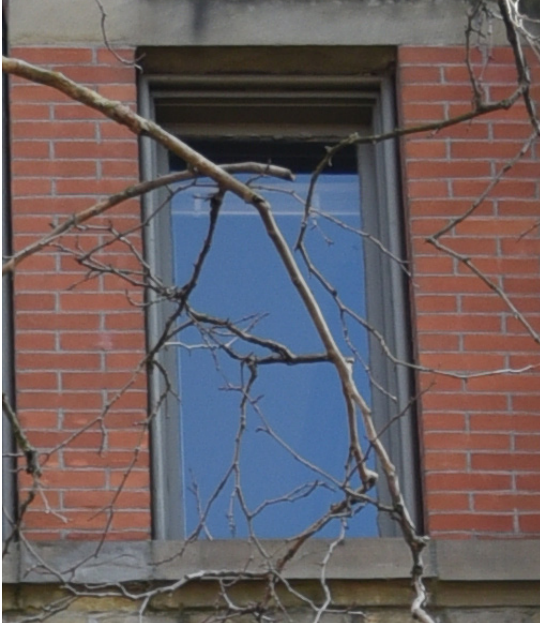
EXISTING - PHOTOGRAPH

EXISTING
MATERIAL	WOOD
GLASS TYPE	SINGLE, CLEAR
FUNCTION	FIXED PICTURE
TRIM	WOOD
MULLIONS	NONE
TRANSOM BAR	NONE
MUNTINS	NONE
COMMENTS	NONE

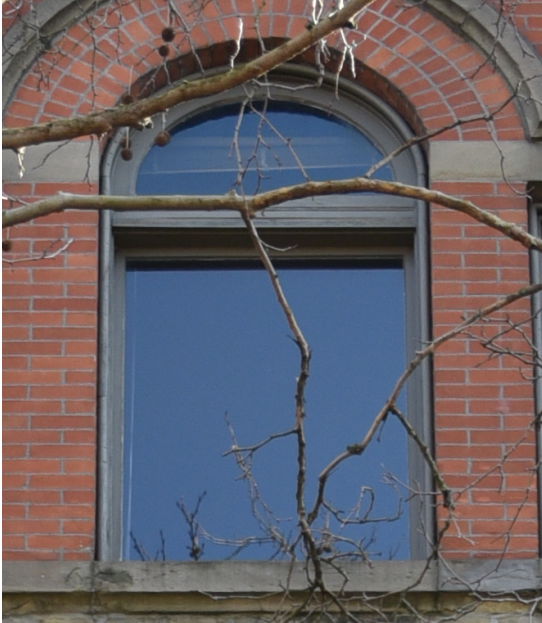
EXISTING - PHOTOGRAPH

EXISTING
MATERIAL	WOOD
GLASS TYPE	SINGLE, CLEAR
FUNCTION	FIXED PICTURE, FIXED TRANSOM
TRIM	WOOD
MULLIONS	NONE
TRANSOM BAR	WOOD
MUNTINS	NONE
COMMENTS	NONE

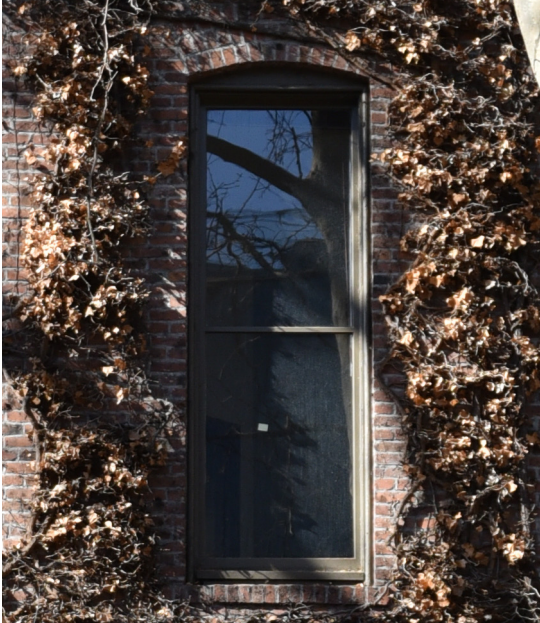
EXISTING - PHOTOGRAPH

EXISTING
MATERIAL	WOOD
GLASS TYPE	SINGLE, CLEAR
FUNCTION	FIXED PICTURE
TRIM	WOOD
MULLIONS	NONE
TRANSOM BAR	NONE
MUNTINS	WOOD
COMMENTS	NONE

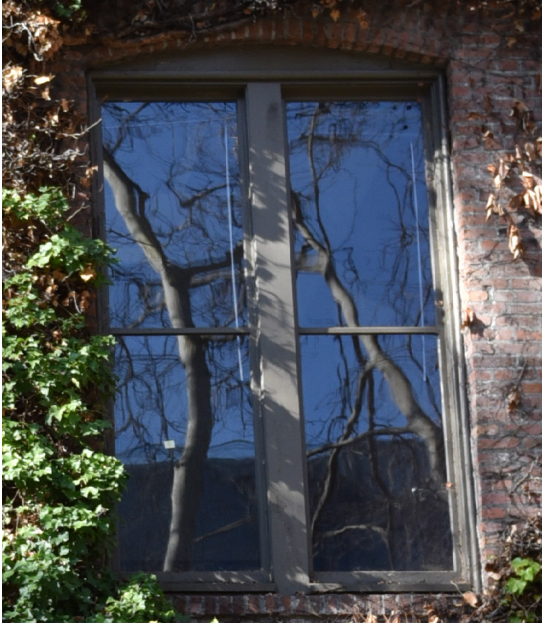
TYPE: WP

EXISTING - PHOTOGRAPH

EXISTING
MATERIAL	WOOD
GLASS TYPE	SINGLE, CLEAR
FUNCTION	FIXED PICTURE
TRIM	WOOD
MULLIONS	NONE
TRANSOM BAR	NONE
MUNTINS	WOOD
COMMENTS	NONE

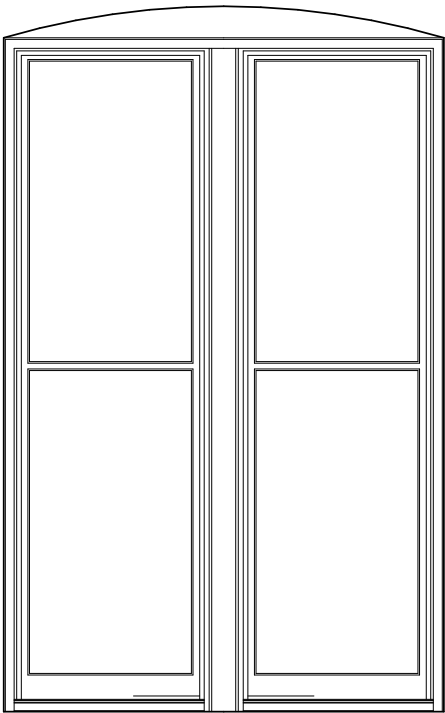
PROPOSED - ELEVATION

PROPOSED
MATERIAL	ALUM CLAD WOOD
GLASS TYPE	CLEAR, DOUBLE, LOW-E
FUNCTION	FIXED PICTURE
TRIM	ALUM
MULLIONS	ALUM CLAD
TRANSOM BAR	NONE
MUNTINS	ALUM CLAD WOOD FDL
FINISH	SIERRA BRONZE

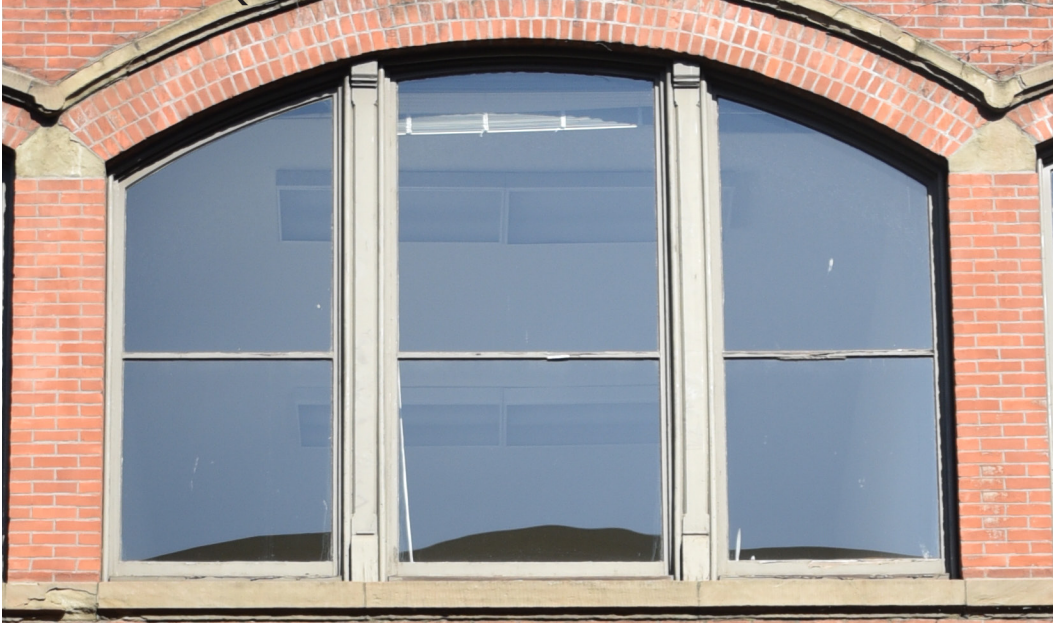
TYPE: WQ

EXISTING - PHOTOGRAPH

EXISTING
MATERIAL	WOOD
GLASS TYPE	SINGLE, CLEAR
FUNCTION	FIXED PICTURE
TRIM	WOOD
MULLIONS	NONE
TRANSOM BAR	NONE
MUNTINS	WOOD
COMMENTS	NONE

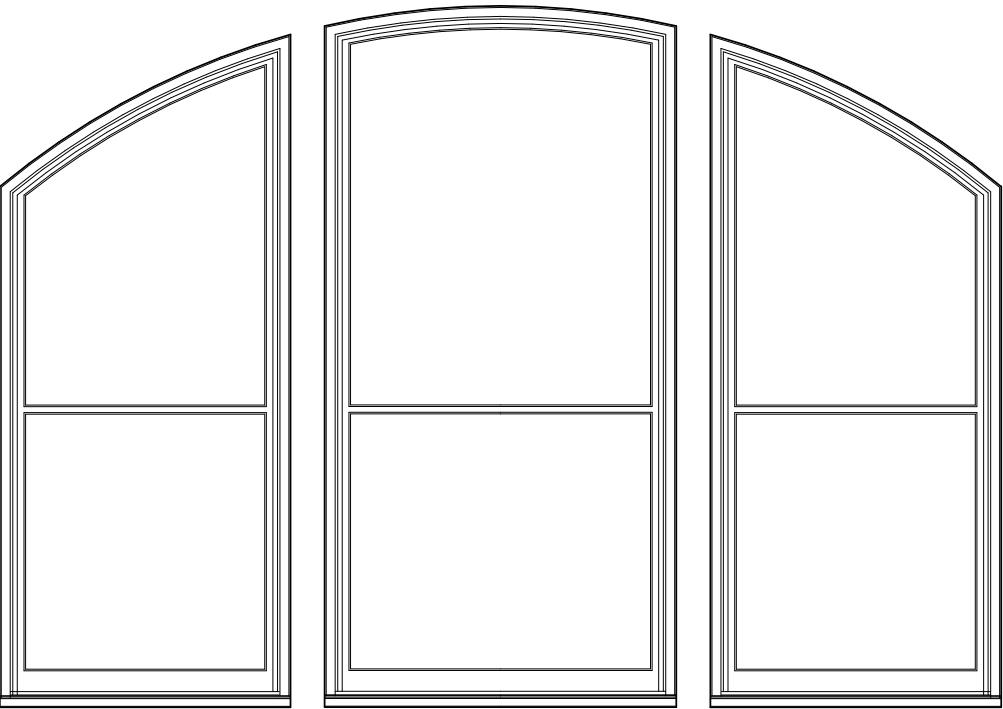
PROPOSED - ELEVATION

PROPOSED
MATERIAL	ALUM CLAD WOOD
GLASS TYPE	CLEAR, DOUBLE, LOW-E
FUNCTION	FIXED PICTURE
TRIM	ALUM
MULLIONS	WOOD (RESTORE)
TRANSOM BAR	NONE
MUNTINS	ALUM CLAD WOOD FDL
FINISH	SIERRA BRONZE

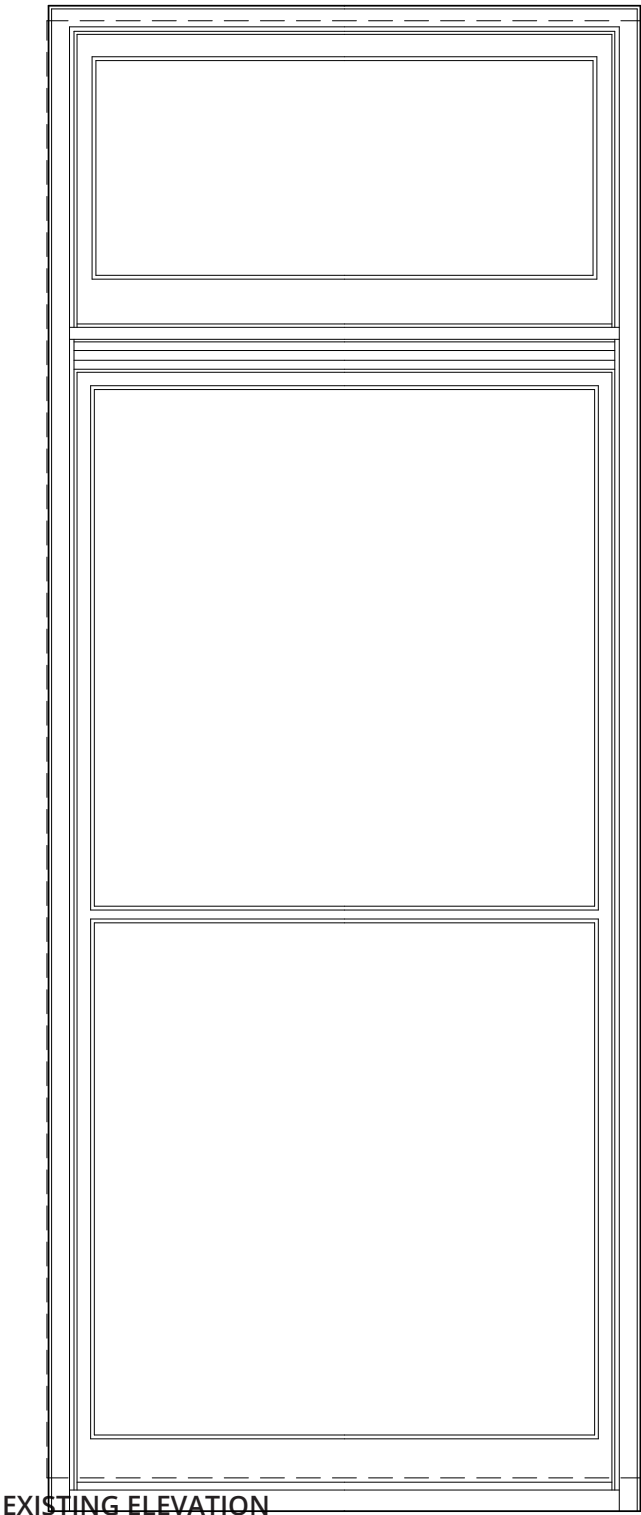
TYPE: WF

EXISTING ELEVATION

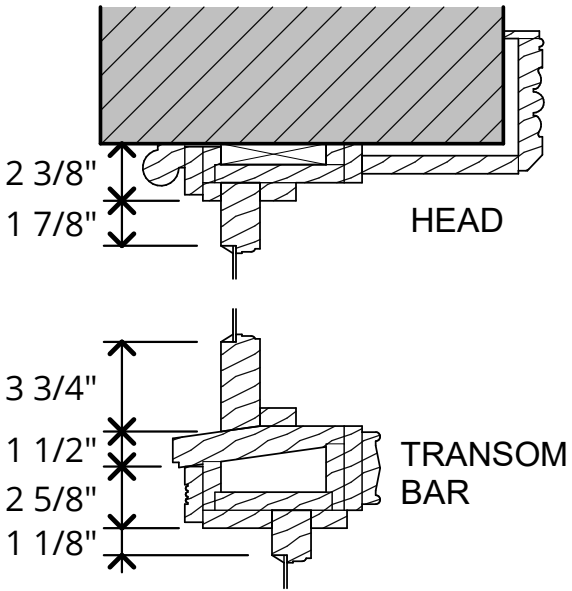
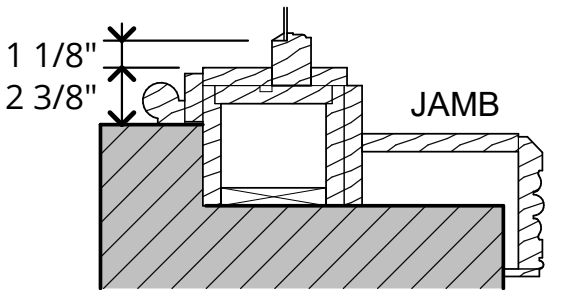
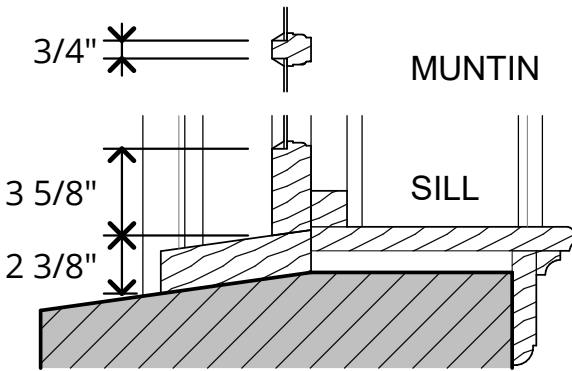
EXISTING SECTION

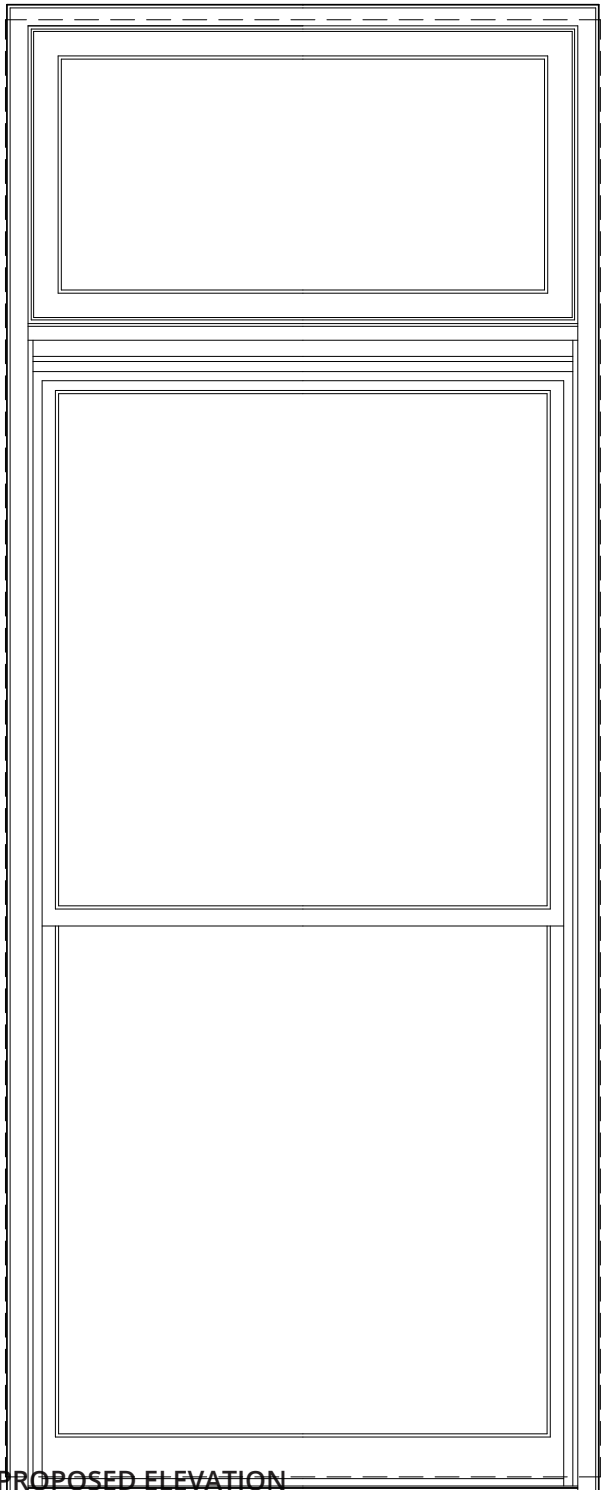
PROPOSED ELEVATION

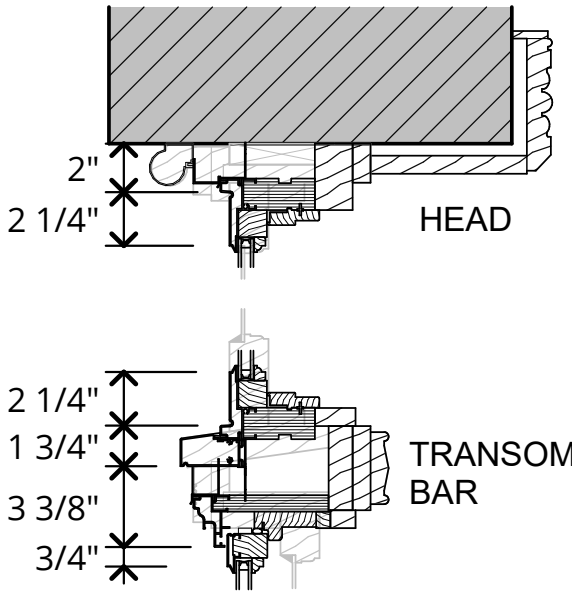
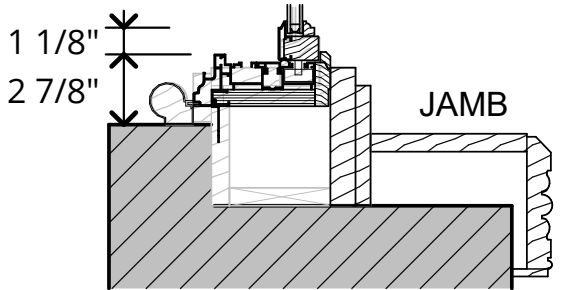
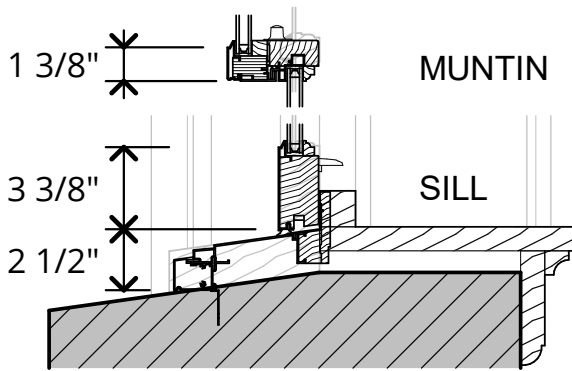
PROPOSED SECTION

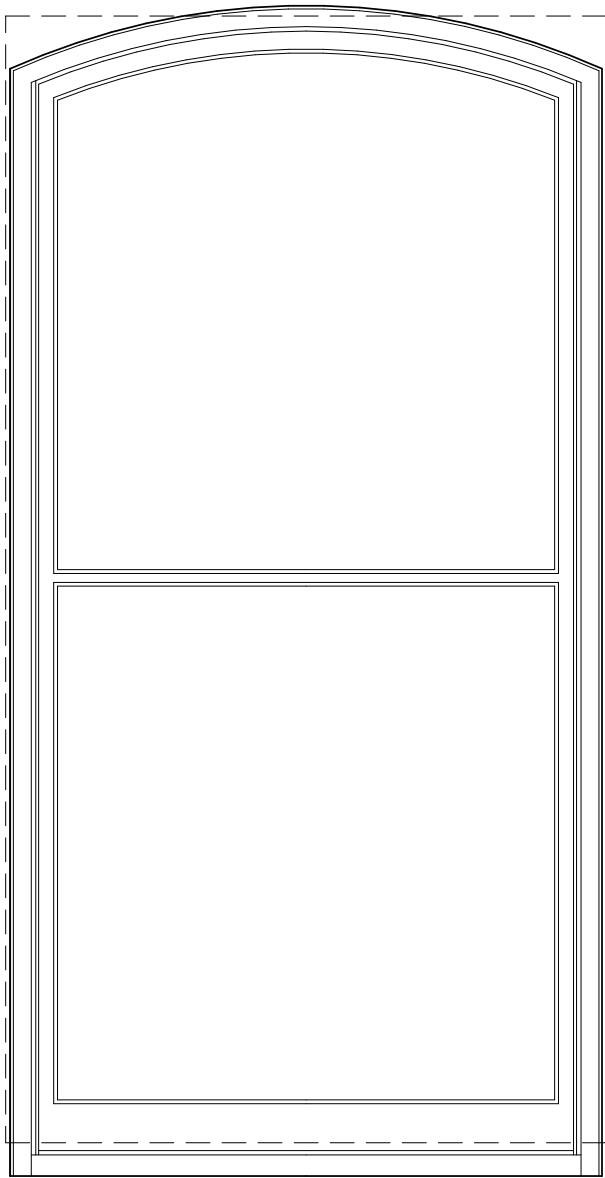
TYPE: WH

EXISTING ELEVATION

PROPOSED
MATERIAL	ALUM CLAD WOOD
GLASS TYPE	CLEAR, DOUBLE, LOW-E
FUNCTION	SINGLE HUNG (INOPERABLE)
TRIM	ALUM
MULLIONS	NONE
TRANSOM BAR	NONE
MUNTINS	NONE
FINISH	SIERRA BRONZE <div></div>
COMMENTS	REPLACEMENT WINDOWS WILL HAVE SAME DETAILING AS WH AND WJ WITHOUT ARCHES. PROFILE COMPARISON NOT PROVIDED.

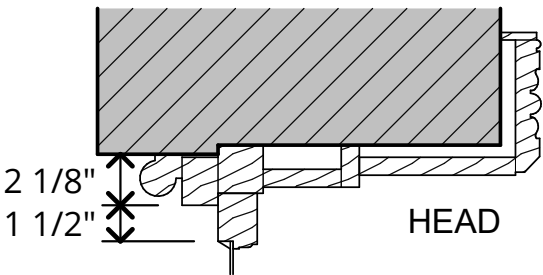
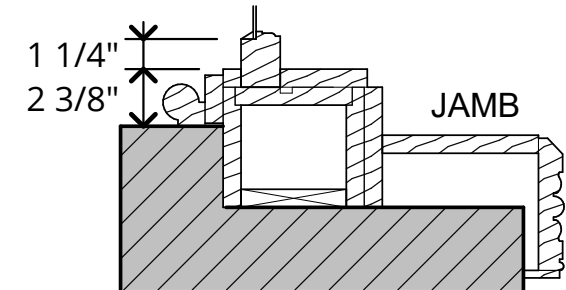
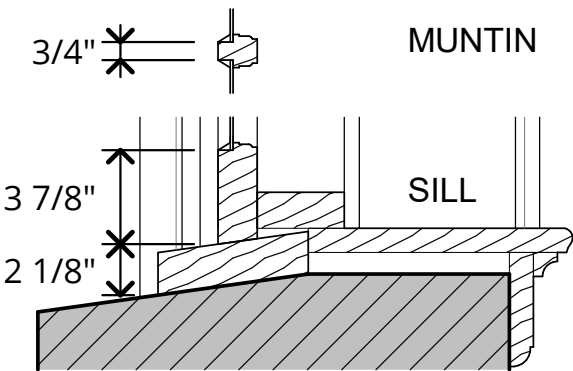
EXISTING SECTION

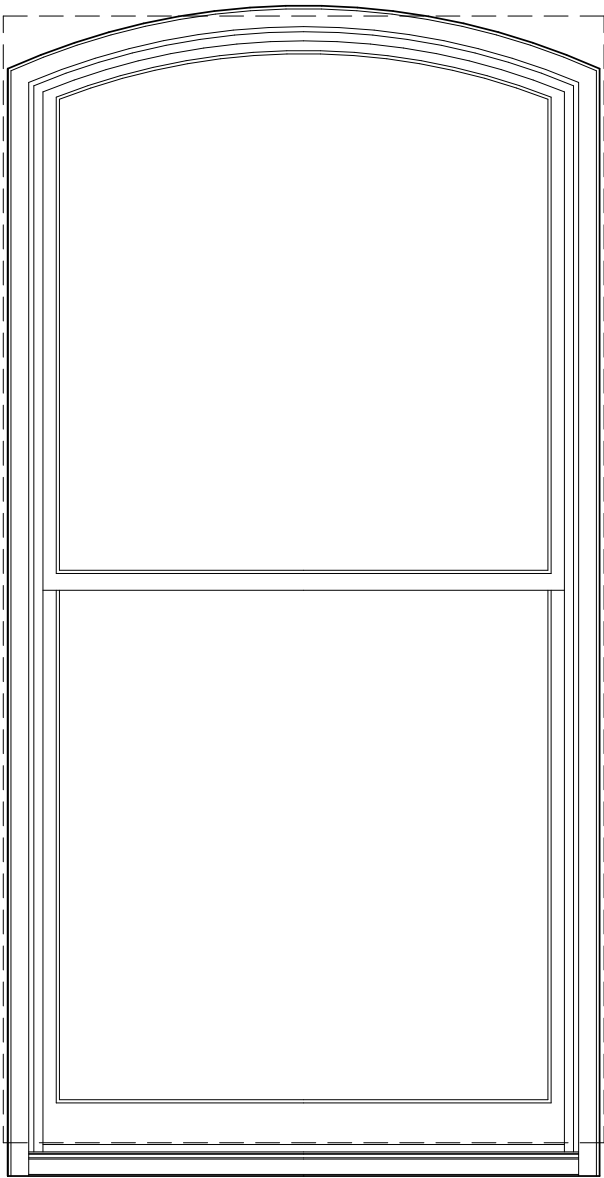
PROPOSED ELEVATION

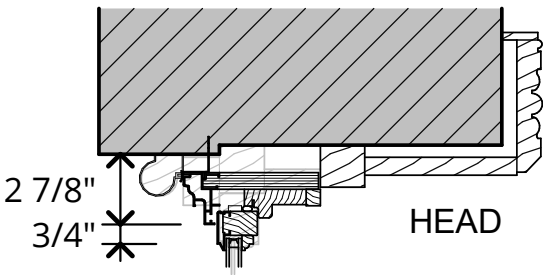
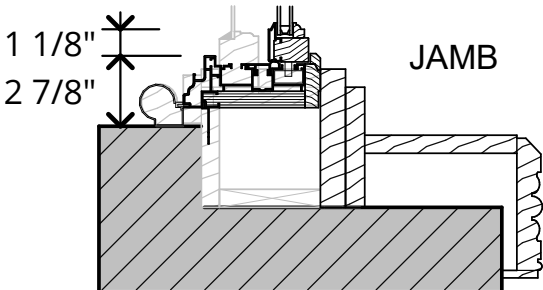
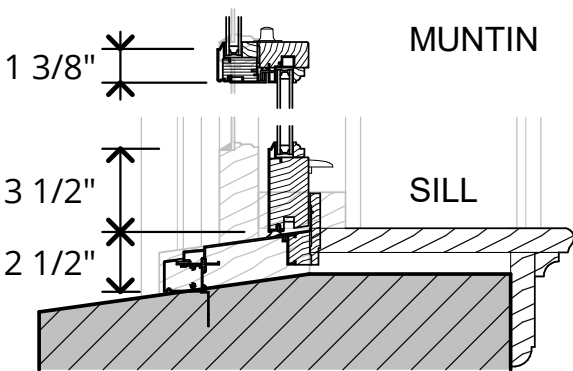
PROPOSED SECTION

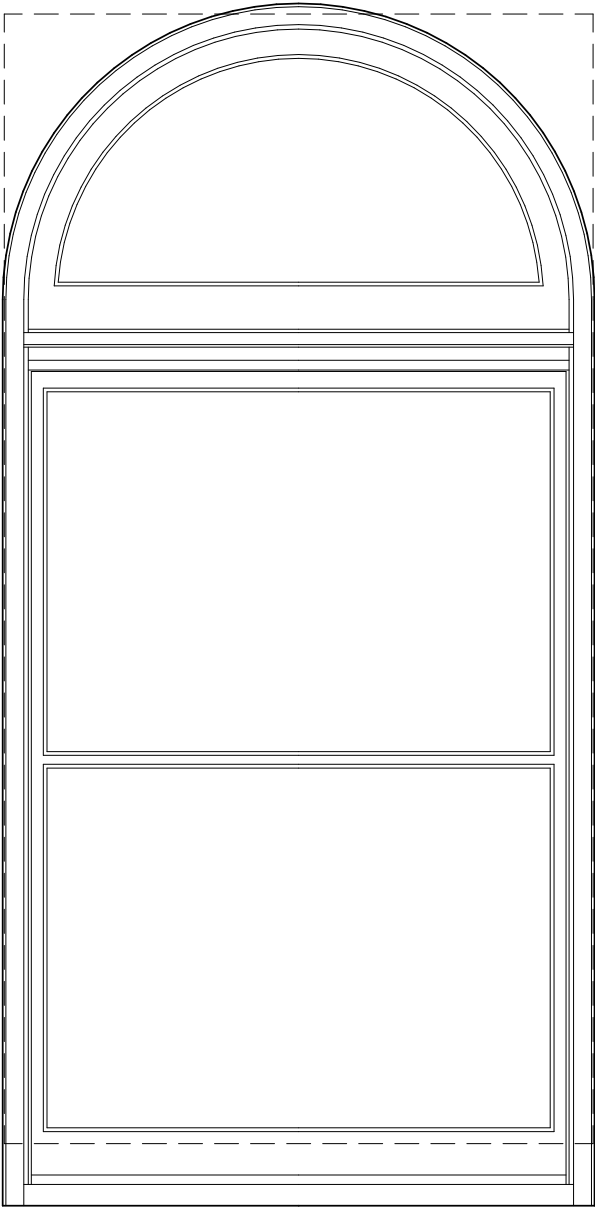
TYPE: WJ

EXISTING ELEVATION
