PSPB COA PROPOSAL - CORRECTIONS

GRAND CENTRAL BLOCK

BRUNSWICK-BALKE-COLLENDER CO + GOTTSTEIN + SQUIRE LATIMER

200 S 1ST ST, Seattle, WA 98104

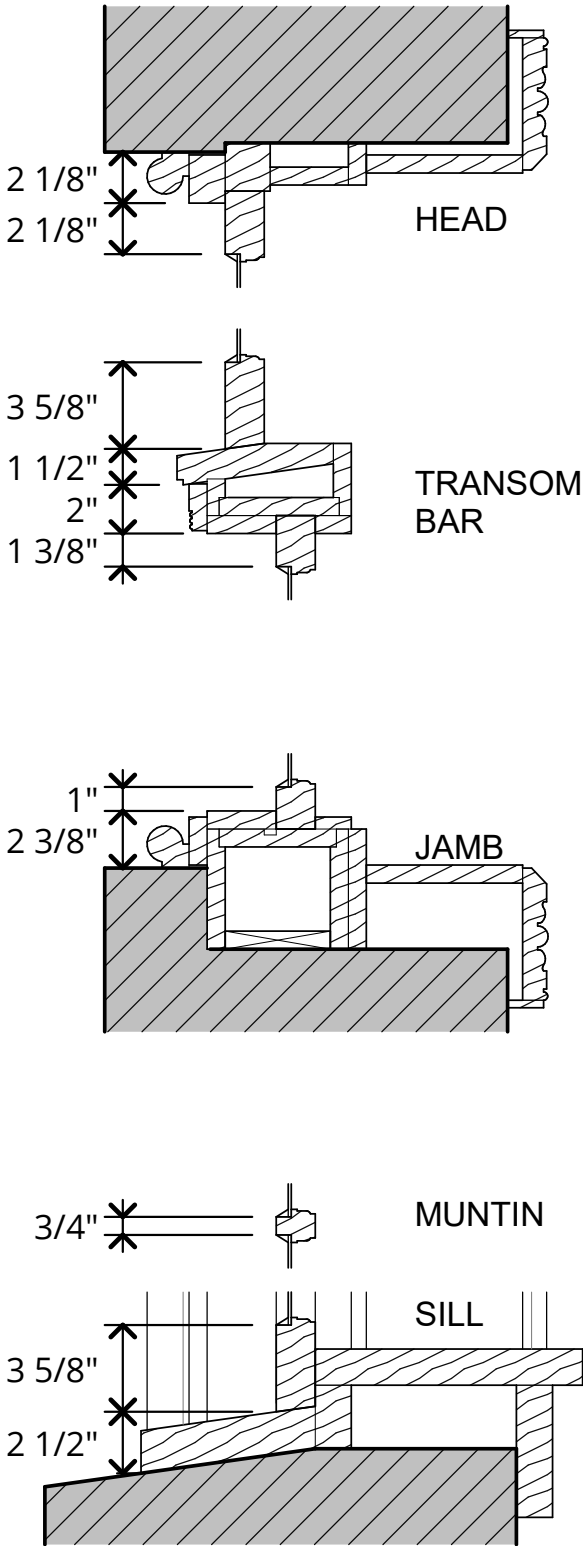
EXISTING SECTION

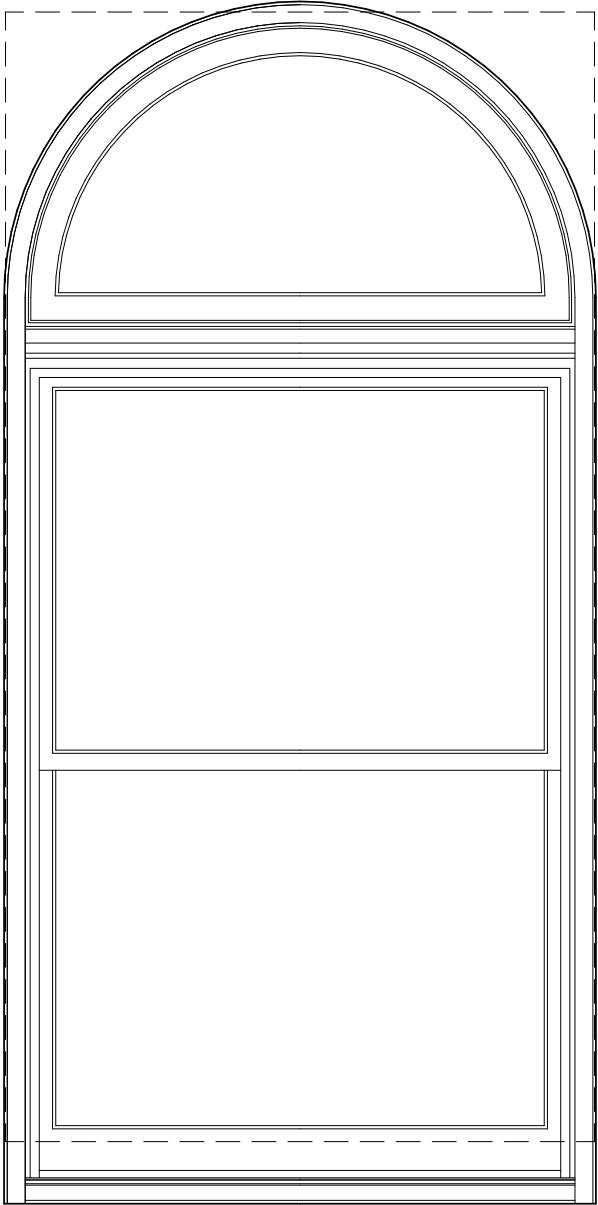
PROPOSED ELEVATION

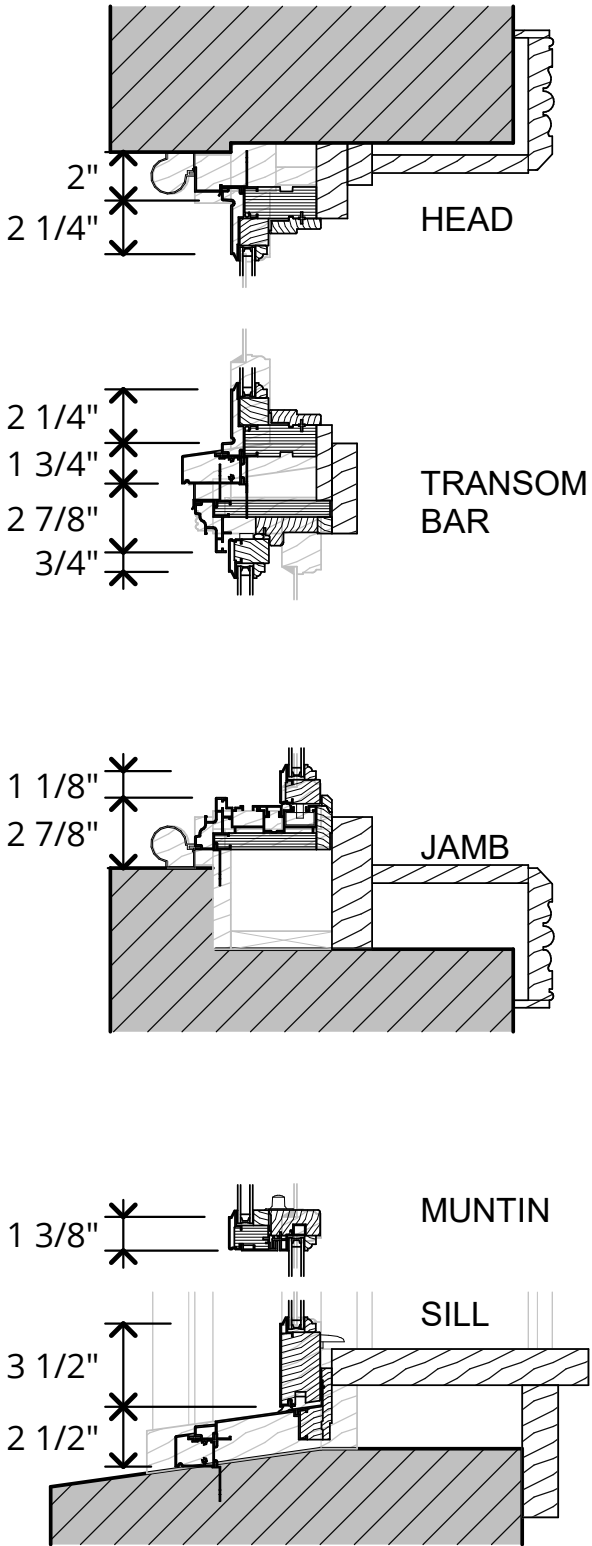
PROPOSED SECTION

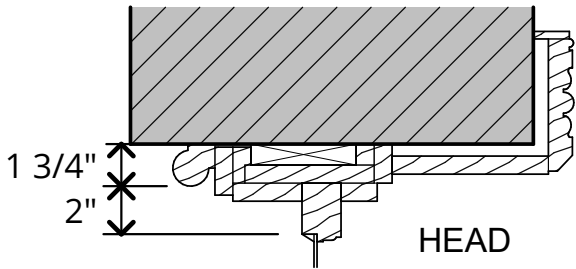
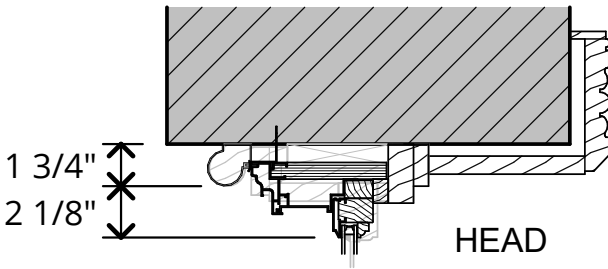
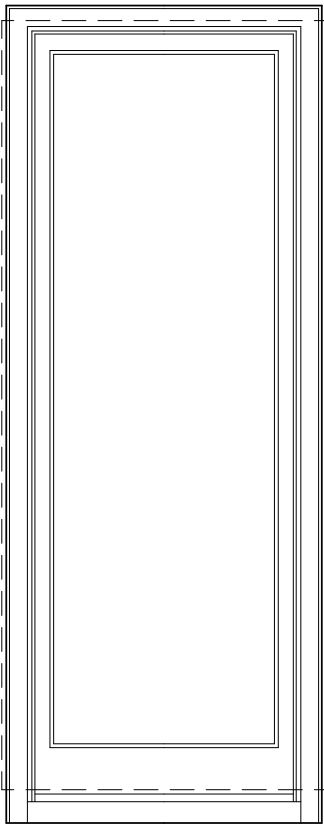
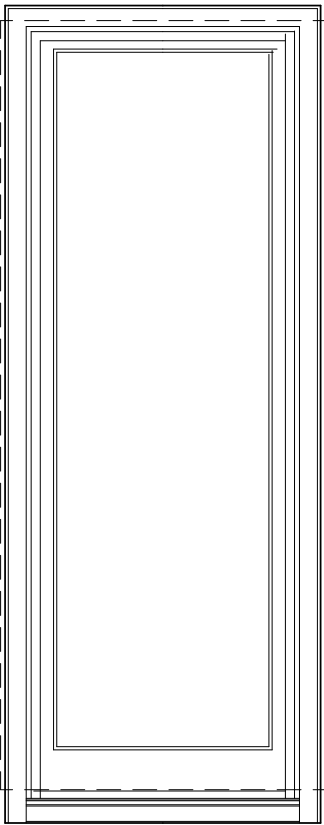
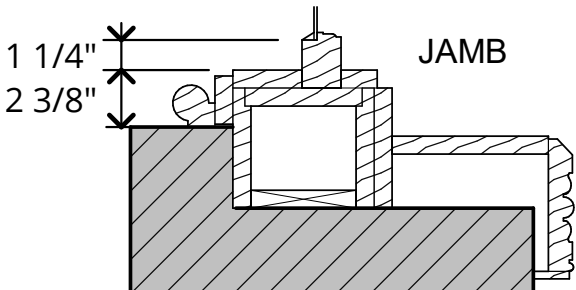
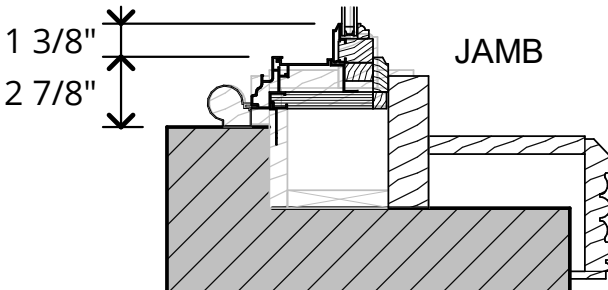
TYPE: WL

EXISTING ELEVATION

EXISTING SECTION

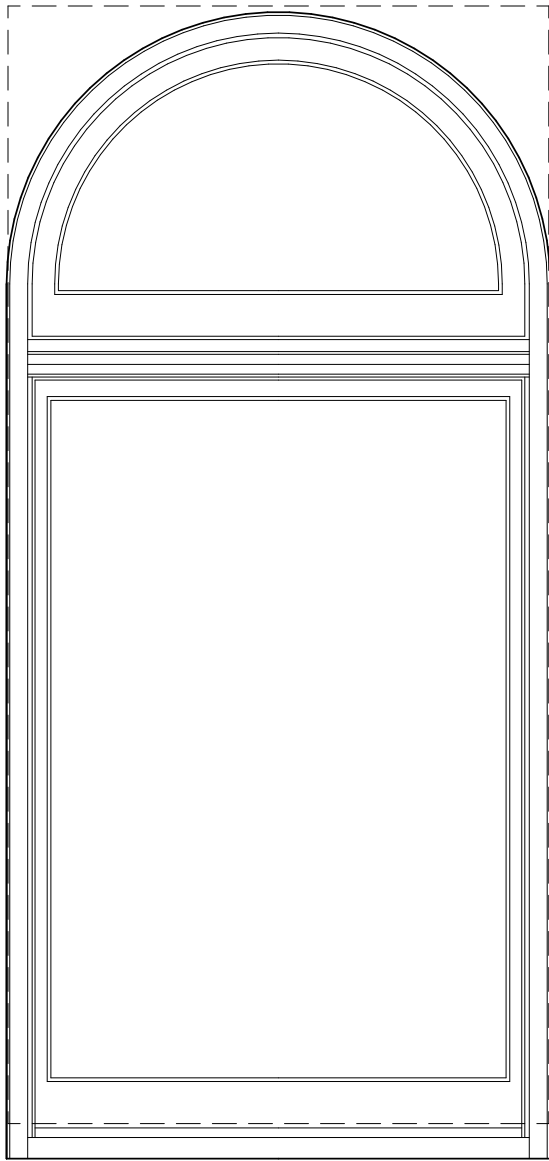
TYPE: WM

EXISTING ELEVATION

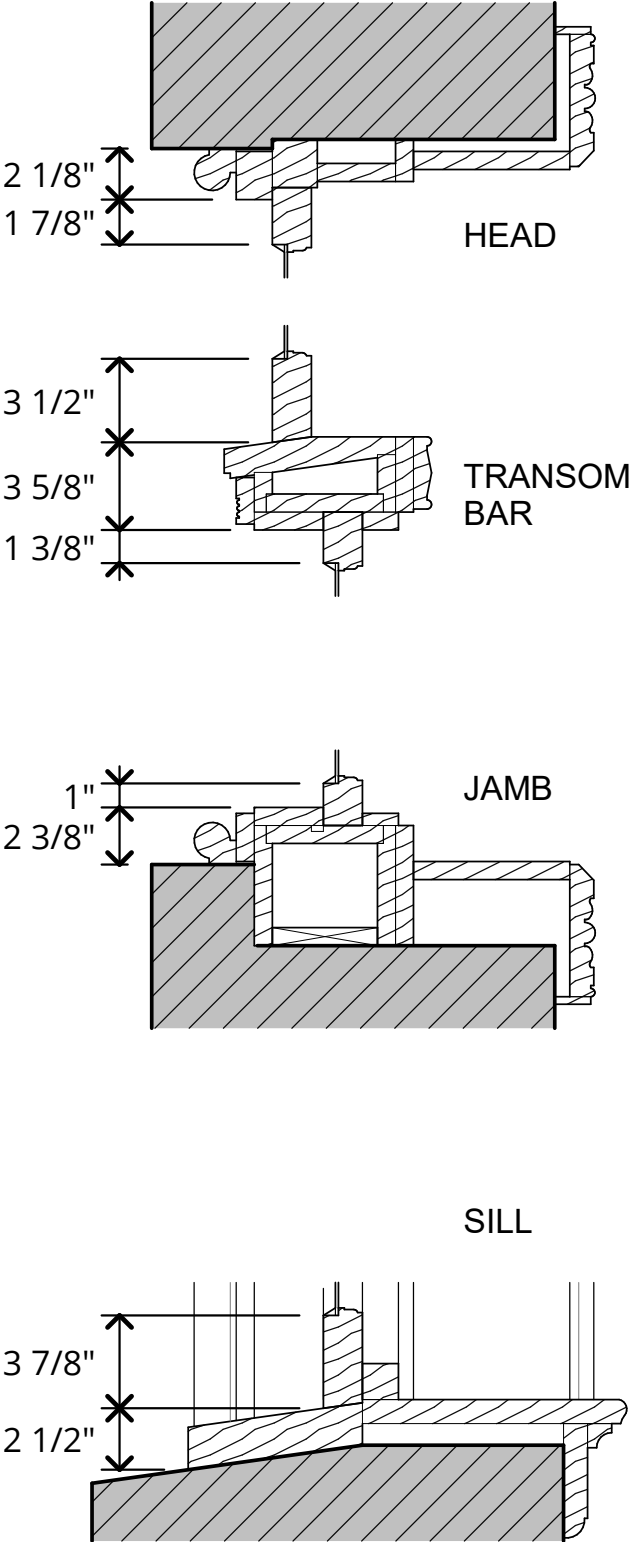
EXISTING SECTION

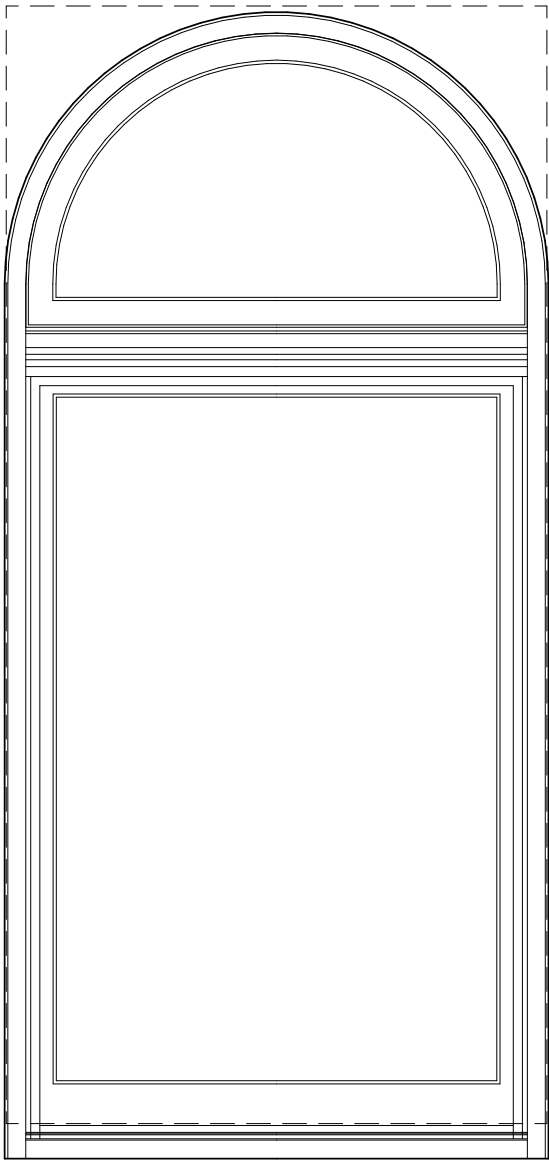
PROPOSED ELEVATION

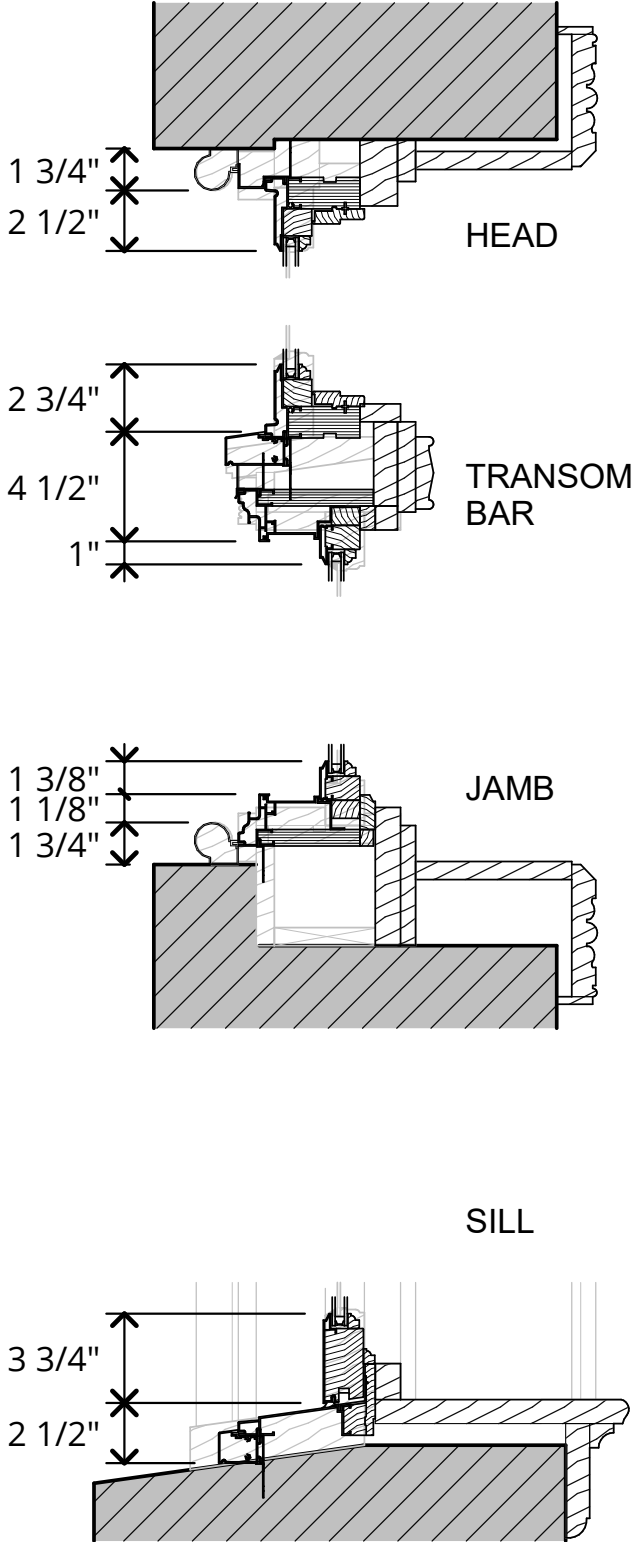
PROPOSED SECTION

WINDOW TYPES - GRAND CENTRAL

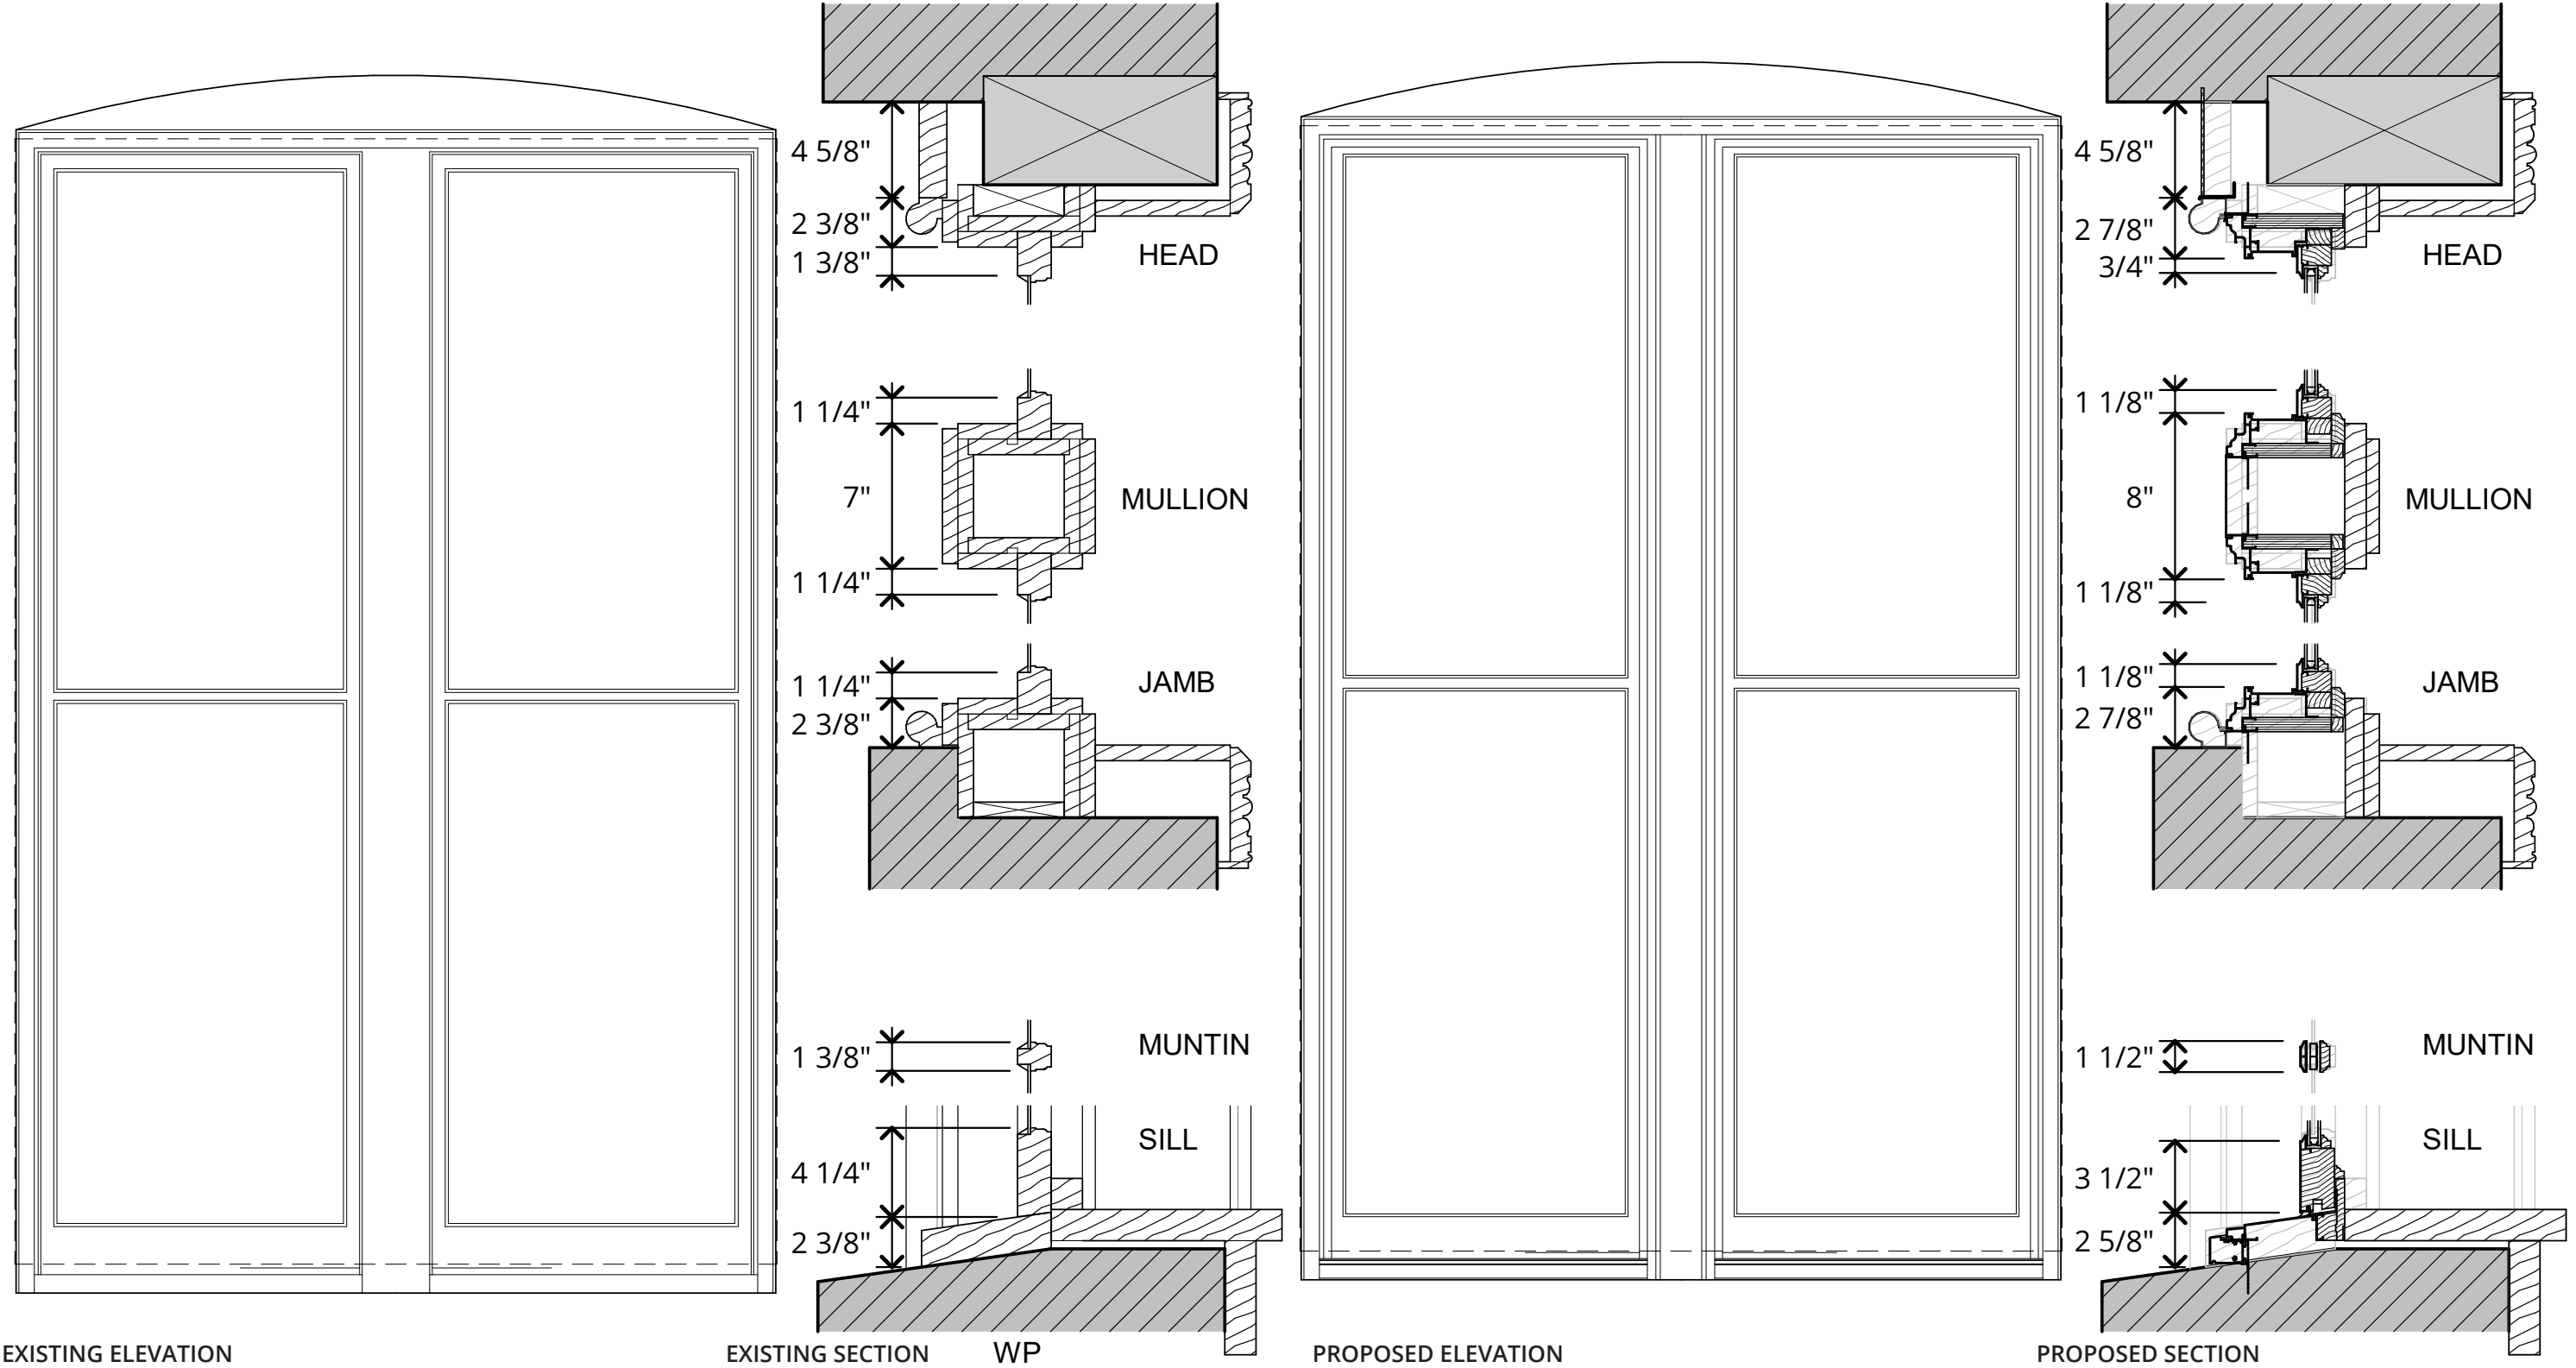
TYPE: WP

EXISTING ELEVATION

EXISTING SECTION WP

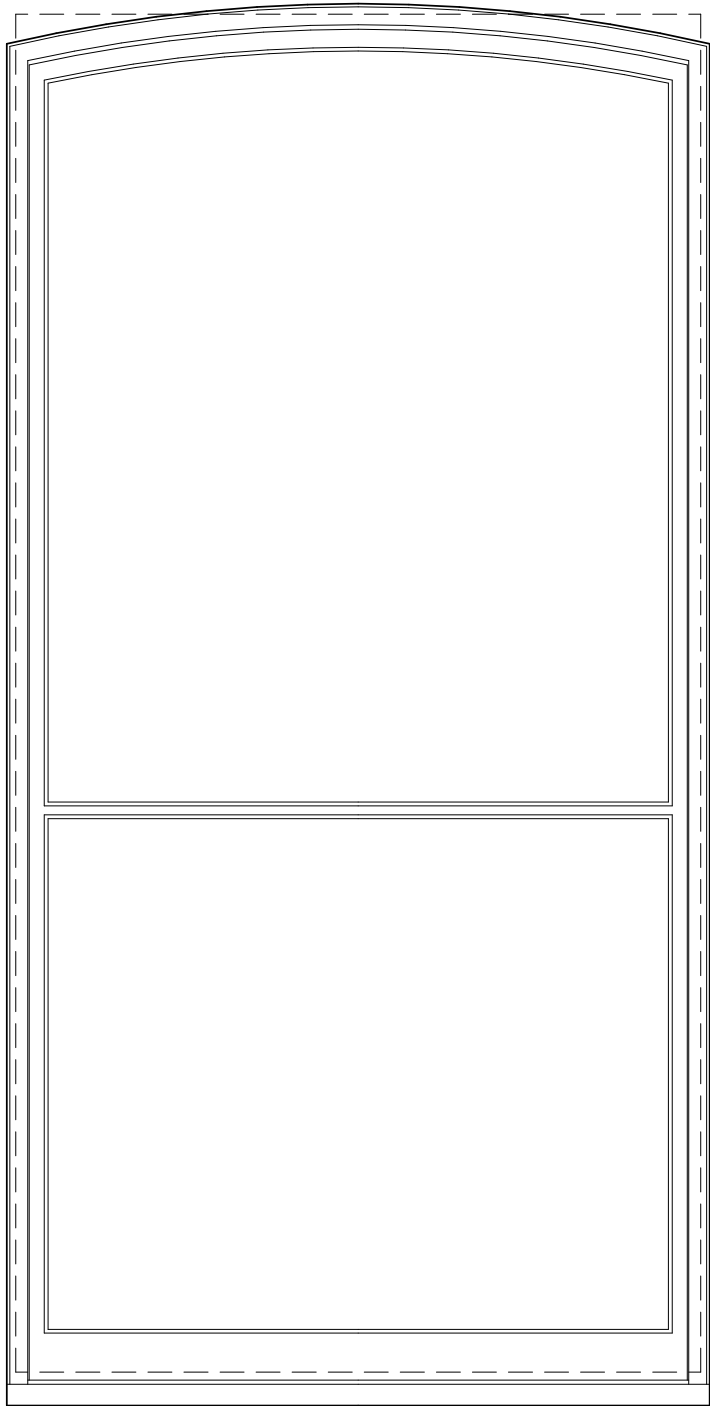
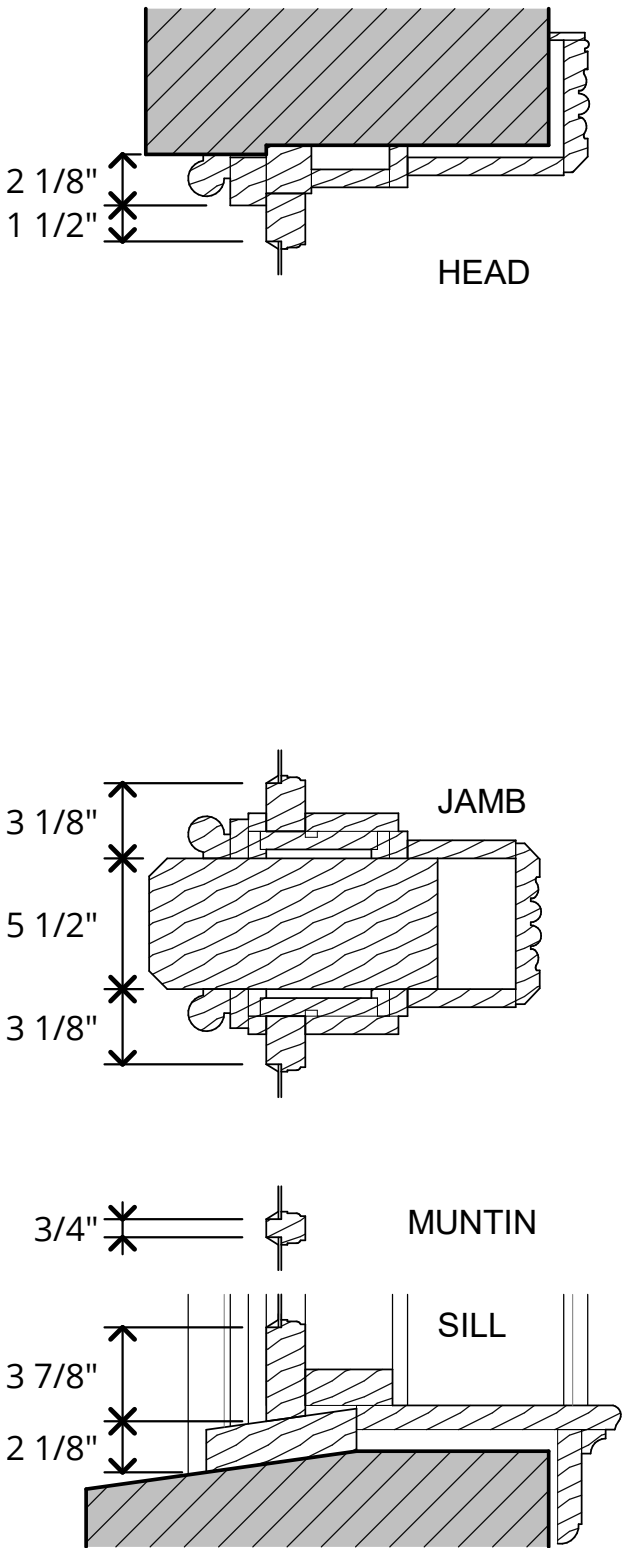
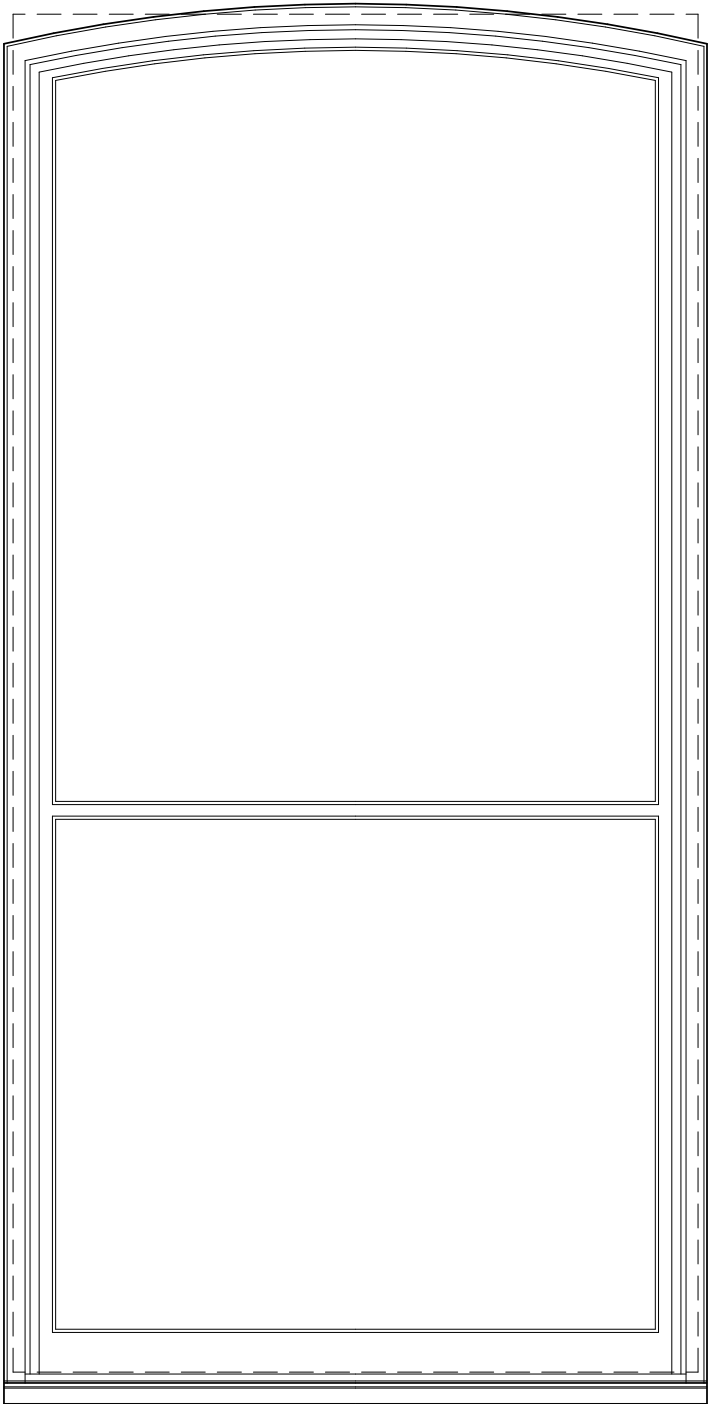
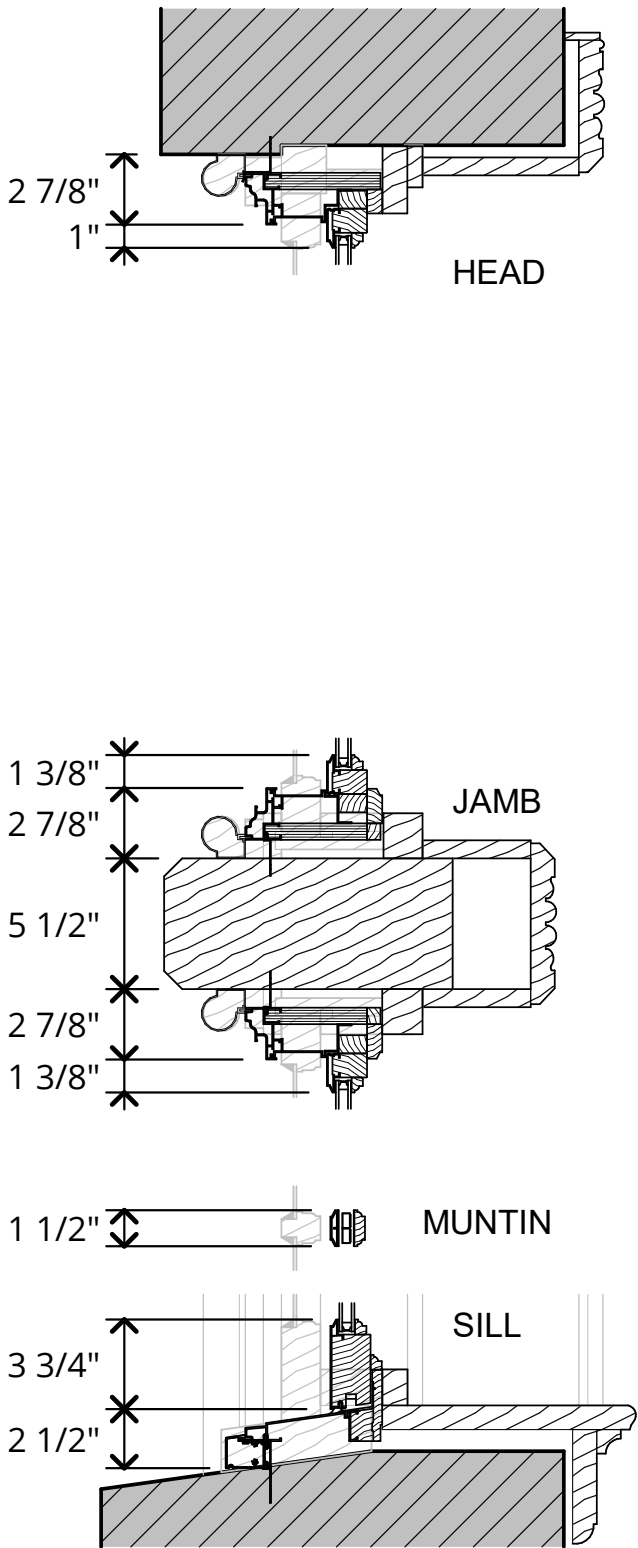
TYPE: WQ

EXISTING ELEVATION

EXISTING SECTION

PROPOSED ELEVATION

PROPOSED SECTION

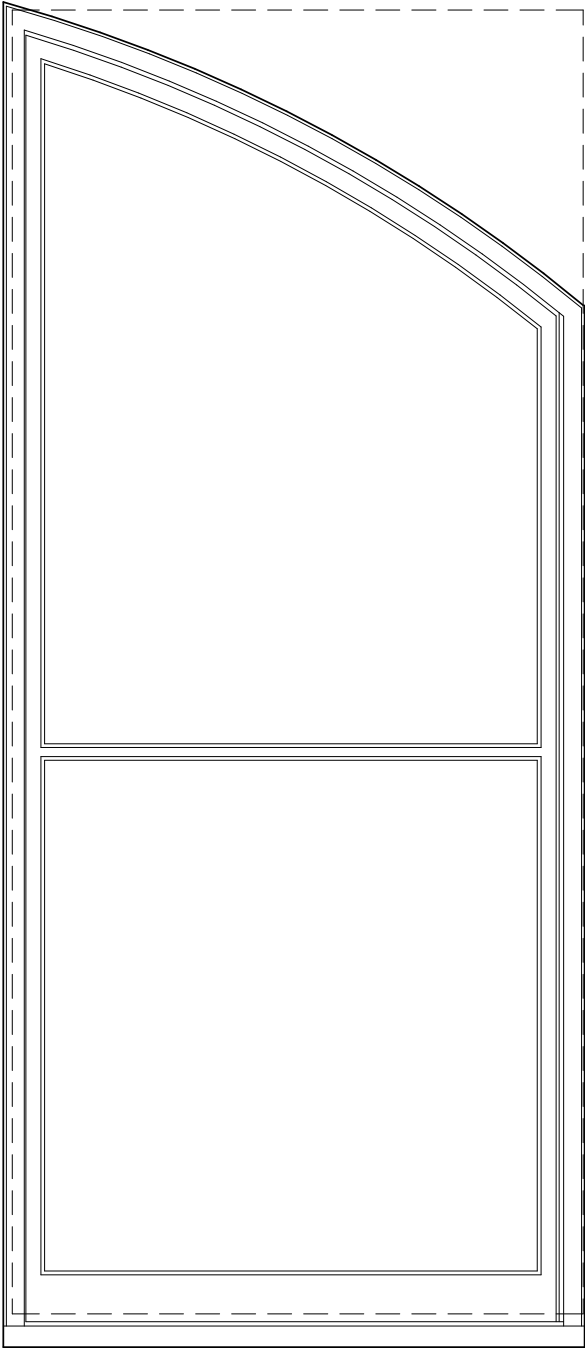
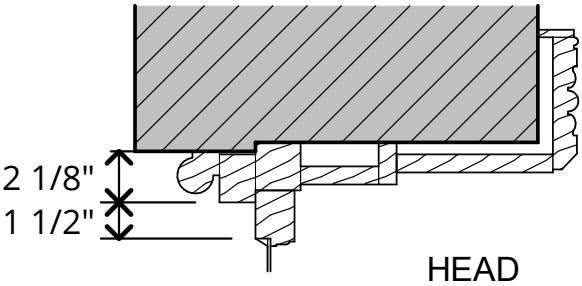
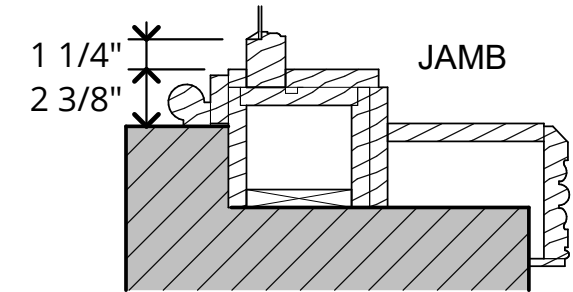
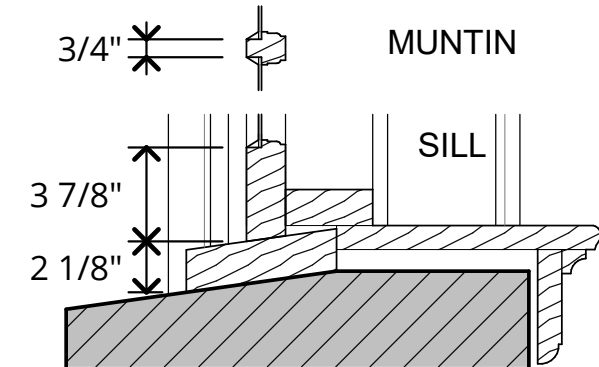
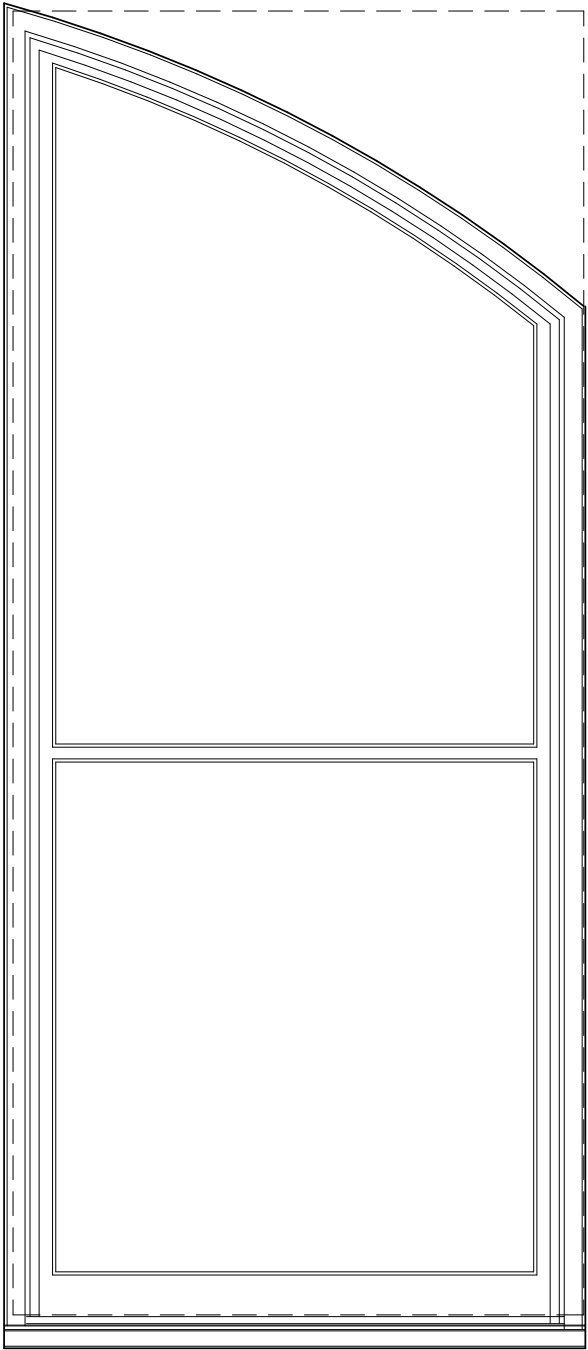
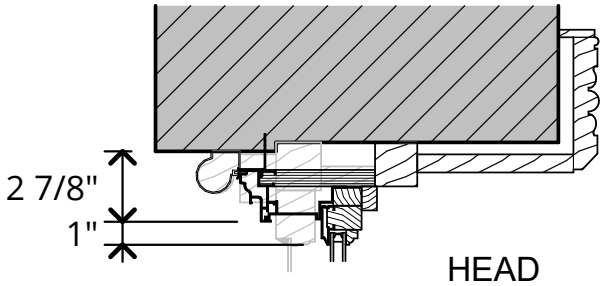
TYPE: WQ

EXISTING ELEVATION

EXISTING SECTION

PROPOSED ELEVATION

PROPOSED SECTION

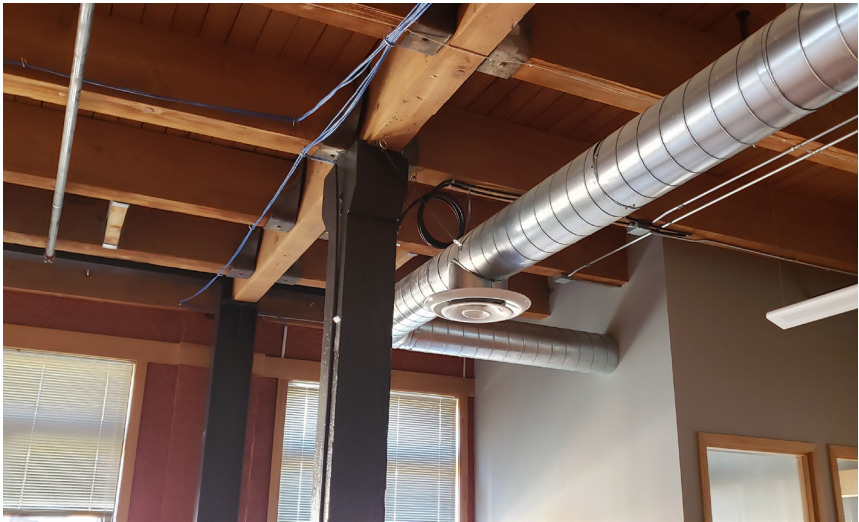
Typical photos of existing Buttnick roof deck from below

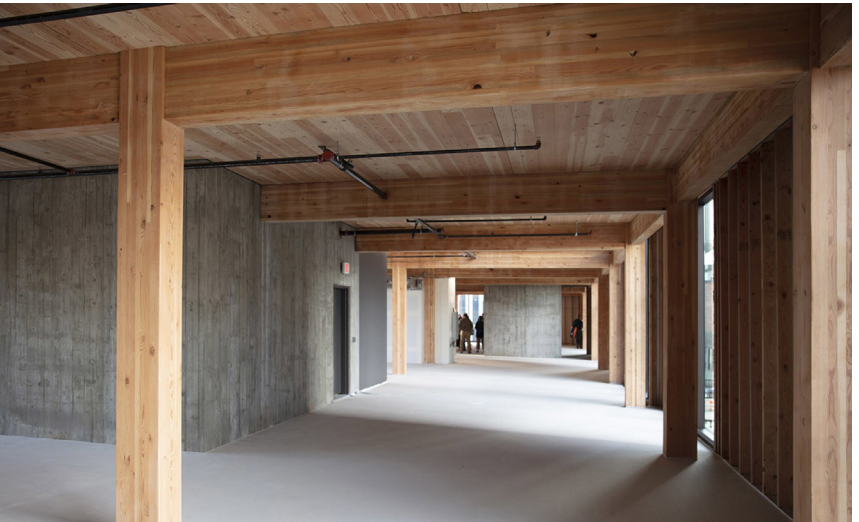
Mass timber system of beams, columns, and decking for 4th floor and roof

5. The remaining small skylights are replacements.
6. Previous renovations included the use of wood glulam beams.
7. New penthouse floor structure is exposed mass timber beams and decking. Mass timber is the modern equivalent of heavy timber. Mass timber provides large solid wood members with a positive environmental impact of carbon sequestration. See photo on previous page.

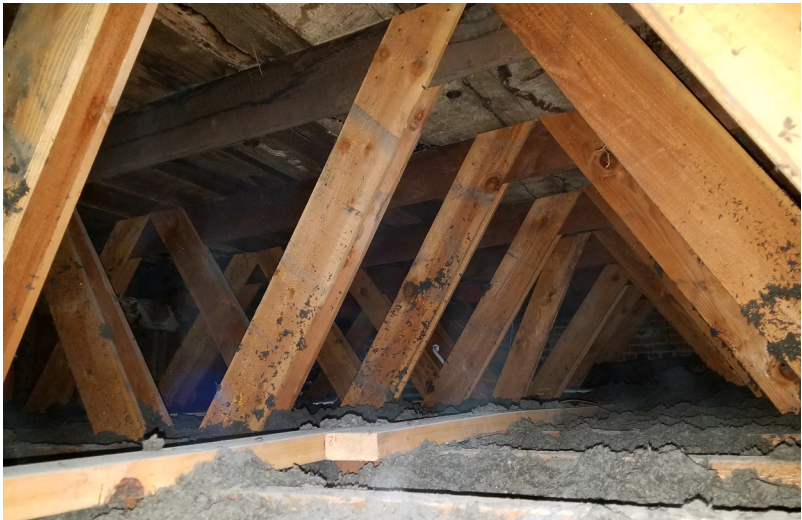
Ceiling cavity of existing roof structure, photo from 2018

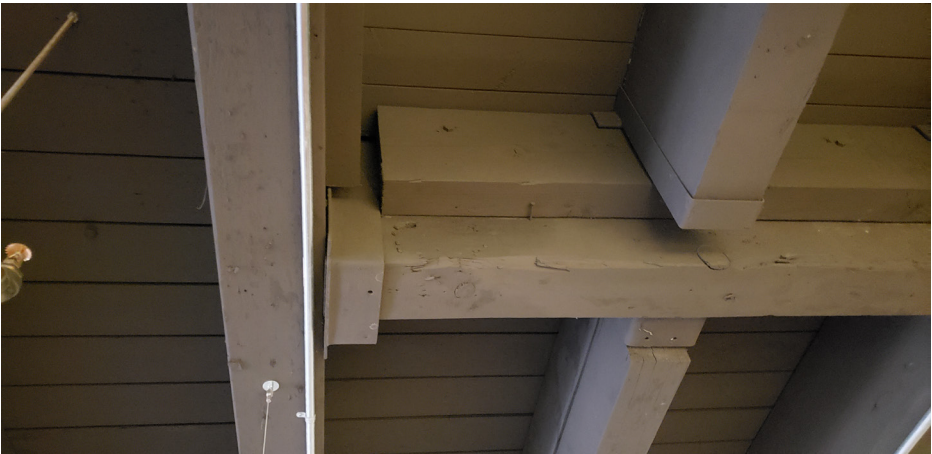
Third floor City Loan showing the result of previous floor revisions

1. Existing roof and floor structure is painted exposed heavy timber with exposed wood decking. (see photo) The floor was heavily modified in previous renovations.
2. The second floor will be disassembled, salvaged, and reconstructed 1' 1-1/2" lower. Heavy timber members will be re-used and supported on the existing brick walls. Replacement decking will match existing. All wood structure will be painted.
3. The fifth floor will be disassembled, salvaged, and reconstructed. Heavy timber members will be re-used and supported on the existing brick. The decking will be mass timber as part of the structural system for the floor.
4. A lower floor area will be built near the 5th floor windows to avoid conflicting with the windows.
5. The new roof is mass timber.
6. The third and fourth floors are left in place and over framed. The over framing height is kept below the window stool.

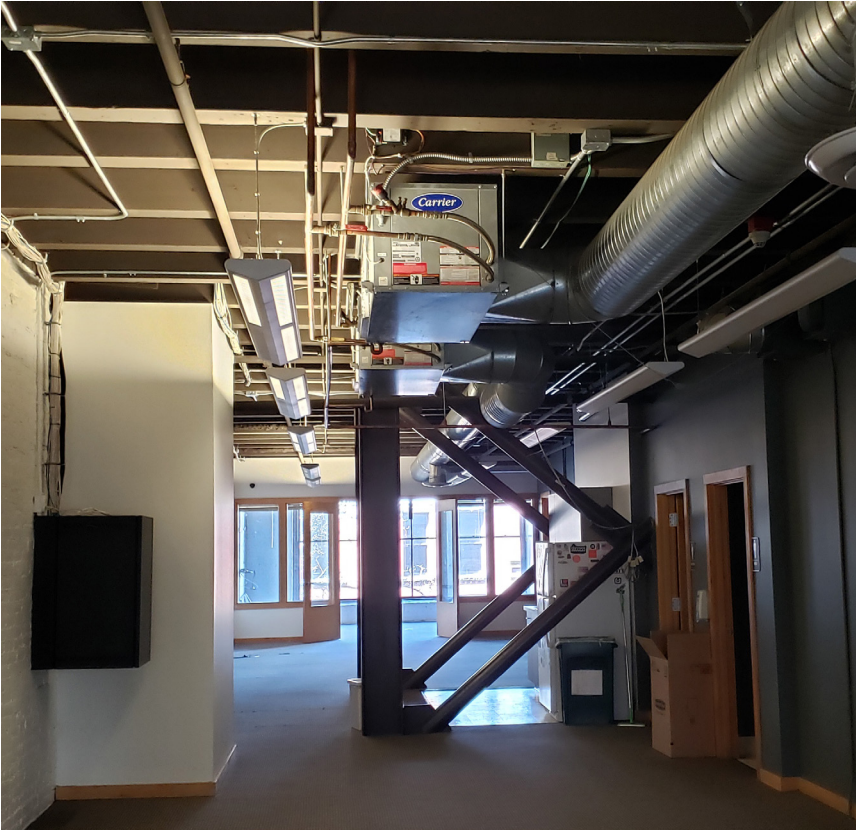
Third floor City Loan with windows beyond
