PSPB COA PROPOSAL - CORRECTIONS

GRAND CENTRAL BLOCK

BRUNSWICK-BALKE-COLLENDER CO + GOTTSTEIN + SQUIRE LATIMER

200 S 1ST ST, Seattle, WA 98104

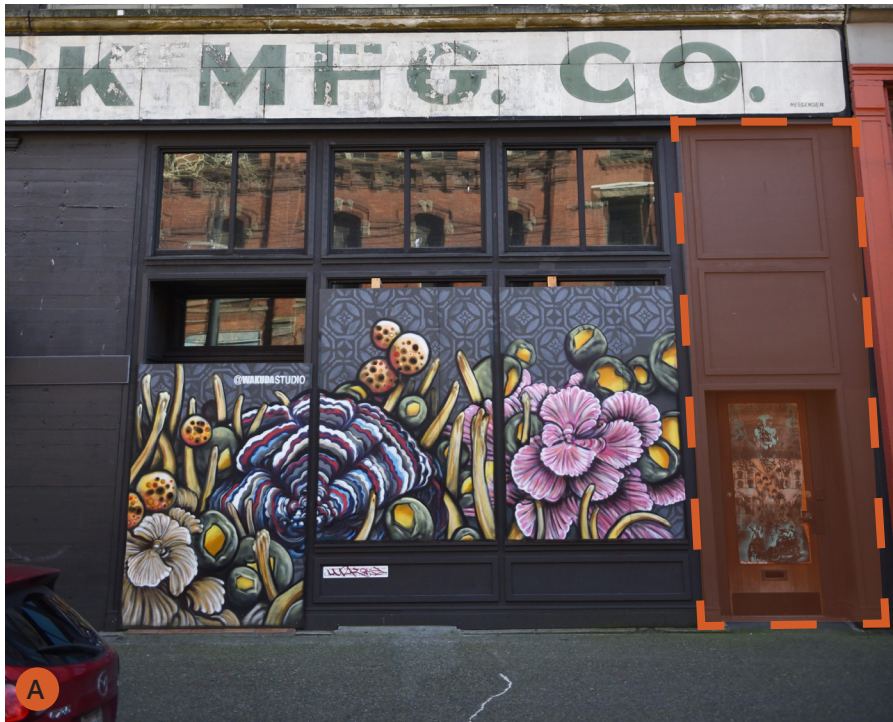
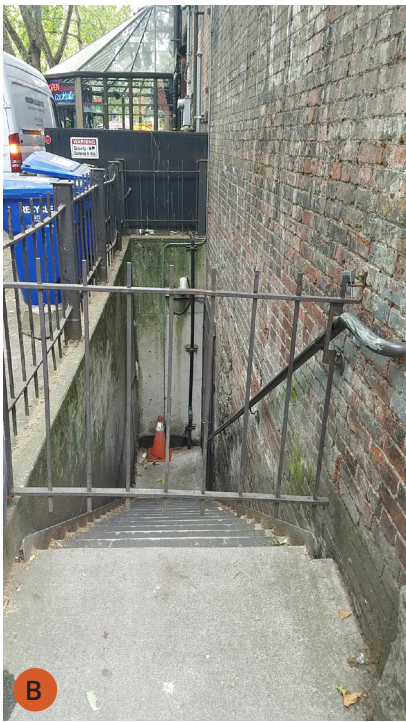
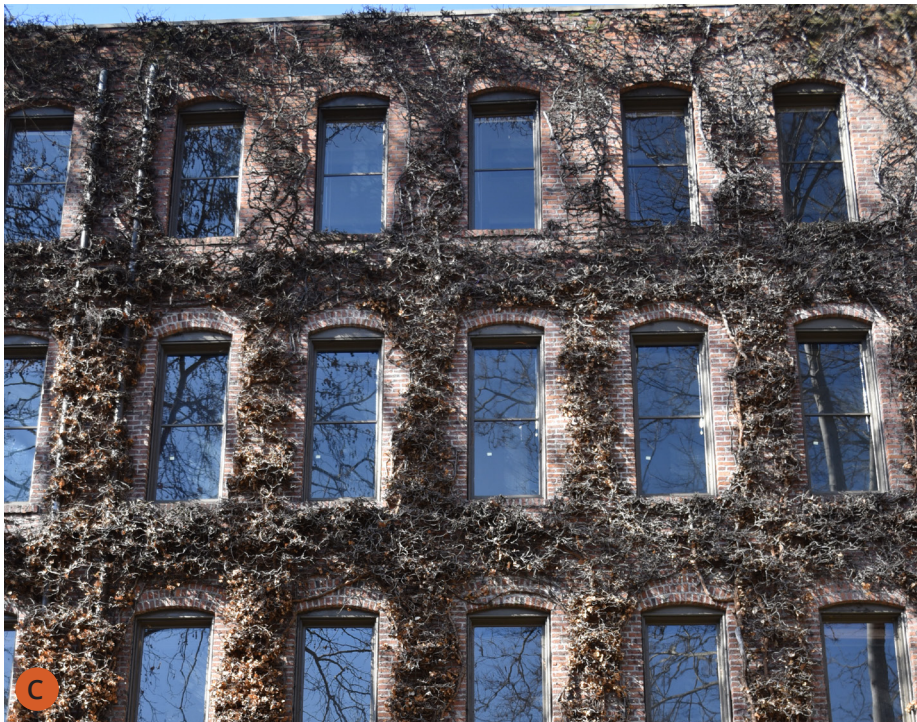
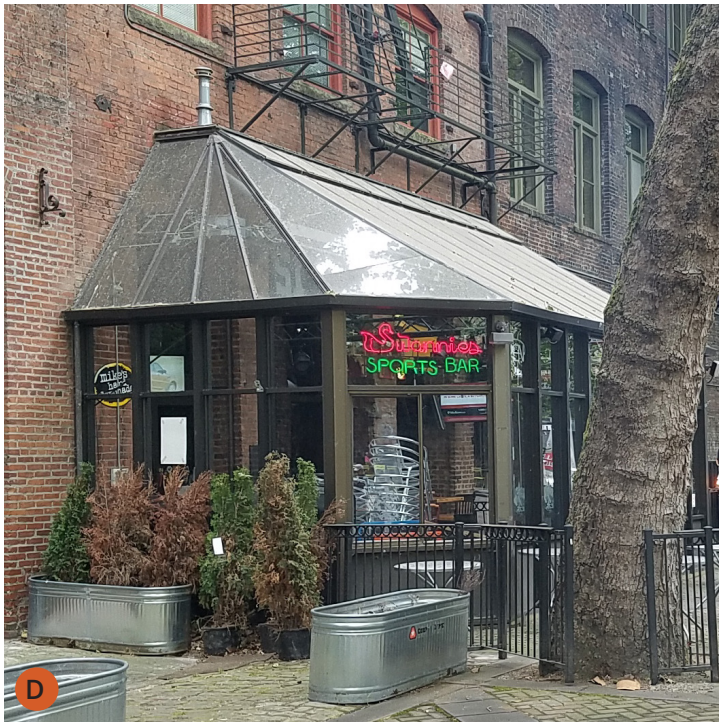
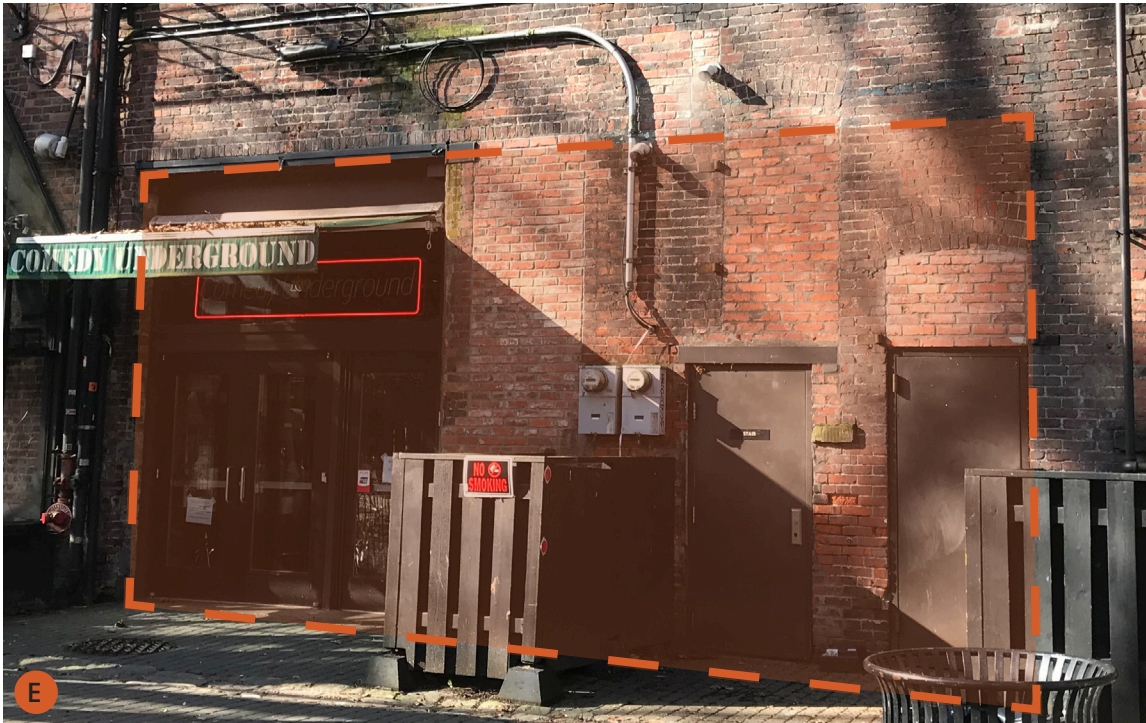
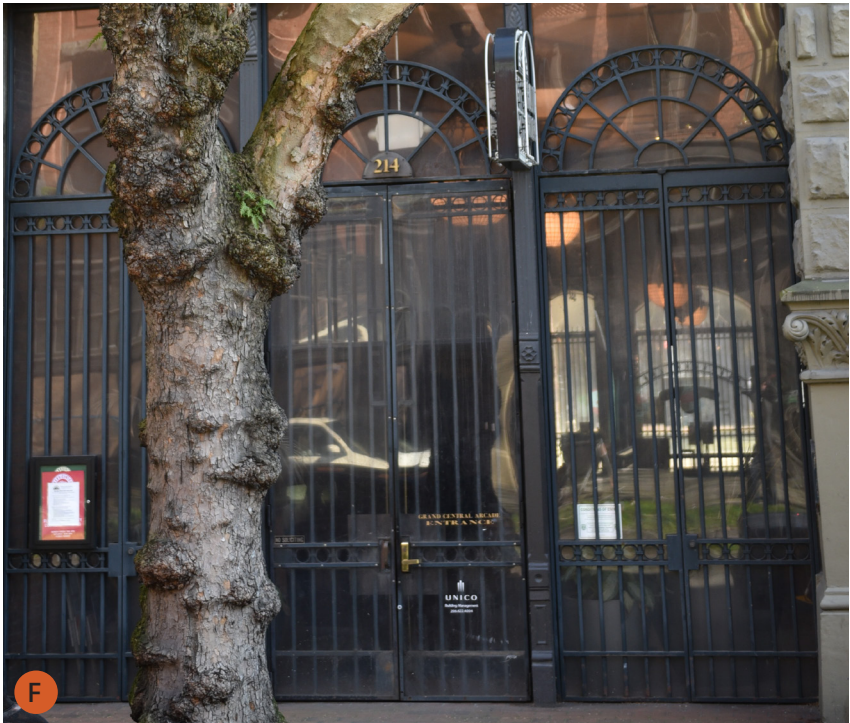
VISIBLE EXTERIOR REMOVED ELEMENTS

IMAGE LIST

- A** Modification at West Buttnick Storefront
- B** Exterior egress stair at Northeast corner of Buttnick
- C** Ivy at Grand Central East facade and Southeast corner
- D** Greenhouse at East City Loan facade
- E** Storefront and URM opening at Northeast Buttnick
- F** Iron bars at Grand Central (multiple locations)

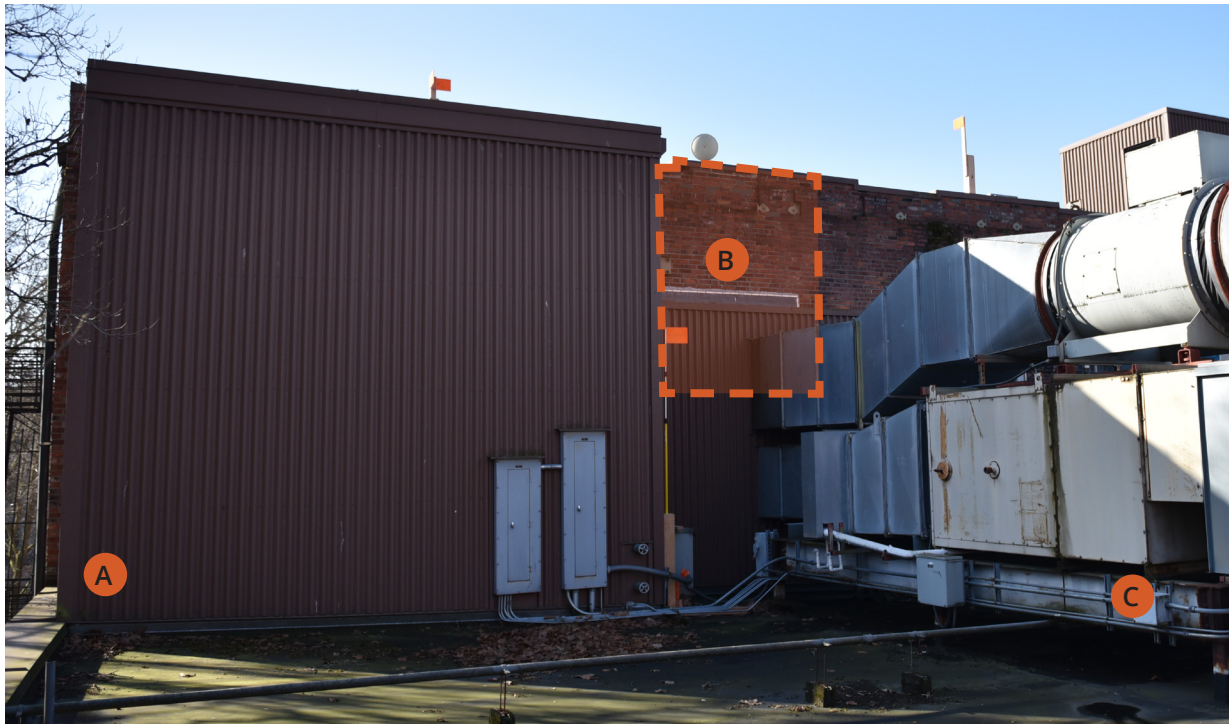
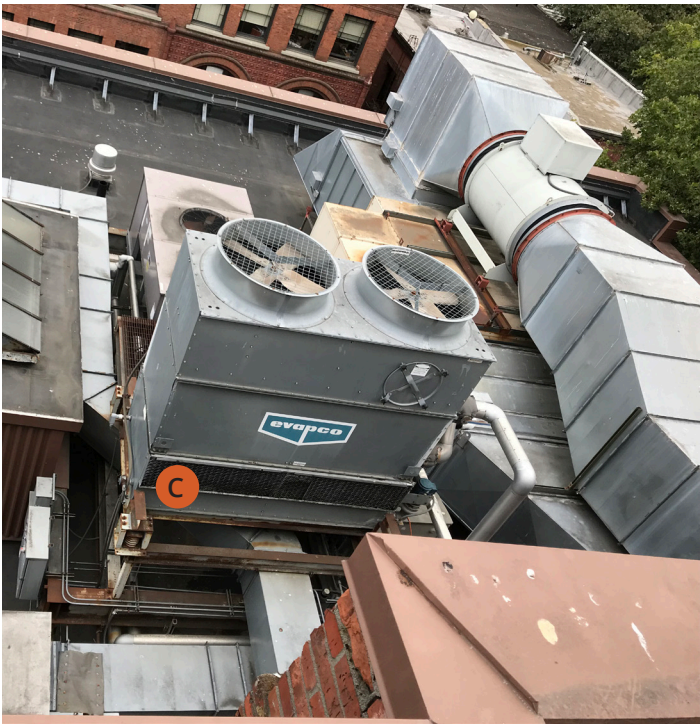
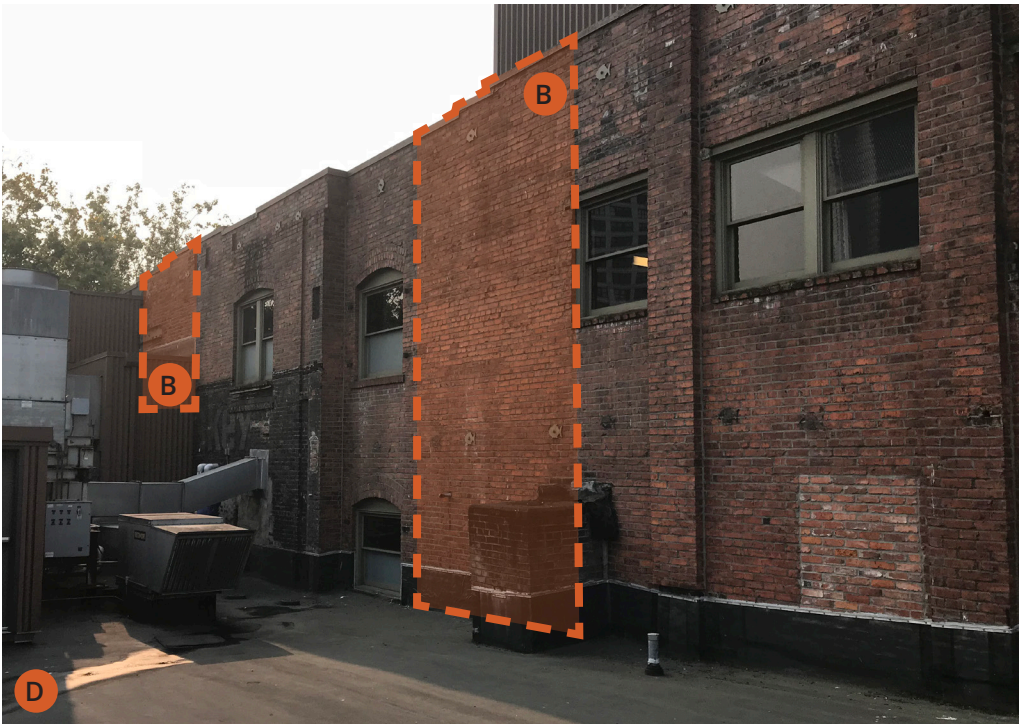
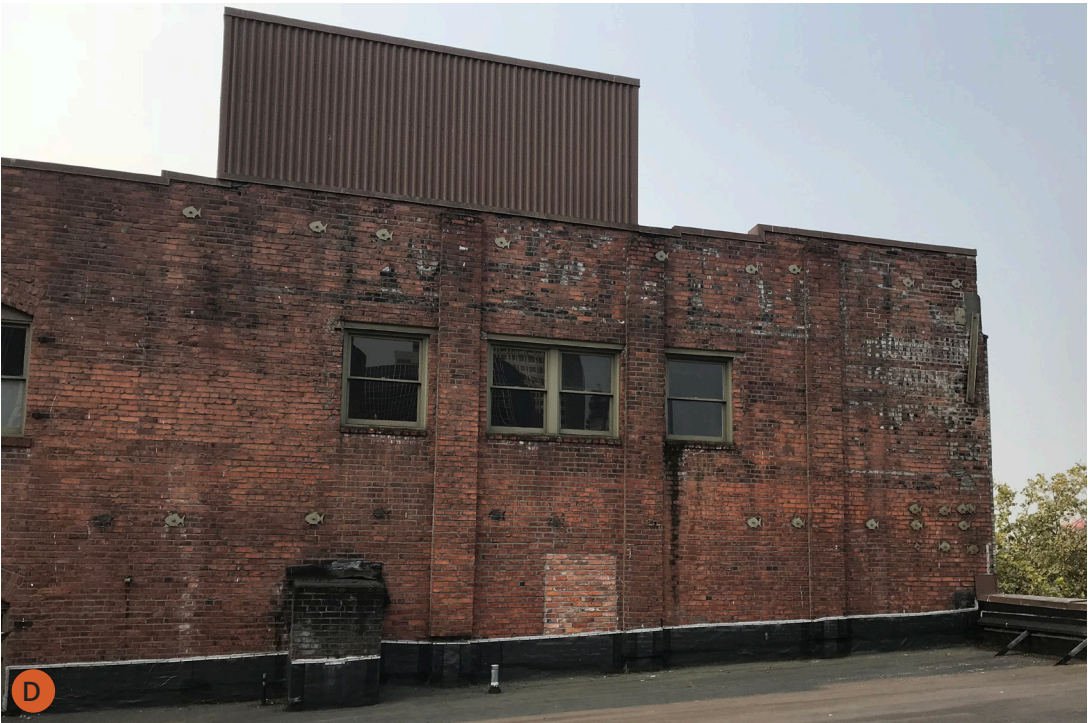
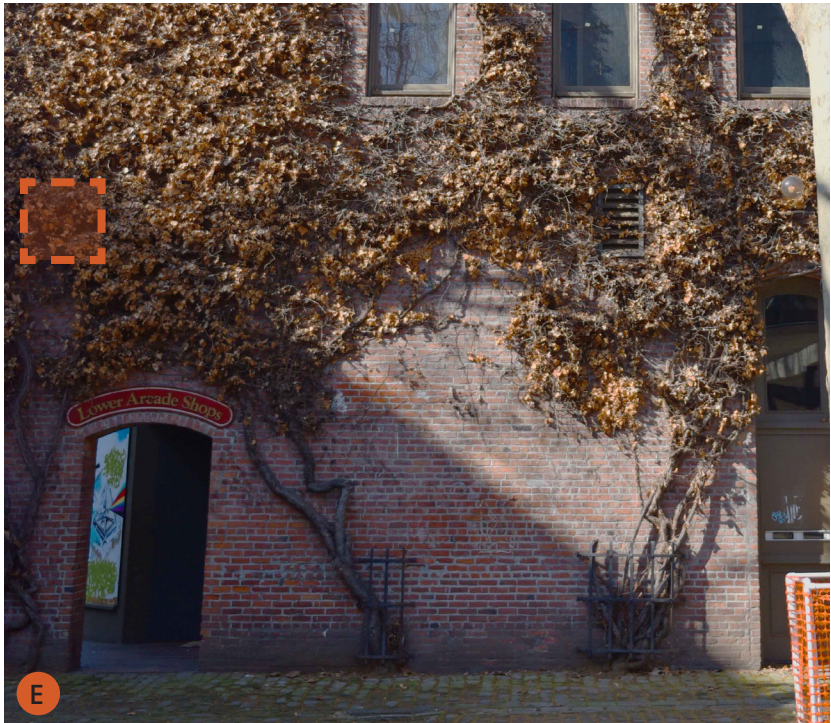
VISIBLE EXTERIOR REMOVED ELEMENTS

IMAGE LIST

- A** Egress stair overrun at Buttnick roof
- B** Brick removal for access between City Loan and Buttnick
- C** Mechanical equipment at Buttnick roof
- D** 1970s windows overlooking Buttnick roof
- E** URM opening for electrical vault exhaust at Southeast corner of Grand Central

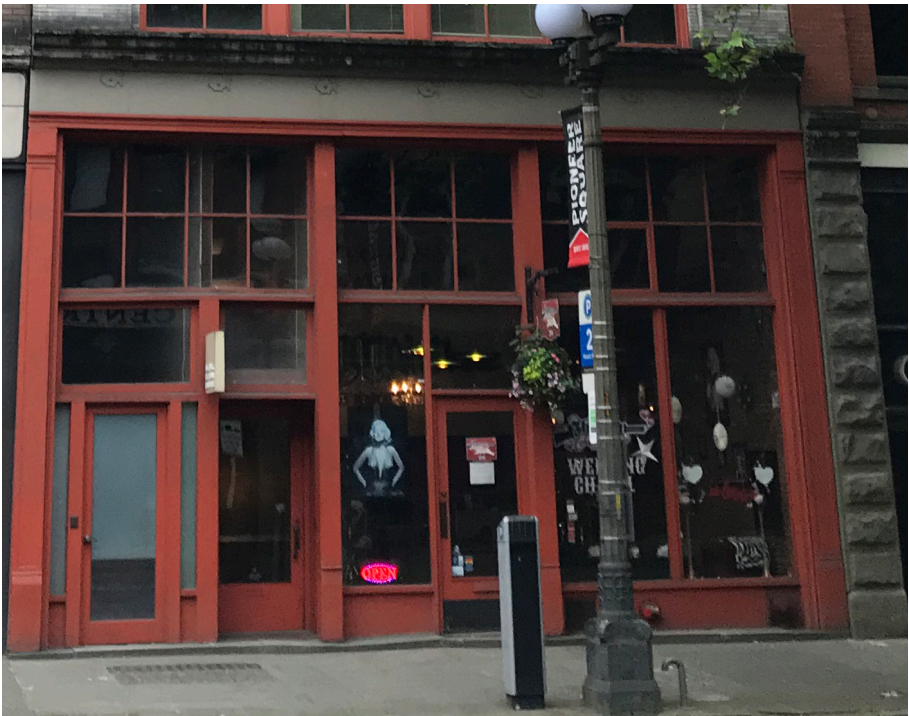
A EXISTING WEST CITY LOAN STOREFRONT

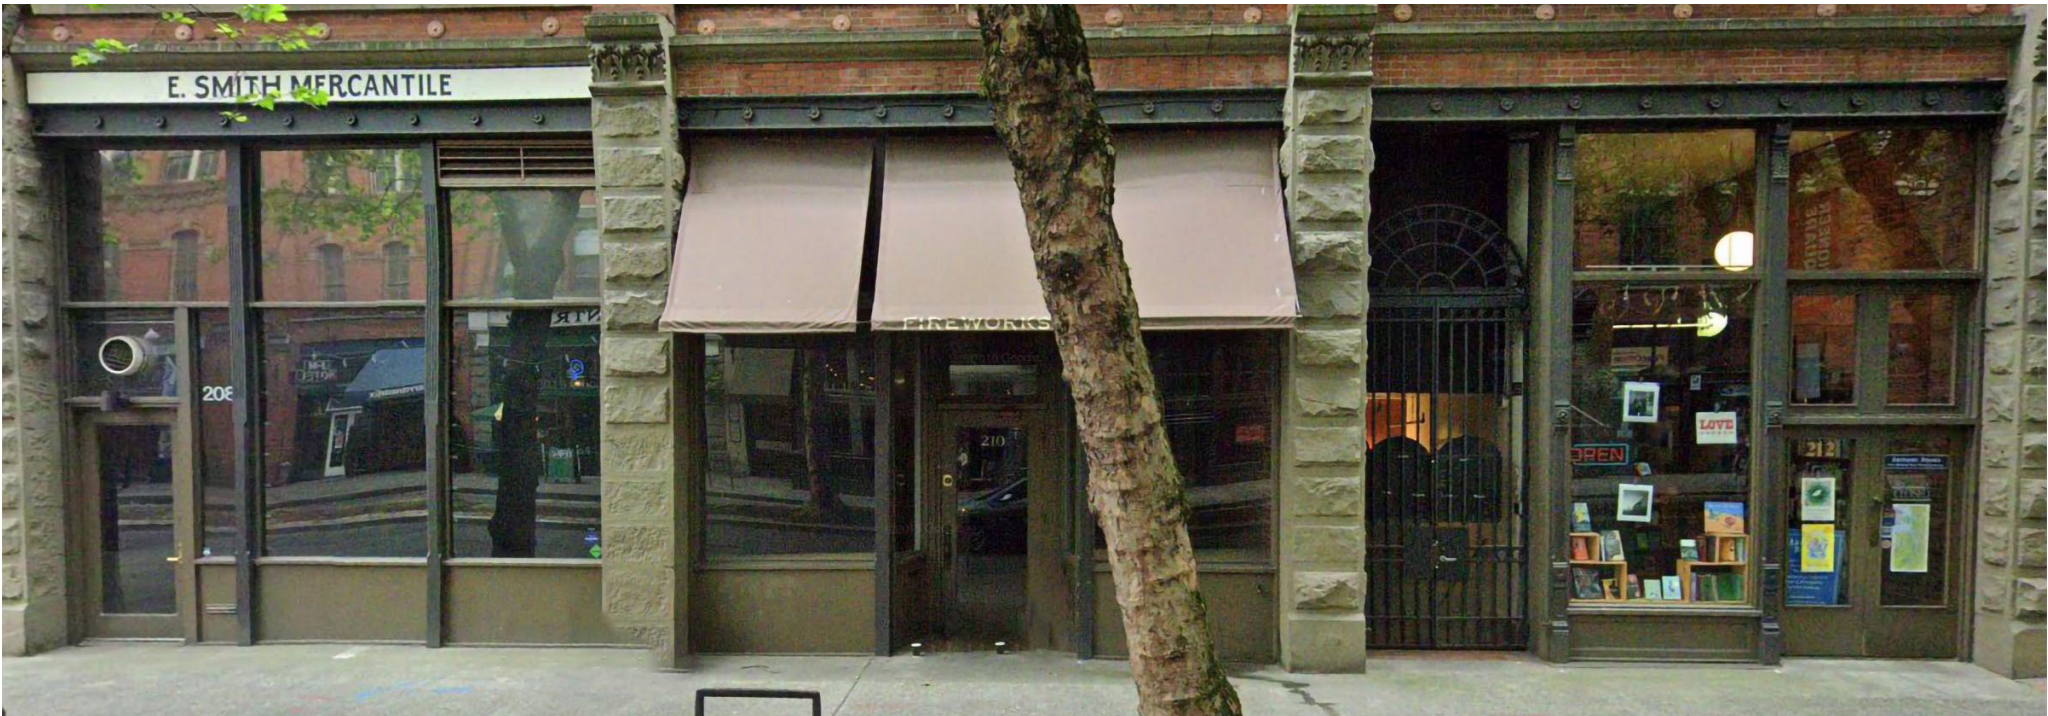
B EXISTING WEST GRAND CENTRAL STOREFRONT

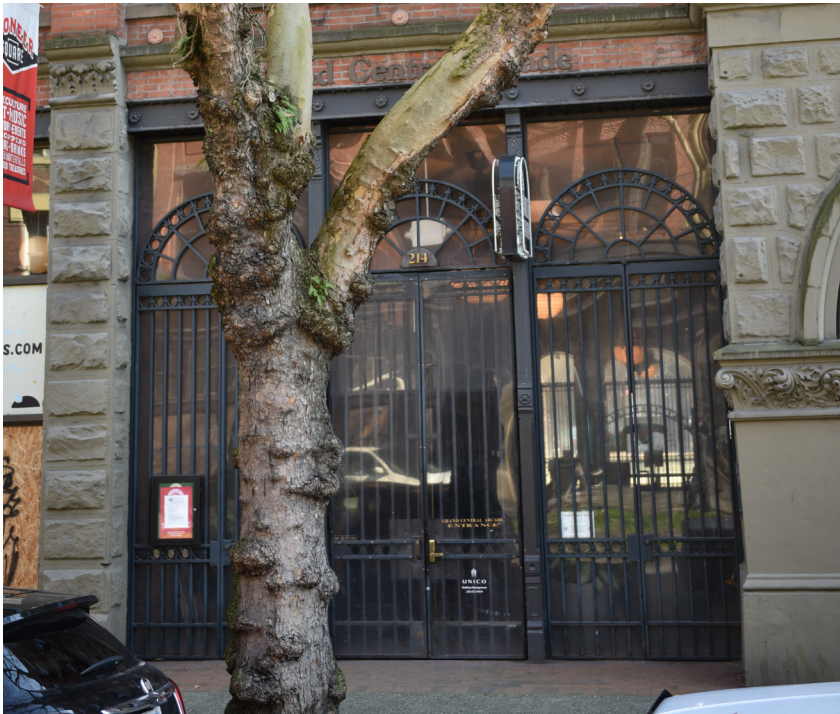
C EXISTING WEST GRAND CENTRAL ARCADE STOREFRONT

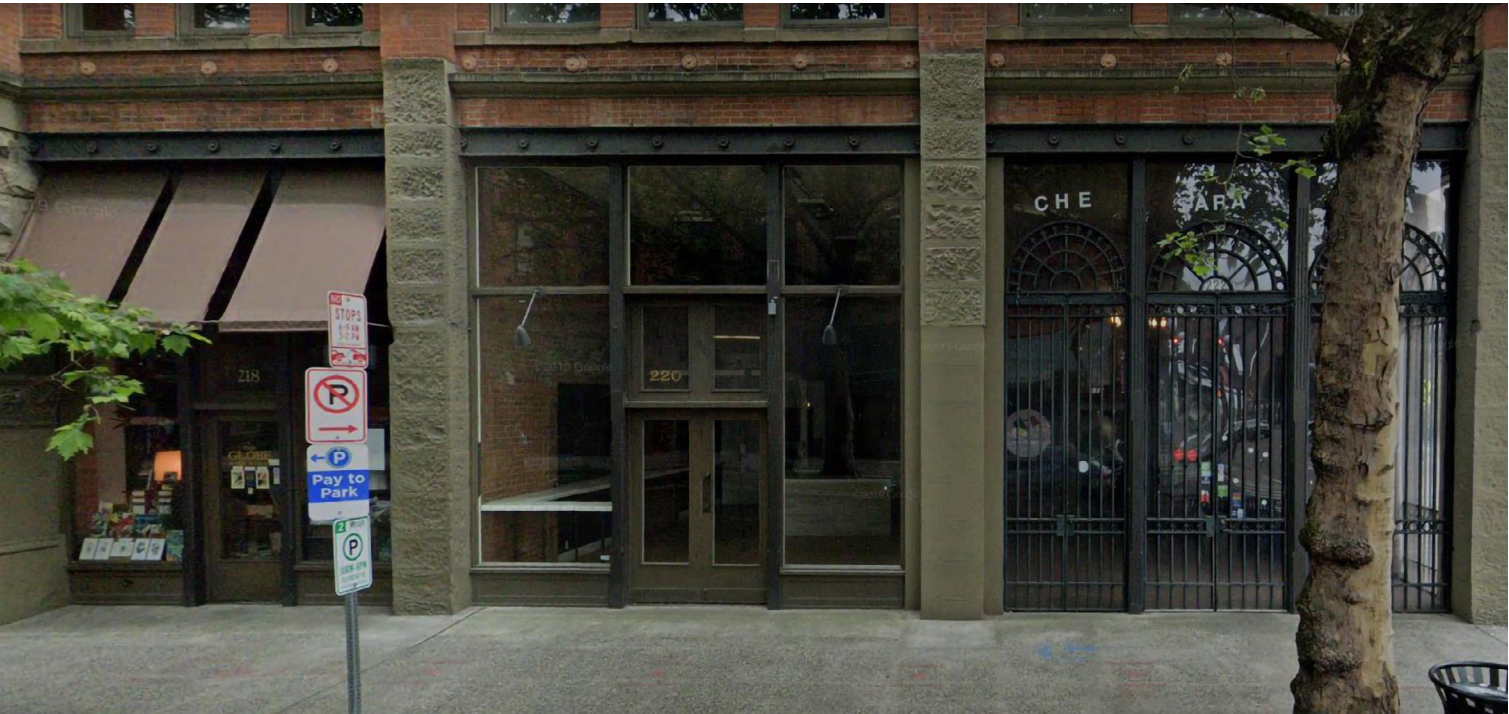
D EXISTING SOUTHWEST GRAND CENTRAL STOREFRONT

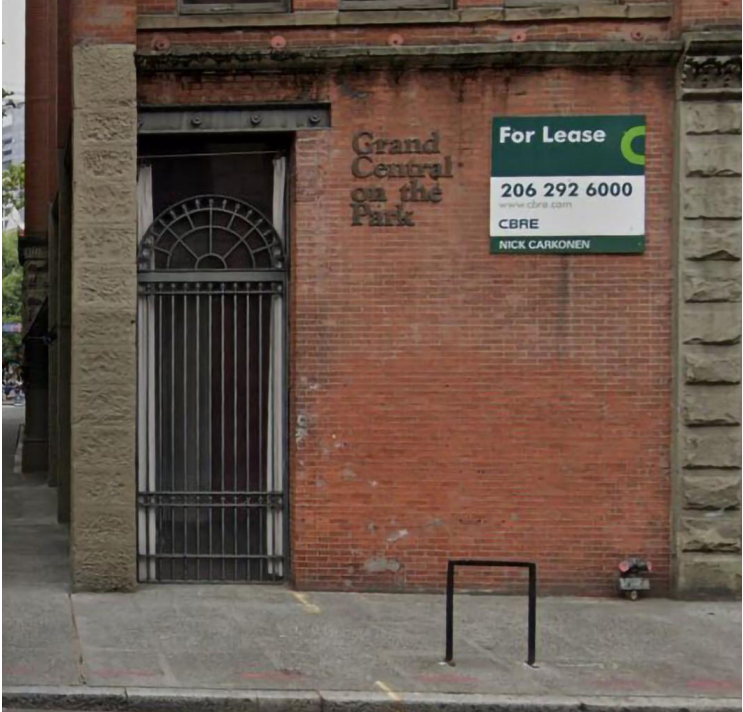
A EXISTING SOUTHWEST GRAND CENTRAL STOREFRONT

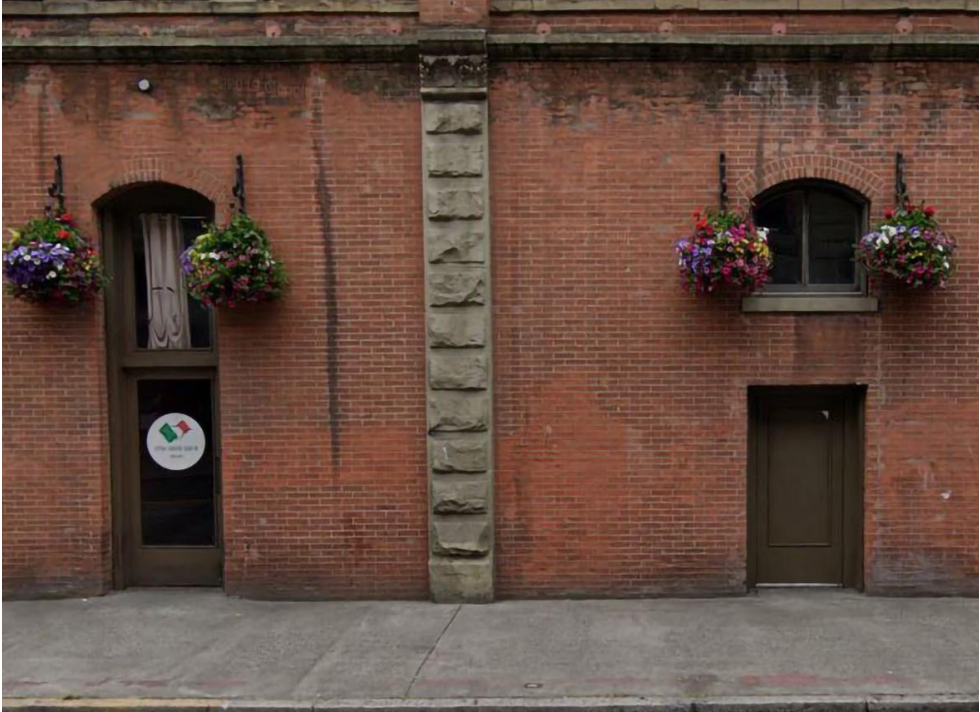
B EXISTING SOUTH GRAND CENTRAL STOREFRONT

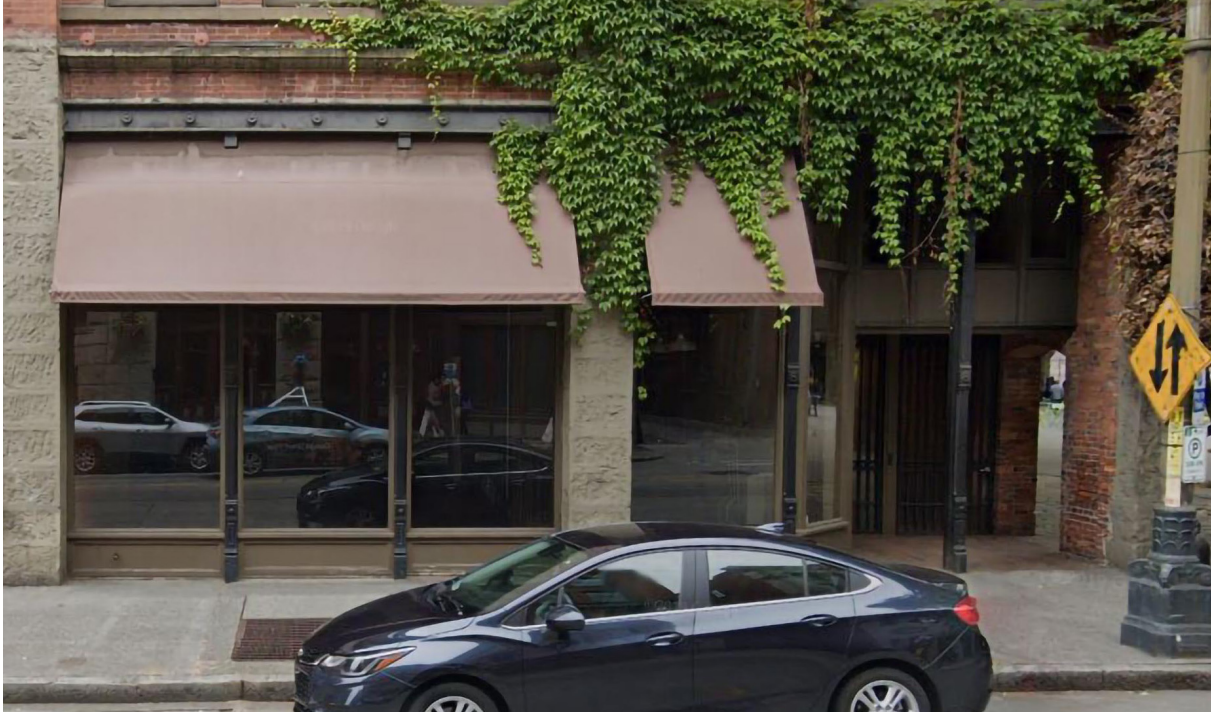
C EXISTING SOUTHEAST GRAND CENTRAL STOREFRONT

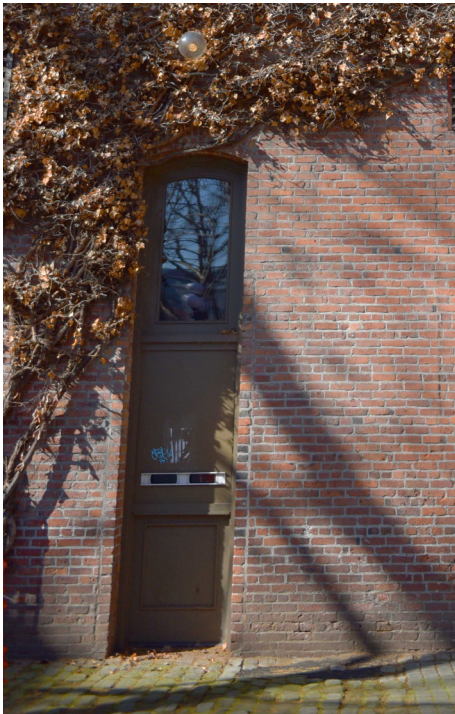
D EXISTING EAST GRAND CENTRAL STOREFRONT

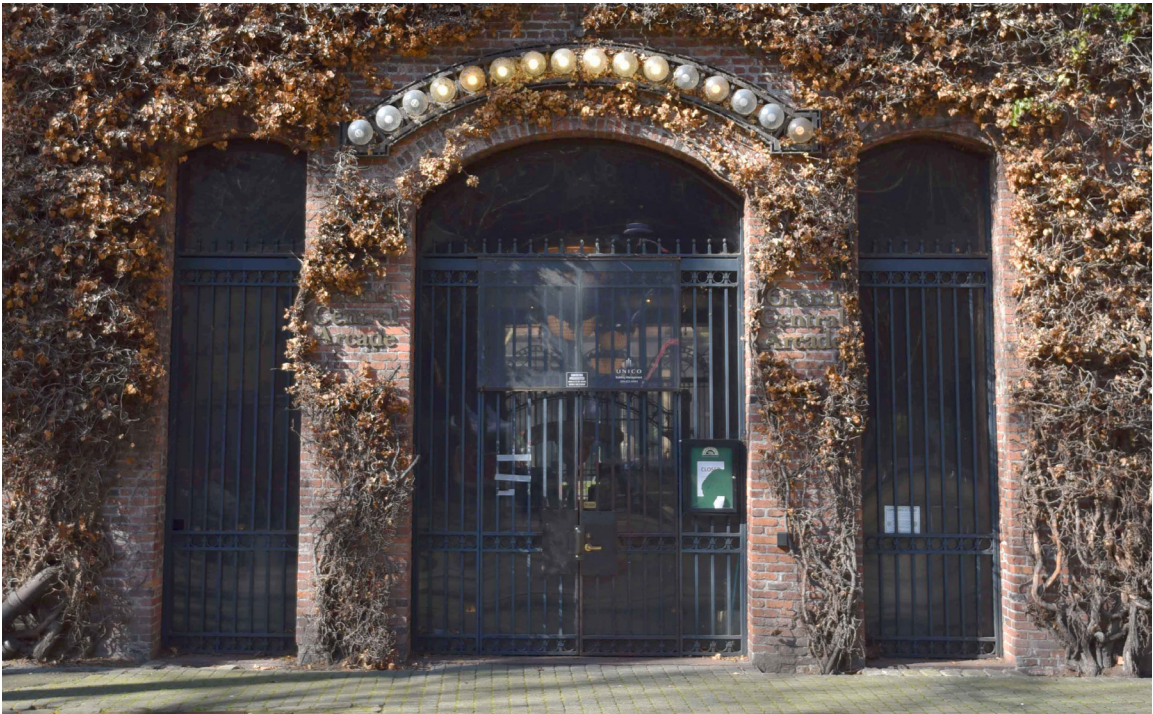
E EXISTING EAST GRAND CENTRAL ARCADE STOREFRONT

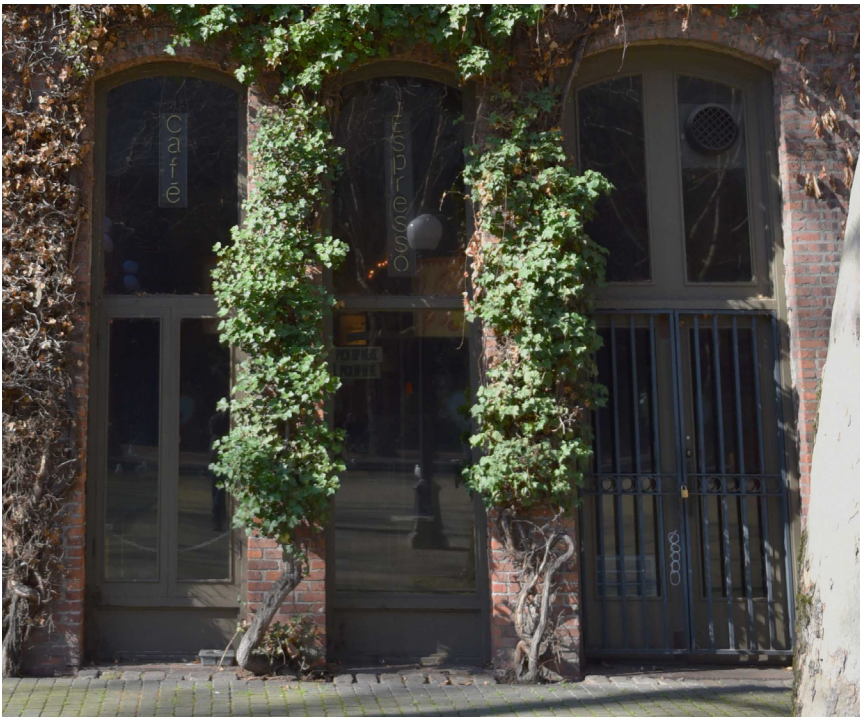
A EXISTING EAST GRAND CENTRAL STOREFRONT

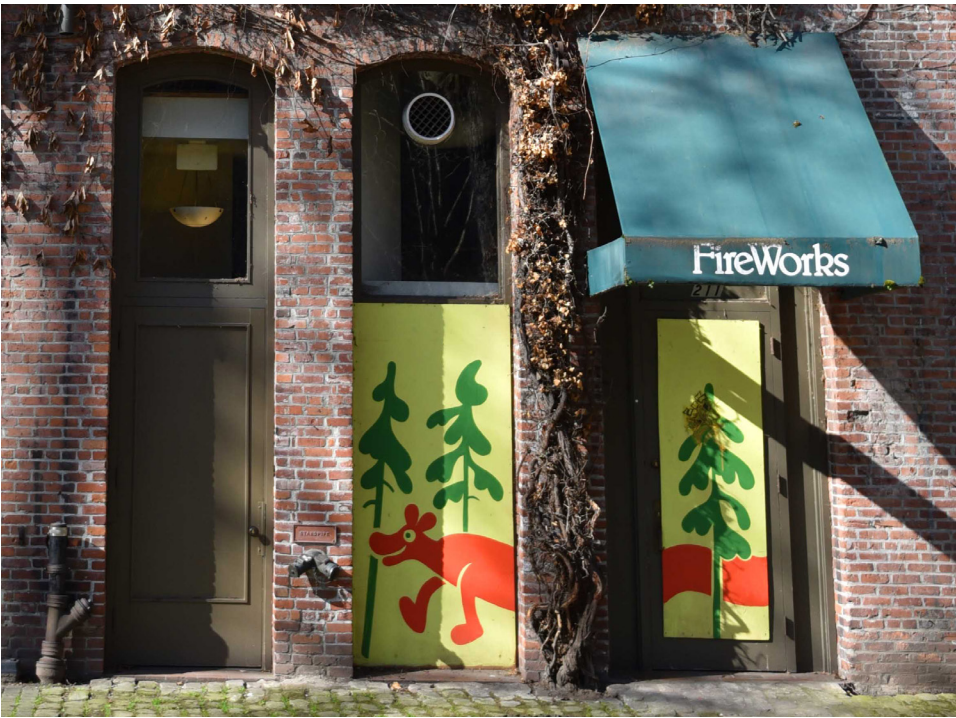
B EXISTING EAST GRAND CENTRAL STOREFRONT

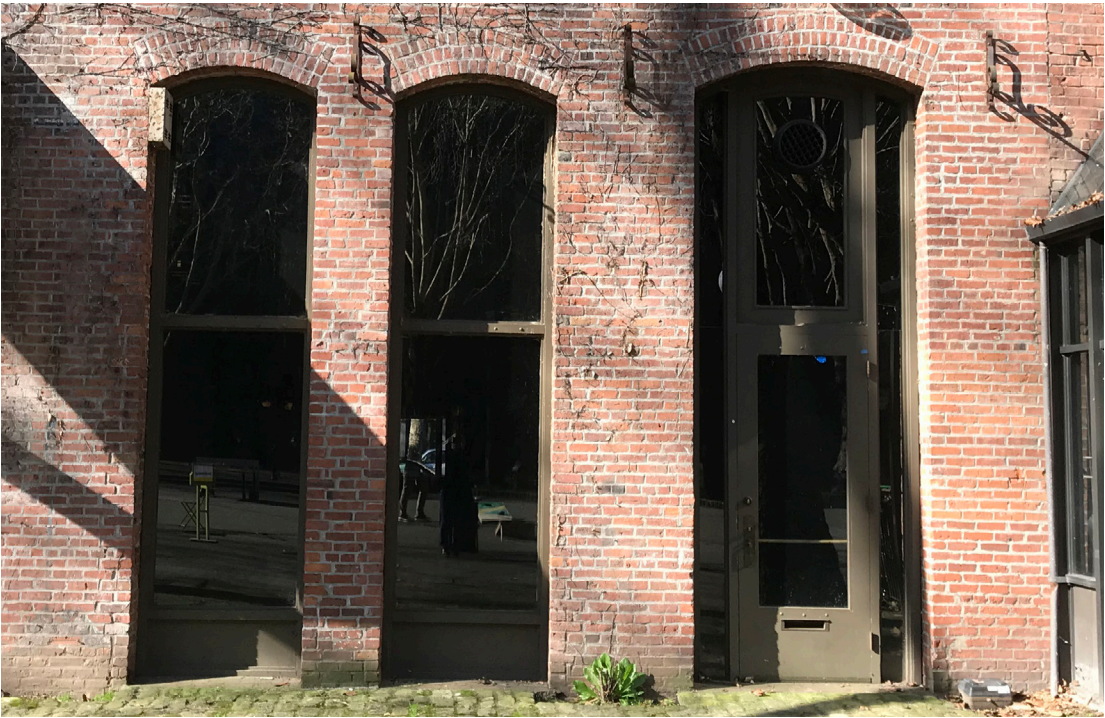
C EXISTING EAST GRAND CENTRAL STOREFRONT

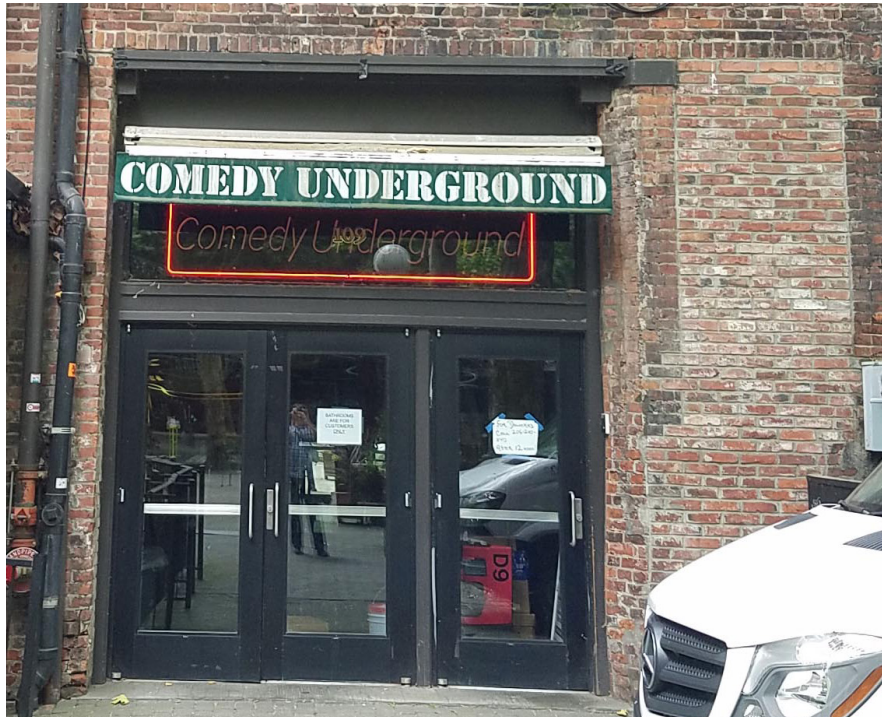
D EXISTING EAST BUTTNICK STOREFRONT

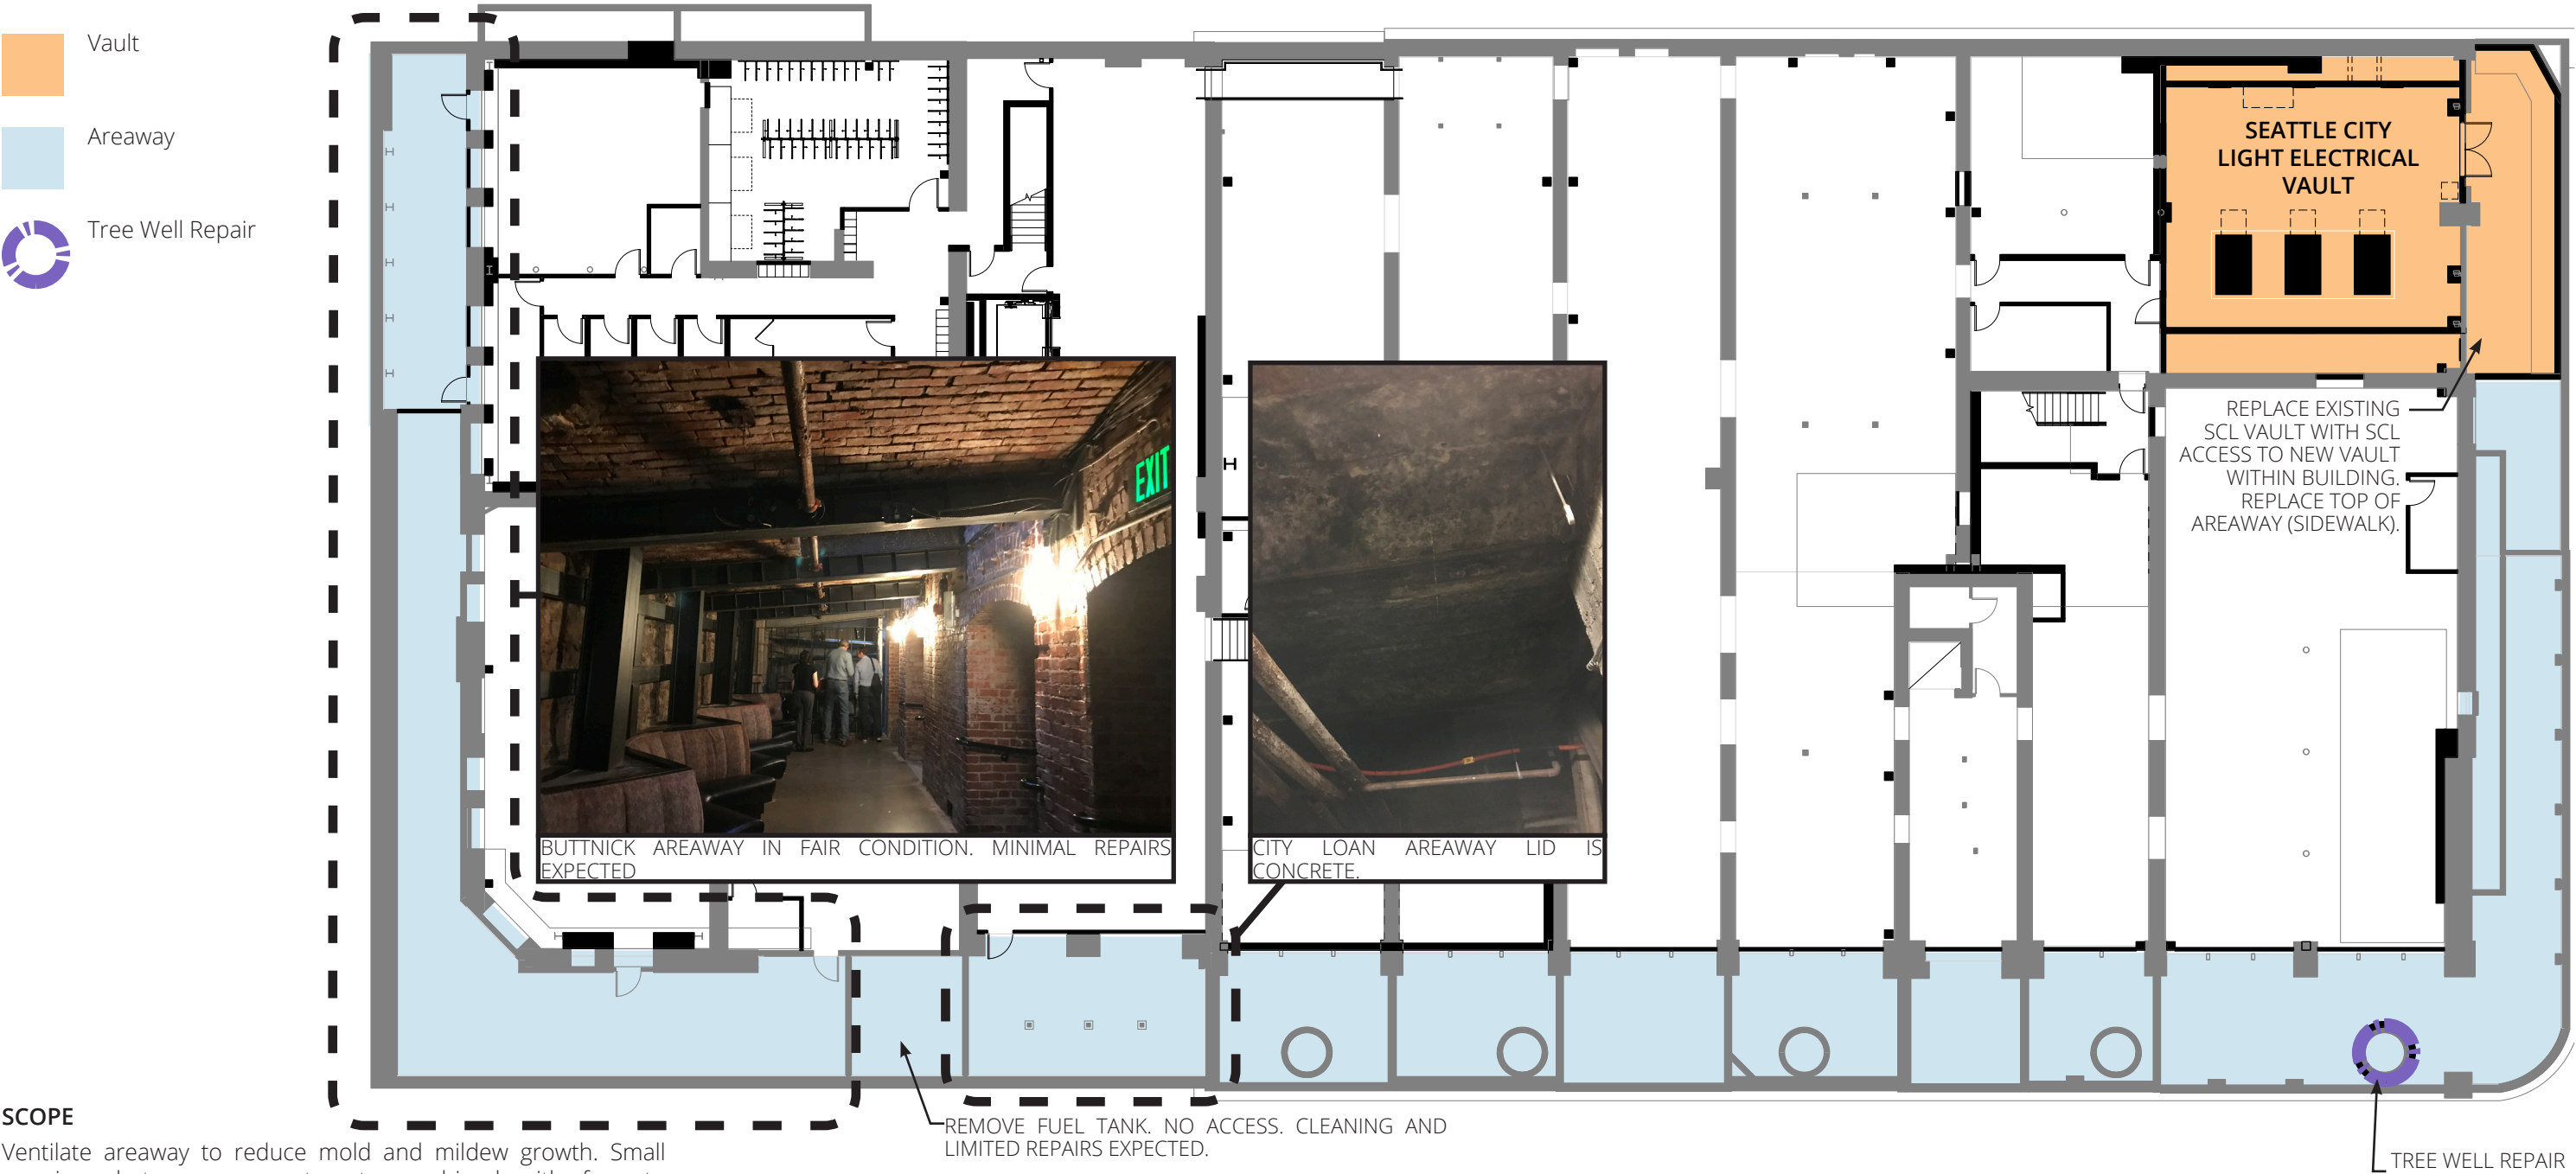
BASEMENT AREAWAY - SCOPE OF WORK

Ventilate areaway to reduce mold and mildew growth. Small openings between compartments combined with fans to encourage circulation.

Resupport brick arches and sidewalk where failing, see structural details on next sheet. Exact locations to be determined.

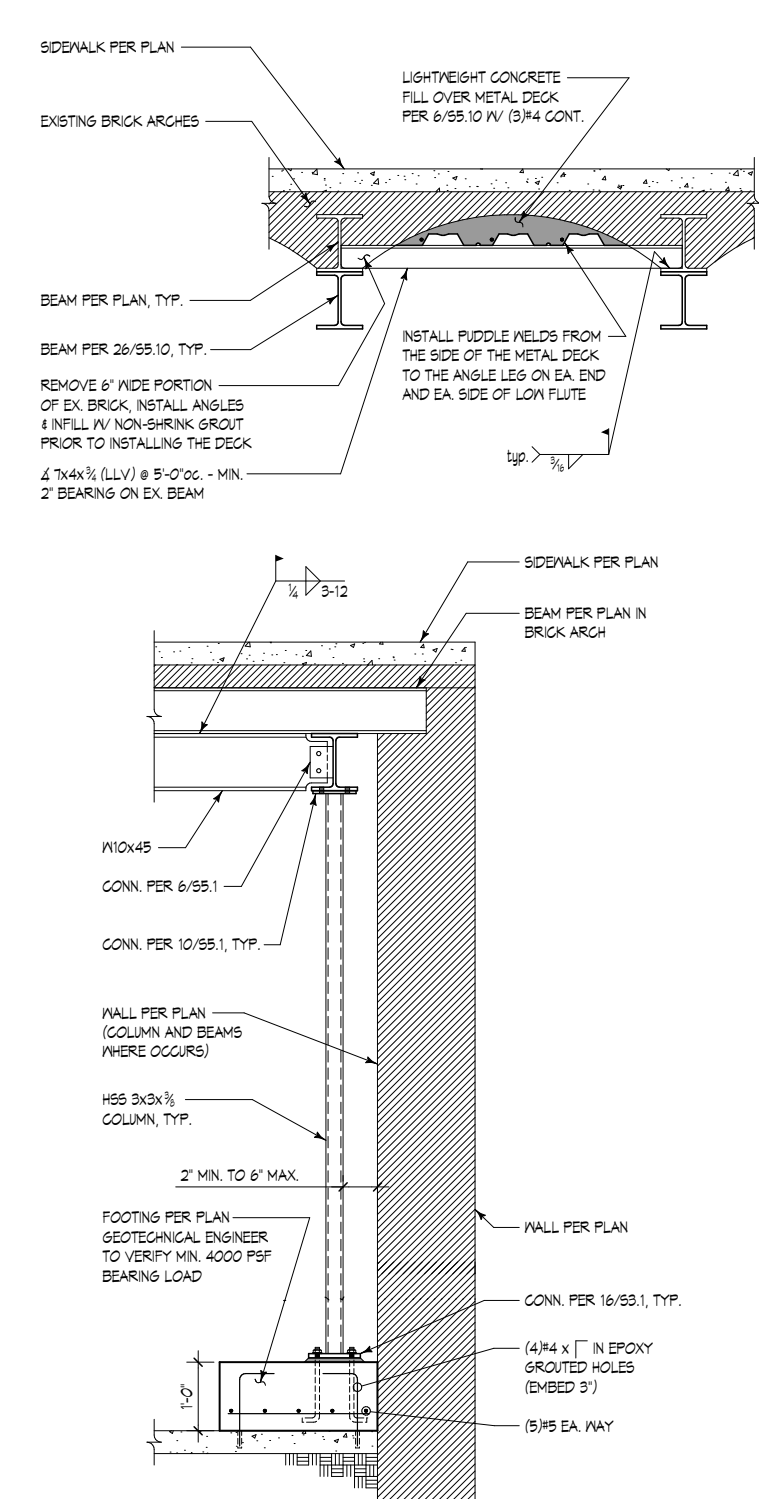
STRUCTURAL DETAILS

GRAND CENTRAL AREAWAY - STRUCTURAL DETAIL AND CONDITION PHOTOS
