PSPB COA PROPOSAL - CORRECTIONS

GRAND CENTRAL BLOCK

BRUNSWICK-BALKE-COLLENDER CO + GOTTSTEIN + SQUIRE LATIMER

200 S 1ST ST, Seattle, WA 98104

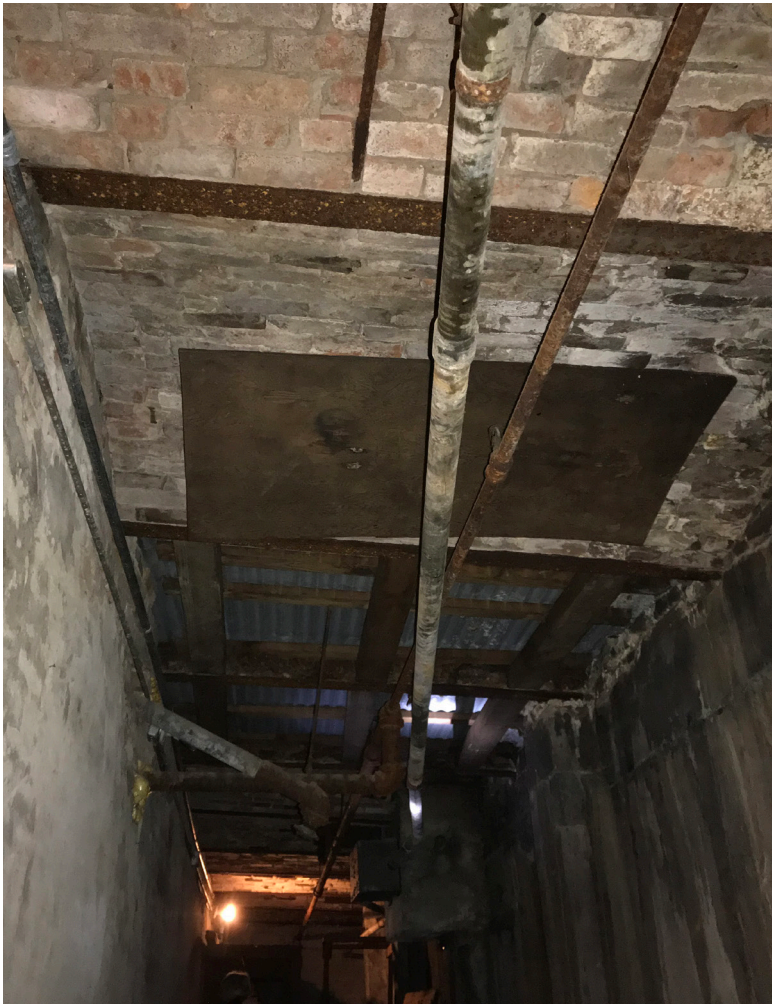
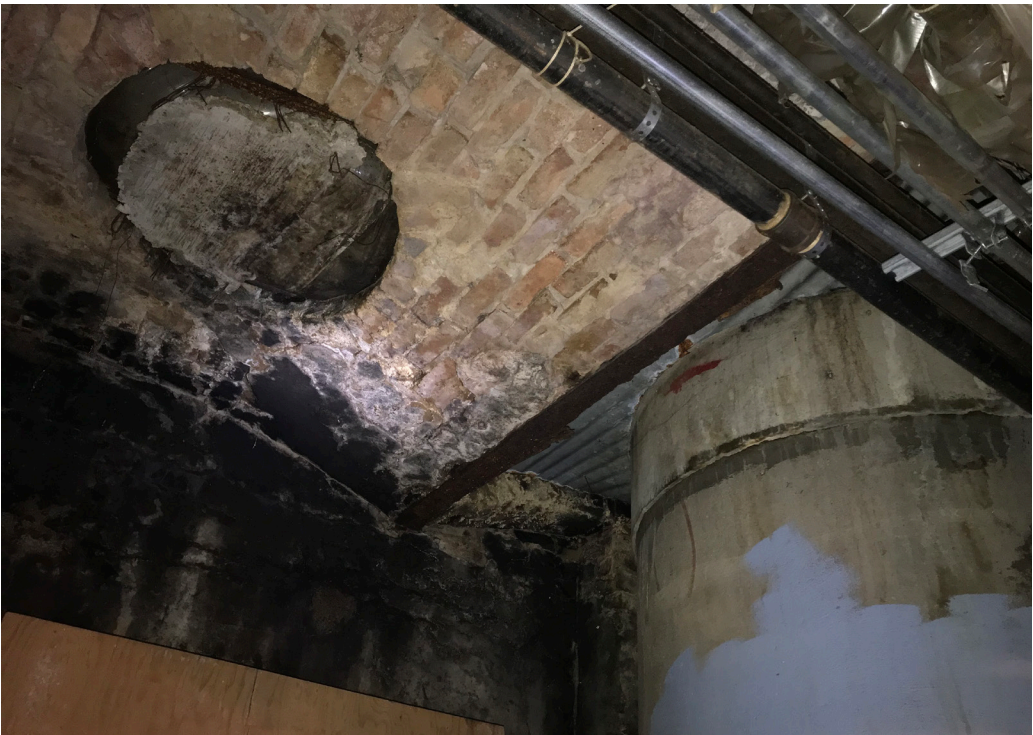
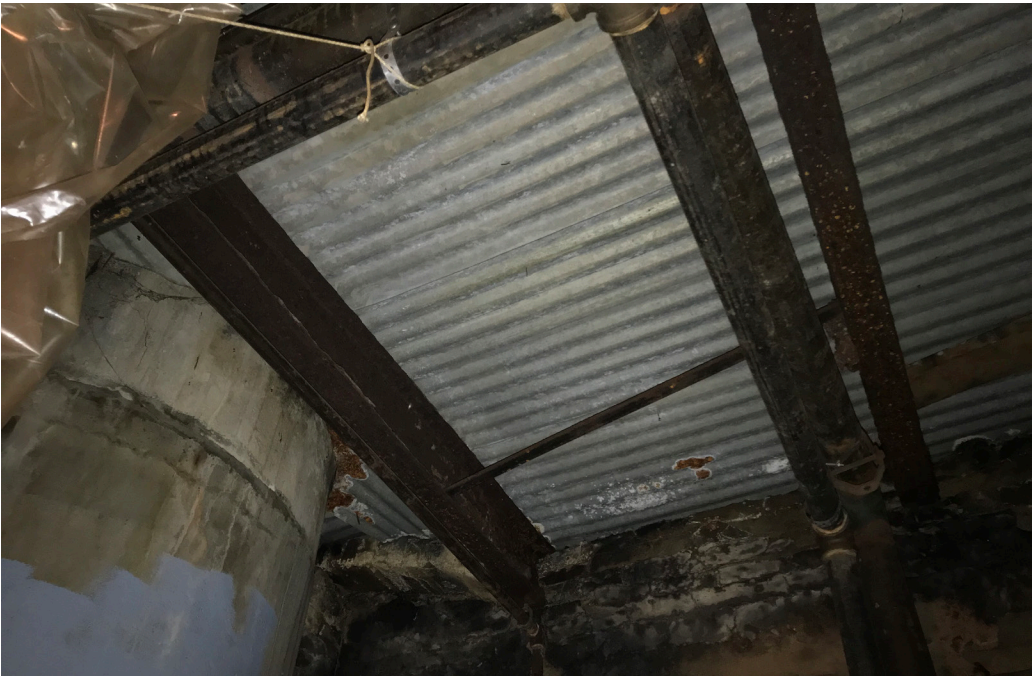
Condition within the grand central areaway is mixed.

- Some brick arches remain.
- Patches of concrete and corrugated metal are commom.
- At tree wells, brick arches were removed and replaced with concrete and corrugated metal.

A full inventory of conditions will be performed to determine where strengthening is required to support the sidewalk above and inhibit further deterioration of the areaway. Ventilation and water infiltration control will improve the lifespan of the existing areaway .

GRAND CENTRAL - AREAWAY CONDITION

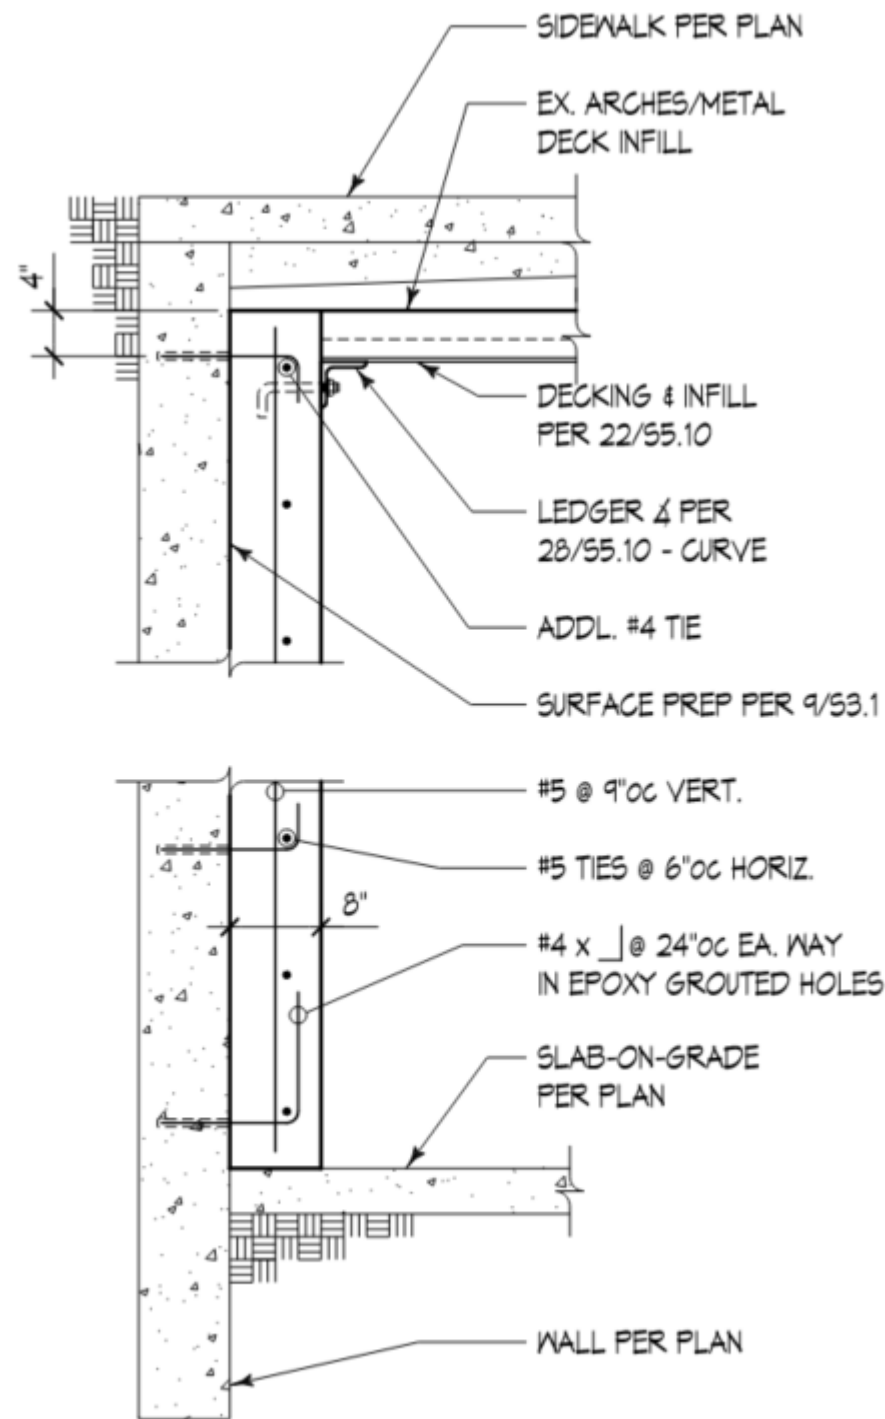
STRUCTURAL DETAIL 23/S5.10 FOR TREE WELL WALL REPAIR

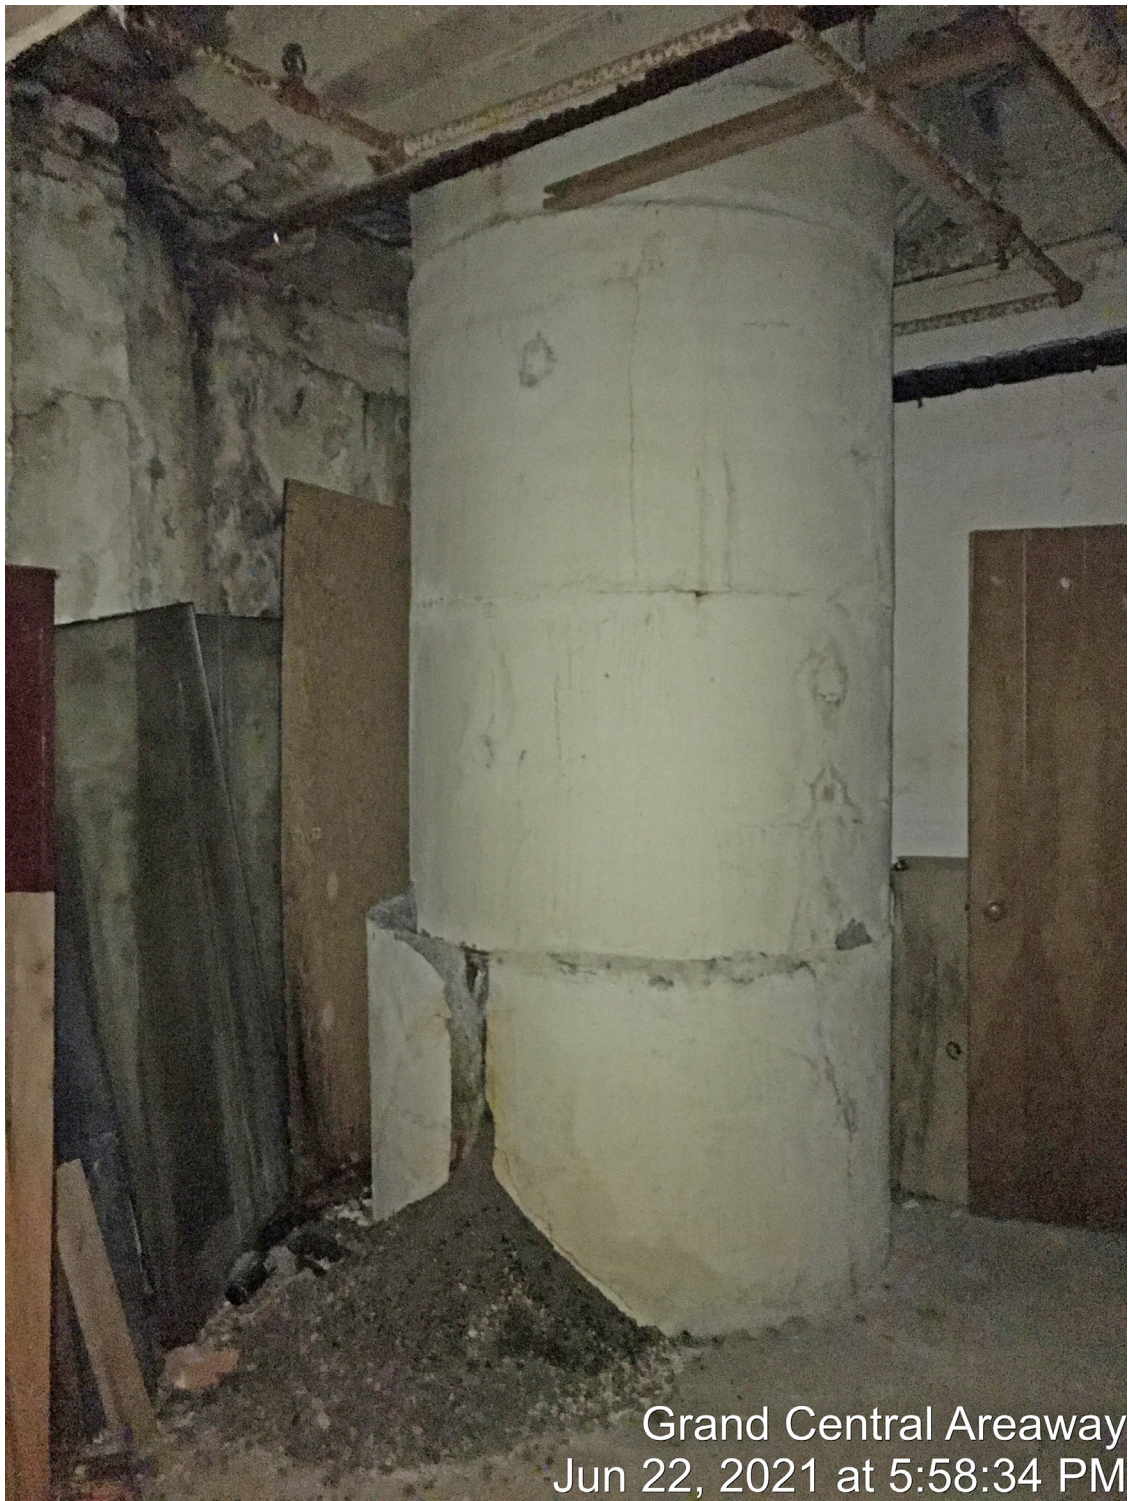
GRAND CENTRAL - DAMAGED TREE PIT

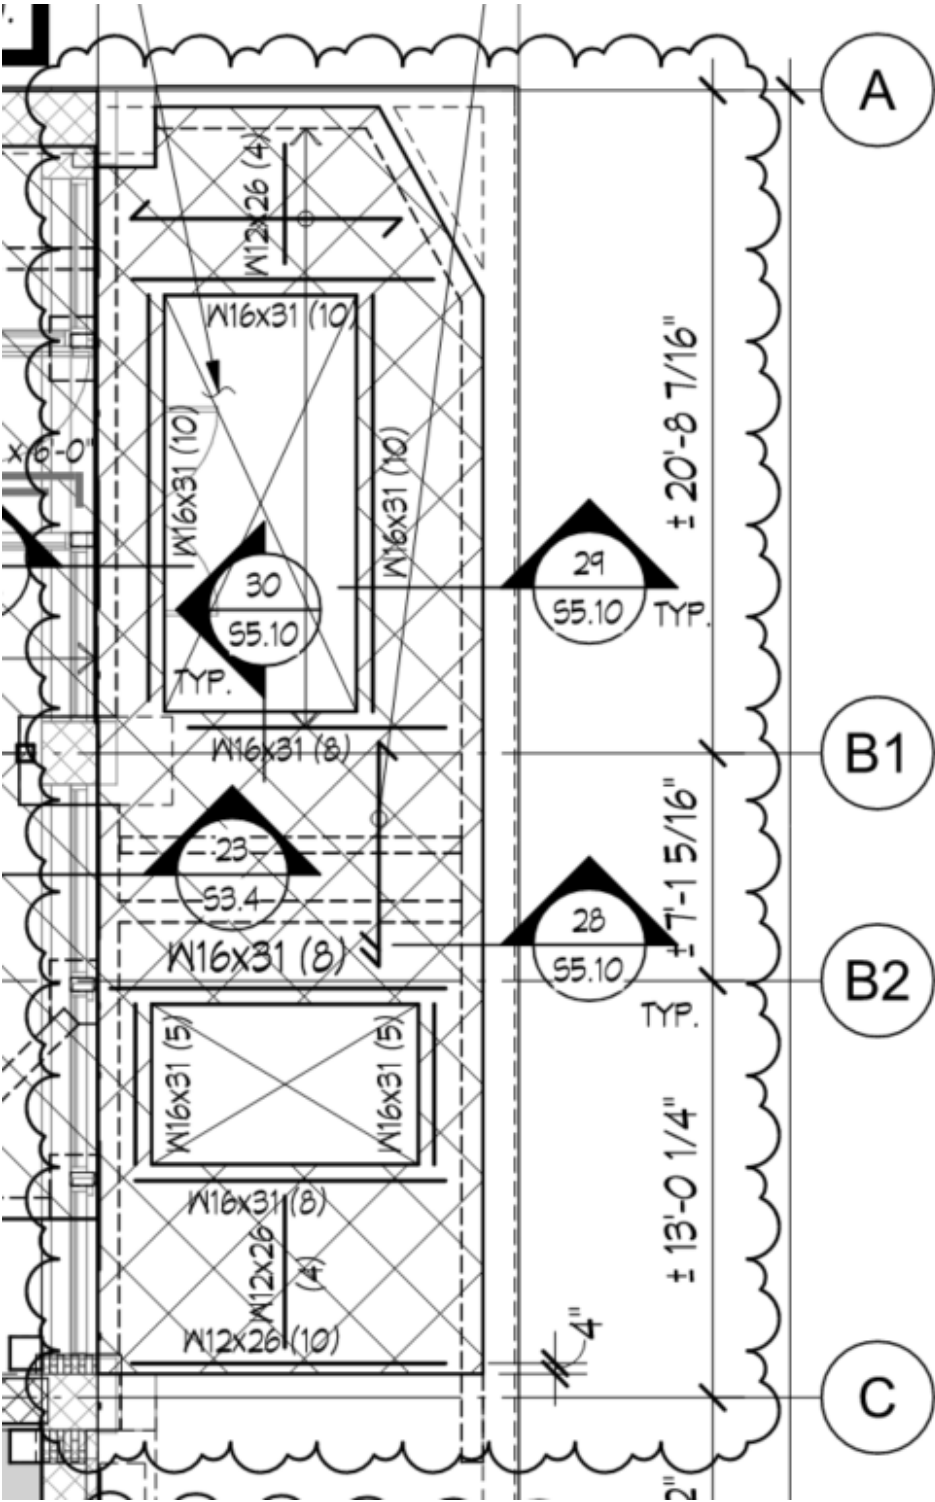
EXTENT OF SIDEWALK REPLACEMENT

We are coordinating with the Pioneer Square East-West streets project which has work in the same locations. We will match the existing sidewalk (shown in the picture to the right) or the approved sidewalk of the East West streets project.

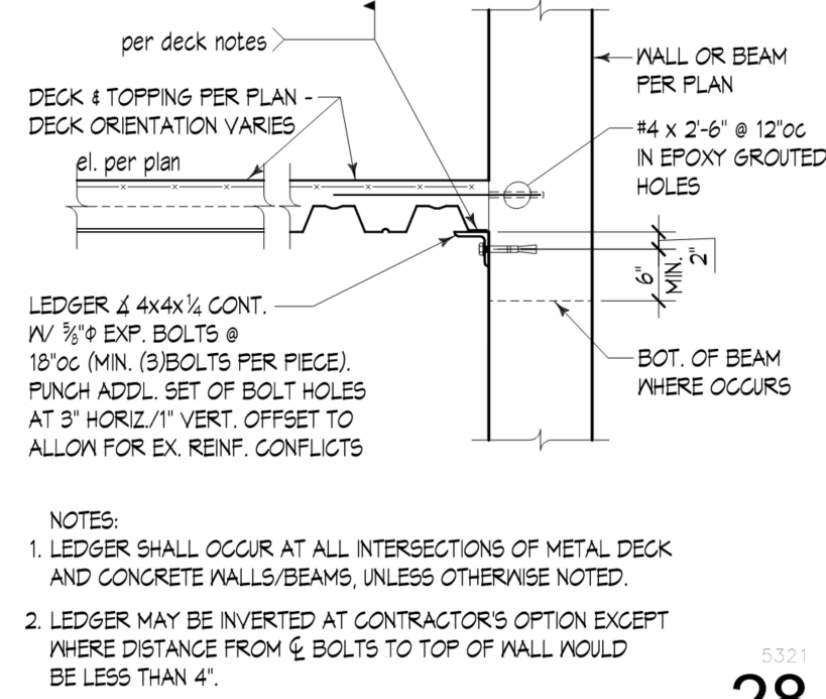
STRUCTURAL DETAIL OF SIDEWALK REPLACEMENT

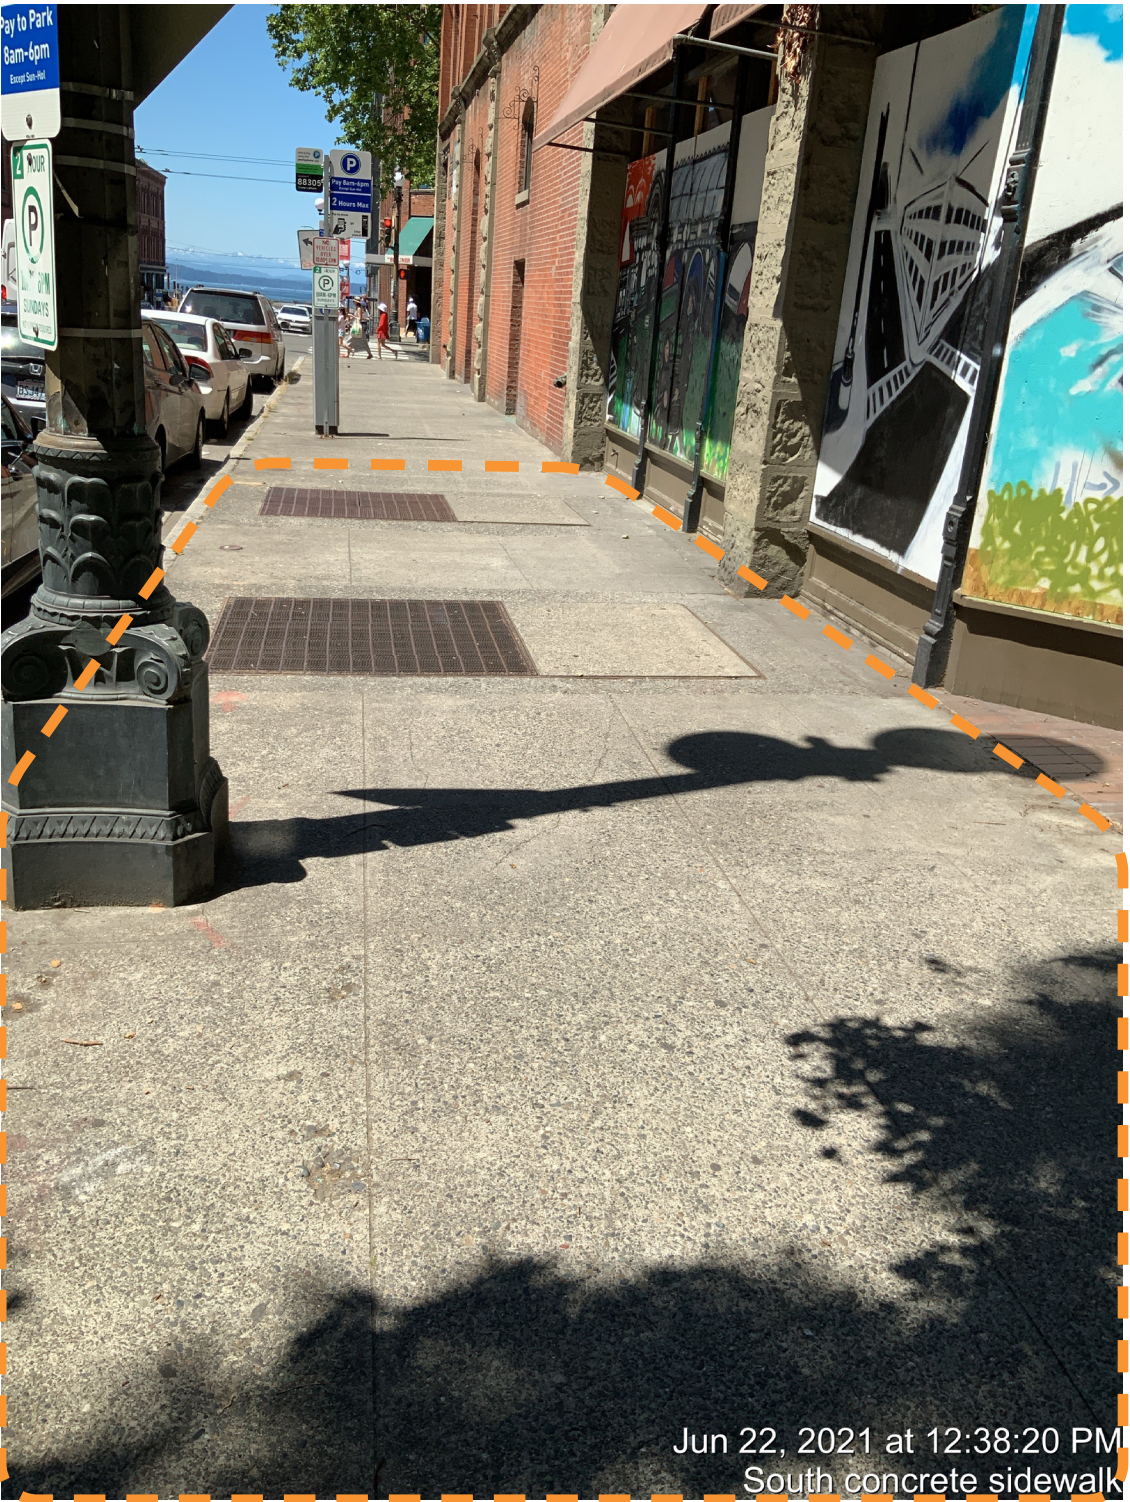
GRAND CENTRAL - DAMAGED TREE PIT

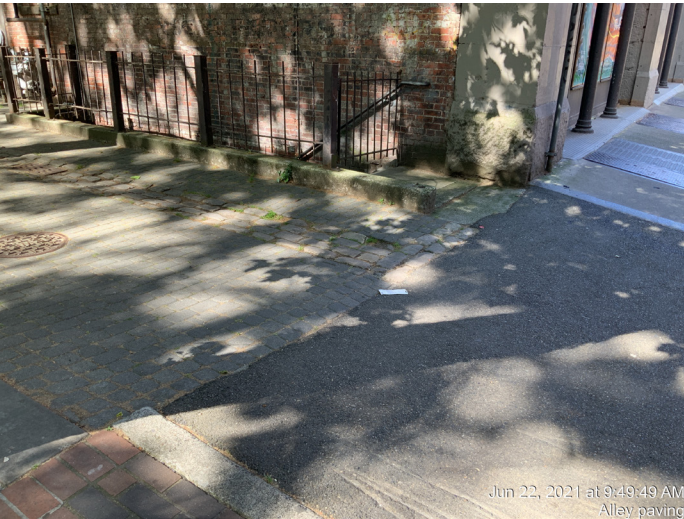
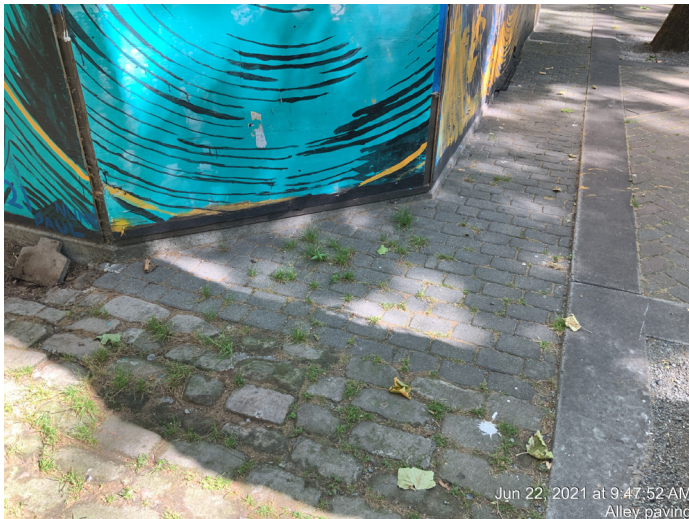
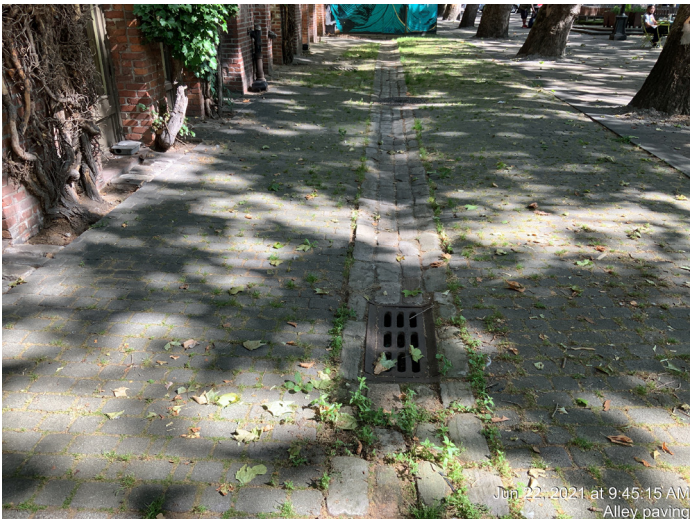
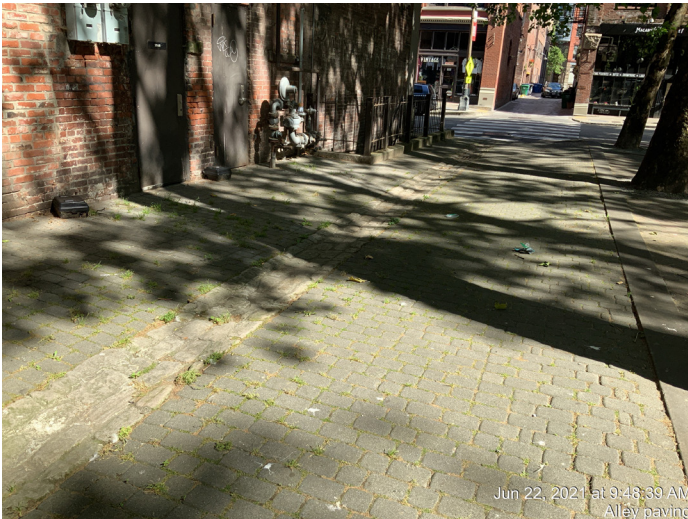
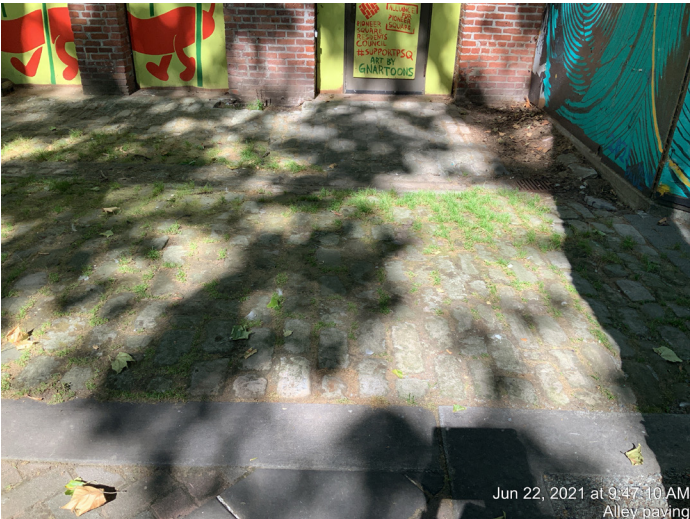
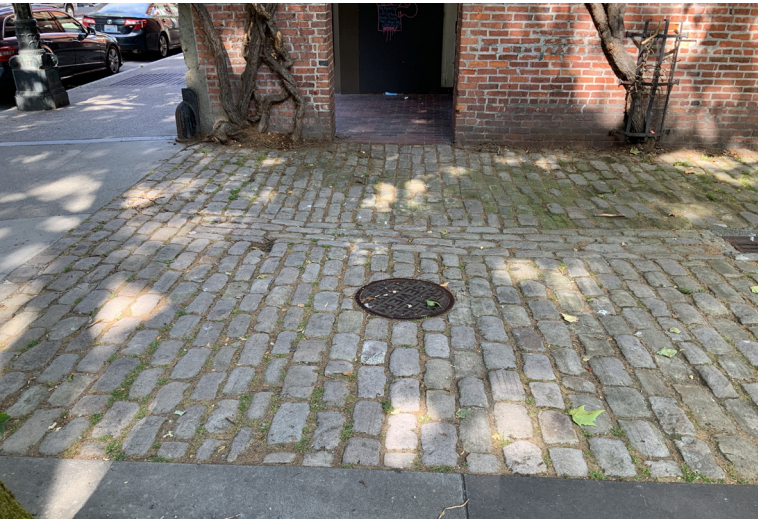
GRAND CENTRAL EXISTING ALLEY FINISH

- NOTES
- 1. The current paving is very uneven and does not allow for accessible use of the alley. Regrading for even surfaces is required.
 - 2. All non-cobblestone pavers date to the 1990s or later. Non-historic pavers will not be salvaged.

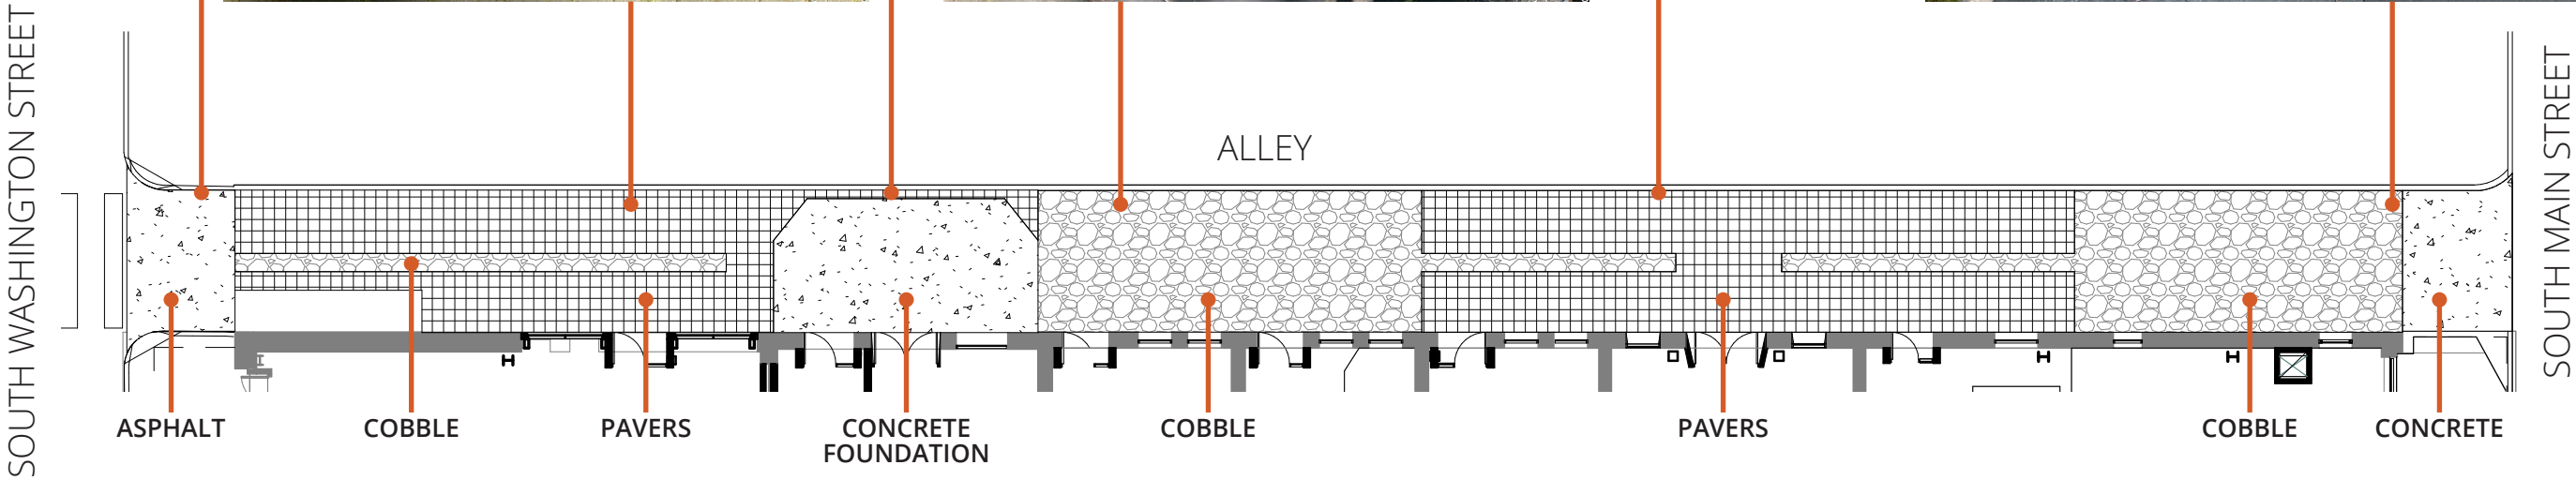
Alley Paver Plan

1. We used the Pioneer Square Alley Design Manual as our guide to coordinate with other improvements in Pioneer Square.
2. Historic cobble will be reused as shown to form a 1 foot wide border next to the building.
3. The majority of the alley will be a 50/50 mix of stone pavers and brick pavers. The mix will feather towards more brick near the building and more stone near the park.
4. An 80/20 mix of brick pavers to stone pavers will be used at the main entries to the arcade and to the office lobby. The mix will still feather to more stone near the park.
5. The boundaries of all zones will be blurred by mixing the pavers together.
6. All pavers will be the preferred Pioneer square paver materials (see materials to right). There are no existing bricks in the alley so new red brick pavers will be used near the buildings.

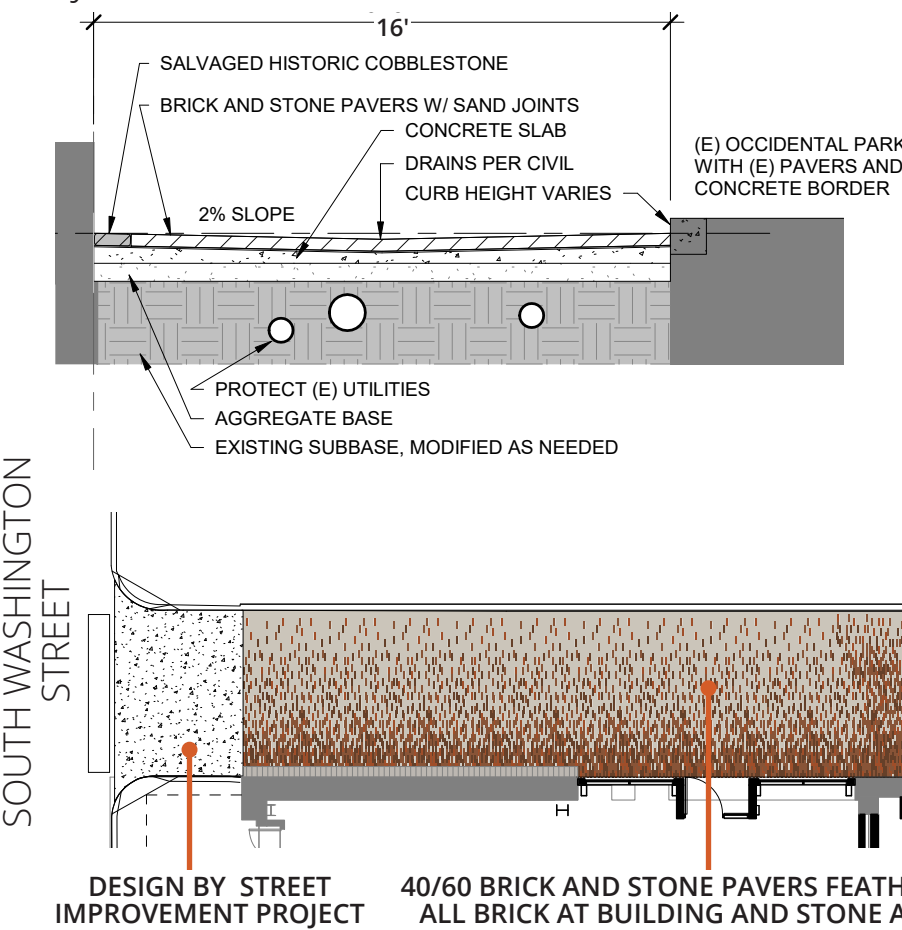
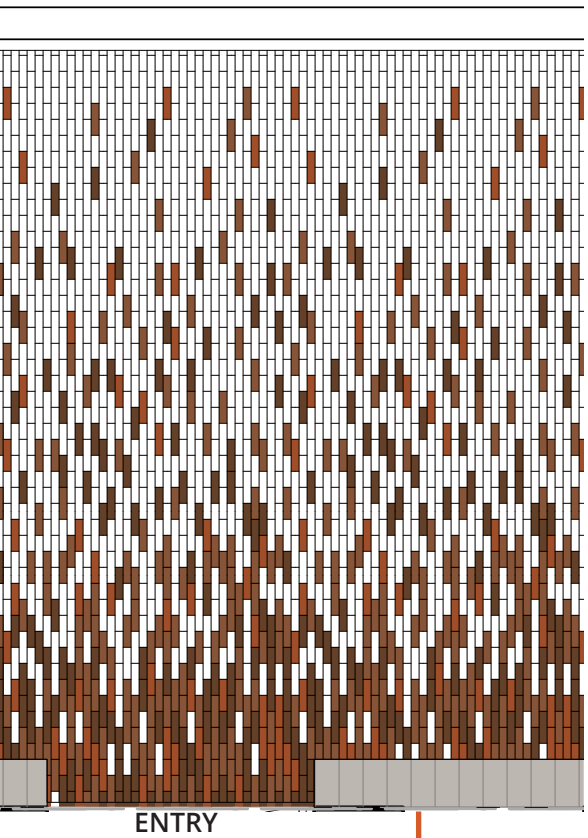
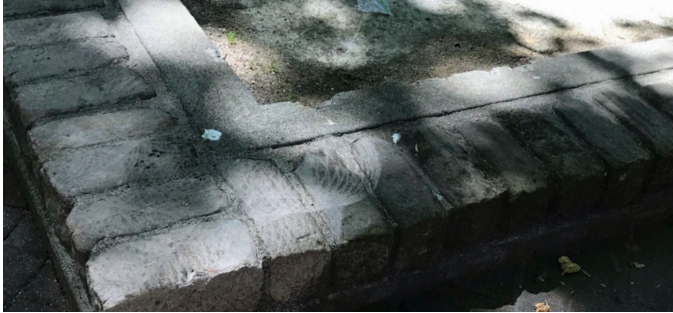
Historic Cobblestone Plan

Historic cobble will be carefully salvaged prior to any other alley work.

The remaining cobble will be provided to the SDOT material yard. The east west streets project will be notified and a hold will be placed on the cobble for reuse as retaining walls and other trim. See photo below for example of cobble reuse as wall. Photo taken in Occidental Park.
