### **PSPB COA PROPOSAL - CORRECTIONS**

# **GRAND CENTRAL BLOCK** BRUNSWICK-BALKE-COLLENDER CO + GOTTSTEIN + SQUIRE LATIMER

200 S 1ST ST, Seattle, WA 98104

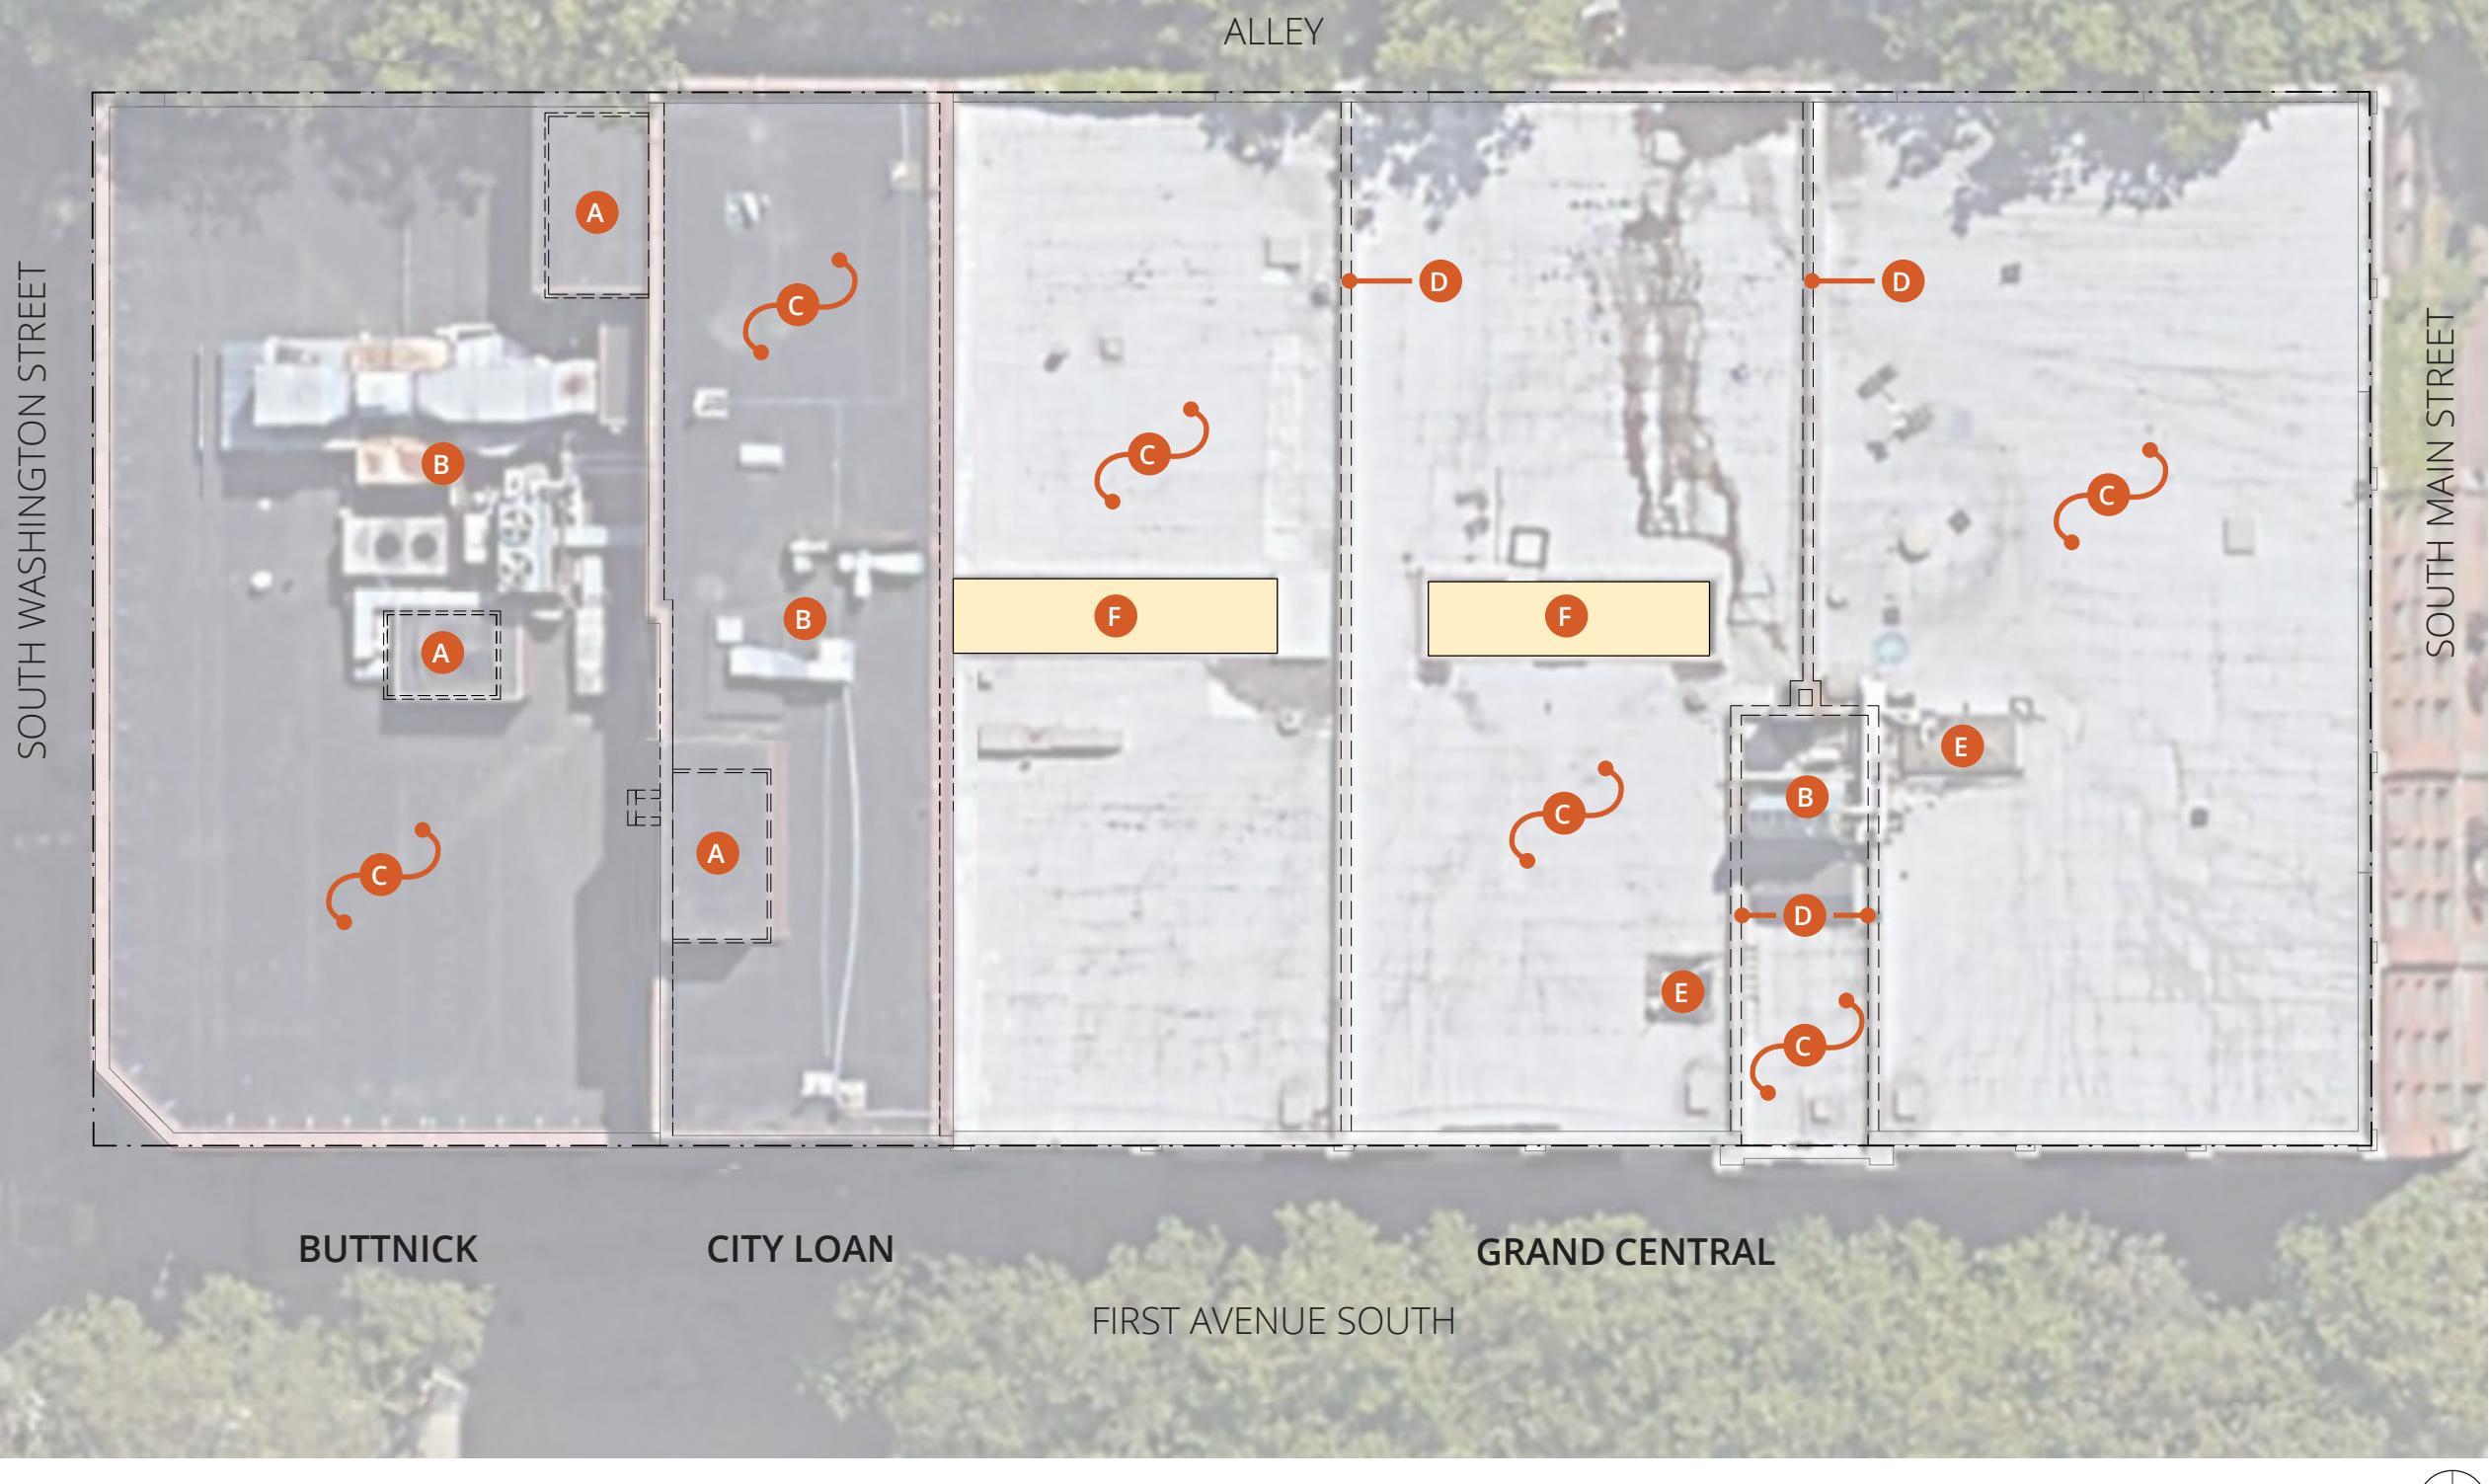
### **ROOF PLAN**

The plans stated that the coverage is 53% which is over the 50% allowed in the code for use as an office or residential penthouse. SMC 23.41.012 lists measurements and maximum size of use as items that are not departable. (Staff Report 8/5/2020)

### The penthouse has been reduced to 50% roof coverage.

- A Light gray TPO roof
- B Mechanical
- C Occupied roof deck
- D Elevator overrun
- E Light well to remain

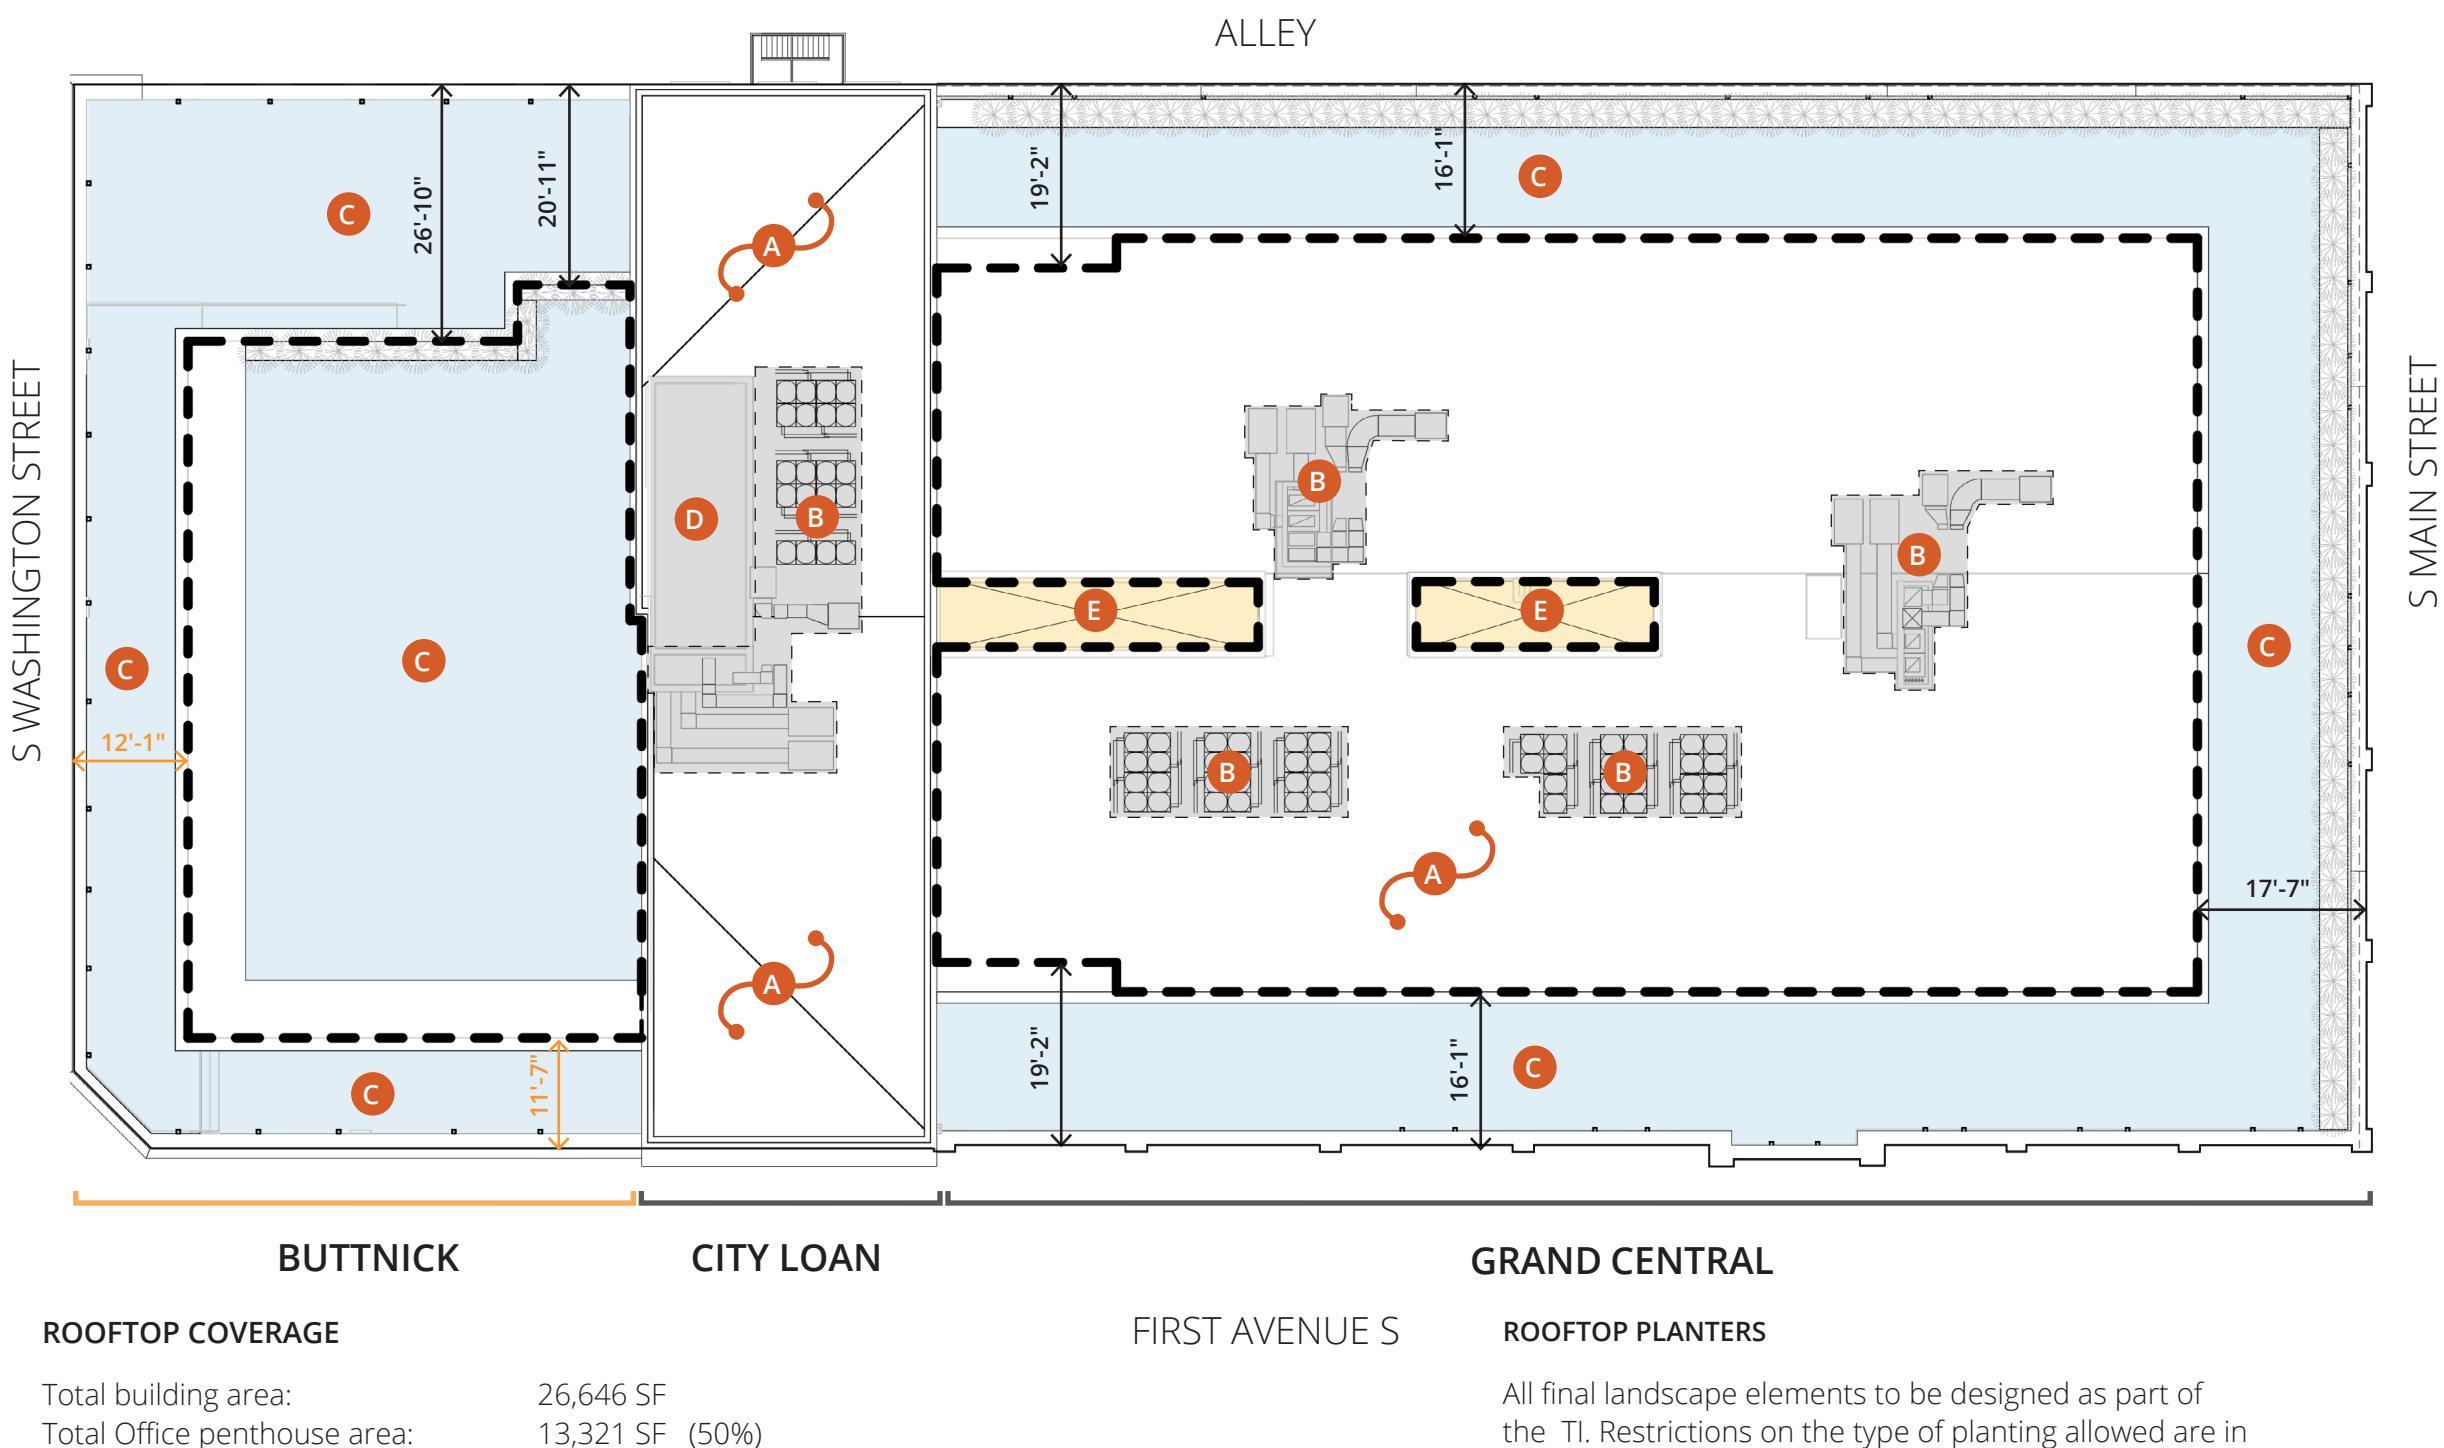
Total Elevator penthouse area:

Total Mech penthouse area:

321 SF (1%)

1,482 SF (6%)

place due to weight limitations. The plants are limited to groundcover, low plants, and grasses. Trees and shrubs are not supported by the rooftop planters and are not allowed.

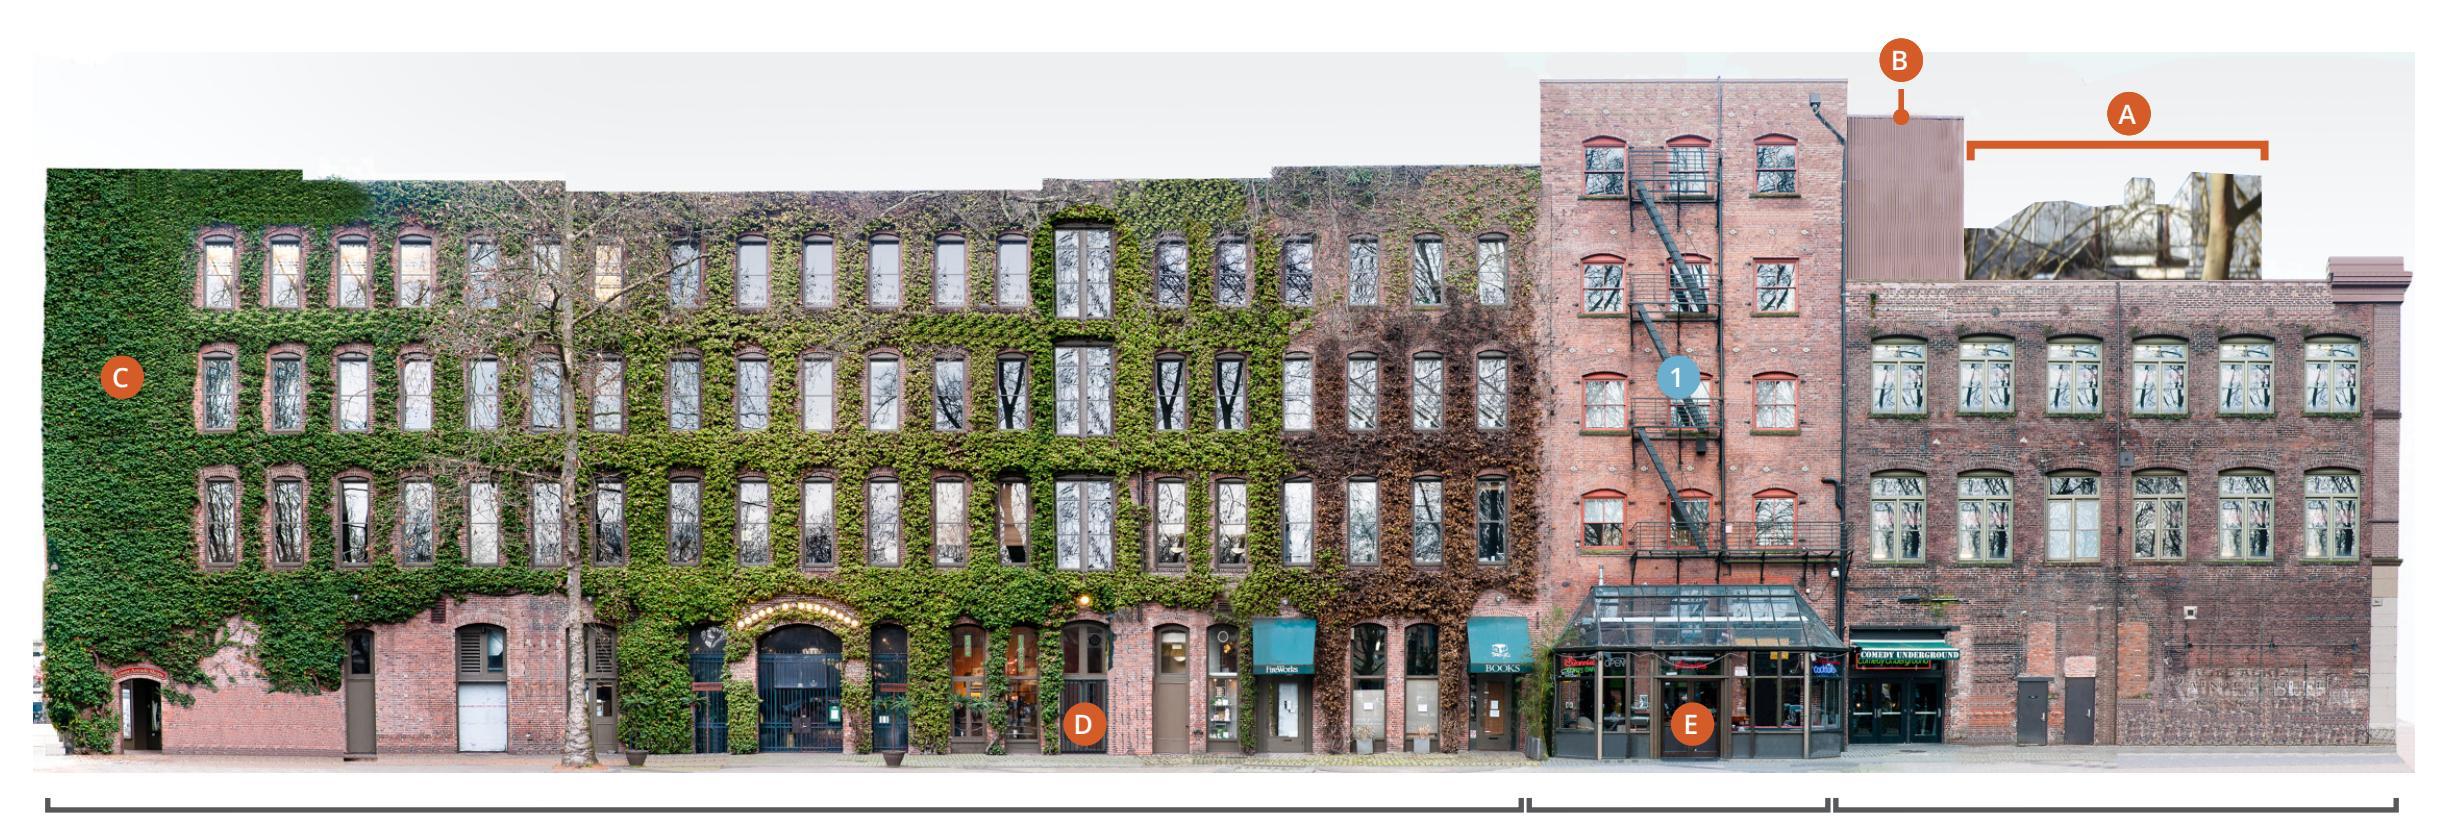
East Elevation - Exterior View From Occidental Square

- A Remove rooftop mechanical
- B Remove stair enclosure
- C Remove Ivy and repair brick underneath
- D Remove existing storefront typ.
- E Remove metal and glass green house to full extent

A full survey of the extent of brick repair cannot be completed until all ivy is removed from the building. Salvaged brick from the building will be used when individual bricks need replacement if the salvaged brick is a good match. Brick color varies for each building and for different elevations. If appropriate salvage brick is not available a new brick in the appropriate color and finish will be used and cut to fit the repair location.

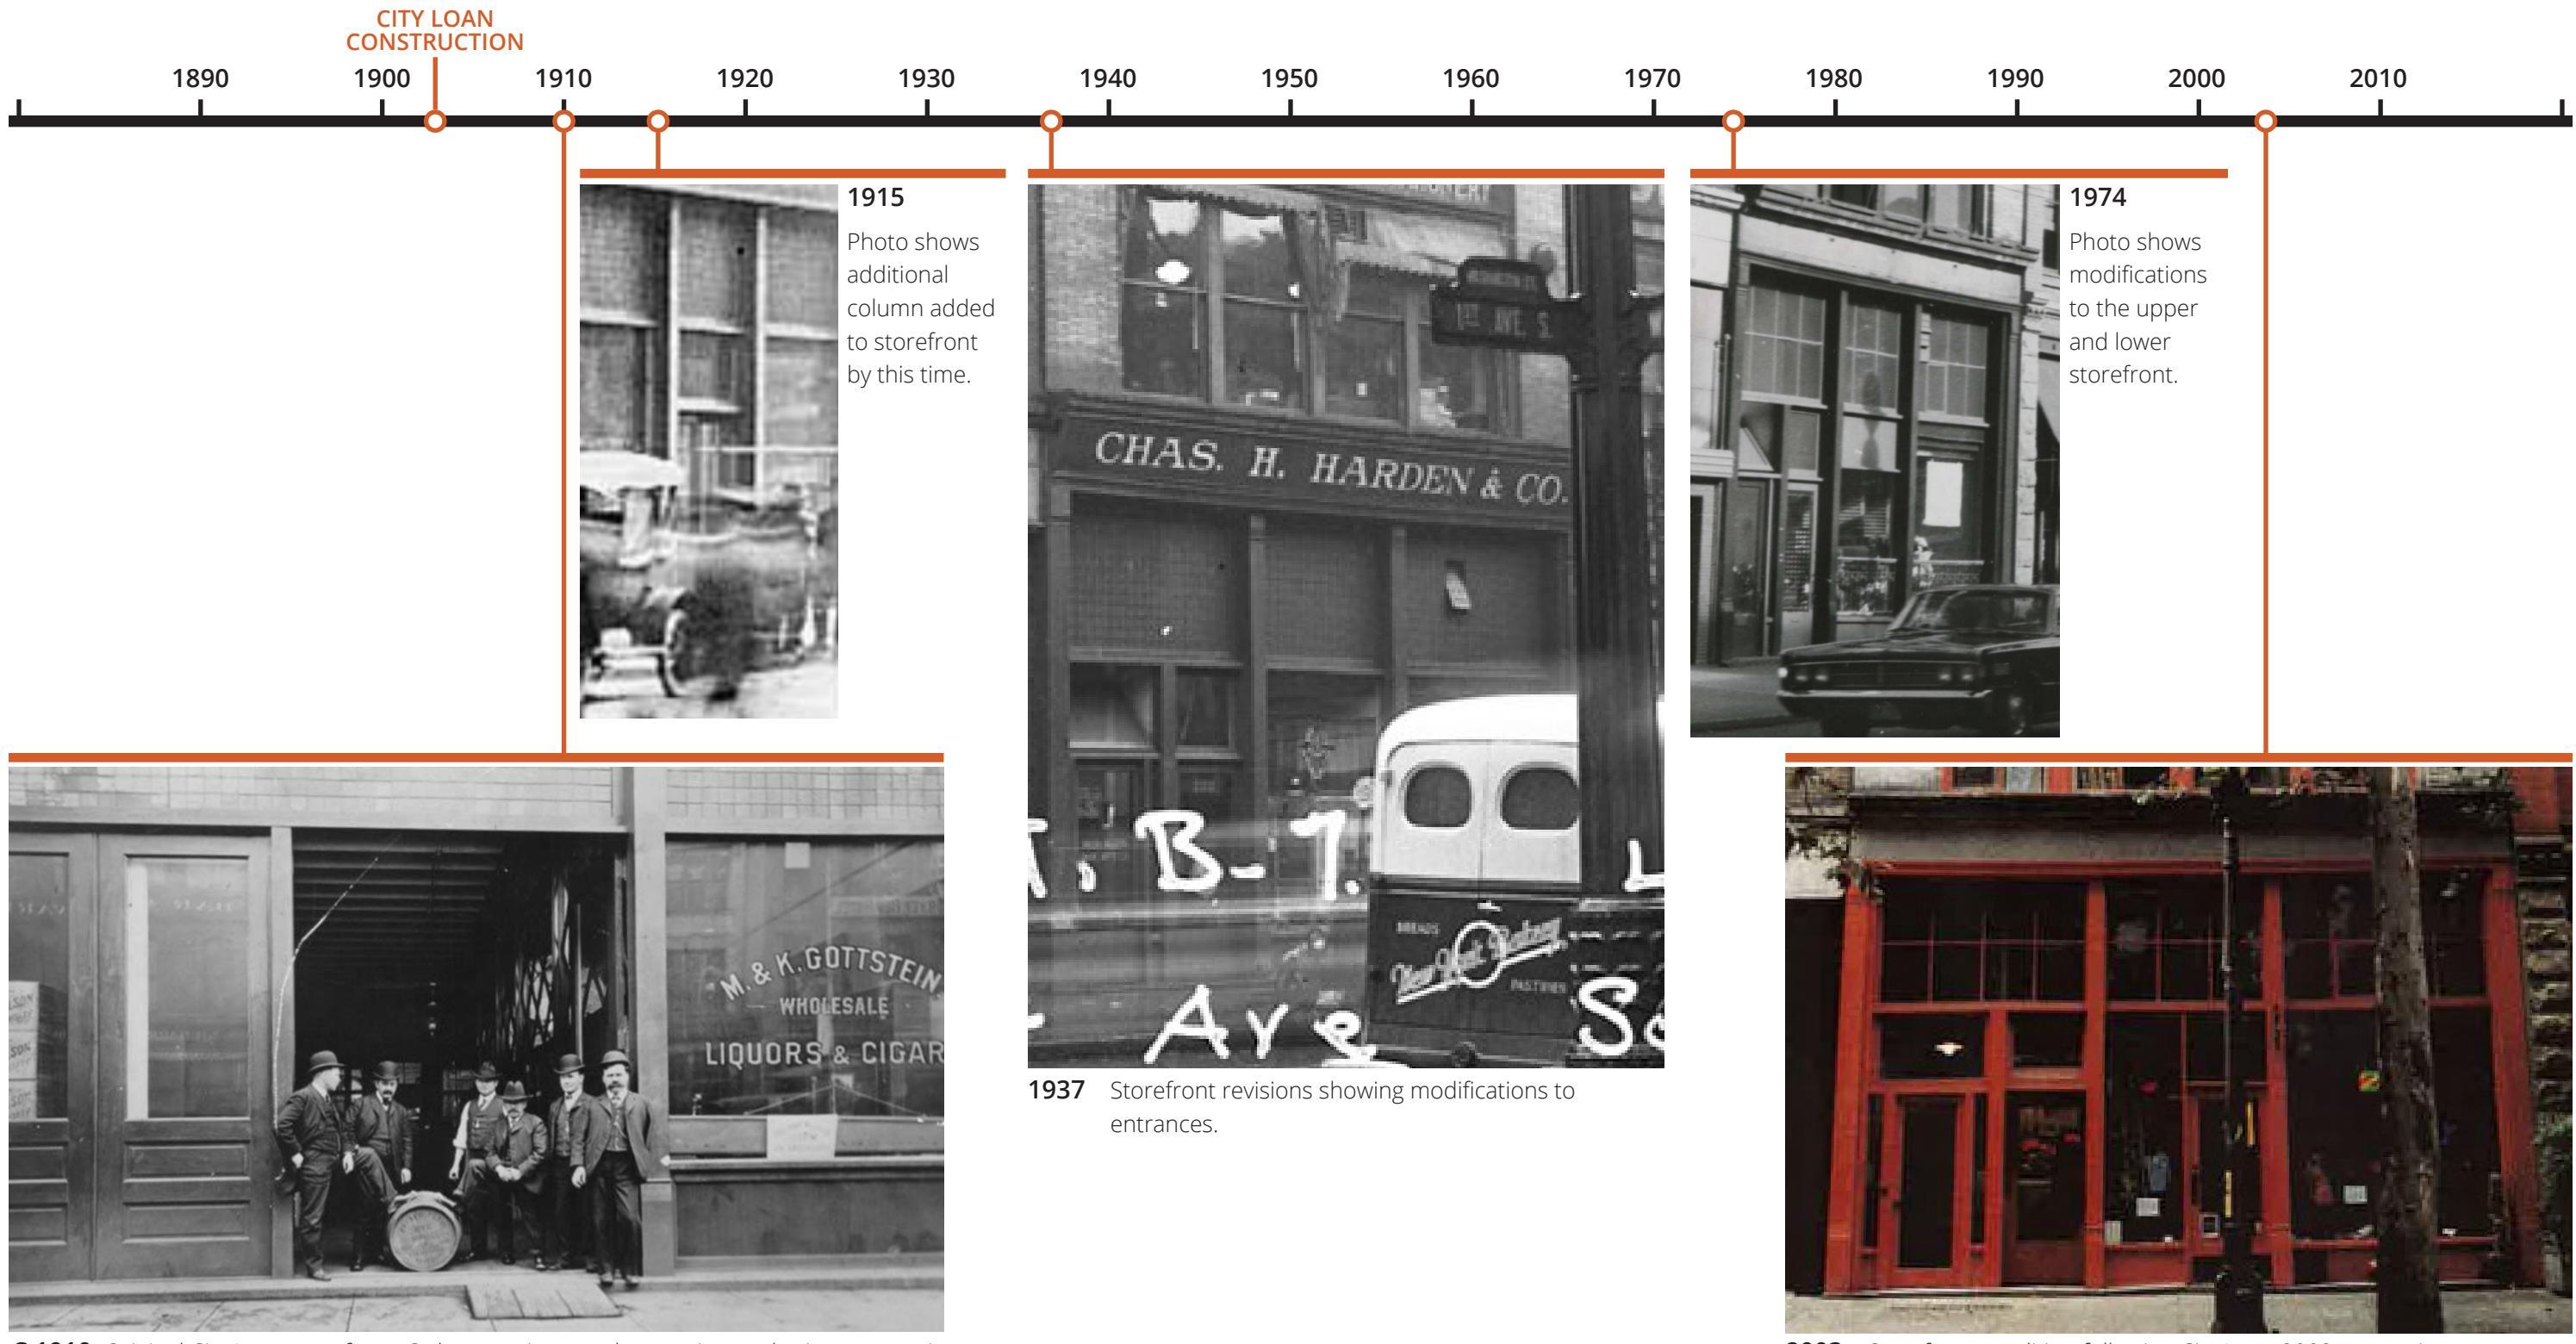
### CITY LOAN STOREFRONT - NOT ORIGINAL

**C.1910** Original City Loan storefront. Only one primary column exists and primary entry is in the center.

2003 Storefront condition following City Loan 2002 renovation.

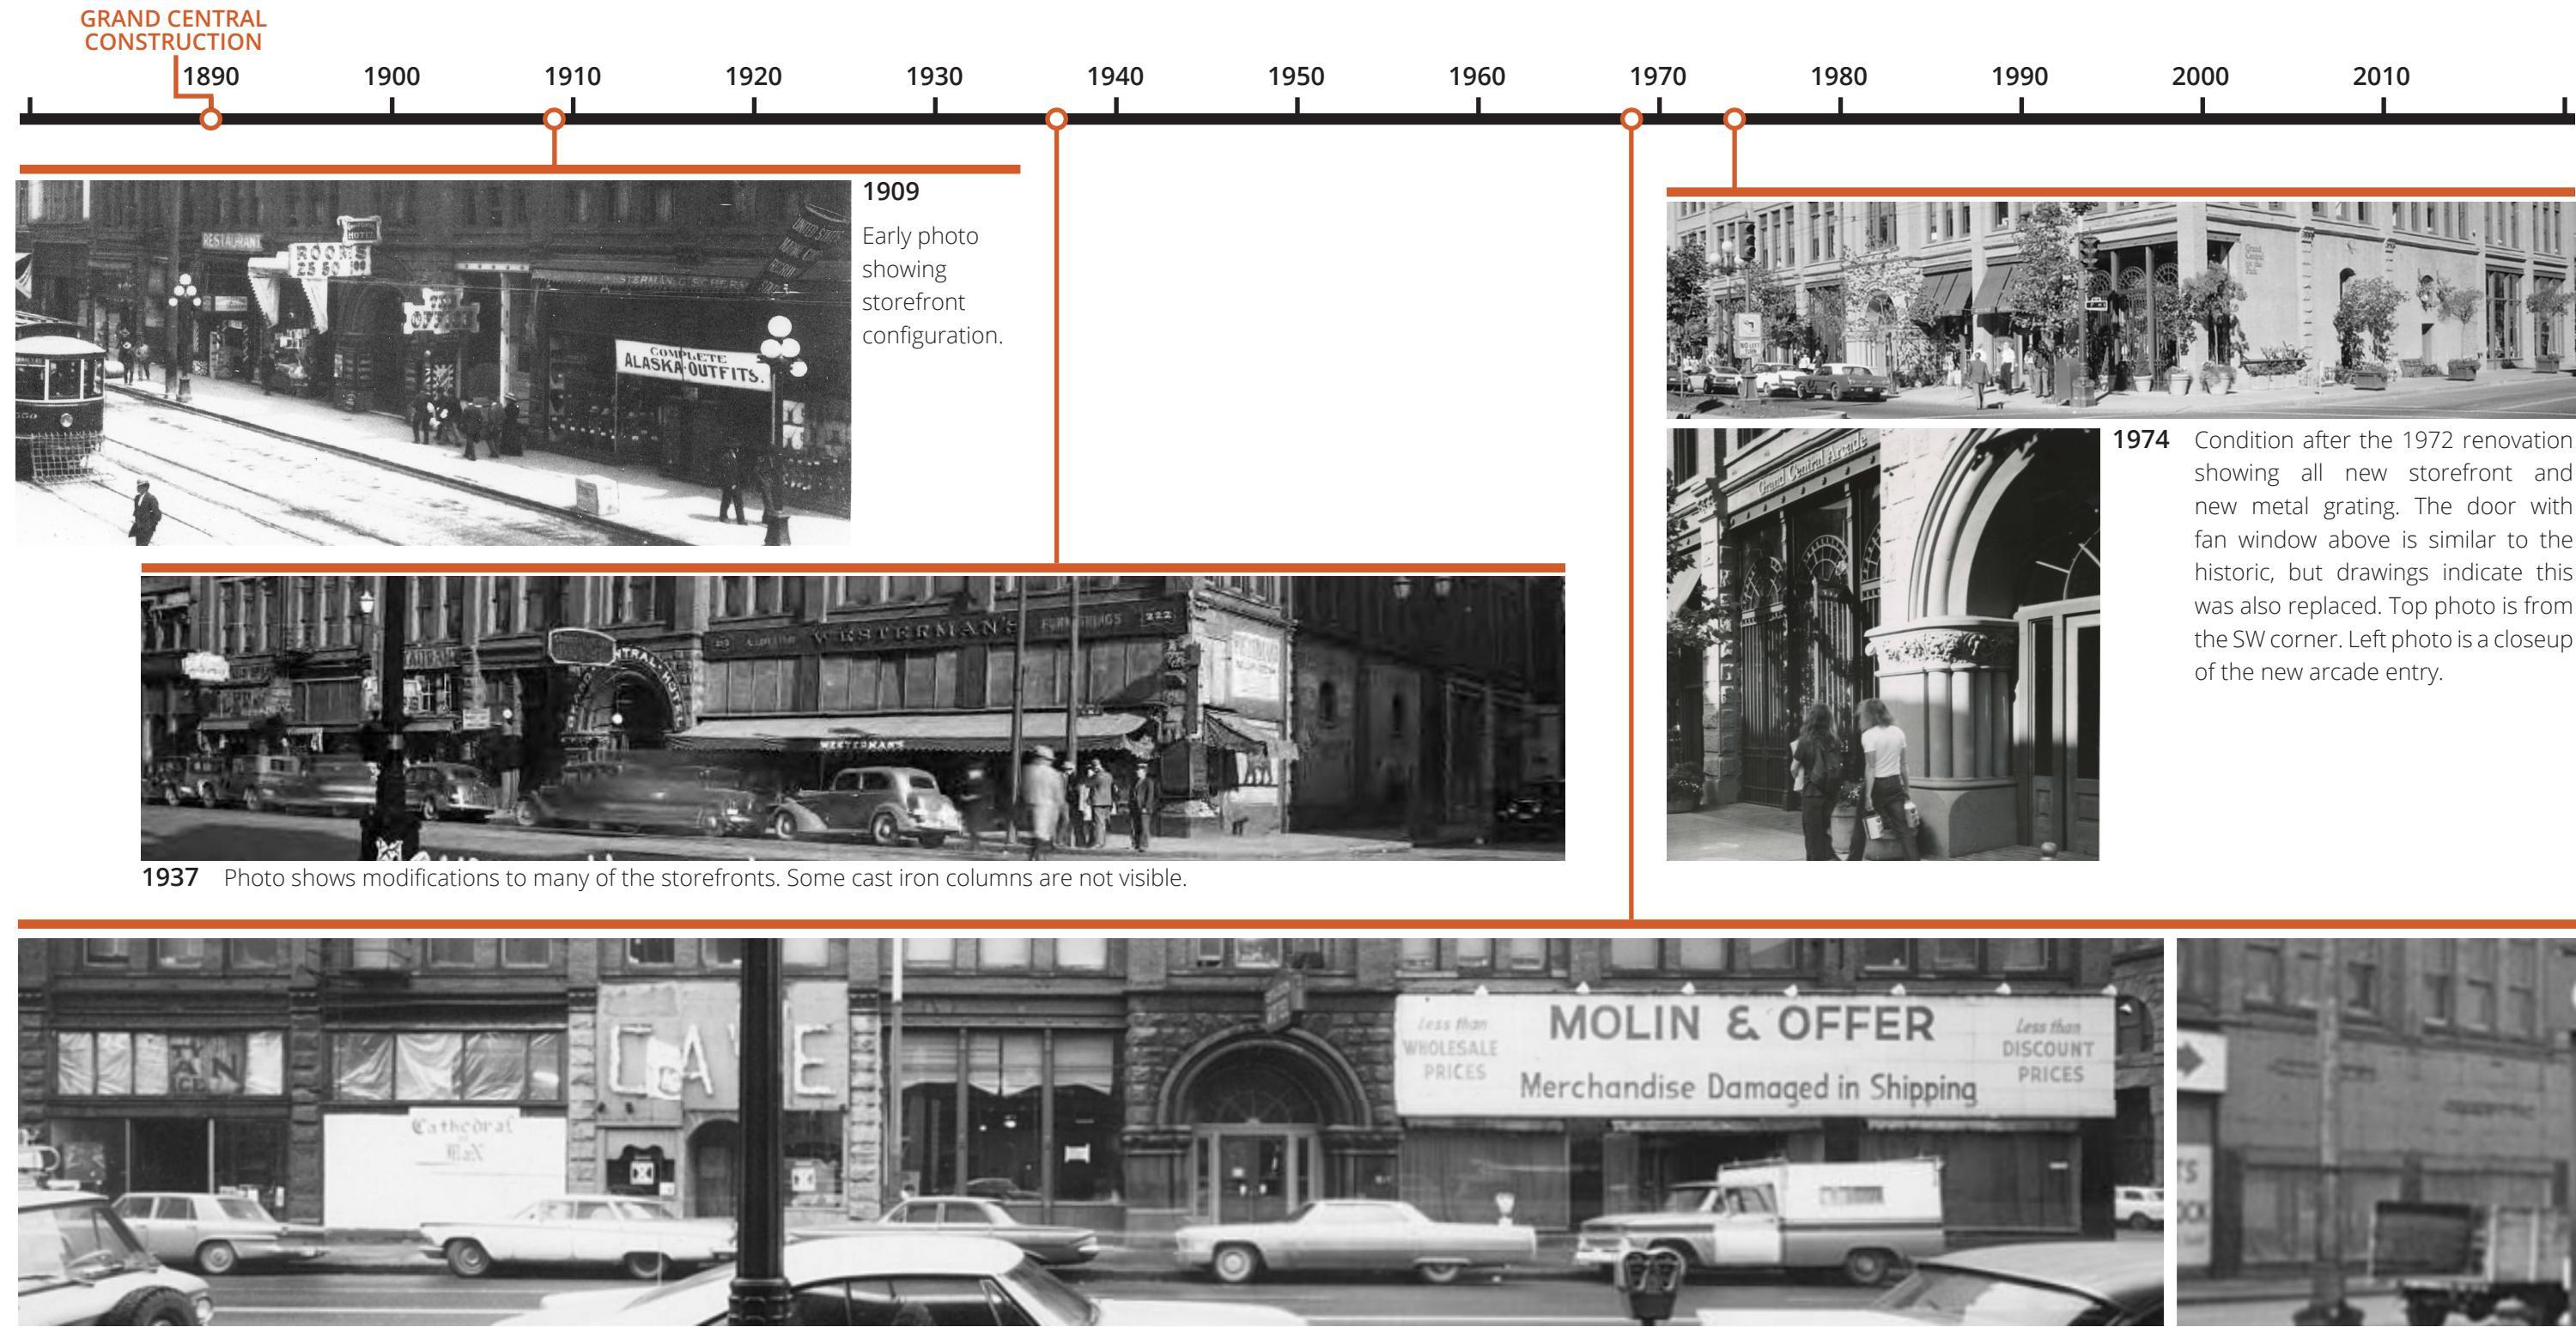
## **GRAND CENTRAL STOREFRONT - NOT ORIGINAL**

**1969** Condition of ground floor storefront prior to 1972 building renovation. Photos shown of the full West elevation and eastern South elevation.

**1974** Condition after the 1972 renovation showing all new storefront and new metal grating. The door with fan window above is similar to the historic, but drawings indicate this was also replaced. Top photo is from the SW corner. Left photo is a closeup

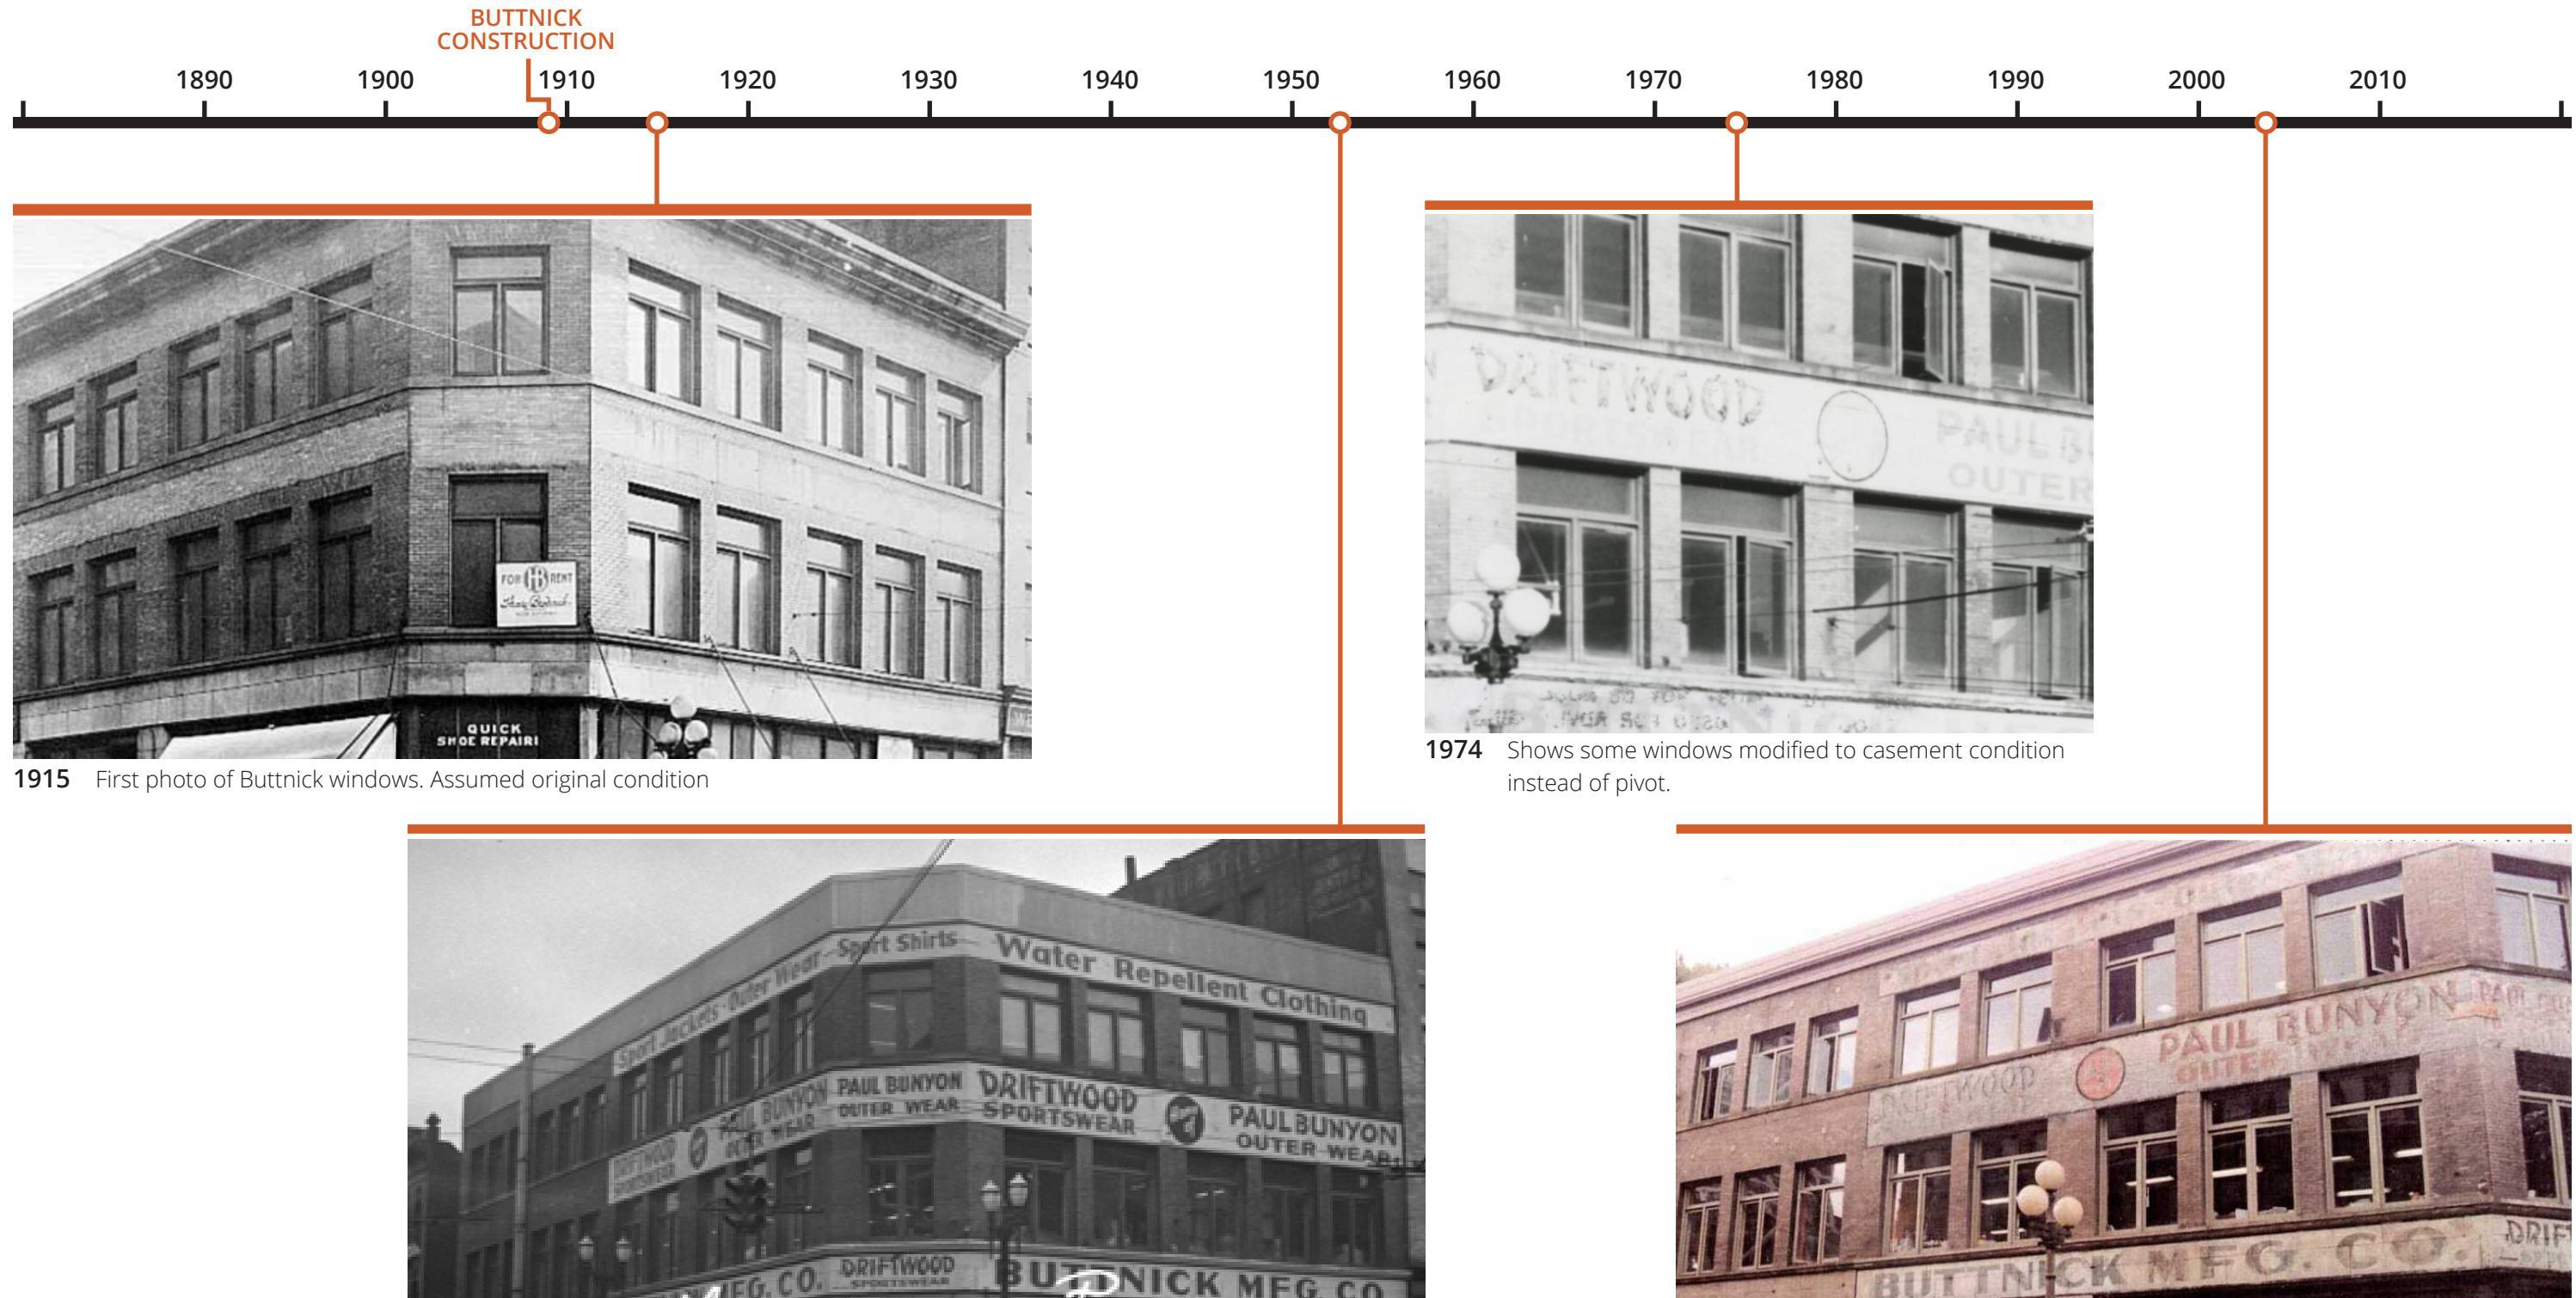
# **BUTTNICK WINDOWS - NOT ORIGINAL**

**1952** Reconstructed Buttnick windows after the 1950 gas explosion in basement and associated upper floor fire.

**2003** Shows windows that were modified in the 2002 renovation project.
