### **PSPB COA PROPOSAL - CORRECTIONS**

# **GRAND CENTRAL BLOCK** BRUNSWICK-BALKE-COLLENDER CO + GOTTSTEIN + SQUIRE LATIMER

200 S 1ST ST, Seattle, WA 98104

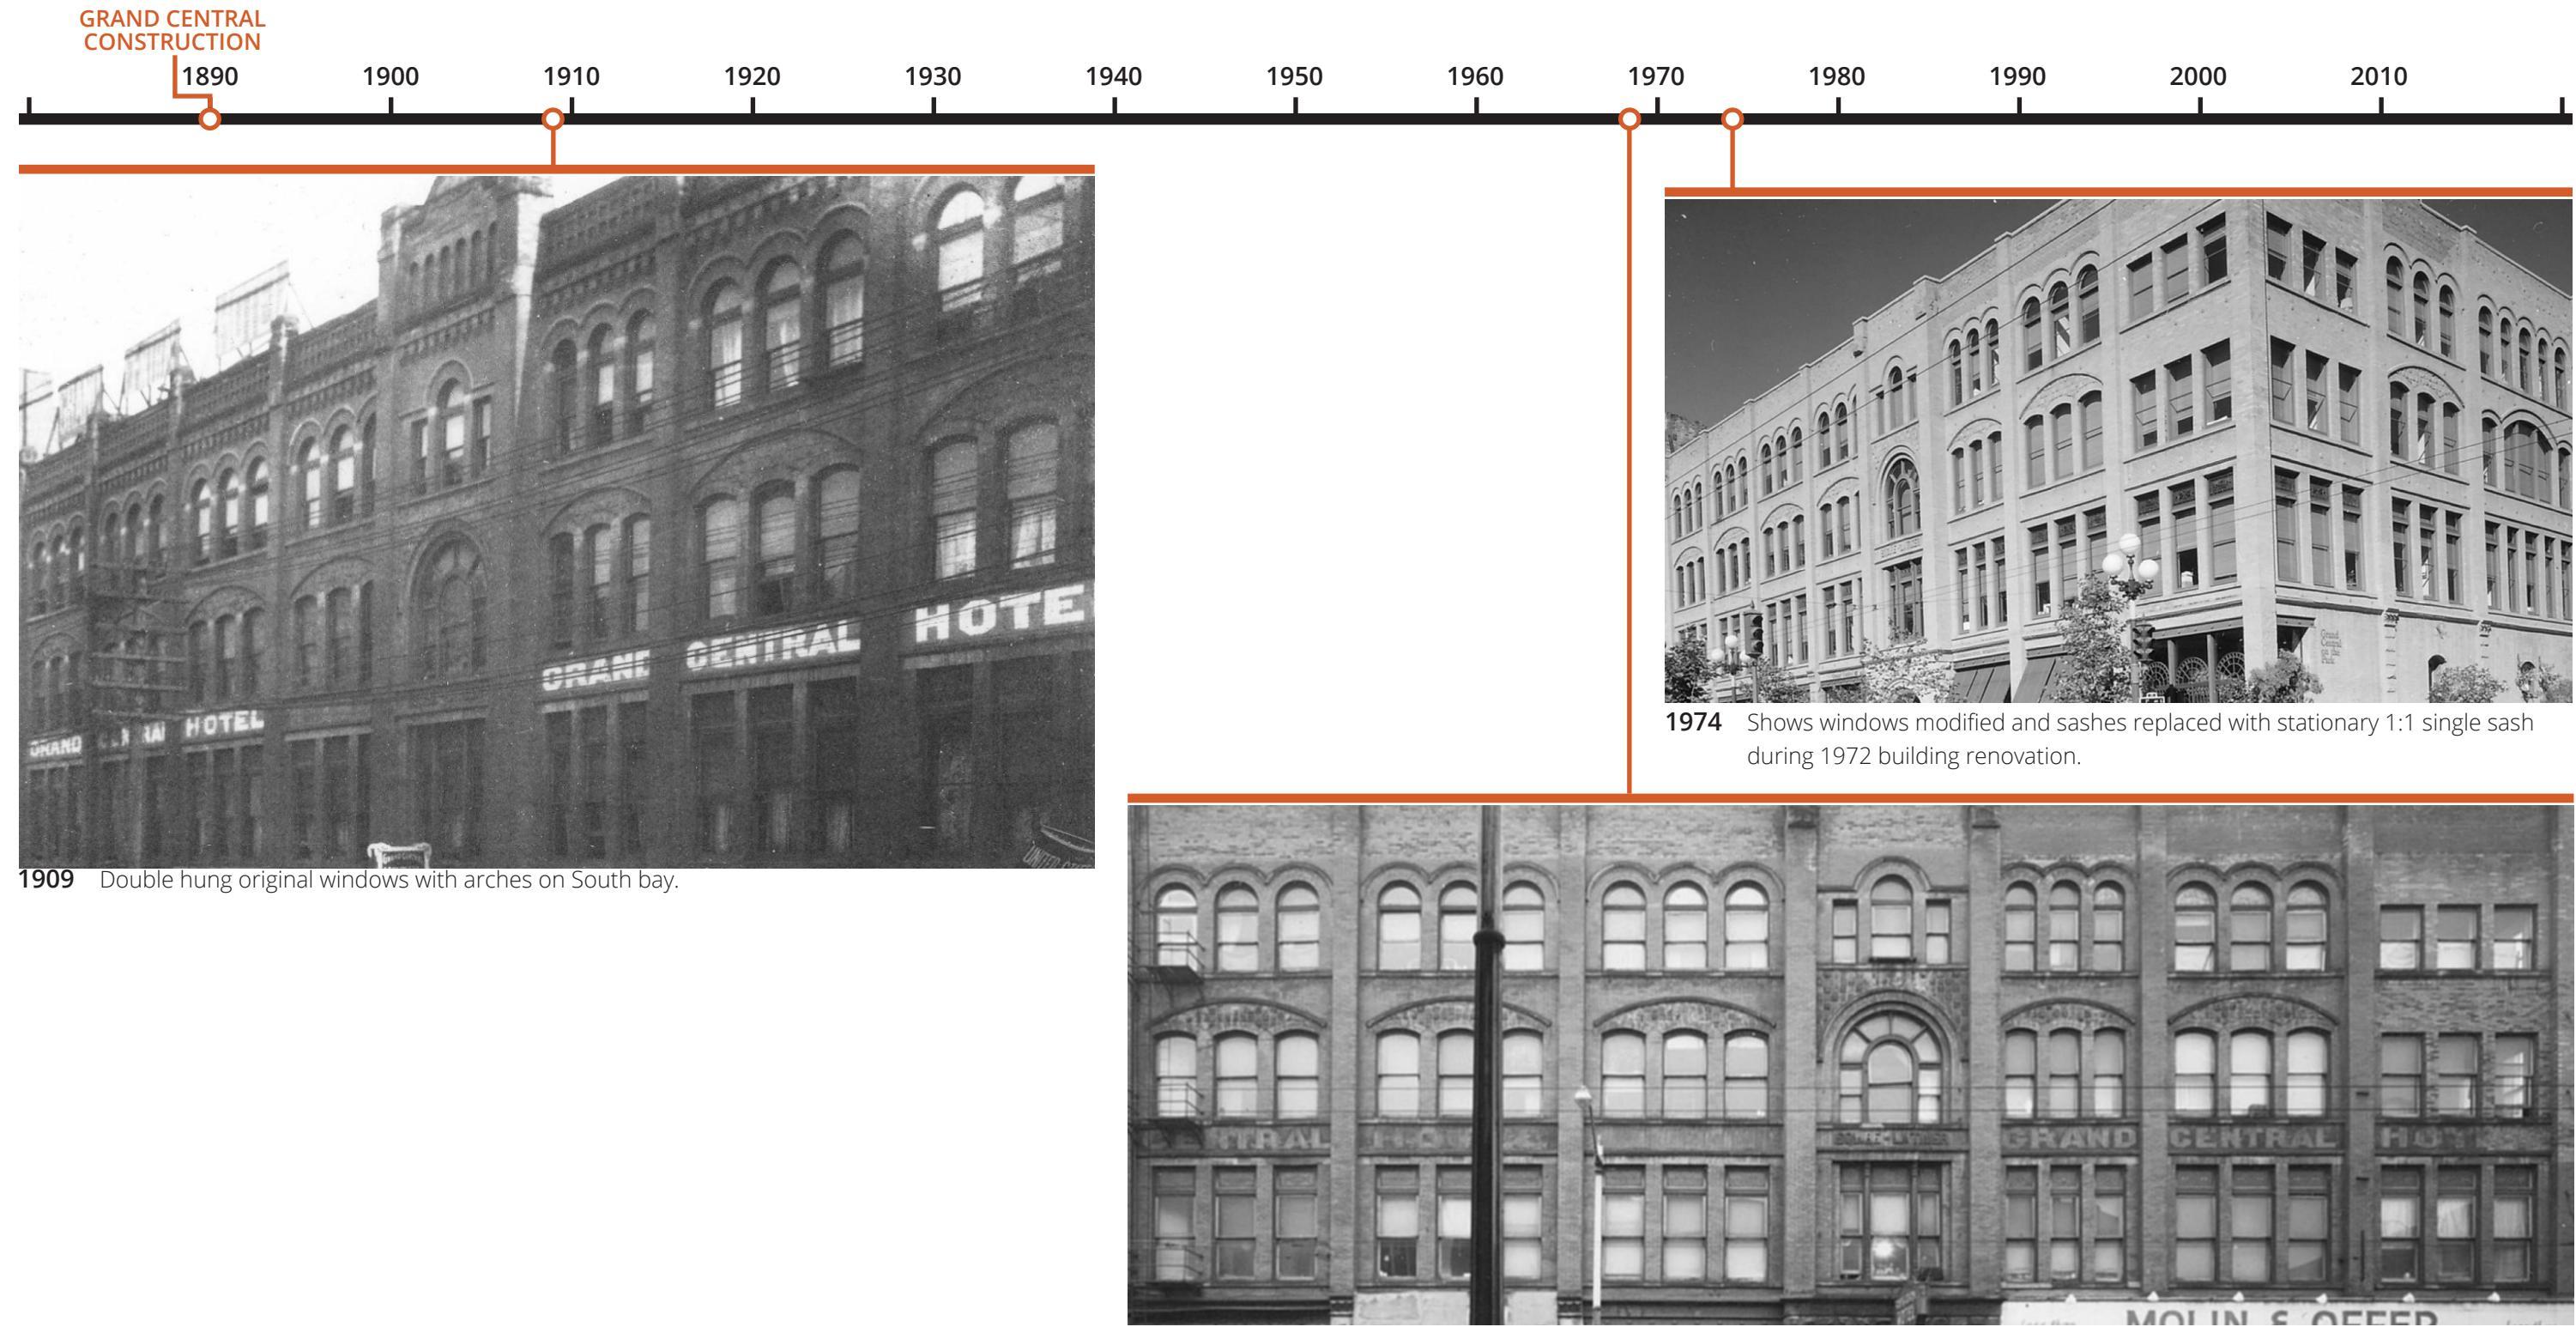
# **GRAND CENTRAL WINDOWS - NOT ORIGINAL**

**1969** Double hung windows in poor condition with crooked sashes and arches missing on South bay.

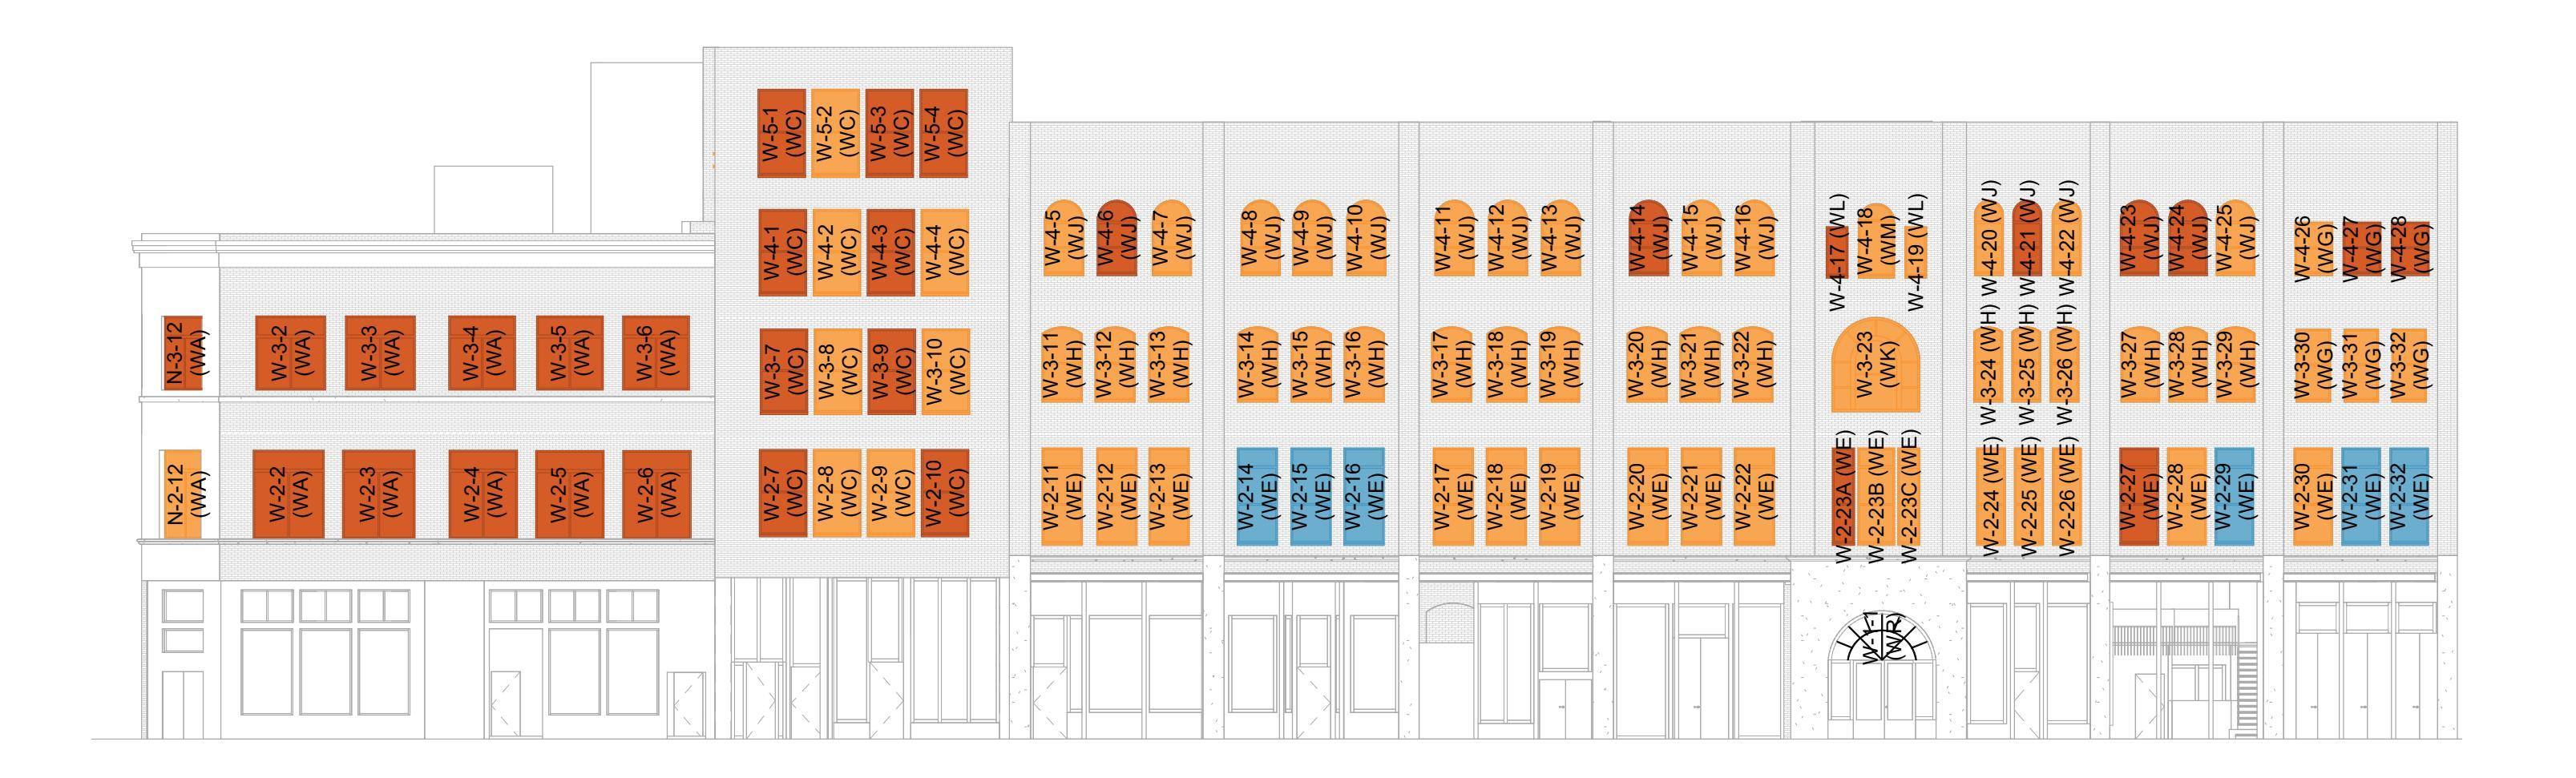
WEST ELEVATION

A SURFACE DEFECTSB MODERATE DAMAGEC SEVERE DAMAGE

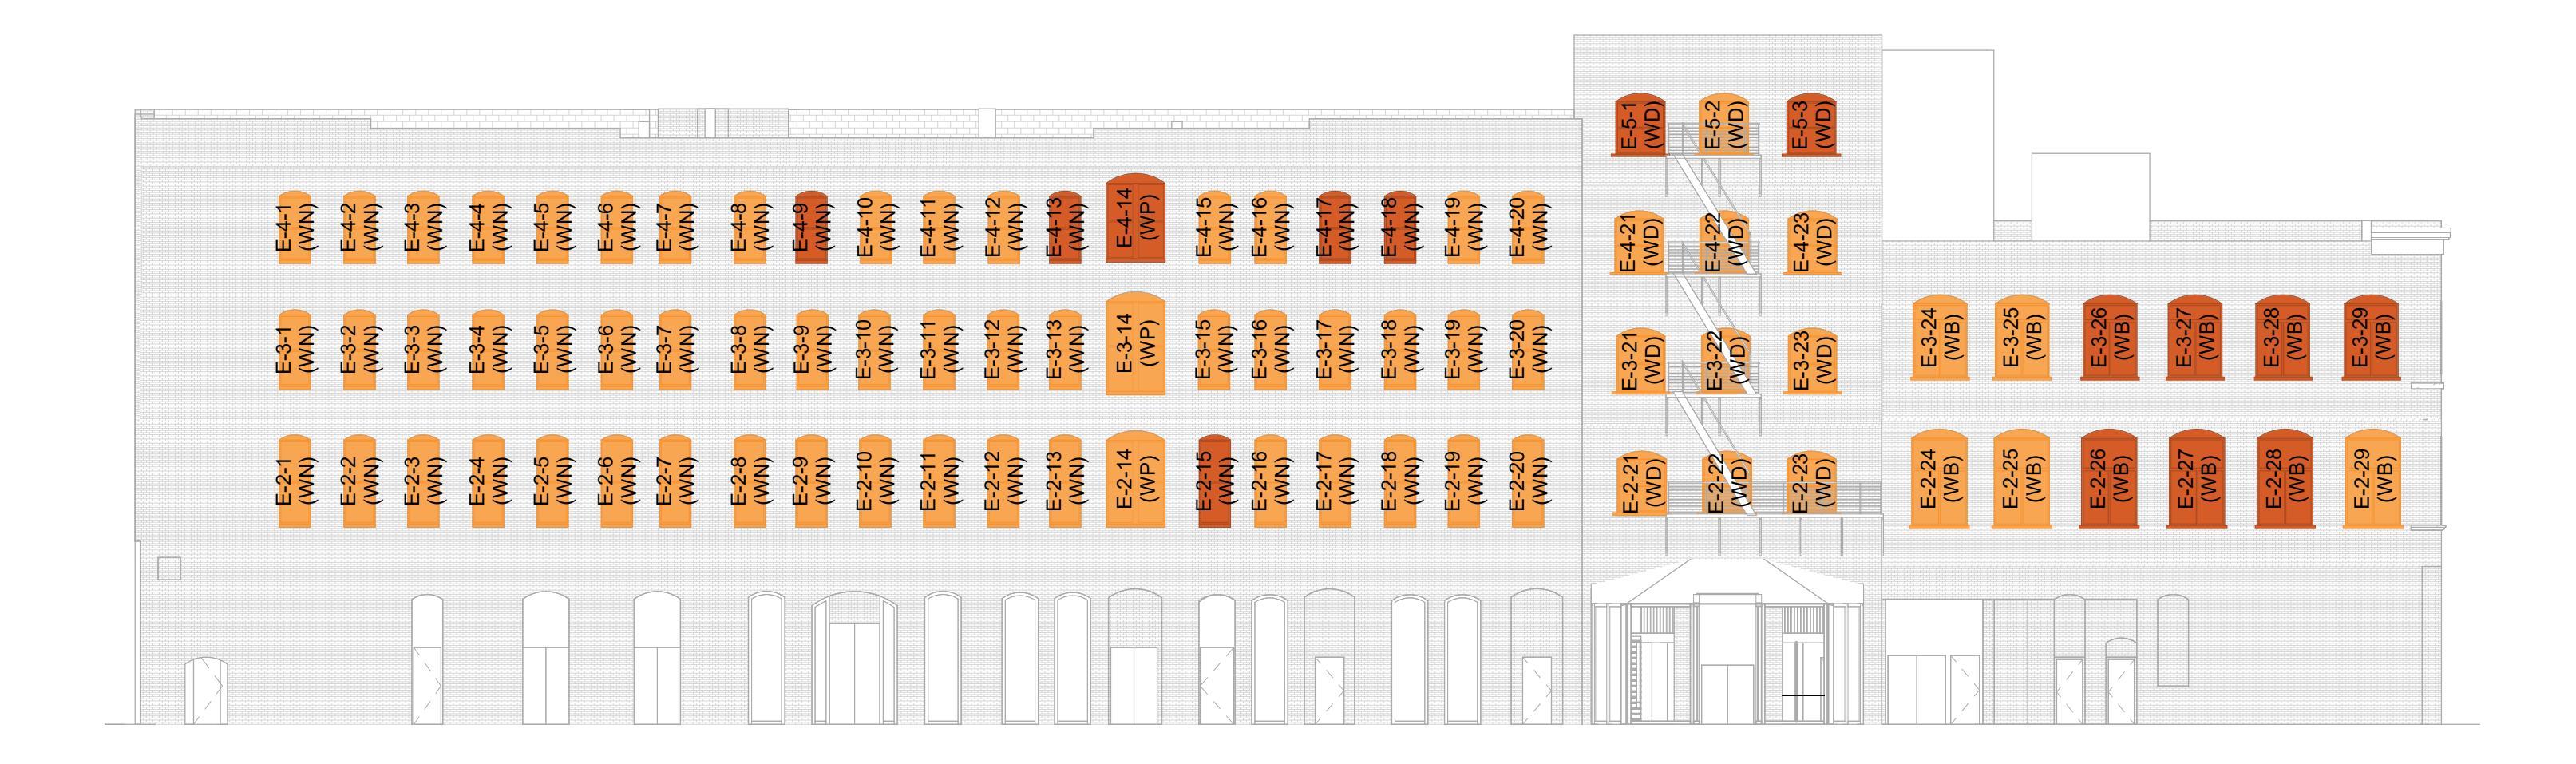
EAST ELEVATION

A SURFACE DEFECTSB MODERATE DAMAGEC SEVERE DAMAGE

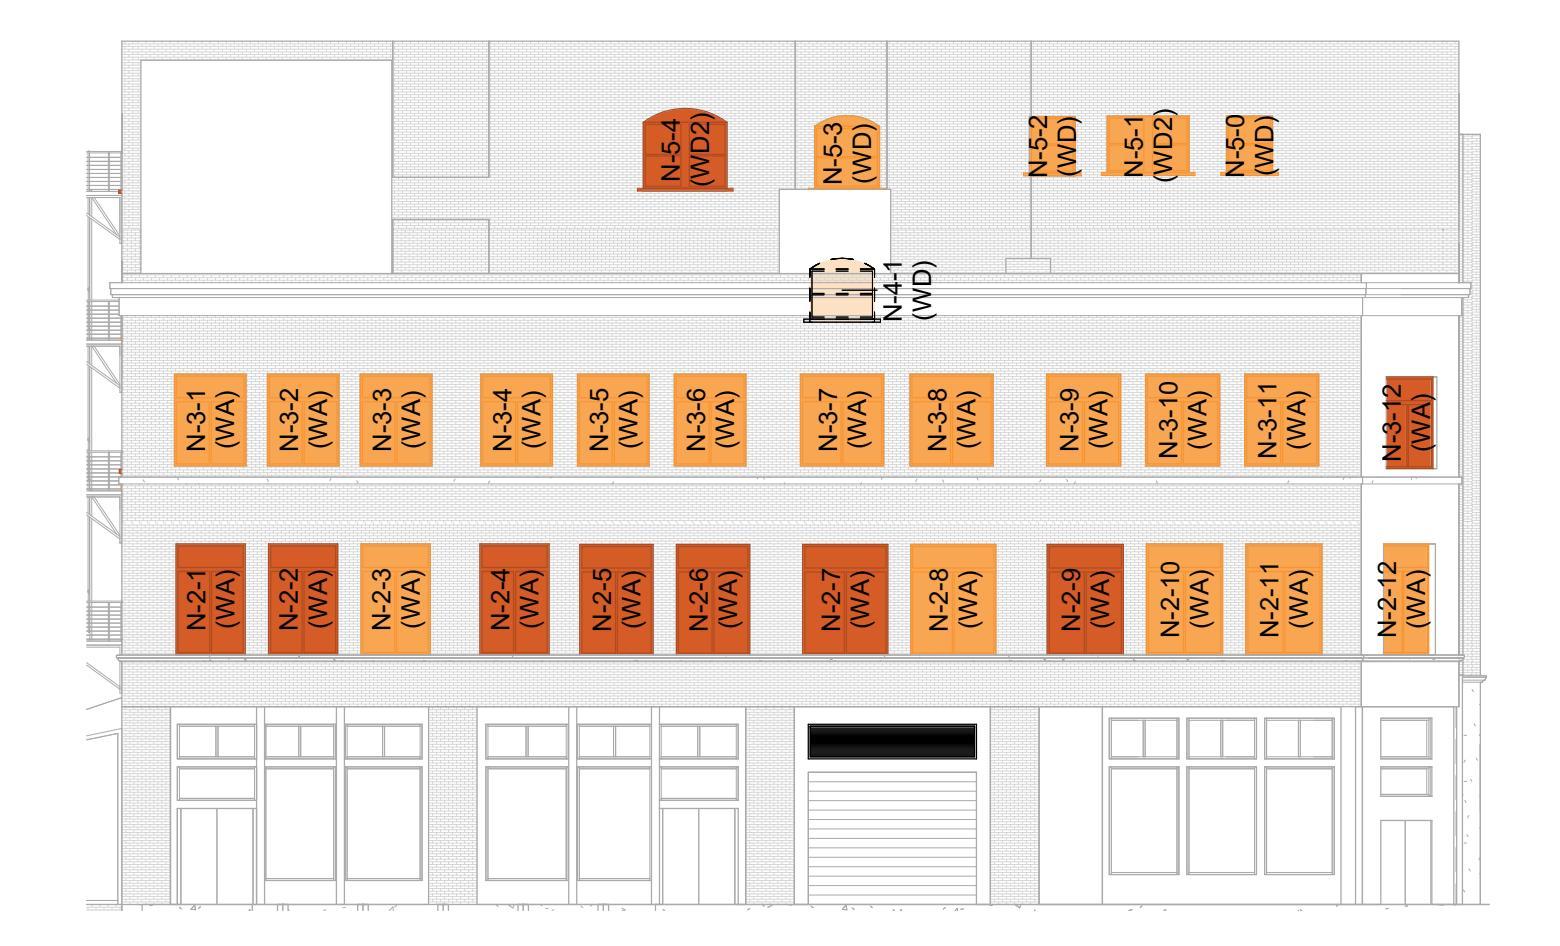
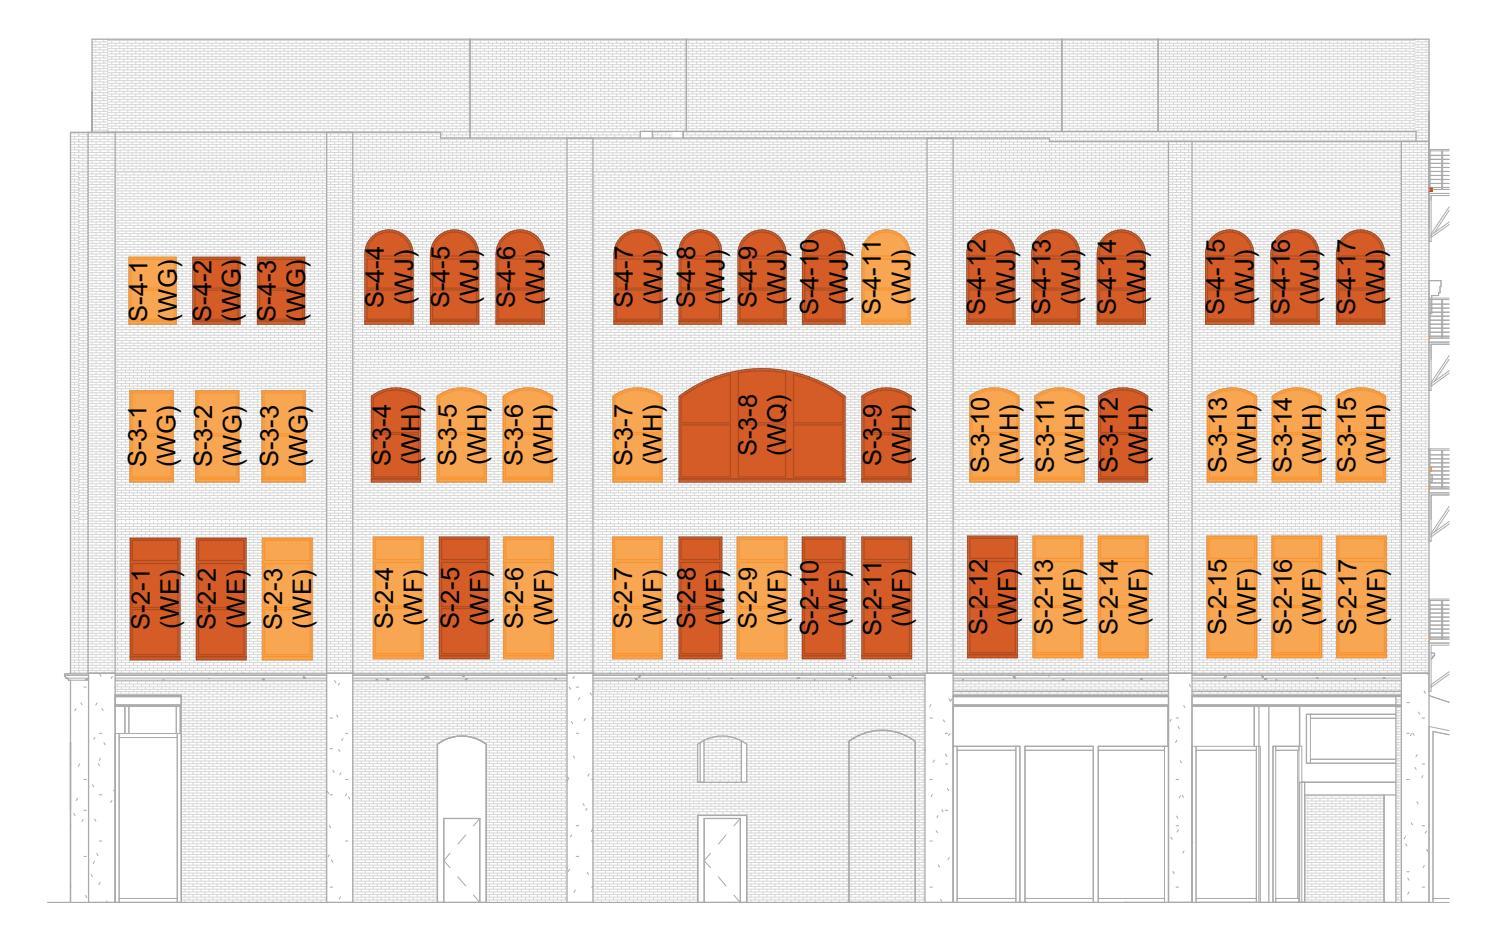
A SURFACE DEFECTSB MODERATE DAMAGEC SEVERE DAMAGE

NORTH ELEVATION

SOUTH ELEVATION

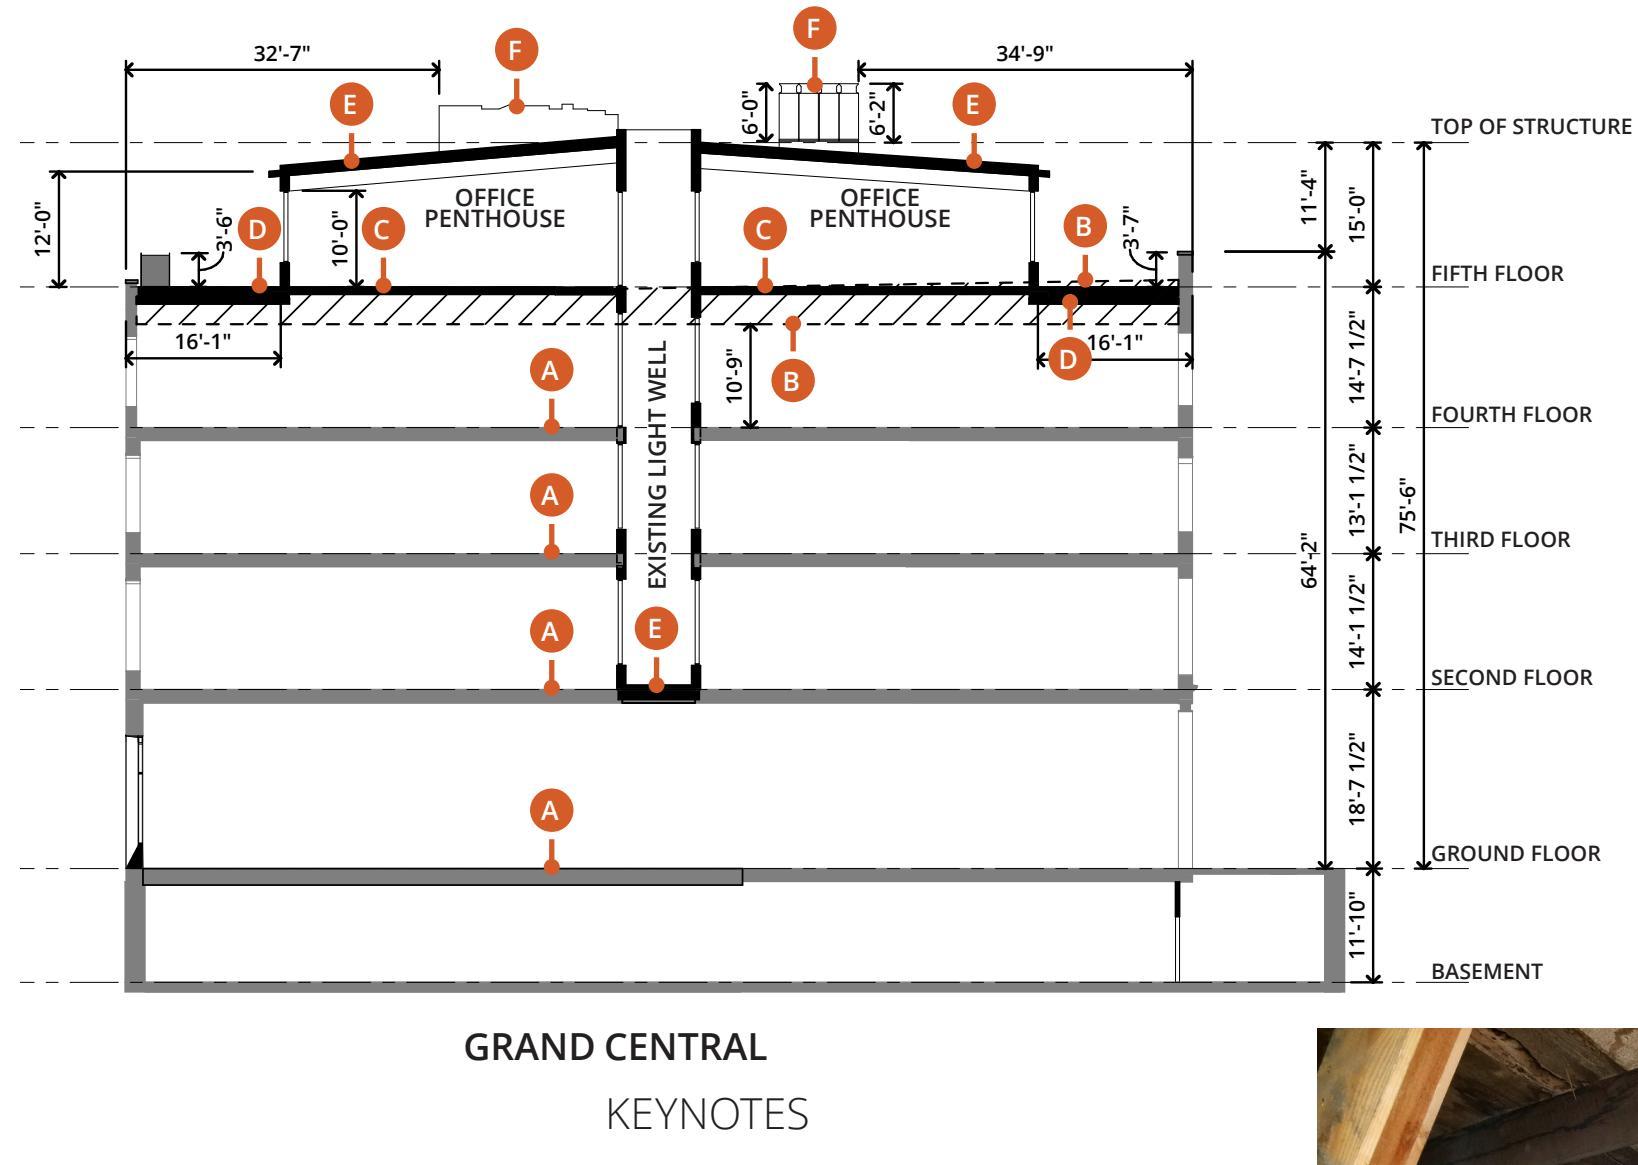
## **PENTHOUSE SECTION - GRAND CENTRAL**

A Existing floor location

3. The existing roof structure was modified and replaced during previous earthquake repairs and renovations, including the 1972

4. The existing South and West parapets and the tops of interior masonry walls were modified and replaced during previous earthquake repairs and renovations, including the 1972 renovation

5. The remaining small skylights are replacements.

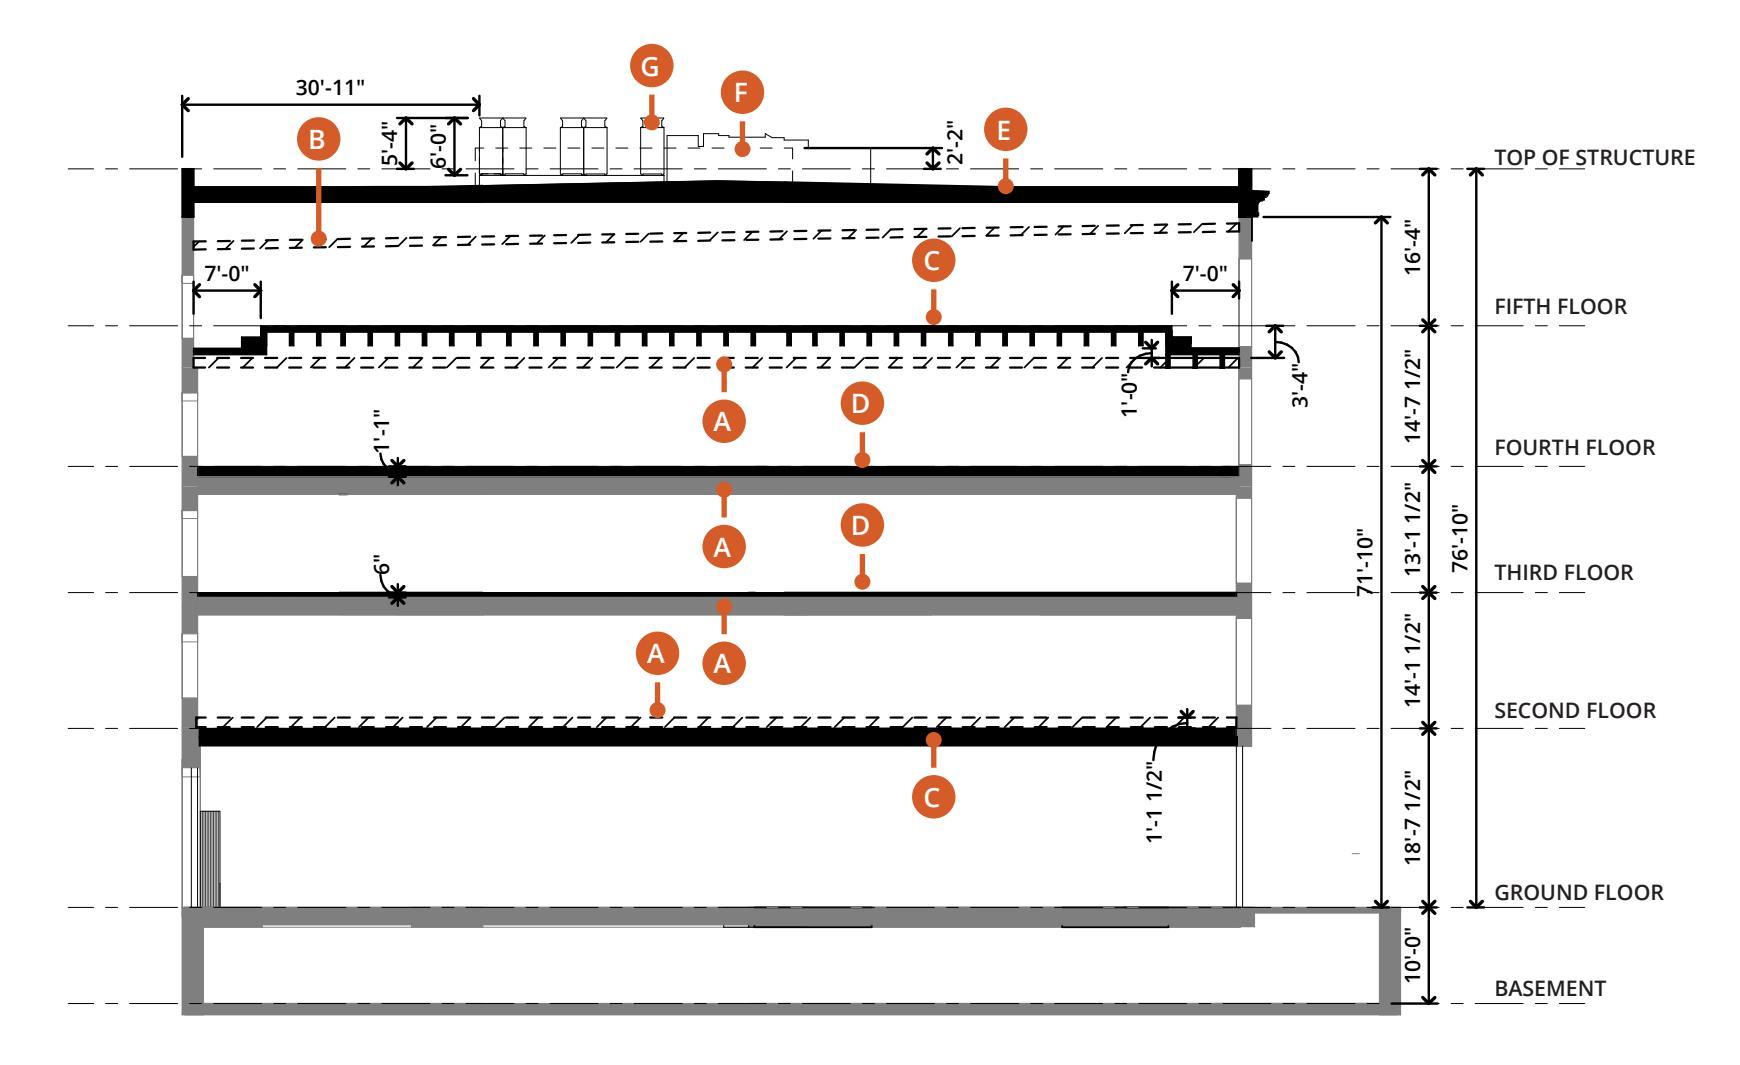
## FLOOR SECTION - CITY LOAN

2. The second floor will be disassembled, salvaged, and reconstructed 1' 1-1/2" lower. Heavy timber members will be re-used and supported on the existing brick walls. Replacement decking will match existing. All wood structure will be painted.

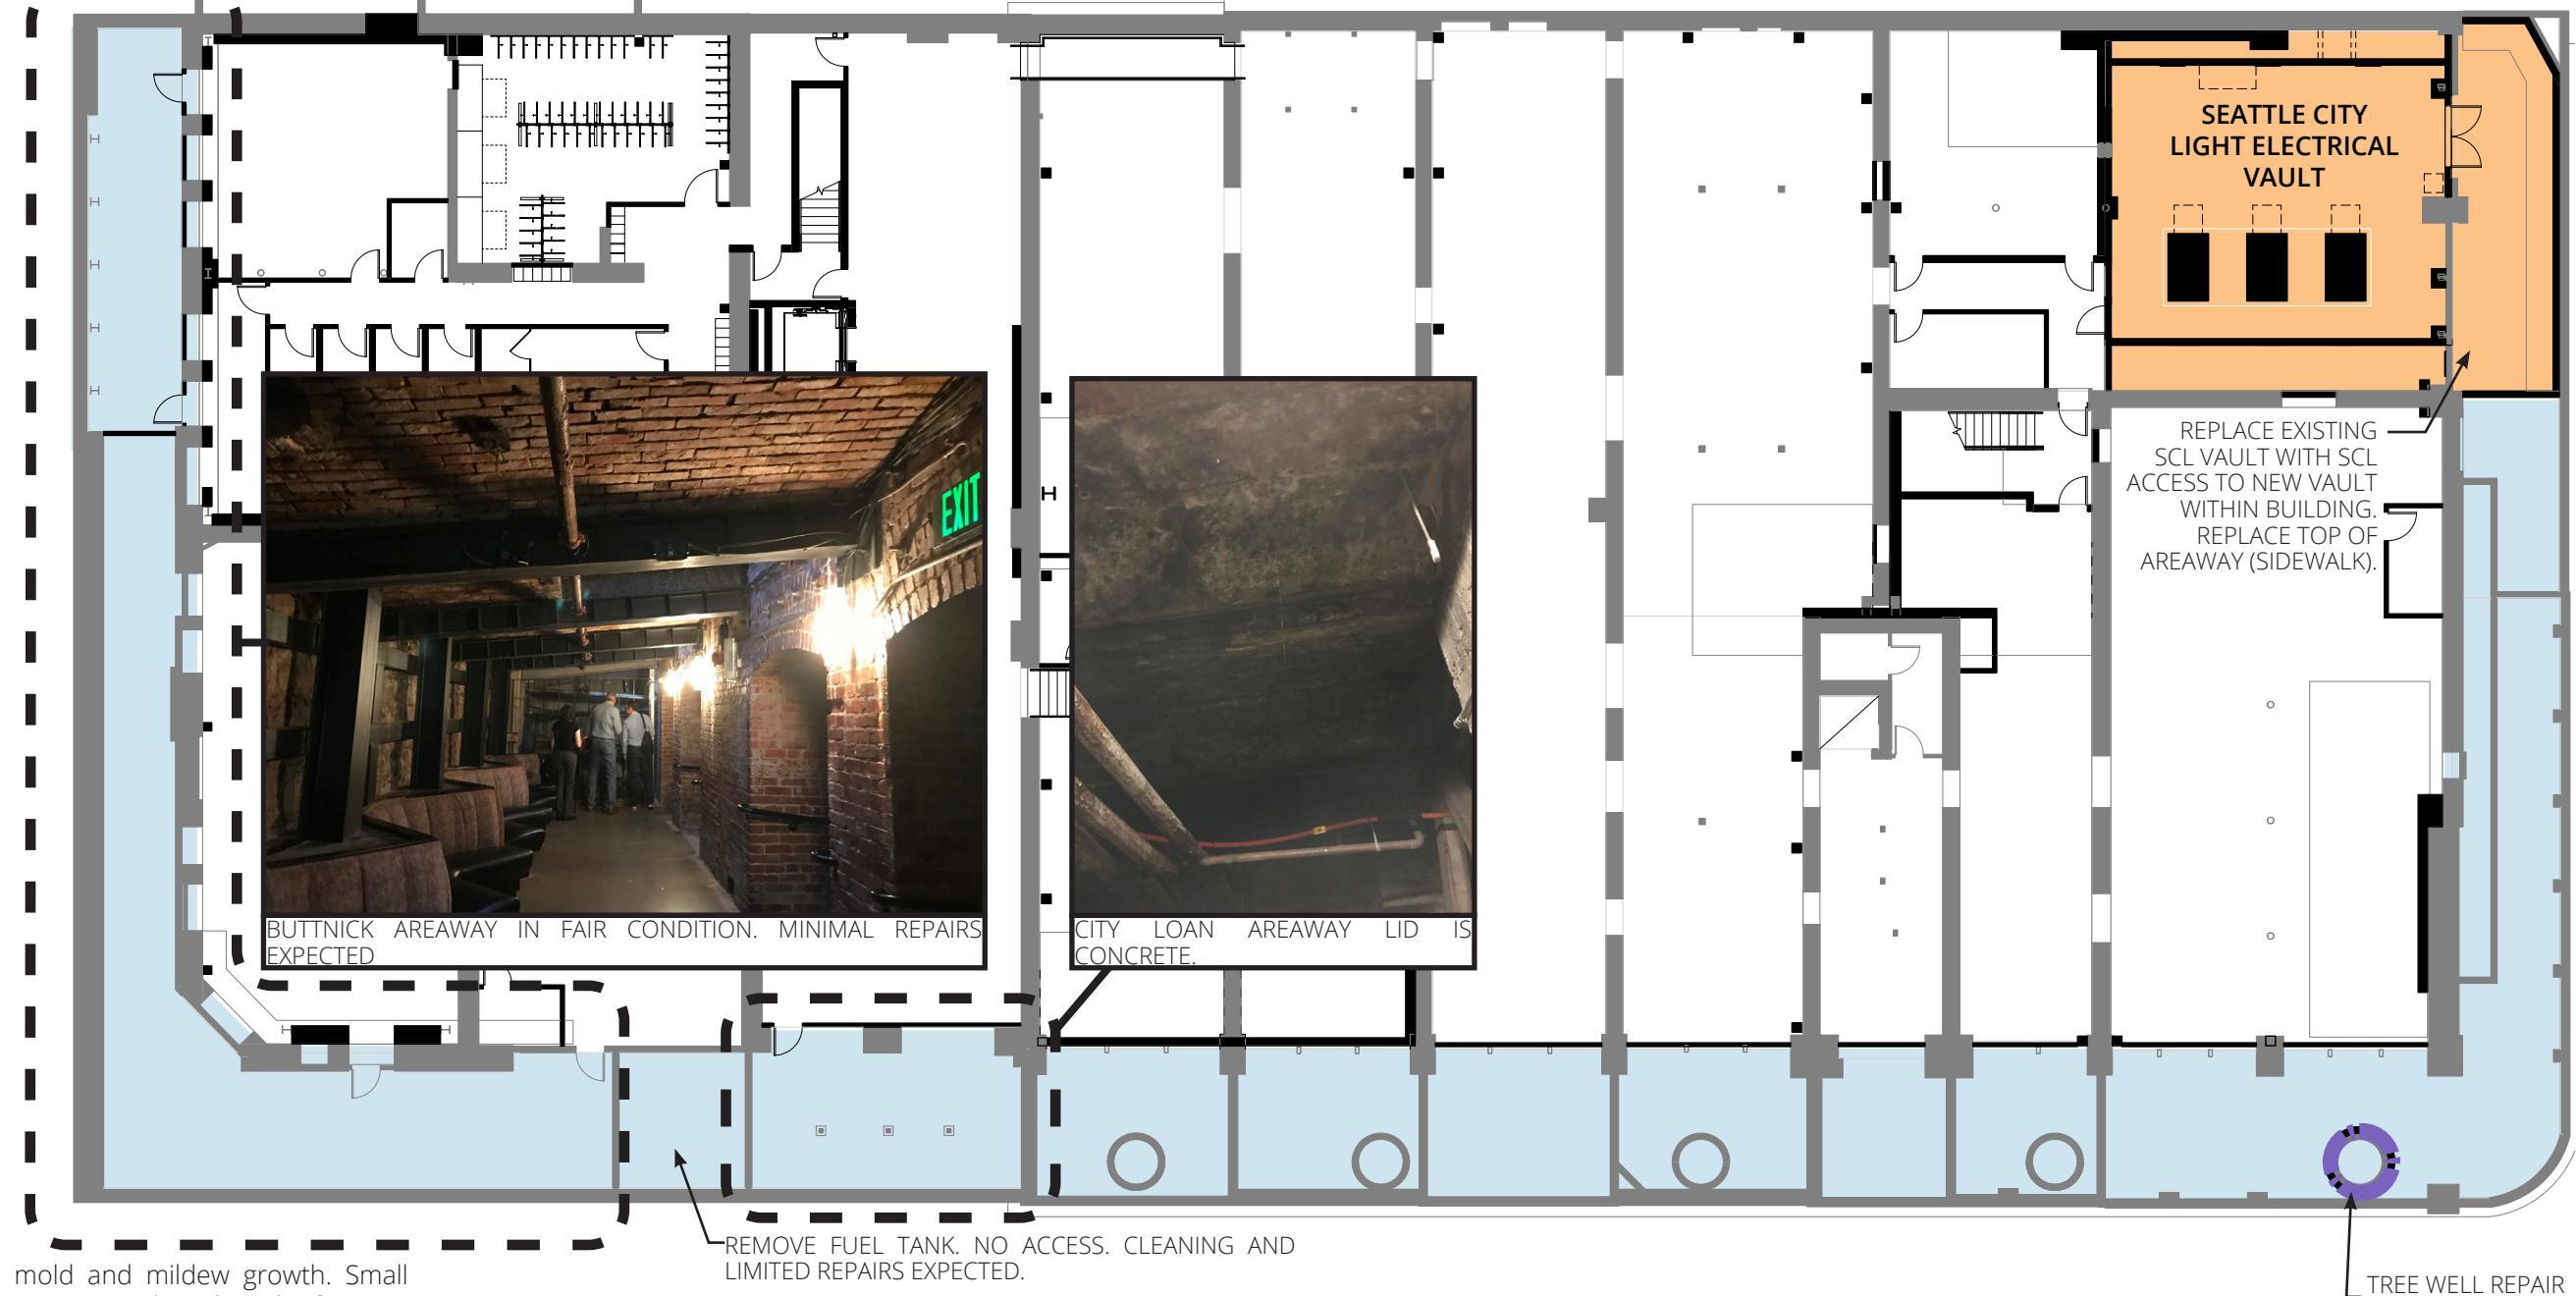
## **BASEMENT AREAWAY - SCOPE OF WORK**

Ventilate areaway to reduce mold and mildew growth. Small openings between compartments combined with fans to encourage circulation.

Resupport brick arches and sidewalk where failing. see structural details on next sheet. Exact locations to be determined.

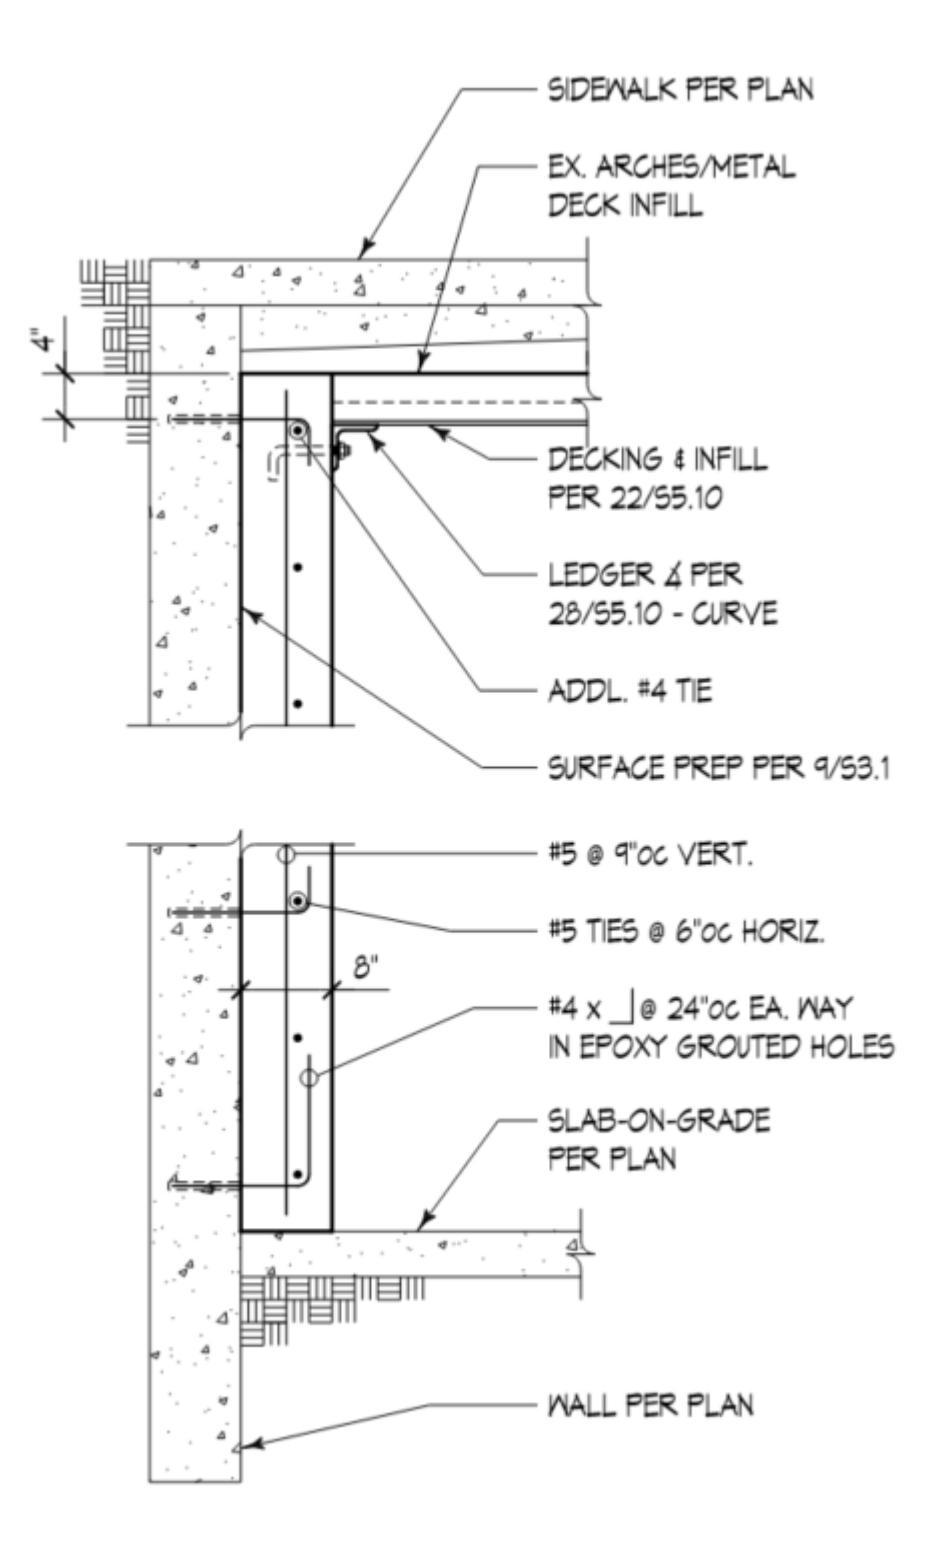
STRUCTURAL DETAIL 23/S5.10 FOR TREE WELL WALL REPAIR

### GRAND CENTRAL AREAWAY - TREE WELL REPAIR
