SDOT Paving Repairs In Magnuson Park Area

C J Jackson
Pavement Management

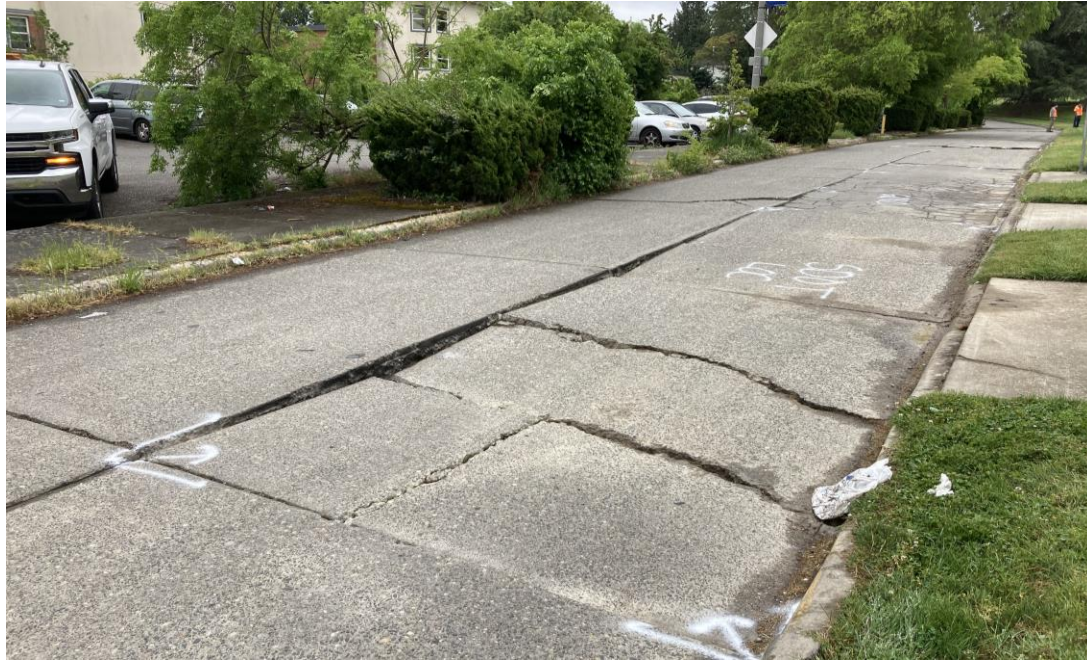
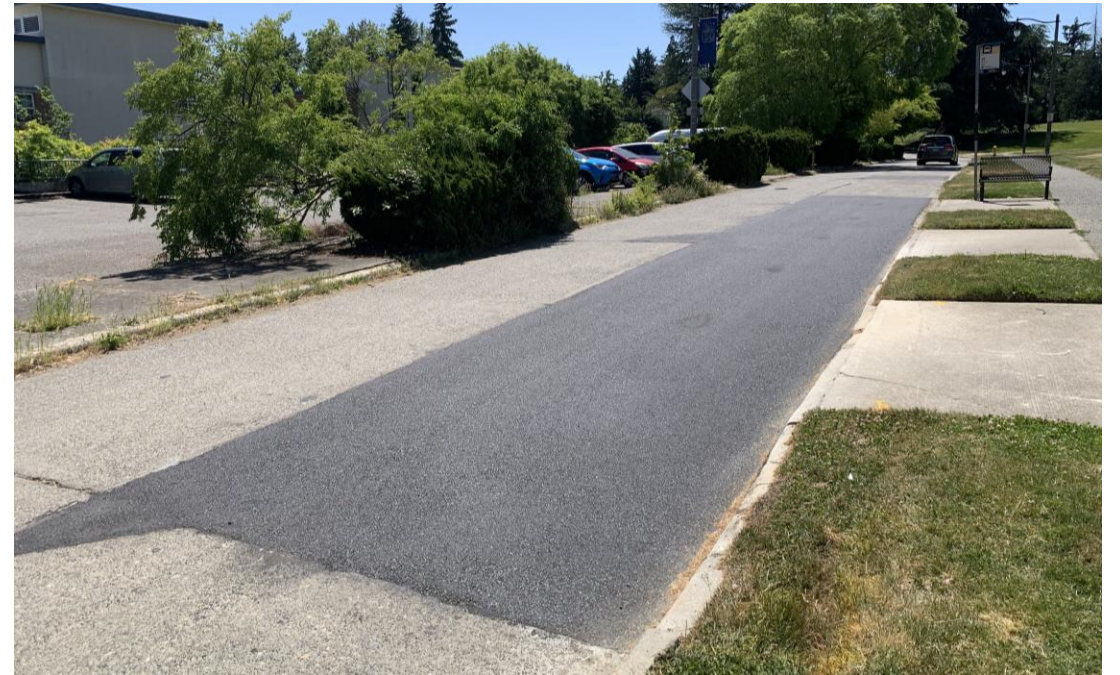
62nd Ave NE between NE 65th St & NE 70th St

- Non-arterial concrete street
- Bus route
- Pavement is failing due to heavy bus traffic
 - Likely not designed for bus traffic
- Construction vehicles and increased traffic have also likely contributed to pavement damage
- Pavement damage exacerbated by subgrade conditions
 - Marginal backfill
 - Groundwater

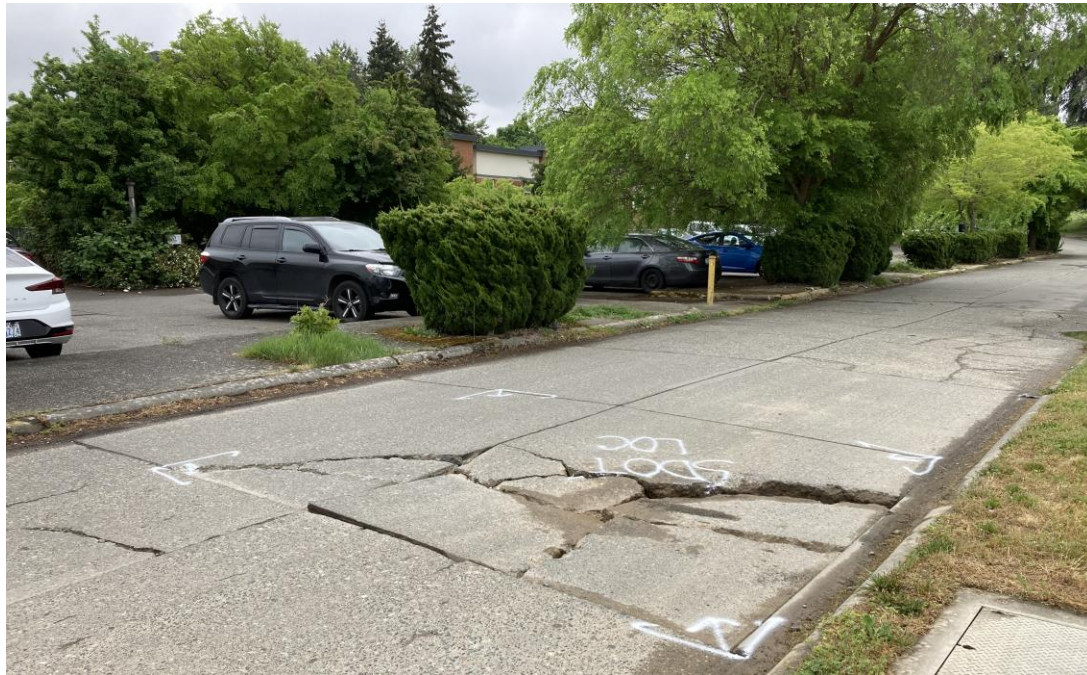
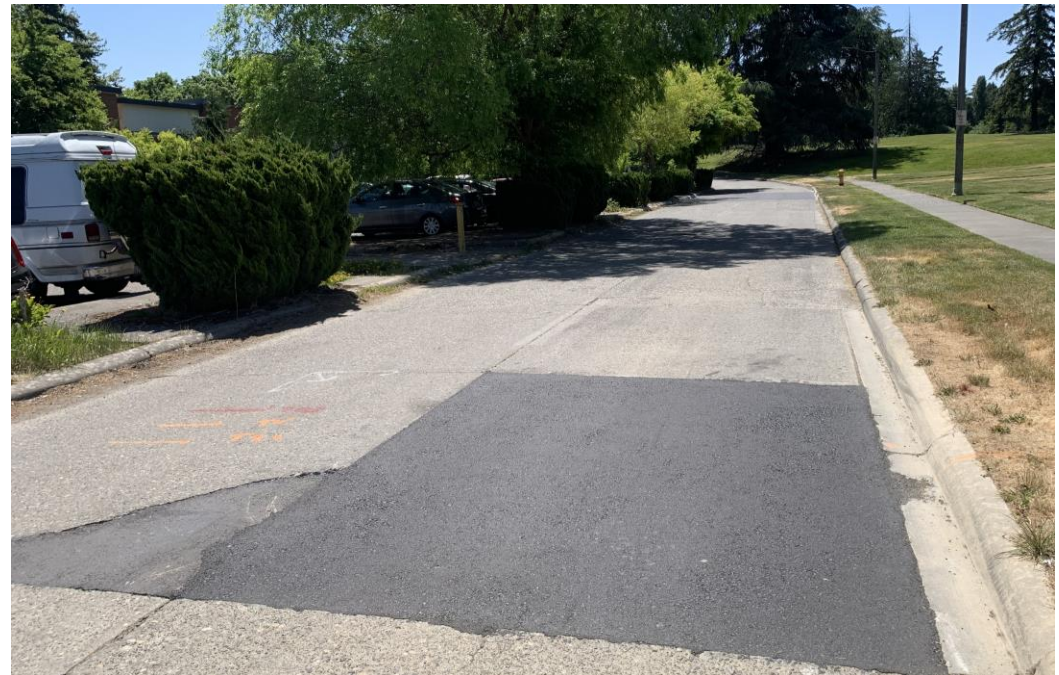
62nd Ave NE between NE 65th St & NE 70th St

- SDOT paving crews performed full-depth asphalt patching at several locations in 2019 and 2023
- SDOT street maintenance crews have also responded multiple times over last several years to perform minor asphalt patching (potholes, shims)
- Repairs have focused on 62nd Ave NE from NE 65th St to NE 70th St; but segment from NE 70th St to NE 74th St is also distressed

- Recent full-depth asphalt repairs, pothole repairs, and asphalt shimming efforts have been performed to address the most damaged areas and keep the street in safe and serviceable condition.
- Asphalt repairs were deemed the most cost-effective maintenance option due to the extensive amount of damaged pavement.
- Concrete repairs are more expensive; and it is likely that replaced panels will fail prematurely due to the poor condition of the adjacent panels.

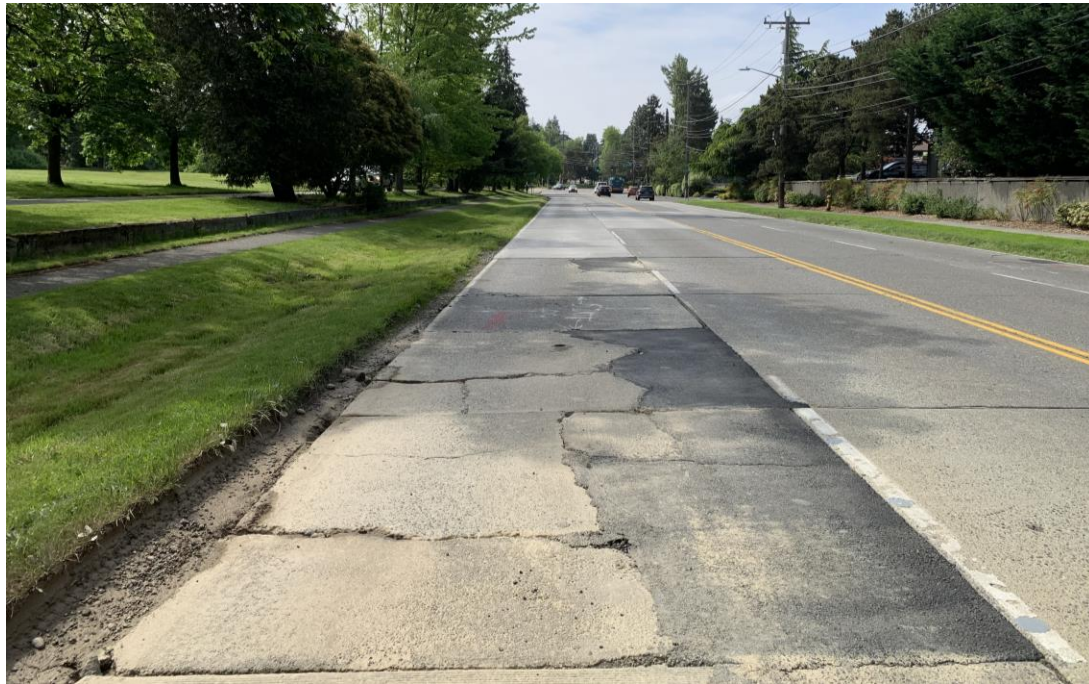
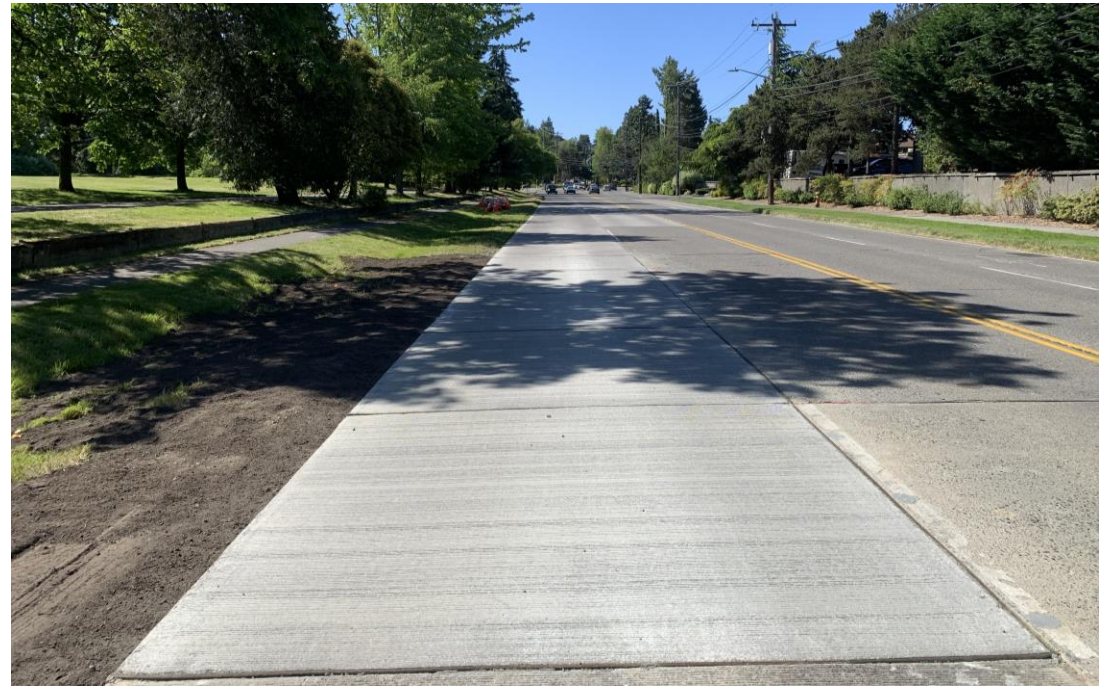
Sand Point Way NE between NE 65th St & NE 70th St

- Arterial concrete street
- Bus route
- Pavement is failing due to heavy bus traffic
 - Likely not designed for bus traffic
