Protecting Seattle's Waterways

Wastewater Collection System: 2015 Annual Report

March 28, 2016

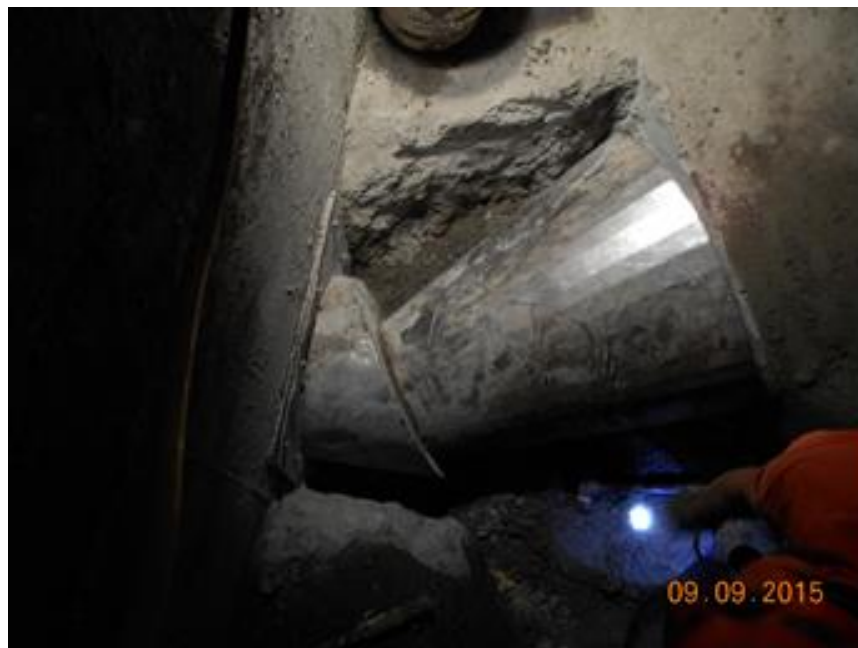
Figure 4-1. Former North Union Bay HydroBrake

The North Union Bay Area is located in the University District near the Burke-Gilman Trail. Retrofit work in this area has occurred in two different sub-basins: 18A and 18B. Retrofit work in sub-basin 18A was completed in 2012 and is performing as intended (see 2014 Annual Report). In sub-basin 18B, flow monitoring data indicated that the HydroBrake in the basin was not operating according to its design performance curve, which resulted in underutilization of existing CSO storage. To remedy the situation, SPU decided to replace the HydroBrake with an automated slide gate to restore the original design performance of the system. This is the sewer system improvement project identified in the approved Plan to Protect Seattle's Waterways. Design of the project was completed in early 2015 and construction began in mid-2015. The project is anticipated to be completed and operational by mid-2016, ahead of the previously projected December 31, 2017 completion date. Post project performance monitoring will commence upon completion of construction. Figures 4-1 and 4-2 show the HydroBrake that was removed and the newly installed gate.

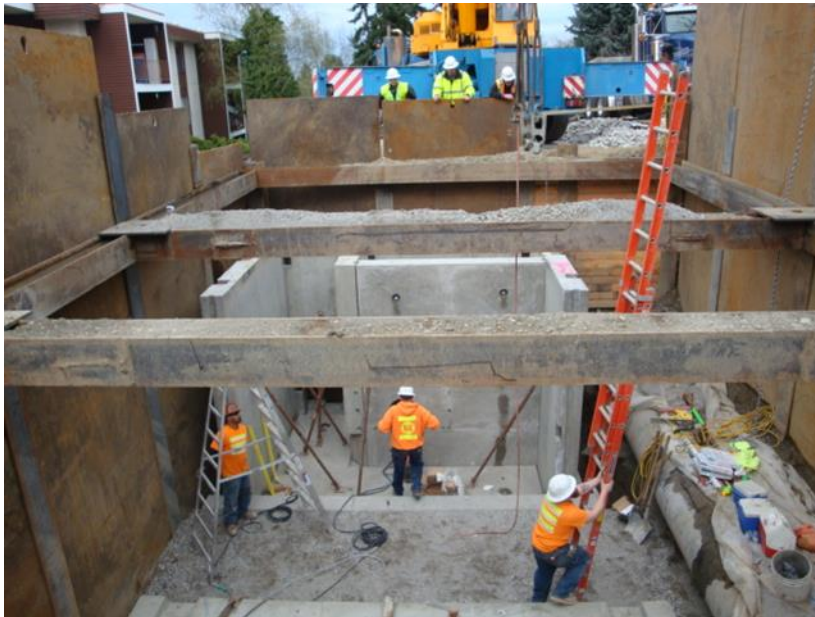
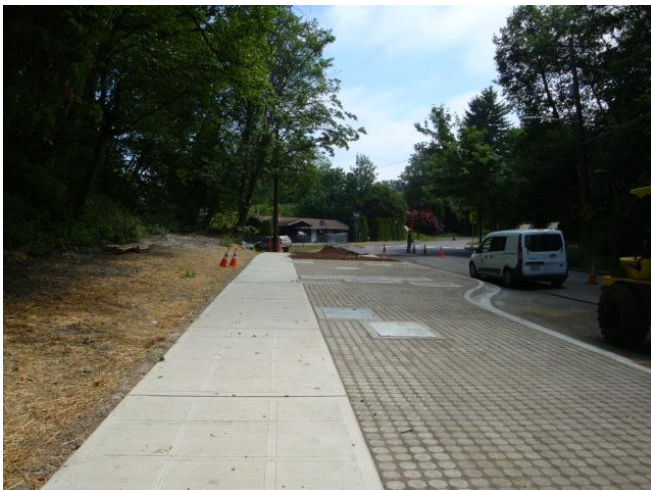
Figure 4-3. New Delridge Diversion Structure (upper) and Finished Appearance (lower)

During 2012, SPU completed a detailed analysis of sewer system improvements in the Delridge Area (Basins 168 and 169). SPU selected improvements that optimize the performance of CSO Storage Facilities 2 and 3 by replacing existing HydroBrakes with improved upstream diversion structures, actively controlled valves, and an upstream and downstream flow monitoring system. These improvements are anticipated to reduce the frequency of surcharging in the downstream sewer system, reduce CSOs at Outfalls 168 and 169, and reduce the need for preventive maintenance and the frequency of unscheduled maintenance. Design was completed in 2014. Construction started in February 2015 and was substantially completed by the NPDES permit deadline of November 1, 2015. SPU will be monitoring the performance of the improved facilities starting in 2016. Figure 4-3 shows the construction of one of the new diversion structures the finished surface after the installation of the diversion structures and piping.

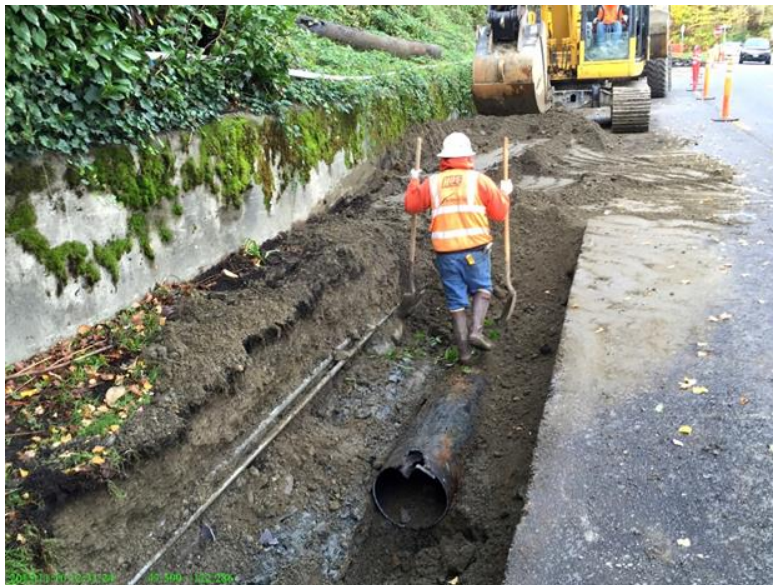
Figure 4-4. Combined Sewer Replacement in Leschi

- Replace approximately 1,500 linear feet of combined sewer,
- Reline approximately 3,000 linear feet of combined sewer,
- Install a low flow diversion structure in Basin 35,
- Seal the overflow structure to CSO Outfall 33 and remove CSO Outfall 33 from service, and
- Remove the HydroBrakes in Basins 33 and 29.

Figure 4-4 shows combined sewer pipe being replaced as part of Phase 2.

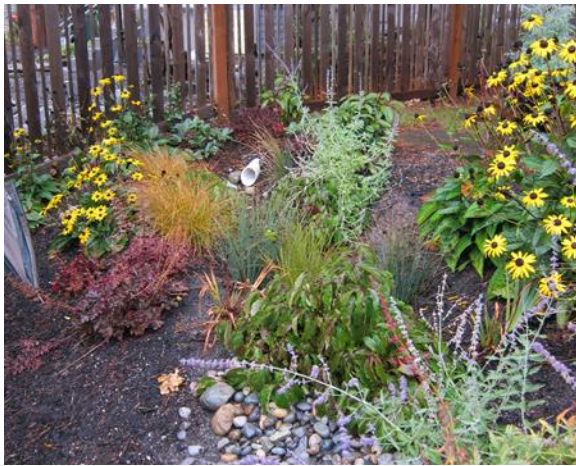
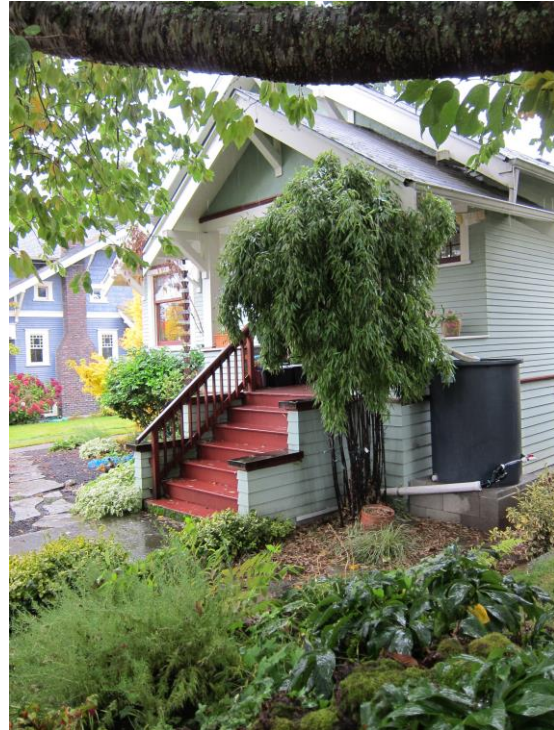
Figure 4-5. Raingarden (left) and Cistern (right)

Upon completion, installations are inspected by a RainWise inspector and homeowners apply for the rebate. RainWise rebates for rain gardens are currently three dollars and fifty cents per square foot of roof area controlled. Rebates for cisterns equal 64 percent or more of the rain garden rate, depending on the size of the cistern and contributing area. The average 2015 installation now controls the runoff from nearly 1,300 square feet of roof area. Typical RainWise installations are shown in Figure 4-5.

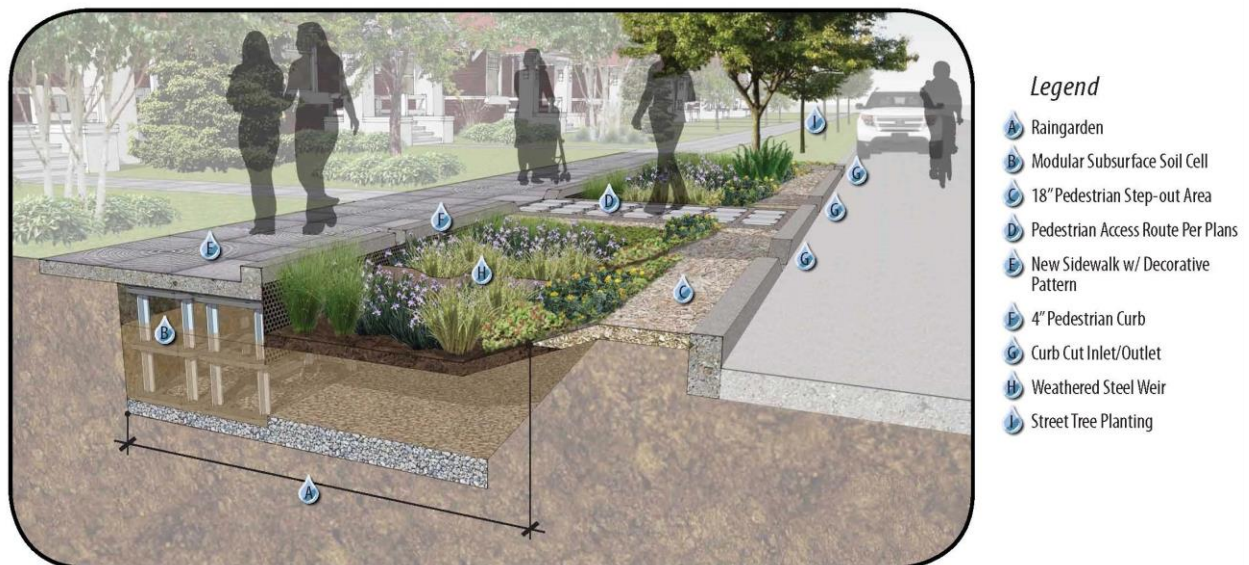
Figure 4-6. Ballard NDS 2015 Modular Soil Cells

- Completed the Engineering Report, which was submitted and approved by Ecology.
- Completed the project design, which includes a new concept using modular soil cells (see Figure 4-6). These maximize the efficiency of each raingarden, resulting in a reduced number of cells required along each block.
- Advertised and awarded the construction contract before the October 31, 2015 regulatory deadline.

* Illustration represents approximately 3 years growth following installation.

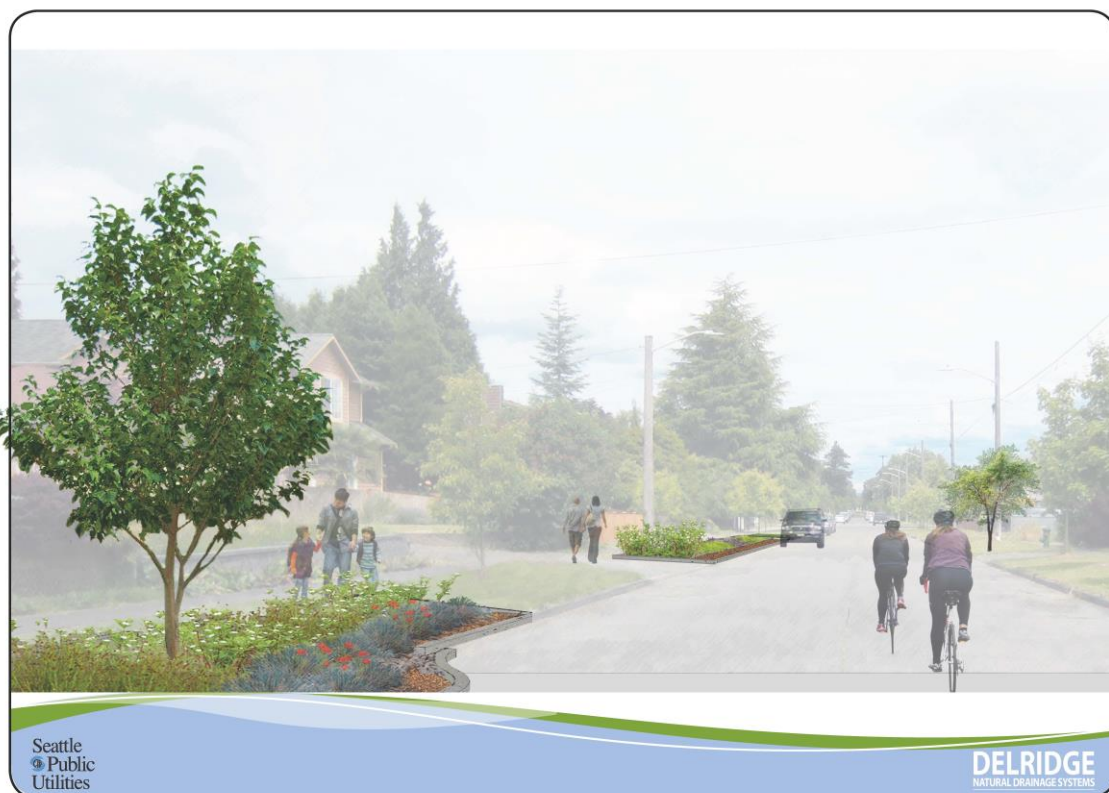
Figure 4-7. Delridge NDS 2015 Conceptual Drawing

In 2016, the Delridge NDS project will complete construction of 23 underground injection control (UIC) wells, including pretreatment via bioretention cells connected with underdrains.

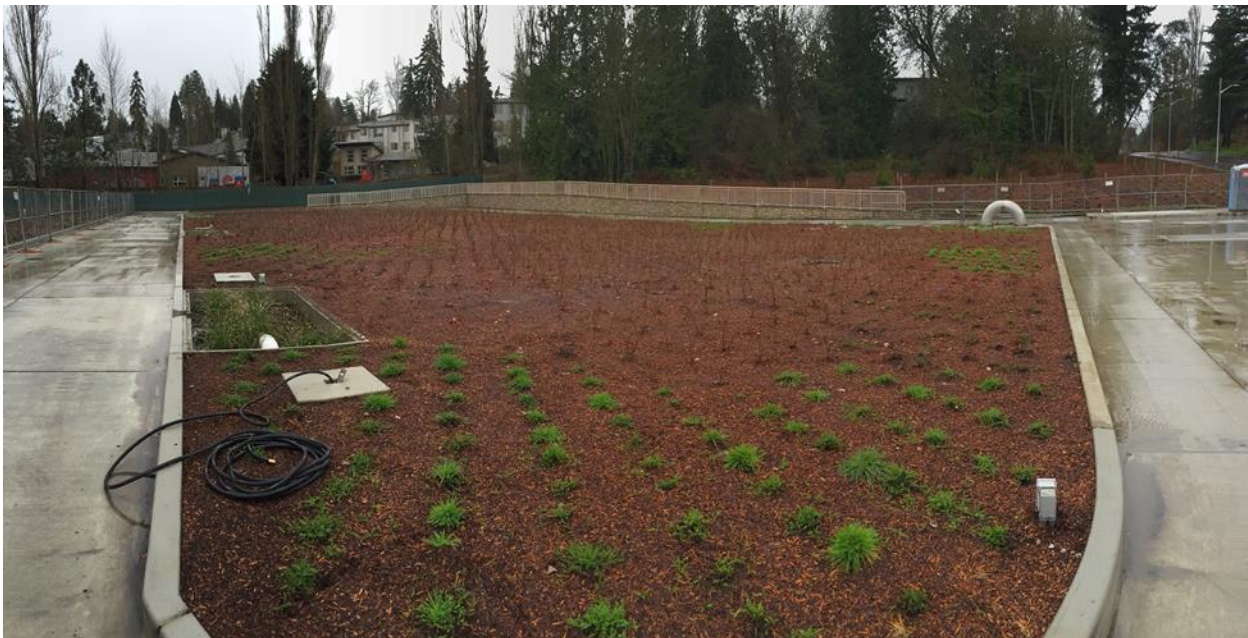
Figure 4-8. Completed Windermere CSO Storage Facility

Construction began in October 2012 and the work was substantially complete in March 2015. The facility went through a stabilization process in Spring 2015 and project reached construction complete on July 31, 2015. Post Project Performance Monitoring began August 1st.

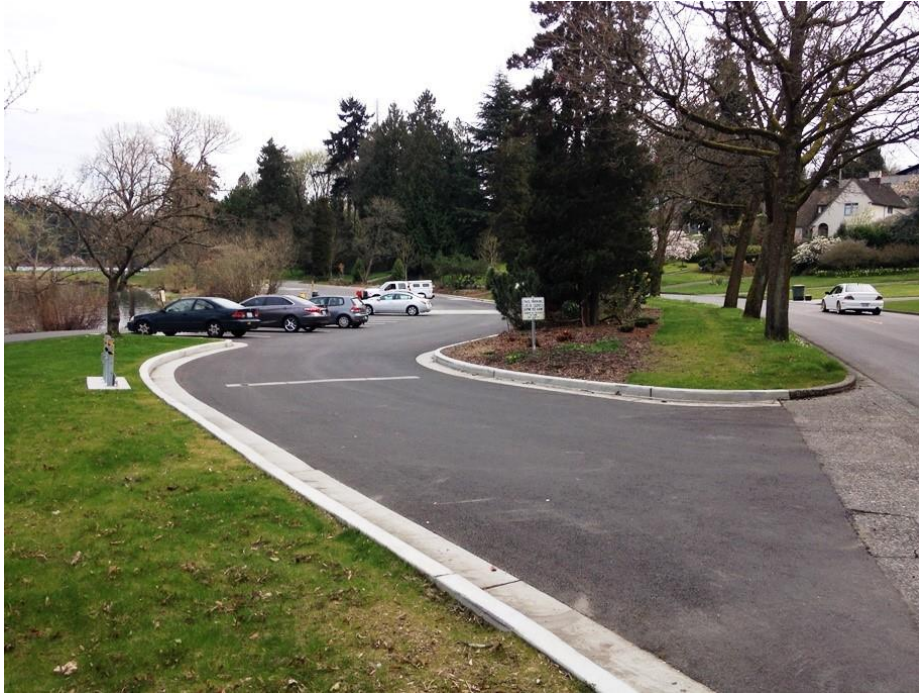
Figure 4-10. Completed Genesee CSO Storage Facility 9A

Construction began in April 2013 using the General Contractor / Construction Manager delivery method. In 2015, SPU completed construction of the new facilities, including testing and commissioning activities. Upon placing the facilities in service, SPU encountered an issue with the electrical cabinets overheating. Modifications were made to the electrical cabinets by SPU crews. These modifications were completed prior to the regulatory deadline for construction completion.

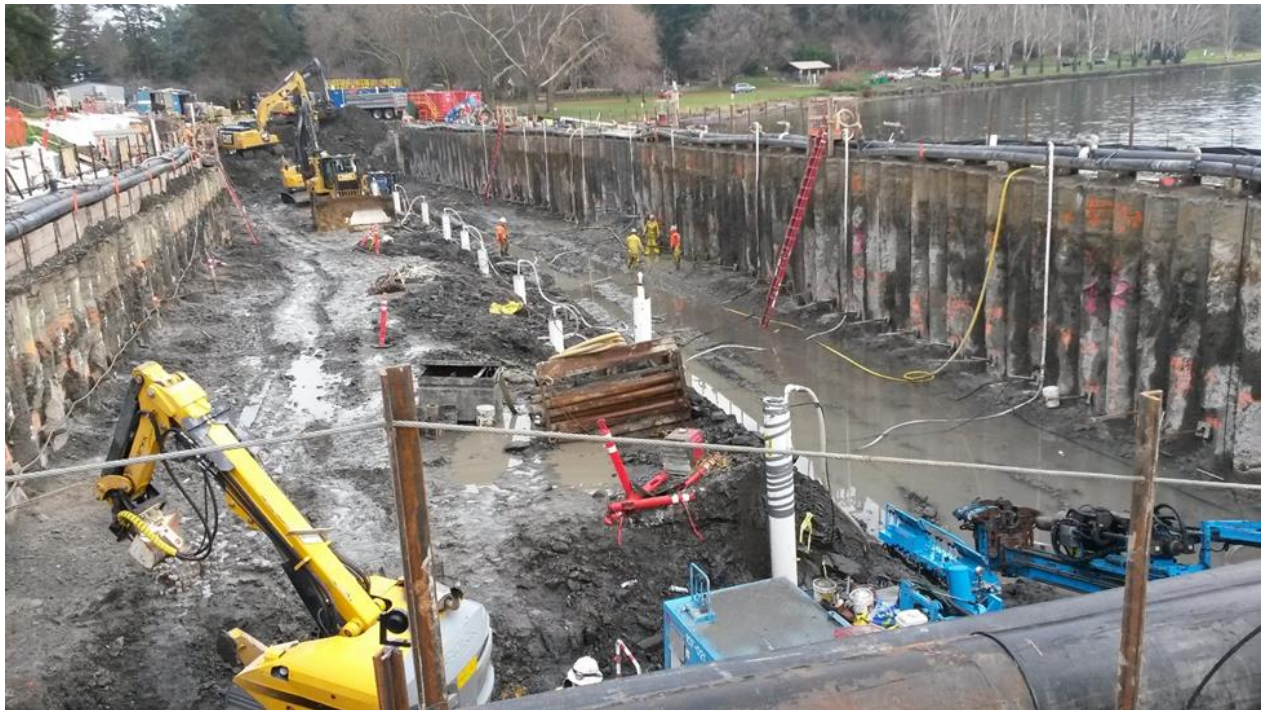
Figure 4-12. North Henderson CSO Storage Facility during Construction

In 2015, construction began on the project. Significant accomplishments include completion of the sewer system improvements adjacent to Martha Washington Park, replacement of Outfall 44 at Seward Park, completion of site piping, and construction of the shoring system for the new storage facility in Seward Park.

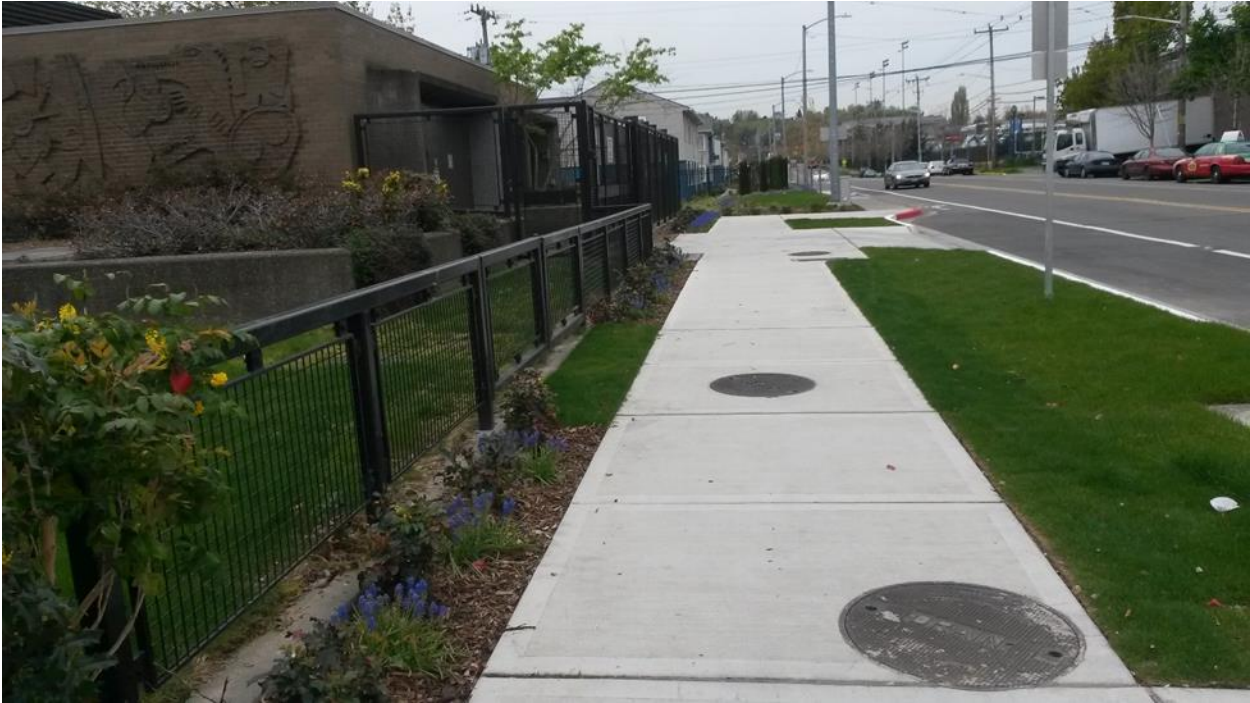
Figure 4-14. Completed 52nd Ave S Combined Sewage Conveyance Project

The 52nd Ave S Conveyance Project will reduce the number and volume of combined sewage overflows from Outfalls 47 and 171 in the South Henderson area. The project includes a new diversion system and pipeline to convey peak flows to DNRP's Henderson Pump Station.

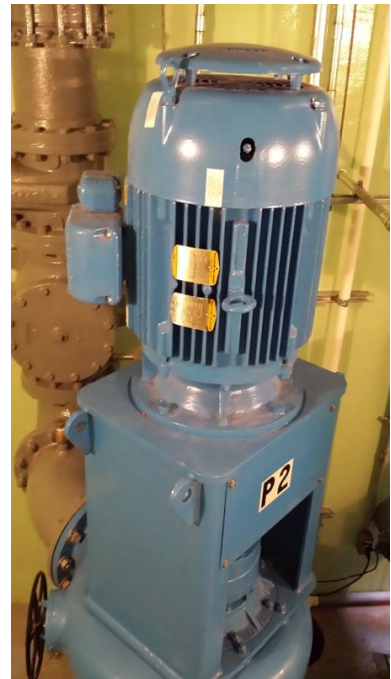
Figure 4-15. Completed Pump Station 9 Rehabilitation Project

The Pump Station 9 Rehabilitation Project will reduce the number and volume of combined sewage overflows from Outfall 46 in the South Henderson area. In 2015, SPU replaced the existing pumps with two higher capacity pumps, and upgraded the electrical and mechanical systems. The project reached construction completion on December 15.
