## Water System Operational Highlights

October 24, 2011 – October 31, 2011

## Seattle Public Utilities Water System Synopsis as of October 24, 2011

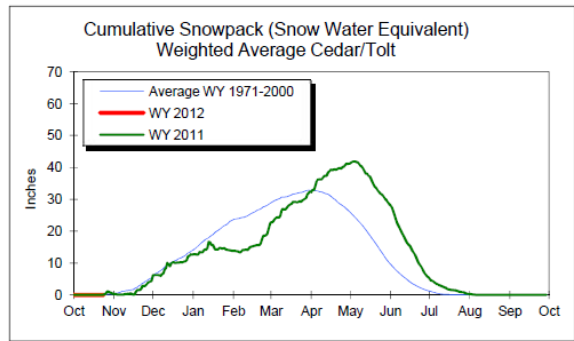
The average snow accumulation across the sites that we monitor is estimated to be about 0.0 inches snow water equivalent which is at the long term average for this time of the year.
