LOWMAN BEACH PARK

Feasibility Study Report

Prepared for
Seattle Parks & Recreation Department

December 7, 2017

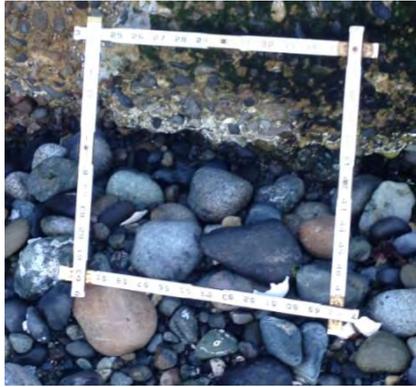
A. Private seawall toe cobble north of park

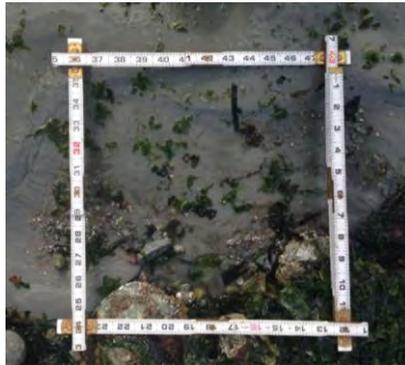
D. Exposed clay & cobble at north end of park

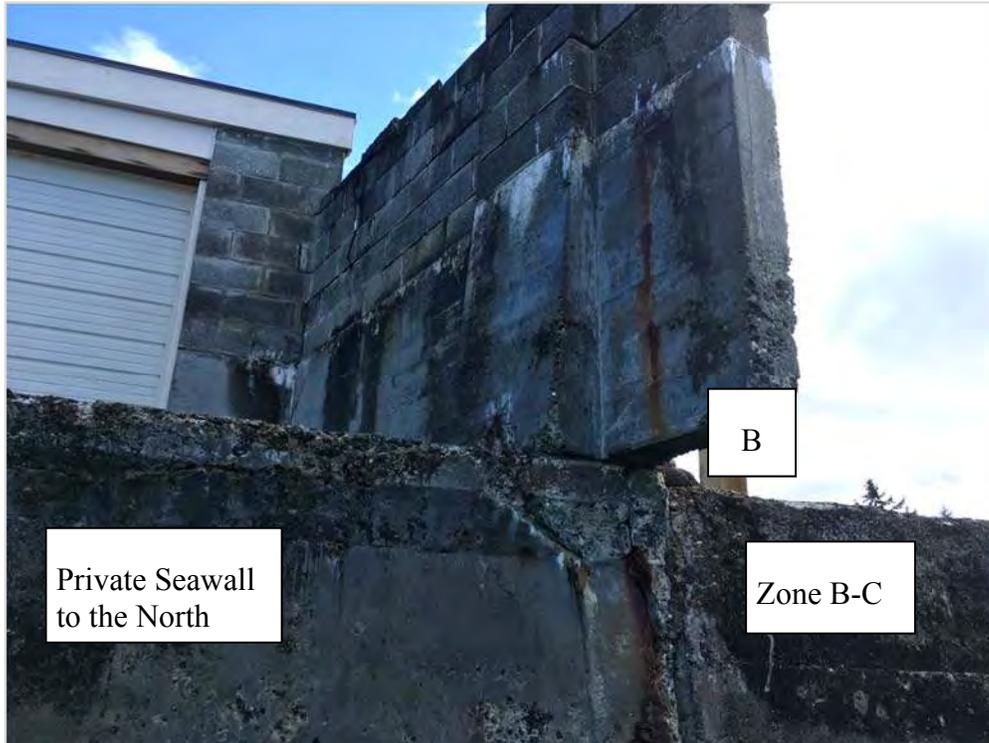
Photo 8. Zone B-C, Adjacent Property.
Source: Reid Middleton Site Visit 10/18/2016

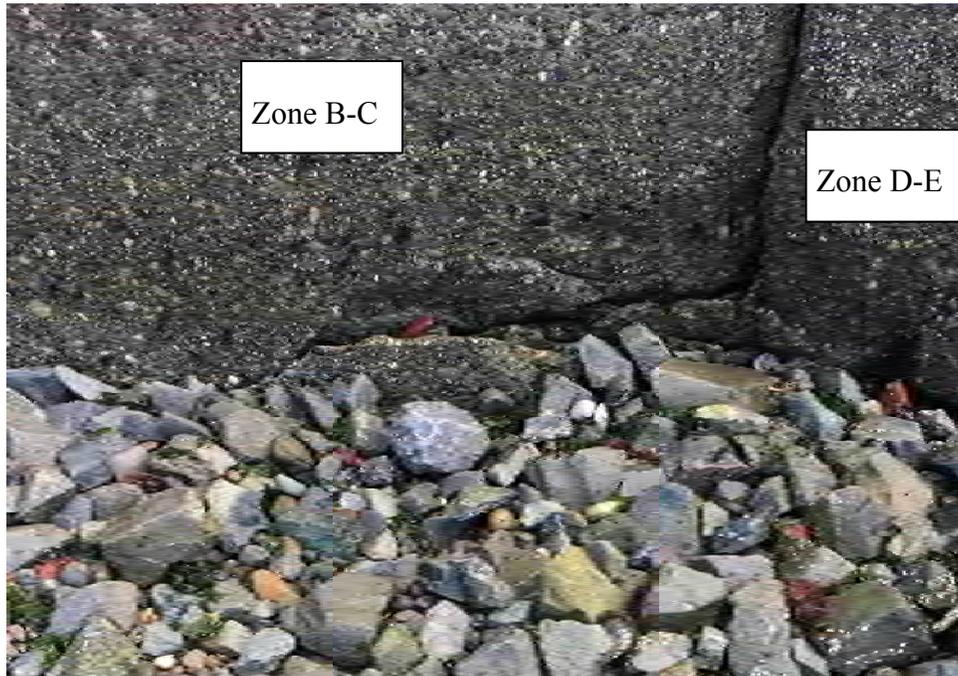
Photo 13. Zones B-C & D-E, Beach Material.
 Source: Reid Middleton Site Visit 10/18/2016

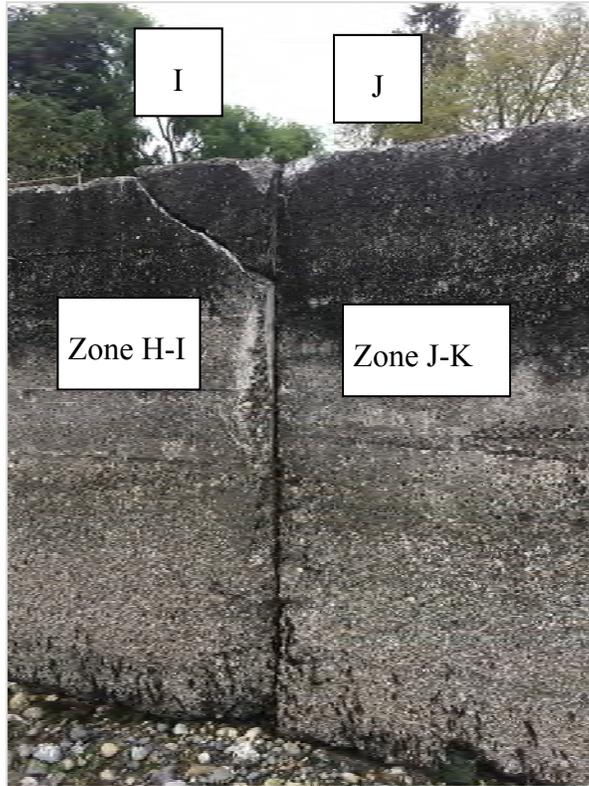
Photo 19. Zones H-I & J-K.
Source: Reid Middleton Site Visit 5/31/2017

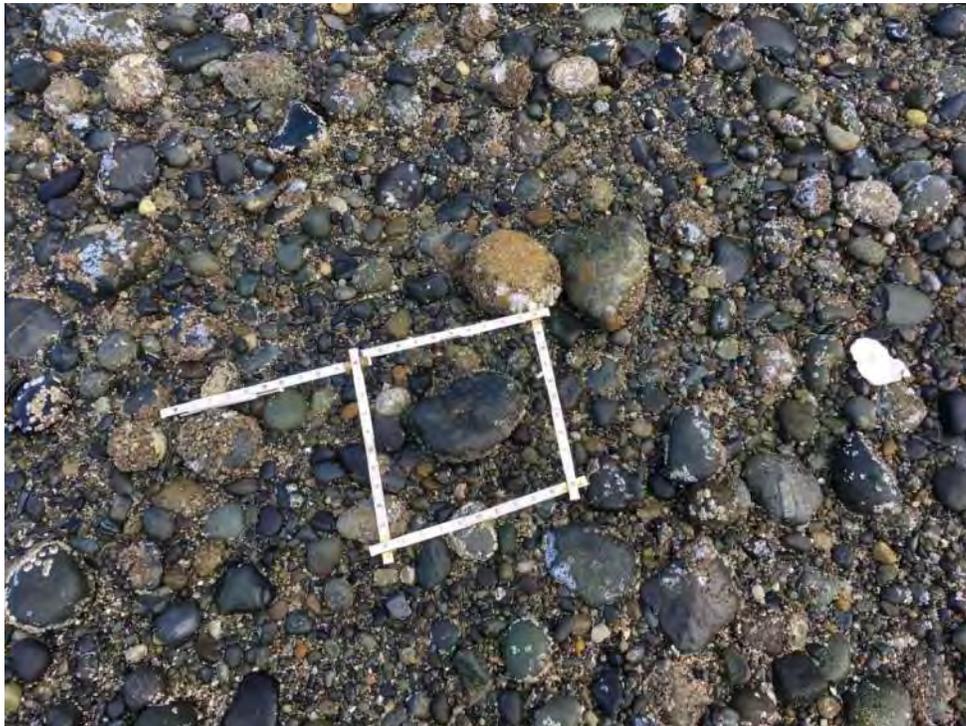
Photo 20. Beach Material at Zone J-K.
Source: Reid Middleton Site Visit 10/18/2016

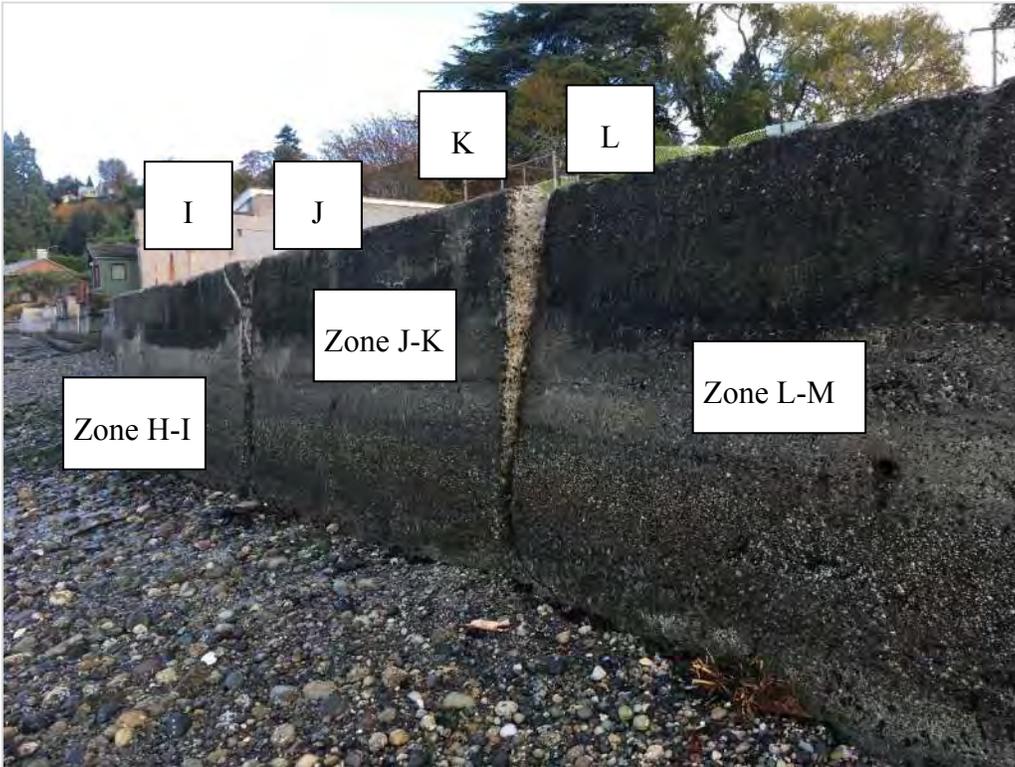
Photo 21. Zones I-J, J-K, & L-M.
 Source: Reid Middleton Site Visit 10/18/2016

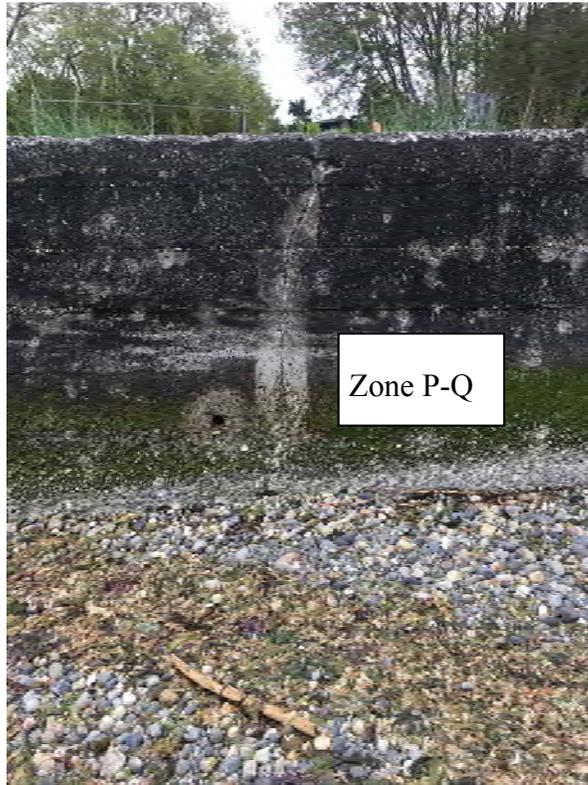
Photo 27. Zone P-Q.
Source: Reid Middleton Site Visit 5/31/2017

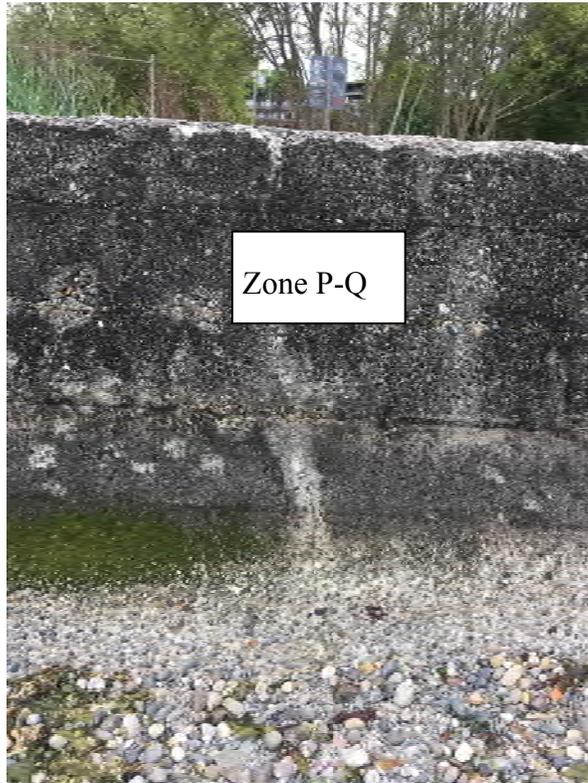
Photo 28. Zone P-Q.
Source: Reid Middleton Site Visit 10/18/2016

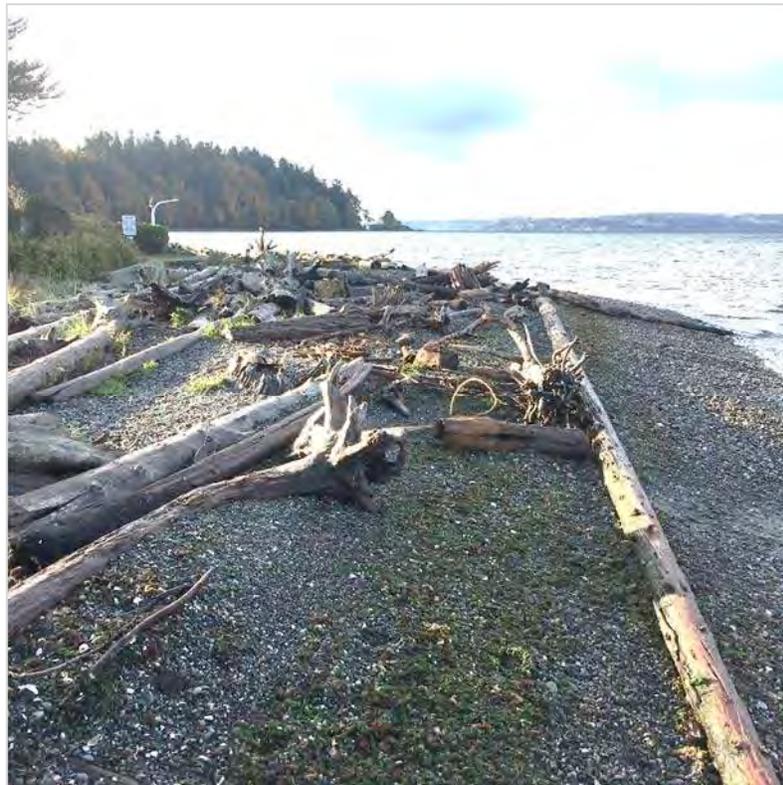
Photo 32. View to the South from Zone R-S.
 Source: Reid Middleton Site Visit 10/18/2016
