# Morrison Hotel

Certificate of Approval Application, Window Survey

509 Thrid Avenue South - Seattle, WA 98104

Survey conducted by SMR Architects in conjunction with DESC on the days of 07/09/2026, 07/10/2026, 7/23/2026.

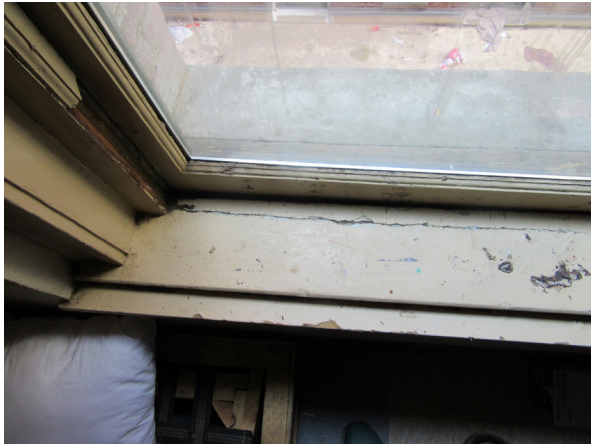
POOR Stool & Frame

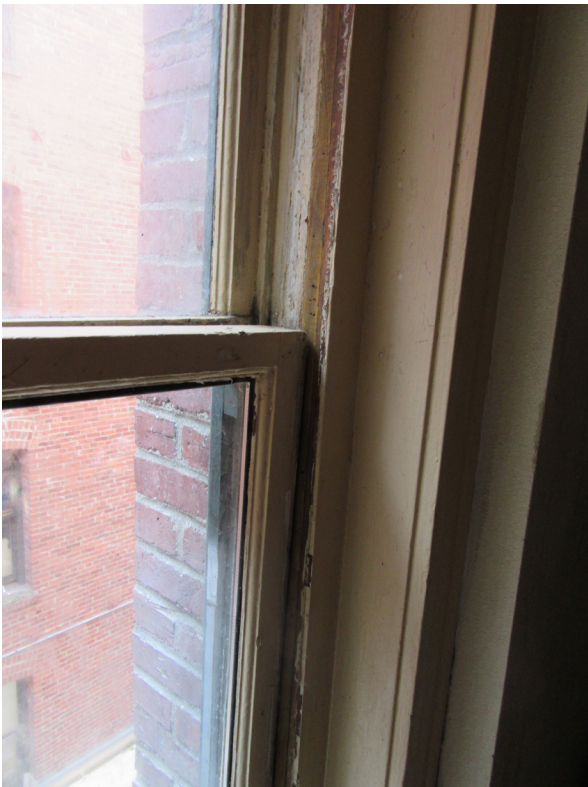
POOR Cord

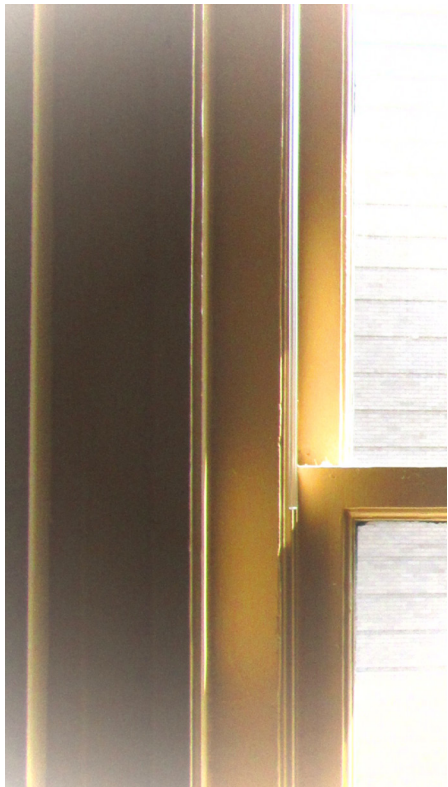
FAIR Frame

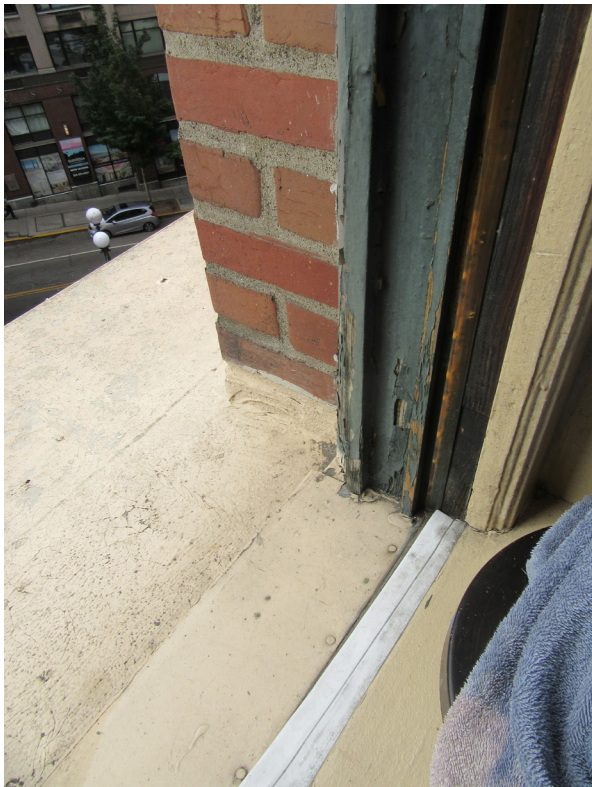
POOR Frame

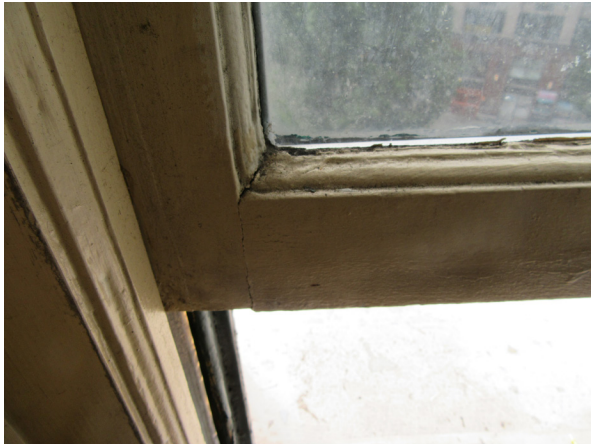
POOR Sash

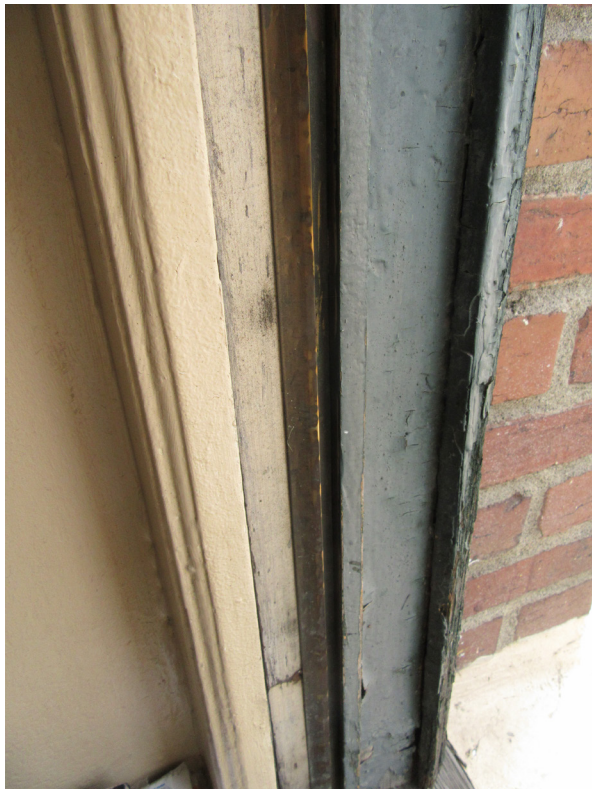
POOR Frame

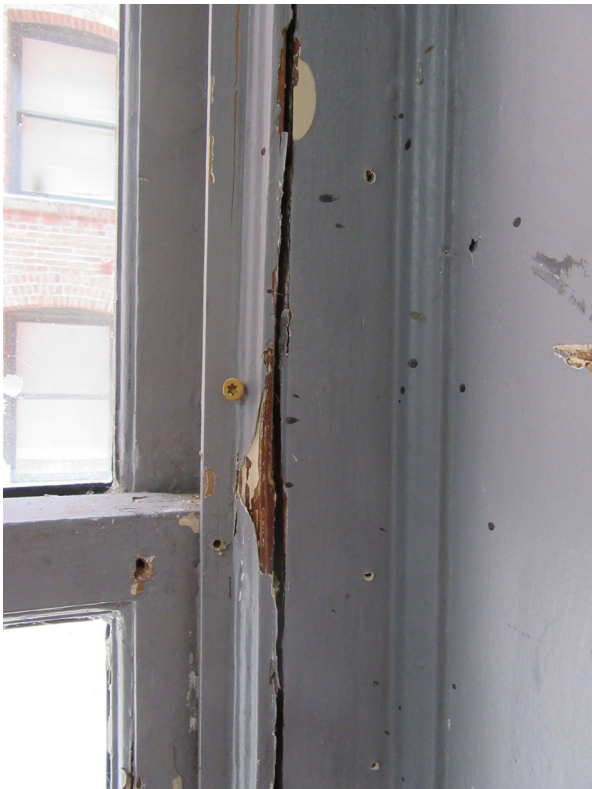
POOR Frame

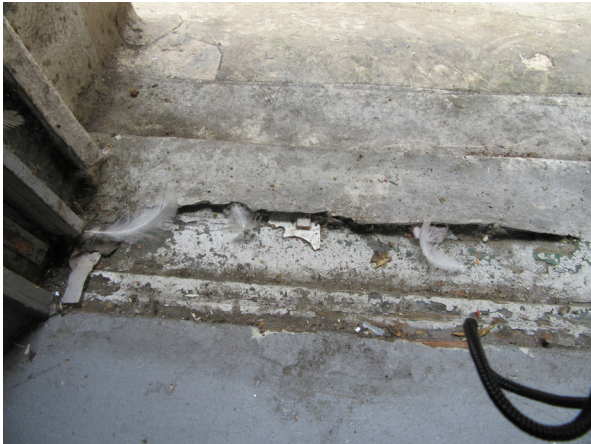
POOR Stool and Sill

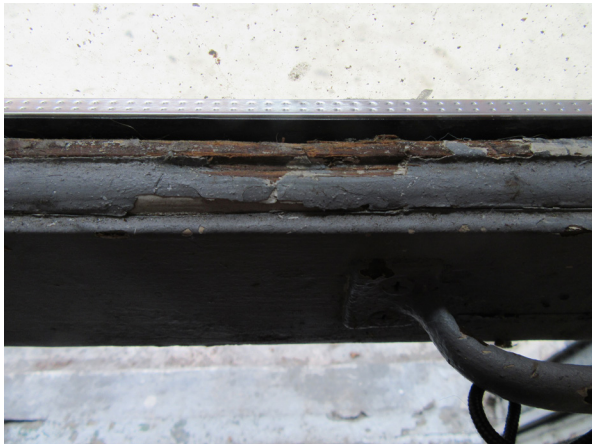
POOR Sash

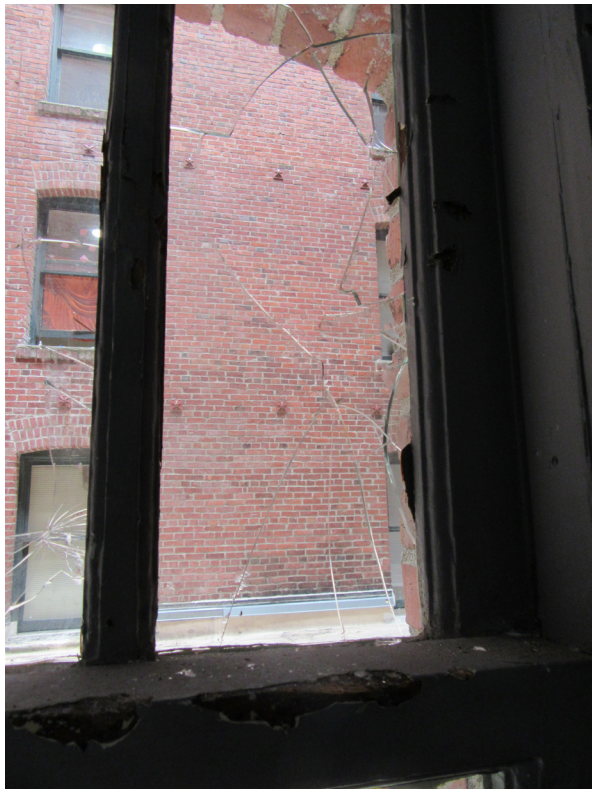
POOR Glazing

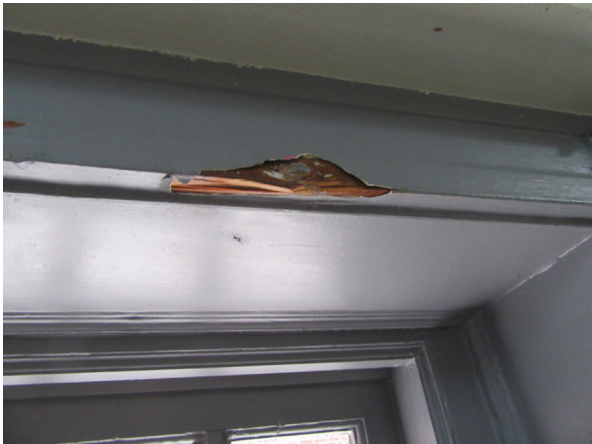
POOR Trim

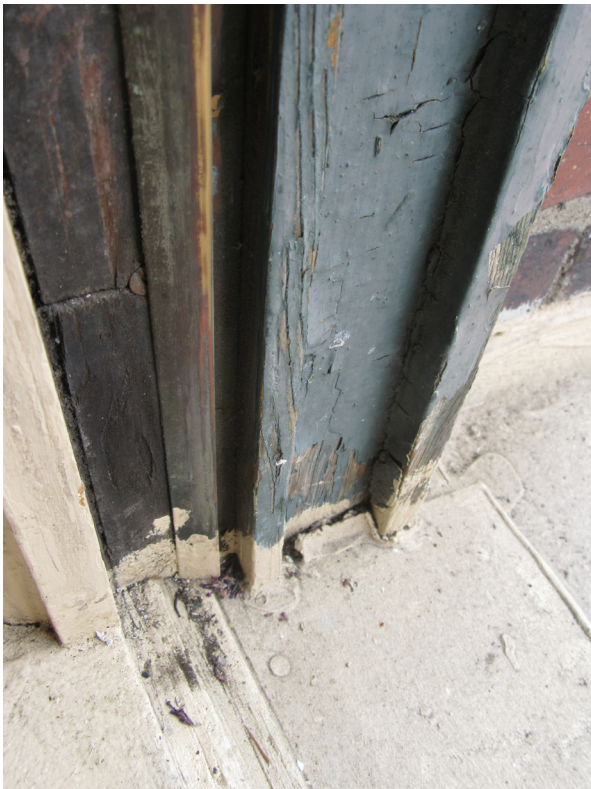
POOR Frame

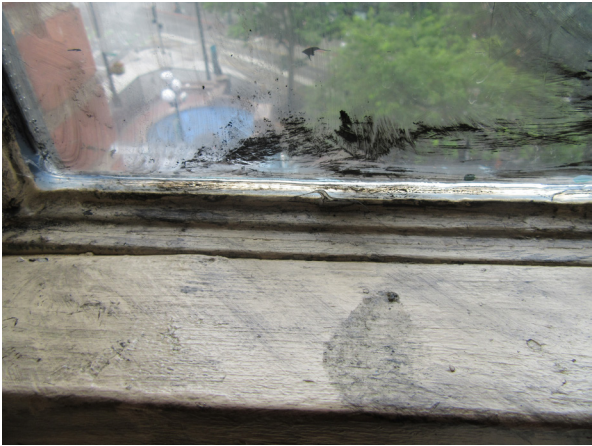
POOR Glazing

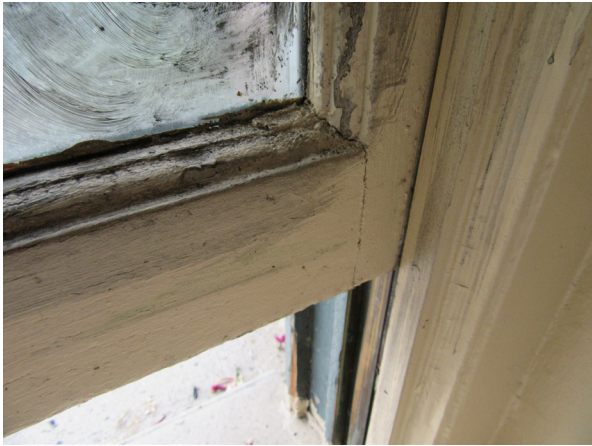
POOR Sash

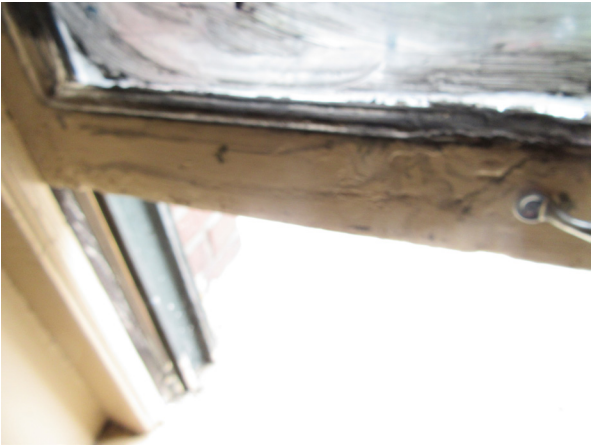
POOR Sash

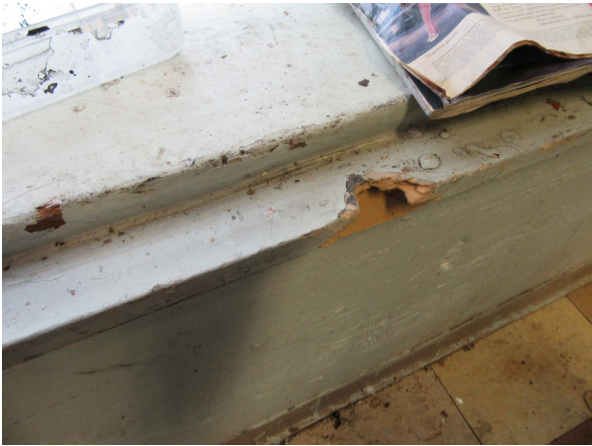
POOR Stool

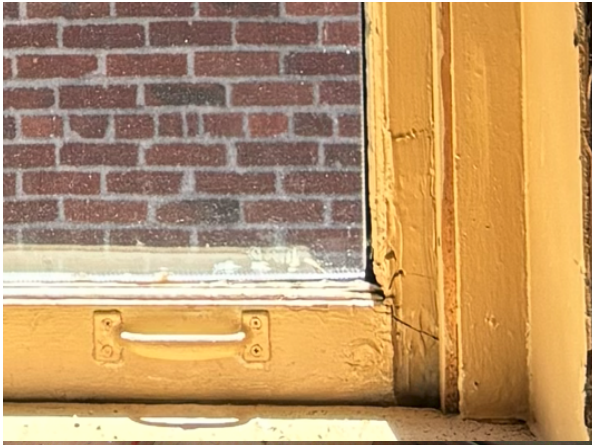
POOR Sash

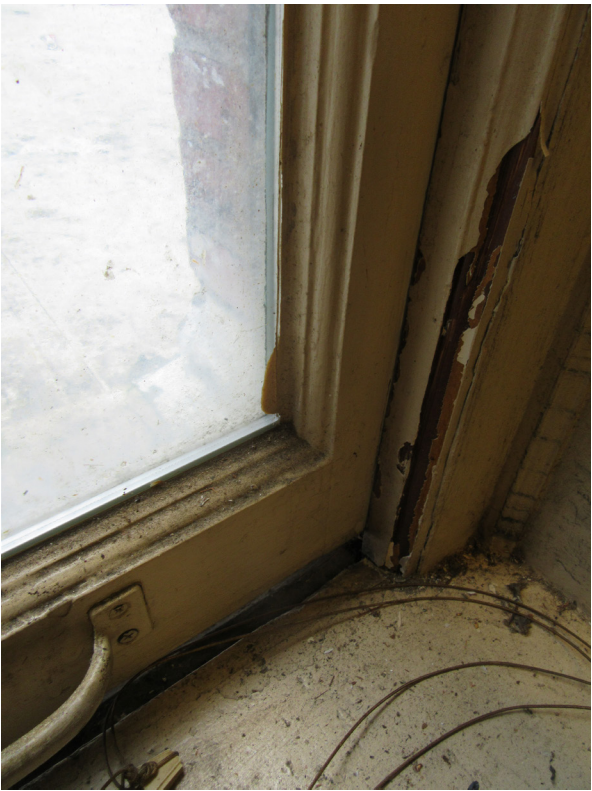
POOR Frame

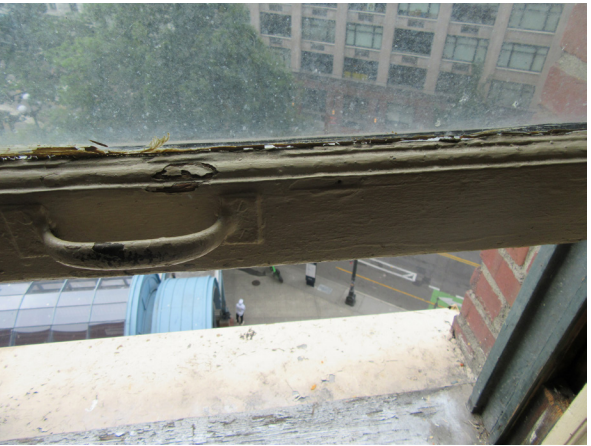
POOR Sash

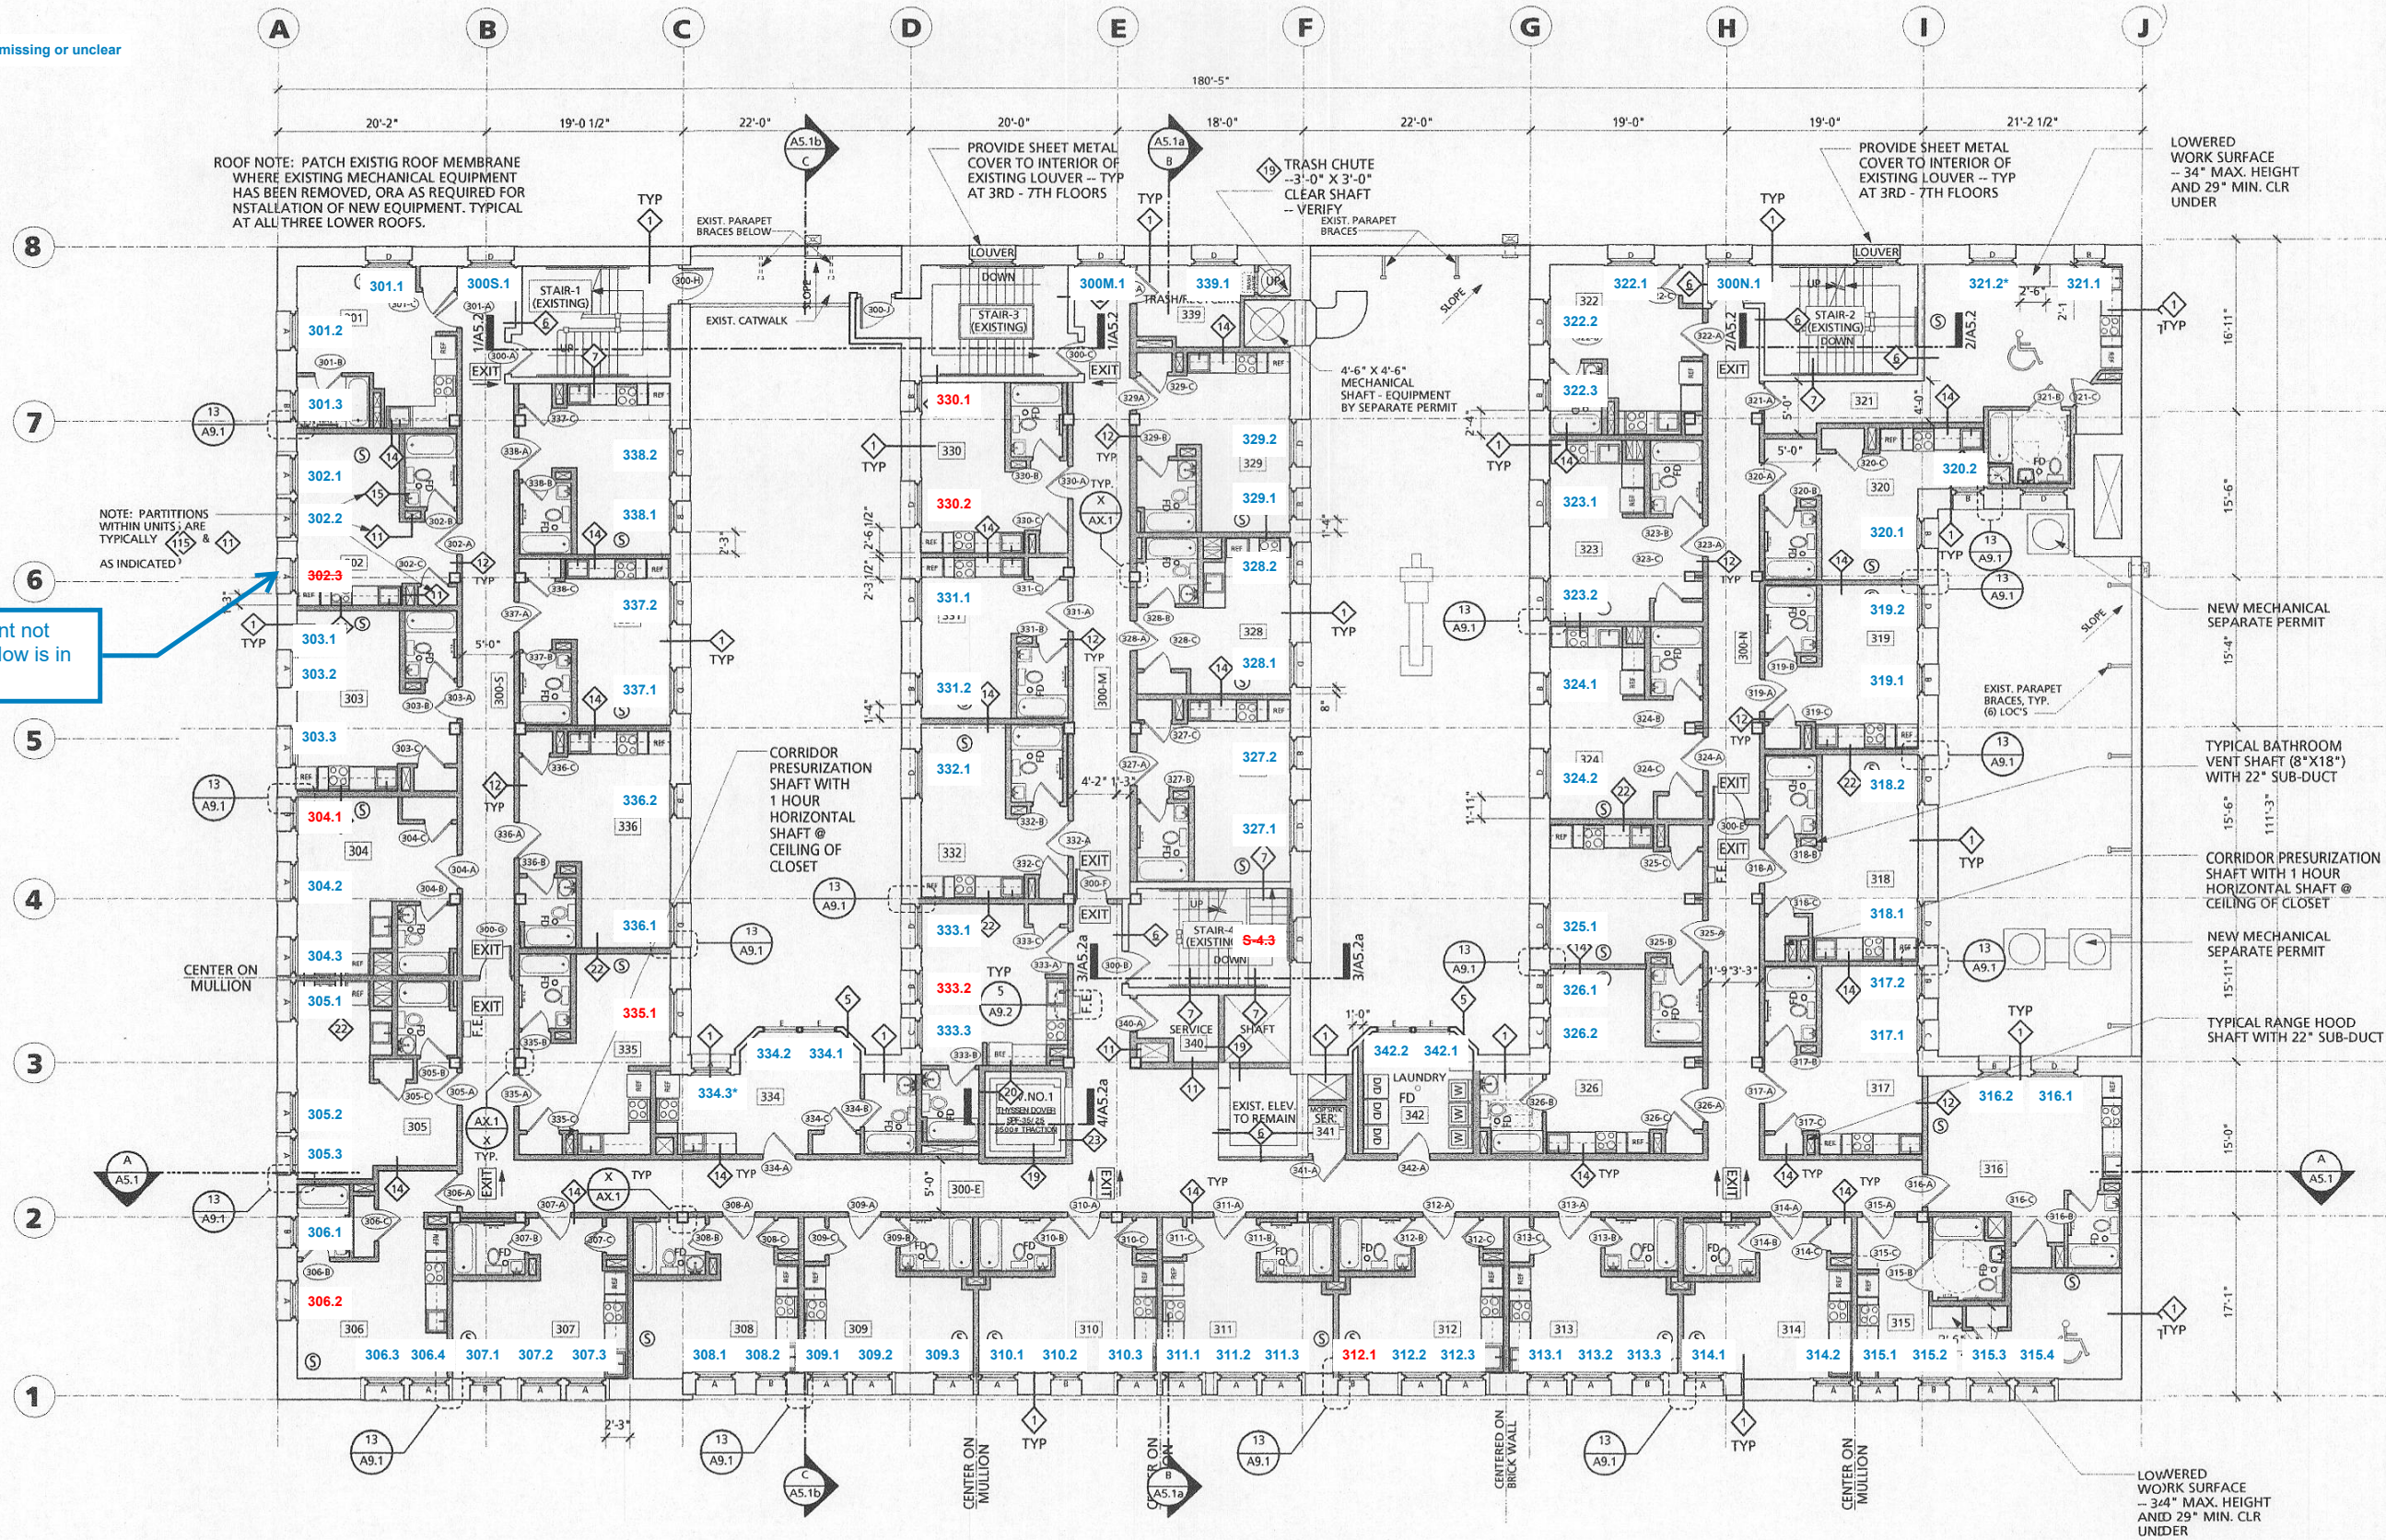
THIRD FLOOR PLAN

Window placement not correct. This window is in the X03 stack.

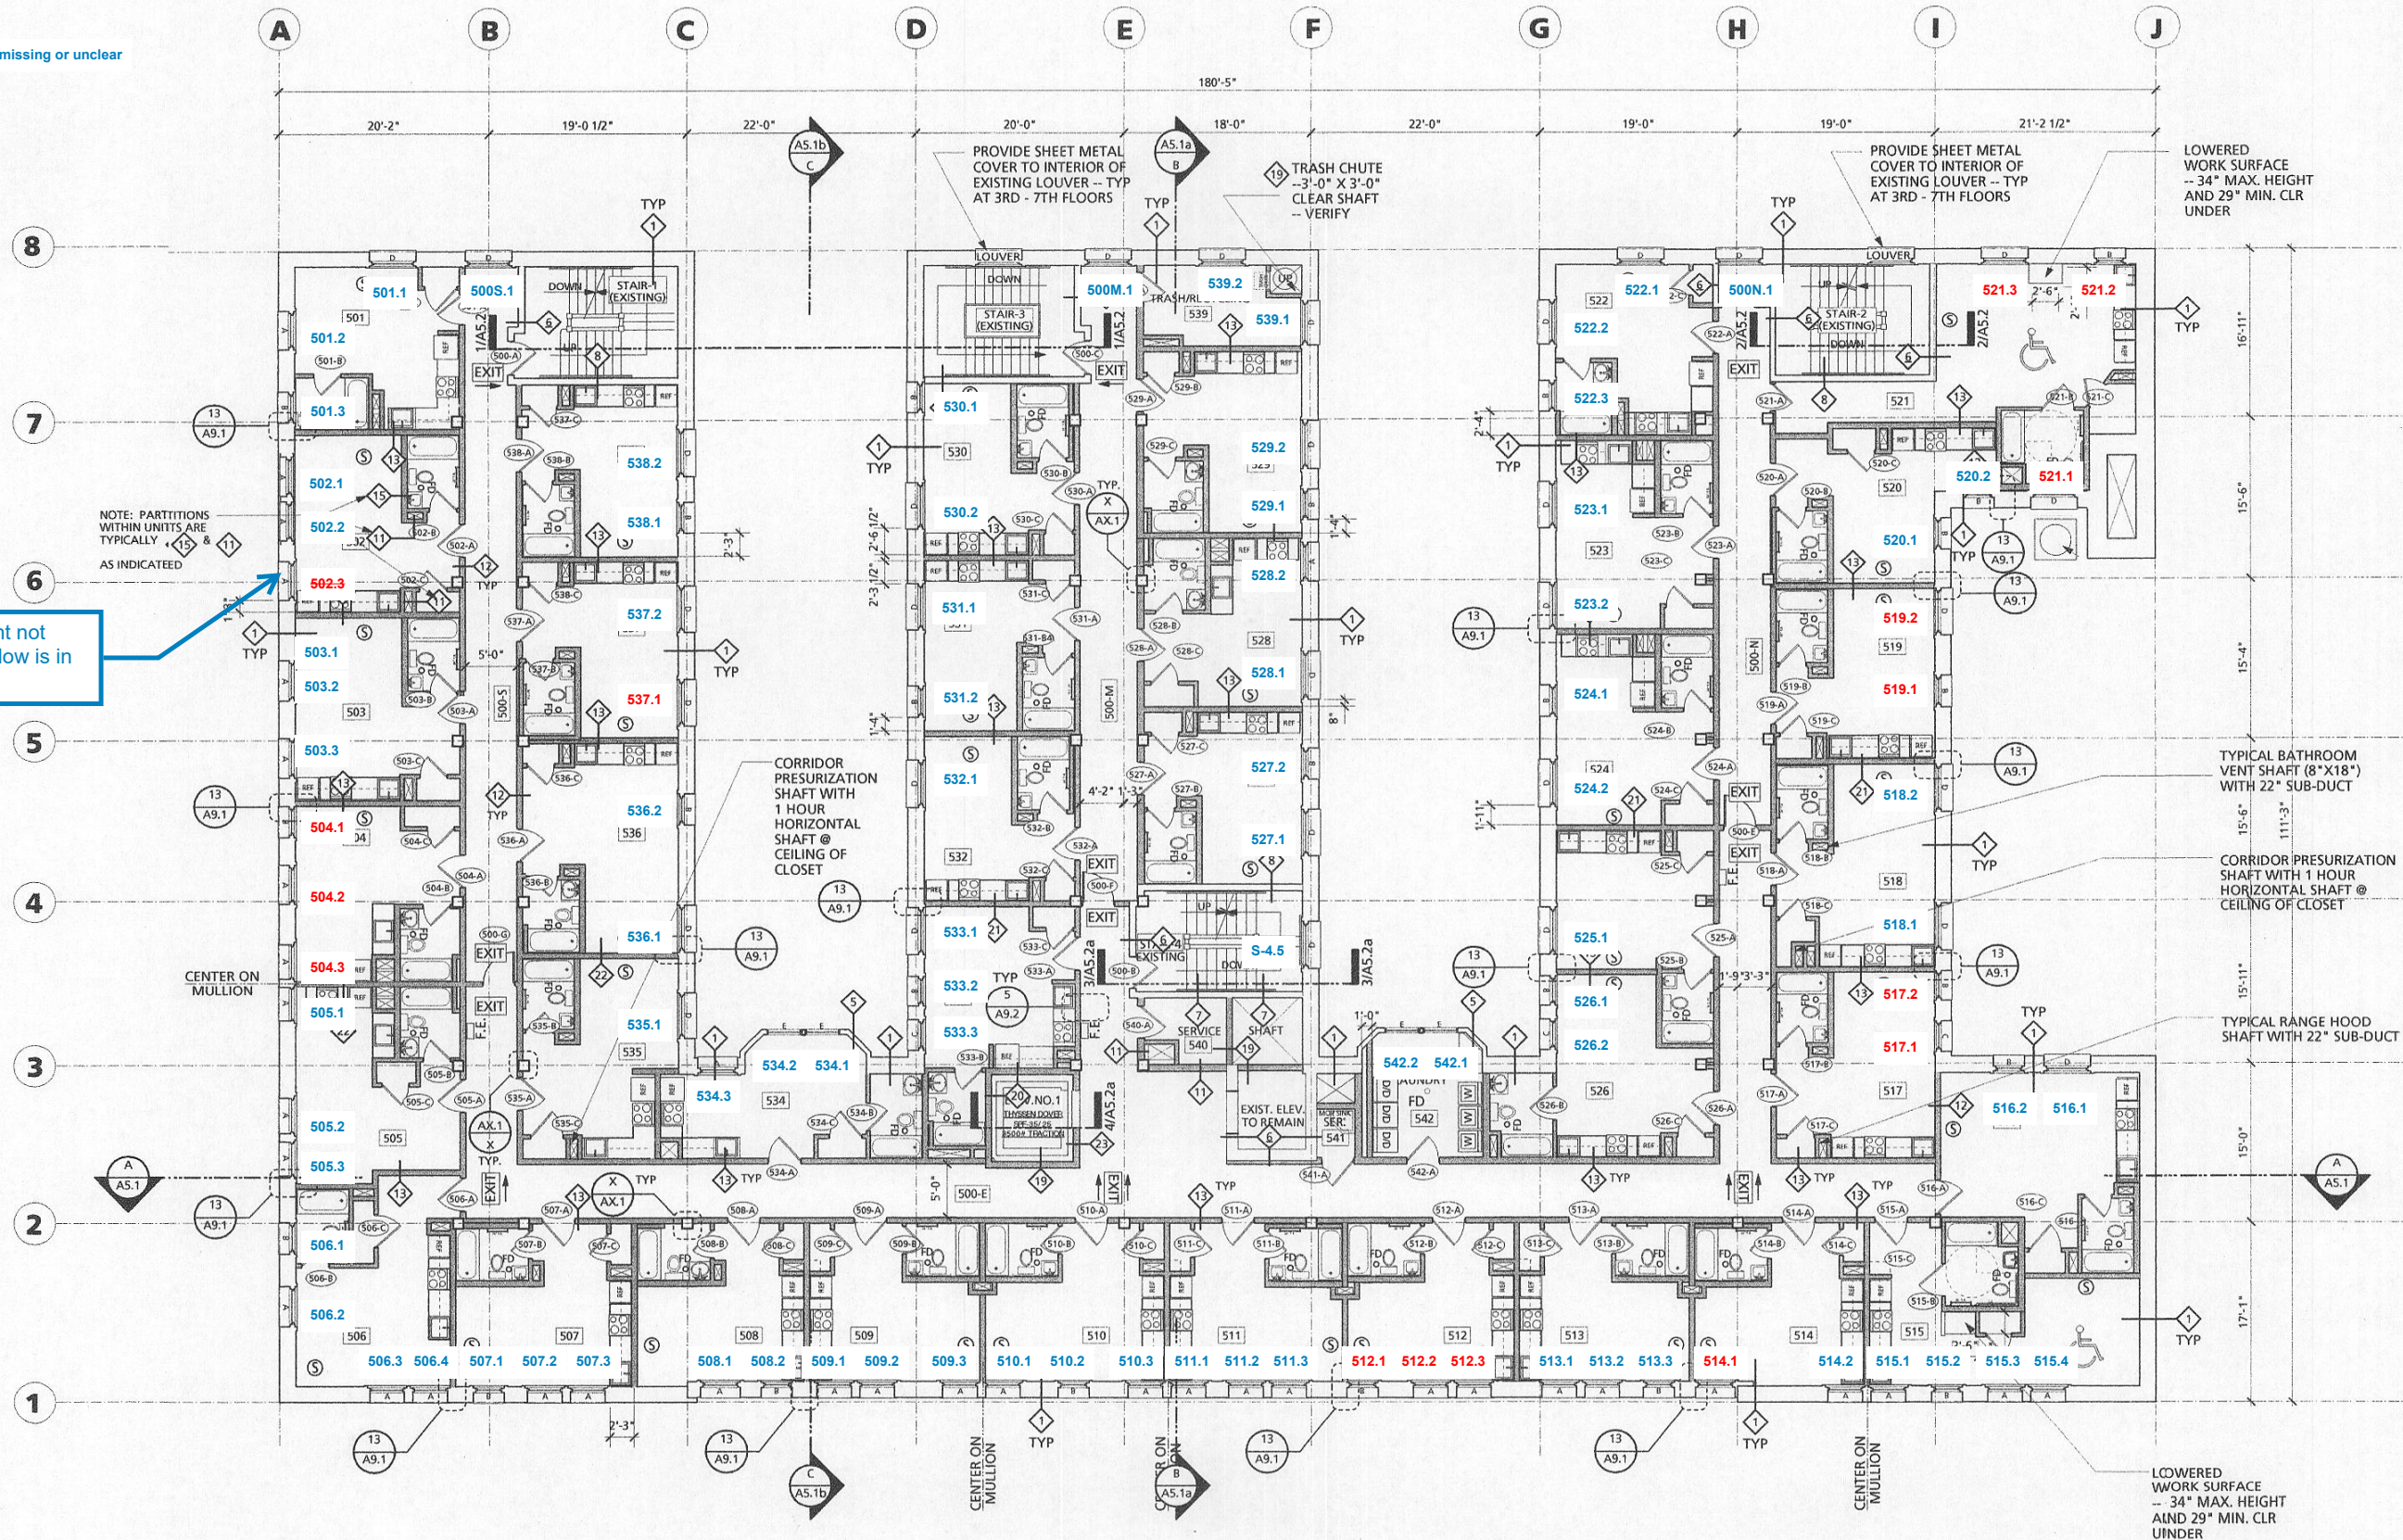
FIFTH FLOOR PLAN

window placement not correct. This window is in the X03 stack.

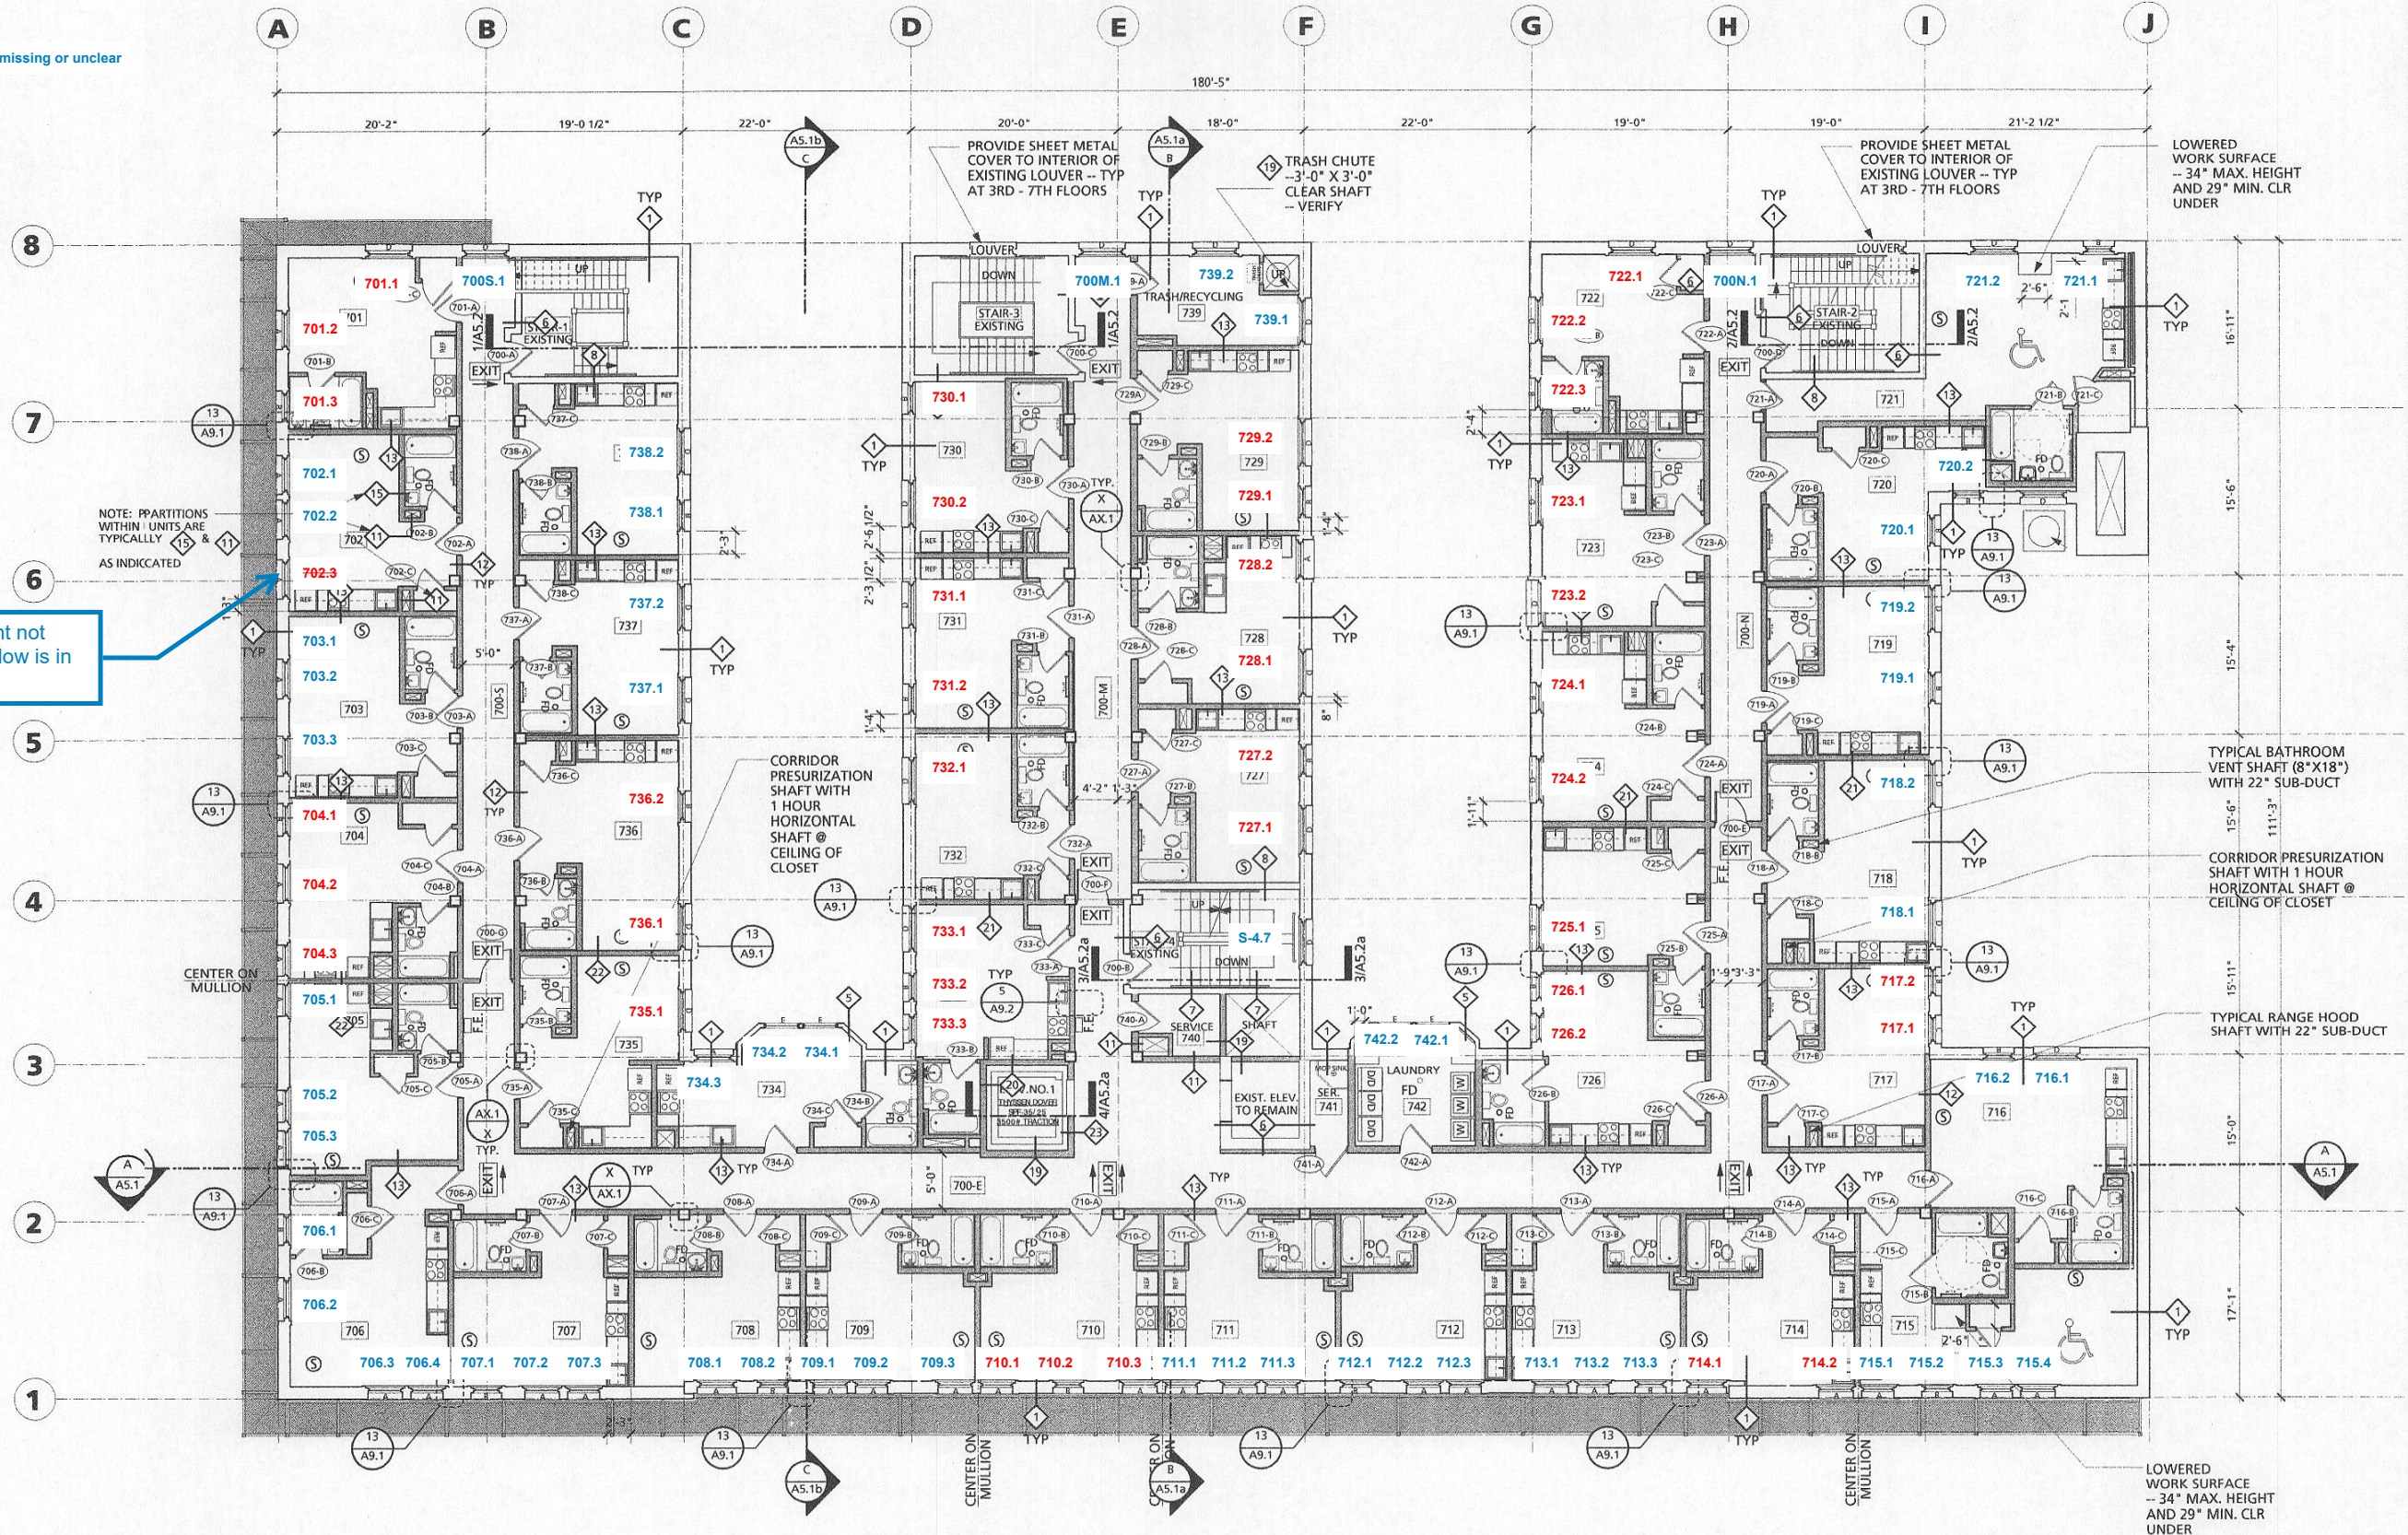
SEVENTH FLOOR PLAN

window placement not correct. This window is in the X03 stack.
