# Gatewood Elementary

Historic Wood Window Refurbishment & Glazing Replacement

Seattle Public Schools

Seattle Department of Neighborhoods  
Historic Preservation & Landmarks

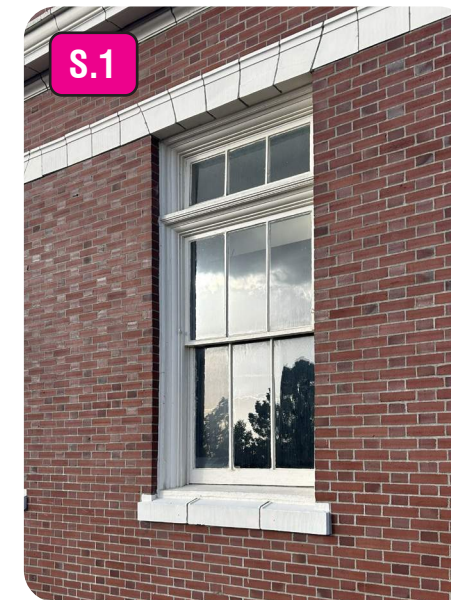
**Level 2-3**

Operable pivoting transom window over double hung operable windows at classrooms. The window in this photo is the mock-up window

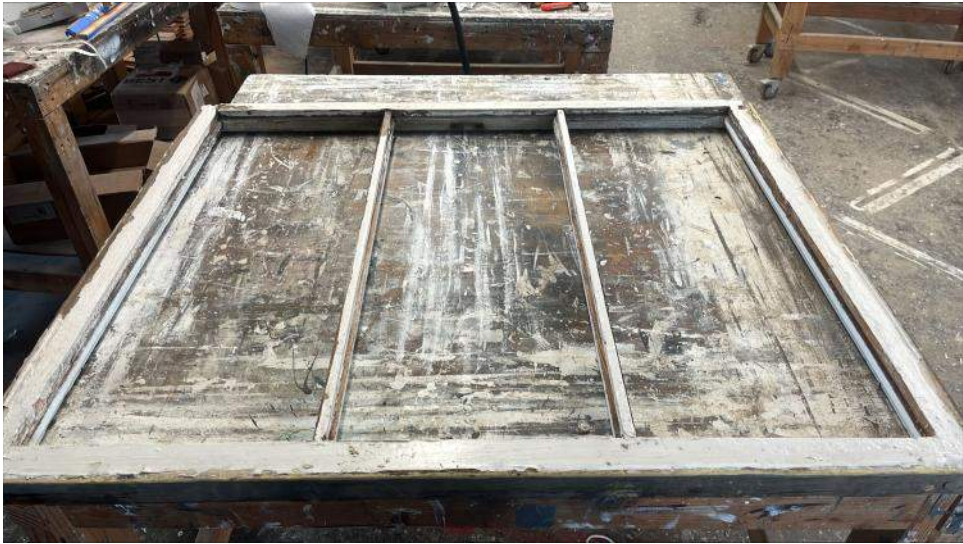
Rot beginning in Muntins and failing paint

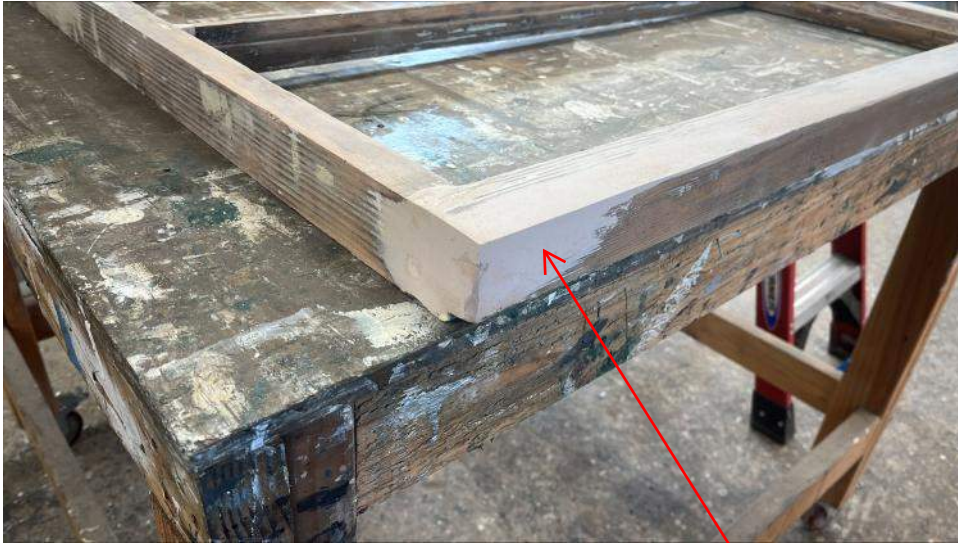
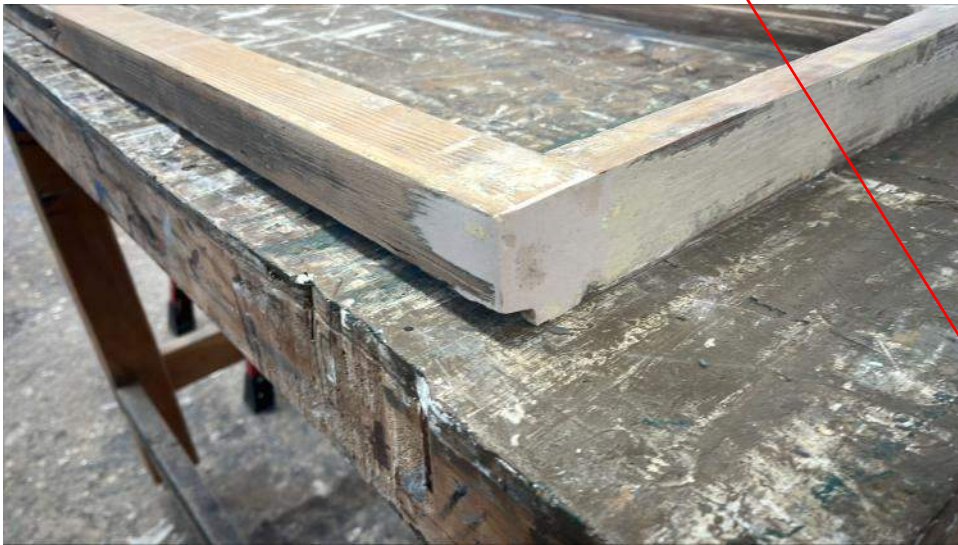
Rot has been removed and consolidated with System three "Rot Fix" then filled and patched with "Sculpwood" Epoxy

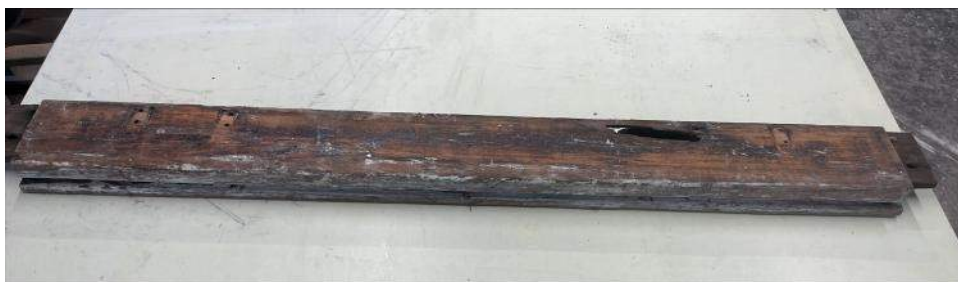
The bottom rail of the bottom sash was rotten beyond repair

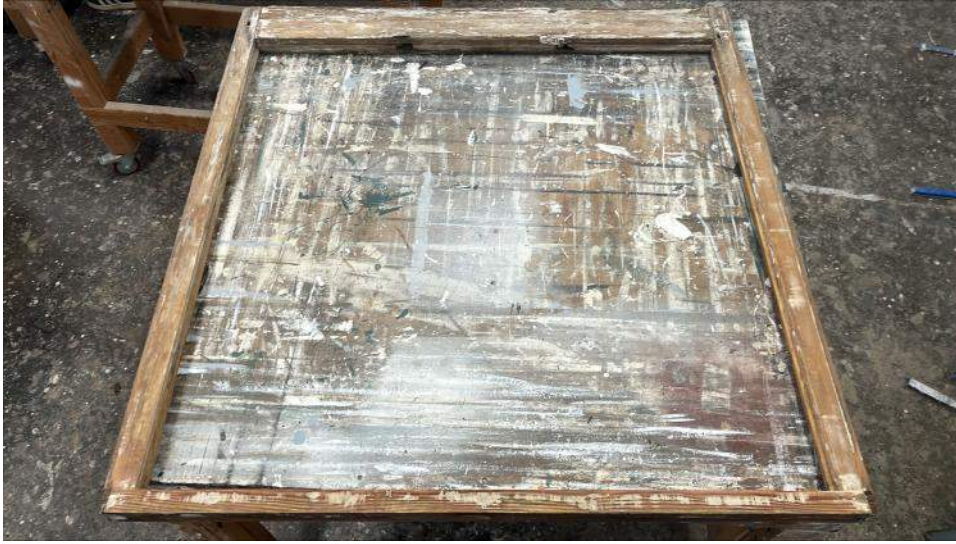
Sticking (Muntins) will be reassembled along with the bottom rail replacement
