LEONA CONDOMINIUMS REMEDIATION

916 QUEEN ANNE AVE. N, SEATTLE, WA 98109

WINDOW REPLACEMENT PROPOSAL

THE SURVEY OF WINDOWS AND DOORS AT THE LEONA CONDOS WERE COMPLETED IN APRIL 2021. MOST OF THE WINDOWS APPEAR TO HAVE DETERIORATED AND THE CONDITION OF THE WINDOWS/DOORS HAVE WORSEN FOR THE LAST TWO YEARS.

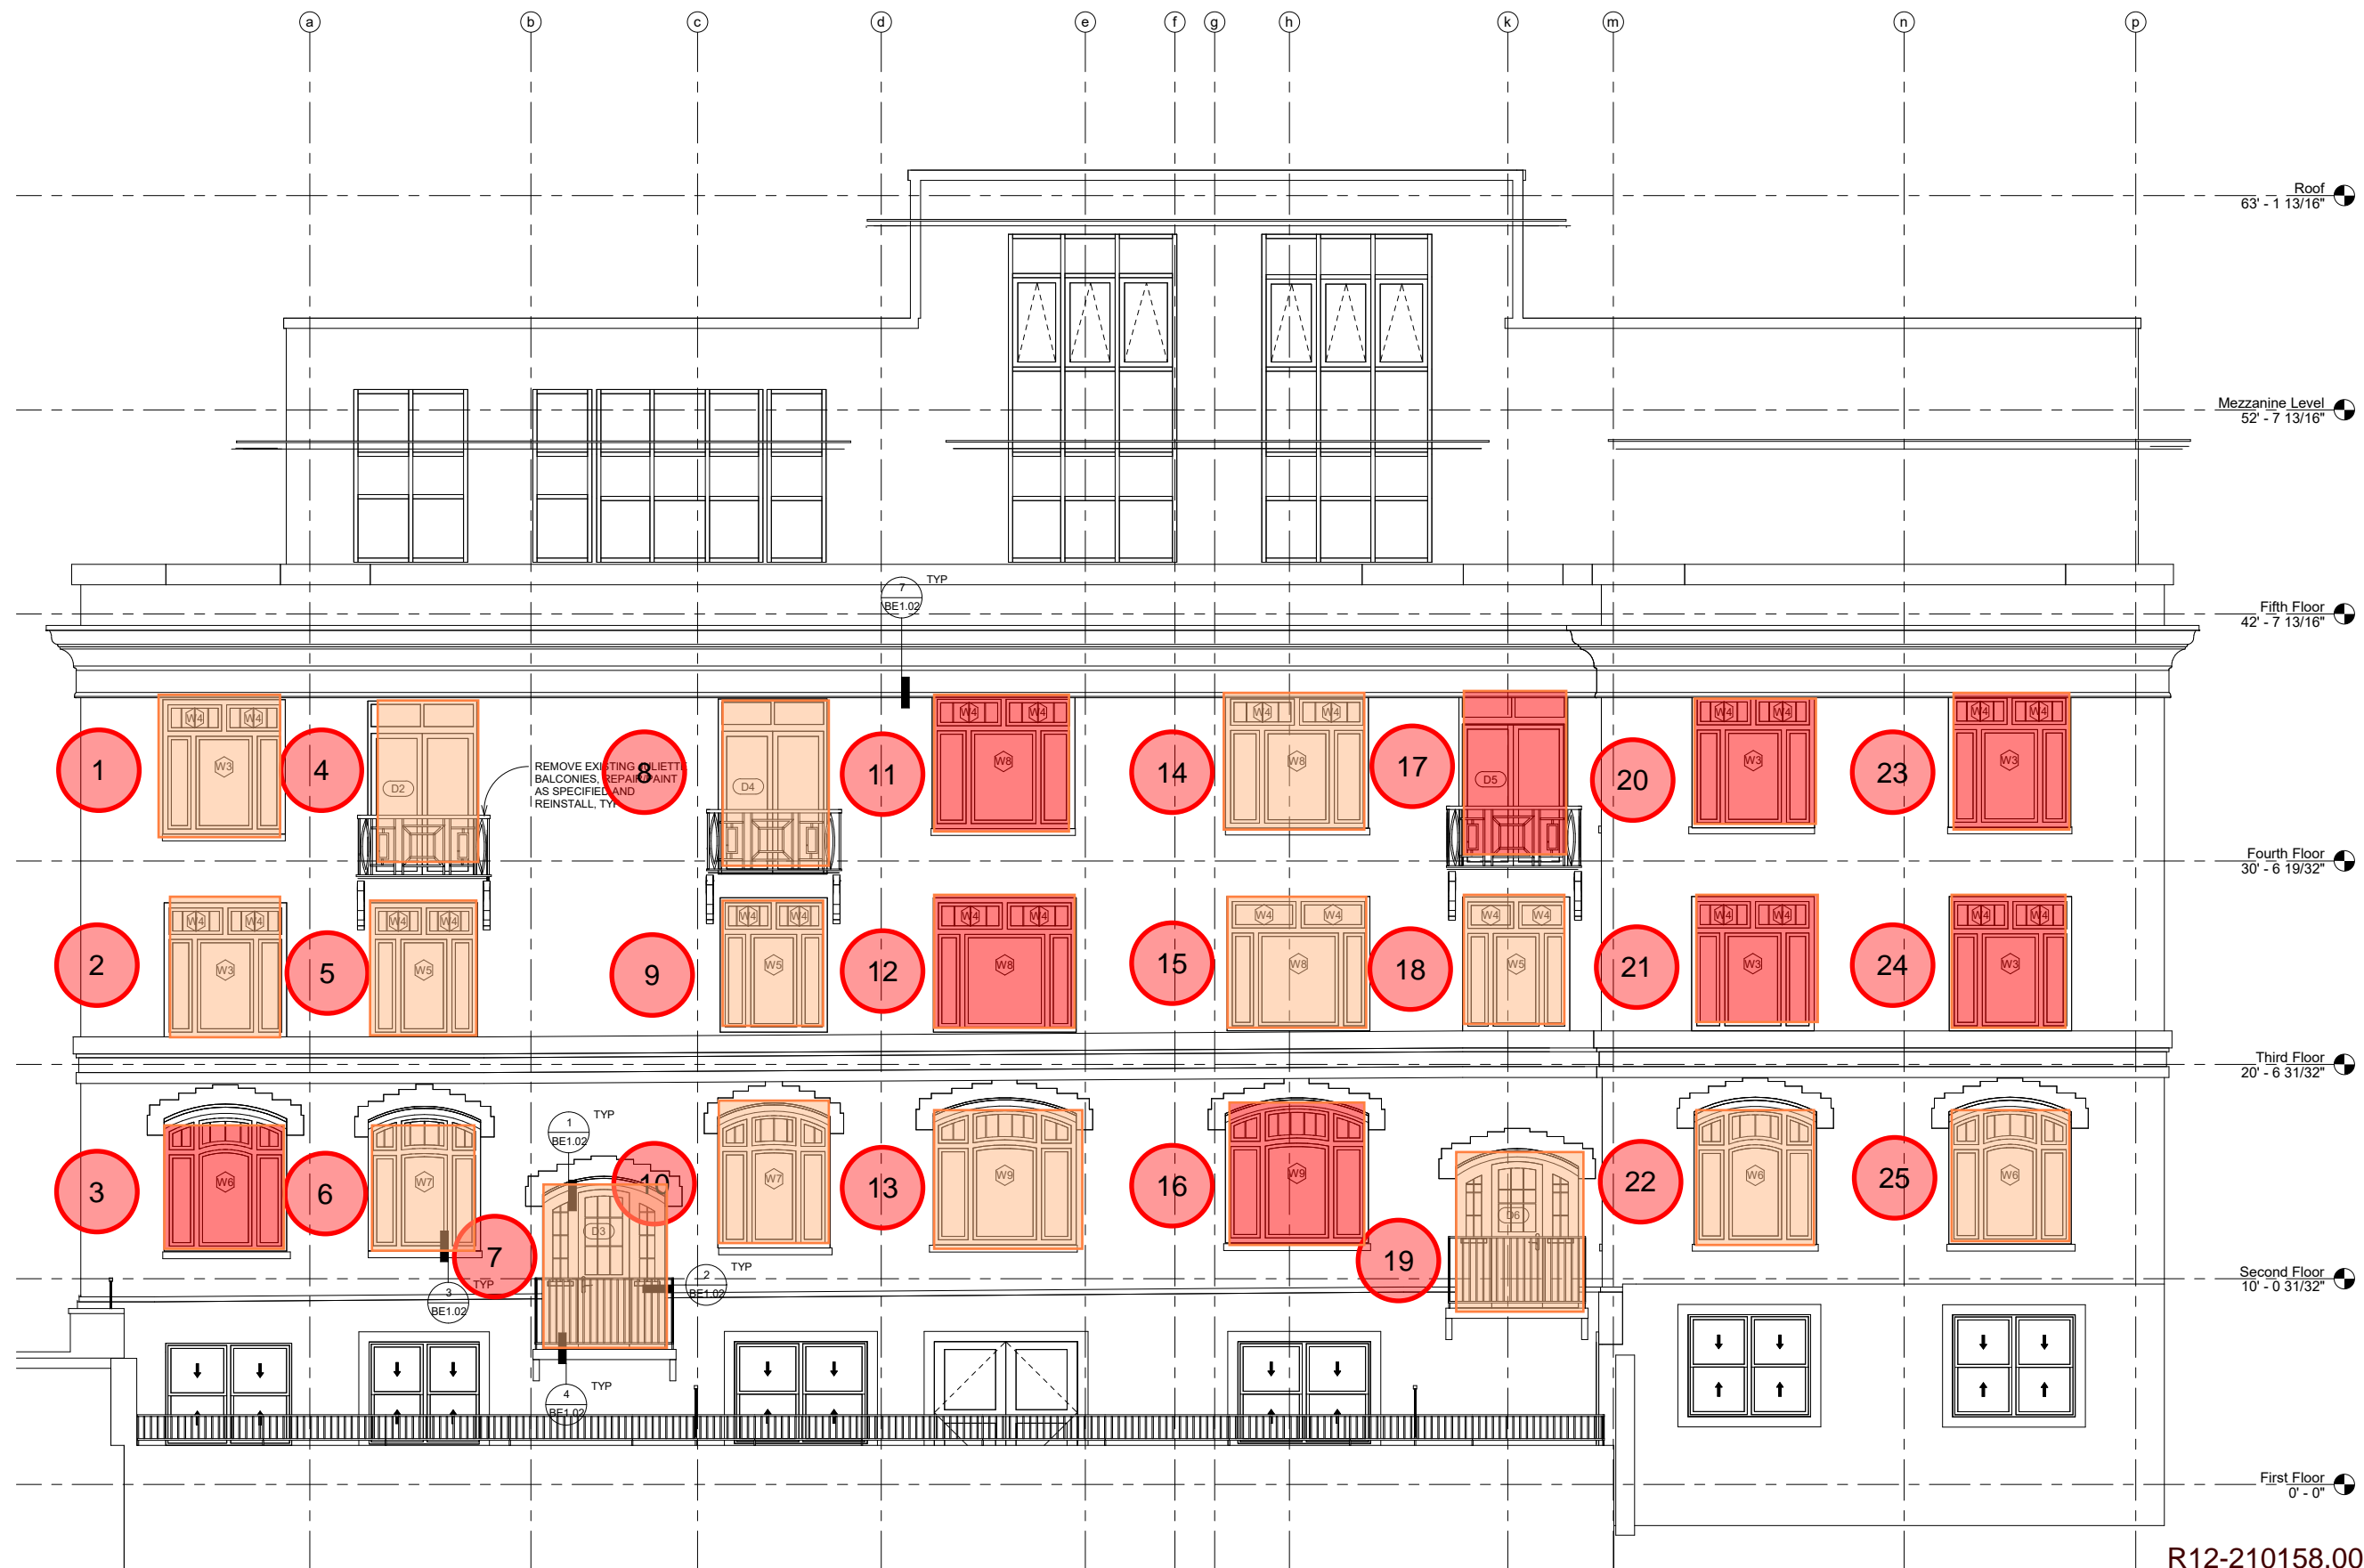
① SOUTH ELEVATION
1/4" = 1'-0"

- MODERATE UNIT CONDITION
- POOR UNIT CONDITION

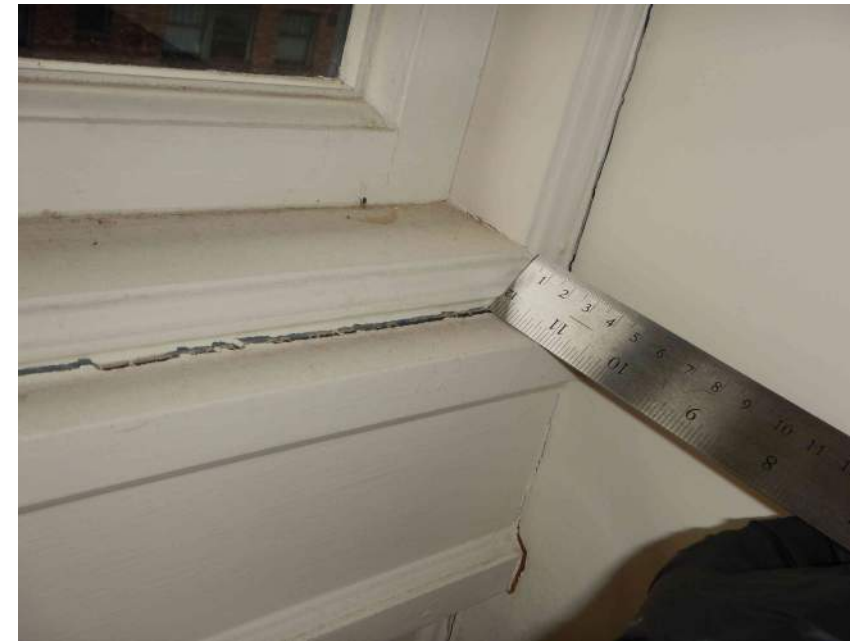
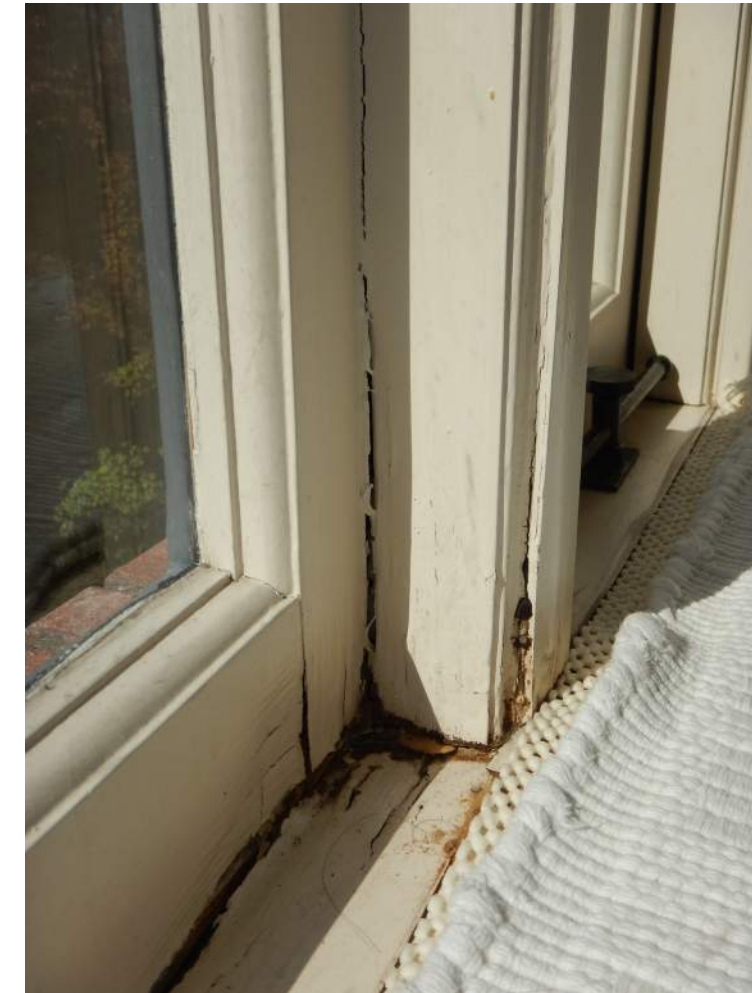
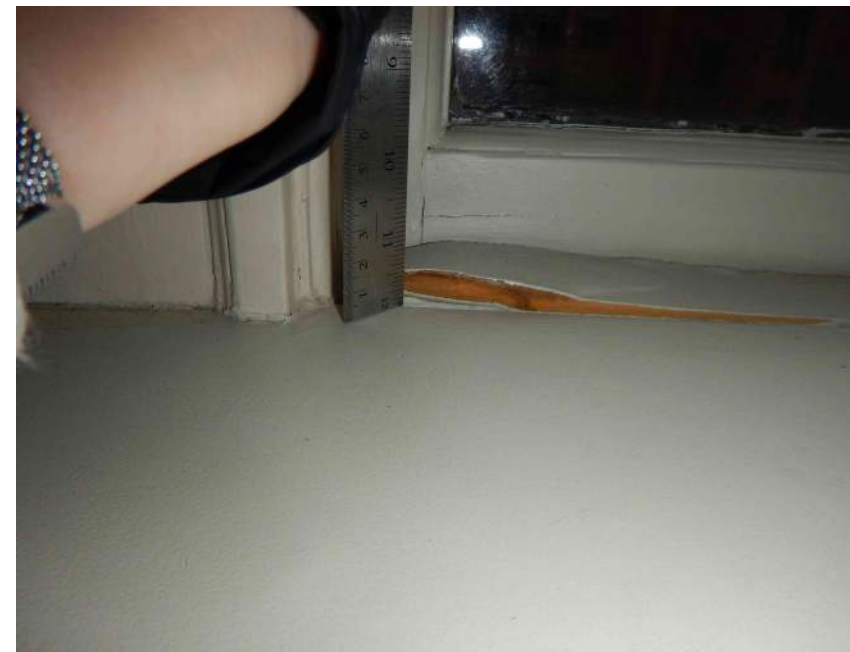
WINDOW - 1

Surface Defect Conditions - Heavily deteriorated paint at sills and frame, deteriorated sealant at rough opening

Moderate Conditions - Cracking at frame and joints, separation at rough opening

Poor Conditions - Deteriorated frame, swelling, cracking and separation of joints between elements, corroded lintels

Condition: Moderate

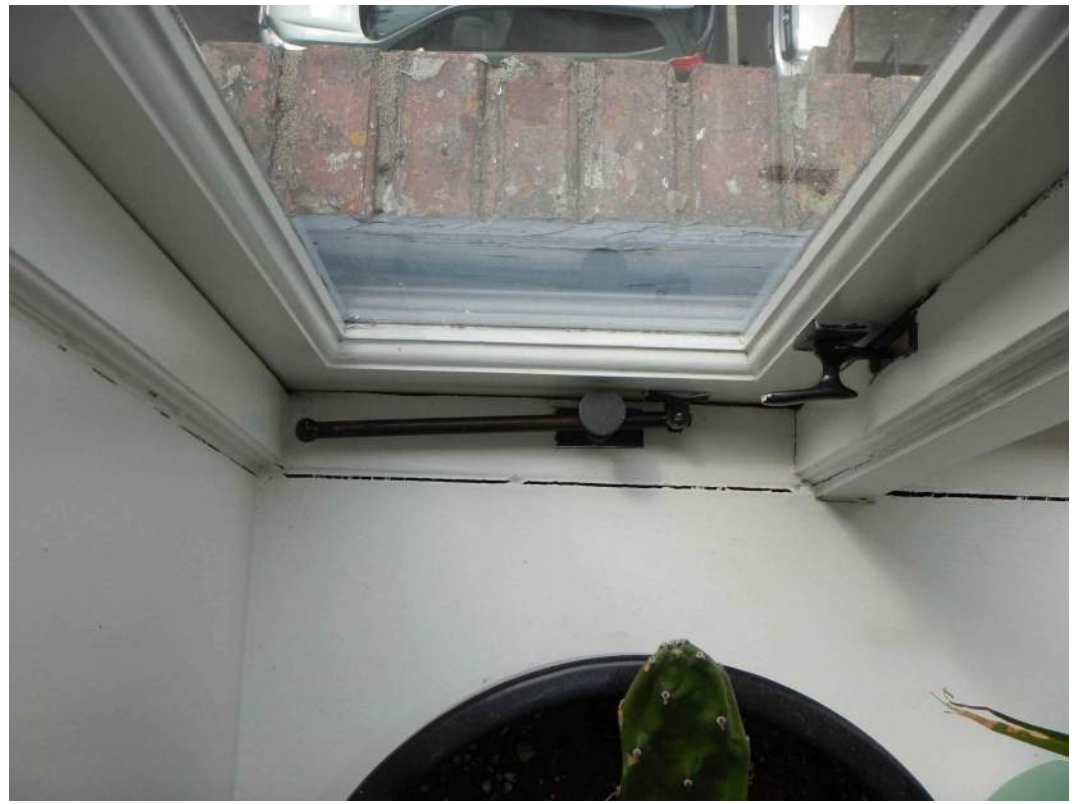
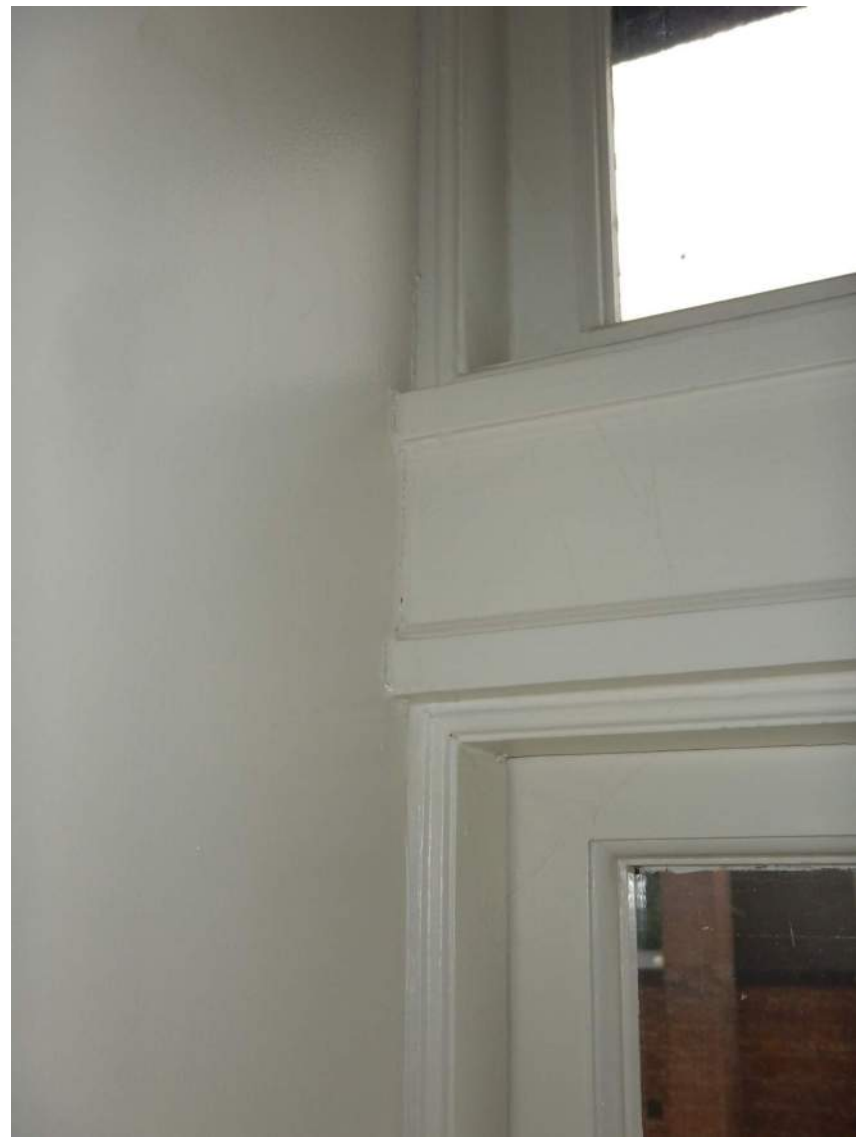
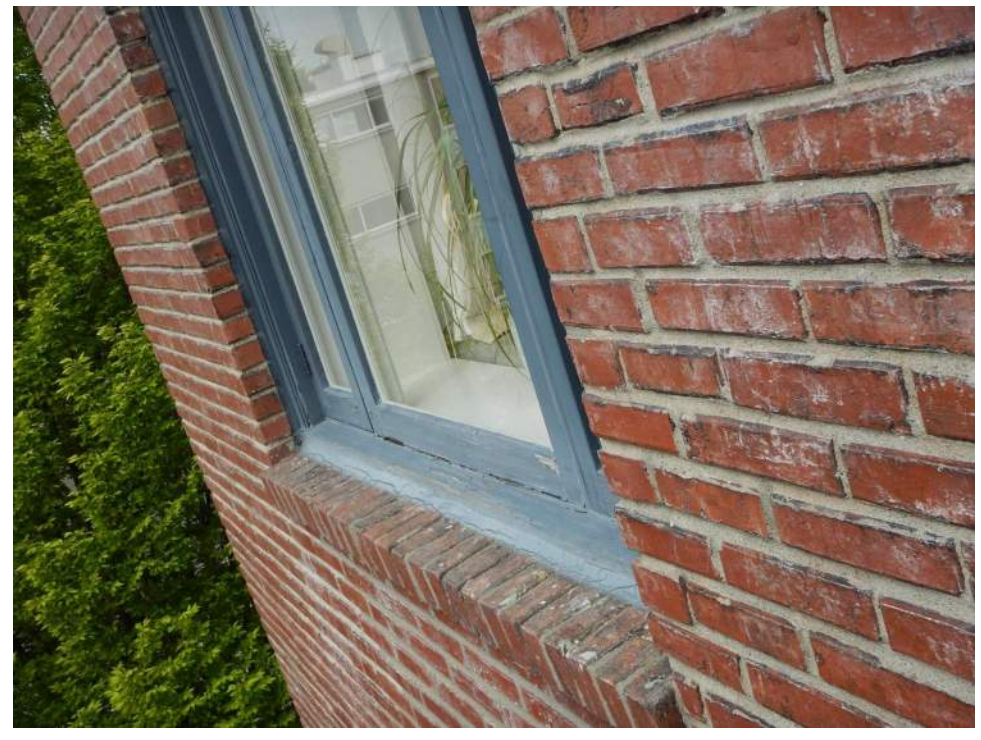
WINDOW - 2

Condition: Moderate

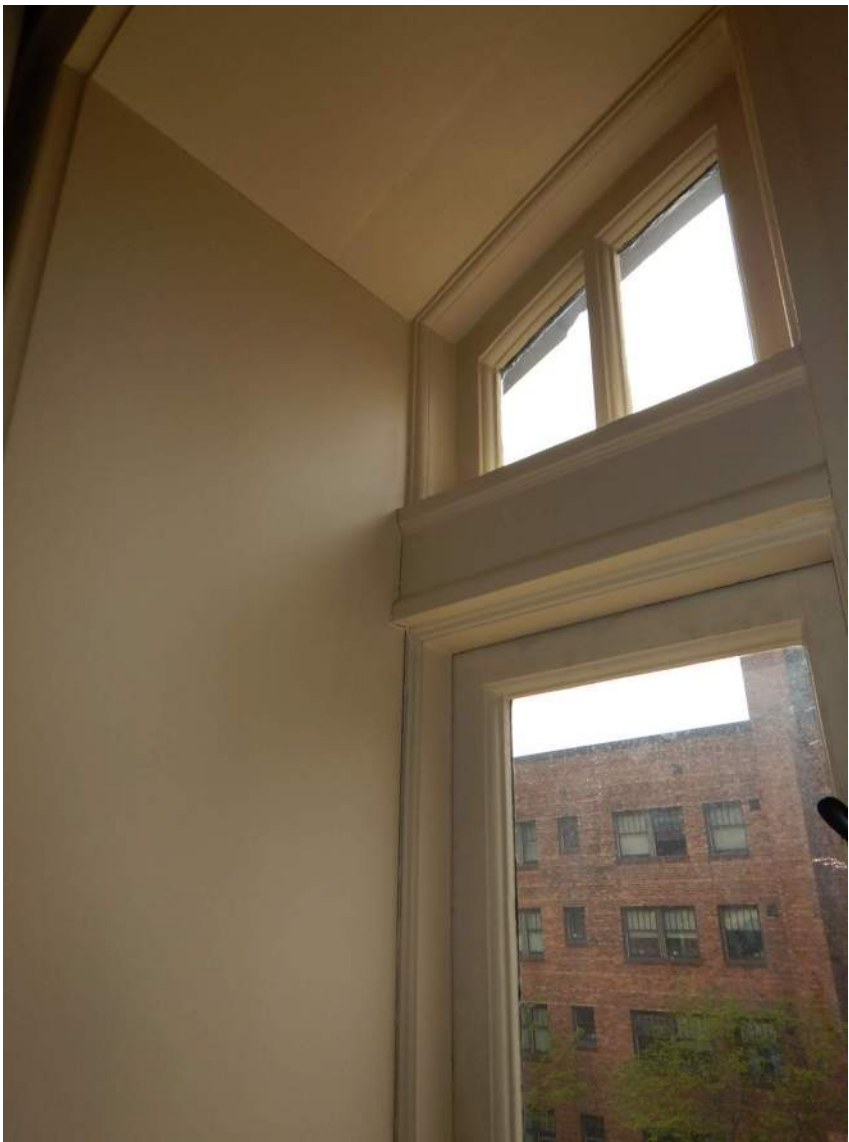
DOOR - 4

Condition: Moderate

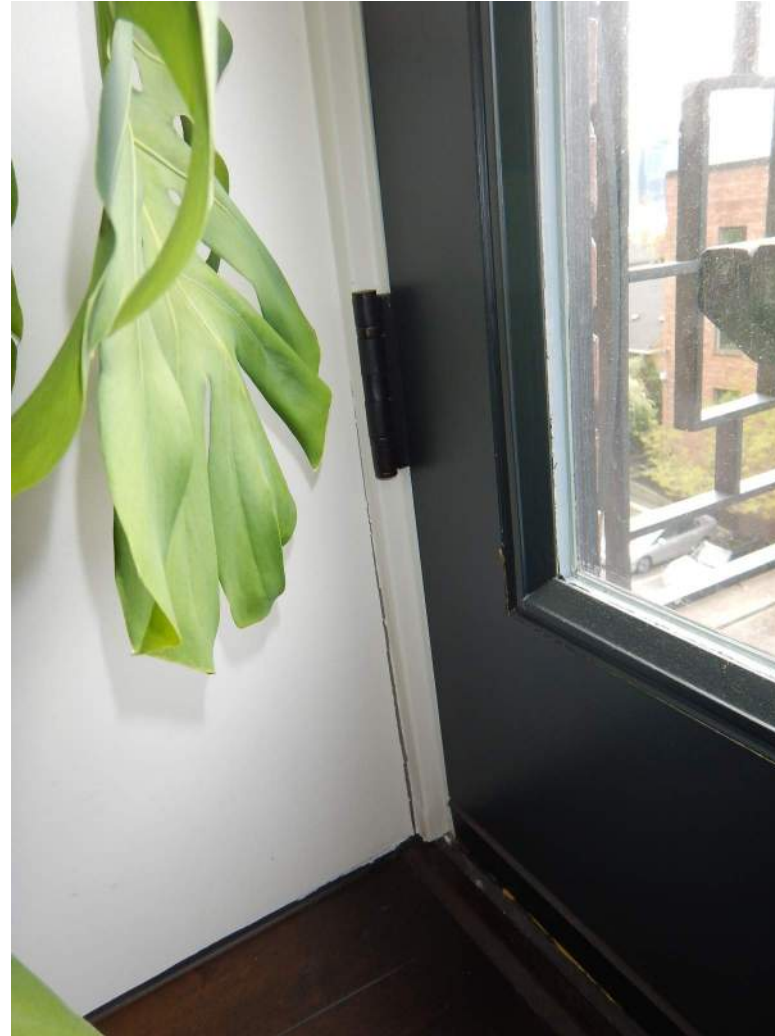
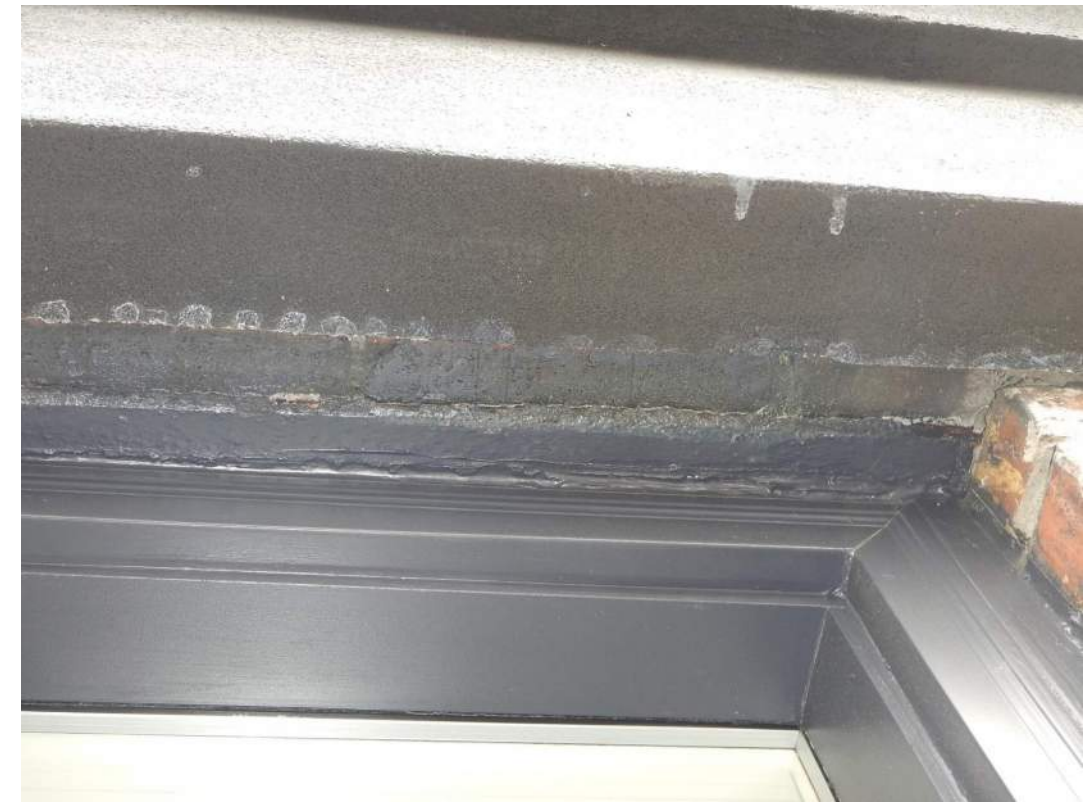
WINDOW - 5

Condition: Moderate

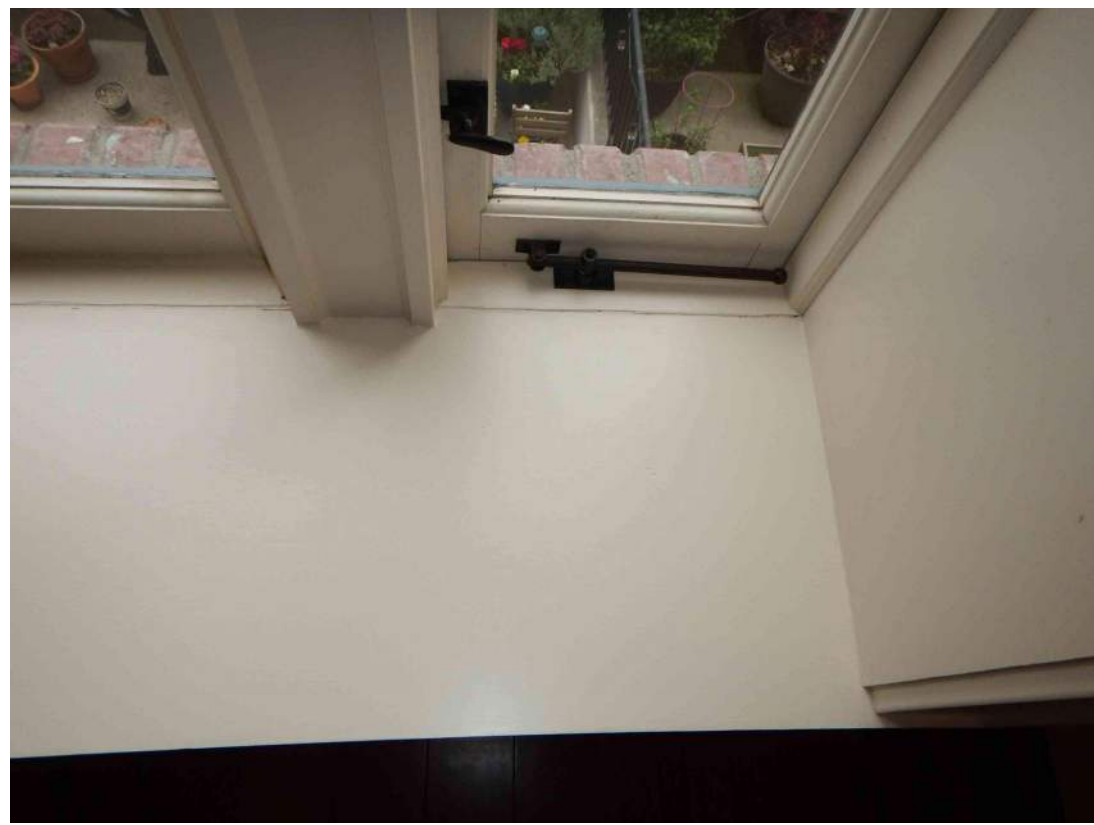
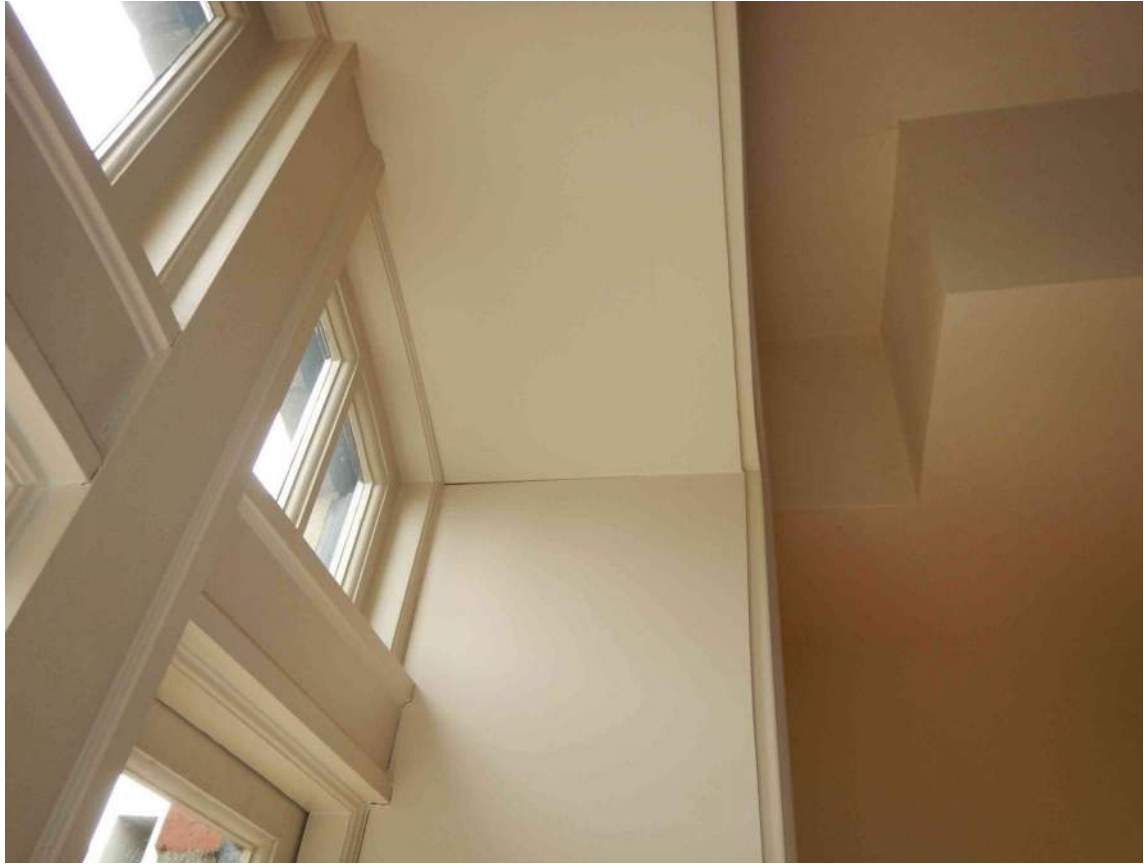
WINDOW - 11

Condition: Poor

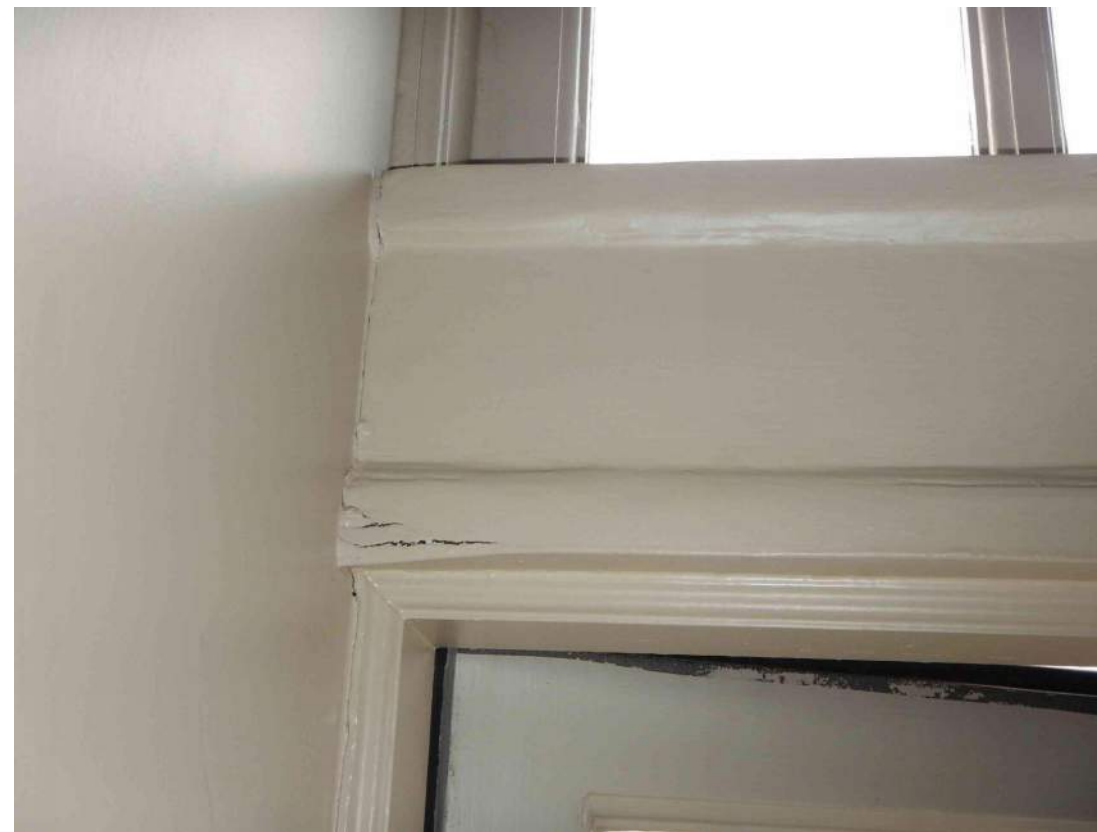
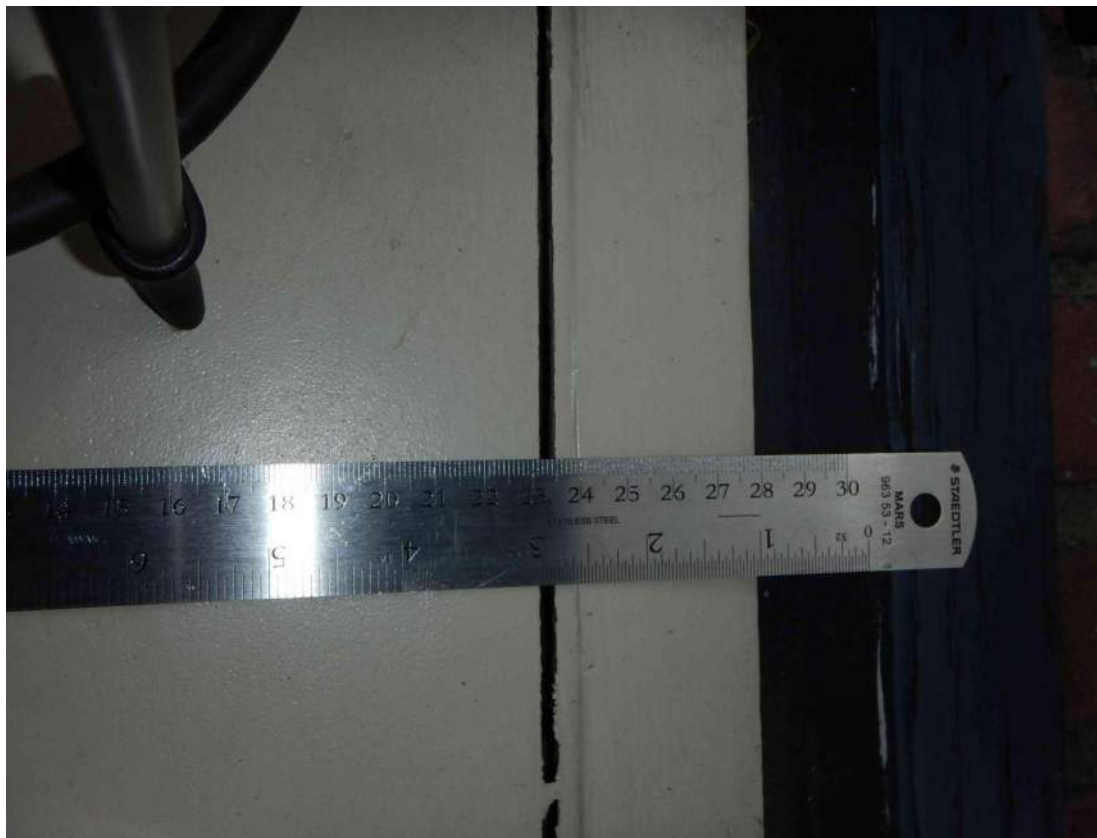
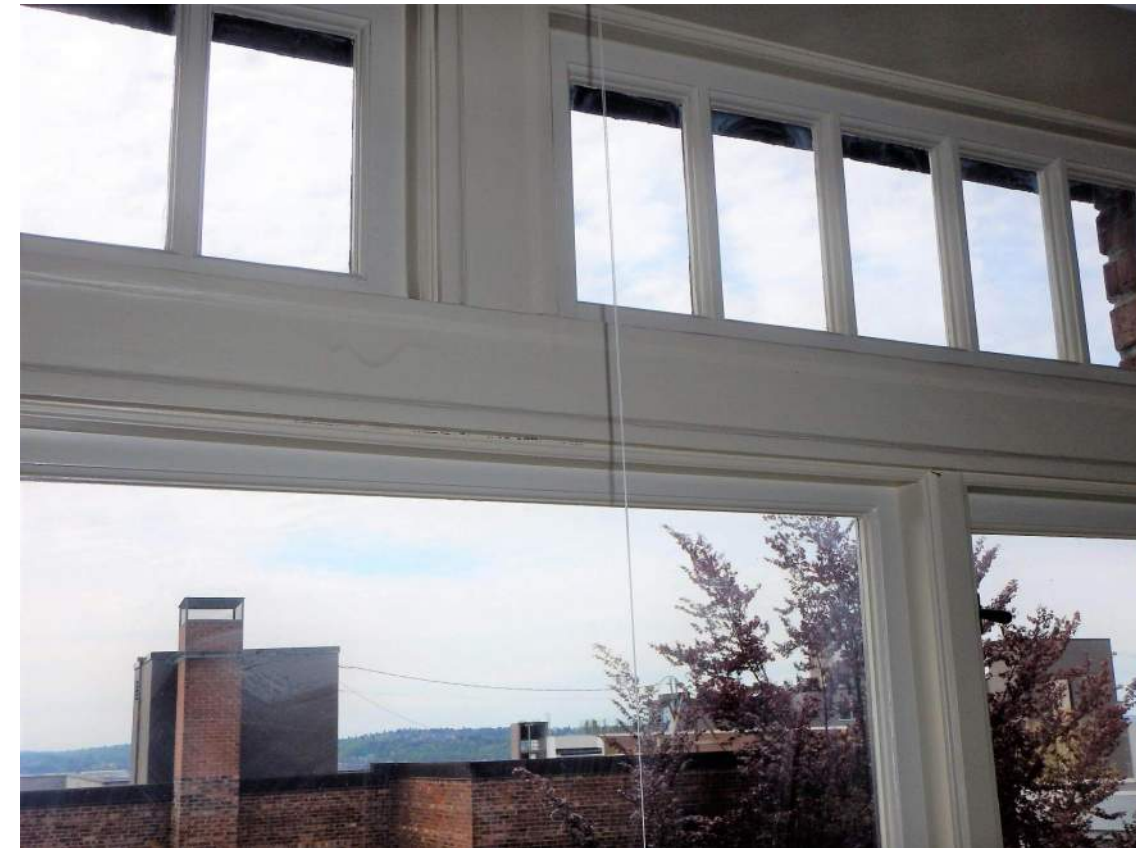
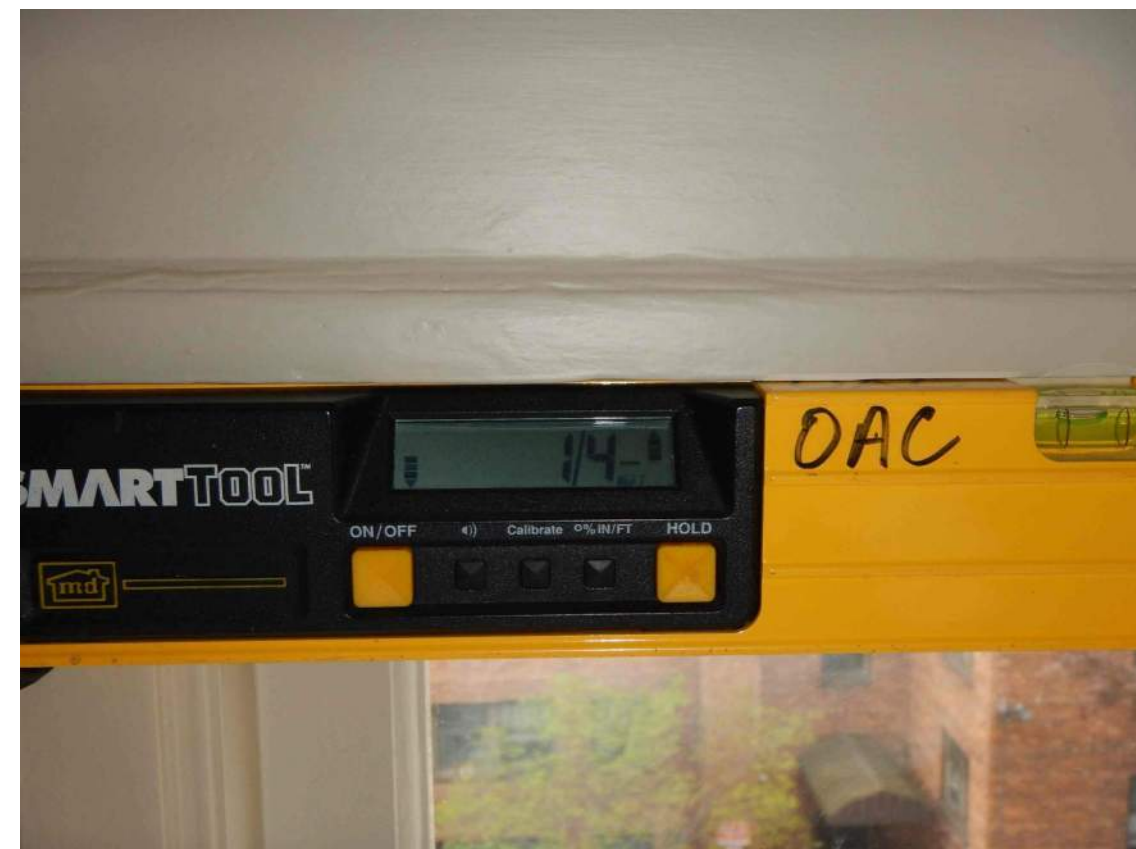
WINDOW - 12

Condition: Moderate

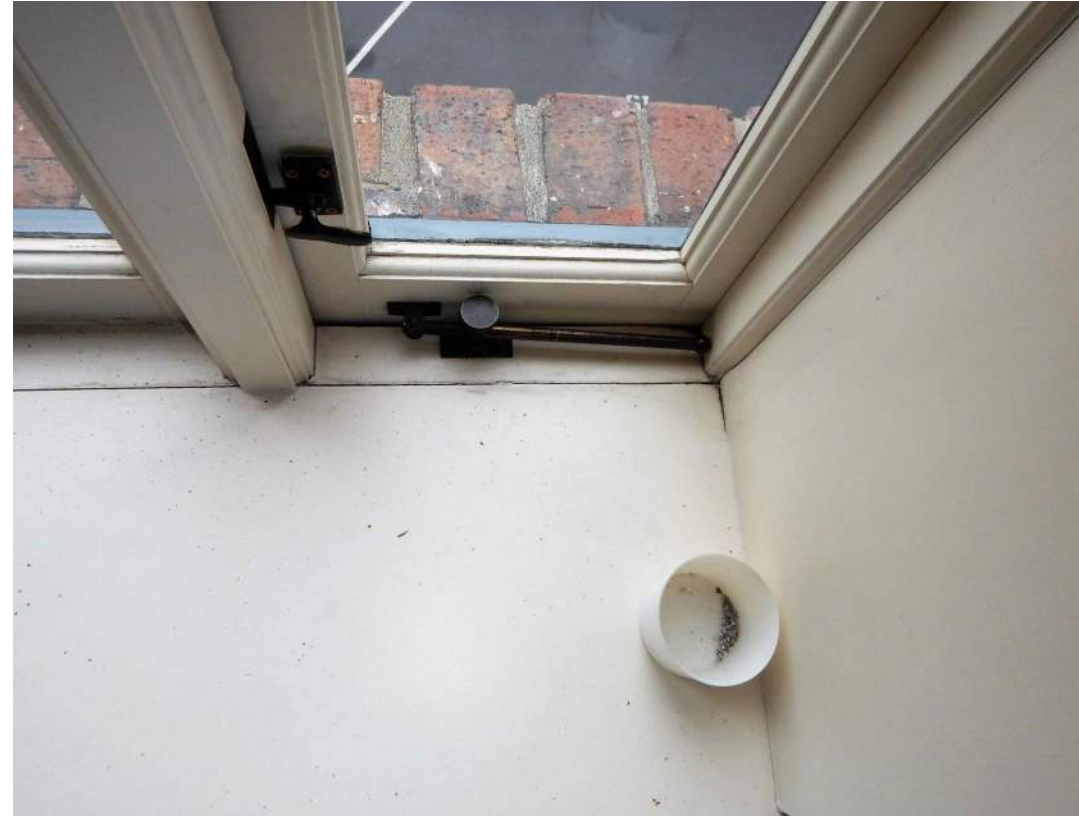
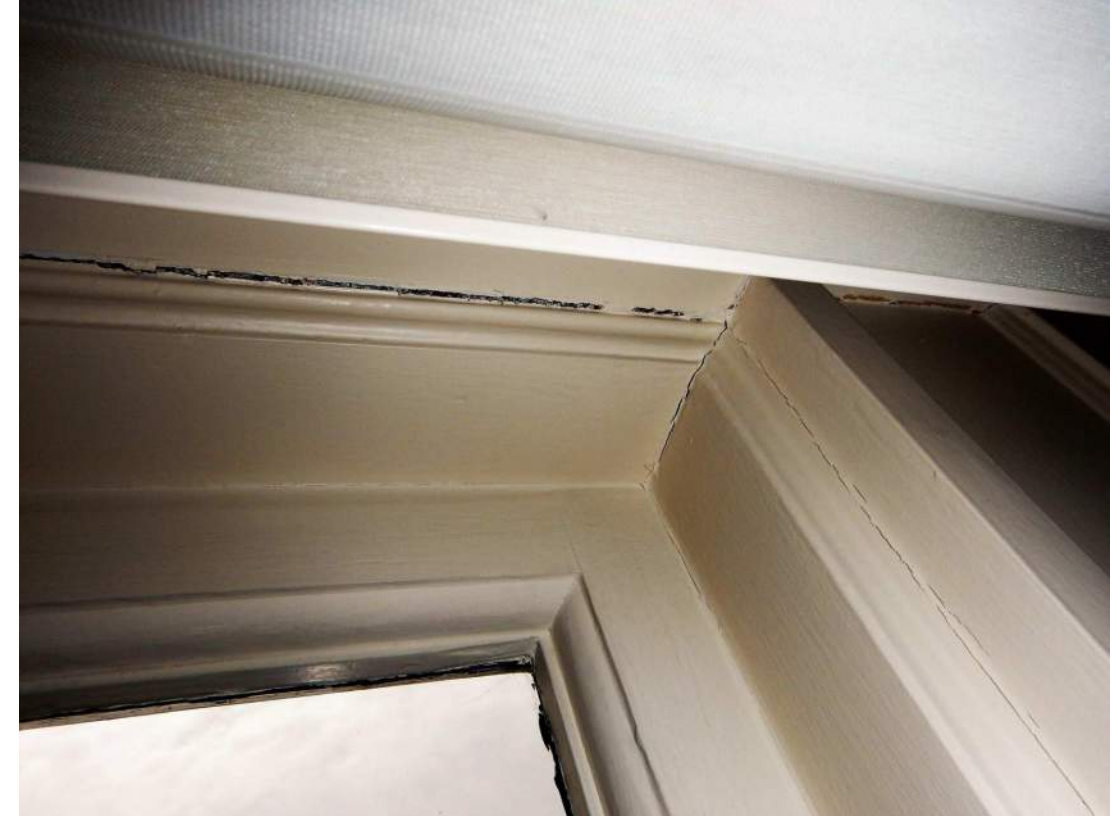
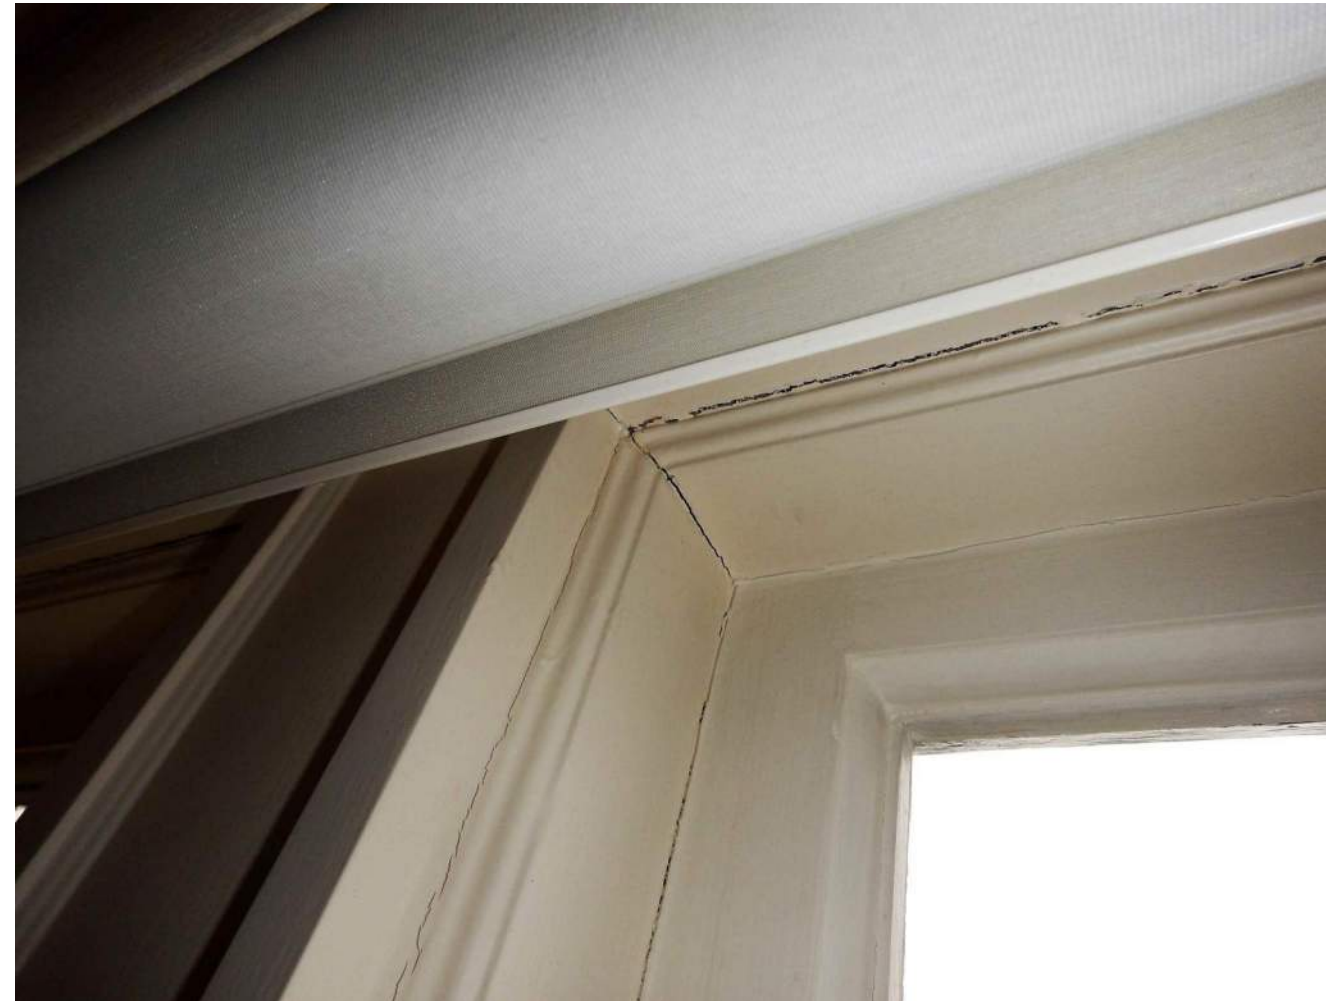
Type: W9

Condition: Moderate

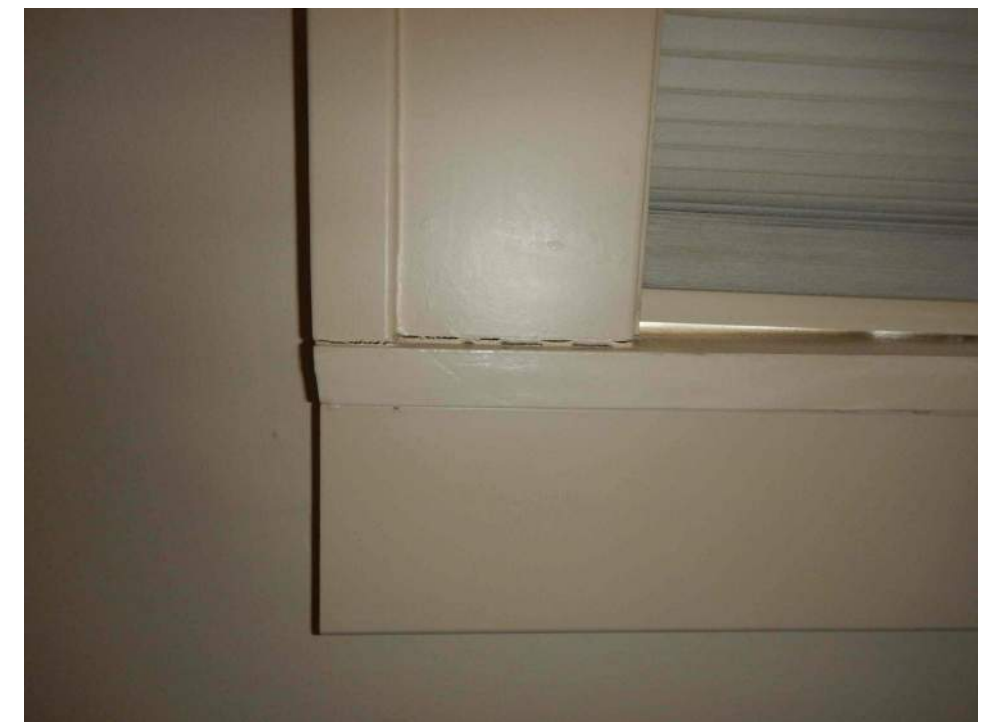
WINDOW - 15

Condition: Moderate

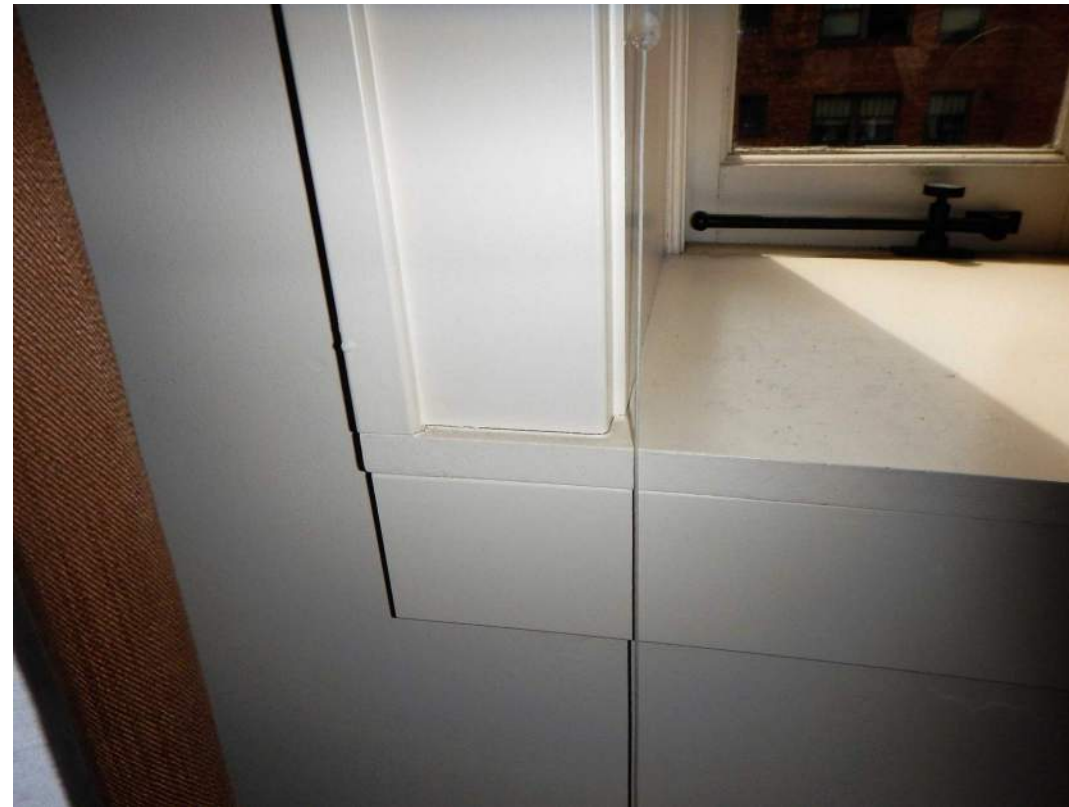
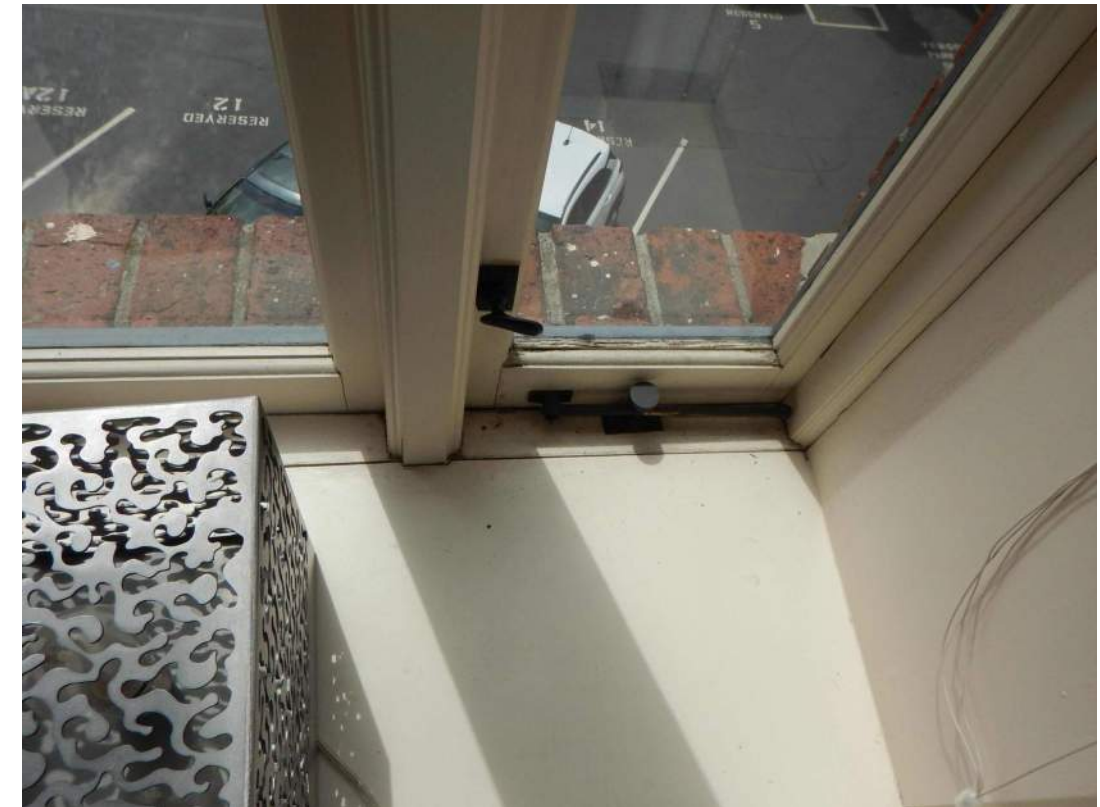
WINDOW - 16

Condition: Poor
