LEONA CONDOMINIUMS REMEDIATION

916 QUEEN ANNE AVE. N, SEATTLE, WA 98109

WINDOW REPLACEMENT PROPOSAL

THE SURVEY OF WINDOWS AND DOORS AT THE LEONA CONDOS WERE COMPLETED IN APRIL 2021. MOST OF THE WINDOWS APPEAR TO HAVE DETERIORATED AND THE CONDITION OF THE WINDOWS/DOORS HAVE WORSEN FOR THE LAST TWO YEARS.

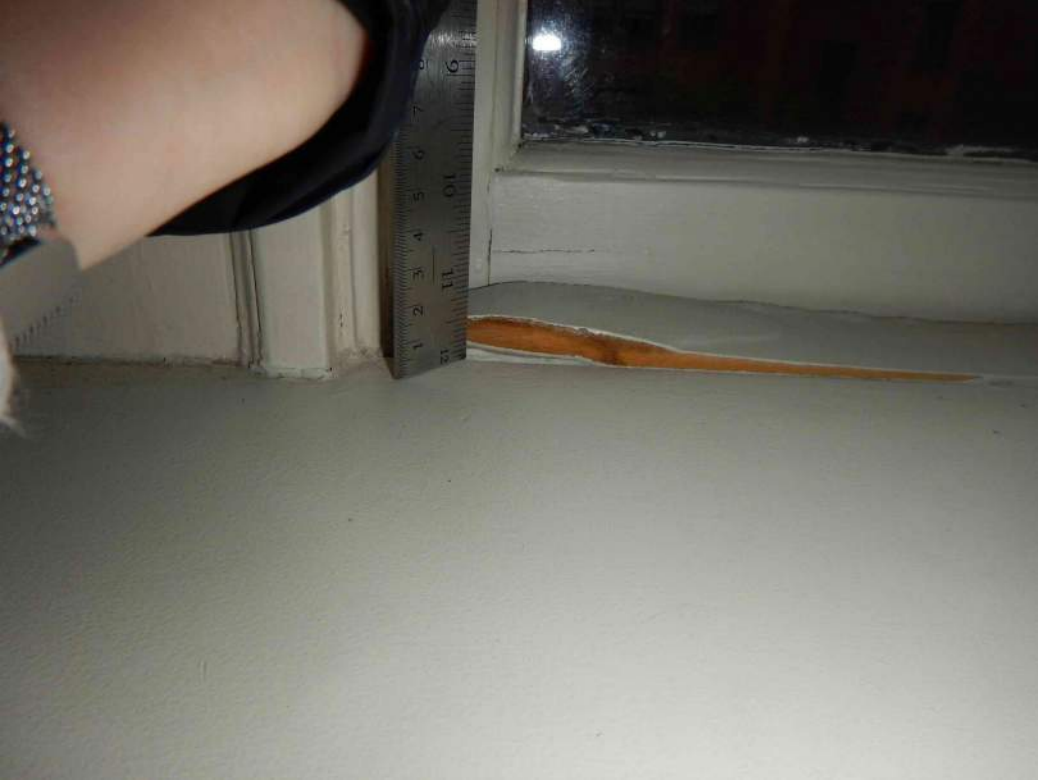
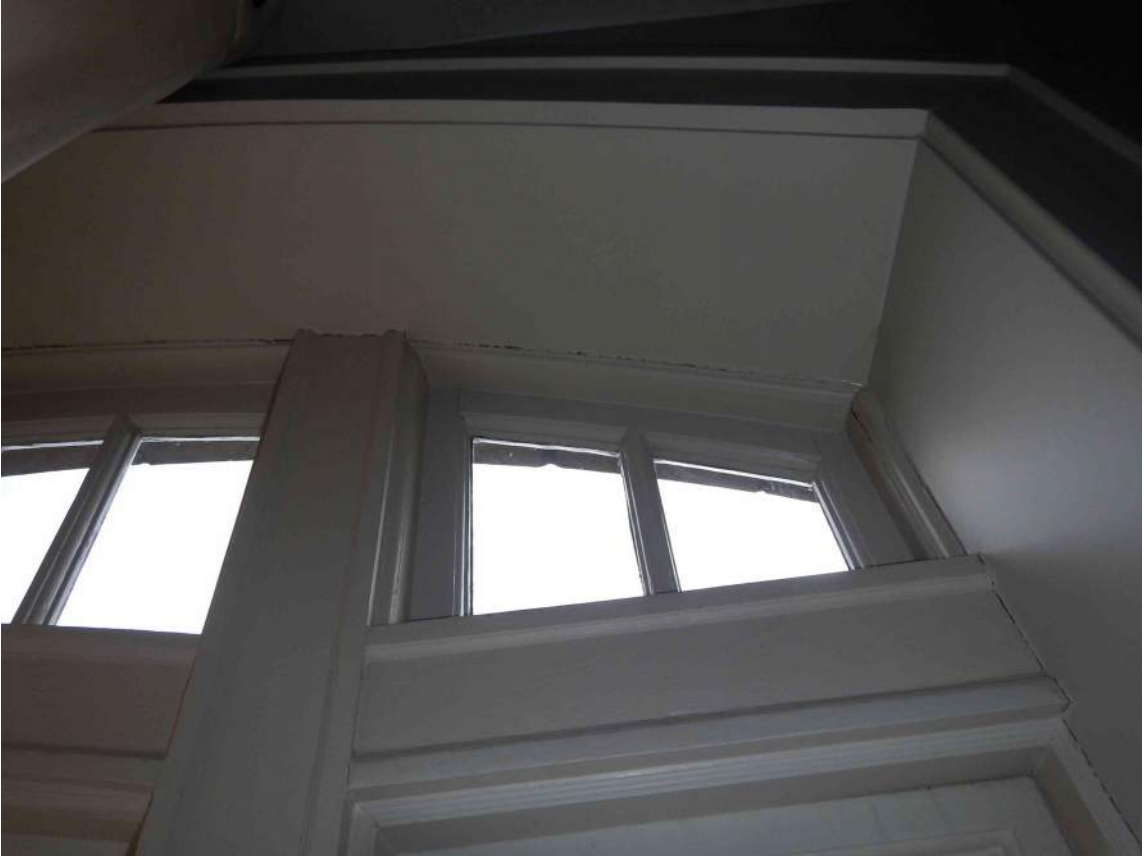
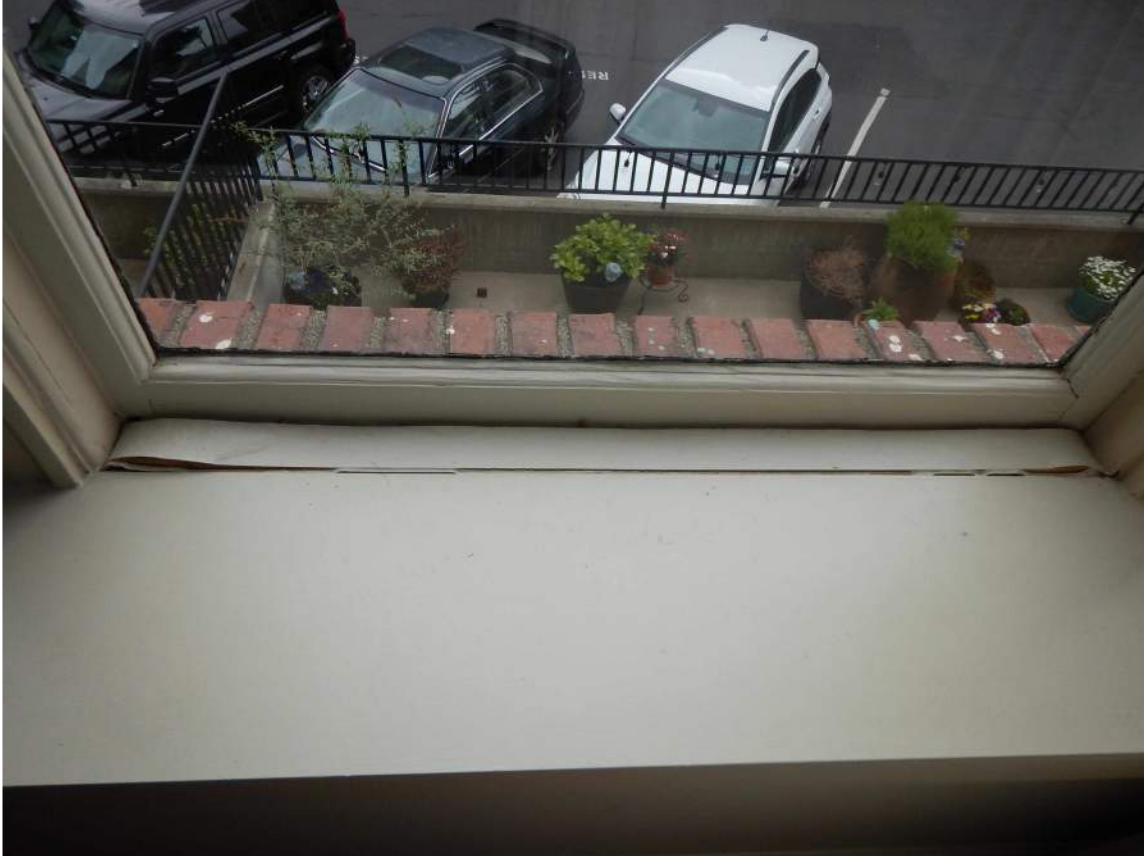
DOOR - 17

Condition: Poor

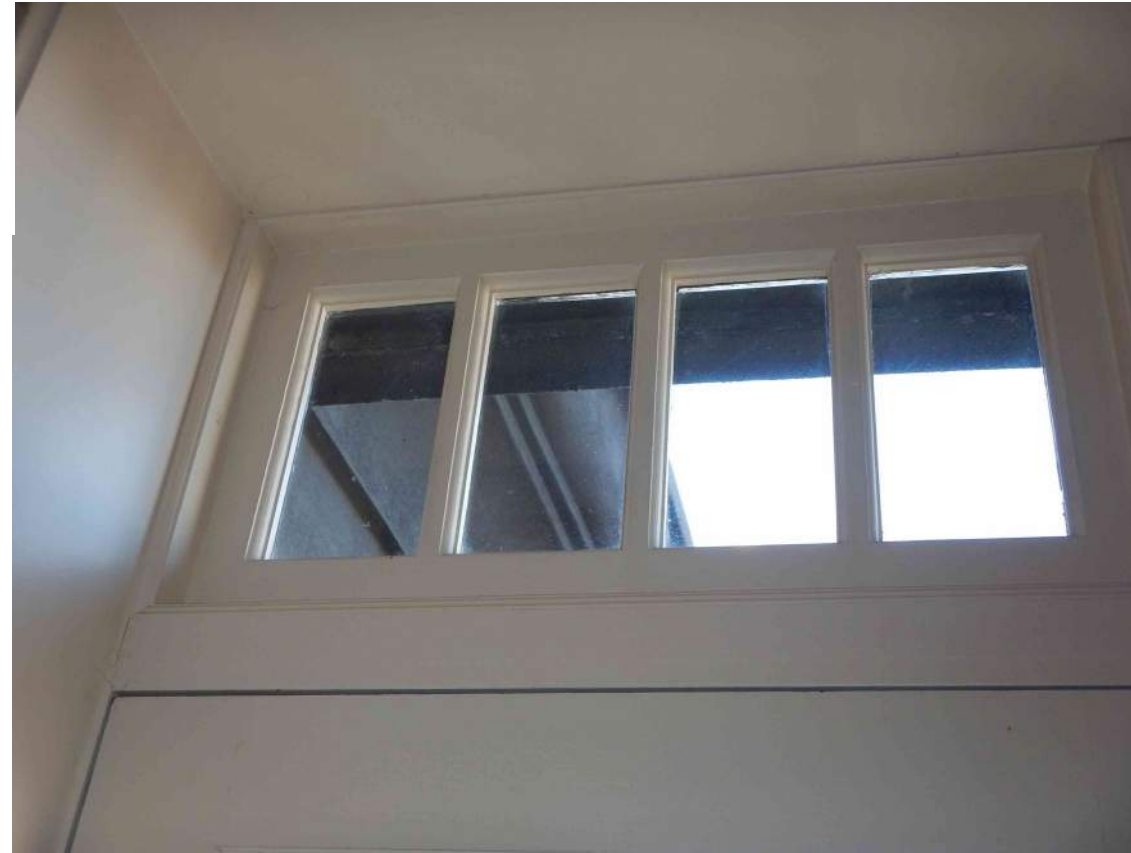
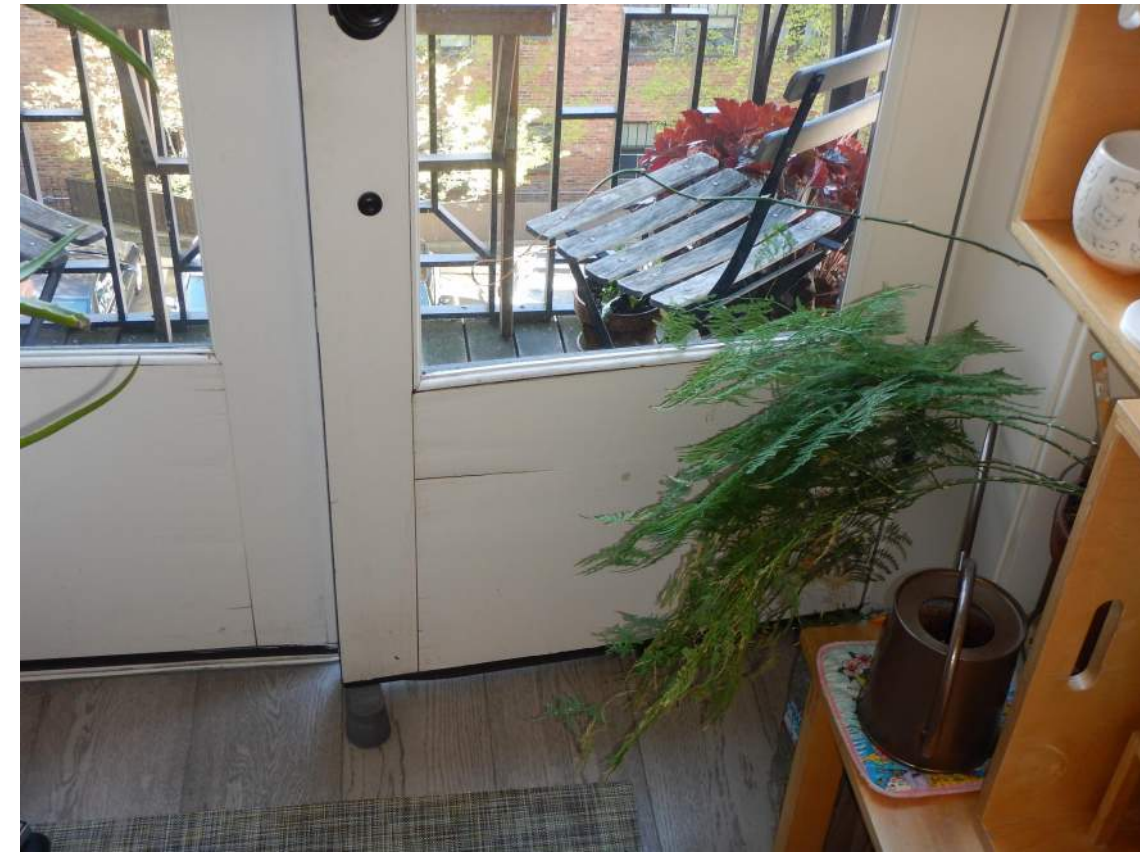
WINDOW - 18

Condition: Moderate

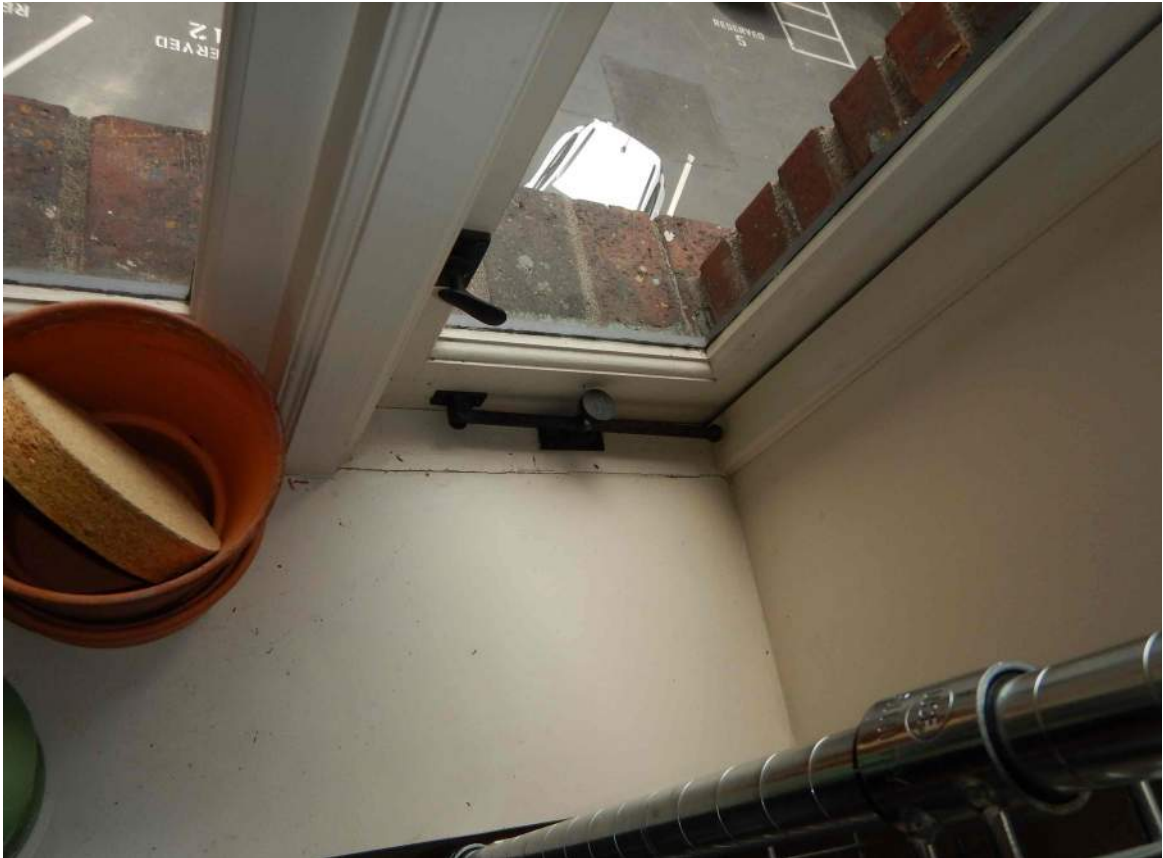
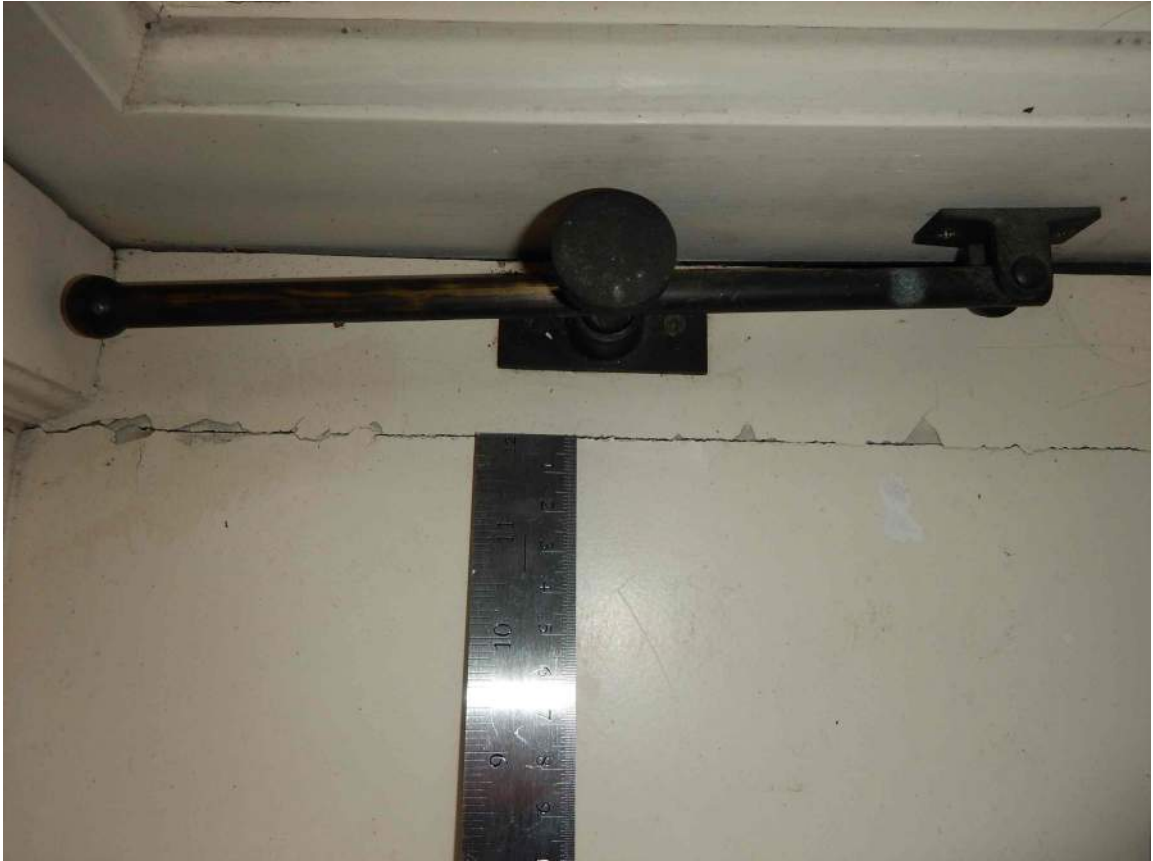
DOOR - 19

Condition: Moderate

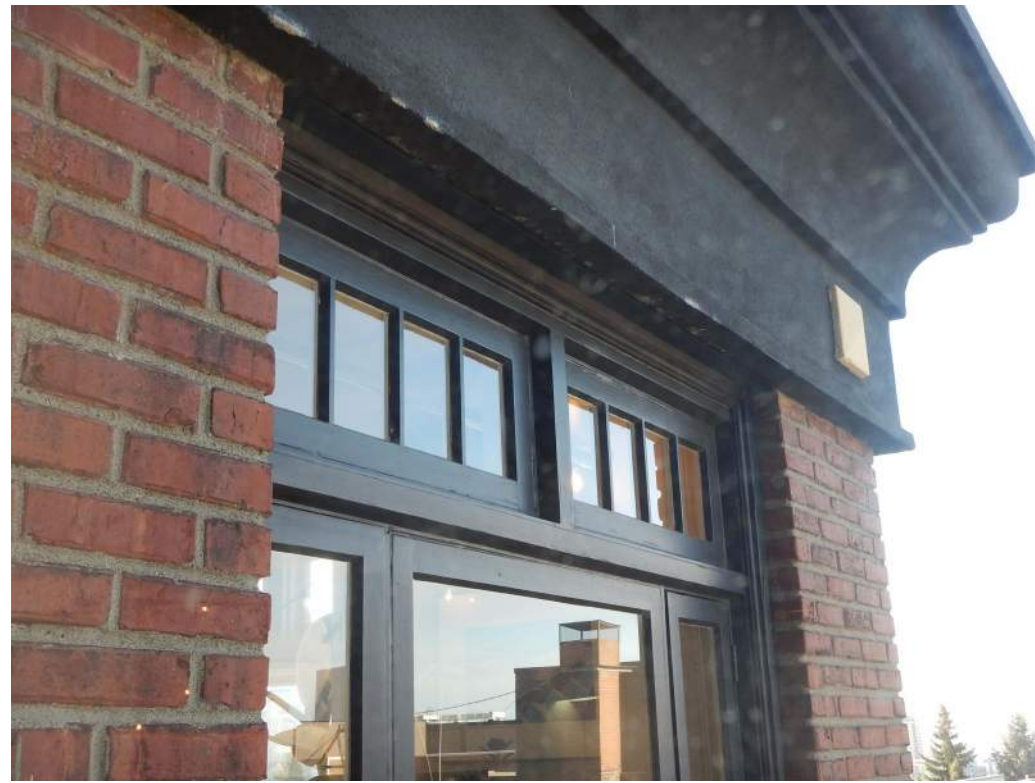
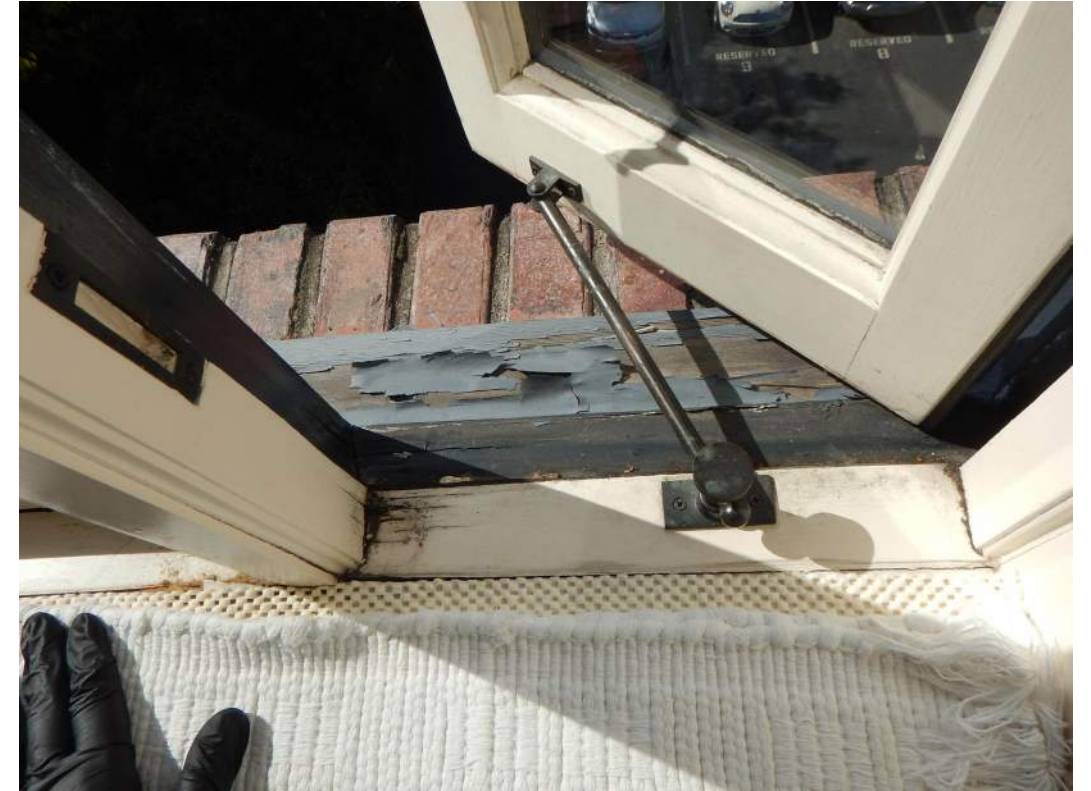
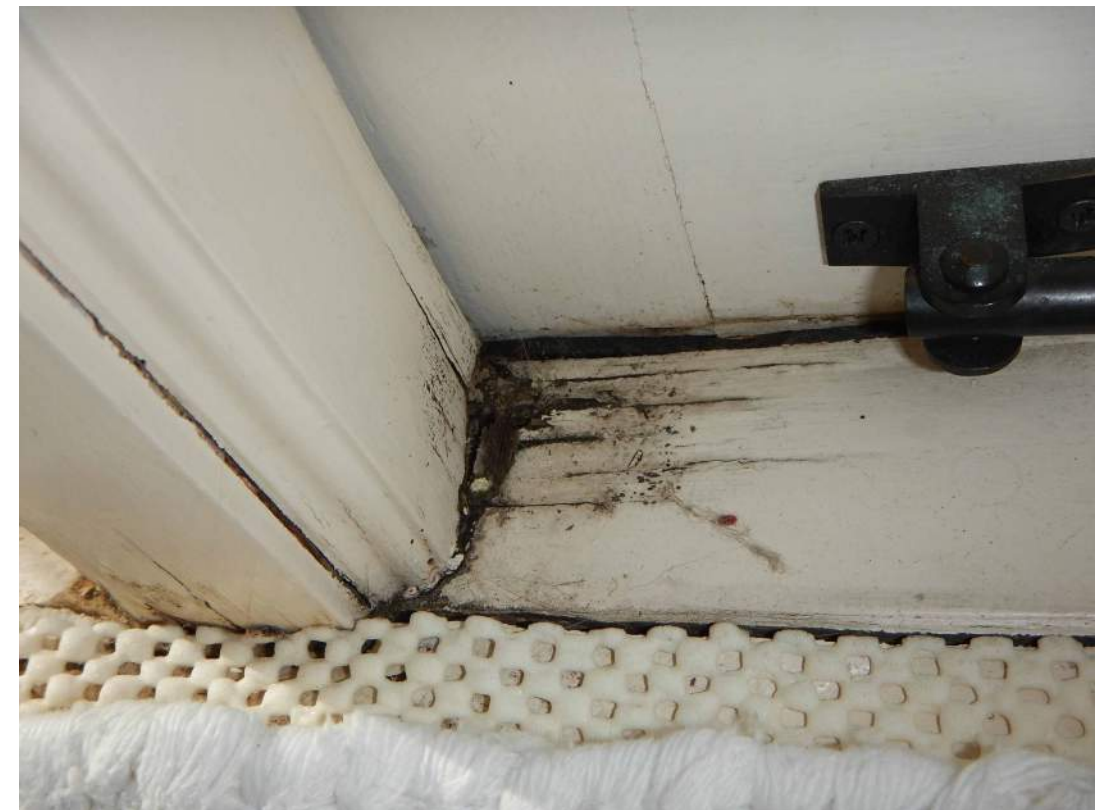
WINDOW - 21

Condition: Poor

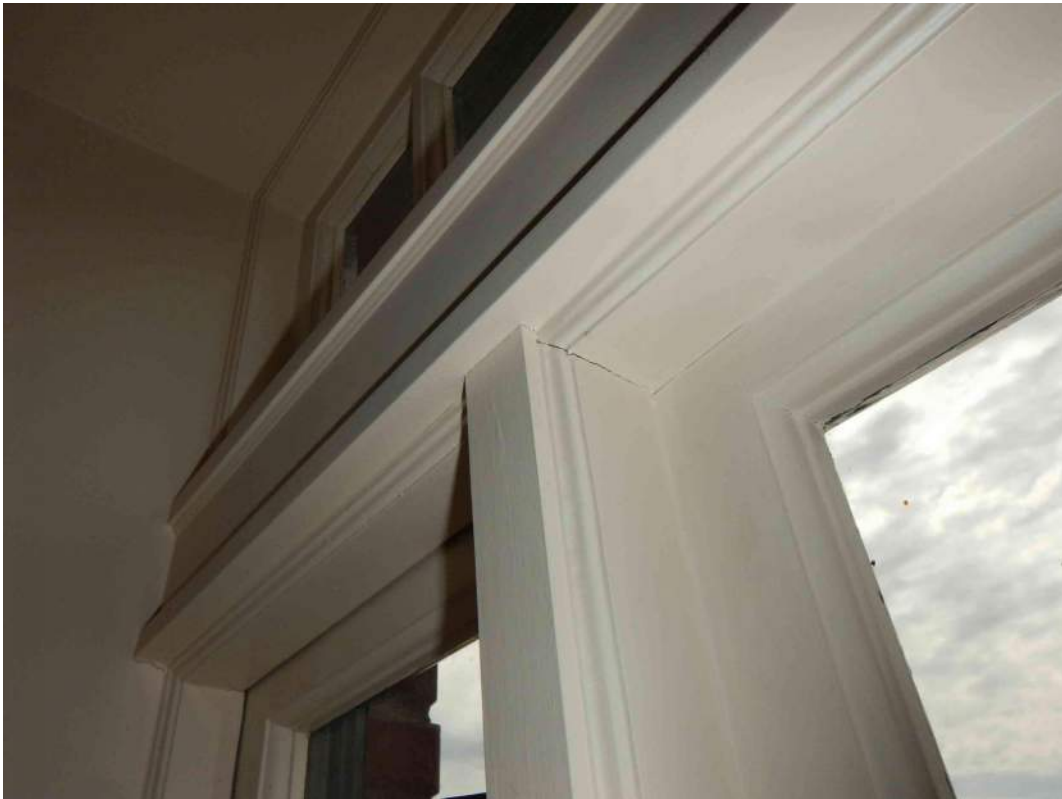
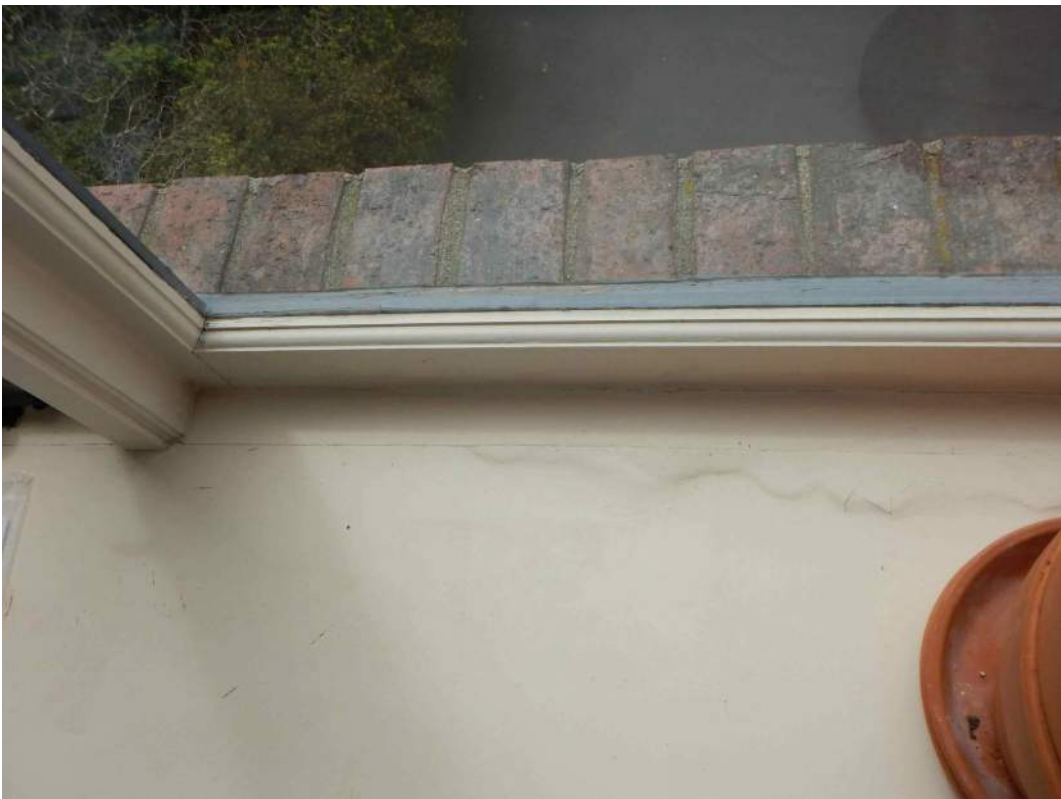
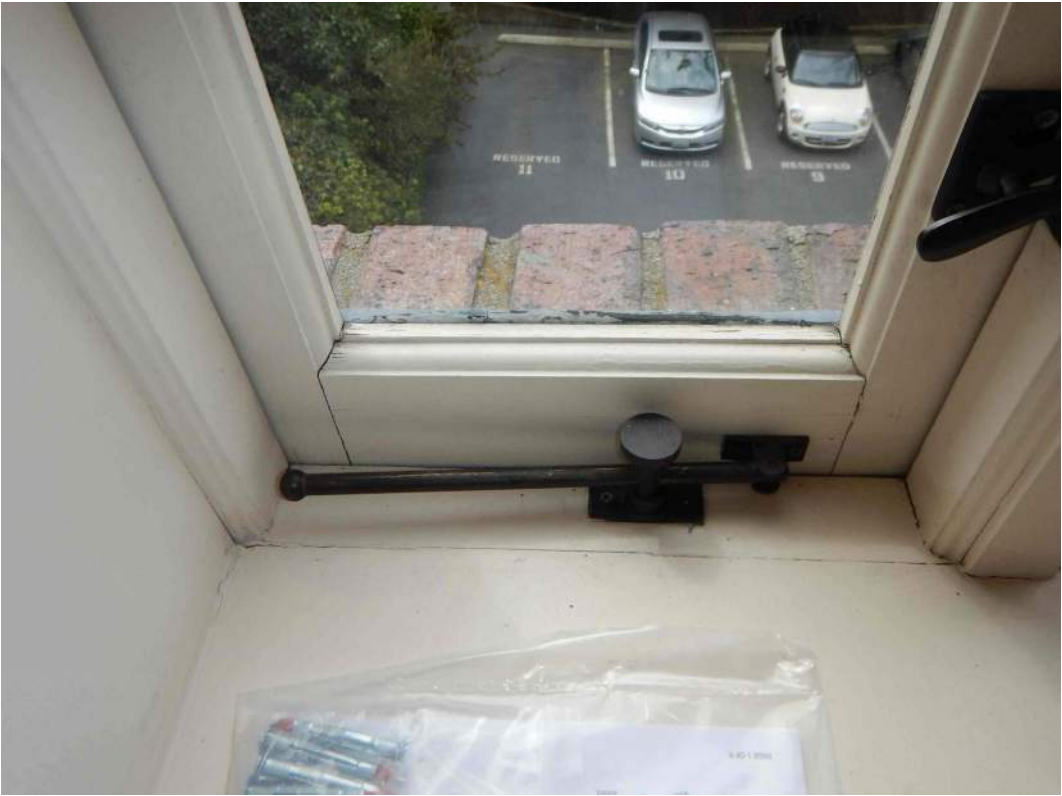
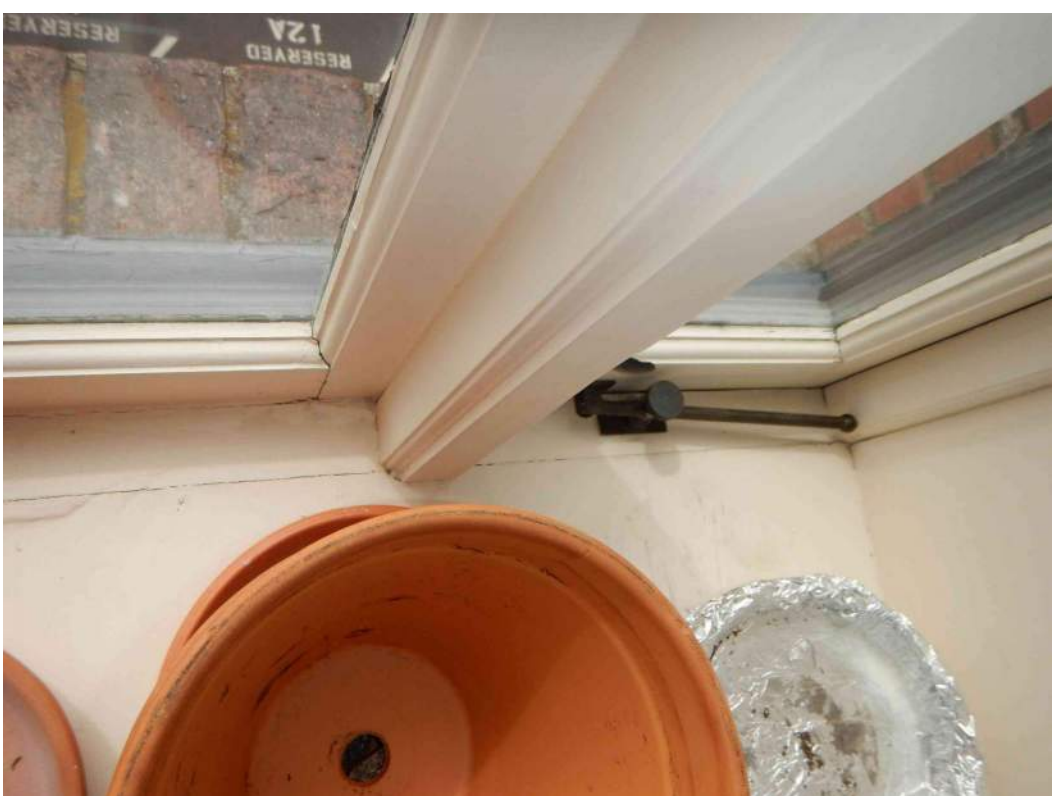
WINDOW - 22

Condition: Moderate

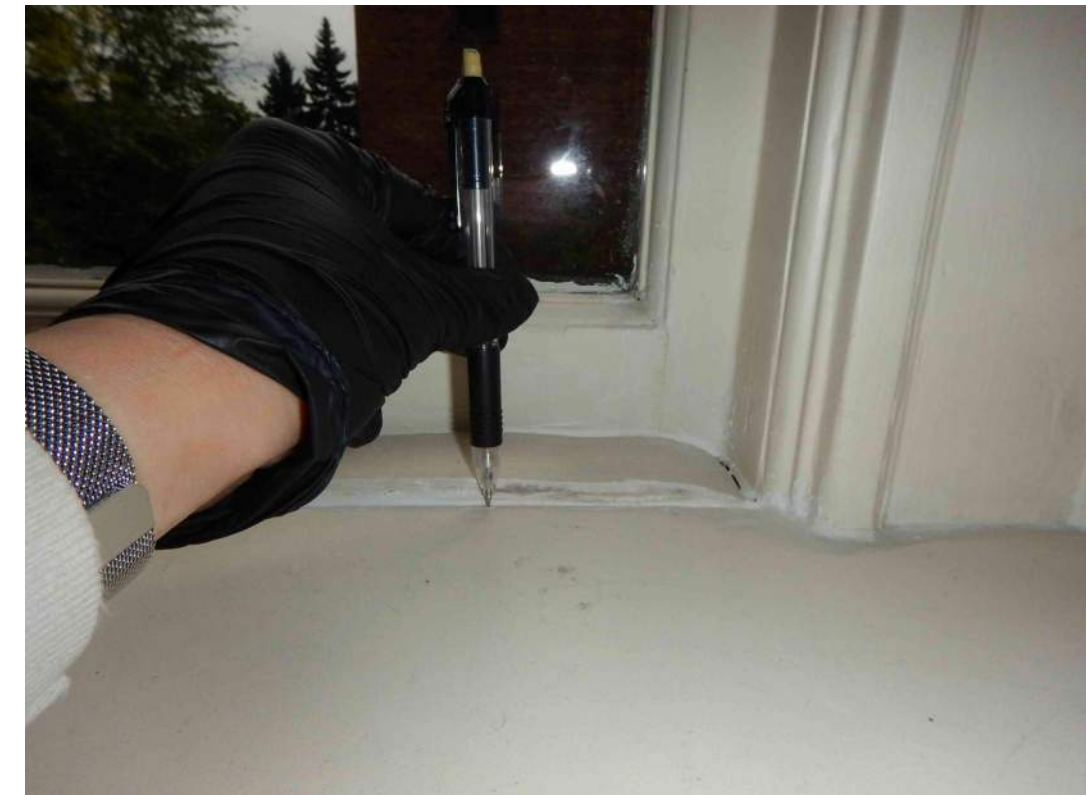
WINDOW - 23

Condition: Poor

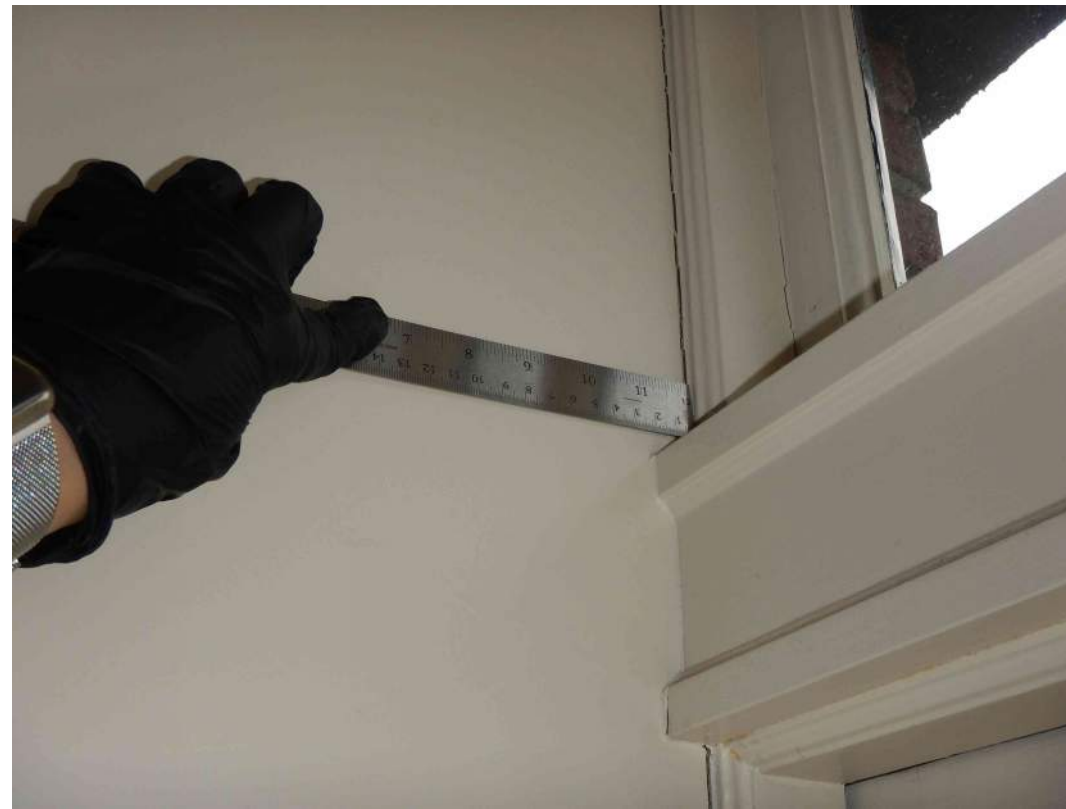
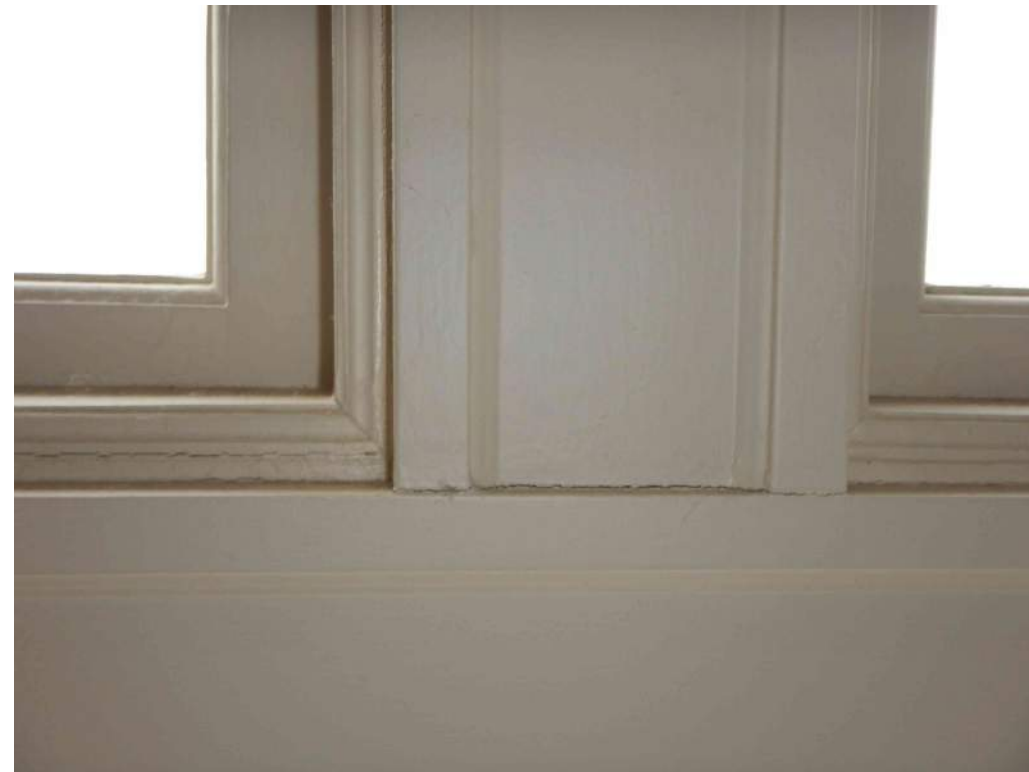
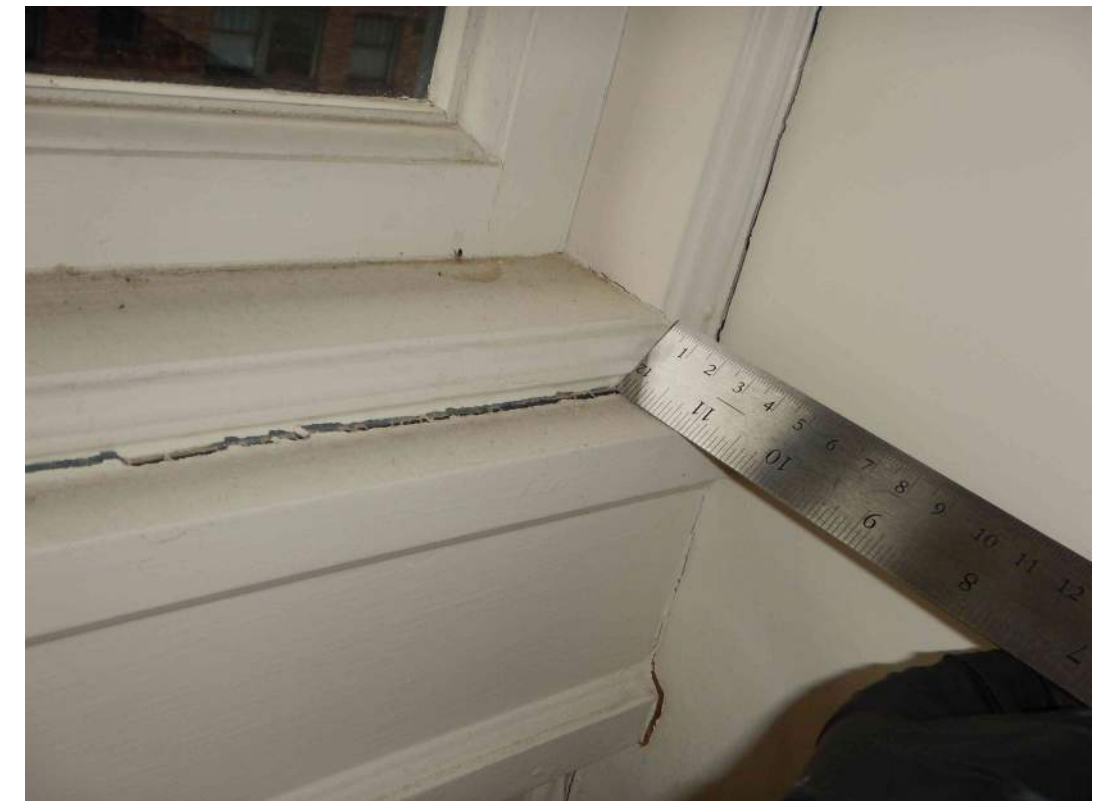
WINDOW - 24

Condition: Poor

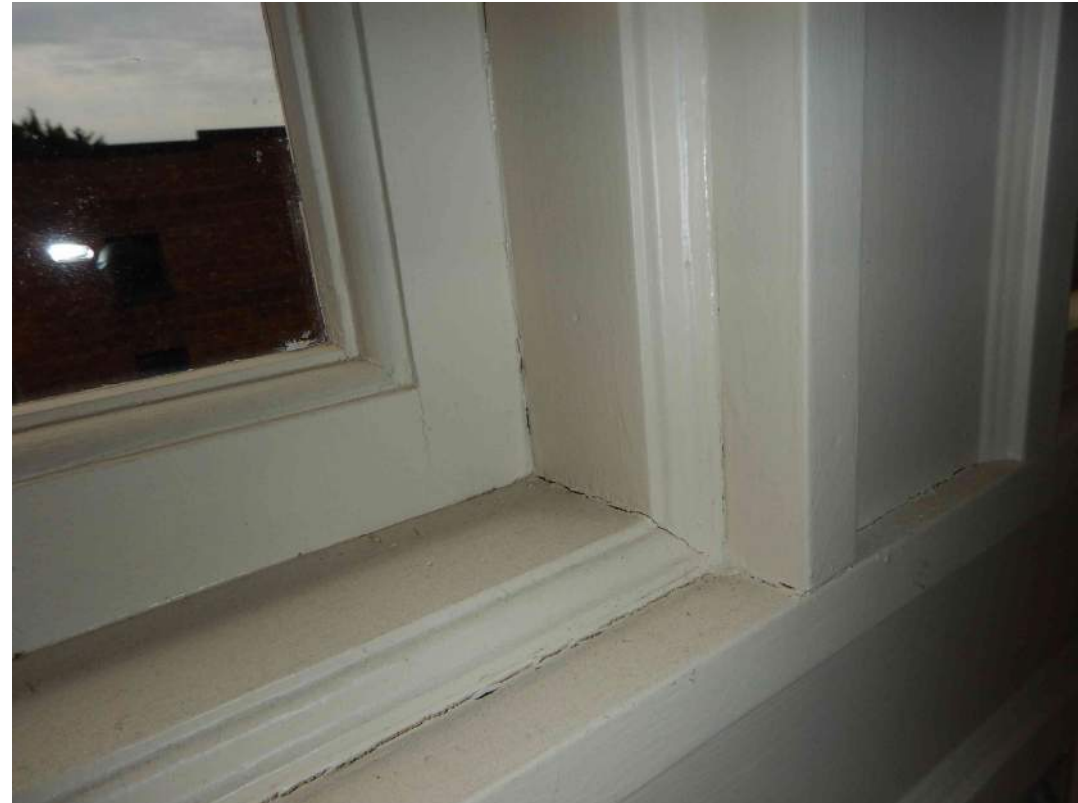
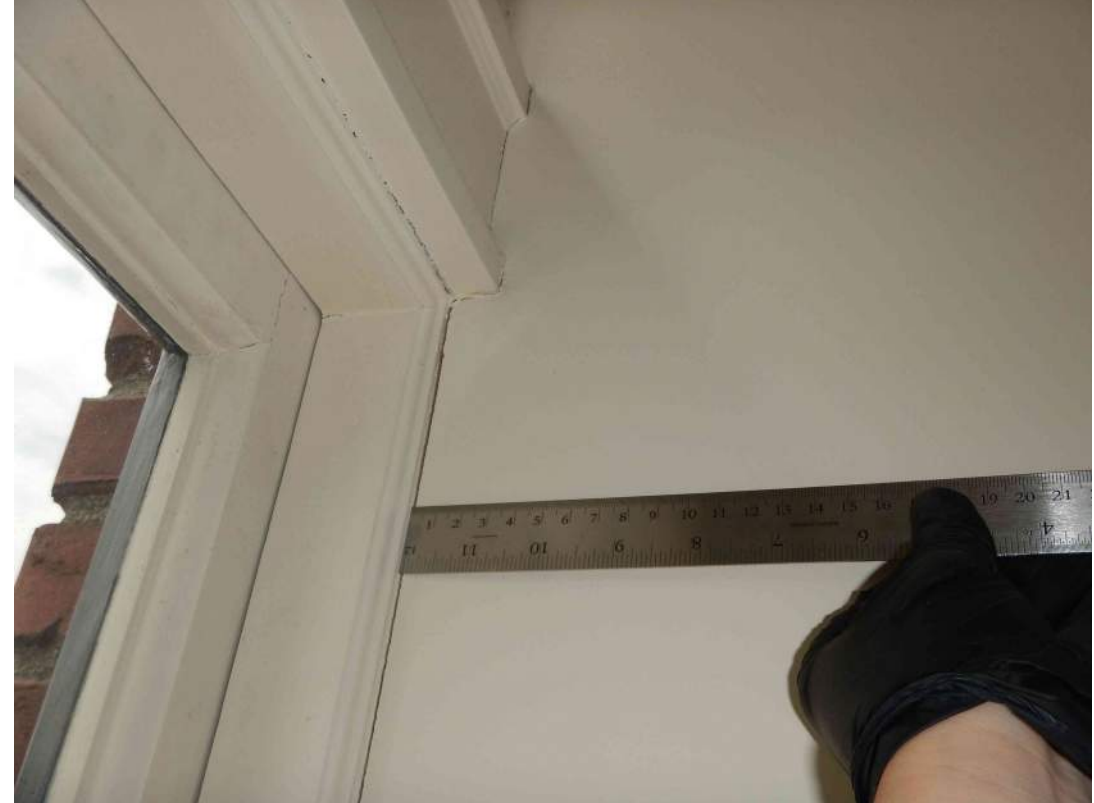
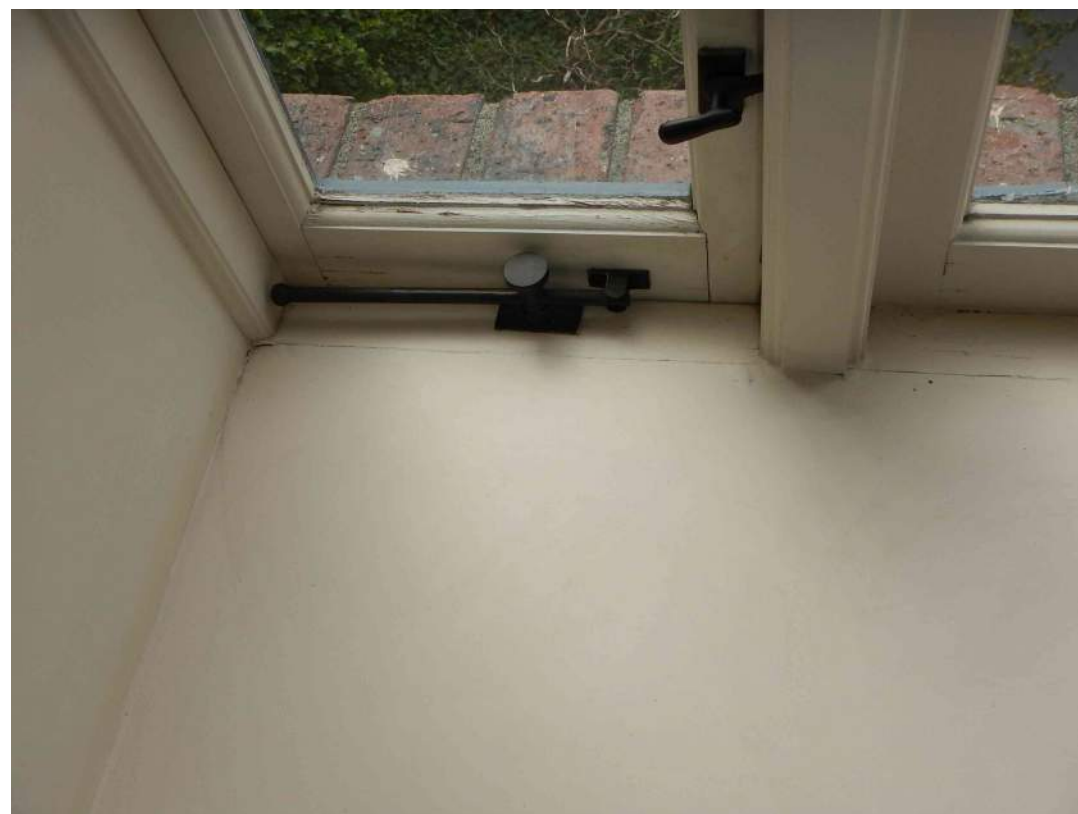
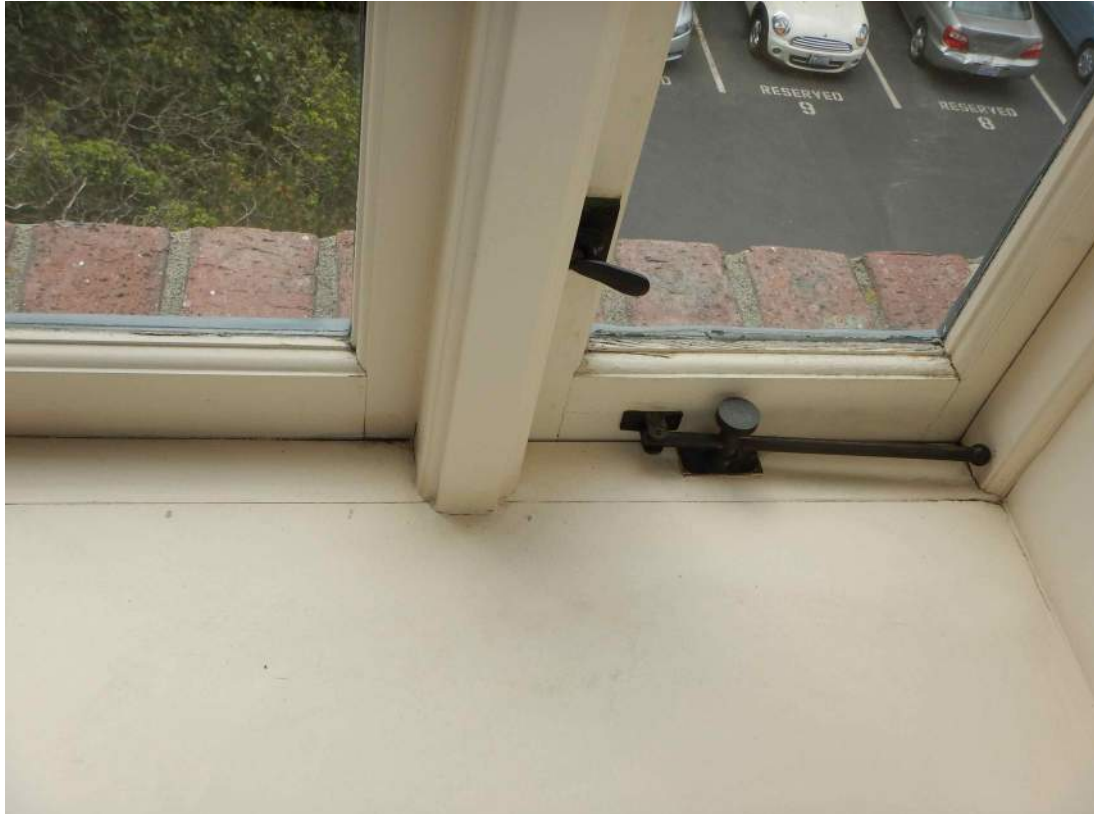
WINDOW - 25

Condition: Moderate

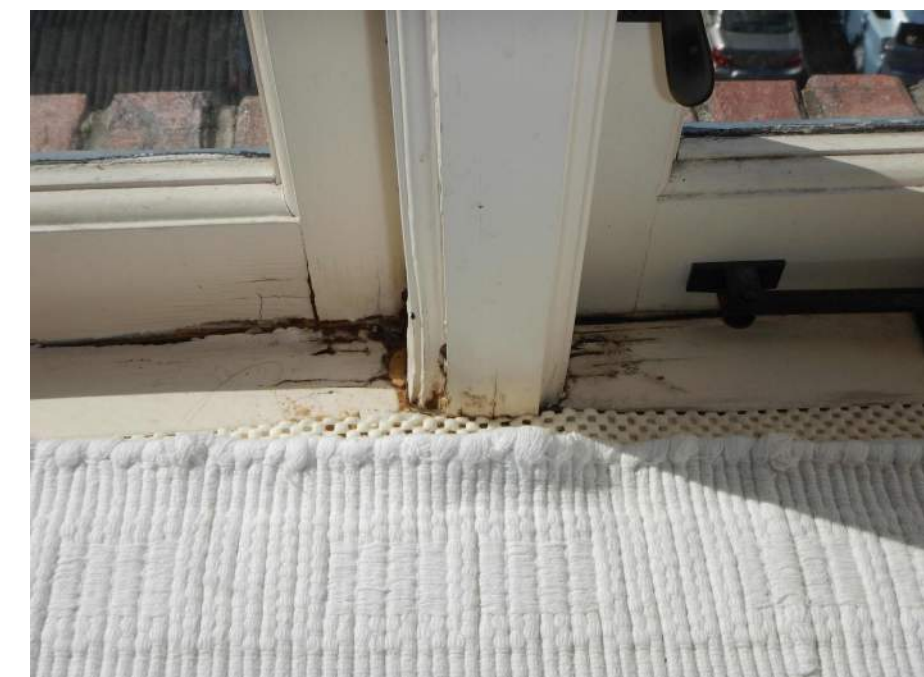
WINDOW - 27

Condition: Moderate

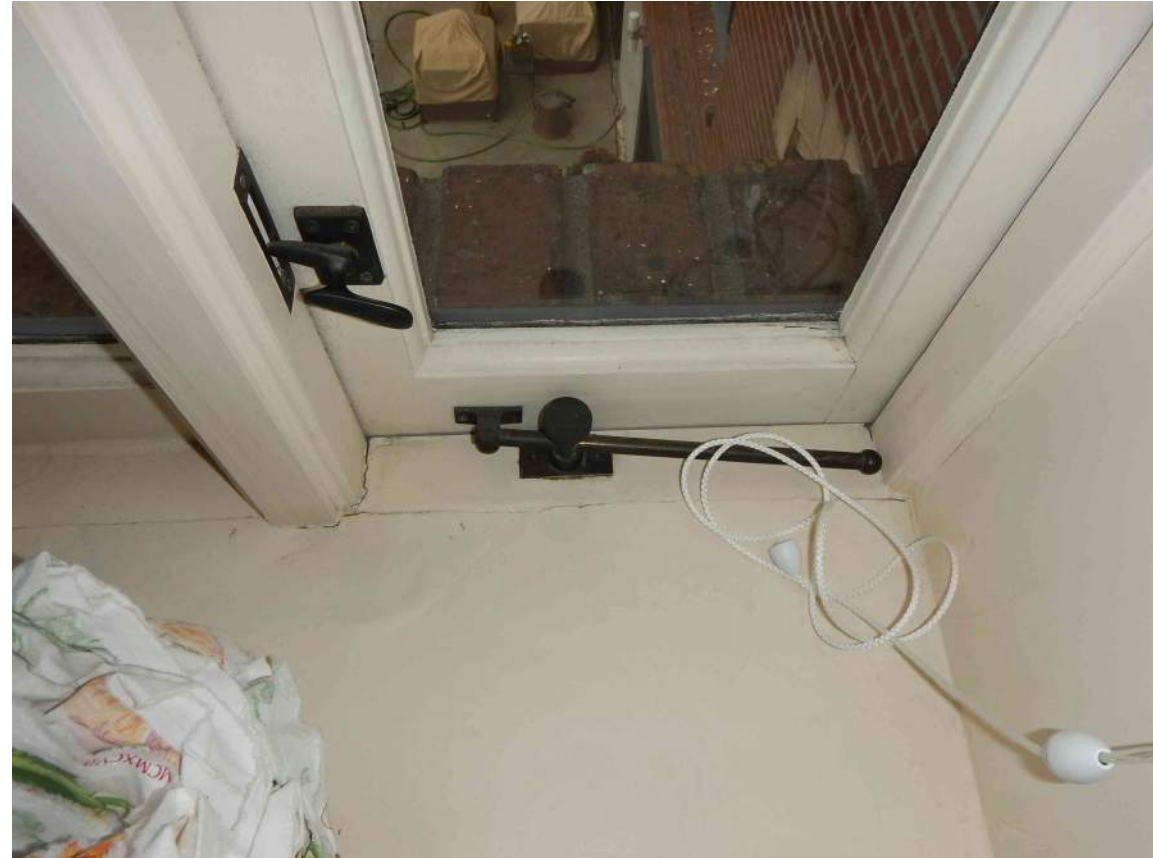
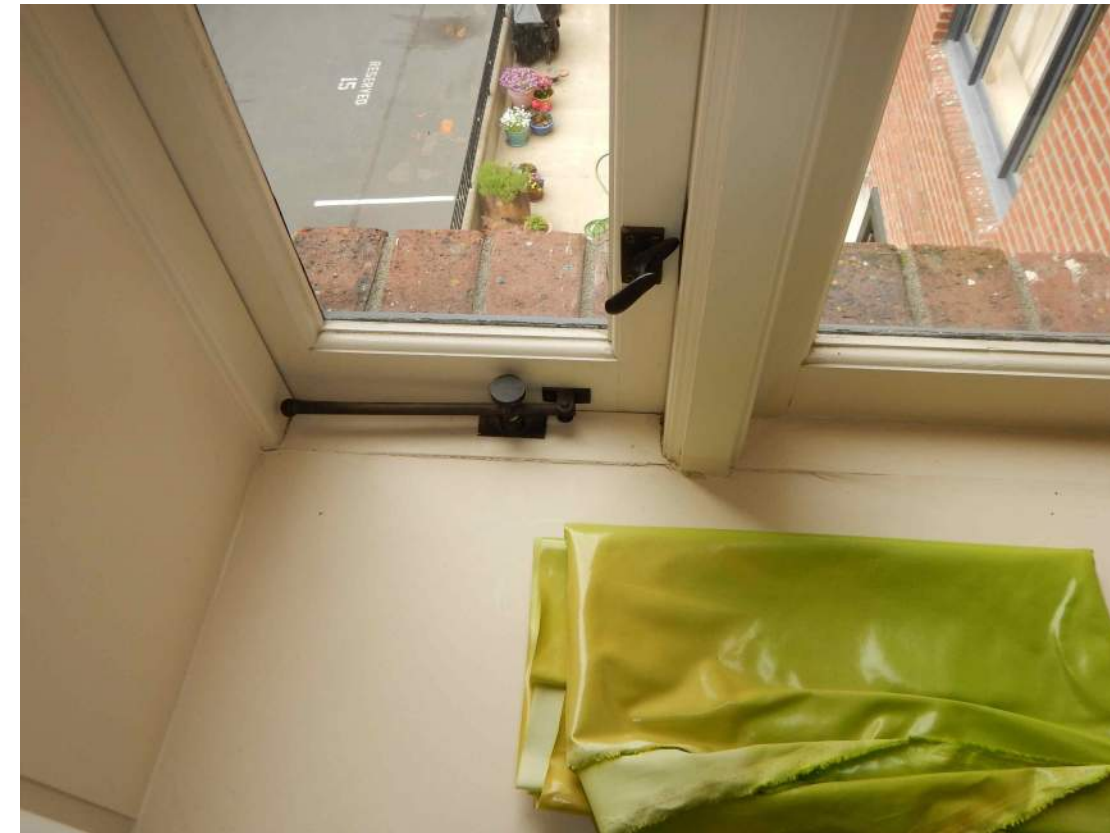
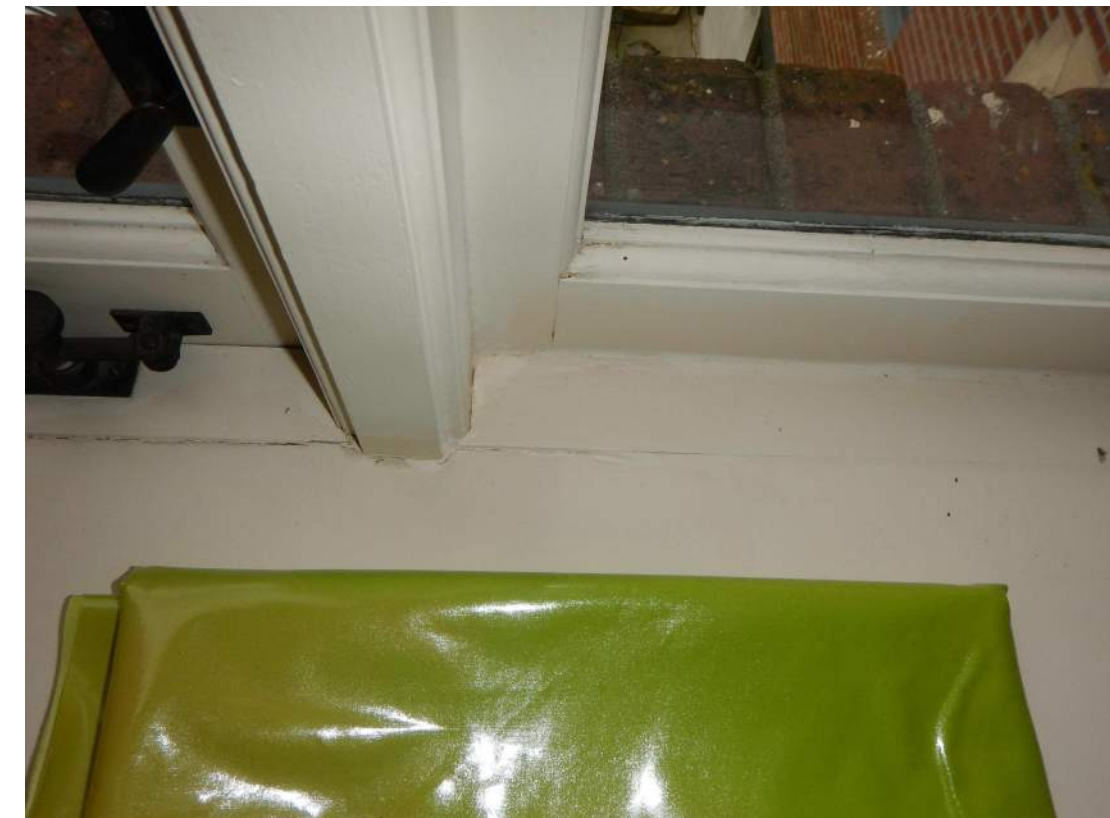
WINDOW - 28

Condition: Poor
