LEONA CONDOMINIUMS REMEDIATION

916 QUEEN ANNE AVE. N, SEATTLE, WA 98109

WINDOW REPLACEMENT PROPOSAL

THE SURVEY OF WINDOWS AND DOORS AT THE LEONA CONDOS WERE COMPLETED IN APRIL 2021. MOST OF THE WINDOWS APPEAR TO HAVE DETERIORATED AND THE CONDITION OF THE WINDOWS/DOORS HAVE WORSEN FOR THE LAST TWO YEARS.

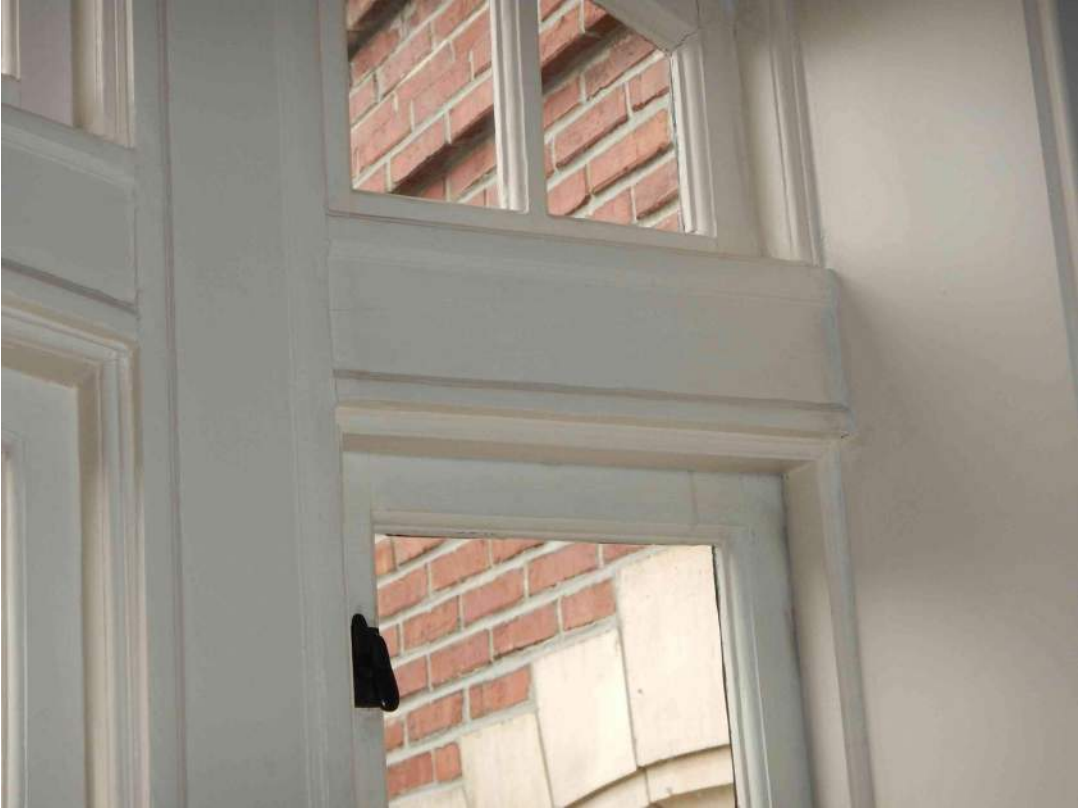
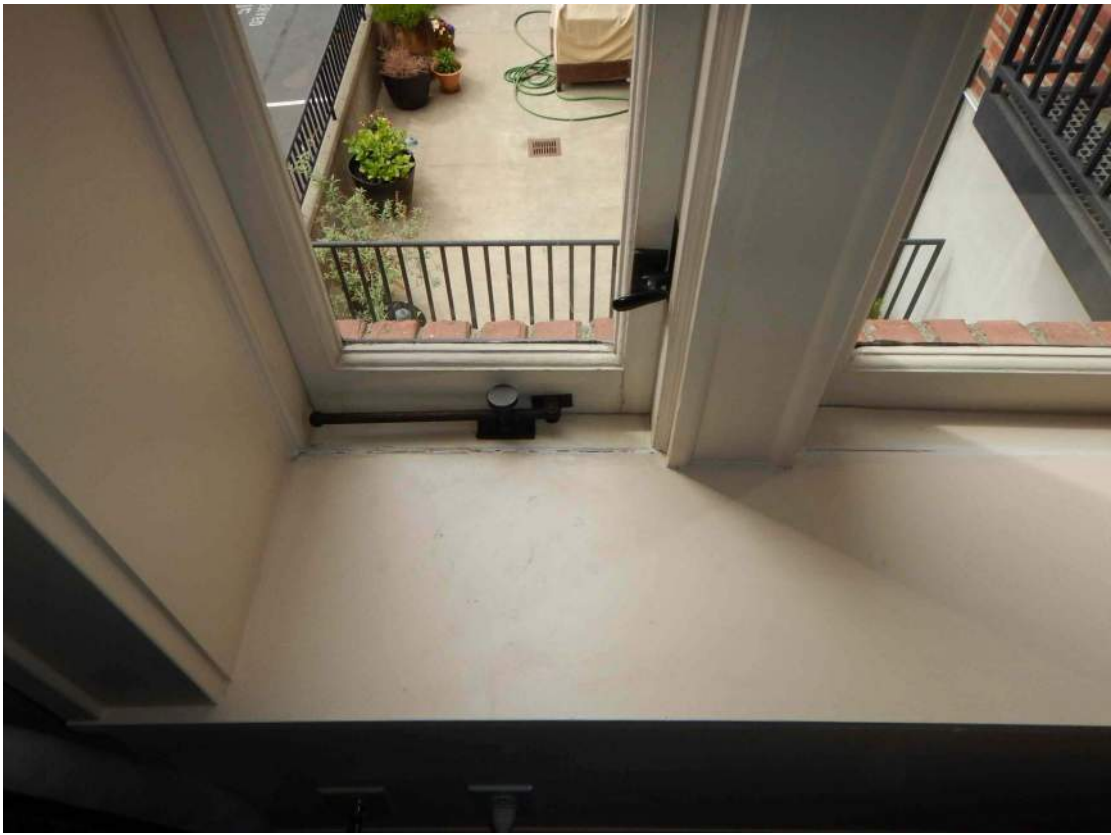
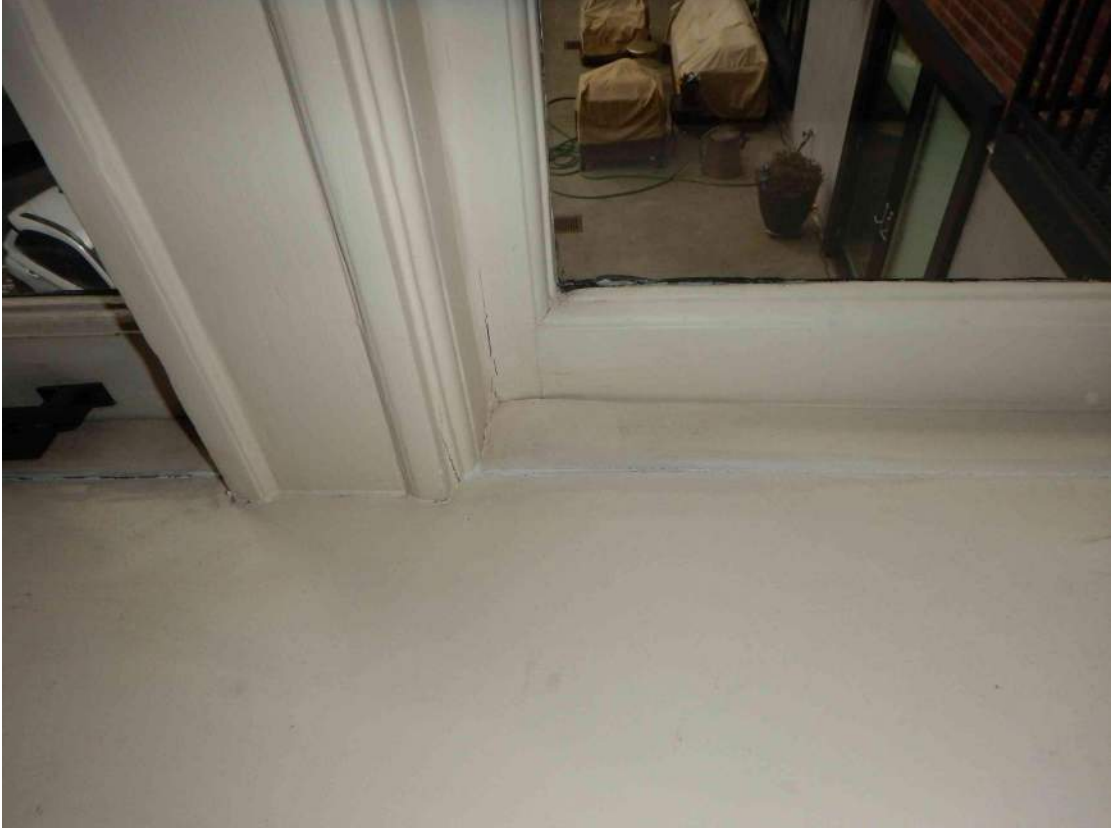
WINDOW - 29

Condition: Moderate

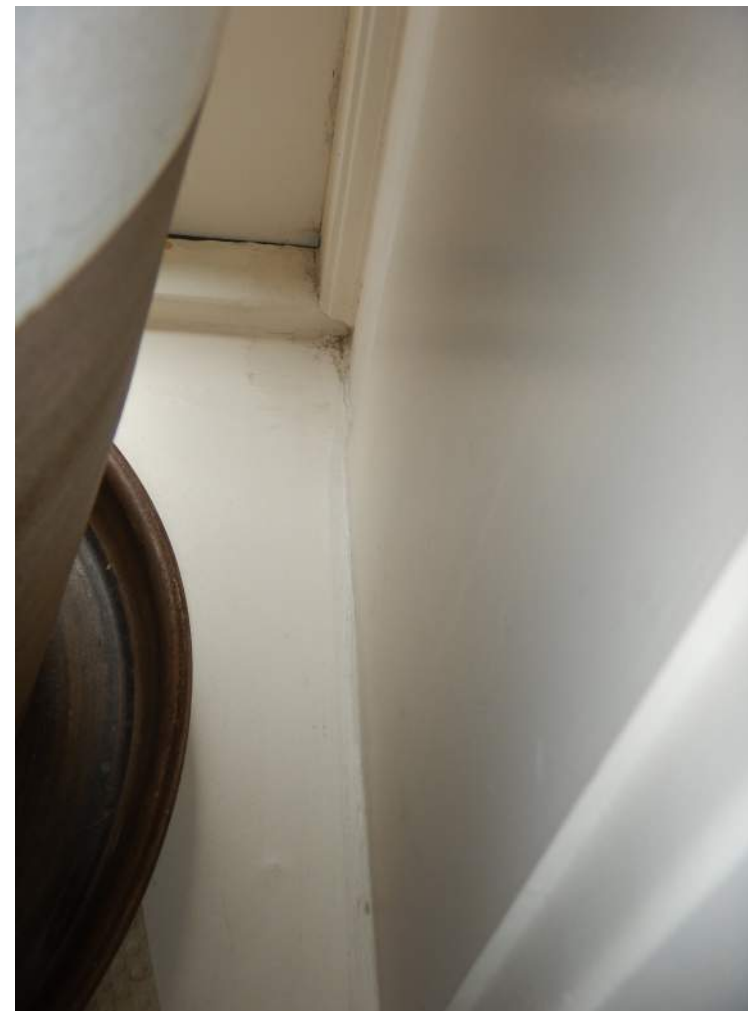
WINDOW - 32

Condition: Moderate

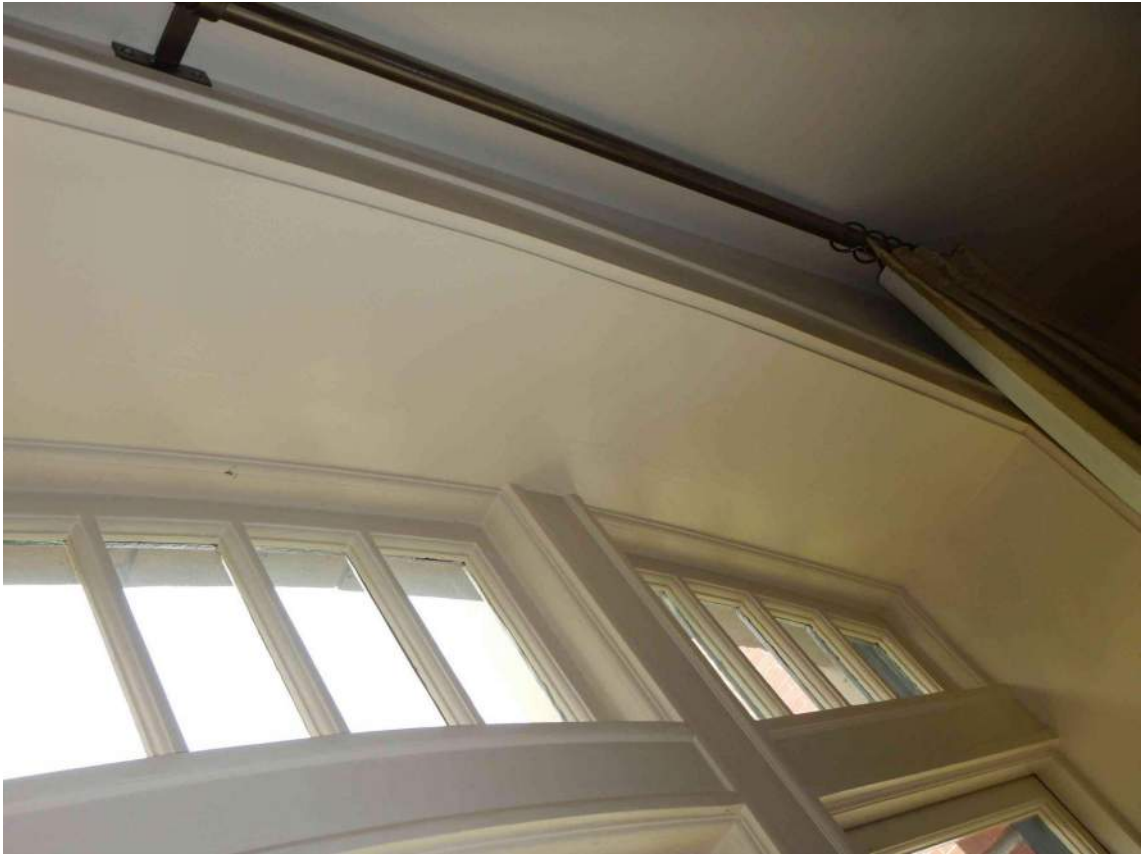
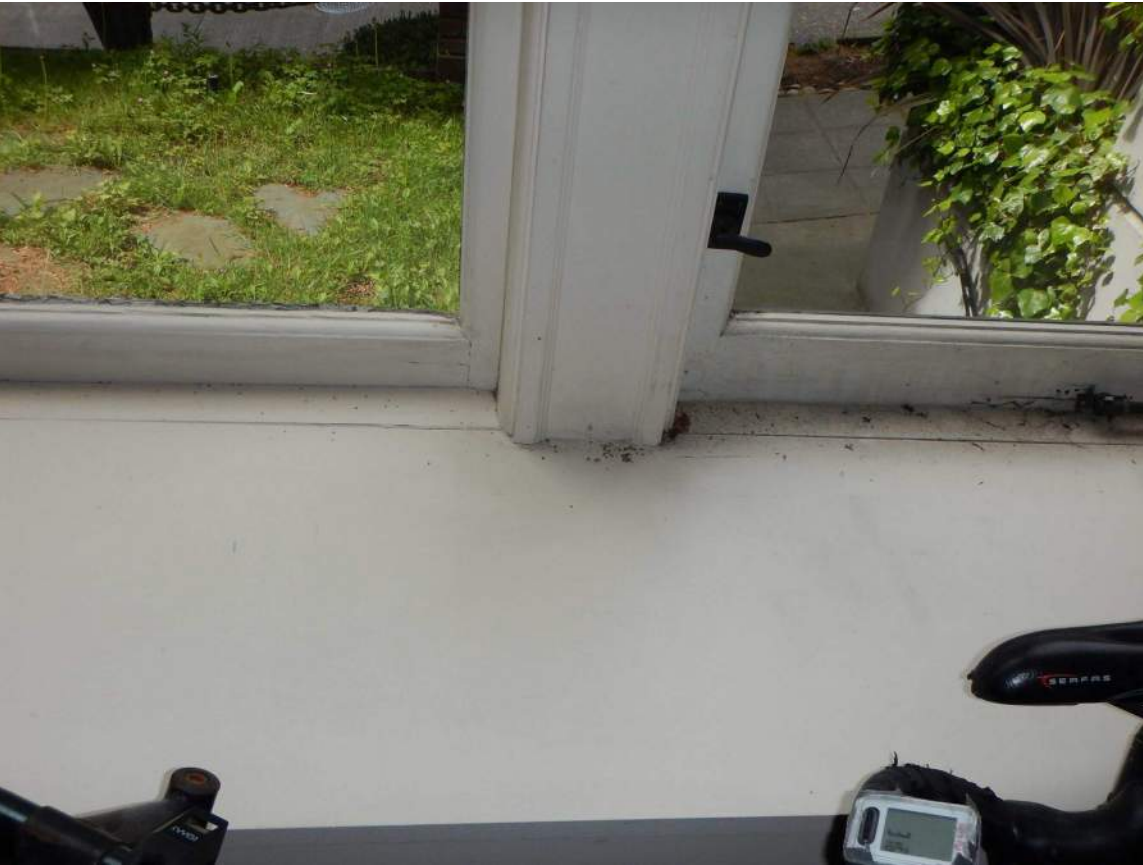
WINDOW - 37

Condition: Moderate

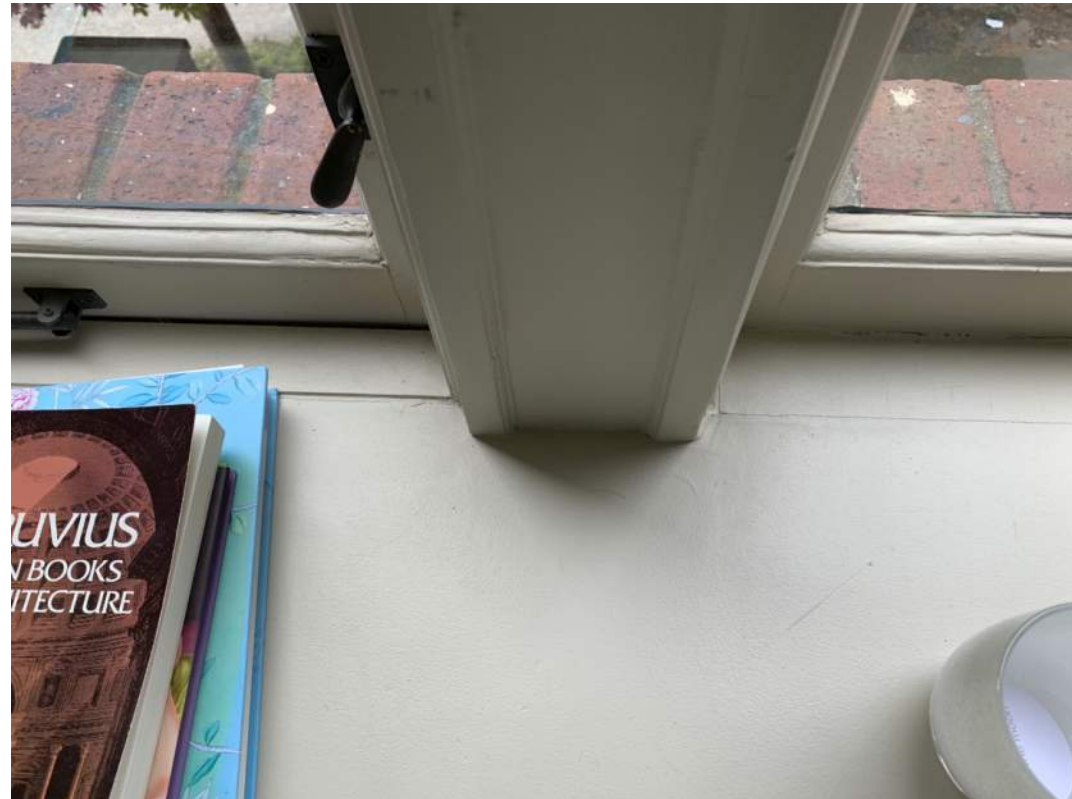
WINDOW - 39

Condition: Moderate

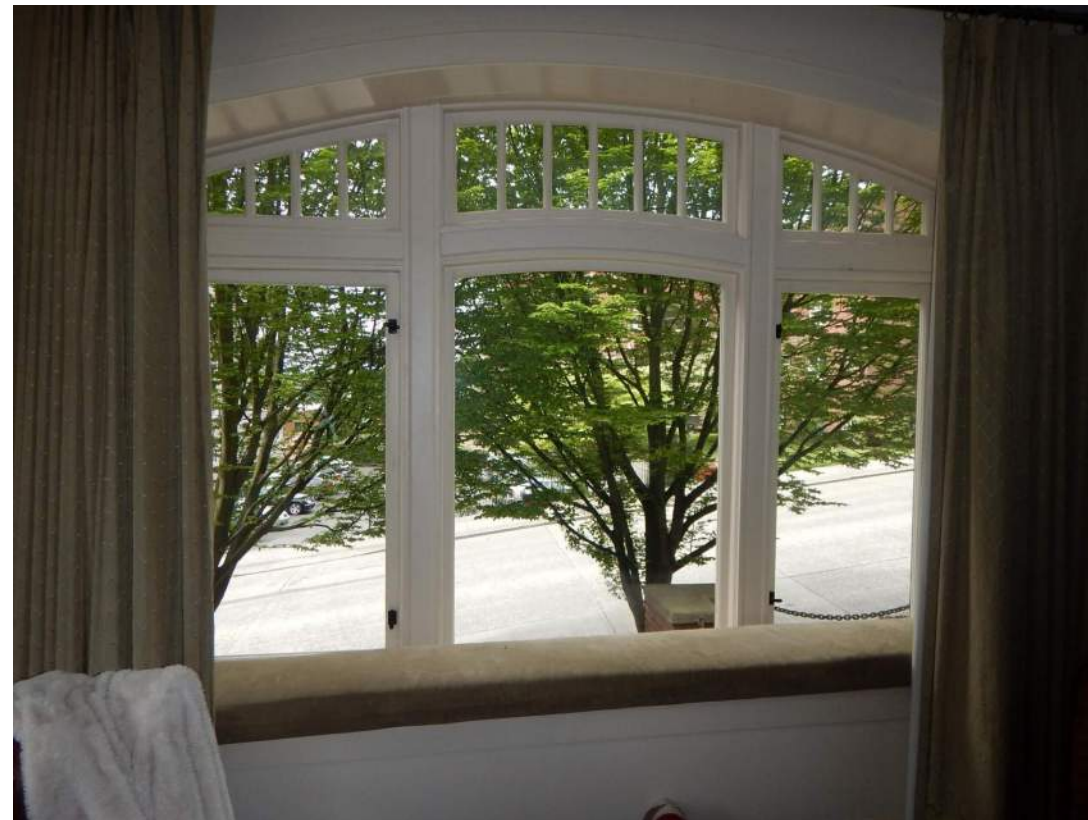
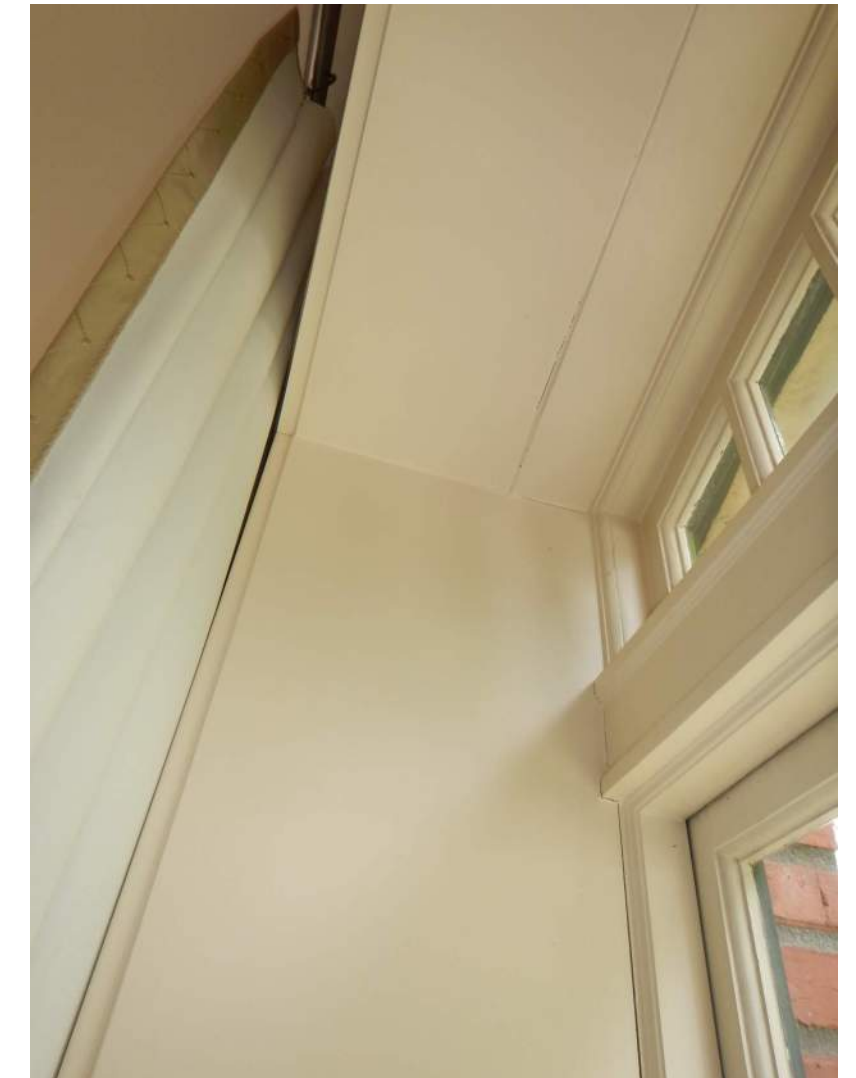
WINDOW - 40

- 1. Deterioration at the Sash
- 2. Deterioration at the Frame
- 3. Deterioration at Exterior Paint
- 4. Corroded Lintel
- 5. Operation Difficulty
- 6. Lock damage/missing/not engaging
- 7. Water intrusion
- 8. Separation at joint
- 9. Separation at rail/stile/muntin
- 10. Swelling at sill
- 11. Cracking of frame

Condition: Moderate

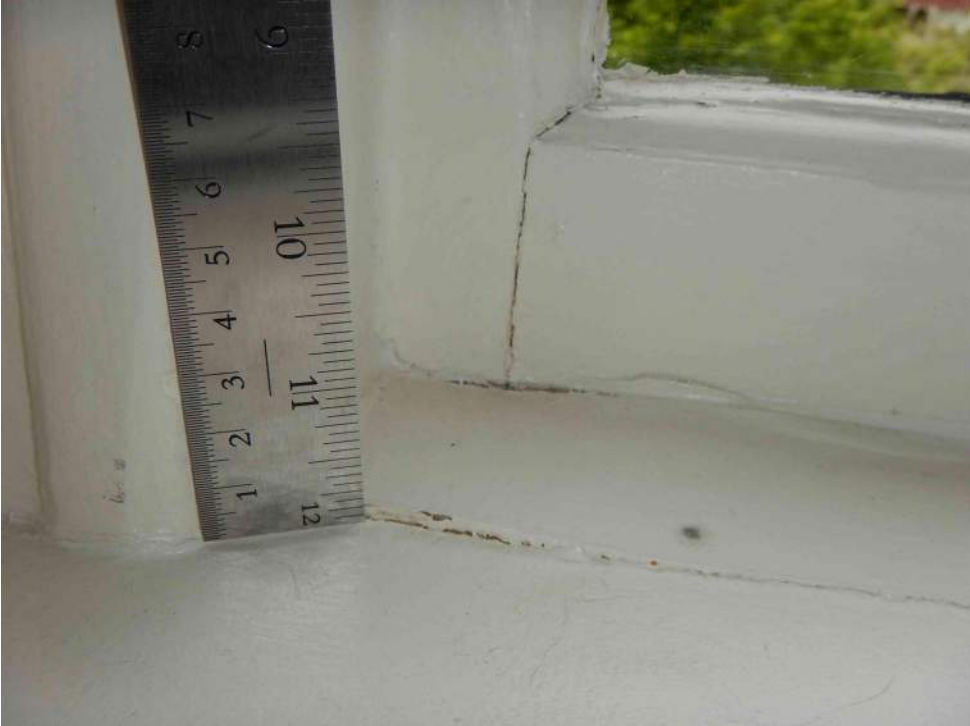
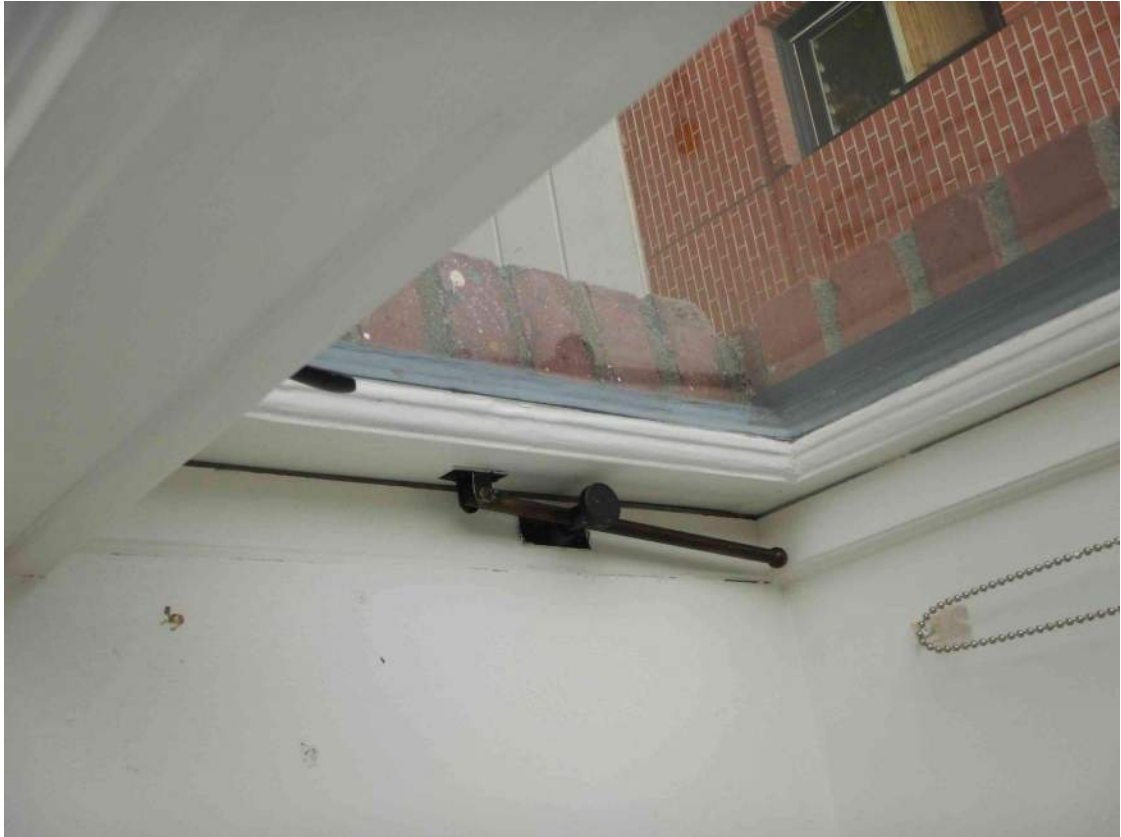
WINDOW - 41

- 1. Deterioration at the Sash
- 2. Deterioration at the Frame
- 3. Deterioration at Exterior Paint
- 4. Corroded Lintel
- 5. Operation Difficulty
- 6. Lock damage/missing/not engaging
- 7. Water intrusion
- 8. Separation at joint
- 9. Separation at rail/stile/muntin
- 10. Swelling at sill
- 11. Cracking of frame

Condition: Moderate

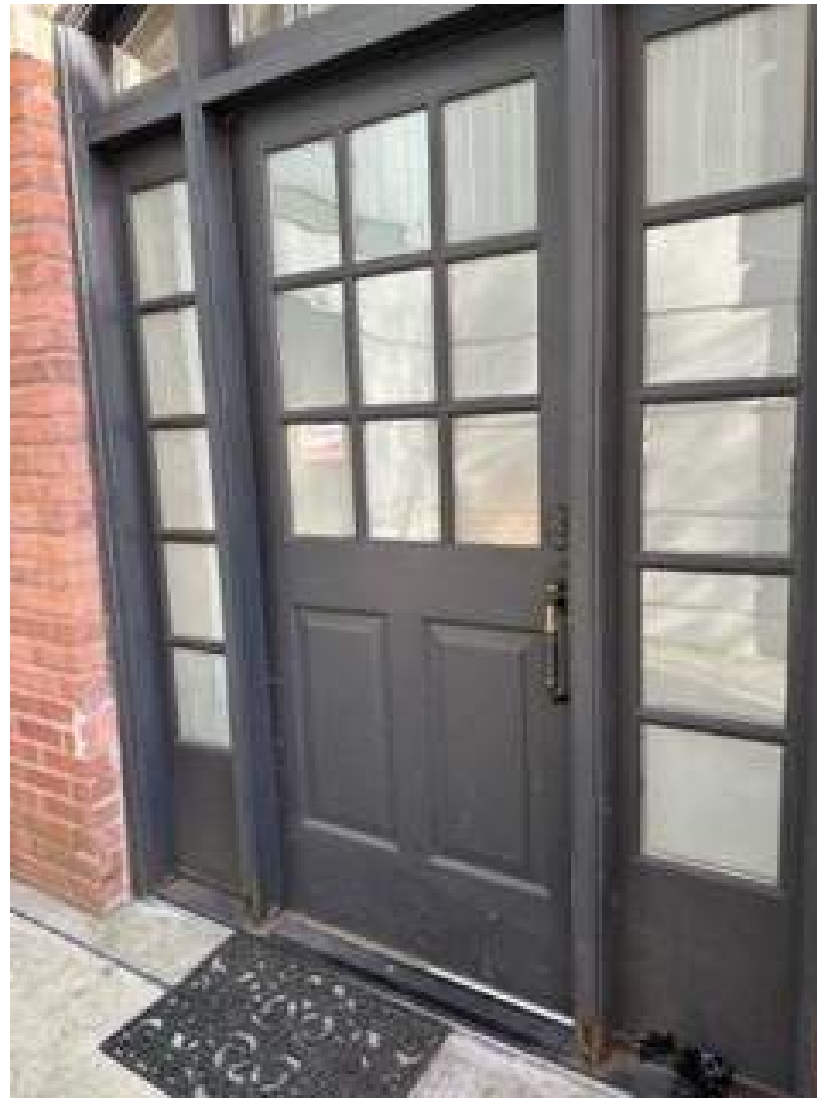
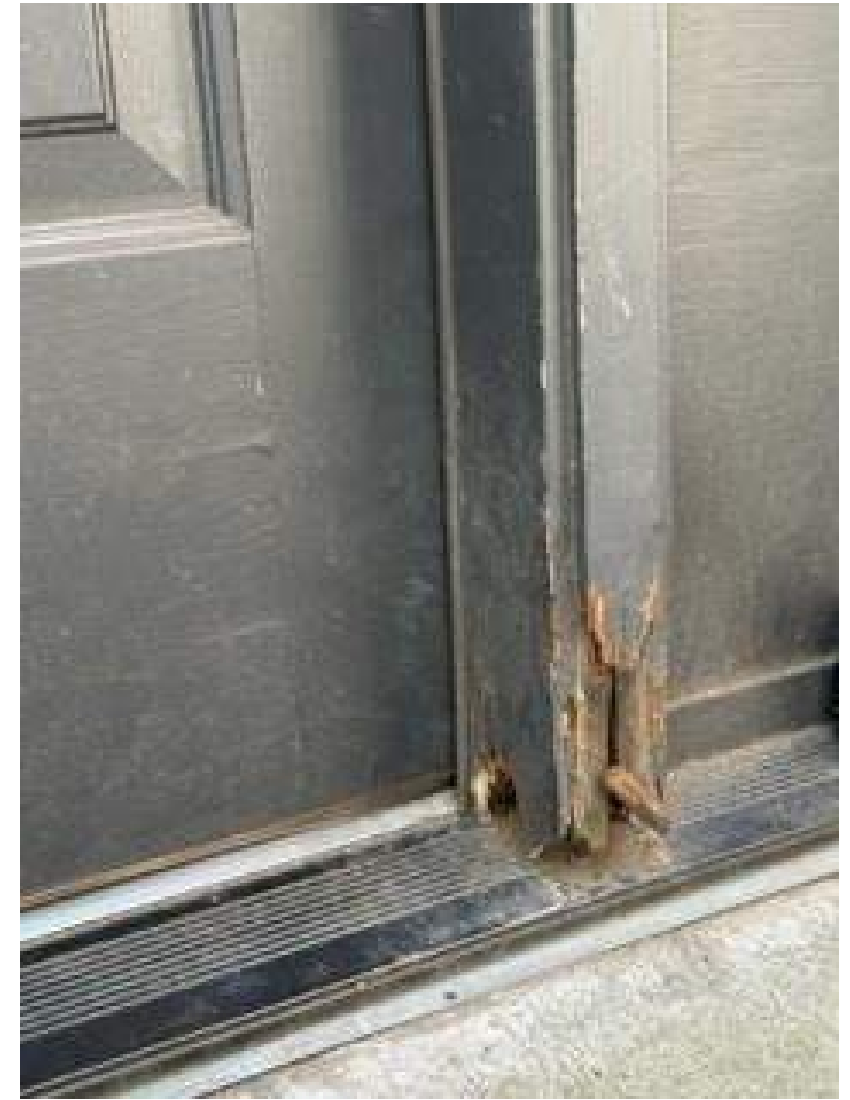
WINDOW - 43

1. Deterioration at the Sash
2. Deterioration at the Frame
3. Deterioration at Exterior Paint
4. Corroded Lintel
5. Operation Difficulty
6. Lock damage/missing/not engaging
7. Water intrusion
8. Separation at joint
9. Separation at rail/stile/muntin
10. Swelling at sill
11. Cracking of frame

Condition: Moderate

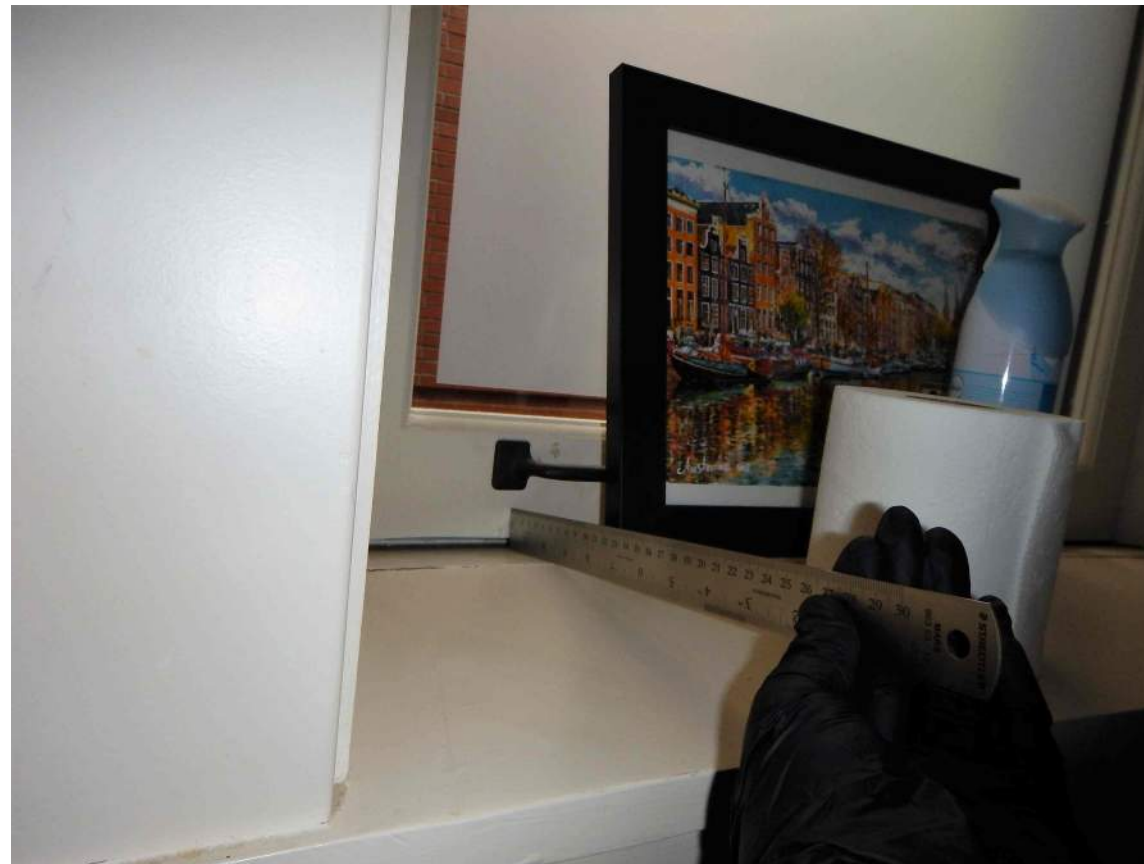
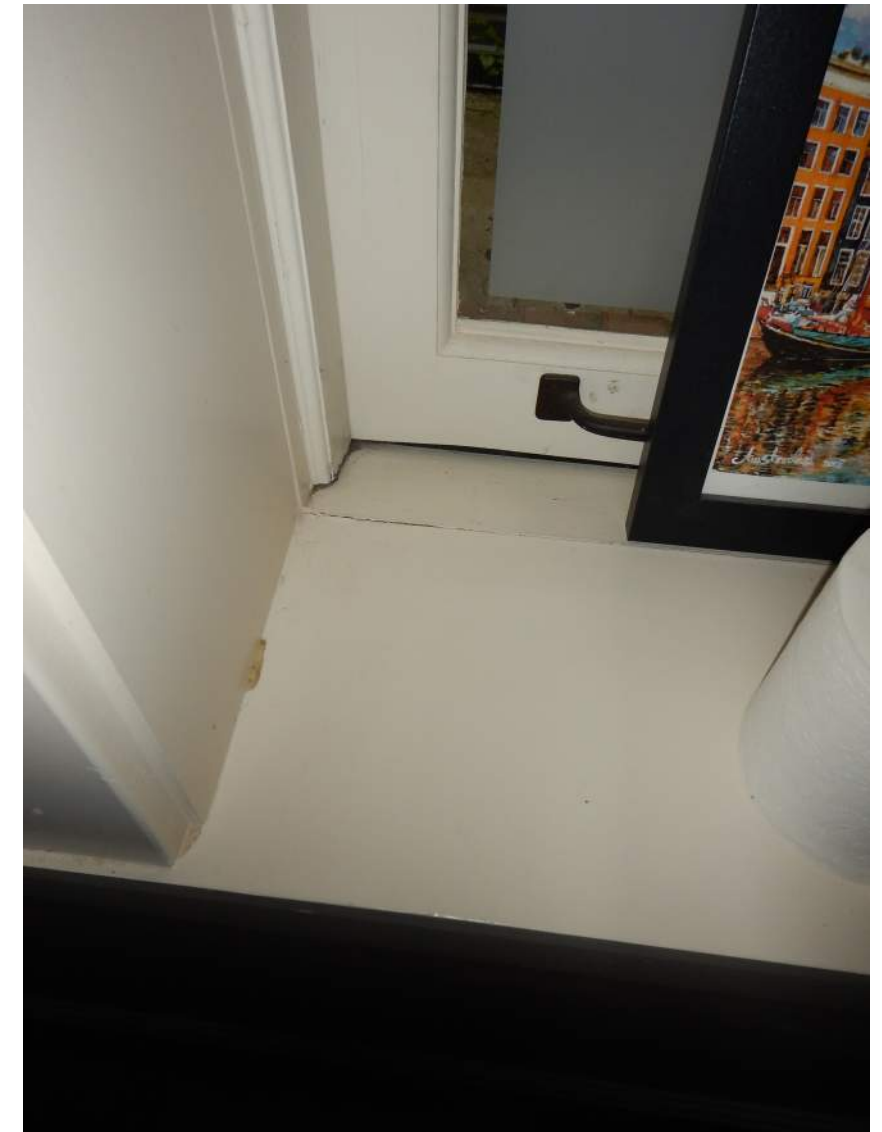
1. Deterioration at the Sash
2. Deterioration at the Frame
3. Deterioration at Exterior Paint
4. Corroded Lintel
5. Operation Difficulty
6. Lock damage/missing/not engaging
7. Water intrusion
8. Separation at joint
9. Separation at rail/stile/muntin
10. Swelling at sill
11. Cracking of frame

Condition: Moderate
