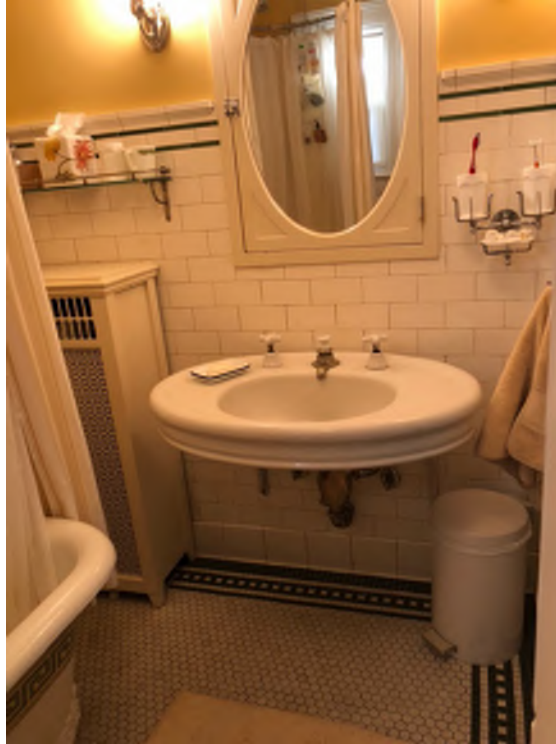
Original primary bathroom sink and faucet. (Photo taken: September 23, 2021)

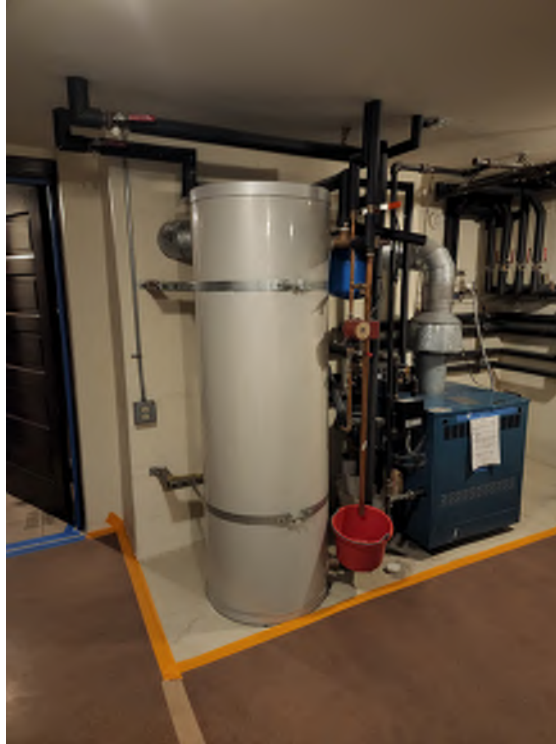
Existing boiler and water heater. (Photo taken: August 9, 2022)

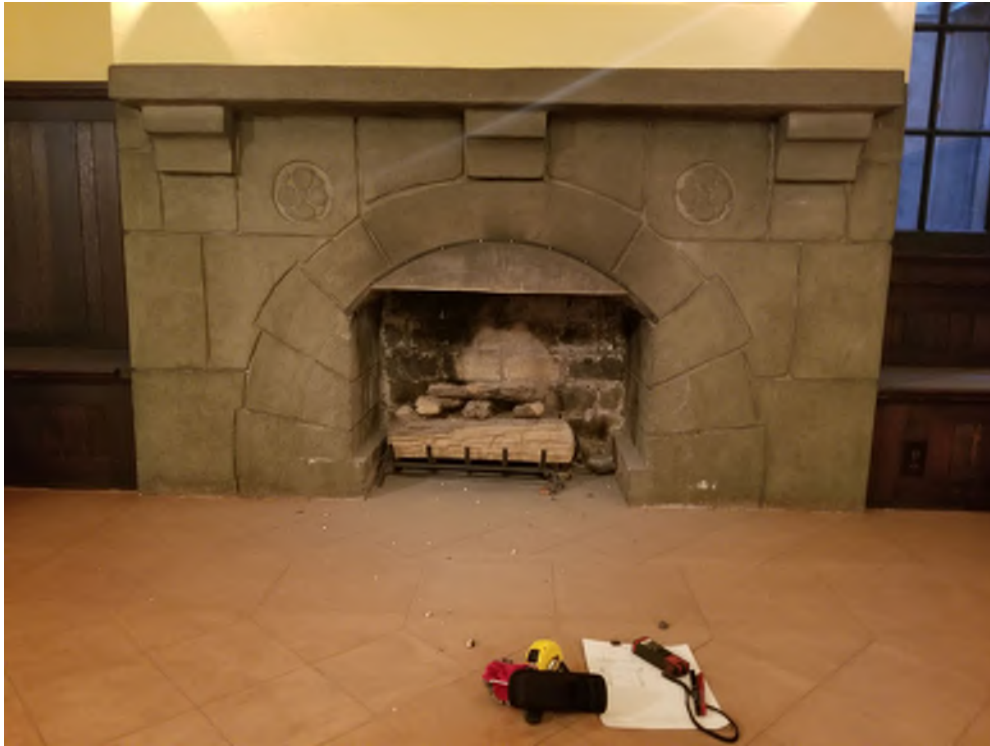
Original rathskeller fireplace surround. (Photo taken: June 25, 2021)

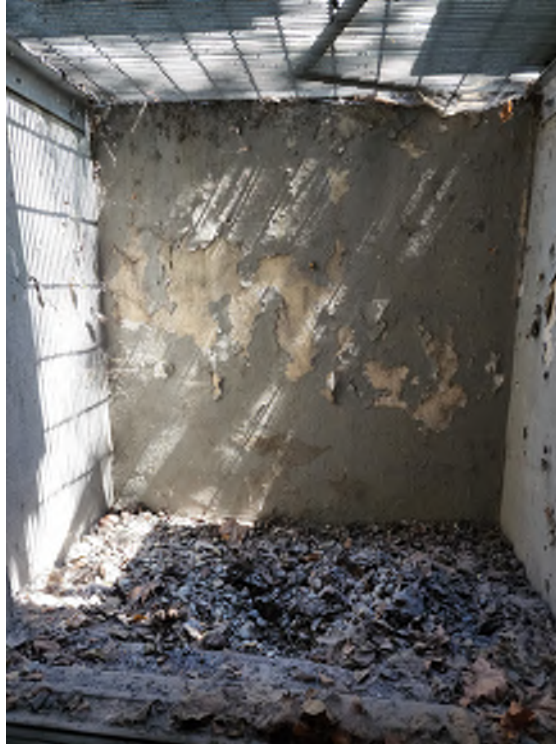
Peeling paint applied to the inside of the window wells by a previous owner was removed. (Photo taken: August 2, 2022)
